Re: Monthly Report Summary #10 for the Valley-Ivyglen 115-kV Substation (VIG) Project

CPUC Site Inspection Reports

Valley – Ivyglen Subtransmission Project CPUC Site Inspection Form

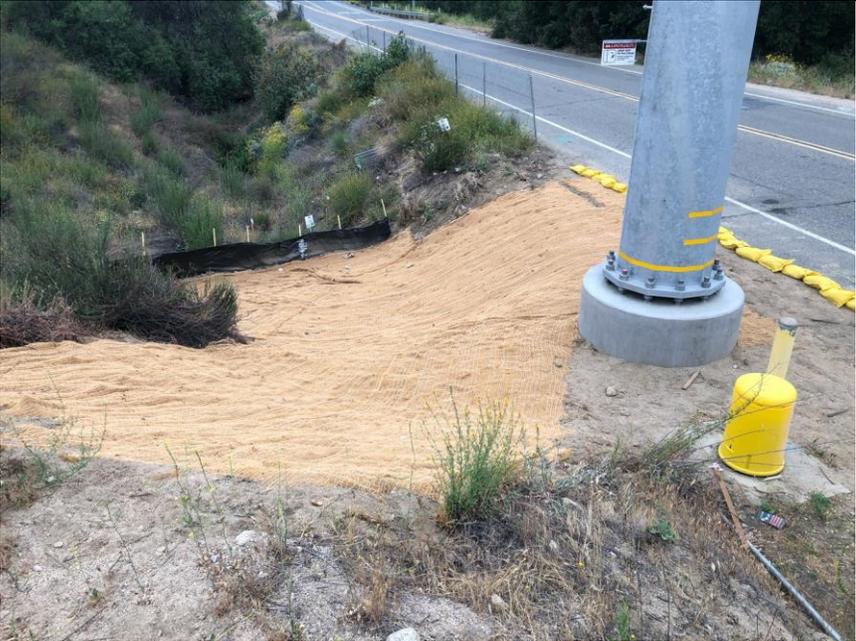
Our first stop was at tubular steel pole (TSP) 574E where sediment and erosion problems existed. According to the EI, sediment was removed from around the TSP prior to regrading and installing a coconut erosion blanket (Photo 1).

Photo 1 – Restoration work around TSP 574E. Photo facing north.
5/07/21	VIG Project

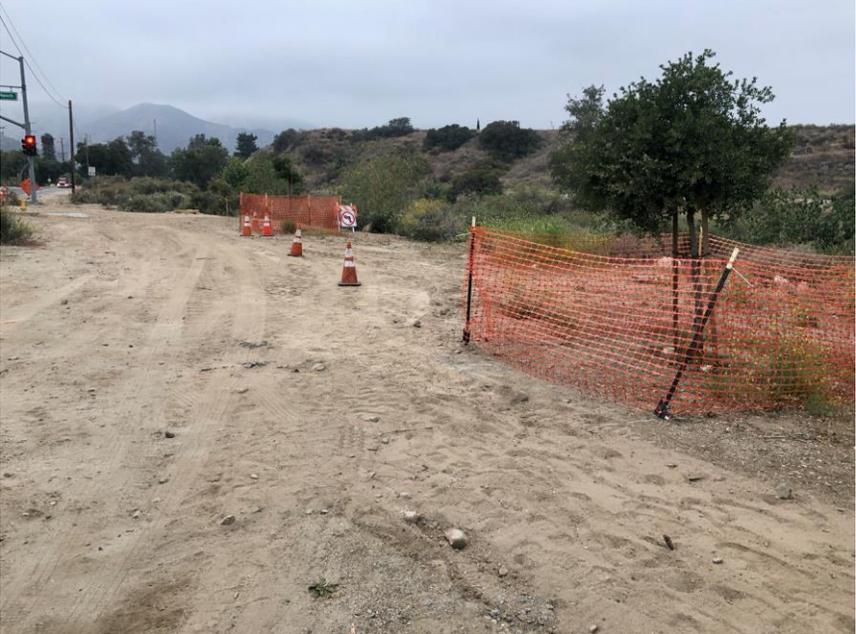
We drove to segment 8 by the IvyGlen Substation where crews had installed vault 2 and underground conduit along the roadway (Photo 2). Preparation was underway to excavate for vault 1 (Photo 3) with installation of the vault planned for the following Monday. I asked the foreman about covering the open hole over the weekend; he said it would be covered with metal plates and plastic to prevent people or animals from entering.

Photo 2 – Vault and underground conduit installation within segment 8. Photo facing northwest.

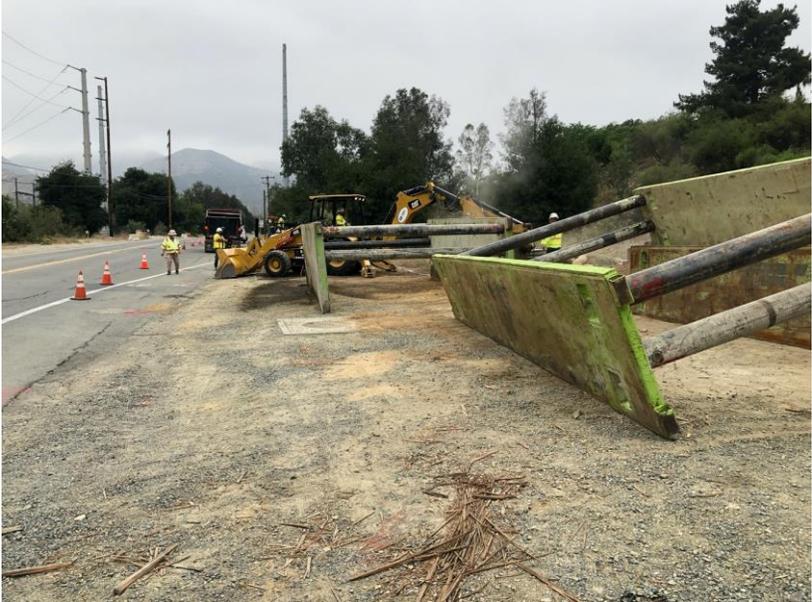
Photo 3 – Preparation for vault excavation near the IvyGlen Substation. Photo facing west.

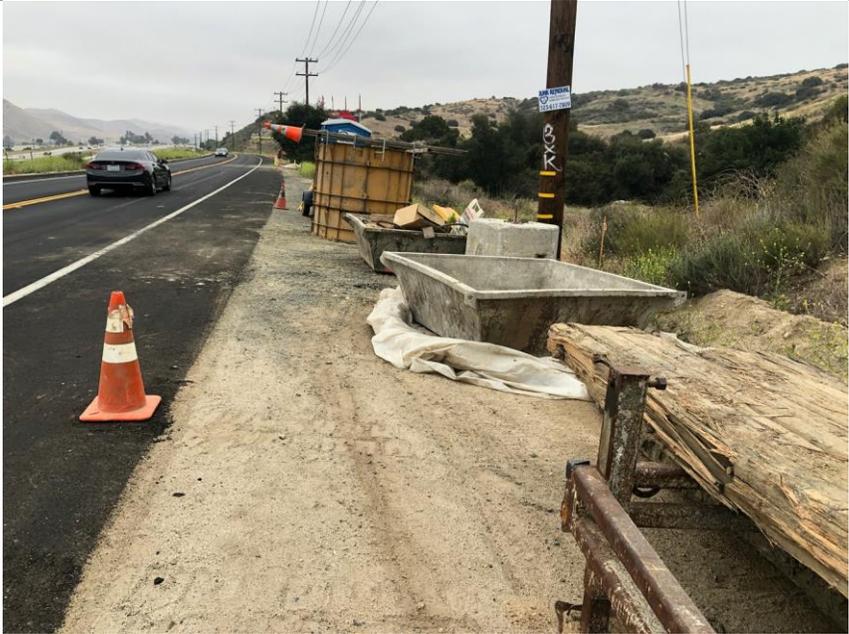
TSP drilling was being conducted by the Aldridge crew along DePalma Road. The crew was off for a few days, so we inspected the drilling locations, the staged materials, and the parked equipment (Photo 4). Several of the TSP locations were located on the steep, west side of the roadway. Steel posts and plywood were used to keep the excavated soils from falling down into the arroyo. TSP 553E was drilled and covered with wood and plastic (Photo 5). The plastic did not adequately cover the drilled foundation hole that was next to quality wildlife habitat; I pointed this out to the EI.

Photo 4 – Staged drilling equipment and materials along DePalma Road. Photo facing south.

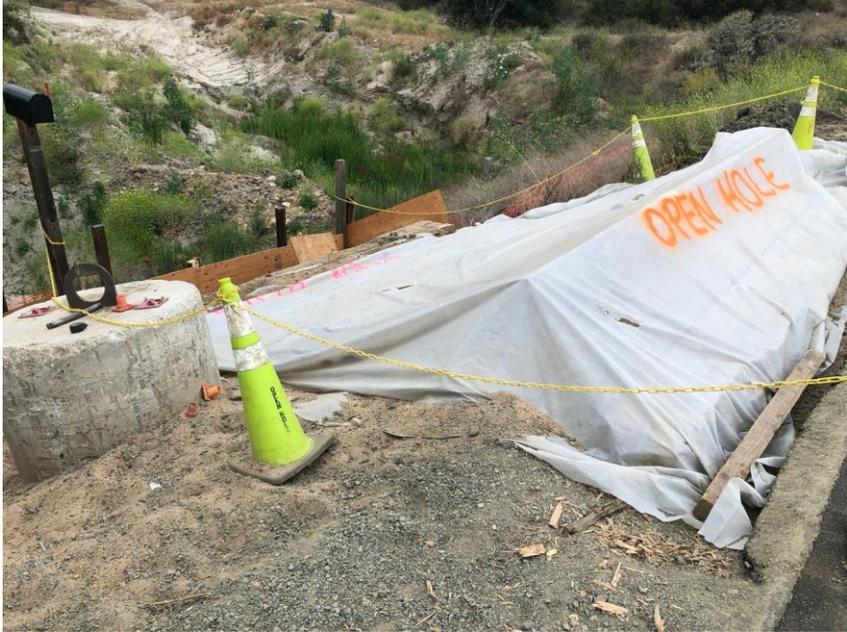
<p>Photo 5 – TSP 553E was drilled and mostly covered. Photo facing west.</p>

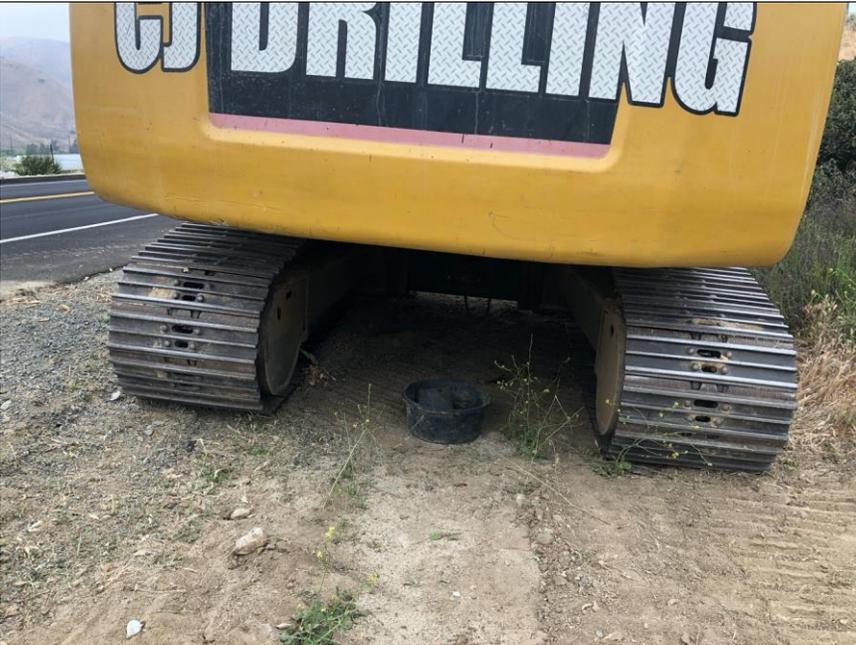
A large drilling rig was parked nearby with a small drip pan underneath it (Photo 6). Fluid was leaking from the engine compartment and landing on the soil beneath. The EI scooped up the contaminated soil and moved the drip pan underneath the leak.

Photo 6 – A drill rig with an inadequate drip pan under it. Photo facing south.

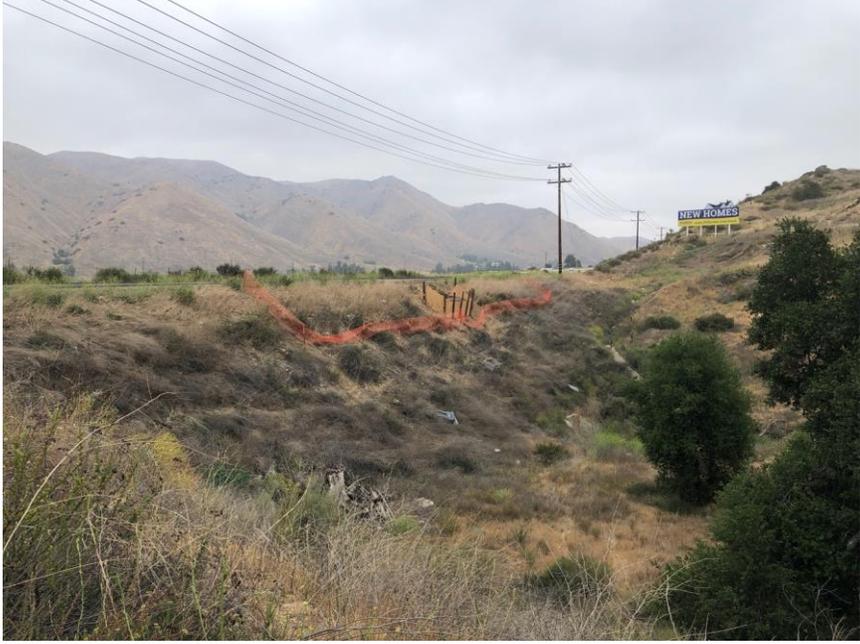
The next TSP location that was planned to be drilled was 549E on a steep side slope. Construction fencing was delineating the work area with posts and plywood used to retain the soil (Photo 7).

Photo 7 – TSP 549E was set up in preparation for drilling the foundation. Photo facing southeast.

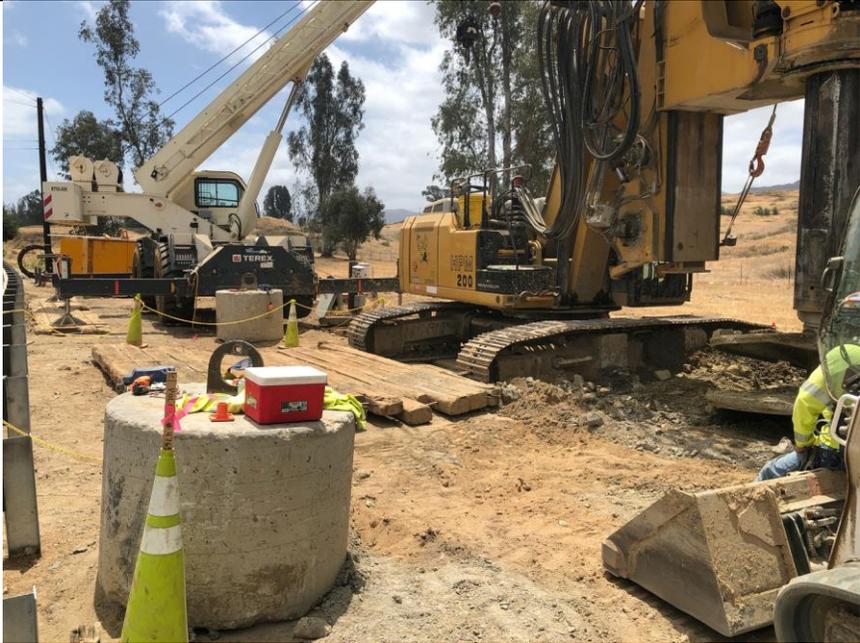
We traveled to the drilling site at tubular steel pole (TSP) 475 along Lake Street (Photo 1). The crews were within the approved workspace. The area was dusty, so I discussed the need for water to be used for dust suppression. There were several eucalyptus trees surrounding the site, but the EI said no nesting birds had been found. I didn't observe much bird activity in the trees but did observe a pair of Silky Flycatcher (*Phainopepla nitens*) flying in and around a large elderberry bush across the street. I asked the EI to ensure an avian biologist inspect this site.

Photo 1 – Drilling work underway at TSP 475. Photo facing south.
5/20/21	VIG Project

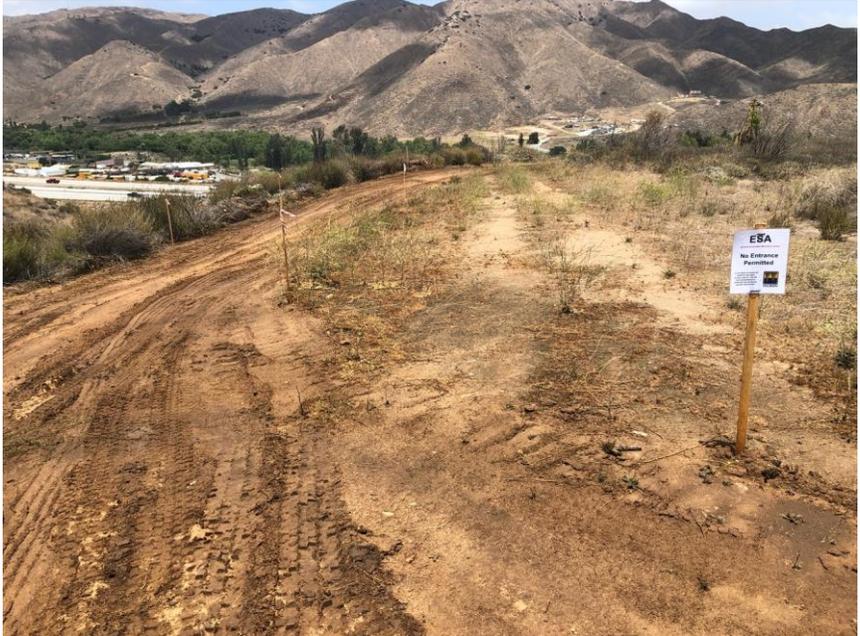
We drove north to TSP 526 and 527 where crews were working. Access roads to these locations were long and traveled through excellent natural habitat (Photo 2). Roads were well marked with Environmentally Sensitive Area (ESA) signage, and lath stakes delineated the boundaries. However, roads were dusty, so water trucks were regularly watering them.

Photo 2 – Access roads leading to TSP 526 and 527. Photo facing east.

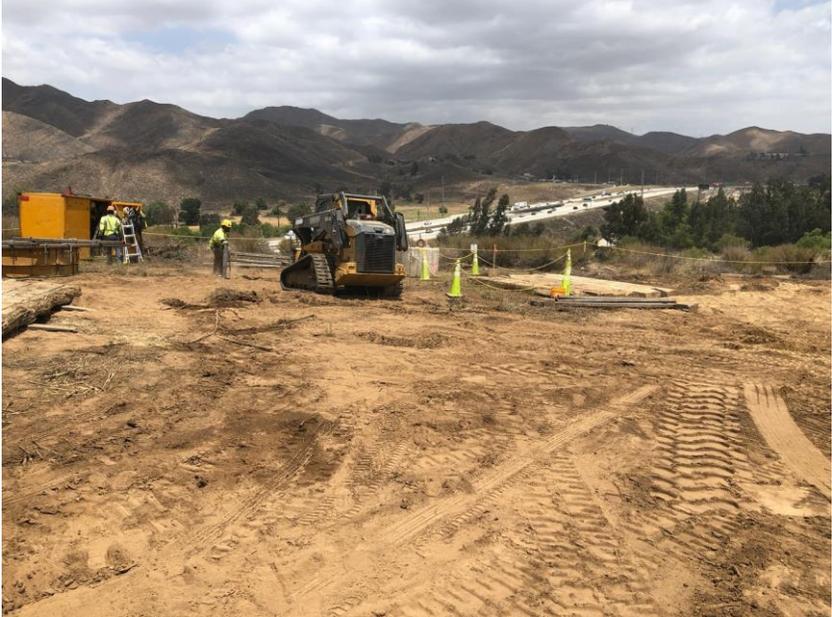
The TSP 526 foundation hole was drilled and the covered with large wood mats (Photo 3). Topsoil had been stockpiled at TSP 526 and 527 since additional grading was needed (Photos 4 and 5). Trucks were delivering the rebar cage and the anchor bolt at TSP 526 and placing it in the excavation prior to concrete foundation pouring. The sites were in excellent native habitat, and I discussed the need to tightly seal the holes to prevent animals from falling in. While we were onsite, I observed a small mammal and a lizard in the nearby vegetation, reinforcing the need to cover holes.

Photo 3 – TSP 526 site with wood mats covering the drilled foundation hole. Photo facing east.

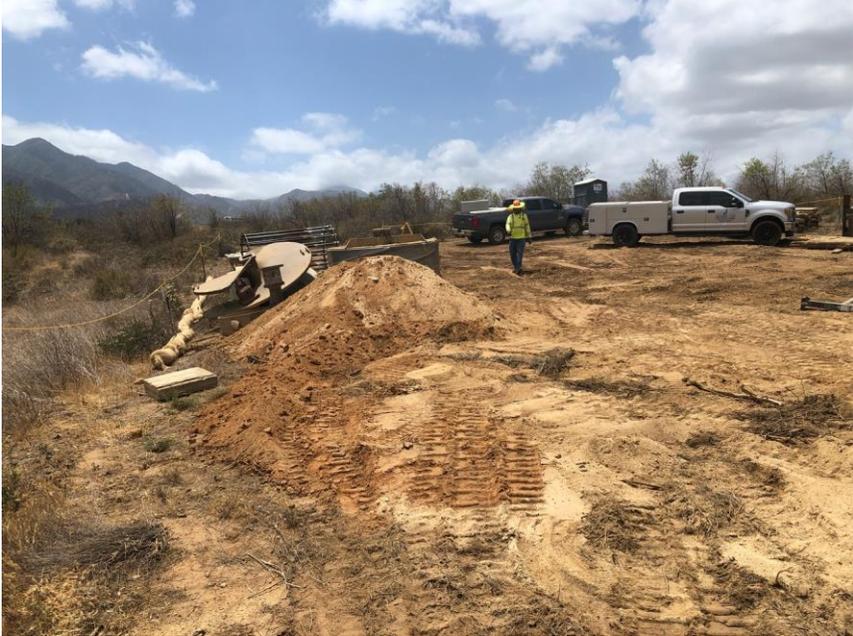
<p>Photo 4 – Stockpiled topsoil and staged equipment at TSP 526. Photo facing west.</p>

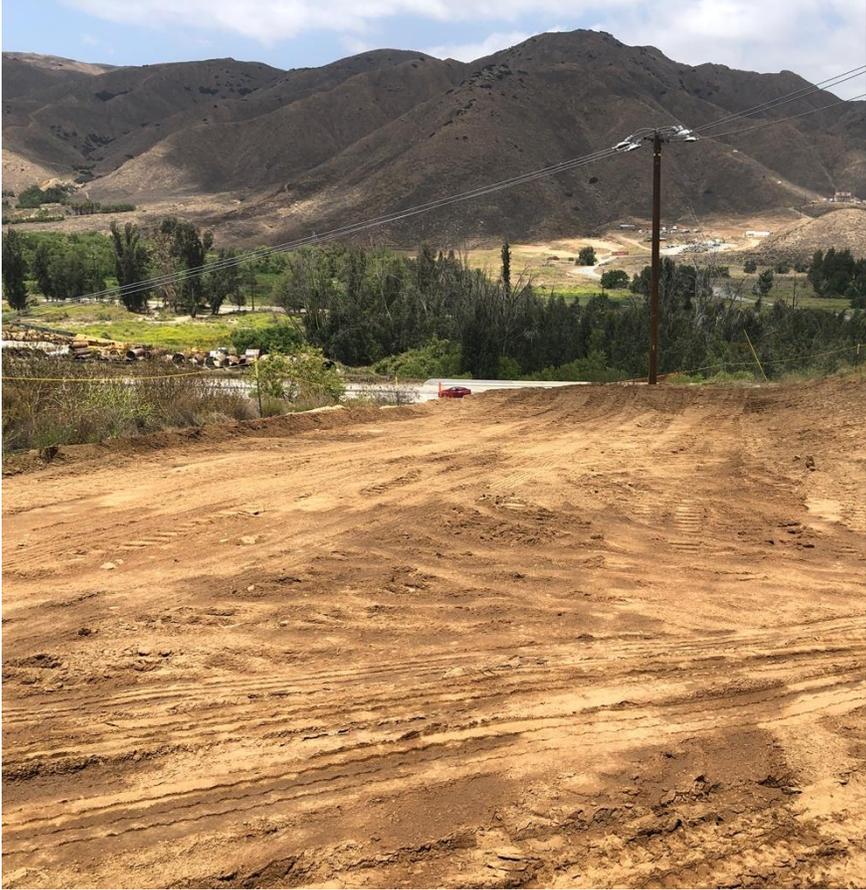
Extensive grading was completed at TSP 527 with topsoil stockpiled nearby (Photo 5). The grading was required to make room for additional equipment to be stored onsite for wire and pole work. Construction fence and silt fence were installed below the graded area to capture soil (Photo 6). A drill rig was parked at this location and did not have any secondary containment in place. This was the same rig seen leaking earlier in the month and it continued leaking. The EI made a note to have crews place drip pans beneath it. If the leak continued, maintenance would be required.

Photo 5 – Graded area at TSP 527. Photo facing east.

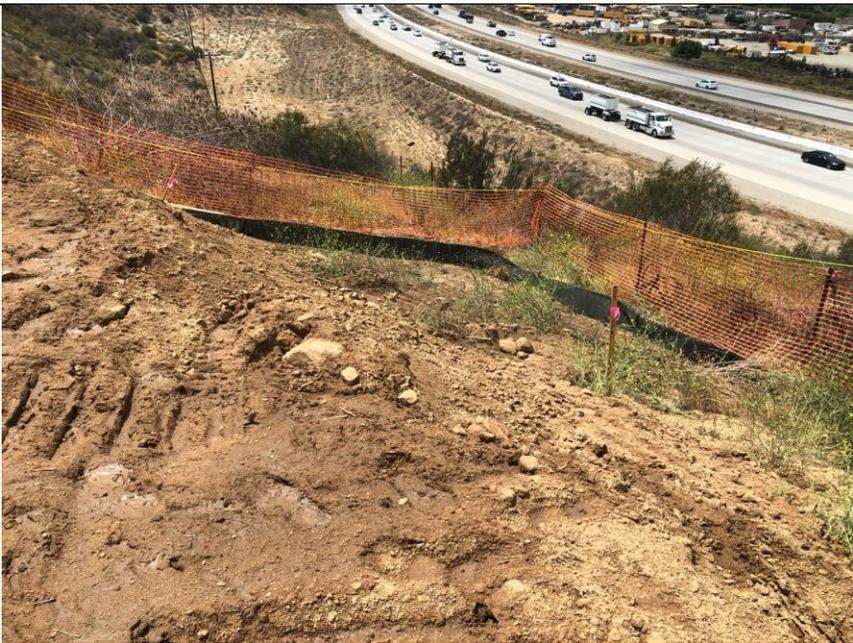
Photo 6 – Fencing below the TSP 527 foundation hole site. Photo facing northeast.

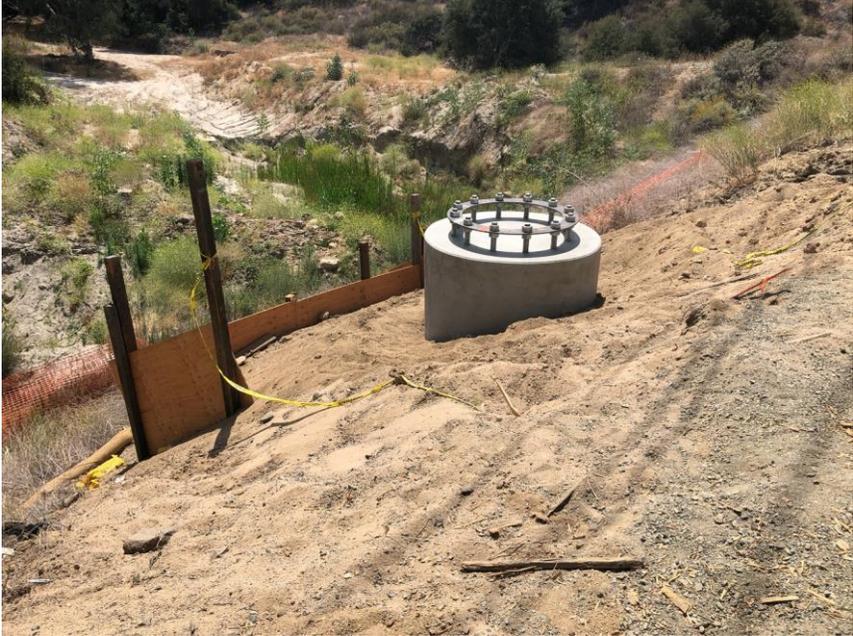
We stopped along DePalma Road to inspect the poured TSP foundations (Photo 7). The sites appeared to be in good condition but required additional restoration work once the poles were set.

Photo 7 – TSP 549E foundation along DePalma Road.
