Re: Monthly Report Summary #12 for the Valley-Ivyglen 115-kV Substation (VIG) Project

CPUC Site Inspection Reports
July 8 and 22, 2021

Valley – Ivyglen Subtransmission Project CPUC Site Inspection Form

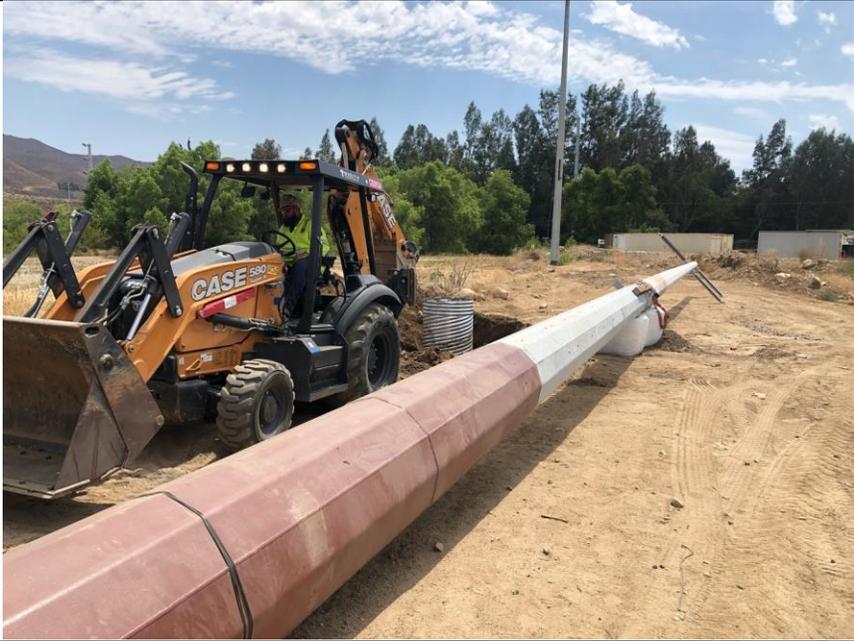
Our first stop was at tubular steel pole (TSP) 524, which was within a truck staging area near Temecula Creek. Crews had drilled and set the metal casings in the holes for TSPs 524 and 605. These TSPs will use light steel poles (LSP) that do not require poured foundations. A small backhoe was working around the 524 location where a pole was erected (Photo 1).

Photo 1 – Installation of lightweight steel poles at TSP 524. Photo facing south.
7/8/21	VIG Project

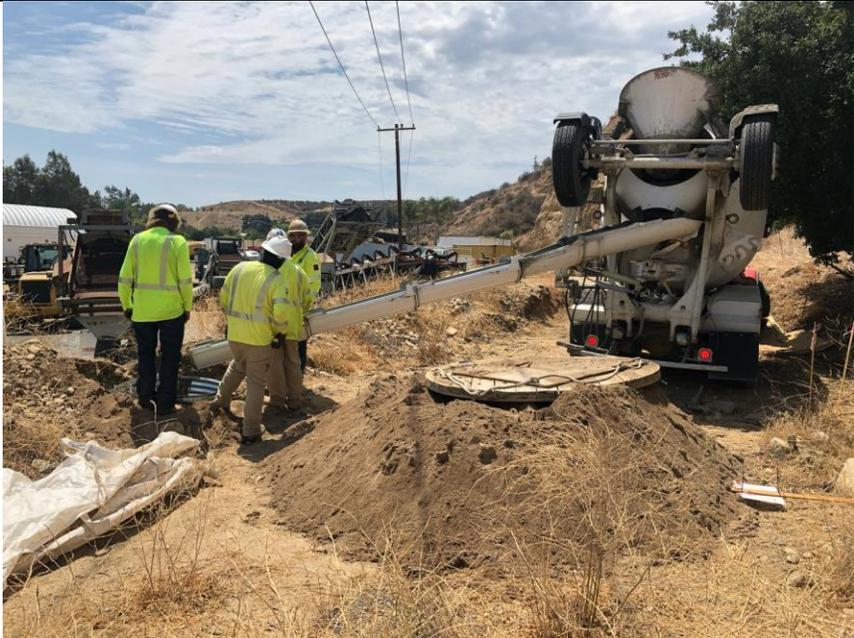
Metal casings and concrete were used at these locations to stabilize the holes and the poles were backfilled with native material (Photo 2). One of the biology monitors was onsite overseeing the construction activity due to its proximity to an environmentally sensitive area (ESA). Surveys were completed each morning to search for nesting birds around the site. The weather was hot and no bird activity was observed. I discussed covering excavation holes overnight with the EI.

Photo 2 – Pouring concrete around the casing at TSP 605. Photo facing south.

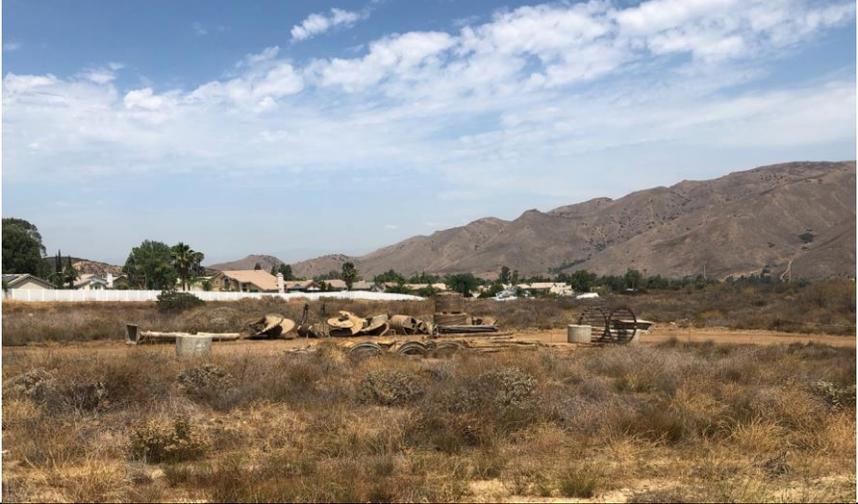
We drove to the Horsethief Canyon Road area where the initial portion of the access road was being used as a staging area for drilling equipment (Photo 3). The drilling crew was working at TSP 528 with a paleontology monitor present to observe the tailings (Photo 4). According to the EI, nothing of significance had been discovered and drilling work had gone smoothly.

Photo 3 – Staging area along the access road near the Horsethief Canyon area. Photo facing northeast.

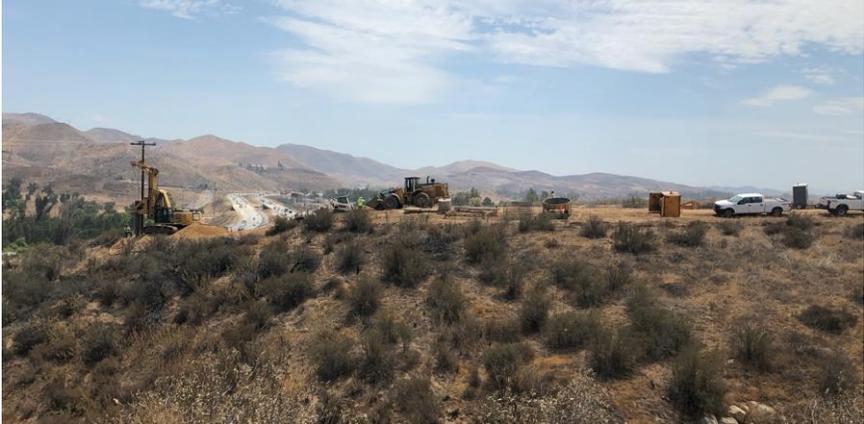
<p>Photo 4 – TSP drilling operation at TSP 528 with a paleontology monitor present to monitor the tailings. Photo facing south.</p>

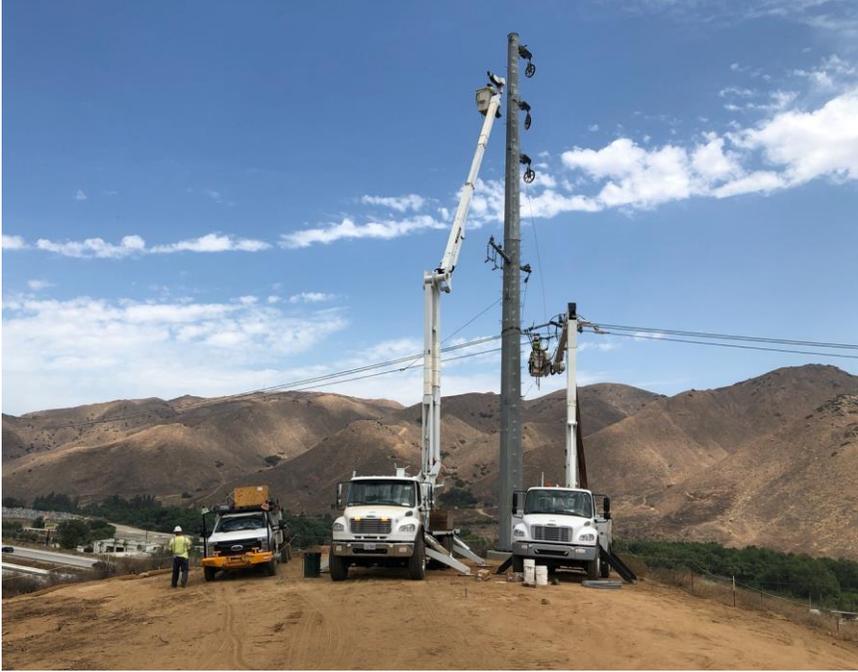
At TSP 529 a crew was installing the pole and stringing wire (Photo 5). This area was dusty. The next tower to the north, TSP 530, was erected with wire strung to it (Photo 6). The final restoration of the access road and work site around the pole would be completed following final wire work.

Photo 5 – Wire stringing at TSP 529. Photo facing east.

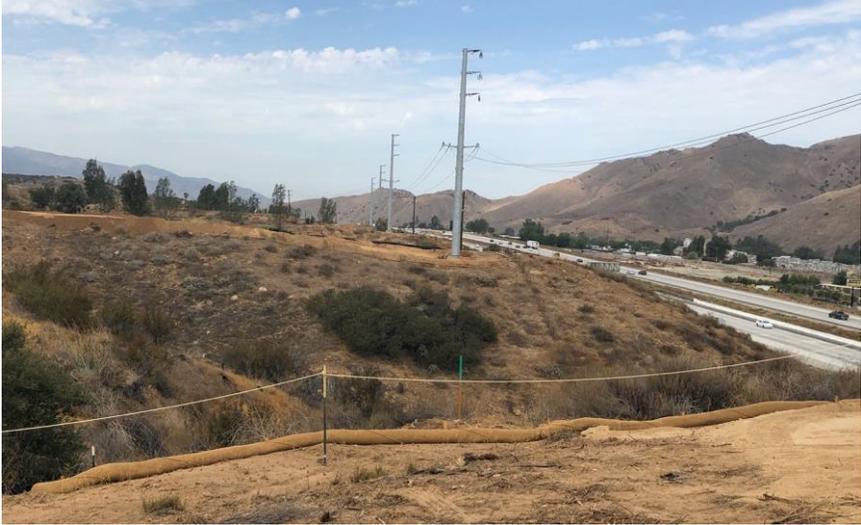
Photo 6 – Poles erected north of TSP 529 with wire stringing and restoration remained to be completed. Photo facing north.

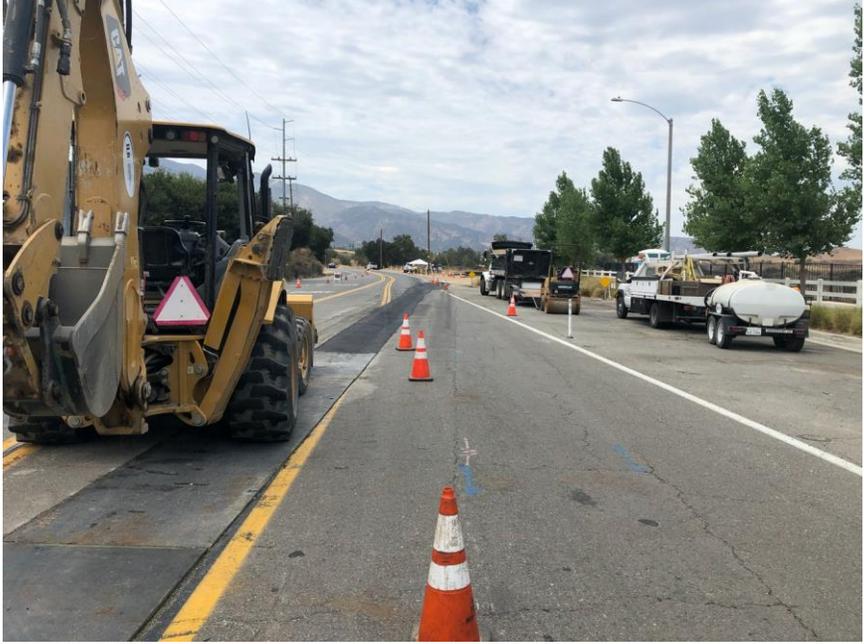
My final stop was at the underground work along segment 8 between vaults 3 and 4. Crews were working within the roadway, with traffic control personnel in place (Photo 7).

Photo 7 – Underground conduit installation within segment 8. Photo facing northwest.

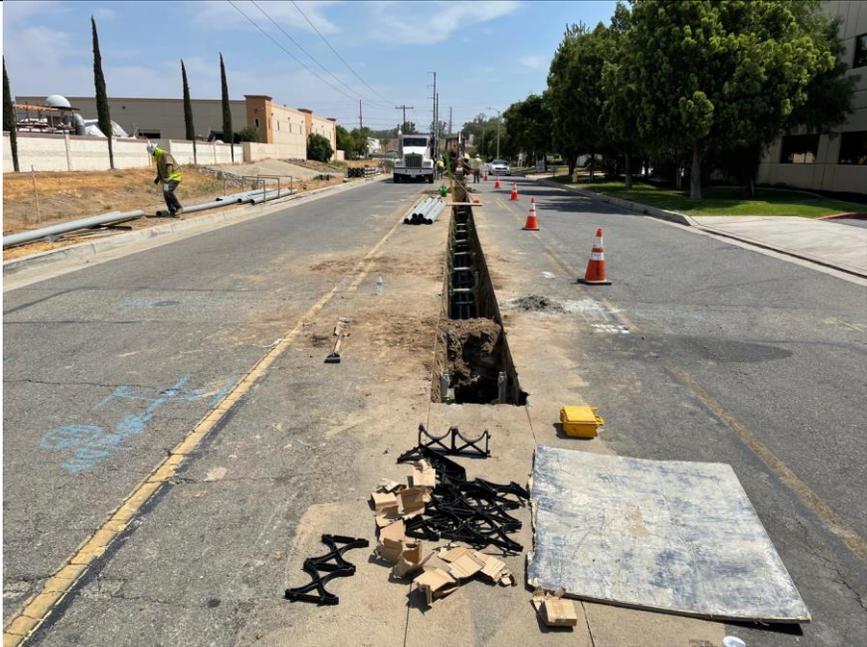
I arrived onsite at the Concordia staging area at 1030 and met with the Lead Environmental Inspector (LEI) and the Environmental Inspector (EI). We discussed construction activities and traveled south to segment 4 where underground conduit installation was being completed. Crews were performing concrete saw cutting, trench excavation, and conduit installation (Photo 1). The location was west of Highway 15 and south of Highway 74 and bordered a jurisdictional drainage. The environmental team had installed signs along the drainage to delineate the boundaries where crews were to avoid.

Photo 1 – Underground conduit work in segment 4. A jurisdictional drainage is located north of the work area. Photo facing east.
7/22/21	VIG Project

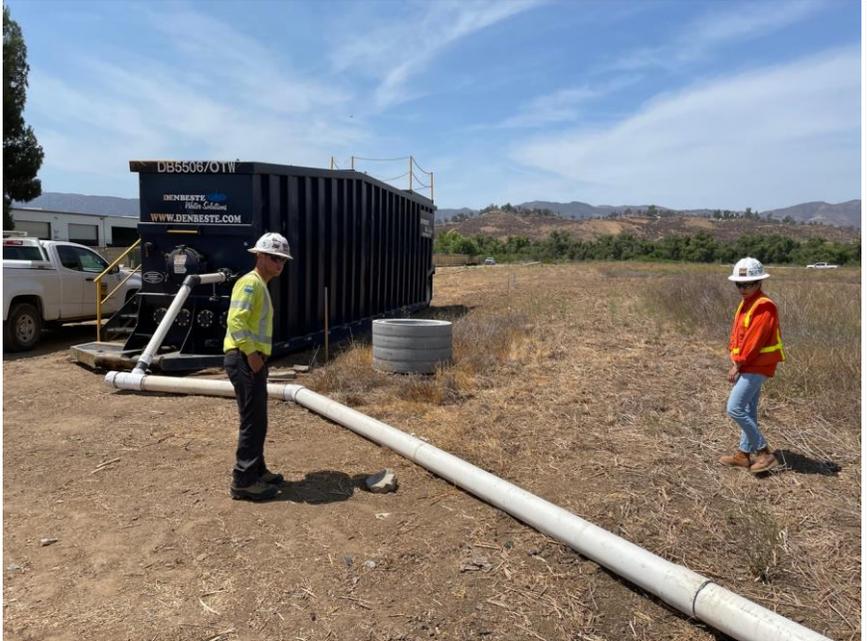
Farther north on segment 4, a dewatering system around TSP 358 was installed. Groundwater was shallow, so three dewatering wells were drilled to pump water into a baker tank (Photo 2). The baker tank allowed sediment to be separated from the water and remain in the tank. The clean water was released into a nearby field (Photo 3).

Photo 2 – Baker tank being utilized for dewatering around TSP 358. Photo facing west.

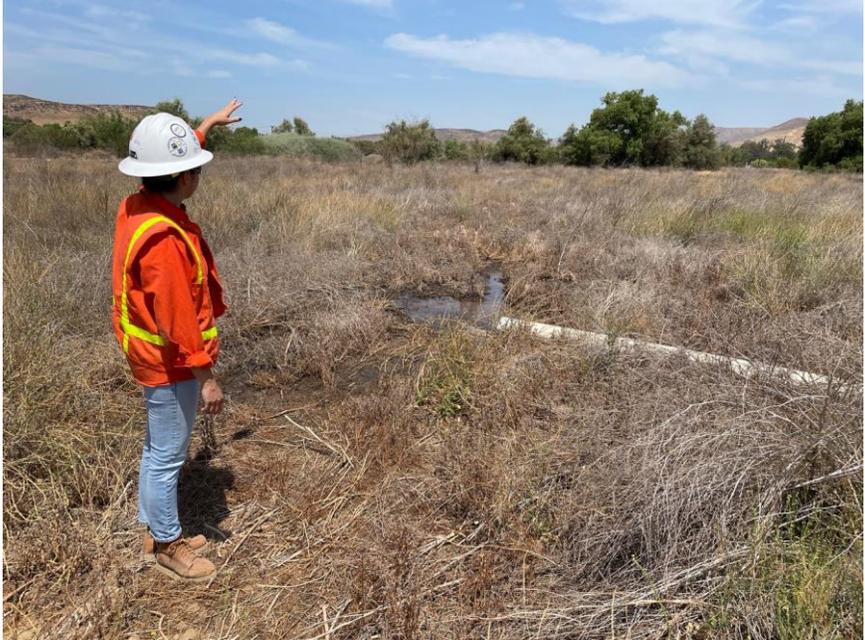
Photo 3 – Water from the baker tank was drained into a nearby field. Photo facing north.

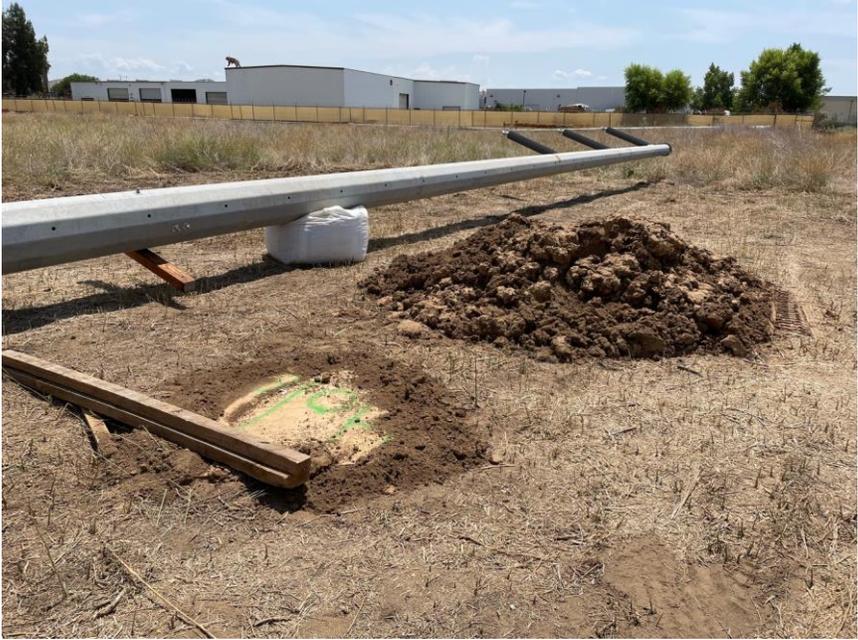
Additional holes for TSP 361 and 363 were drilled and covered with plywood (Photo 5). Crews had completely covered the edges of the plywood with soil to cover any openings. LSPs were staged nearby for installation.

<p>Photo 5 – A pole staged near the drilled foundation hole at TSP 363 with the excavation adequately covered. Photo facing south.</p>

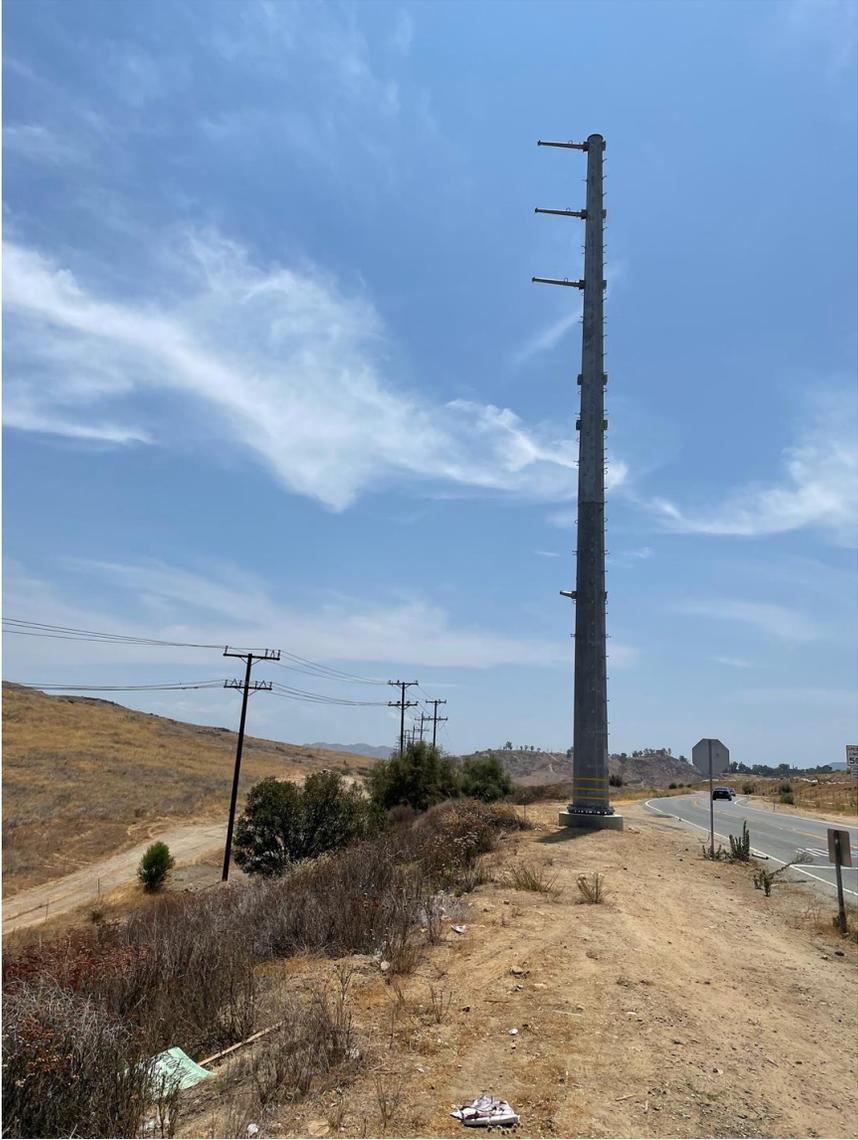
We traveled north to segment 5 near TSP 435 (Photo 6). The area east of the powerline corridor was a preserved open space and the environmental crew worked to minimize the area of disturbance (Photo 7).

Photo 6 – Segment 5 along Nichols Road near TSP 435. Photo facing south.

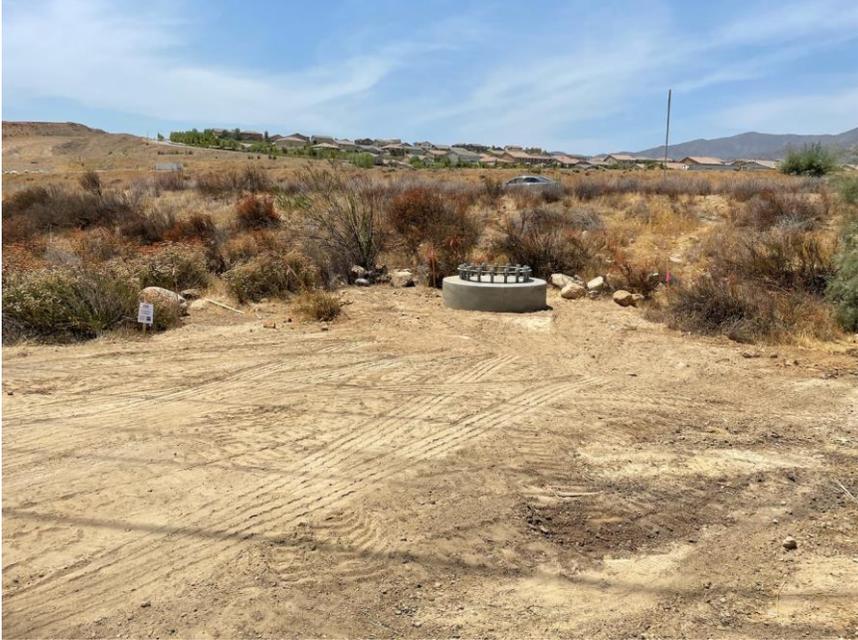
Photo 7 – TSP 435 foundation work near a preserved open space. Photo facing west.

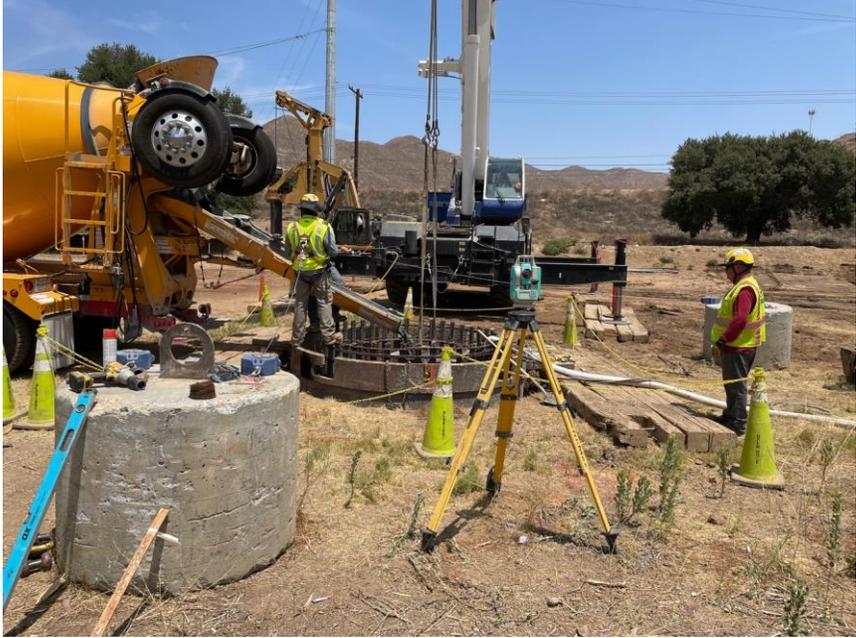
We continued north along Lake Street to TSP 4765-493 where a crew was pouring the TSP foundation (Photo 8). The foundation hole was 8 feet wide by 40 feet deep and required a large amount of concrete. Three concrete trucks were onsite with one washing out in the designated location (Photo 9). Groundwater was reached at 9 feet, and a baker tank was used to capture it. The crew began to drill the foundation at TSP 492, which is surrounded by oak trees.

Photo 8 – Foundation work at TSP 4765-493. Photo facing southeast.

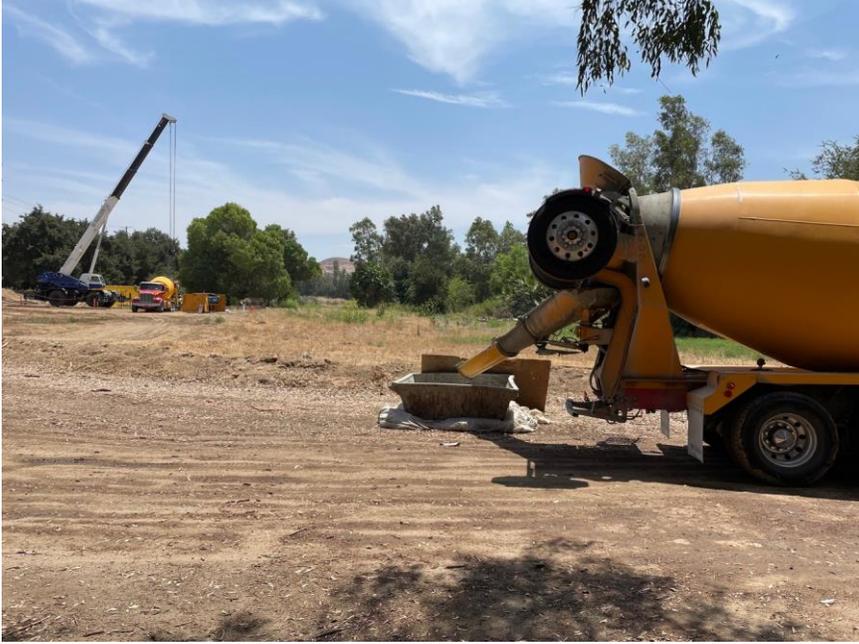
A yellow concrete mixer truck is parked on a dirt area at a construction site. The truck's discharge chute is extended towards a concrete basin. In the background, there is a crane and other construction equipment under a clear blue sky with some light clouds. The ground is dry and dusty.	Photo 9 – Concrete washout area near TSP 493. Photo facing south.

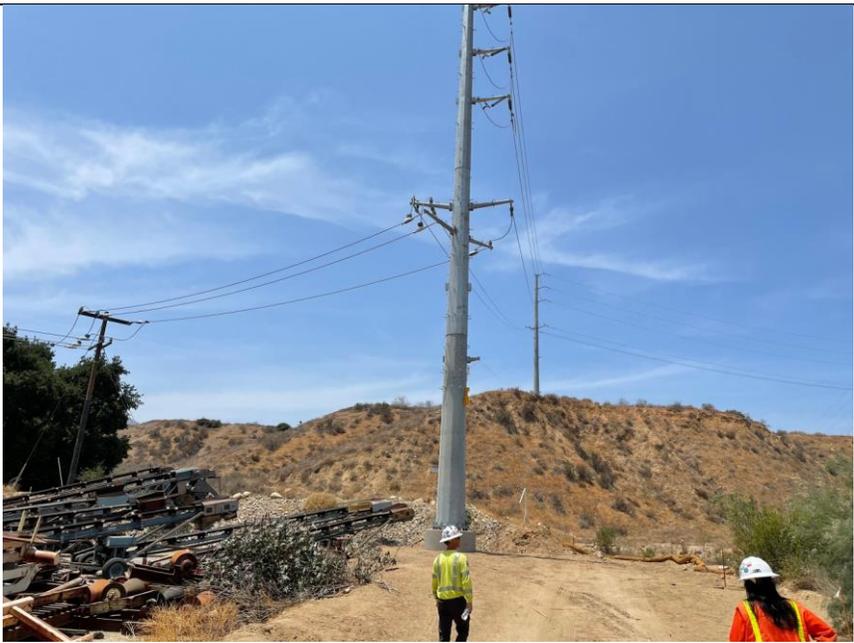
Our final stop was at TSP 525E next to a dry creek wash and the Temecula Creek drainage (Photo 10). The LEI explained the wires were moved to the newly installed poles. Wire work was underway on the TSPs to the north along Horsethief Canyon Road. A road crew was expected to upgrade and stabilize the access roads leading to TSP 525E.

Photo 10 – Wires were strung to TSP 525E and most of the existing wooden poles were removed. Photo facing north.
