**Re: Monthly Report Summary #14 for the Valley-Ivyglen 115-kV Substation (VIG) Project**

CPUC Site Inspection Reports  
September 3 and 16, 2021

## Valley – Ivyglen Subtransmission Project CPUC Site Inspection Form

<b>Project:</b>	Valley – Ivyglen Project	<b>Date:</b>	September 3, 2021
<b>Project Proponent:</b>	Southern California Edison (SCE)	<b>Report #:</b>	VS029
<b>Lead Agency:</b>	California Public Utilities Commission (CPUC)	<b>Monitor(s):</b>	Vincent Semonsen
<b>CPUC PM:</b>	Michael Rosauer, Energy Division	<b>AM/PM Weather:</b>	Clear, cool, and calm
<b>CPUC-CM (WSP):</b>	Chuck Cleeves	<b>Start/End time:</b>	0600 to 1000
<b>Project NTP(s):</b>	Notice to Proceed (NTP)-1, NTP-2, and NTP-3

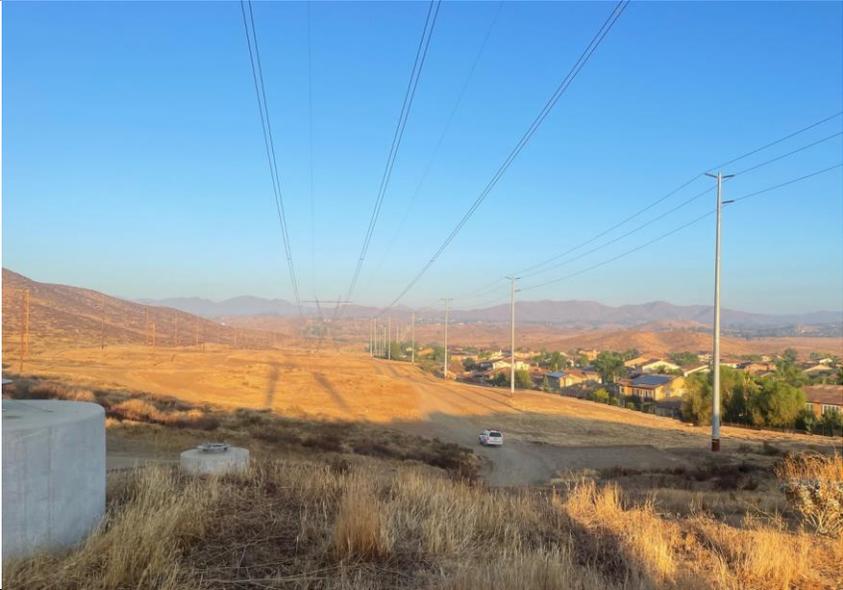
The Aldridge crew completed drilling the final tubular steel pole (TSP) at location 120 in segment 1. The LEI, EI, and I traveled east along the transmission corridor (Photo 1). The access road was dusty, and a water truck followed us and watered down the road. The TSP locations appeared stable and no trash or construction materials were observed in the area. One of the biological monitors was onsite and cleared the work area that morning. A nesting bird survey was conducted prior to the crews moving into the area and no nesting activity was found. The drilling progress at this location had been going slowly due to rock in the subsurface (Photo 2). A small crew was onsite and anticipated to continue drilling for an additional week. The location was adjacent to the creek corridor and had been delineated by silt fence with all work activities taking place within the designated construction zone.

Photo 1 – The new transmission corridor along segment 1. Photo facing northwest.
9/03/21	VIG Project

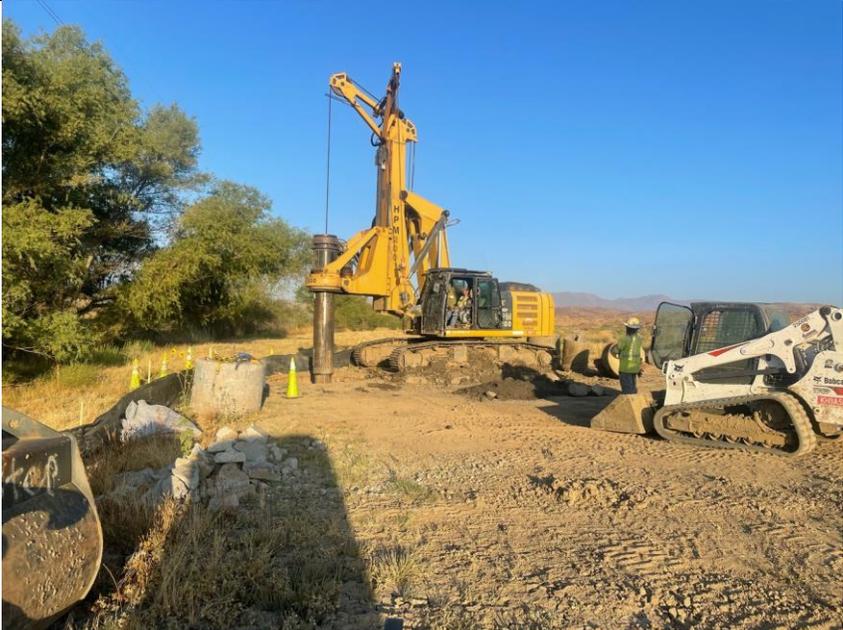
Photo 2 – The drilling of the final TSP (120). Photo facing west.

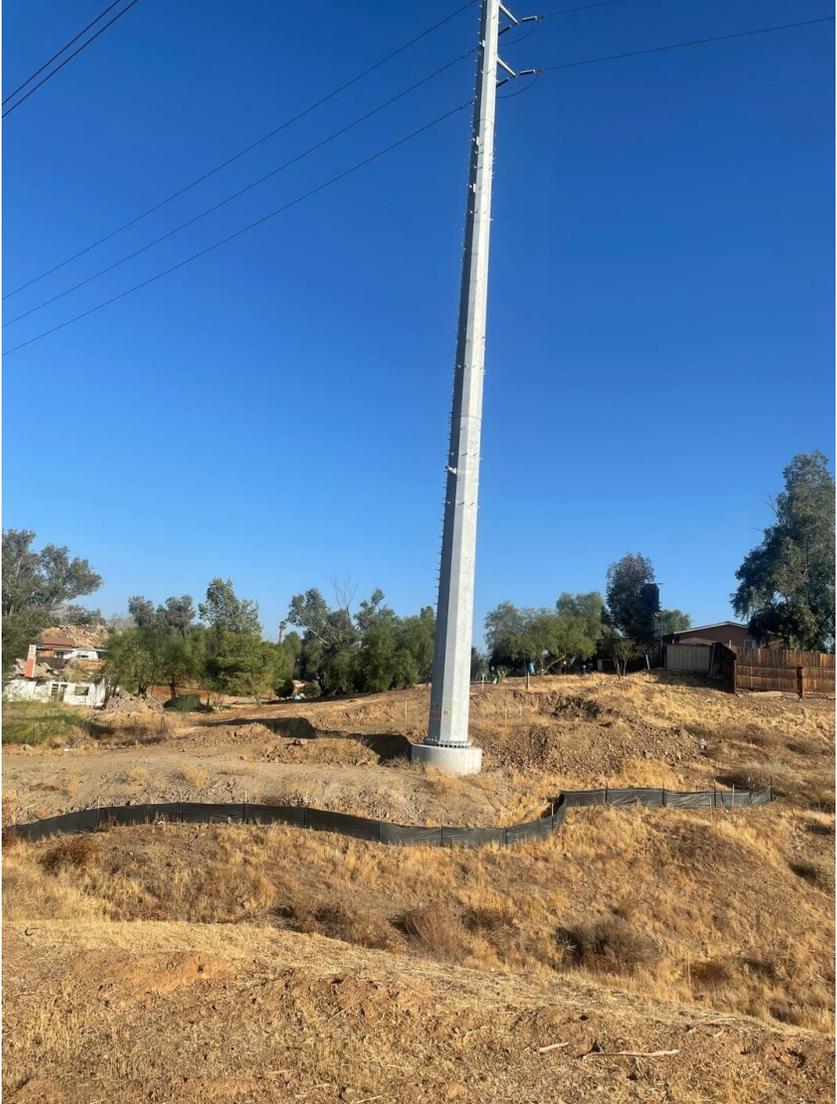
We drove west along the transmission corridor to Highway 74. Most of the tower sites were stable with very little trash (Photo 3). Some erosion rills were noted around TSP 145 within the buffer zone of a cultural site. A rock gabion was planned for the small swale crossing the access road to TSP 145, but was eliminated per agreement with the Native American community. Minimal erosion control work was planned along this portion of the access road prior to the next rainy season (Photo 4).

Photo 3 – TSP 144 with BMPs in place below the impacted area. Photo facing north.

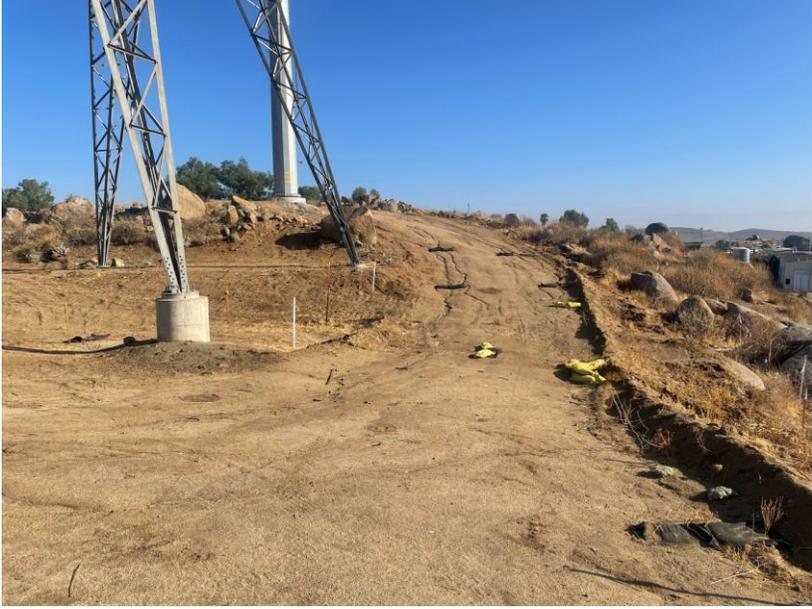
<p>Photo 4 – The access road to TSP 145 had minor erosion that needs to be addressed prior to the next rainy season. Photo facing north.</p>

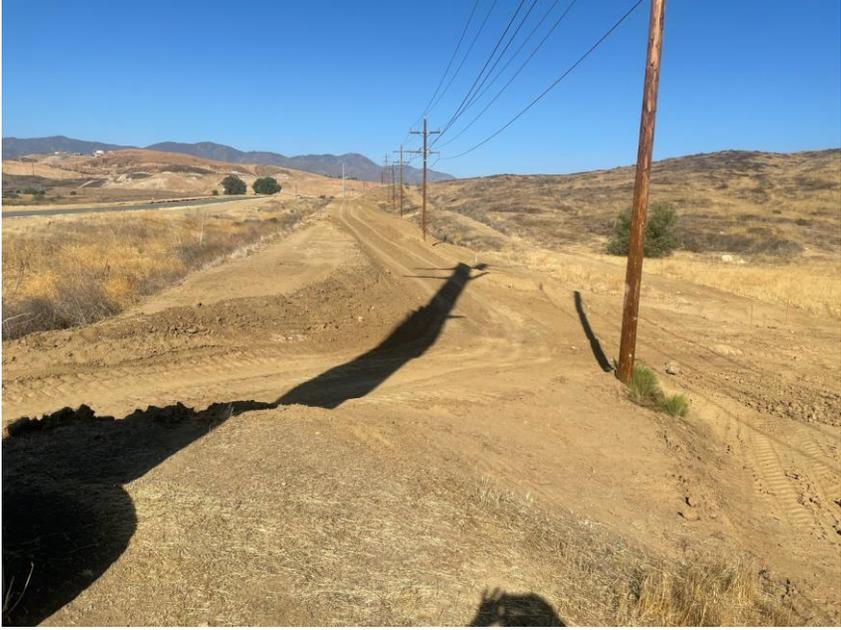
We drove to segment 5, along Nichols Road, where work on the access road had been completed (Photo 5). Installation of the lightweight steel poles (LSP) was scheduled to begin soon. Sensitive plant transplants needed to be completed prior to riprap installation.

Photo 5 – The access road along the transmission corridor in segment 5 was completed. Photo facing northwest.

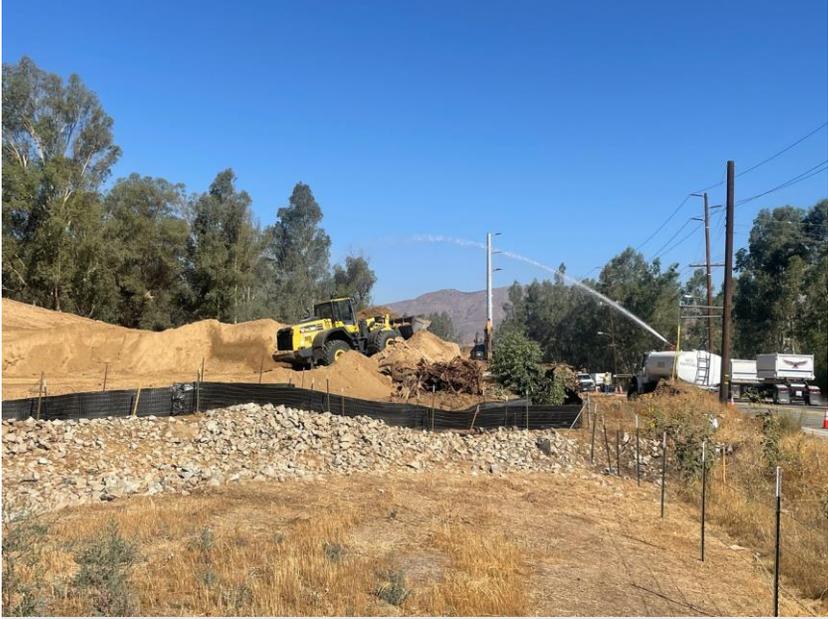
Soil removal continued along Lake Street in preparation for road widening. The soil piles were being watered before being loaded into haul trucks. Additional best management practices (BMPs) were added along the jurisdictional drainage (Photo 6). The earthwork was almost complete around the newly installed TSP foundations (Photo 7). Crews were completing additional road grading and widening along Lake Street near Highway 15 and TSP 474 (Photo 8).

Photo 6 – Soil removal along Lake Street with BMP upgrades near the jurisdictional drainage. Photo facing northeast.

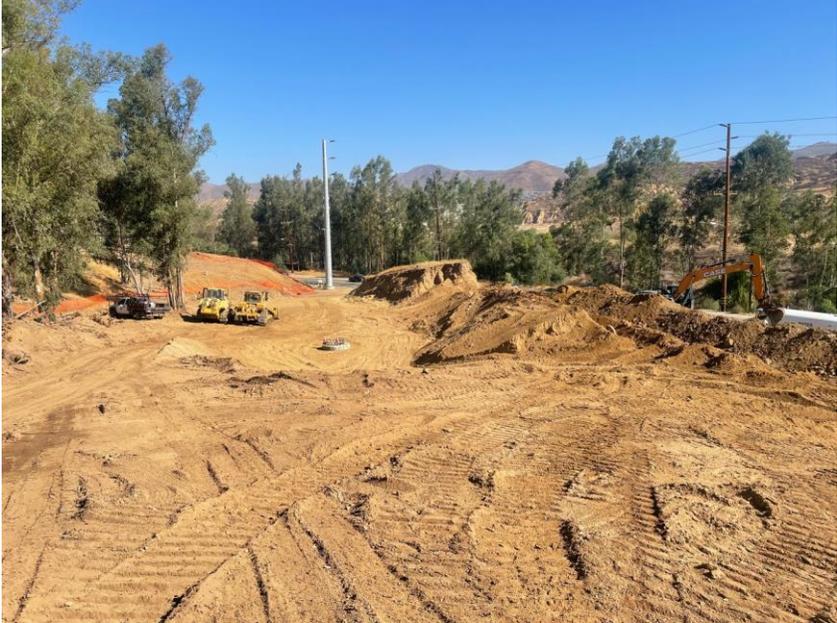
Photo 7 – Soil removal from the road expansion activities. Photo facing northeast.

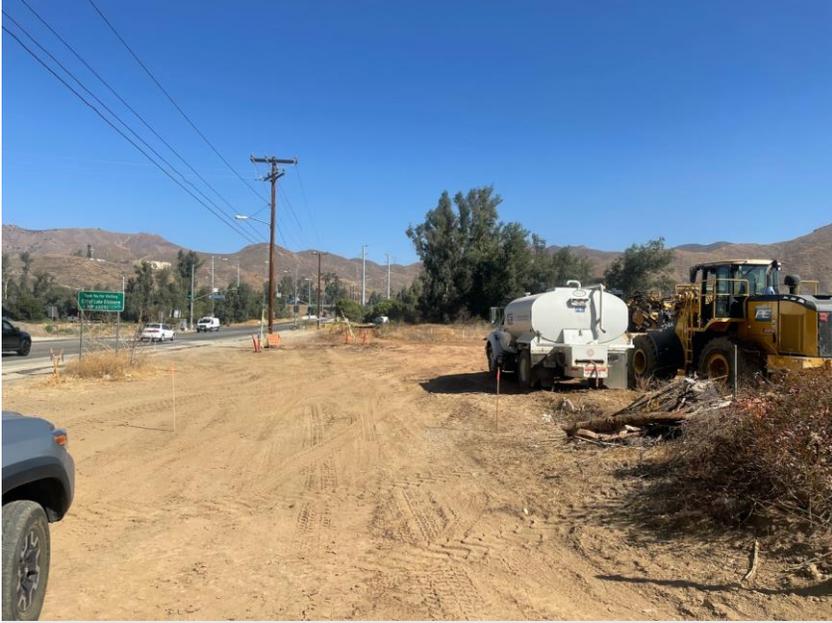
Photo 8 – Grading being completed along Lake Street as part of road expansion. Photo facing east.

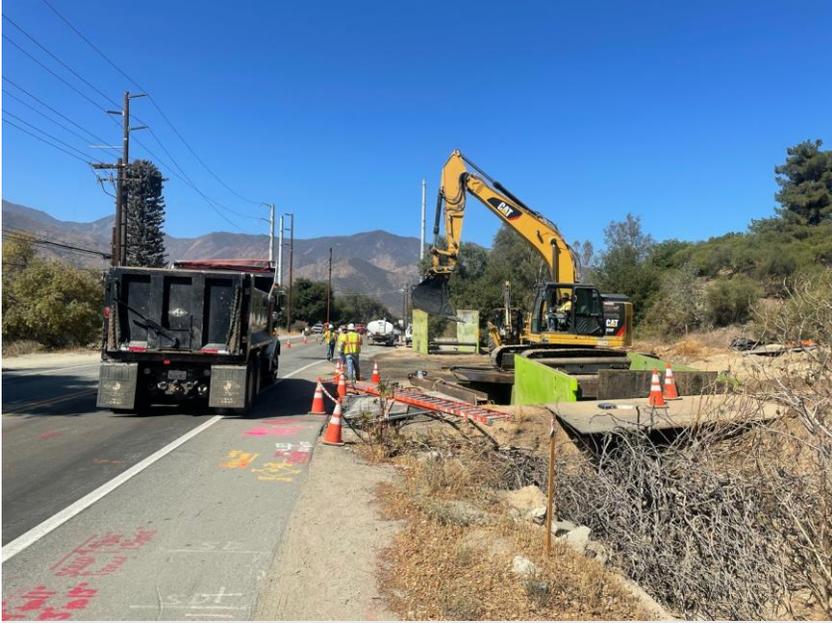
A crew was preparing for directional drilling along Temescal Canyon Road near the IvyGlen Substation (Photo 9). The open holes and trenches were to be covered over the weekend and when active work was not underway.

Photo 9 – Conduit installation along Temescal Canyon Road near the IvyGlen Substation. Photo facing west.

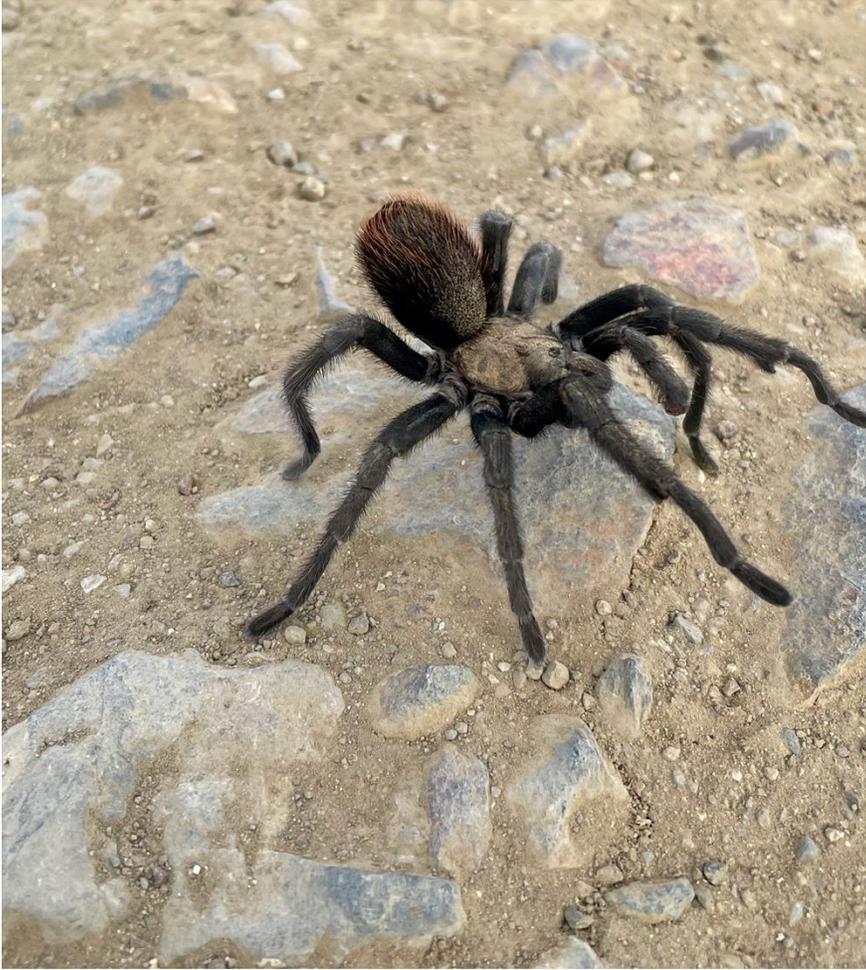
On the access road, we encountered a tarantula migrating and stopped to move it off the road (Photo 5).

Photo 5 – Tarantula on the access road.
