**Re: Monthly Report Summary #15 for the Valley-Ivyglen 115-kV Substation (VIG) Project**

CPUC Site Inspection Reports  
October 6 and 21, 2021

## Valley – Ivyglen Subtransmission Project CPUC Site Inspection Form

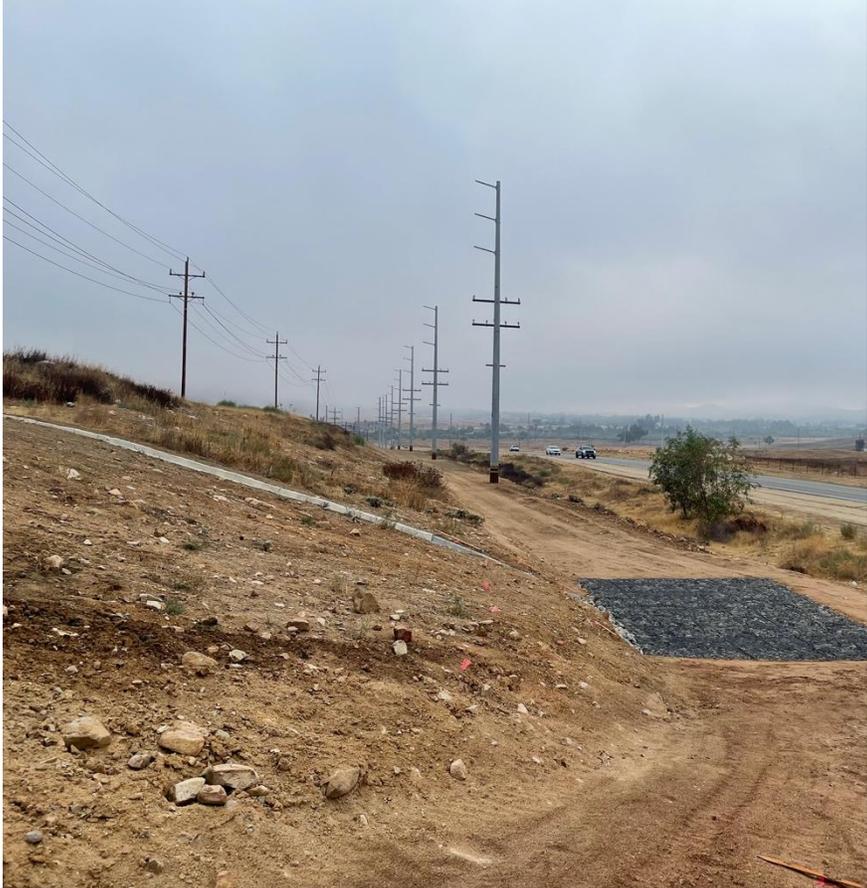
We headed south and stopped along Nichols Street at tubular steel pole (TSP) 420 to inspect the completed work activities. All the lightweight steel poles were installed, and crews had completed the V-ditch and rock gabion upgrades along the access road (Photo 1). During my previous site visit I noted some of the steel pole foundation holes had not been adequately covered. I asked the LEI about whether the environmental crews checked for trapped animals prior to setting the poles, and whether they found any. The LEI said crews completed inspections, and no animals were found.

Photo 1 – V-ditch and gabion installation near TSP 421. Photo facing south.

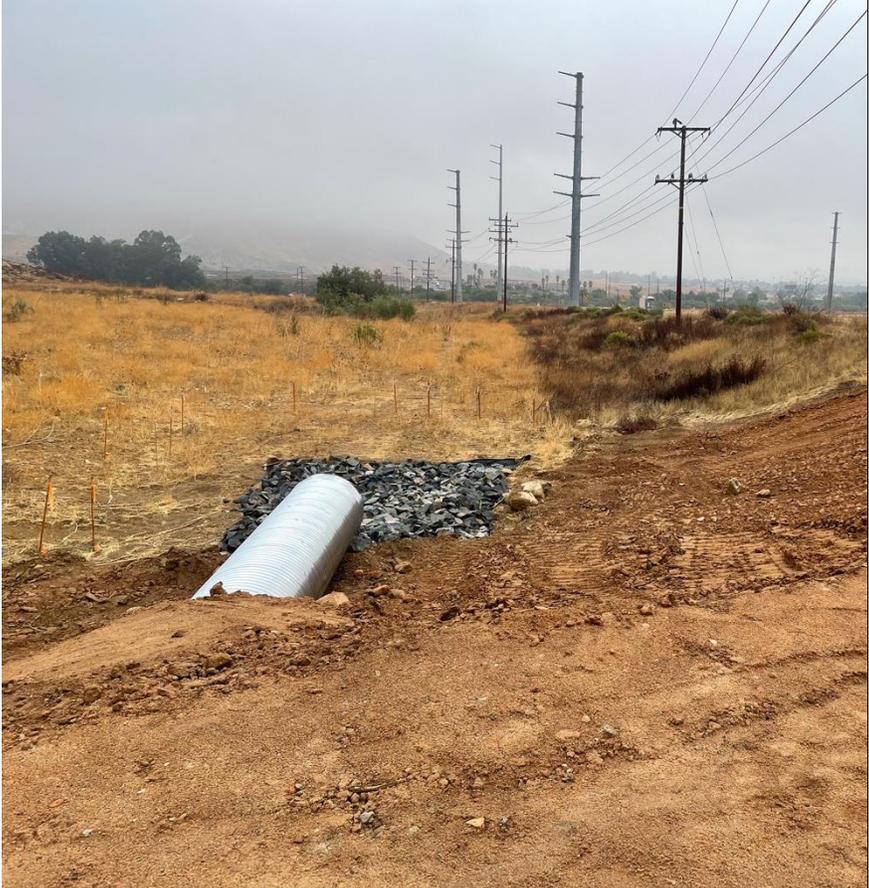
We stopped at TSP 413 where a drainage culvert was installed along with a rock gabion (Photo 2). The project botanist transplanted vegetative bulbs from the area impacted by the rock gabion. The disturbed ground was track rolled and will be hydroseeded later this fall.

<p>Photo 2 – A drainage culvert and rock gabion installed near TSP 413. Photo facing southeast.</p>

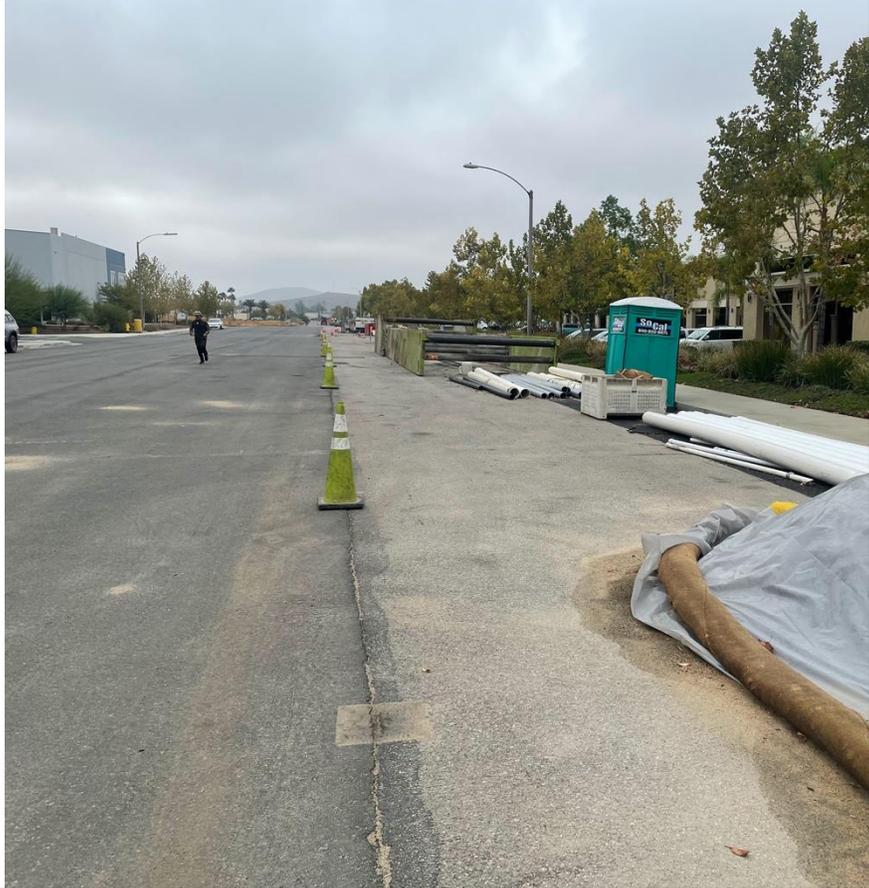
Photo 3 – Equipment staged for the vault excavation. Photo facing south.

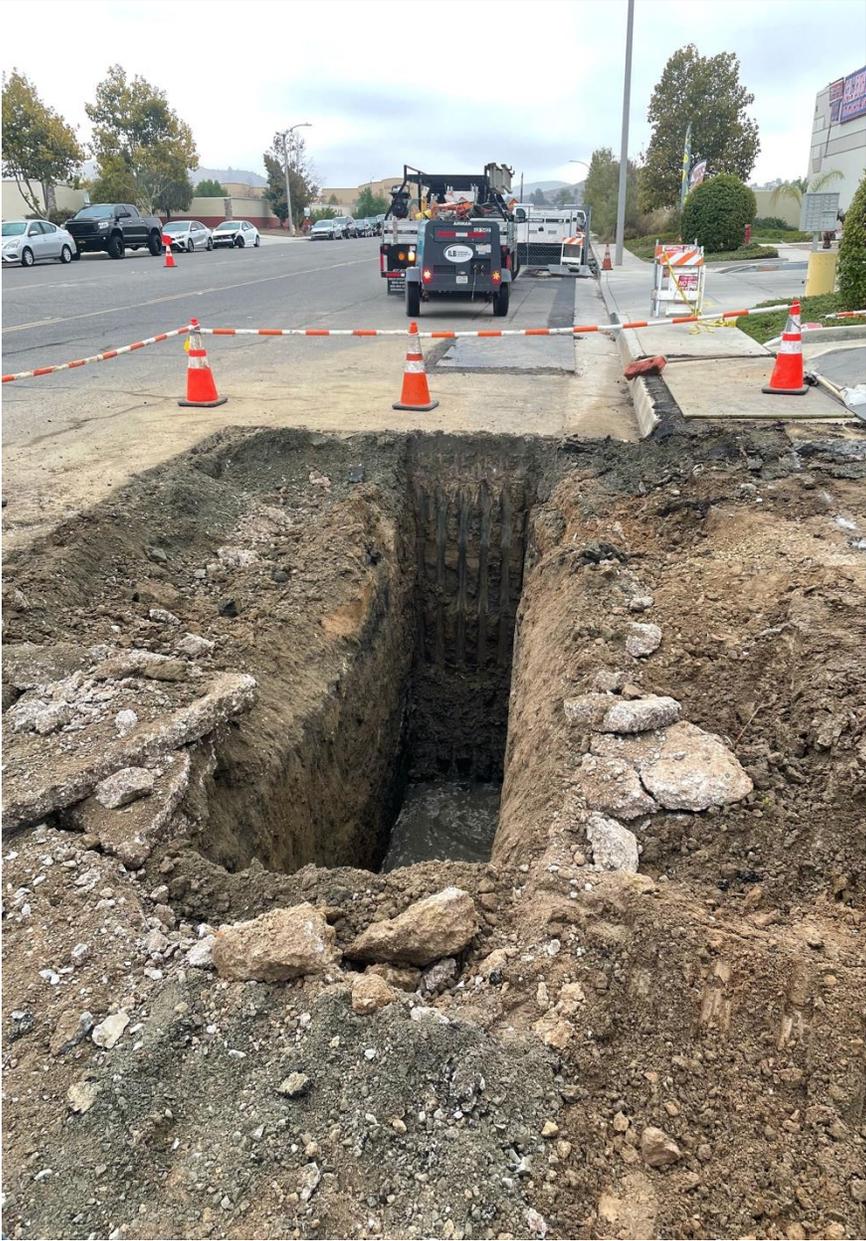
We continued south to segment 4 where a drilling crew continued work on dewatering wells within Pasadena Street (Photo 3). Four additional underground vaults remain to be installed. The crews had excavated down to 9 feet at one vault location and reached groundwater (Photo 4); however, the vault excavation needed to be 15 feet deep, so additional dewatering well locations are needed. The dewatering system including the baker tank. The outflow pipe appeared in good condition. The water was clear and was encouraging plant growth in the open field (Photo 5).

Photo 4 – Vault excavation that hit groundwater at 9 feet. Photo facing south.

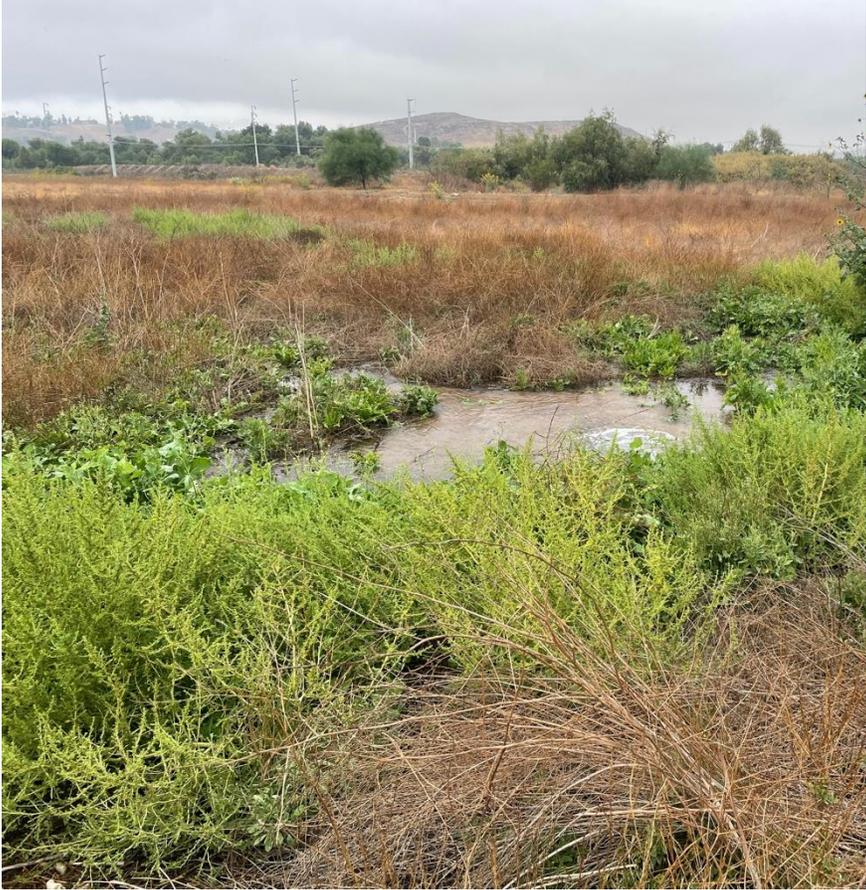
Photo 5 – Water exit site for the dewatering operation. Photo facing northwest.

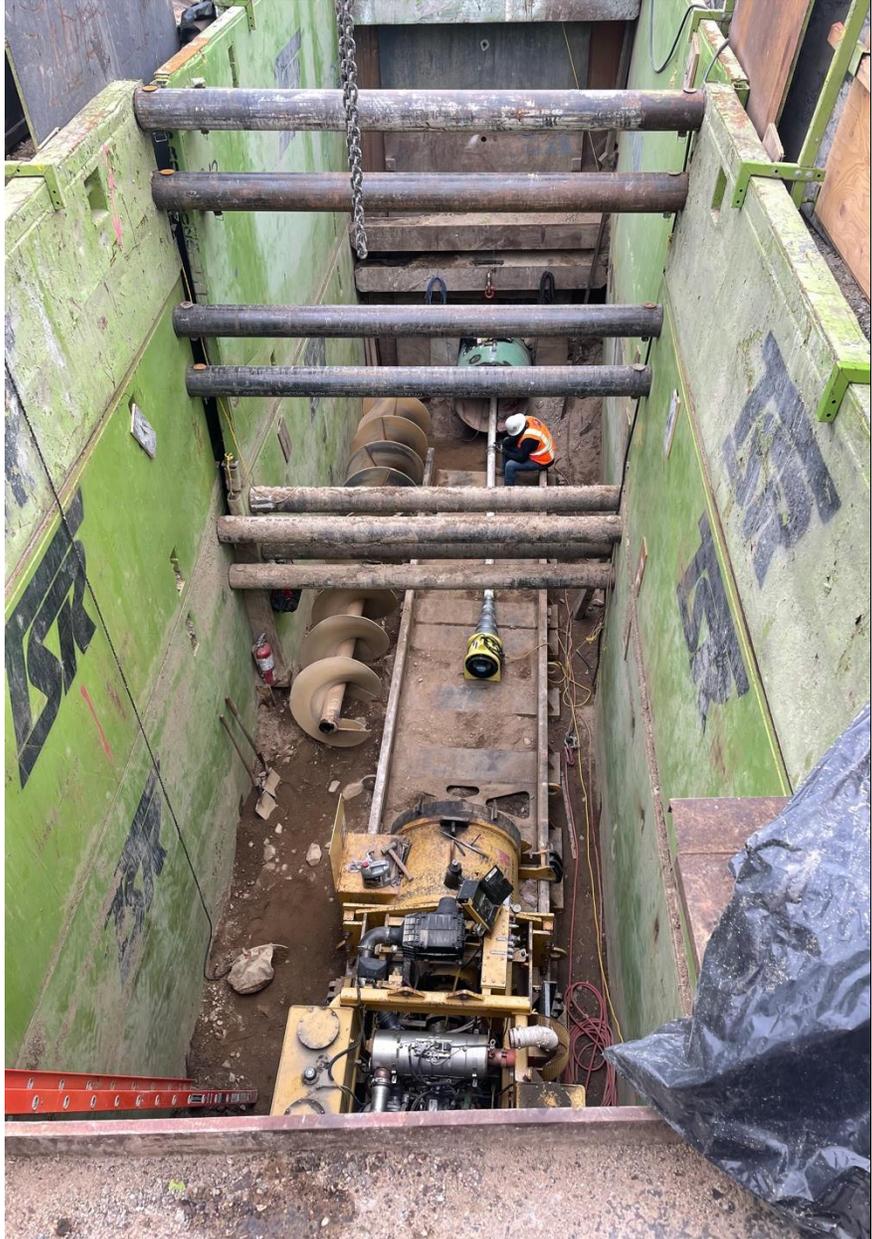
Photo 7 – Bore hole near the IvyGlen Substation.

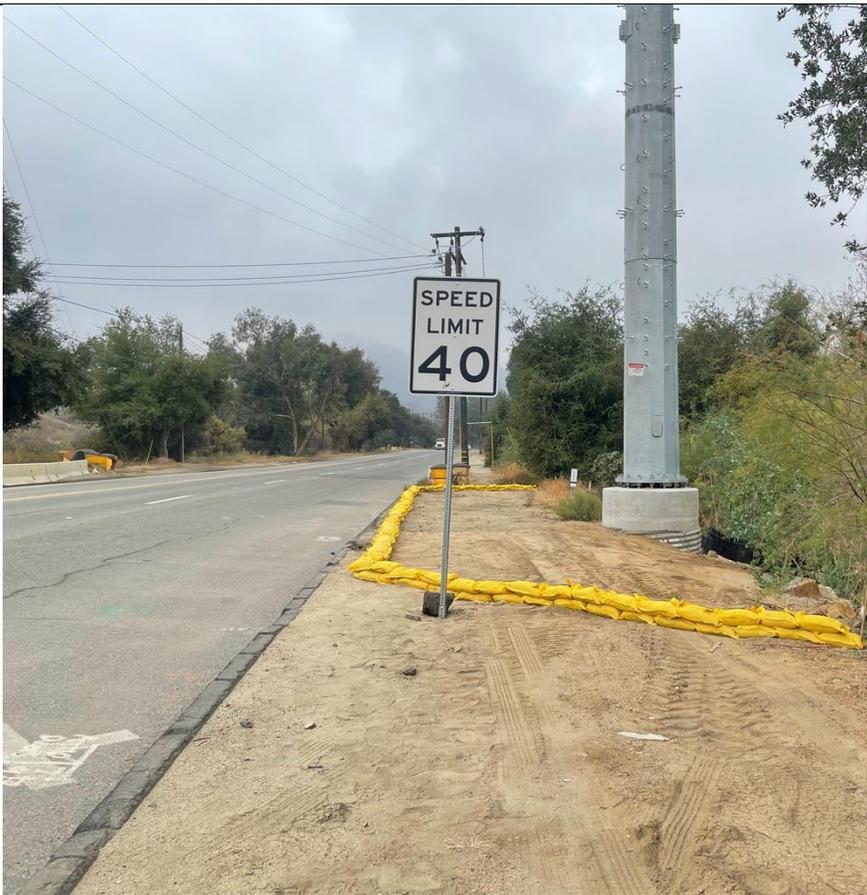
Our final stop was north at the bore site along Temescal Canyon Road, across from the IvyGlen Substation (Photo 6). In the previous week, a rain event occurred creating muddy water in the roadway and filling the bore hole. The crew had pumped out the water and added a temporary asphalt berm and sandbags to prevent any future runoff (Photo 7). Equipment around the bore hole appeared undamaged and remained well contained (Photo 8). Some of the soil around the TSP up the road from the bore pit had been washed away so crews replaced the soil and added a sandbag barrier at this location as well (Photo 9).

Photo 9 – Additional restoration and a diversion barrier around the TSP across from the IvyGlen Substation. Photo facing west.

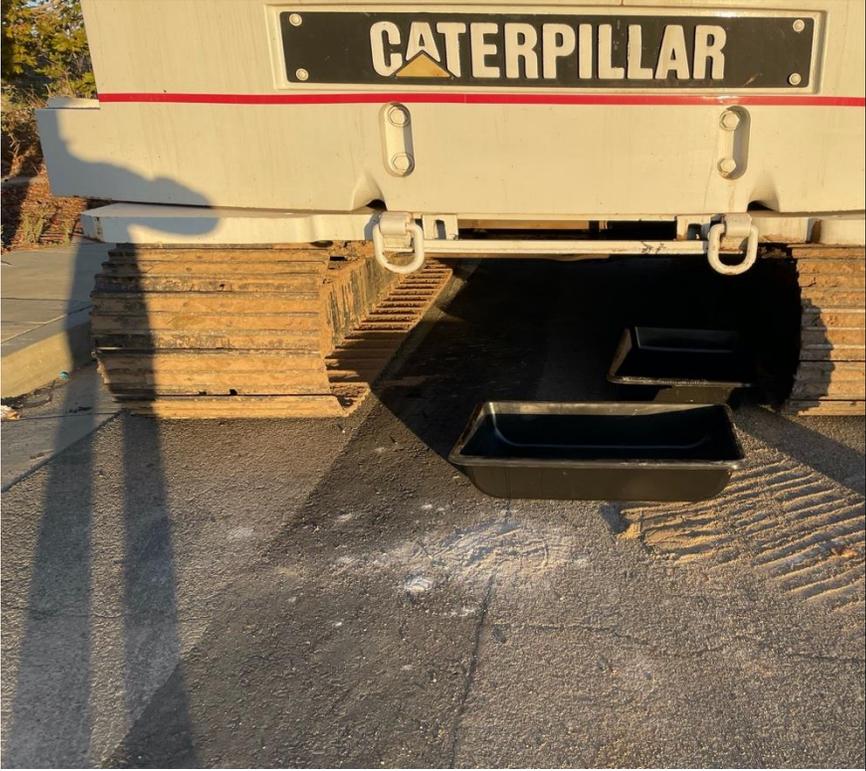
Photo 4 – A drill rig with drip pans parked along Pasadena Street. Photo facing north.

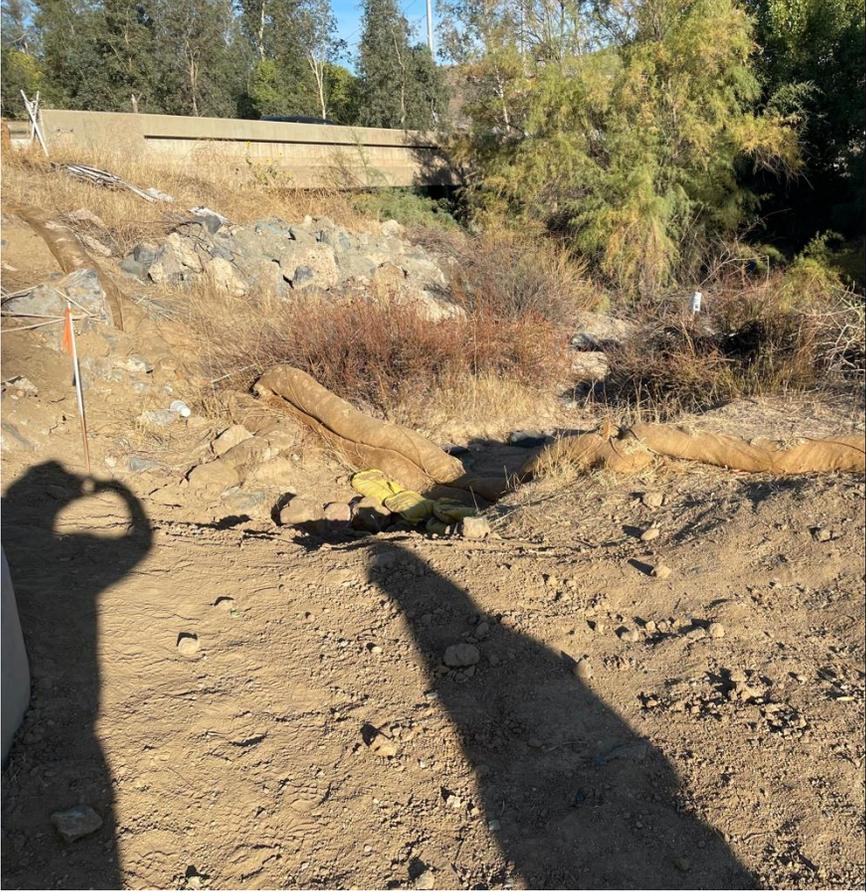
<p>Photo 8 – BMPs at the end of the access road and above the creek drainage near TSP 481. Photo facing northeast.</p>
