**Re: Monthly Report Summary #16 for the Valley-Ivyglen 115-kV Substation (VIG) Project**

CPUC Site Inspection Reports  
November 4 and 18, 2021

## Valley – Ivyglen Subtransmission Project CPUC Site Inspection Form

<b>Project:</b>	Valley – Ivyglen Project	<b>Date:</b>	November 4, 2021
<b>Project Proponent:</b>	Southern California Edison (SCE)	<b>Report #:</b>	VS033
<b>Lead Agency:</b>	California Public Utilities Commission (CPUC)	<b>Monitor(s):</b>	Vincent Semonsen
<b>CPUC PM:</b>	Michael Rosauer, Energy Division	<b>AM/PM Weather:</b>	Clear, sunny, cool, and calm
<b>CPUC-CM (WSP):</b>	Chuck Cleeves	<b>Start/End time:</b>	0600 to 0930
<b>Project NTP(s):</b>	Notice to Proceed (NTP-1), NTP-2, and NTP-3.

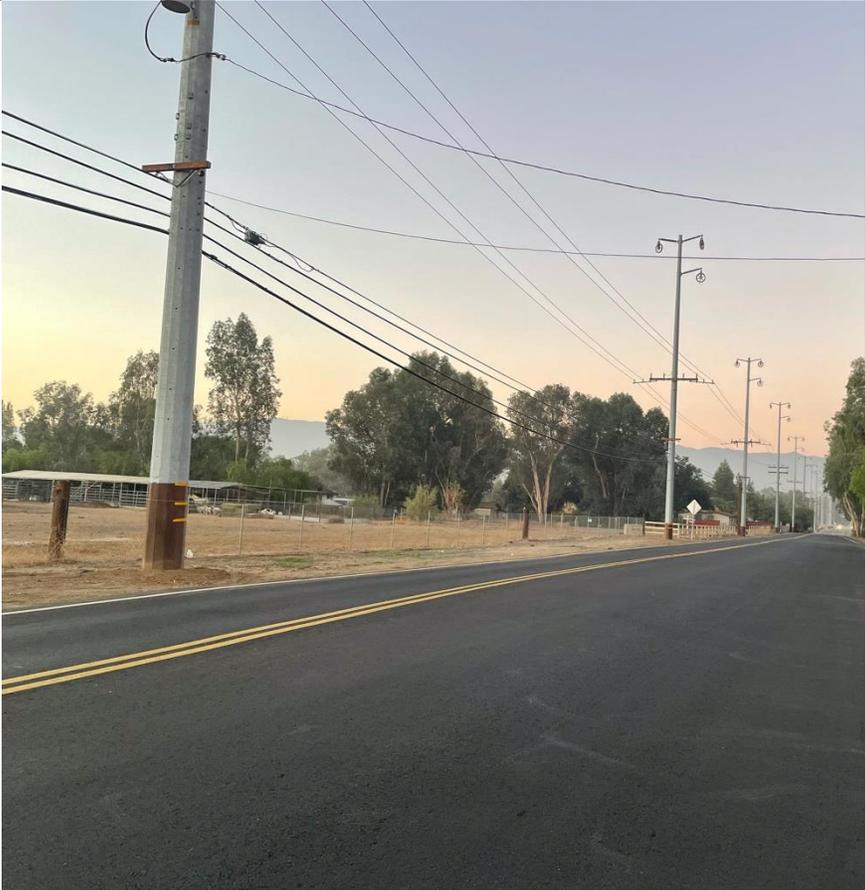
I arrived onsite at the Concordia staging area for the 0600 tailboard meeting. The Lead Environmental Inspector (LEI) and I discussed the various ongoing construction activities and planned the site visit. The LEI needed to set up a noise meter where the wire stringing crew was working along Third Street east of Highway 15, so we headed south. The LEI set up the noise meter, and we signed into the site on the job safety analysis (JSA). A traffic crew was setting up along the roadway, and the stringing crew was scheduled to begin pulling wire shortly (Photo 1).

Photo 1 – Wire stringing was scheduled for this area. Photo facing west.

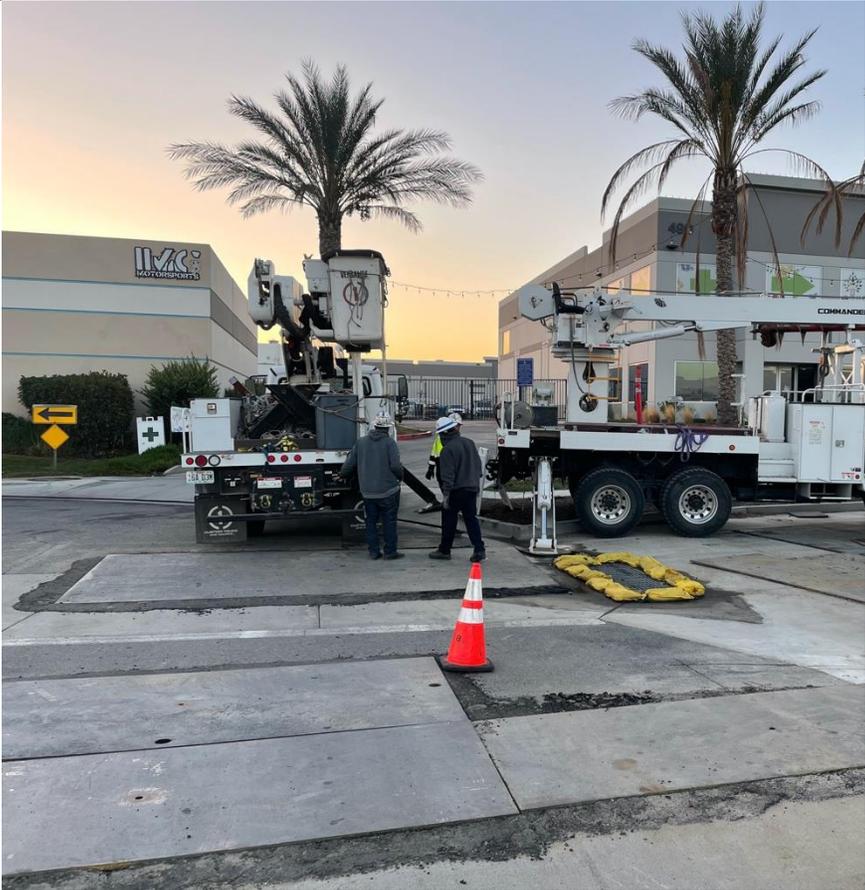
We crossed over Highway 15 to where the underground crews were setting up at the intersection of Third Street and Pasadena Street. The generators were relocated to continue to use of the existing piping and baker tank system located at the northern end of Pasadena Street (Photo 2). The final two dewatering wells were being installed and pumping was set to begin. The bore pit at the intersection of Third and Pasadena Streets was being excavated and upgrades to the street drain best management practices (BMPs) were completed (Photo 3). The drill rig was parked nearby and oil continued to leak. One drip pan was underneath the equipment but was not sufficient to contain the oil. I spoke to the LEI about this issue and the need for better containment under equipment.

Photo 3 – BMPs around the street drain were upgraded as crews prepared to drill additional dewatering wells. Photo facing south.

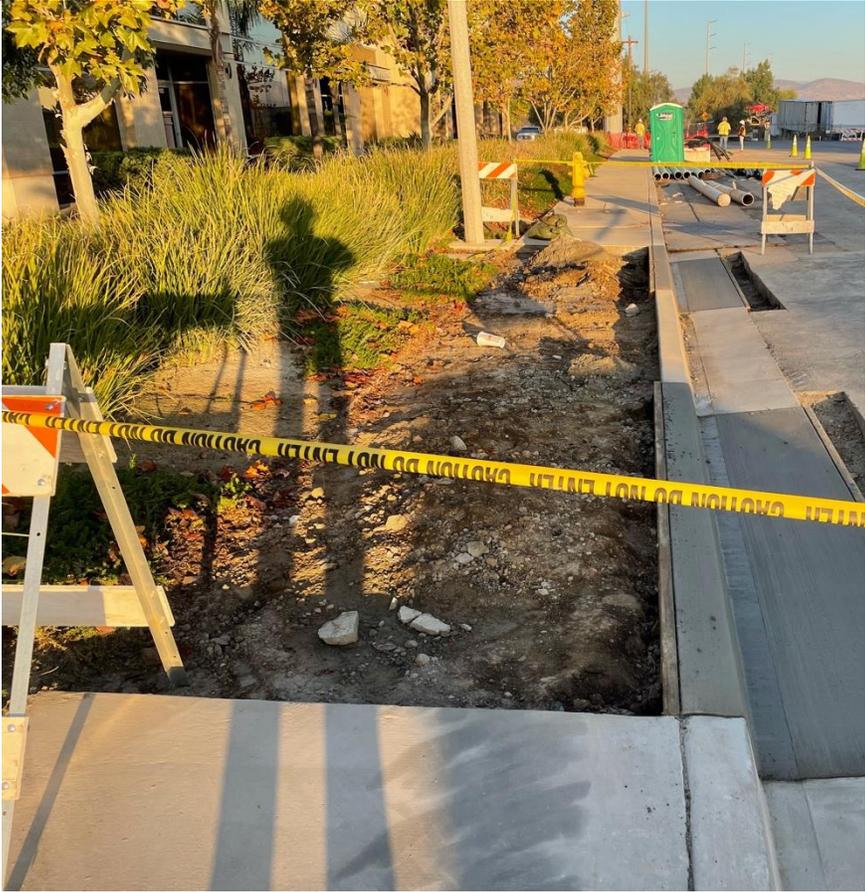
At the north end of Pasadena Street, curb and gutter repair work was underway (Photo 4), and the area around tubular steel pole (TSP) was being repaired and restored (Photo 5).

Photo 4 – Curb and gutter repairs being completed in segment 4 along Pasadena Street. Photo facing north.

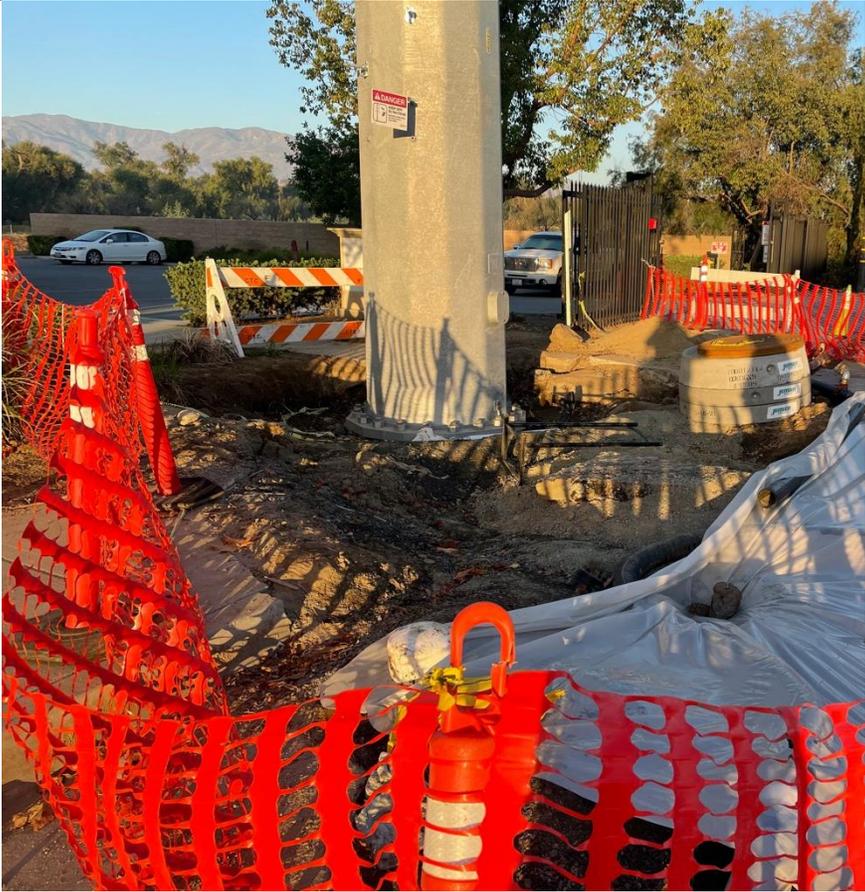
<p>Photo 5 – Final restoration and repairs expected soon around TSP 358. Photo facing north.</p>

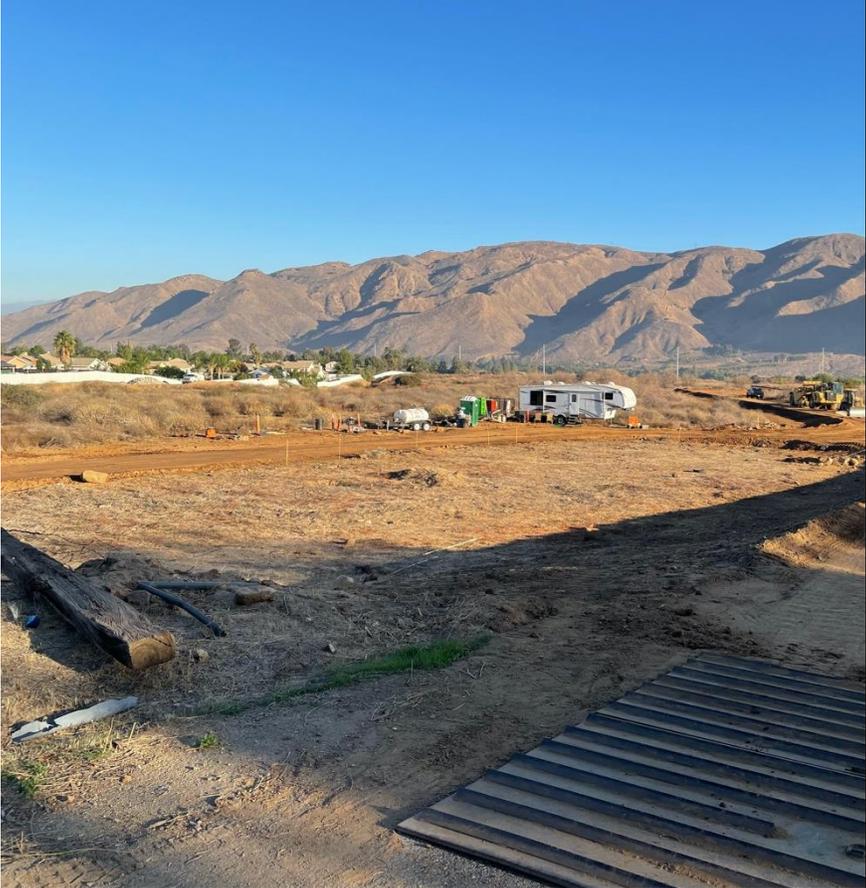
Road crews continued work in the Horsethief Canyon area upgrading the access roads to TSP 528 through 530 (Photo 6). Biological and paleontological monitors were onsite overseeing this work. A large scraper was parked along the roadway with one very small drip pan under it (Photo 7). The equipment was new and did not appear to have any fluid leaks; however, one small drip pan was not sufficient to contain a large piece of equipment. The LEI acknowledged this. The excess soil from the road work was being transported to segment 1 around TSP 145 to be used in road work.

Photo 6 – Access road upgrades in the Horsethief Canyon area. Photo facing east.

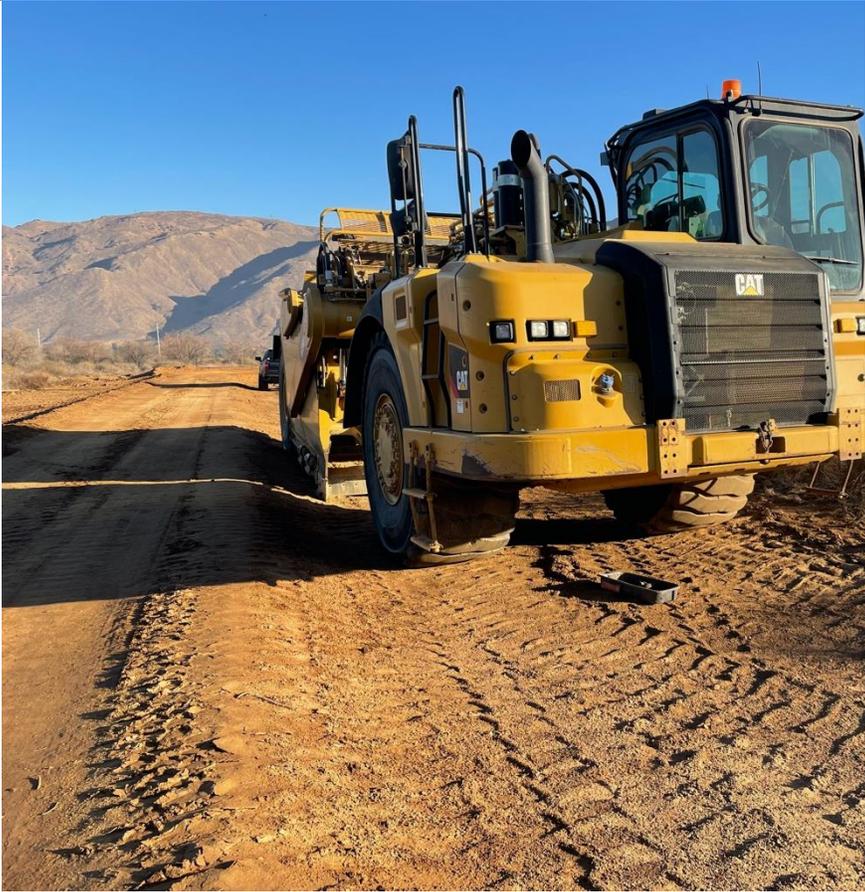
<p>Photo 7 – Small drip pan under a very large scraper. Photo facing east.</p>

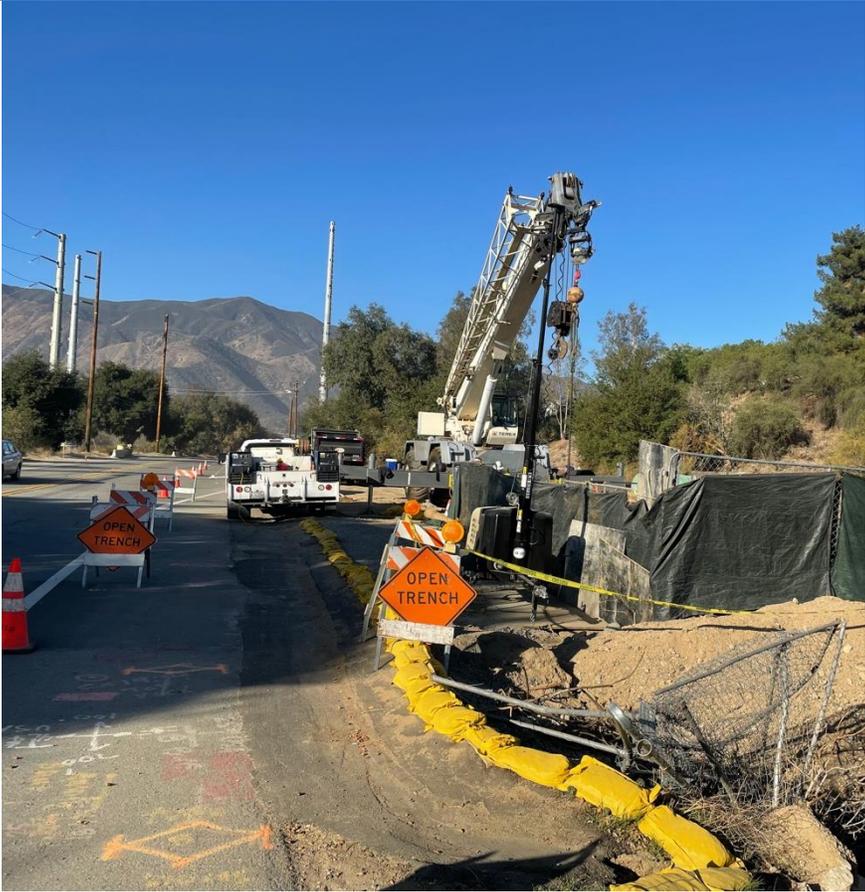
Our final stop was at the bore site in segment 8, along Temescal Canyon Road, and across from the IvyGlen Substation (Photo 8). The progress was slow, and according to the onsite inspector, about 150 feet of the 220-foot bore had been completed.

Photo 8 – Bore pit work area within segment 8 near the IvyGlen Substation. Photo facing northwest.

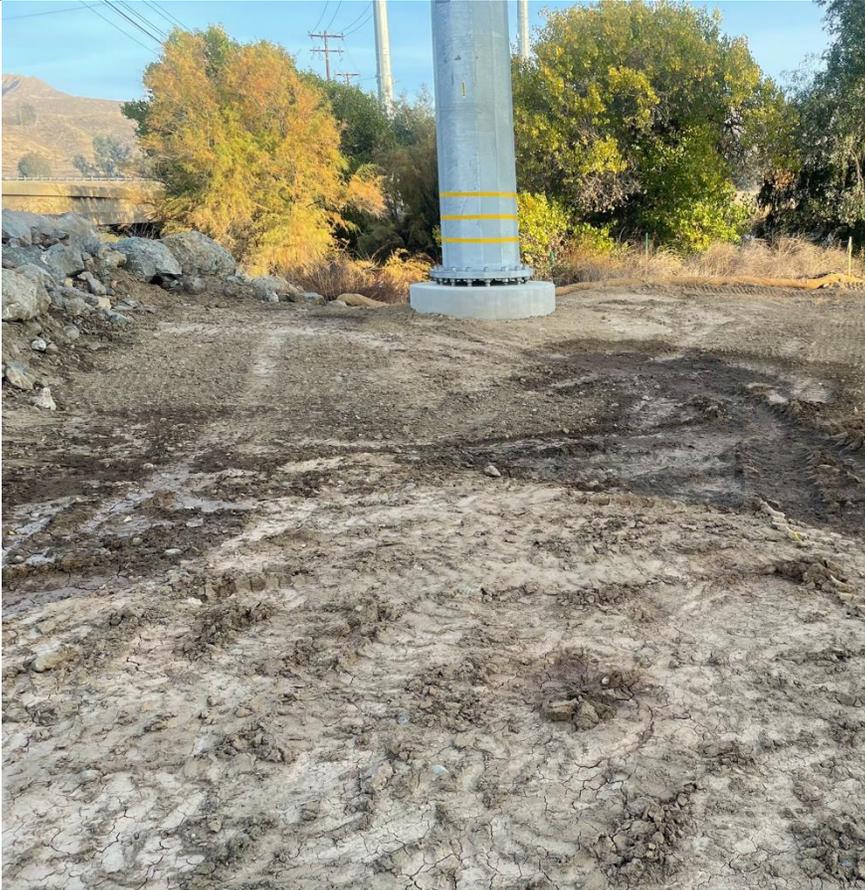
Our first stop was at tubular steel pole (TSP) 481 located along Lake Street and adjacent to a creek channel. The restoration crew accompanied us, and we met two of the biological monitors at the site. I noted ponding near the TSP site (Photo 1). Best management practices (BMPs) at this location were in poor condition and needed to be replaced and upgraded. I felt they would be more effective in a different location and discussed the issue with the LEI.

<p>Photo 1 – Drainage/BM P issues at TSP 481. Restoration crews were inspecting this site. Photo facing east.</p>

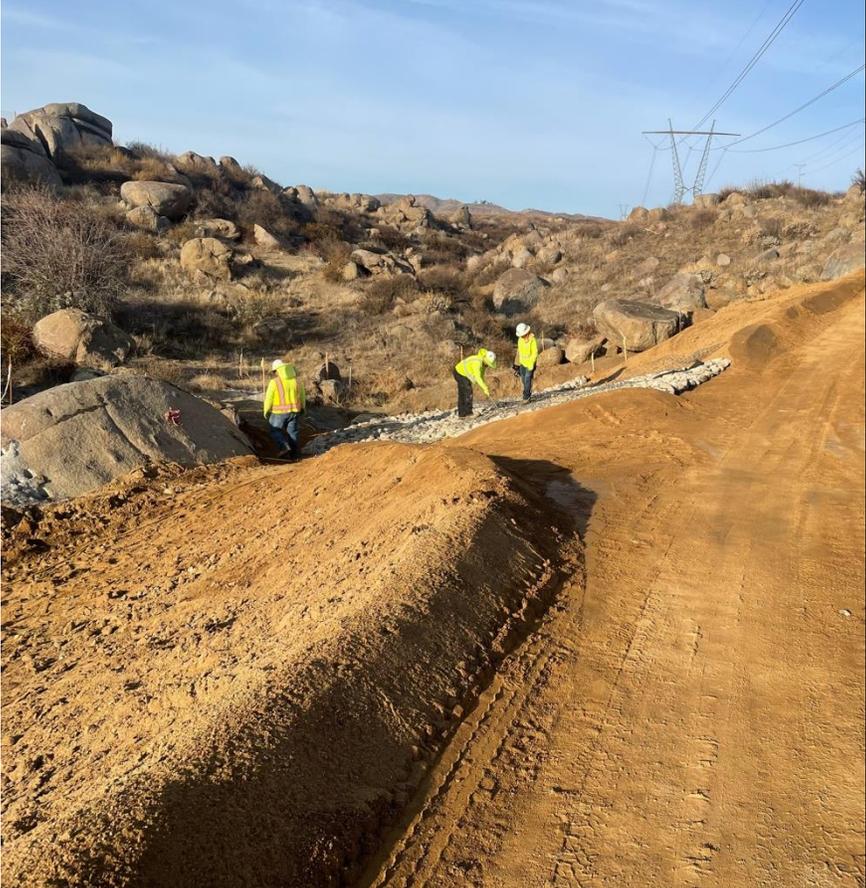
We drove to segment 1 near TSP 145 and the culturally sensitive area. Excess soil from the Horsethief Canyon road work was delivered to the area to fill in low spots in the access road (Photo 2). Culverts were added under the new soil and crews were installing gabion baskets. Minor regrading was completed at several sites along the access road to allow for stormwater drainage (Photo 3). This work had been previously agreed to with the local Native American tribes.

<p>Photo 2 – Soil delivered from the Horsethief Canyon area was used to improve the access roads near TSP 145. Photo facing west.</p>

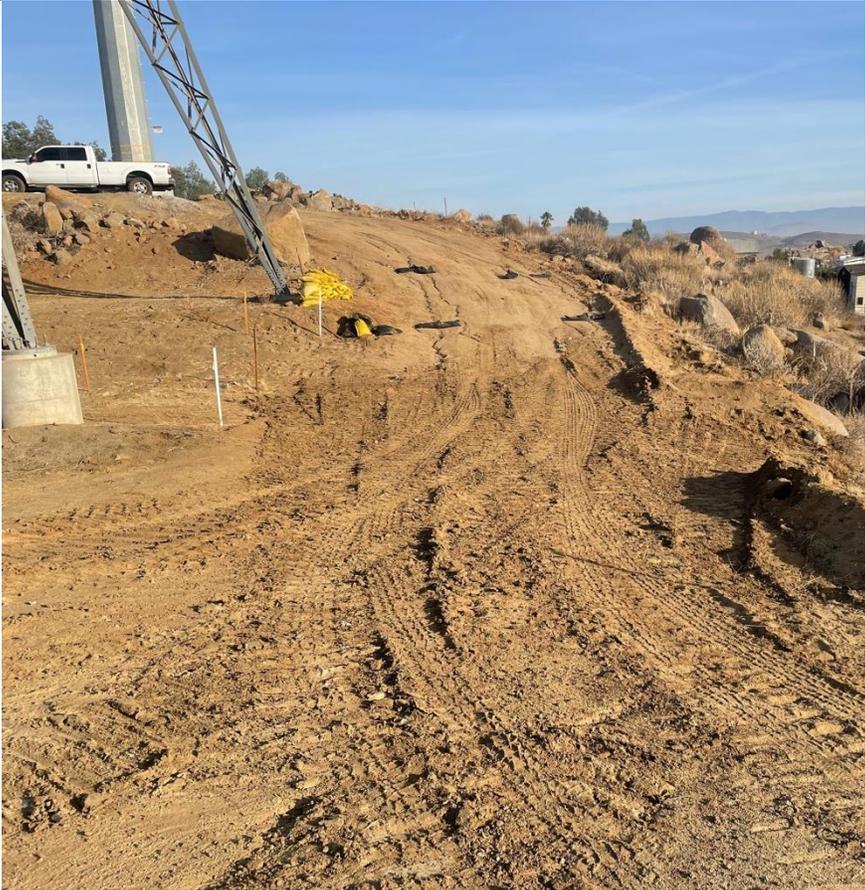
Photo 3 – Minor grading completed around TSP 145. Photo facing northeast.

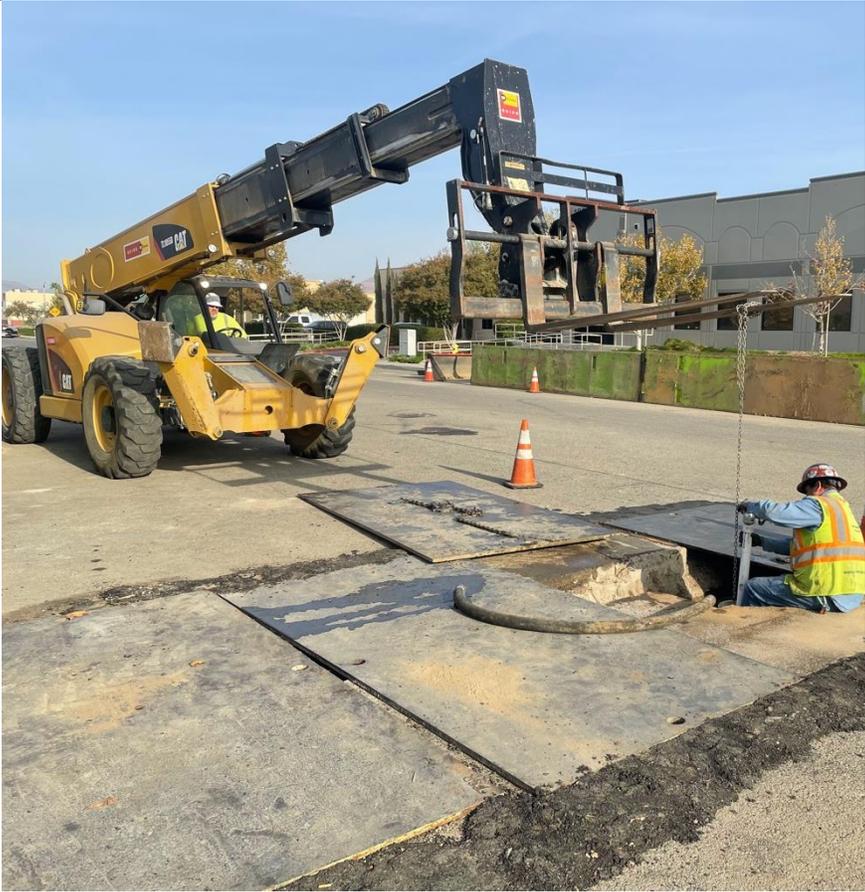
We traveled to the dewatering work at the intersection of Third Street and Pasadena Street (Photo 4). Bore pit excavation was being set up to install conduit under the water channel. Farther north along Pasadena Street, a wire stringing crew was beginning to pull wire to Highway 74 (Photo 5). The access roads in this area were very dusty and had been watered down prior to the wire stringing crews arriving (Photo 7).

Photo 4 – Dewatering work along segment 4. Photo facing north.

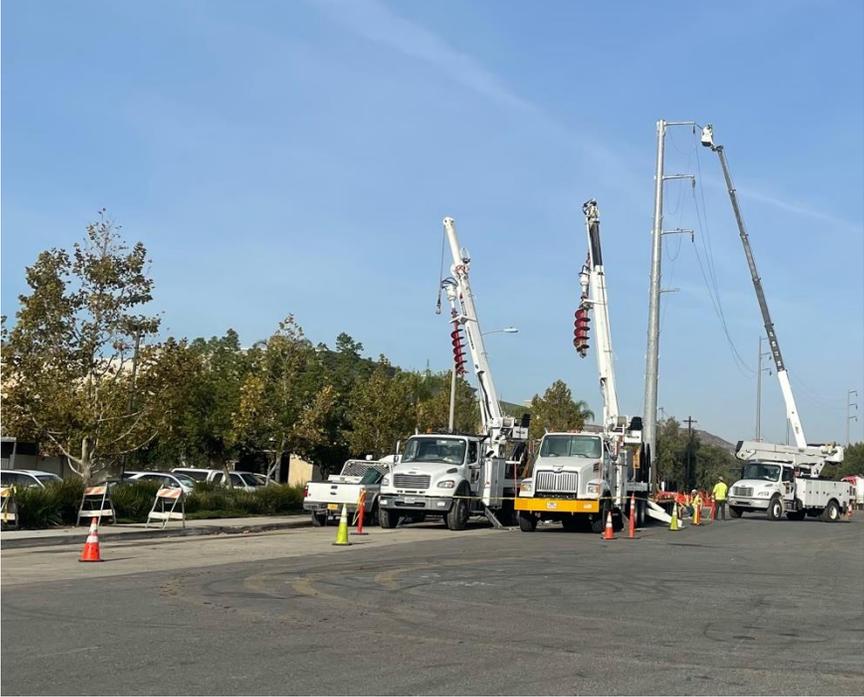
Photo 5 – Wire stringing along Pasadena Street. Photo facing north.

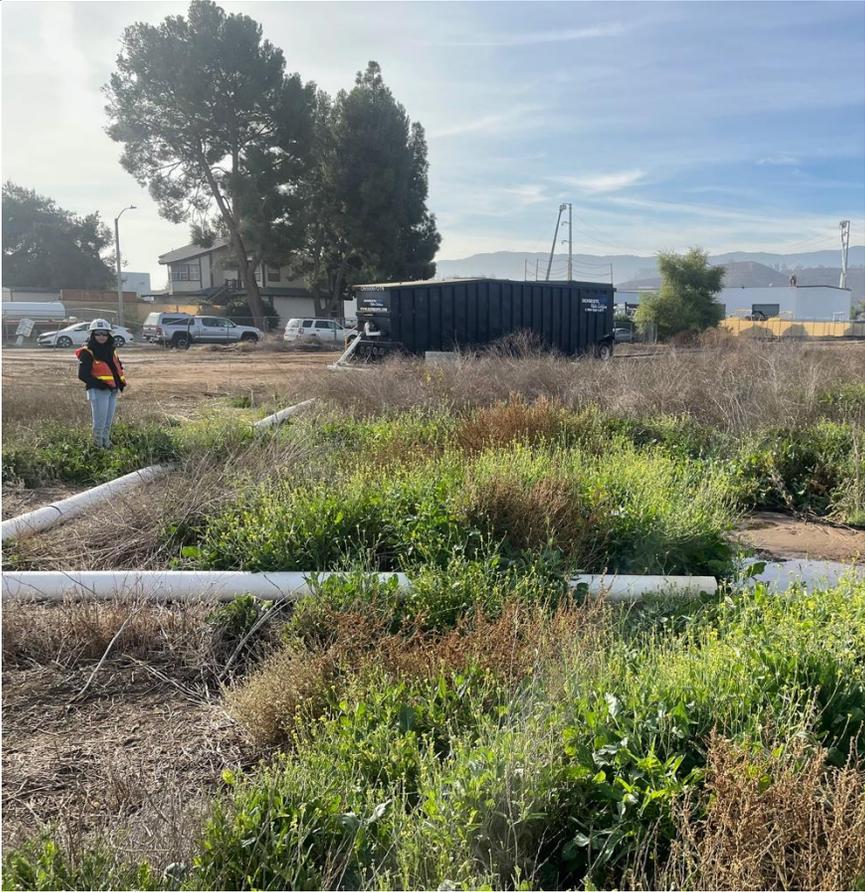
No dewatering was taking place, but we inspected the baker tank and the outflow location; it was in good condition (Photo 6).

Photo 6 – Dewatering system including the Baker tank and outflow pipe. Photo facing southwest.

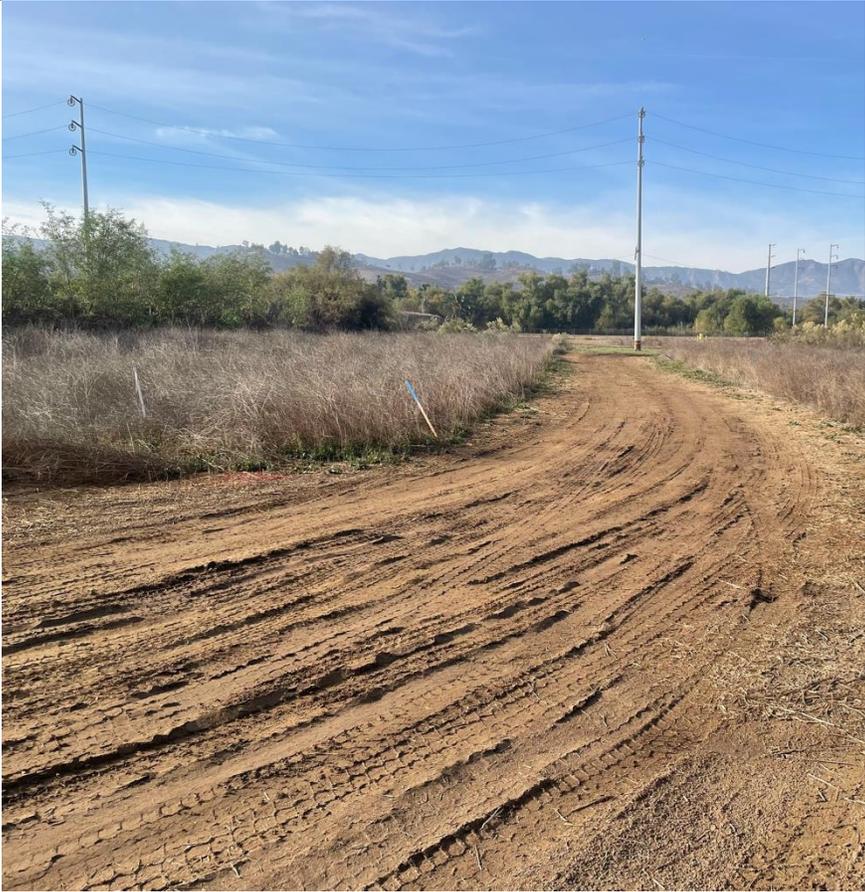
Photo 7 – Dust control on the access roads. Photo facing west.

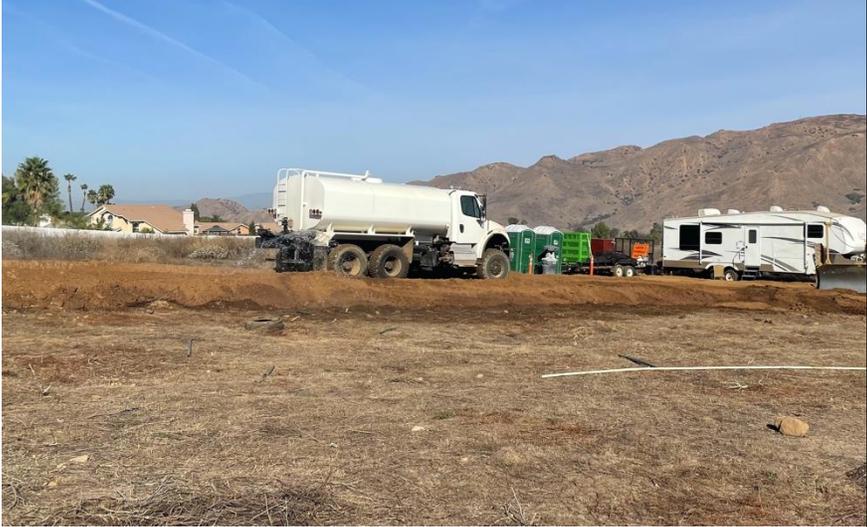
The LEI had to leave, so I headed to the Horsethief Canyon work area to observe the road grading activities (Photo 8). Heavy equipment was working at the site and a paleontology monitor was onsite. Parked equipment had drip pans underneath the engine compartments.

Photo 8 – Access road construction in the Horsethief Canyon area. Photo facing northeast.

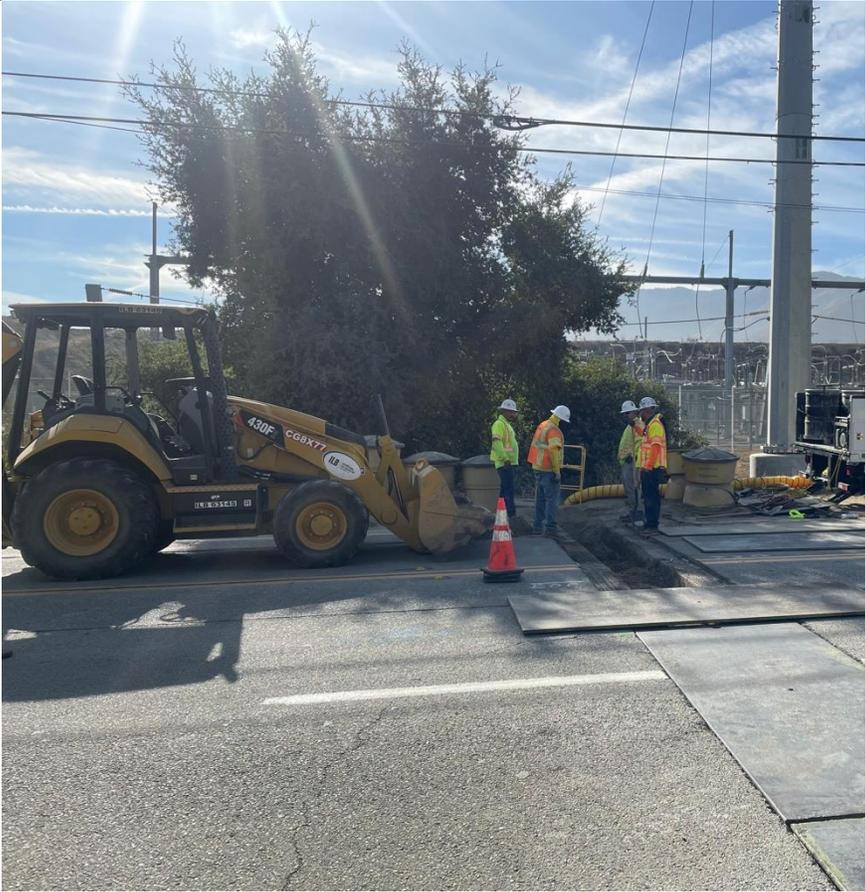
My final stop was at the IvyGlen Substation where crews were working in the roadway (Photo 9). The underground bore had been completed and the crew was dismantling the equipment (Photo 10). The exit hole was open, and work would be completed to connect the various portions of conduit. The exit hole was fenced off but was not covered (Photo 11). Animals could easily get through the fencing and fall into the hole. I spoke with the foreman and the SCE inspector and asked that they ensure an additional barrier be added to the hole. I sent a text to the LEI to alert her of my request.

Photo 9 – Work within the roadway near the IvyGlen substation. Photo facing south.

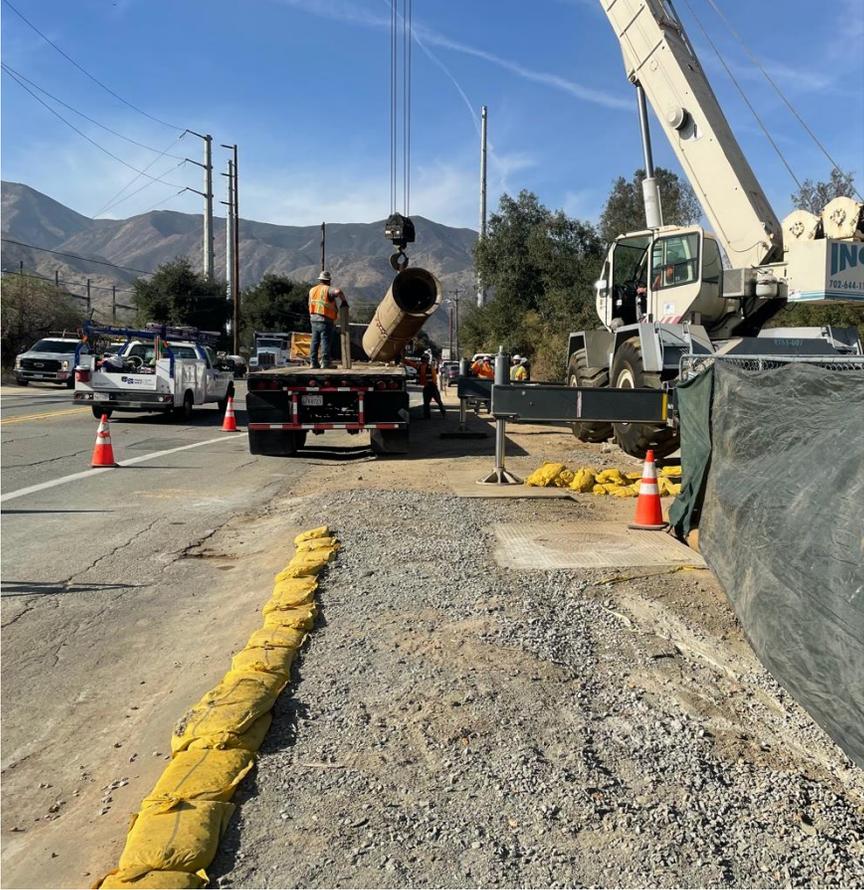
Photo 10 - Bore pit work area within segment 8 near the IvyGlen substation. Photo facing northwest.

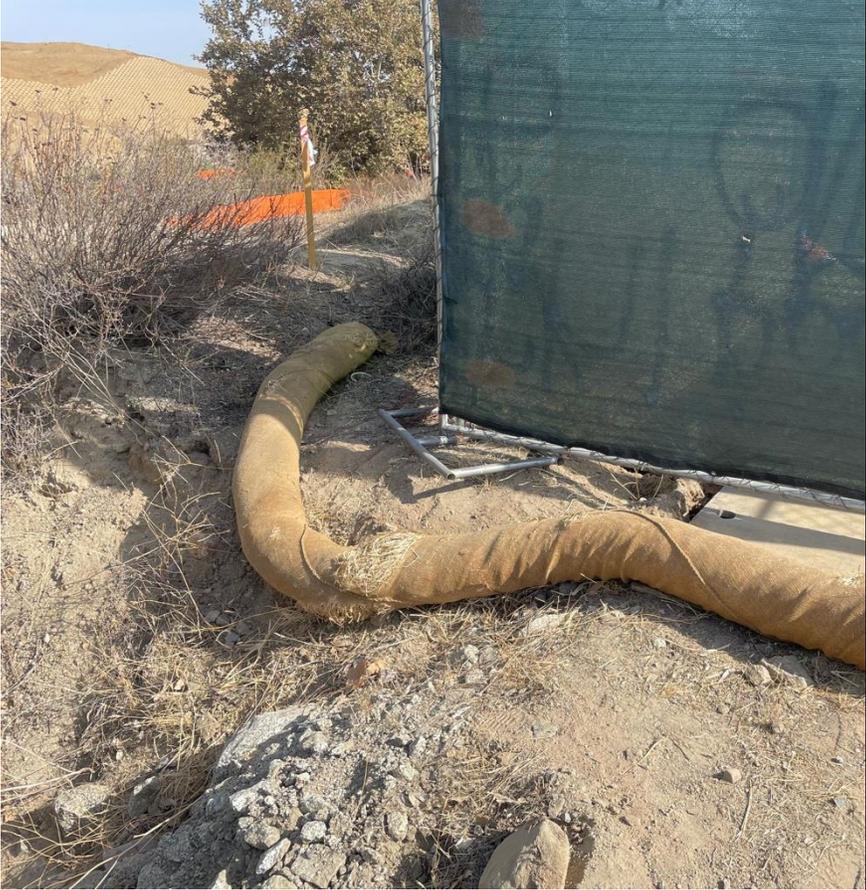
Photo 11 – The bore pit exit hole required additional animal barriers.

RECOMMENDED FOLLOW-UP (i.e., items to check on next visit, minor issues to resolve)  
Ensure all bore holes are covered to prevent animals from falling in.
