Re: Monthly Report Summary #13 for the Mesa 500-kV Substation Project

ATTACHMENT 1

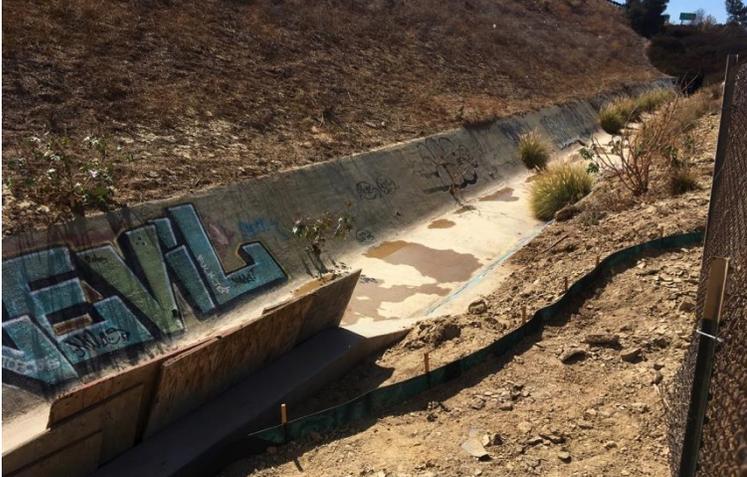
<p>Photo 4 – The offsite drainage ditch has been cleared of sediment.</p>
10/1/18	Mesa substation

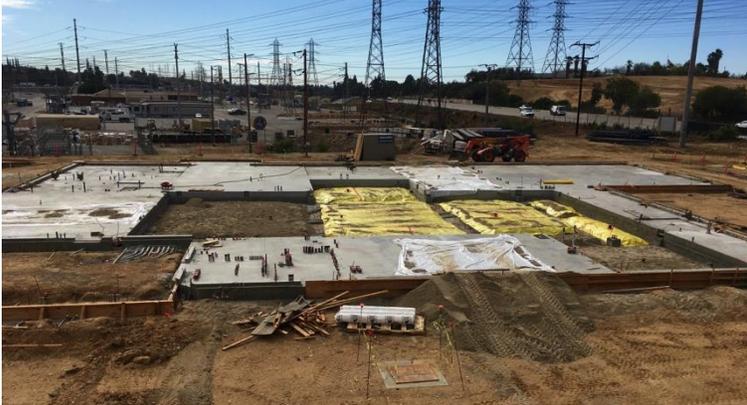
Construction of the Operations Building construction continues. The majority of the building foundation/floors have been poured – Photo 13.

Photo 13 – Mesa Operations Building work (building foundation visible). Photo facing south

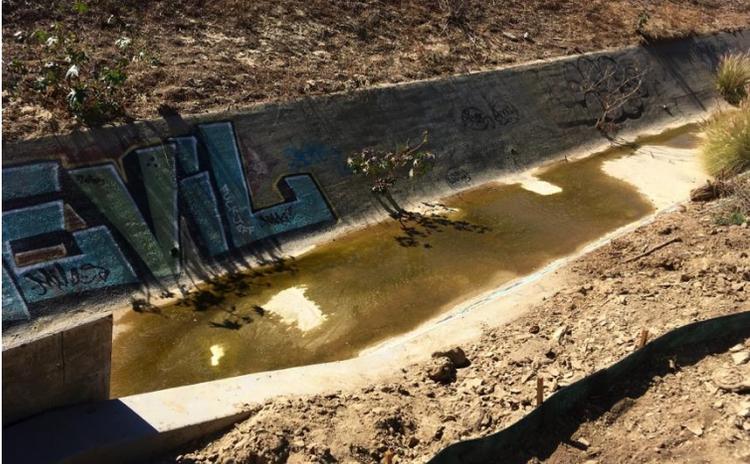
Photo 6 – The offsite drainage ditch contains some water from recent flows from the Marketplace, but has been cleared of sediment.

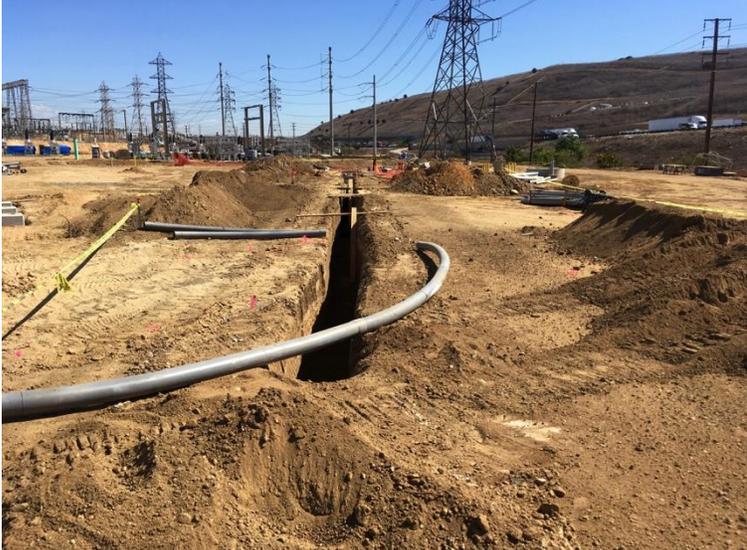
There were substantial conduit trenching and installation activities from the Marketplace HDD location to the 66-kV rack area – Photo 7. Wooden escape ramps were placed in the trench at regular intervals, but they were very steep (MM BR-10). I discussed this with lead monitor Matt Daniele (ICF) who agreed that the ramps were steep, so he was having his crew carefully inspect the trenches each morning; the biological monitors have not observed any animals in the trenches.

Photo 7 – Conduit installation. Photo facing east.
10/12/18	Mesa Substation

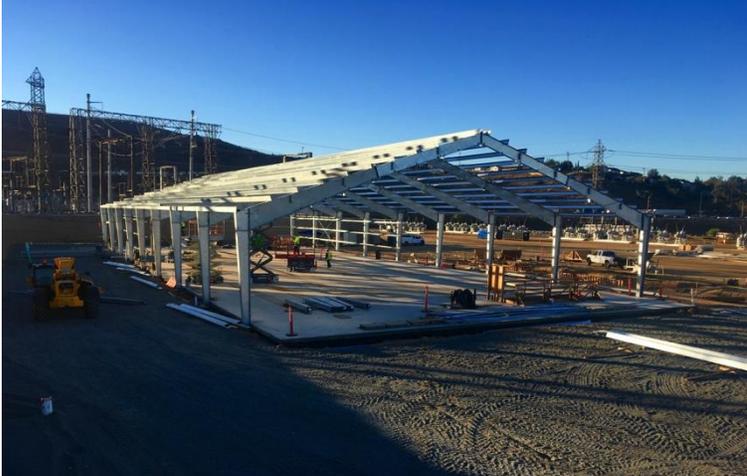
Senior Mechanical Electrical Equipment Room (MEER) construction continues, with some foundation work being done along the MEER's western side – Photo 1, Photo 2. A generator was being utilized for some MEER activities, and it was well-contained. There will be a concrete pour at the MEER soon.

Photo 1 – The Senior MEER with the building installation (walls and roof). Photo facing south.
10/19/18	Mesa substation

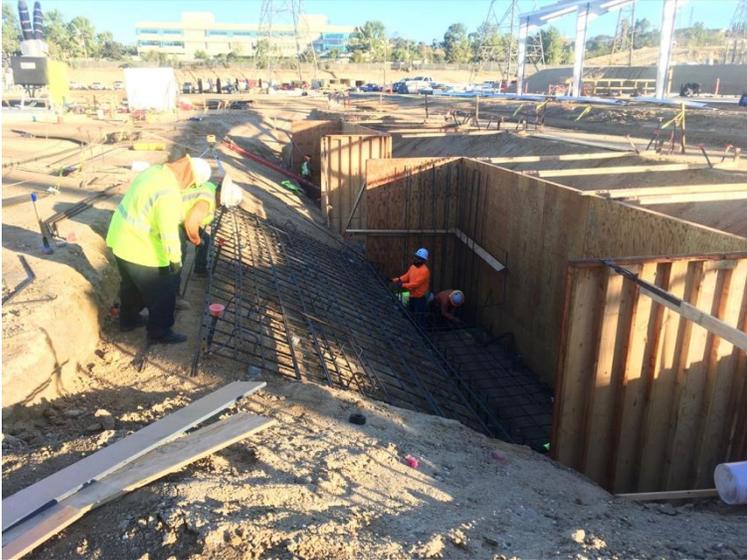
Photo 2 – Construction and concrete foundation work near the Senior MEER. Photo facing north.
10/19/18	Mesa substation

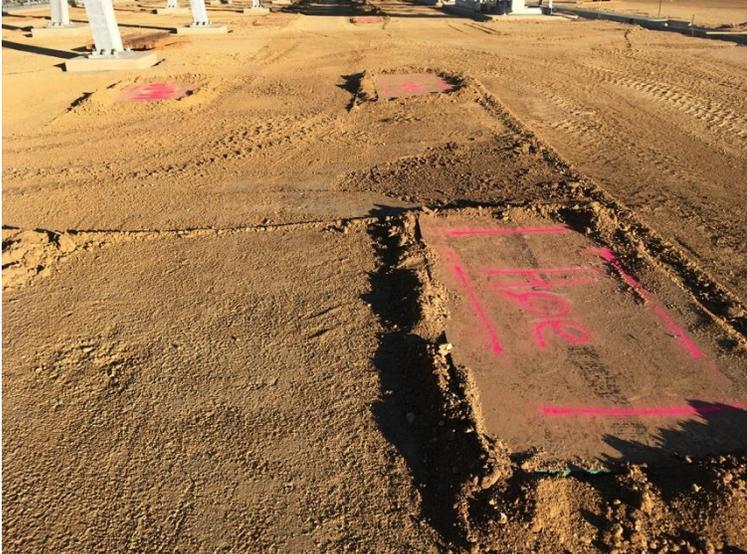
Photo 3 – The numerous open holes in and around the various rack areas are covered with plywood and sealed with dirt.

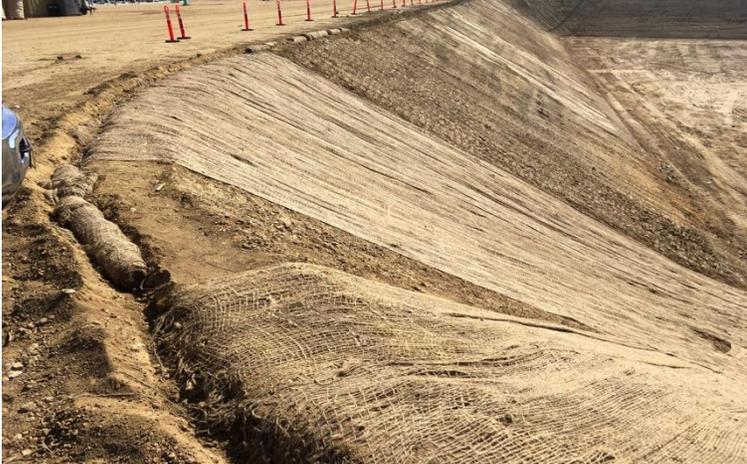
Crews were installing jute netting on the banks of the detention basin – Photo 5. The north-facing slope near the Markland Hotel (offsite) is fully covered with jute netting; crews are installing wattles within this area (both jute and wattles are installed correctly) – Photo 6. I discussed the project conditions with biological monitor Wayne Woodroof (MM BR-1, APM-BIO-03, APM-BIO-04, APM-BIO-06, MM BR-2).

Photo 5 – Jute netting installed along the detention basin slopes. Photo facing south
10/25/18	Mesa substation

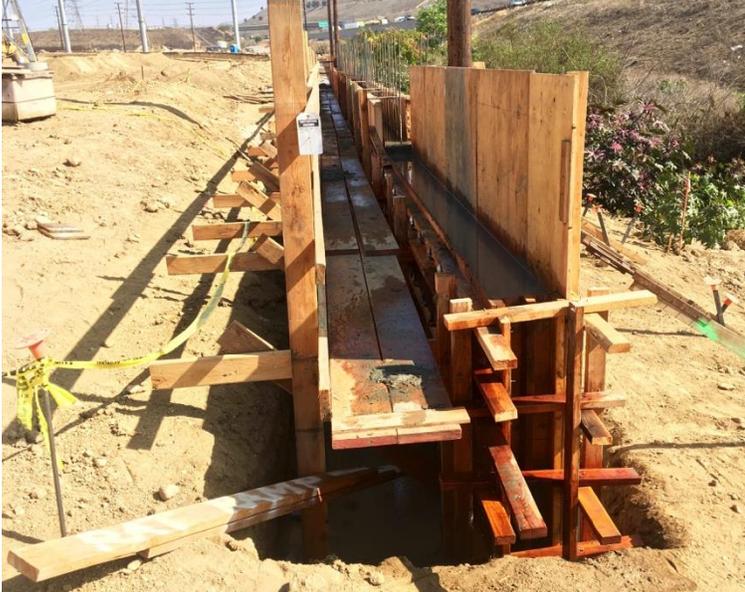
A portion of the “combo wall” along the southern boundary has been poured, and crews continue drilling holes in the wall foundation – Photo 7.

Photo 7 – A concrete pour as part of southern boundary “combo wall” installation. Photo facing east.
10/25/18	Mesa Substation
