January 11, 2019

**Re: Monthly Report Summary #14 for the Mesa 500-kV Substation Project**

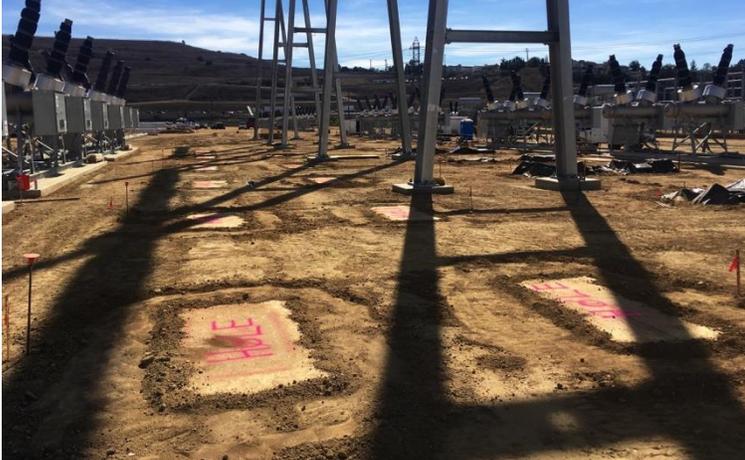
There were numerous foundation holes within the 220-kV rack area; the holes remained covered – Photo 2.

Photo 2 – Tower foundation holes, appropriately covered with plywood (with dirt sealing the edges of the plywood), and labeled within the 220-kV rack area. Photo facing south

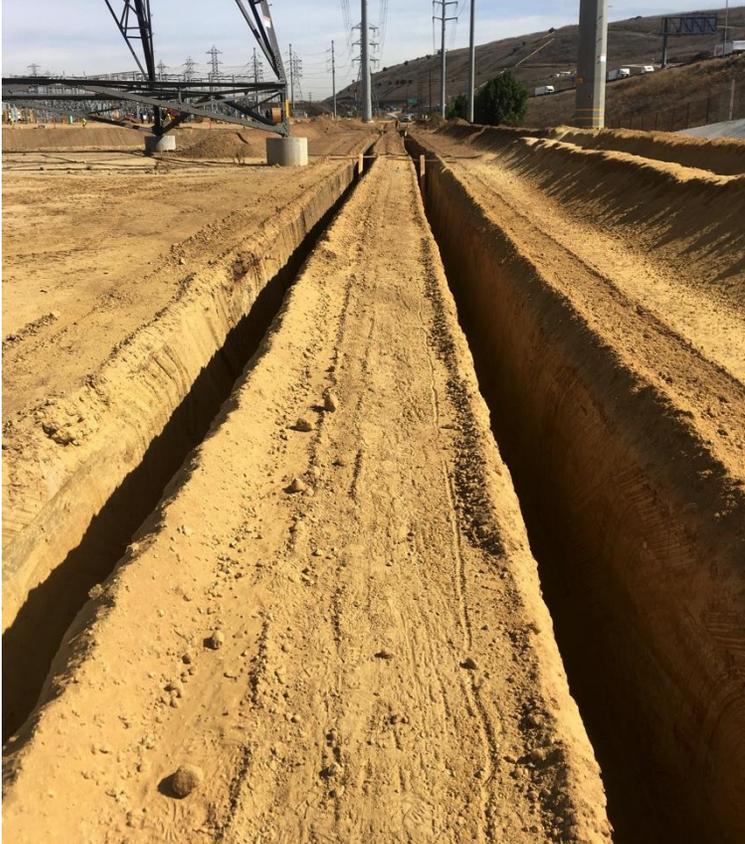
<p>Photo 6 –Conduit trenches remain open, but escape ramps/structures are in place; fugitive dust control methods (water) should be applied to suppress trench spoil dust. Photo facing east</p>
11/01/18	Mesa substation

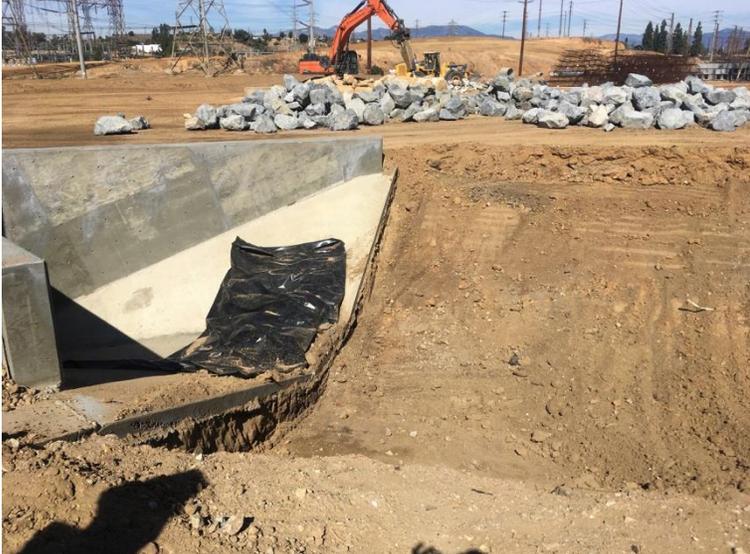
<p>Photo 8 – Riprap installation to be completed between the Highway 60 storm drain (offsite) and the onsite storm water drainage system. Photo facing east</p>
11/01/18	Mesa Substation

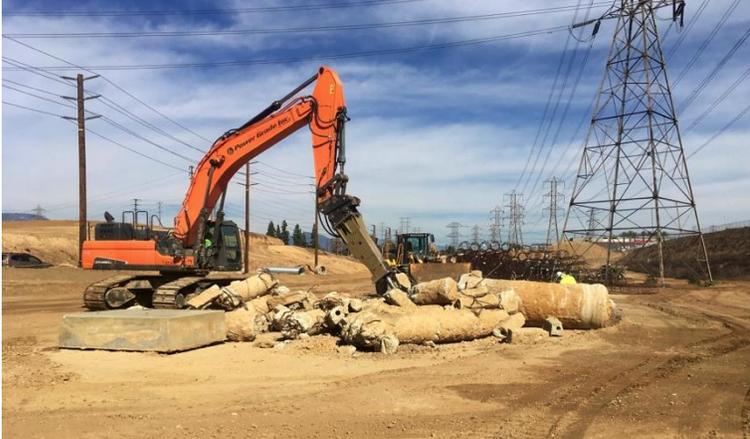
An excavator with a breaker bar was removing rebar from the old concrete tower foundations so that the demolished material can be hauled offsite to be recycled – Photo 9.

<p>Photo 9 – Crews are demolishing old tower foundations. Photo facing east</p>
11/01/18	Mesa Substation

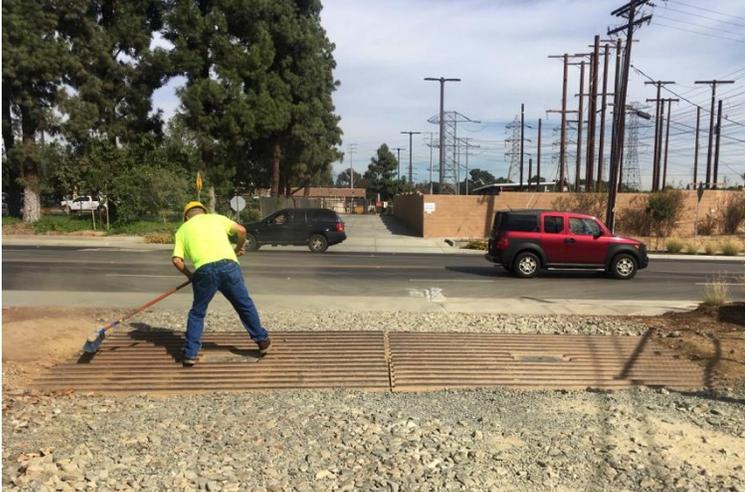
I observed the street sweeping that occurs several times per day; the street sweeping operator also swept the rumble plates at the various project entrances/exits – Photo 12.

Photo 12 – Crew cleaning the rumble plates at the eastern entrance to the project site. Photo facing east
11/01/18	Mesa substation

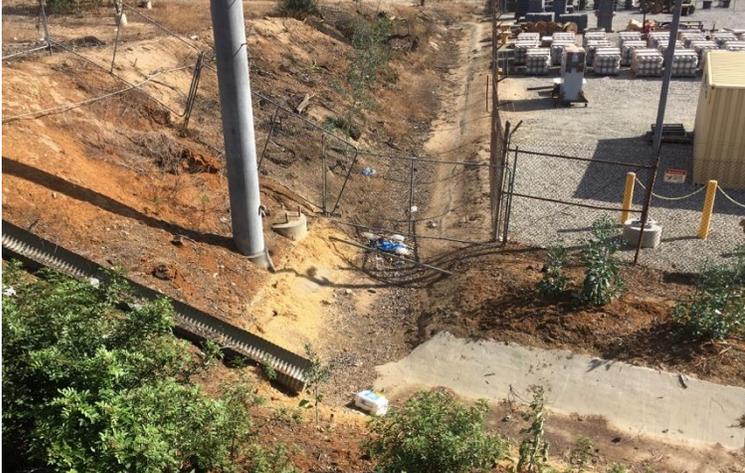
I observed trash in the drainage channel that runs around the old Mesa Substation Site before reaching a dead end at the project entrance, where the water is pumped into the stormwater drainage system – Photo 13, Photo 14. I talked to Craig Pernot (Power Grade Safety Lead) about the trash and the handling of stormwater runoff.

Photo 13 – Accumulated trash and sediment in the drainage channel running along the outside of the old substation.

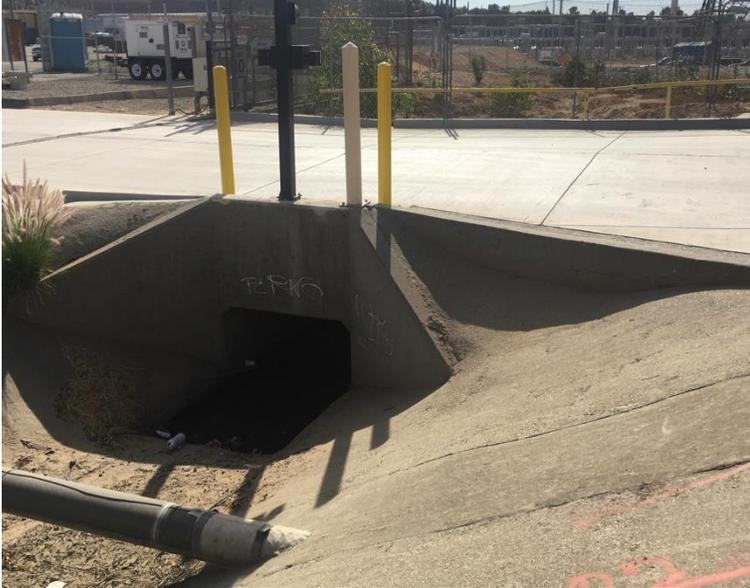
Photo 14 – Old drainage channel that dead-ends at the project entrance. Photo facing west

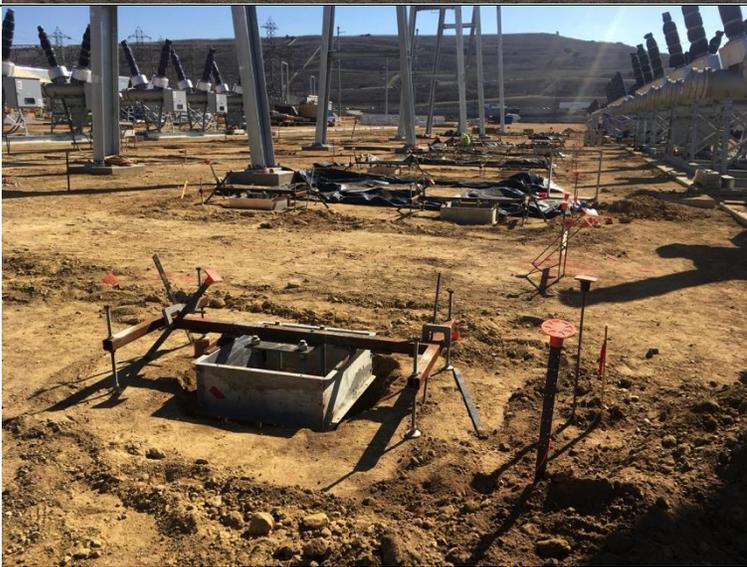
Crews were installing foundations within the 220-kV rack area. The drilled holes now have a rebar cage in them and will be poured soon. – Photo 2.

Photo 2 – The previously covered tower foundation holes now have rebar cages installed. Concrete will be poured for the foundations. Photo facing south

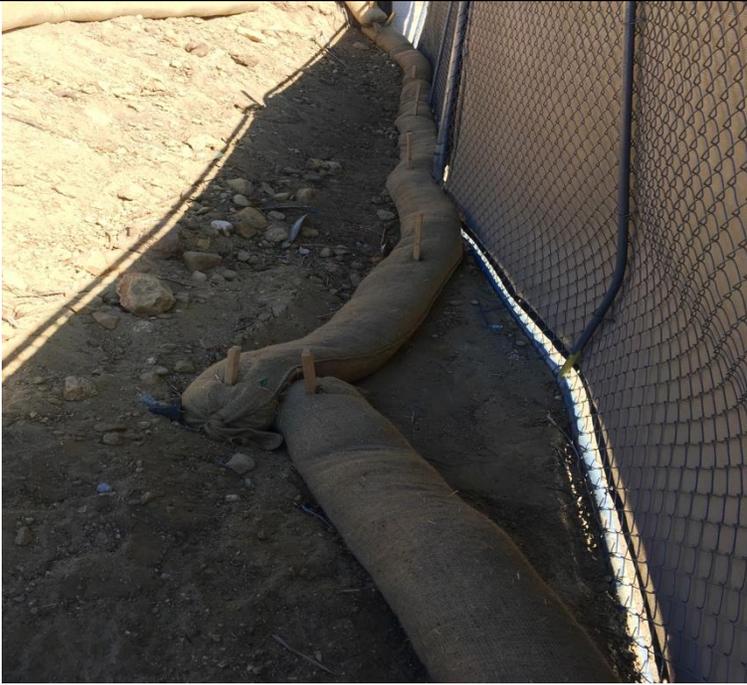
Photo 10 – A street drain covered by dirt and wattles.

I walked by the telecommunications corridor north of Potrero Grande and noted that the existing drain inlet located at the base of the steep, wattle-covered slope was still covered. I will discuss this with Lucy Cortez-Johnson, the Qualified SWPPP Practitioner (QSP).

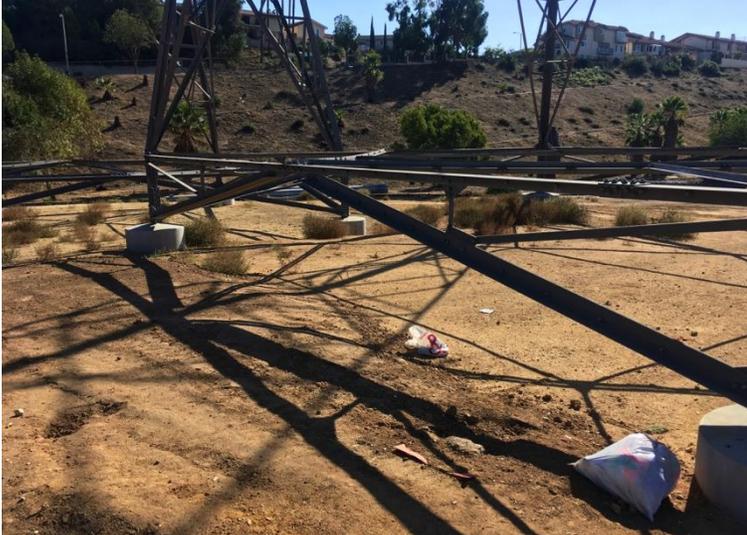
There is substantial accumulated trash and invasive Russian thistle along the telecommunications corridor south of Highway 60 – Photo 11. From the telecommunications corridor, I observed a water truck applying water to the conduit trench spoils.

A photograph showing a telecommunications corridor. In the foreground, there are several metal structures, possibly part of a tower or antenna array, on a dirt ground. There is some trash, including a white plastic bag, and some weeds. In the background, there are hills and some residential buildings under a clear blue sky.	Photo 11 – Trash and weeds within the telecommunications corridor south of Highway 60. Photo facing southwest

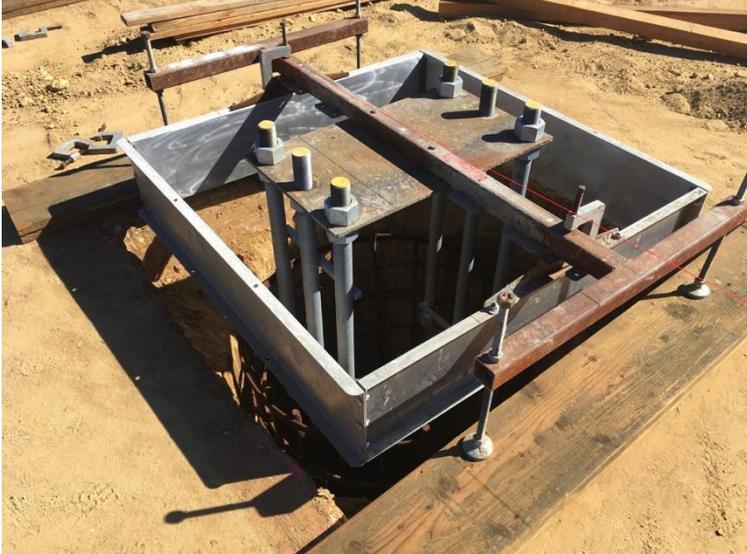
Foundation installation continues in the 220-kV rack area, with rebar cages and associated bolt attachment systems surrounding numerous holes – Photo 2. The holes were uncovered and it is unclear if they were covered overnight (there were no tarps in the area). Many foundations had already been poured with concrete. I asked lead biological monitor Matt Daniele (ICF) when the remaining foundations would be poured, and reminded him that they should be covered overnight to prevent wildlife from becoming entrapped. – Photo 3.

<p>Photo 2 – Previously covered foundation holes now have rebar cages installed; the foundation holes will be poured soon. Photo facing south</p>
11/14/18	Mesa substation

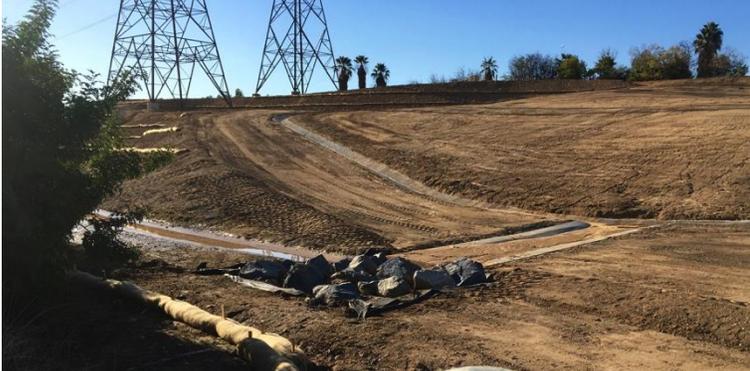
The telecommunications area north of Potrero Grande Drive has BMPs installed, but it has not yet been hydroseeded. Rainwater runoff from a previous storm caused some rilling within this area, and some sediment eroded into the “V” ditches – Photo 3. QSP Lucy Cortez-Johnson said that she would talk to crews about removing the sediment and upgrading the BMPs in this area.

Photo 3 – The “v”-ditches have filled with sediment. Photo facing north
11/26/18	Mesa substation

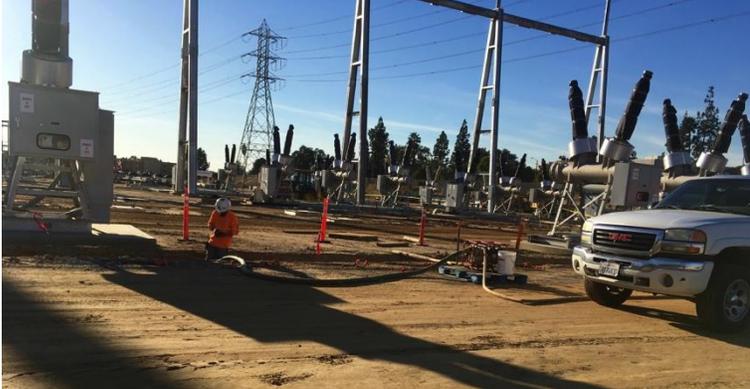
A crew was pumping rainwater runoff out of trenches and into a water buffalo (water trailer); crews used this water to spray site-wide for fugitive dust suppression – Photo 5. There is some runoff remaining in one of the foundation trenches – Photo 6.

Photo 5 – Crews pumping water out of trenches. Photo facing west

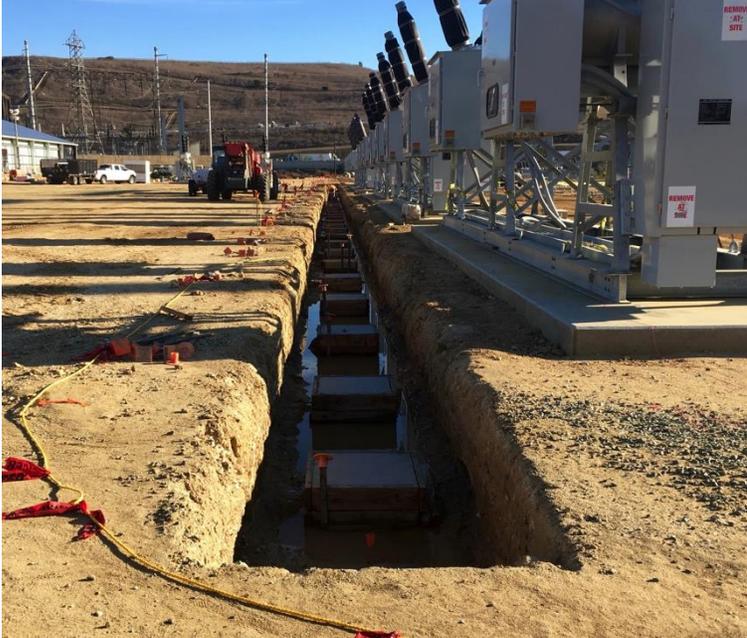
Photo 6 – Trenches with rainwater runoff in the 220-kV rack area. Photo facing south
11/26/18	Mesa substation

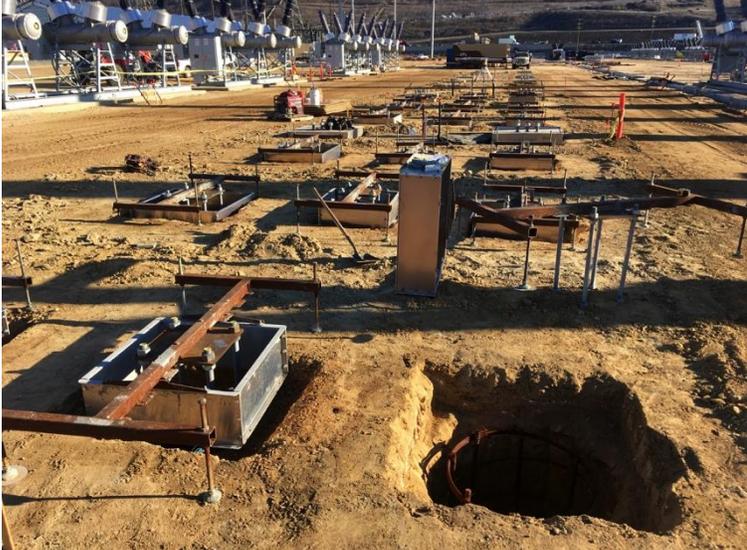
Foundation installation in the 220-kV rack area continues; numerous open holes now have rebar cages and bolt attachment systems installed – Photo 7. I reminded biological monitor Wayne Woodroof (Noreas) to ensure that the foundation holes are covered up if concrete is not poured today.

Photo 7 – Open foundation holes in the 220-kV rack area with rebar and forms installed. Photo facing south
