October 8, 2018

**Re: Monthly Report Summary #10 for the Mesa 500-kV Substation Project**

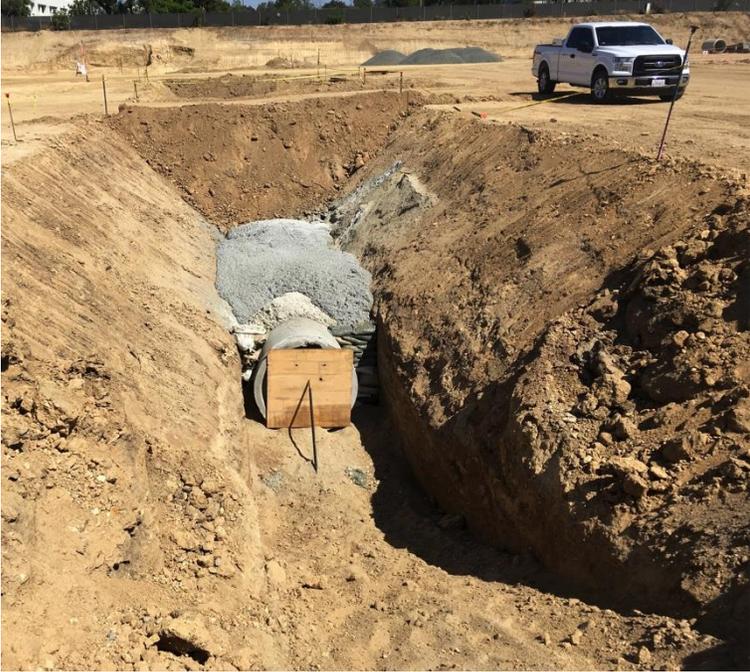
Photo 5 – Storm drain trench remains open. Photo facing north.

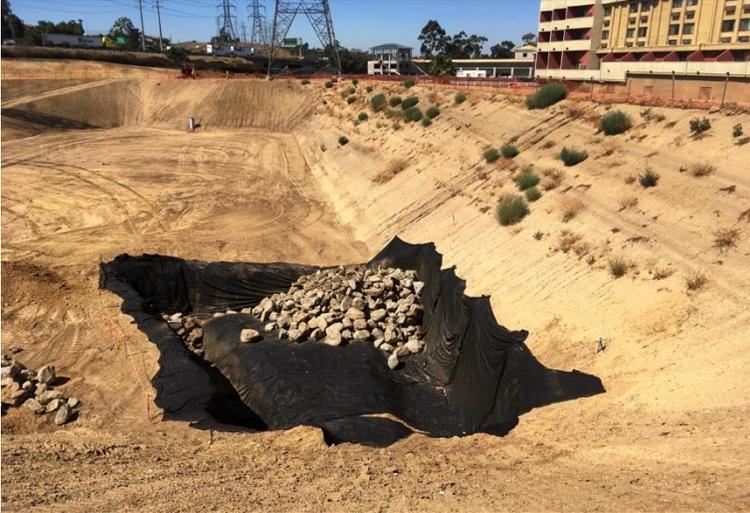
Photo 8 – Detention basin with riprap being brought in. Weeds on the slopes are becoming established and setting seed. Photo facing west.
08/08/18	Mesa Substation

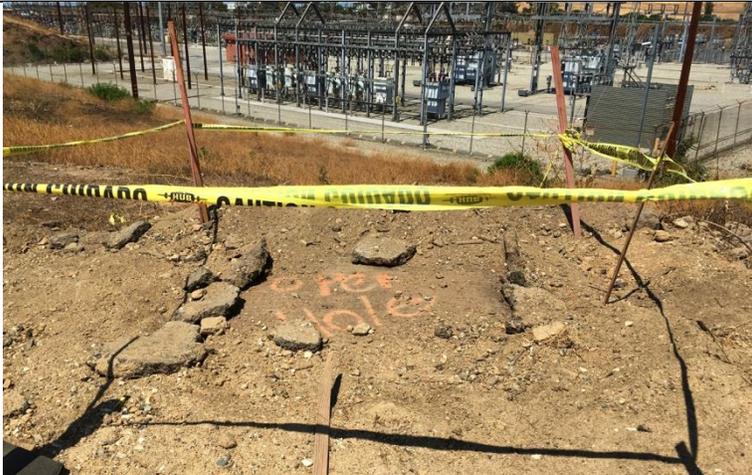
The partially covered hole noted during a previous site visit had been sealed with plywood, rock, and pieces of asphalt (Photo 13).

Photo 13 – Covered hole near the eastern project entrance now sealed. Photo facing north.

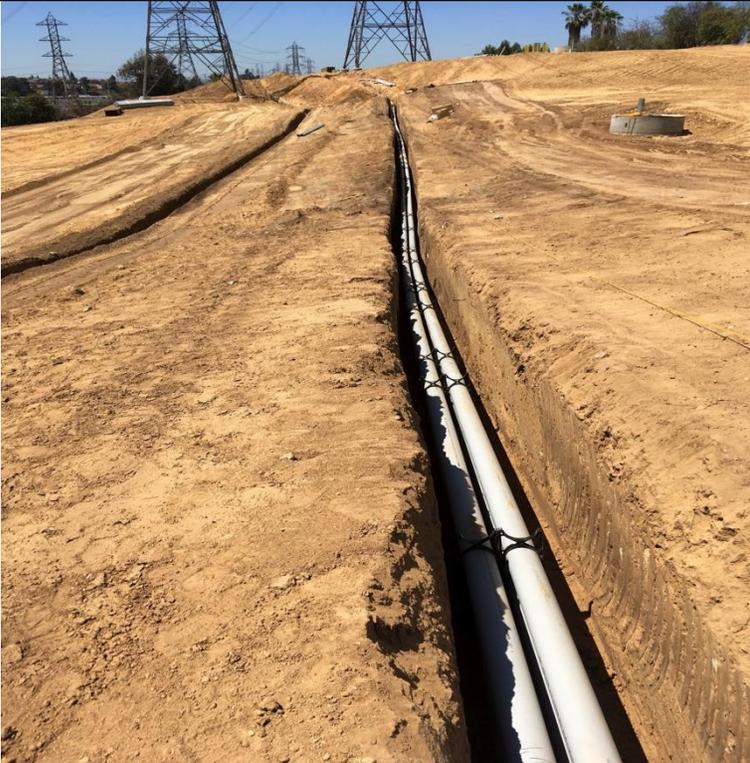
Trenching and conduit installation was being conducted along the Transmission Corridor north of Potrero Grande Drive (Photo 15). I noted a lot of trash in the area, and there was no trash bin to collect it in. In addition, the work area needed dust control, and there were no escape ramps in the trenches. I sent a text to Mesa Project Coordinator Pete Lubich (ULM Services, Inc.) about my concerns with work in this area. According to the biological monitors, wooden escape ramps were installed before the end of the day.

Photo 15 – Conduit trenching and installation within the Transmission Corridor north of Potrero Grande Drive. Photo facing west.

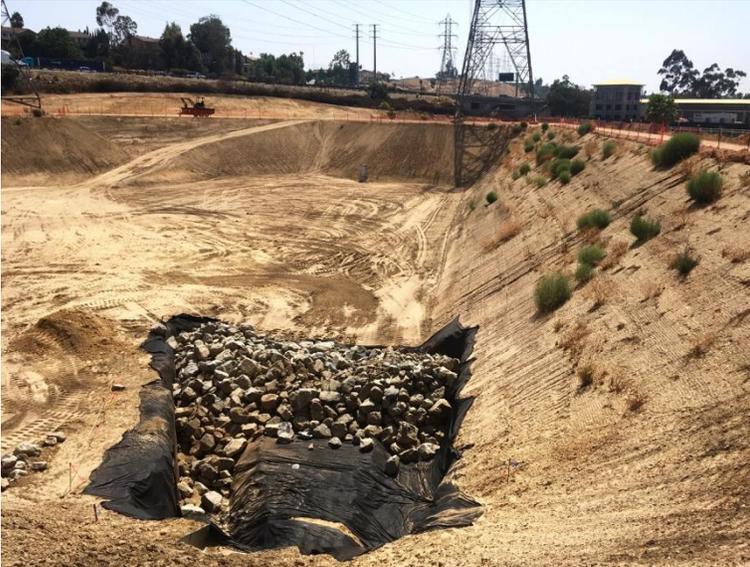
The detention basin remained in the same condition as my last site visit, with some riprap installed and weeds remaining on the slopes (Photo 6).

Photo 6 – Detention basin. Photo facing southwest.

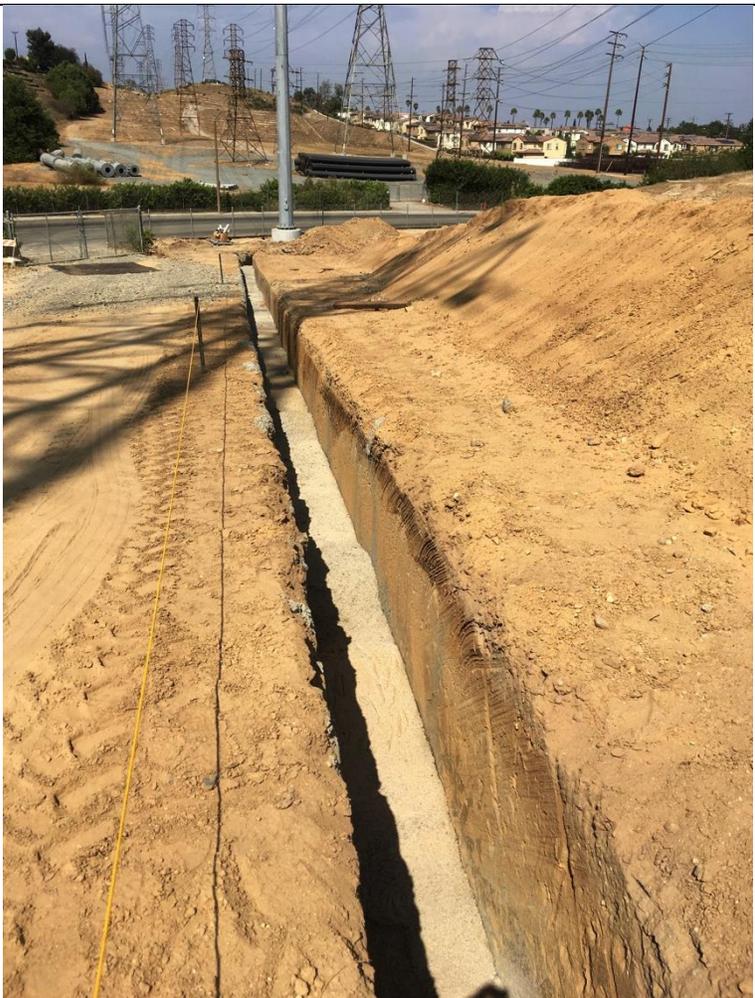
<p>Photo 14 – Conduit trench within the Transmission Corridor north of Potrero Grande Drive. There are no escape ramps in the trench. Photo facing east.</p>
08/16/18	Mesa Substation

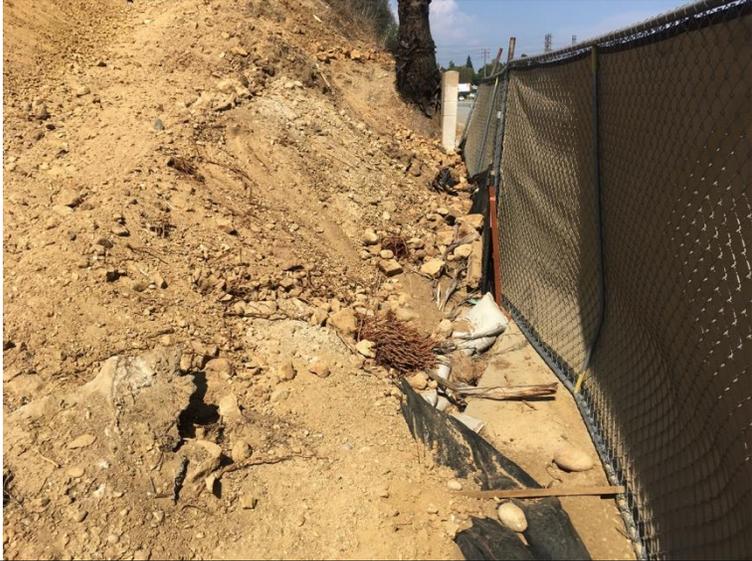
<p>Photo 16 – Street drain near the Potrero Grande Drive HDD exit hole within the Transmission Corridor is in need of debris removal and recontouring. Photo facing east.</p>

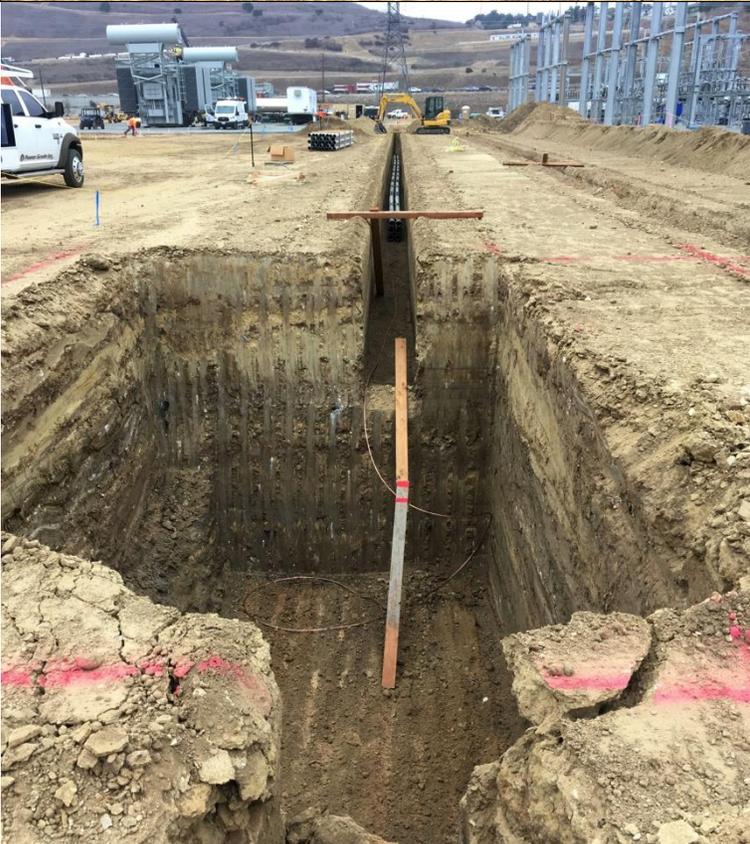
Conduit installation continued from the Potrero Grande Drive HDD location (Photo 6), with trenches leading into the 220-kV switchrack area (Photo 5). Vaults were added at numerous locations; these required very deep, straight-walled excavations. Wooden escape ramps had been placed in the conduit trench and in the vault excavations; however, the vault ramps appeared to be wholly inadequate (MM BR-10). Other solutions should be considered.

Photo 5 – Conduit vault and trench with wooden escape ramps. Photo facing south.

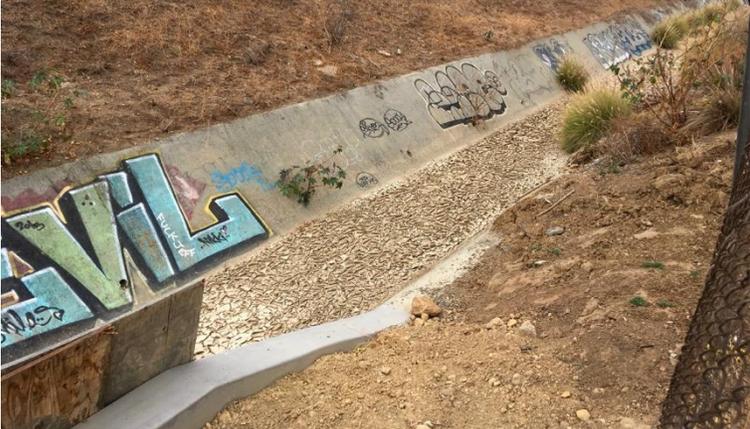
Photo 11 – Dried mud in the offsite drainage channel.
08/21/18	Mesa Substation

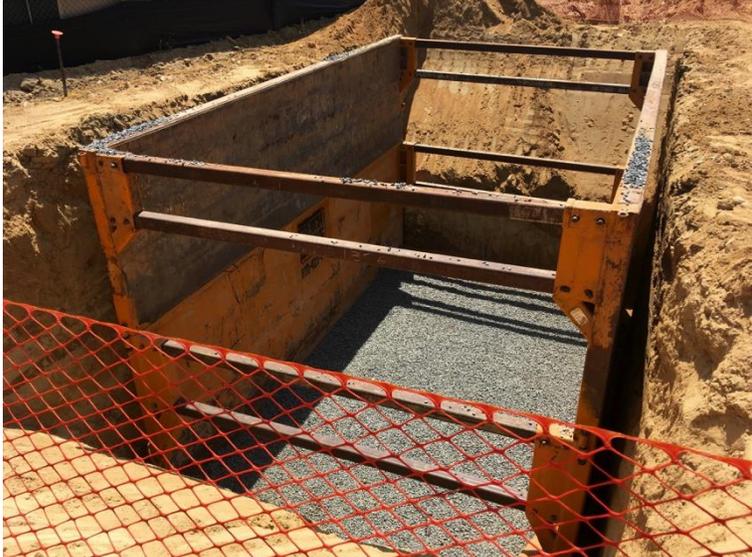
Photo 17 – Conduit vault near the Potrero Grande Drive HDD exit hole; note the lack of any exclusion fencing or escape ramps.
