January 13, 2020

Connie Chen
Project Manager
California Public Utilities Commission
505 Van Ness Avenue
San Francisco, CA 94102

Re: Monthly Report Summary #17 for the Mesa 500-kV Substation Project

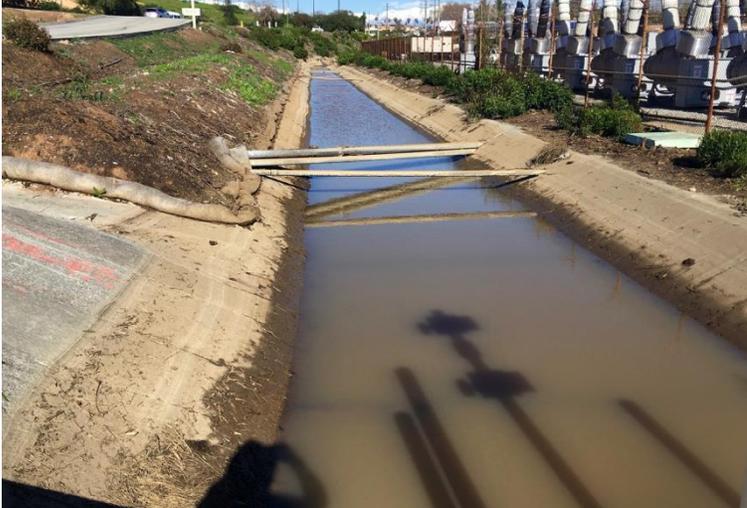
Photo 2 – Concrete channel surrounding the substation is full. Photo facing east.
2/6/19	Mesa Substation

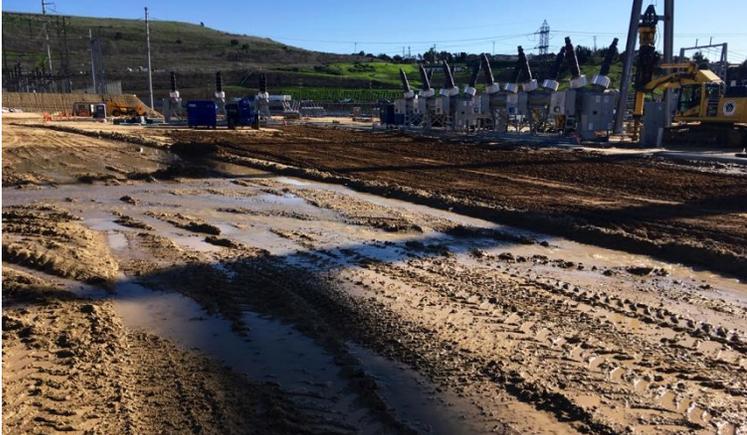
Photo 5 – Flowing water through the site and very muddy conditions. Photo facing south.

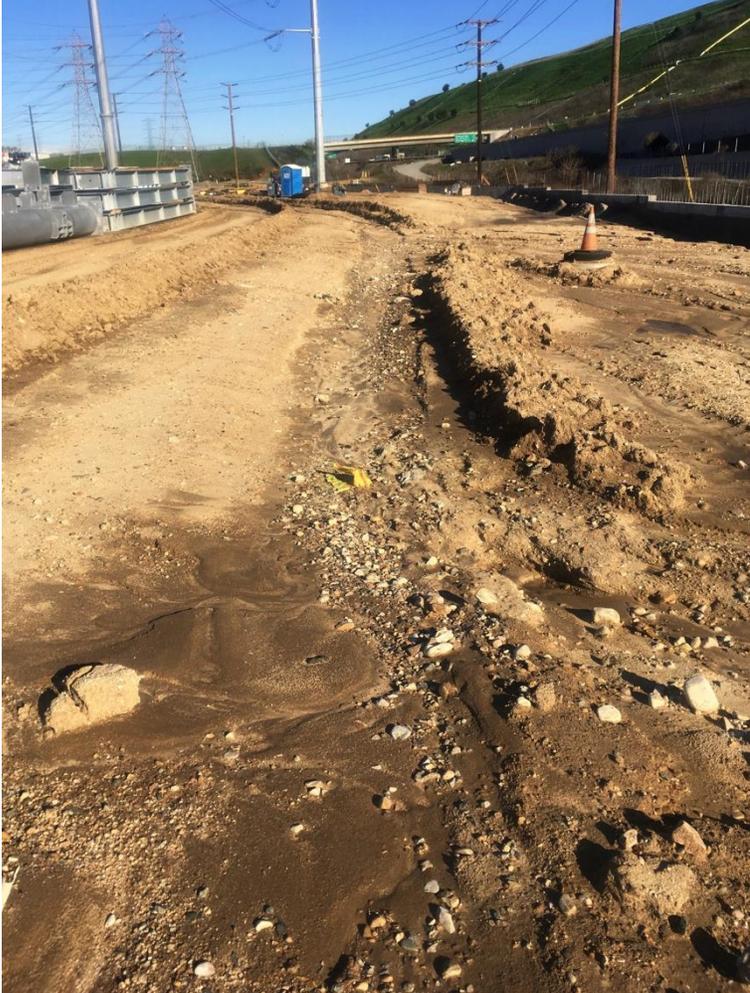
- On February 6, 2019, the CPUC Compliance Monitor observed a berm that required repairs. The berm is intended to redirect surface flows, including pumped conduit vault water, into the detention basin. The Compliance Monitor indicated that the berm required repairs prior to upcoming forecasted rain events, to reinstate redirection of surface flows into the large detention basin.
- On February 6, 2019, the CPUC Compliance Monitor noted that although SCE had re-sealed the standpipe in the large detention basin with plastic and installed gravel bags, this may not effectively retain water within the basin, as the plastic sheeting failed previously.

Photo 12 – Diversion berm breached at several locations. Photo facing east.

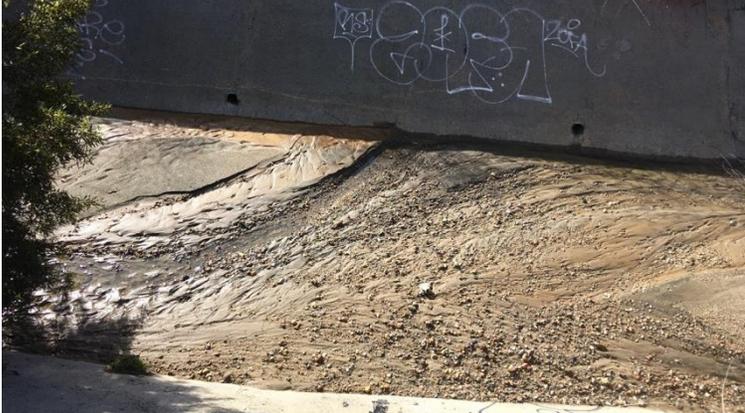
- On February 12, 2019, the CPUC Compliance Monitor noted that the Caltrans channel contained a significant amount of sediment had dropped out in it just downstream of the southern wall gate opening. The Compliance Monitor indicated that the diversion berm was breached and water flowed along a portion of the southern wall and eroded some of the fine, grey colored sand used to backfill the wall, and then subsequently eroded the small slope in the gate opening. Removing remaining sediment was recommended.

I examined the Caltrans channel and noted that a lot of sediment had traveled into it, just downstream of the opening to the southern boundary wall gate – Photo 7. When the diversion berm was breached, water flowed along a portion of the southern boundary wall and eroded some of the fine, gray-colored sand used to backfill the wall. This water subsequently eroded the small slope in the gate opening. The small slope in the gate opening had been restored with BMPs – Photo 8. In addition to the mud and rock in the Caltrans channel, there appeared to be gray sand. I spoke to the Power Grade foreman, Willie Clark, about removing the sediment.

Photo 7 – Sediment in the Caltrans concrete channel outside of the project boundary.
2/12/19	Mesa Substation

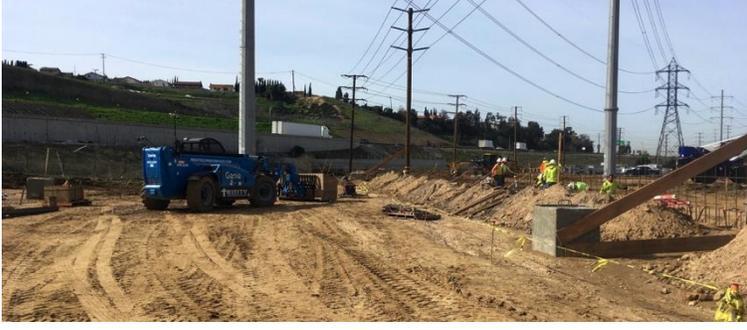
Photo 12 – Wall foundation trenching now prevents diverted rainwater runoff toward the detention basin. Photo facing southwest.

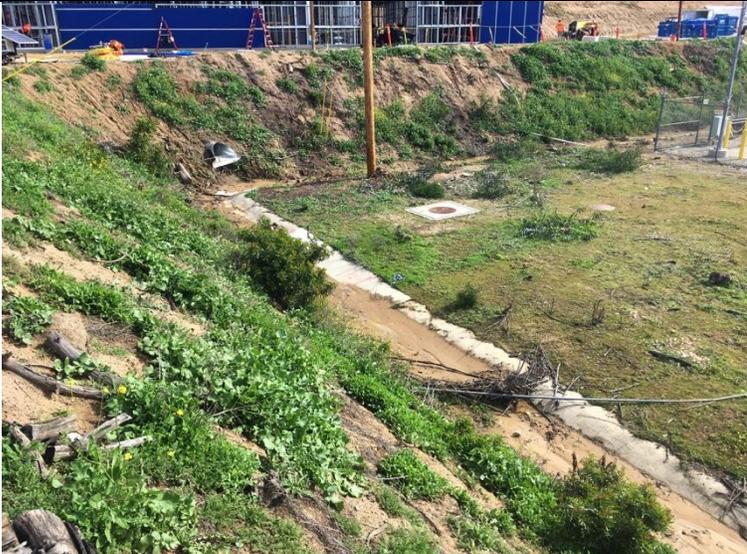
<p>Photo 15 – Mesa Operations Building, stormwater drains into the concrete channel that surrounds the substation. There is mud and debris buildup in this channel. Photo facing east.</p>

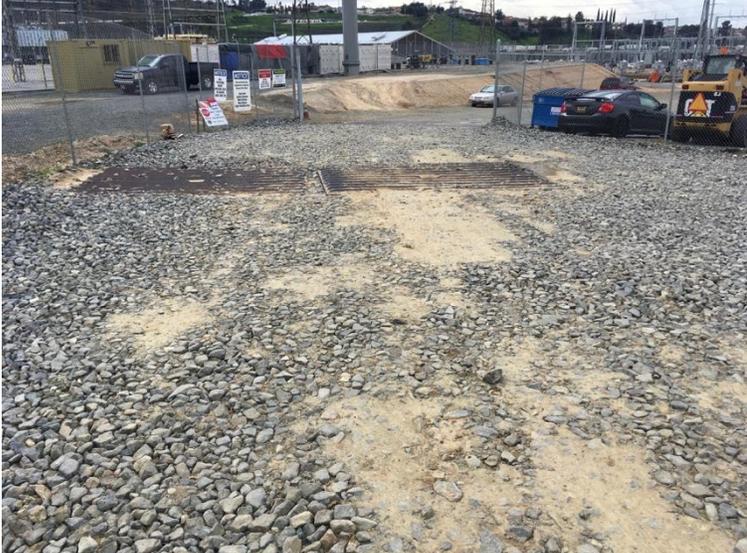
- On February 20, 2019, the CPUC Compliance Monitor observed that both entry/exits needed maintenance since dirt and mud filled in around the rock and inside the rumble plates. In addition, the concrete washout location also needed maintenance, as all the bins were full, and concrete spilled over the plastic ground cover.

Photo 2 – Exit/entry needing mud removal. Photo facing southwest.
2/20/19	Mesa Substation

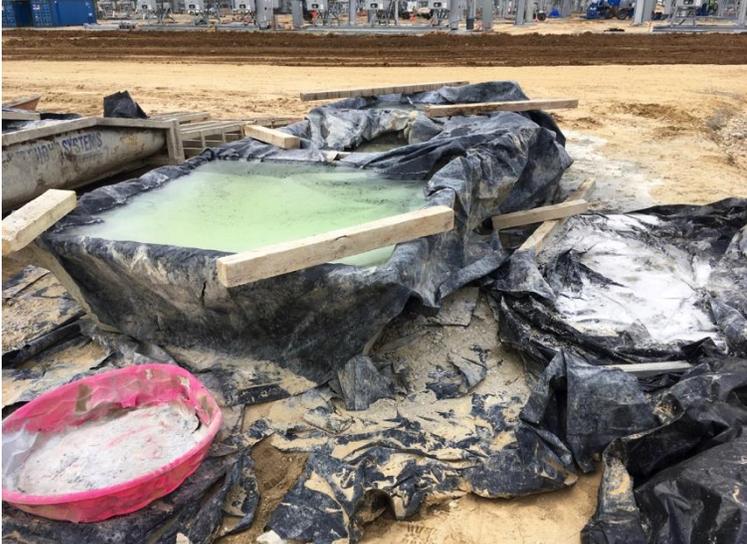
Photo 3 – Concrete washout location needing significant cleaning maintenance.

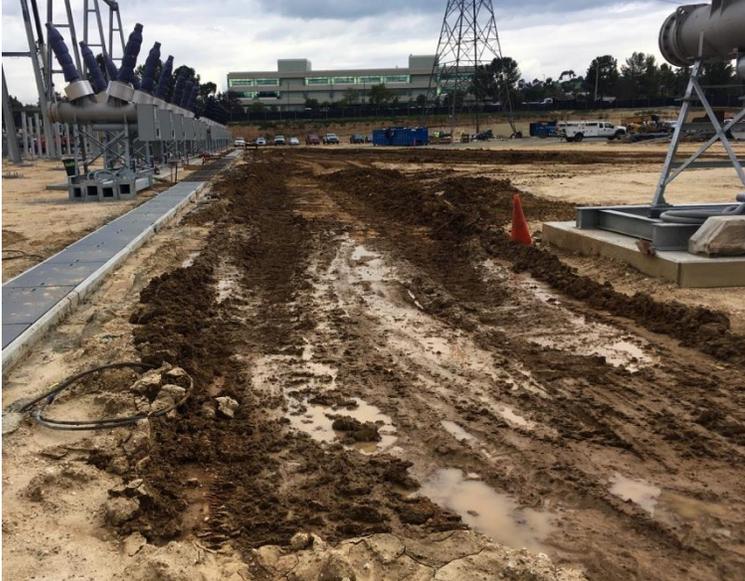
The site conditions were still muddy – Photo 4. Sediment had dropped out along the east side of the 220-kilovolt (kV) switchrack area as it was being collected by a crew using loader.

Photo 4 – Muddy conditions onsite – sediment removal is being completed. Photo facing north.
2/20/19	Mesa Substation

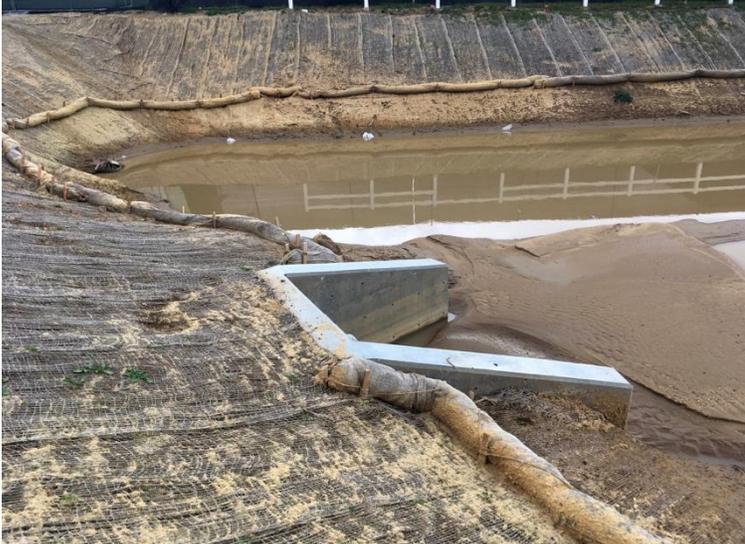
Photo 9 – Smaller triangular retention basin – note sediment that dropped out near the inlet culvert. Photo facing west.

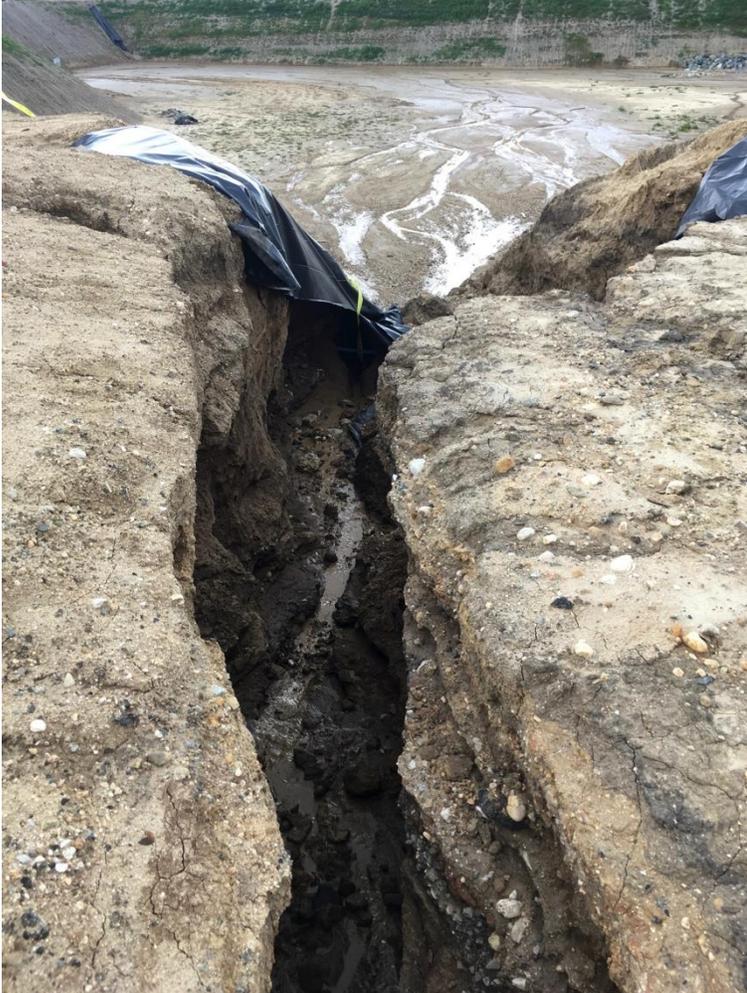
At the retention basin, water continued to drain at the base of the standpipe – Photo 8. Erosion of the basin walls continued at both the northeastern and southeastern corners – Photo 10. The small “triangular” retention basin was still full of water and sediment – Photo 9. I spoke with the Storm Water Pollution Prevention Plan (SWPPP) inspector, Lucy Cortez-Johnson (CASC), about the removal of this sediment; she said removal would be conducted when site conditions were drier. She said the site had received 3.9 inches of rain during the last week.

Photo 10 – Erosion of the southeastern corner of detention basin. Photo facing northwest.
2/20/19	Mesa Substation

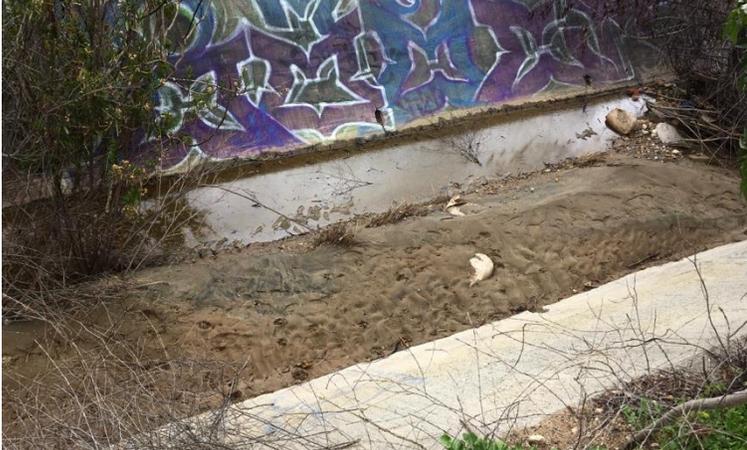
<p>Photo 13 – Some project sediment that dropped within the Caltrans channel. Located on the southern side of the substation.</p>
2/20/19	Mesa Substation

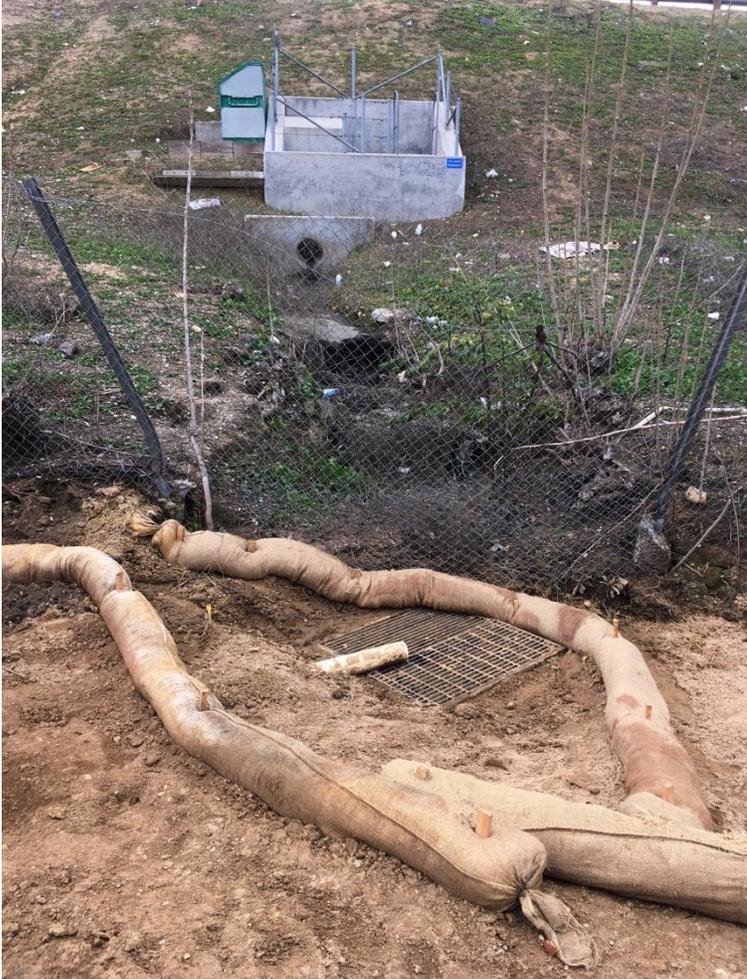
Photo 16 – Drain inlet that clogged up during the storm. The Hwy 60 outlet culvert is located south of the project drain. Photo facing south.

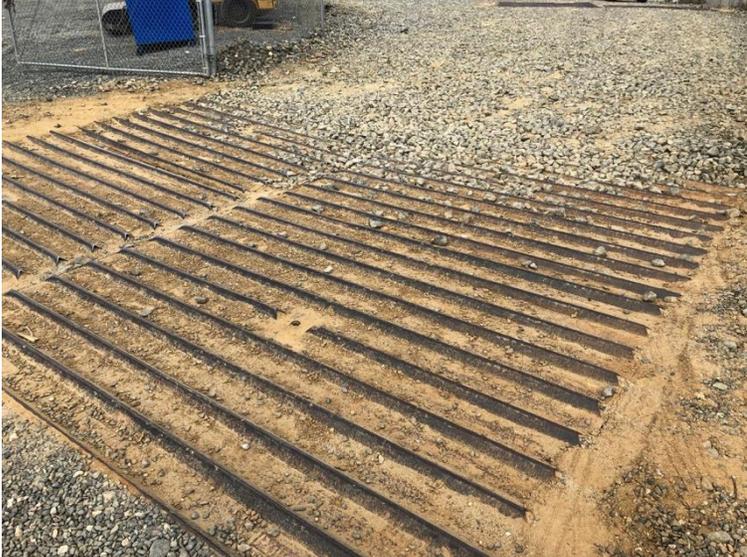
Photo 2 – Entry/exits needing maintenance.

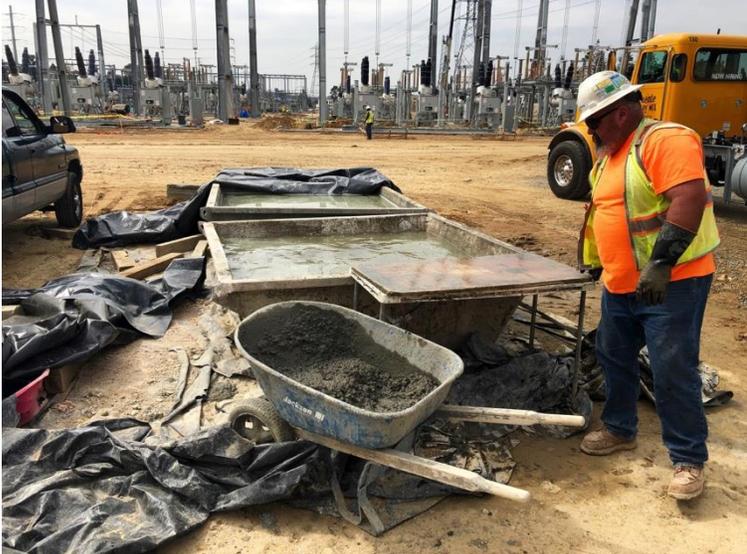
Photo 3 – Concrete washout location needing maintenance. Photo facing west.
2/27/19	Mesa Substation

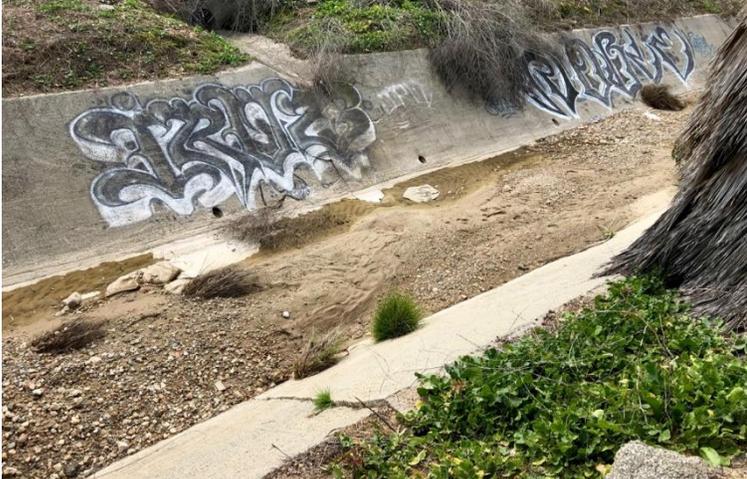
- On February 27, 2019, the CPUC Compliance Monitor examined the Caltrans channel and noted that sediment was still there. Recent rain events had washed away some of the sediment from the upper portion of the channel. The Compliance Monitor also inspected the drainage system located outside of the southern border wall and noticed no changes to the BMPs or the drain inlet grate. The Compliance Monitor recommended upgrading this area since the grate easily clogs up during a rain event.

Photo 9 – Project sediment that dropped out within the Caltrans channel.

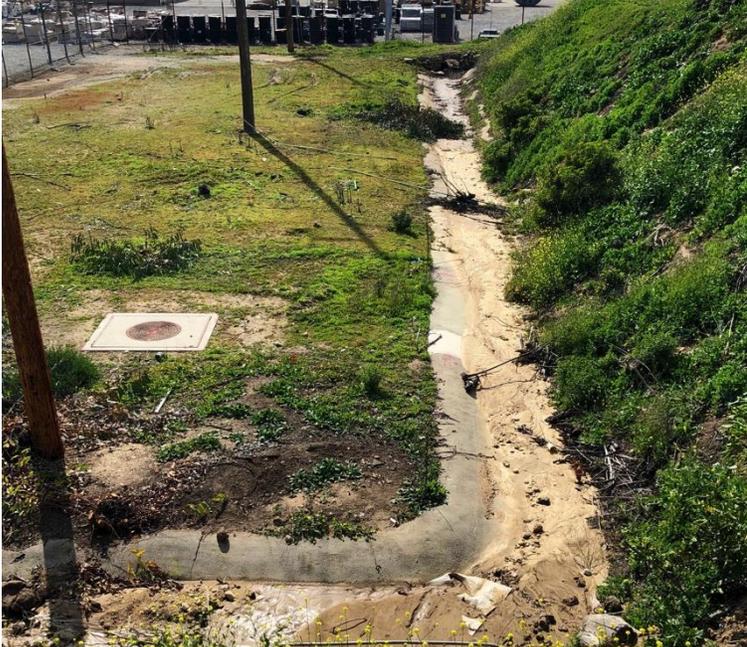
Photo 15 – Concrete drain below the Mesa Operations Building is nearly full of sediment and debris. Photo facing west.
