January 13, 2020

Re: Monthly Report Summary #18 for the Mesa 500-kV Substation Project

This report provides a summary of the compliance monitoring activities that occurred during the period from **March 1 to 31, 2019**, for the Mesa 500-kilovolt (kV) Substation (Mesa Substation) Project in Los Angeles County, California. Compliance monitoring was performed to ensure that all project-related activities conducted by Southern California Edison (SCE) and their contractors comply with the requirements of the Final Environmental Impact Report (Final EIR) for the Mesa Substation Project, as adopted by the California Public Utilities Commission (CPUC) on February 9, 2017.

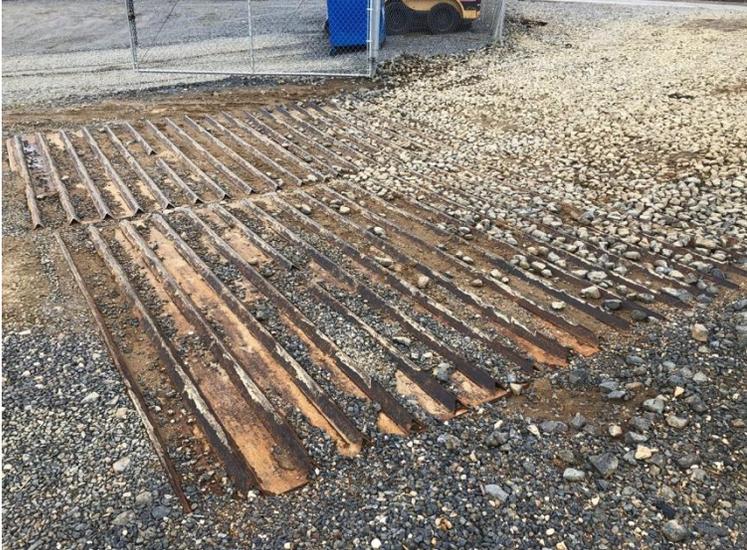
Photo 2 – Exit/entry in need of cleaning maintenance.
3/07/19	Mesa Substation

- On March 7, 13, 20, and 27 2019, the CPUC Compliance Monitor observed the Entry/Exit rumble plates at the main entrance filled with mud and rock. The CPUC Compliance Monitor recommended increasing the frequency of maintaining the rumble plates clean when safe to do so.

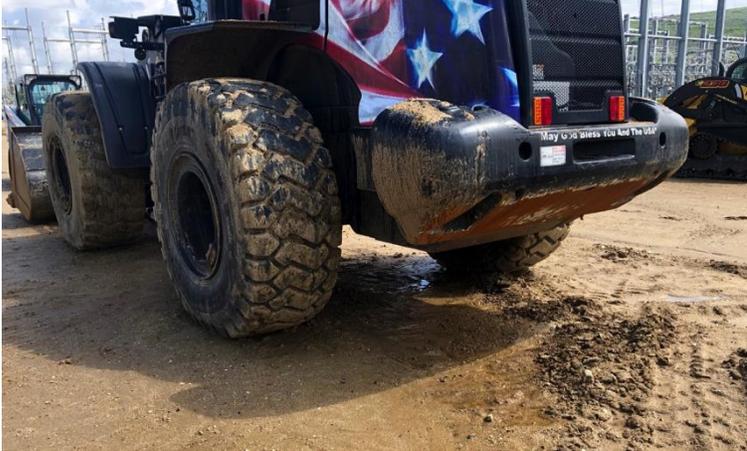
I observed a few parked construction vehicles that did not appear to have drip pans placed underneath. While other equipment had drip pans underneath, the pans were full of water– Photo 4.

Photo 4 – Parked equipment without drip pans underneath.
3/07/19	Mesa Substation

- On March 7, 2019, the CPUC Compliance Monitor noted that few parked construction equipment did not appear to have drip pans placed underneath. Some had drip pans underneath; however, they were full of water. The CPUC Compliance Monitor recommended that clean drip pans get placed underneath parked construction equipment.

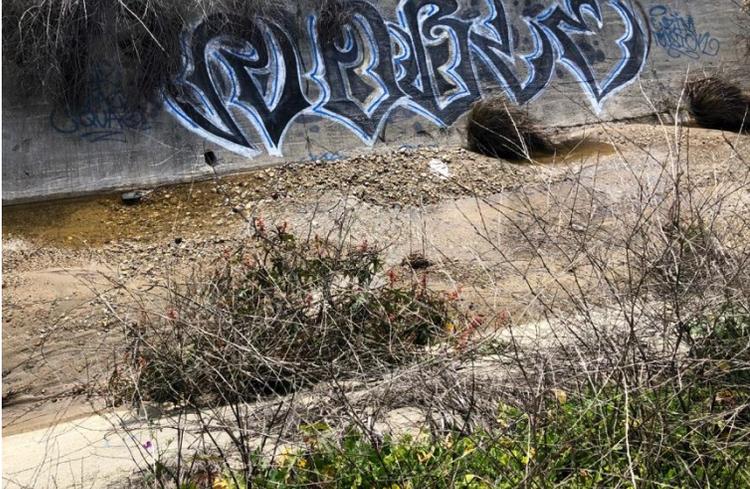
Photo 7 – Project sediment that dropped out within the Caltrans channel.
3/07/19	Mesa Substation

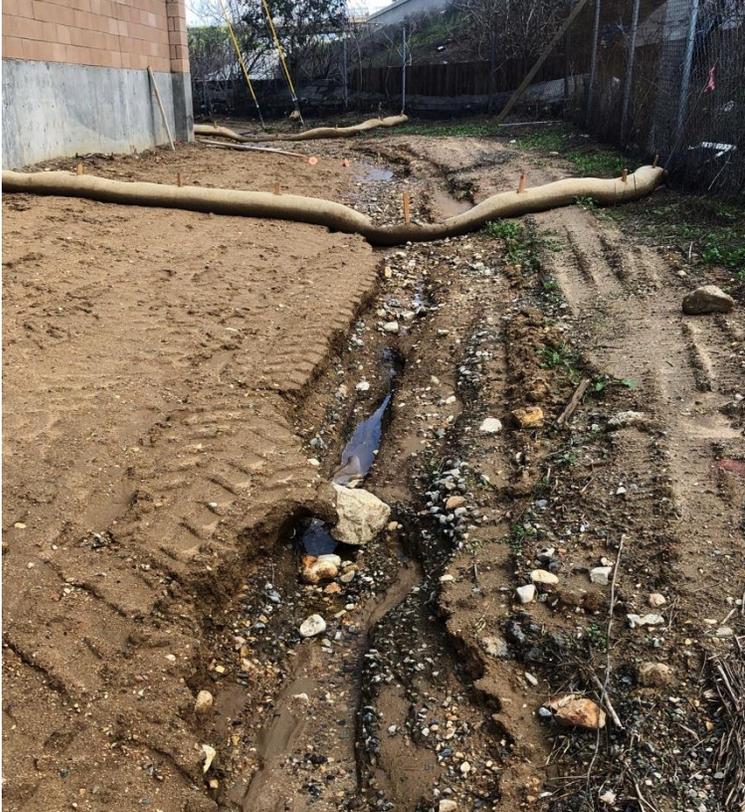
<p>Photo 9 – BMPs along the outside of the southern boundary wall – note they have been overwhelmed. Photo facing east.</p>
3/07/19	Mesa Substation

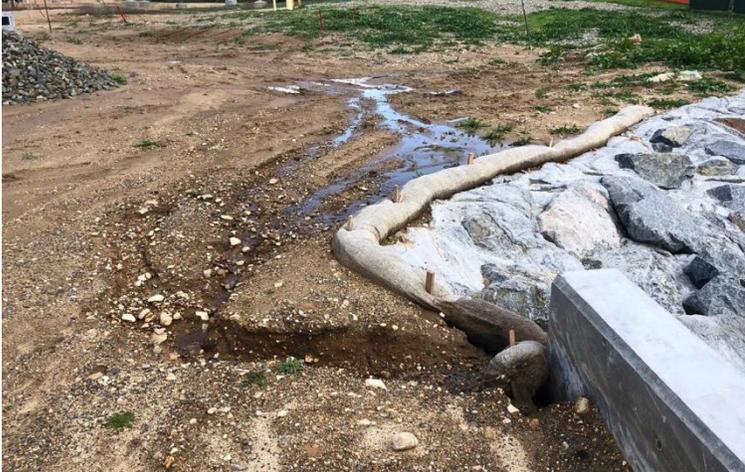
<p>Photo 10 – Project rainwater runoff entering the offsite drainage.</p>

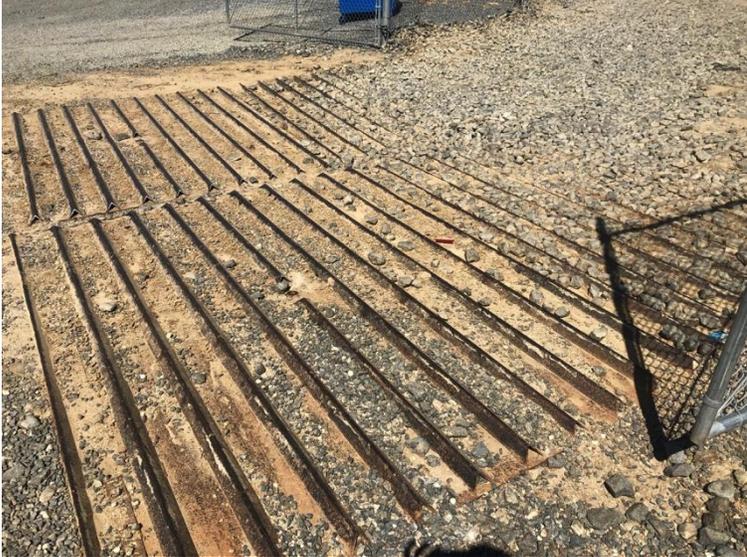
Photo 2 – Rumble plate at the main Exit/Entry needs cleaning maintenance.
3/13/19	Mesa Substation

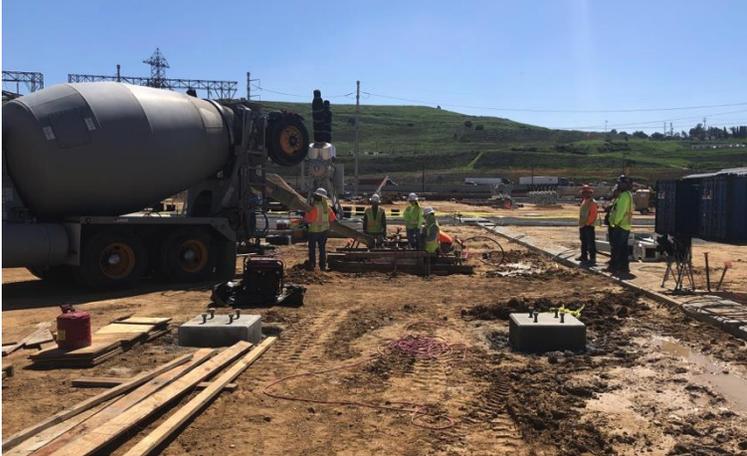
Photo 3 – Foundations being poured - muddy conditions persist. Photo facing south.

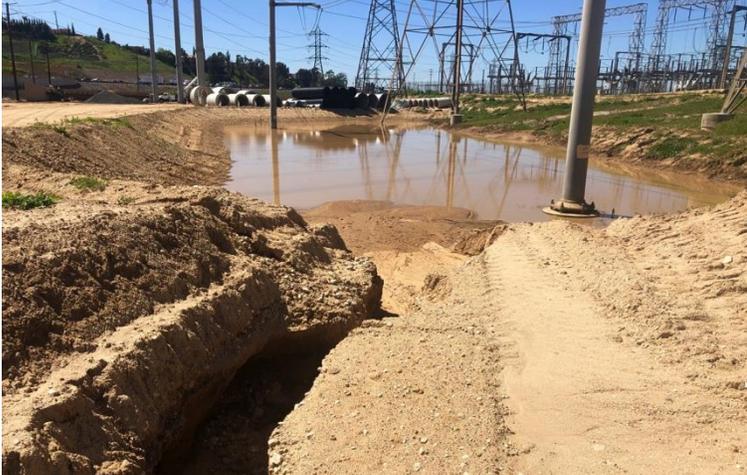
Photo 12 – Catch basin with standing water. Photo facing west.

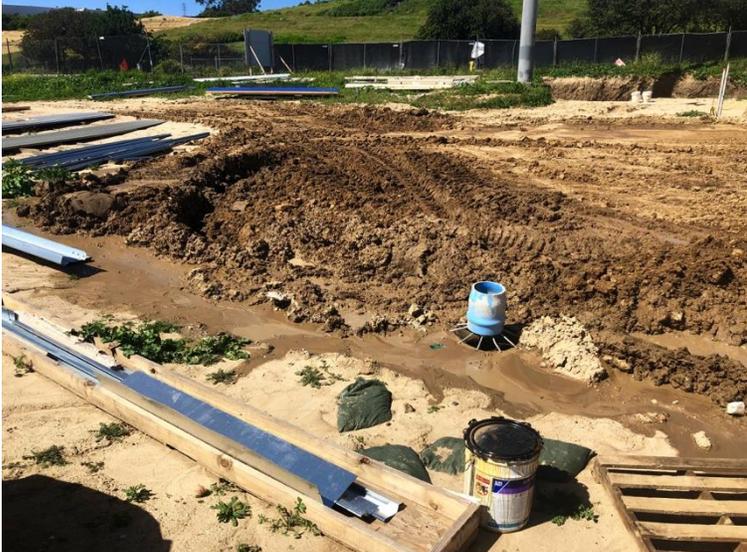
Photo 14 – Mesa operations building drainage standpipe with no BMPs present. Photo facing north.

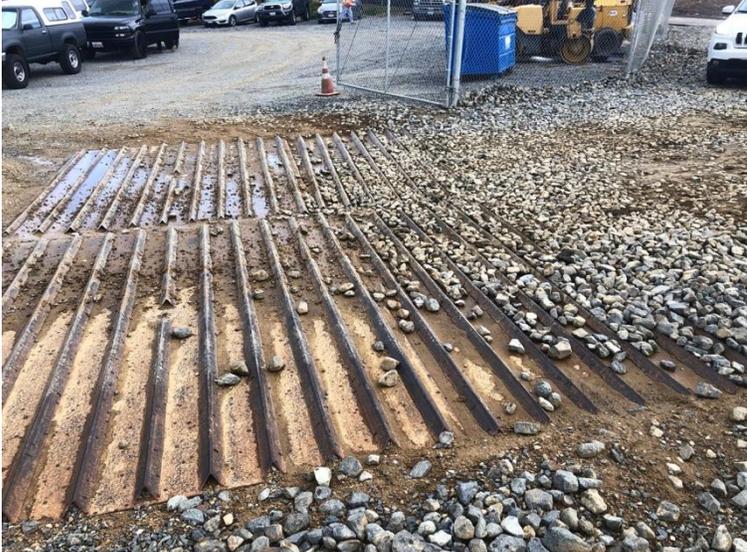
Photo 2 – Rumble plate needs cleaning maintenance.

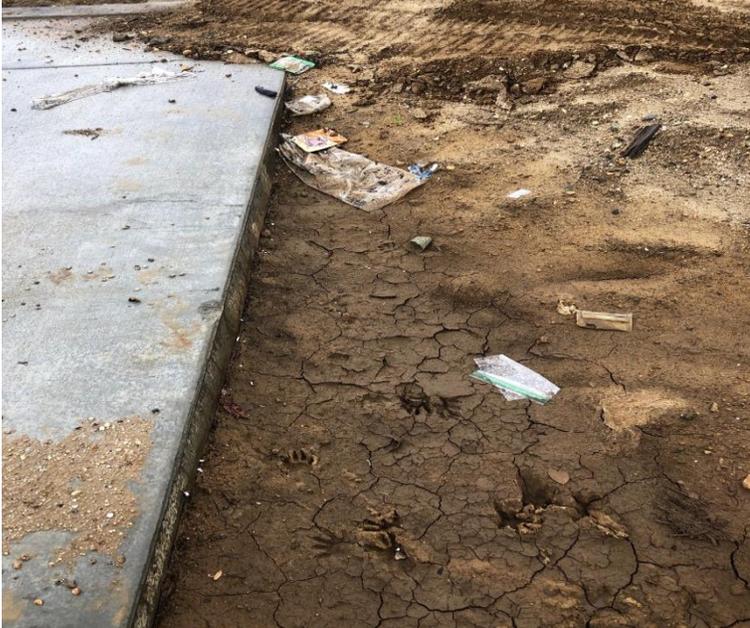
Photo 8 – Micro trash at the western most end of the project site near Markland Ave.
3/20/19	Mesa Substation

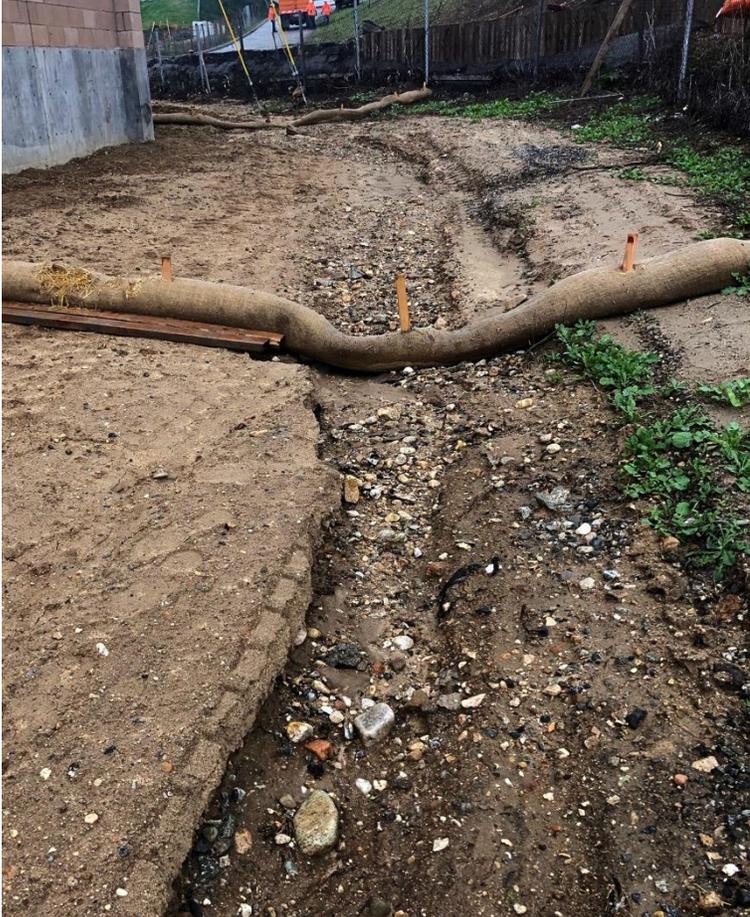
Photo 11 – BMPs located outside of the southern boundary wall are not repaired after the last large storm event. Photo facing southeast.
3/20/18	Mesa Substation

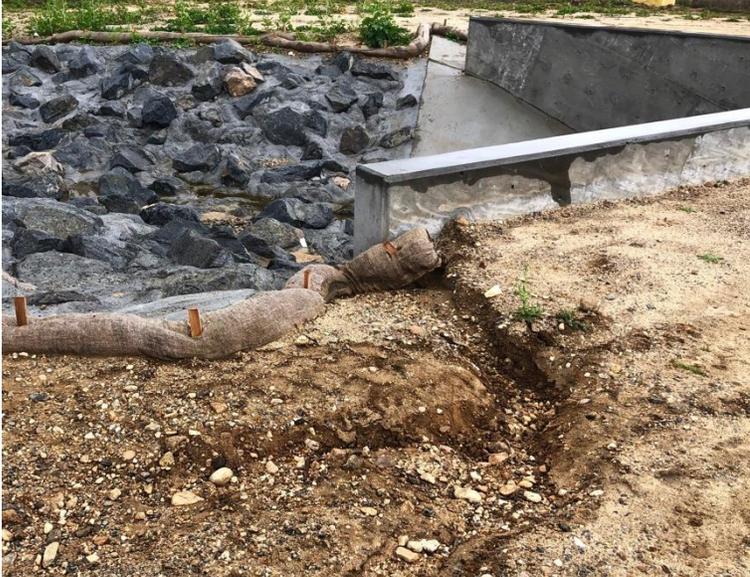
Photo 12 – BMPs still need repairs.

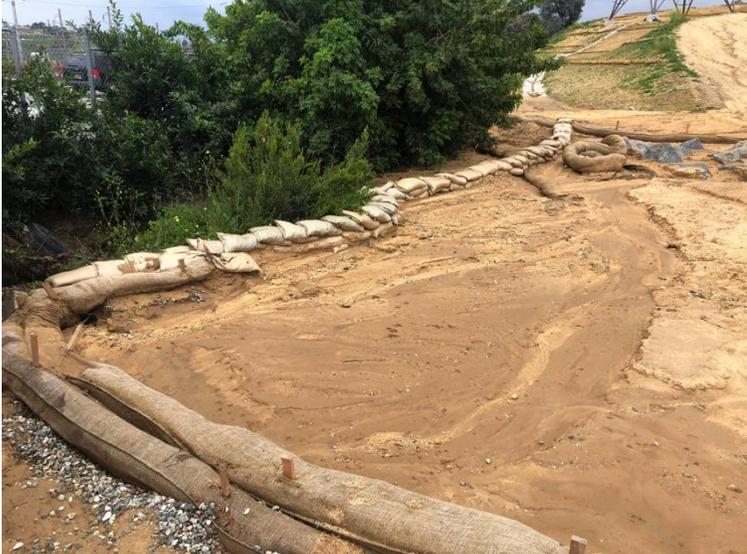
Photo 17 - BMPs within the telecommunications corridor north of Potrero Grande. Sediment has not been removed and wattles and gravel bags are undermined. Photo facing west.
3/20/19	Mesa Substation

- On March 20 12, 2019, the CPUC Compliance Monitor walked along the telecommunications corridor located north of Potrero Grande to inspect the erosion BMPs. The CPUC Compliance Monitor did not observe upgrades to these BMP, which have needed repairs for the last several weeks, and large rills and gullies were still present across the slopes in this area. The CPUC Compliance Monitor recommended upgrades to these BMPs.

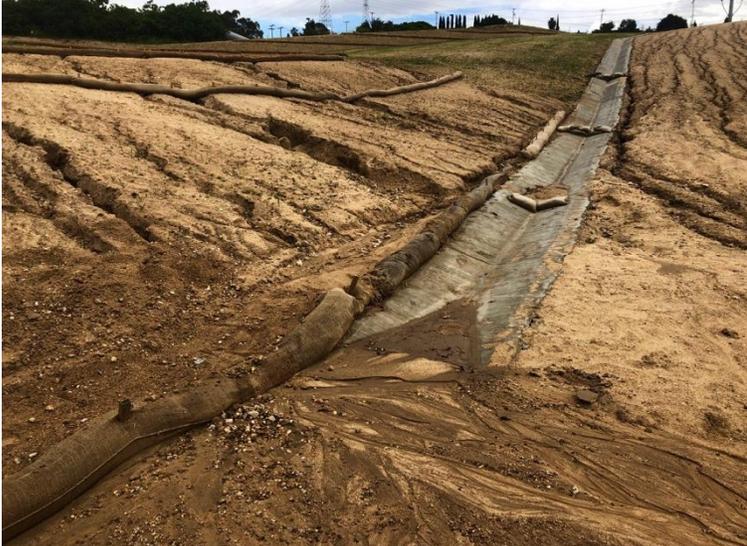
Photo 18 - BMPs within the telecommunications corridor north of Potrero Grande. Heavily riled slopes and filled in wattles. Photo facing northeast.

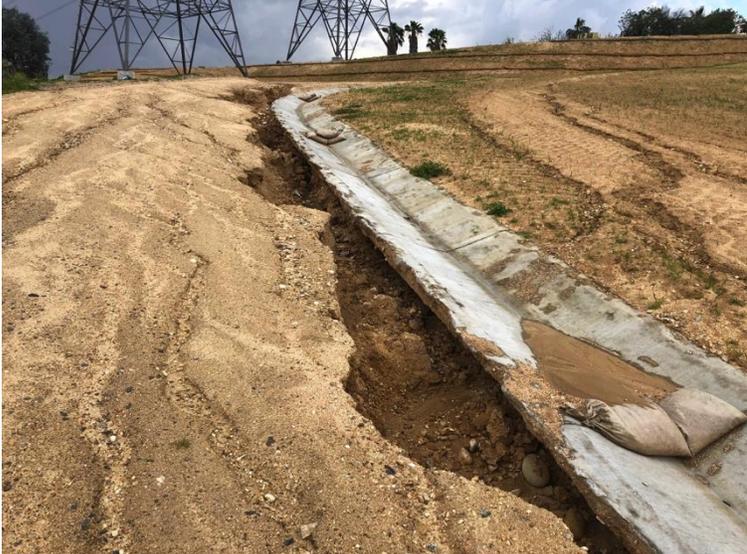
<p>Photo 19 - BMPs within the telecommunications corridor north of Potrero Grande. Large rill undermining the "V" ditch. Photo facing northwest.</p>
3/20/19	Mesa Substation

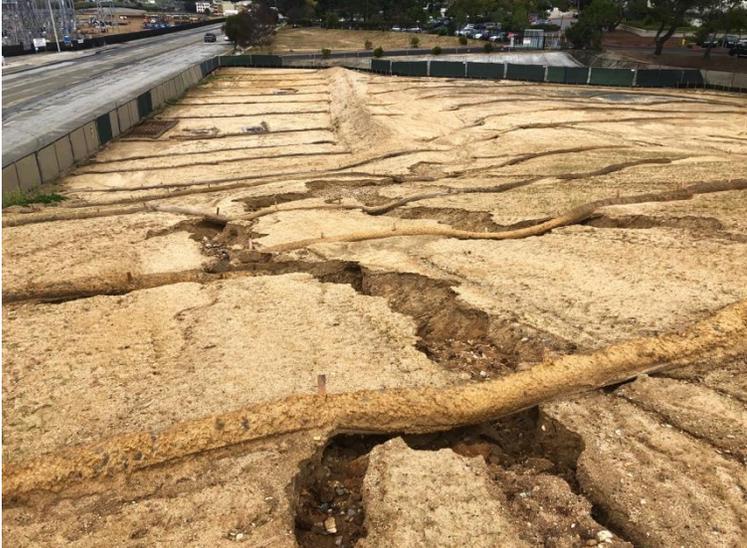
<p>Photo 20 - BMPs within the telecommunications corridor north of Potrero Grande. Large rills undermining all wattles. Photo facing west.</p>

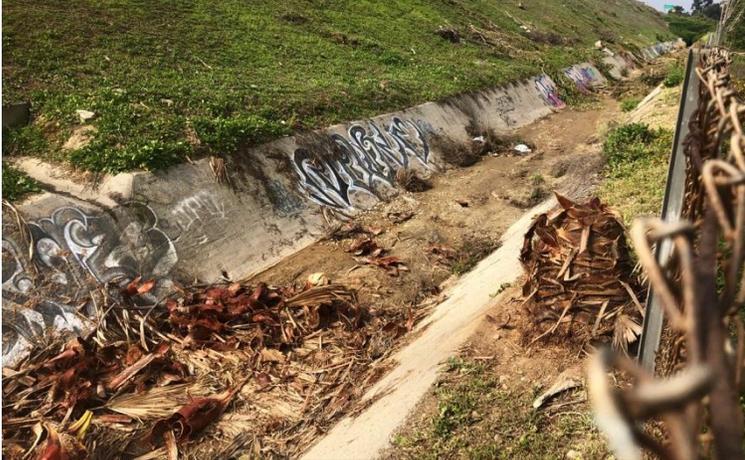
- On March 27, 2019, the CPUC Compliance Monitor inspected the Caltrans concrete channel located just outside of the southern boundary wall. He noted that project sediment remained in the channel and extensive vegetative material was left behind by the Caltrans crew. Unfortunately, the Caltrans crew removed half of the ficus tree with the bushtit nest in it and the nest was gone. The CPUC Compliance Monitor recommended entire cleaning of the Caltrans channel.

Photo 13 – Sediment and vegetative material in the Caltrans channel. Photo facing west.

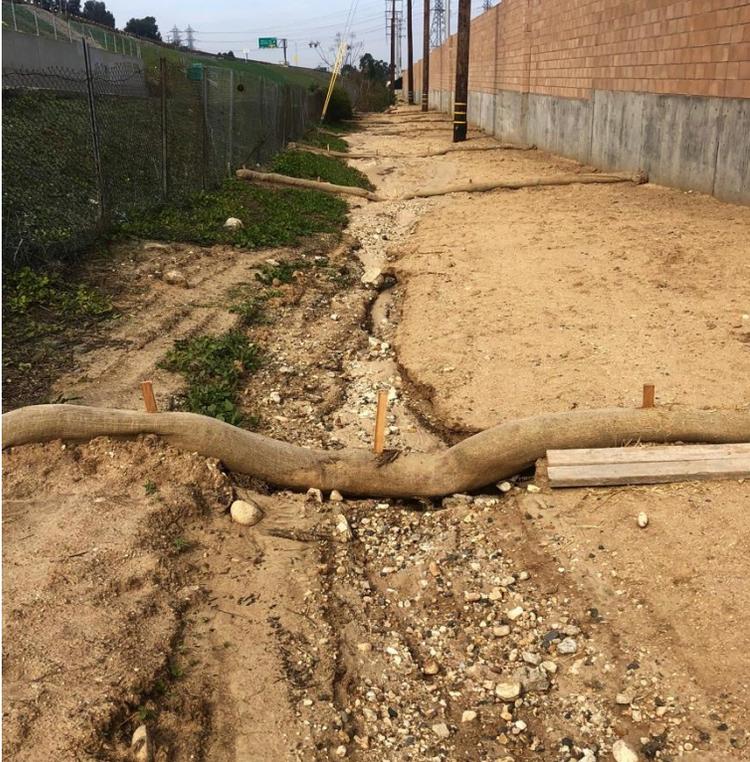
Photo 14 – Undermined wattles outside of the southern boundary wall. Photo facing west.

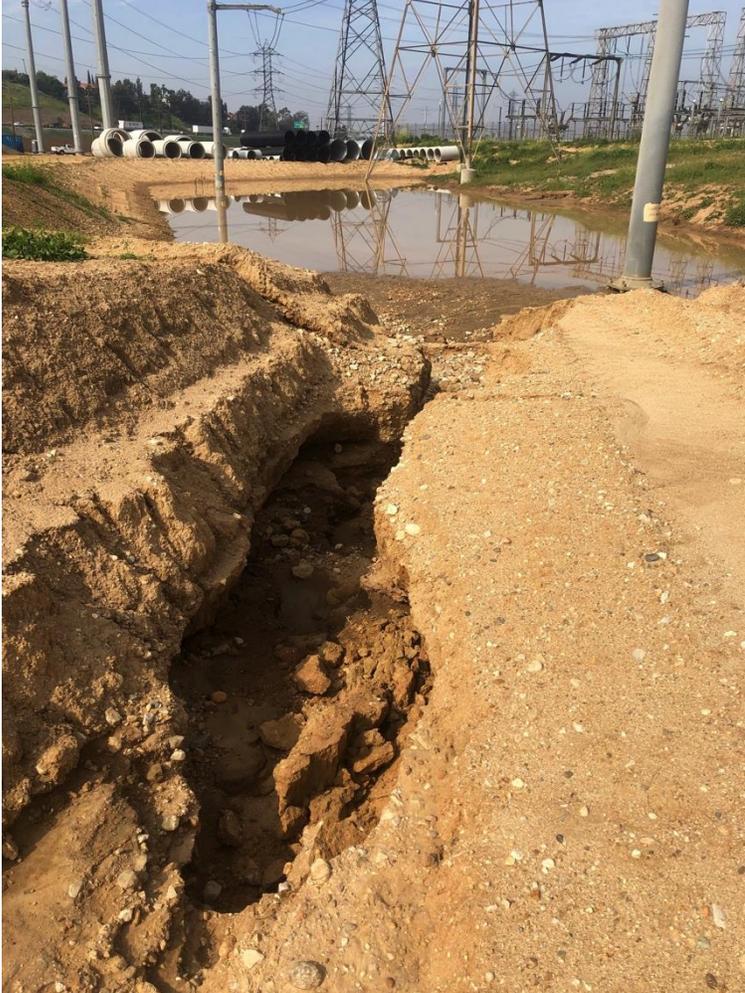
Photo 15 – Catchbasin with eroded inlet channel. Photo facing west.
3/27/19	Mesa Substation

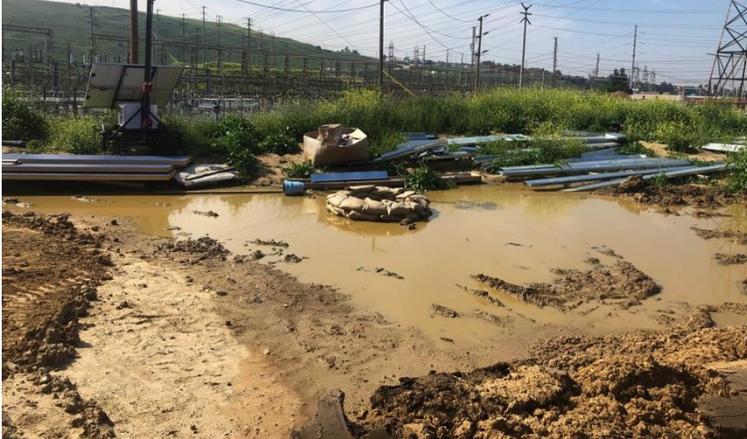
Photo 18 – Pondered rainwater runoff near the Mesa Operations Building. Photo facing south.
3/27/19	Mesa Substation
