Re: Monthly Report Summary #24 for the Mesa 500-kV Substation Project

CPUC Site Inspection Reports
September 5, 18, and 25, 2019

Mesa 500–kV Substation Project CPUC Site Inspection Form

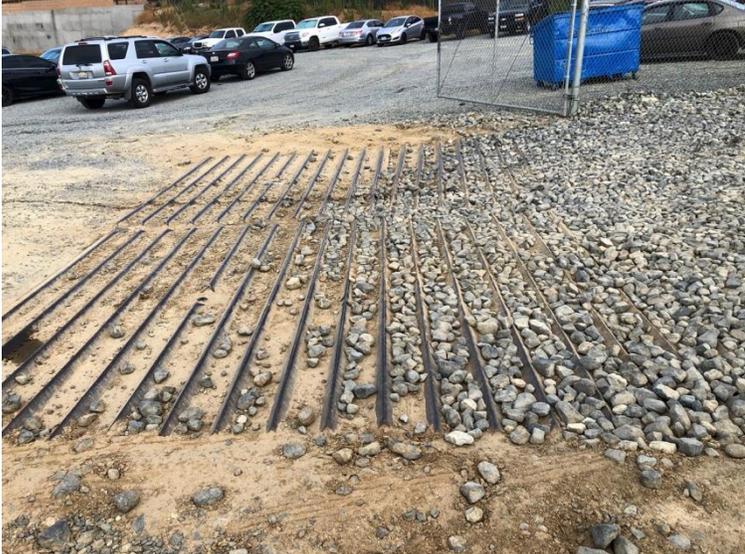
Water trucks were being used to spray the project access roads to minimize dust. I noted that the exit/entry rumble plates needed cleaning – Photo 1.

<p>Photo 1 – Rumble plates at the main project exit/entry needed cleaning. Photo facing north.</p>
9/05/19	Mesa Substation

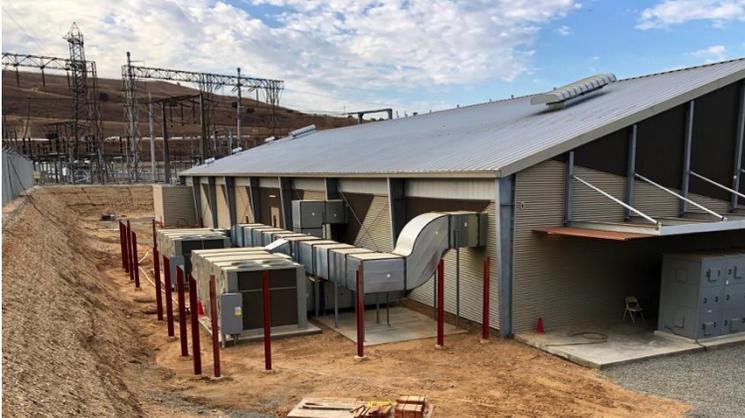
<p>Photo 2 – Protective fencing being installed around equipment located outside of the Senior MEER building. Photo facing south.</p>
9/05/19	Mesa Substation

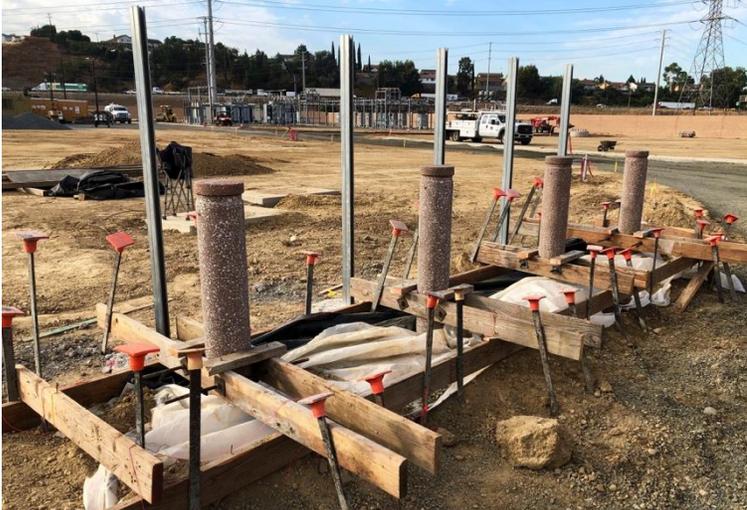
Photo 6 – Protective barriers being installed along the new roadway near the northern retaining wall – note the plastic covering the open holes. Photo facing southwest.

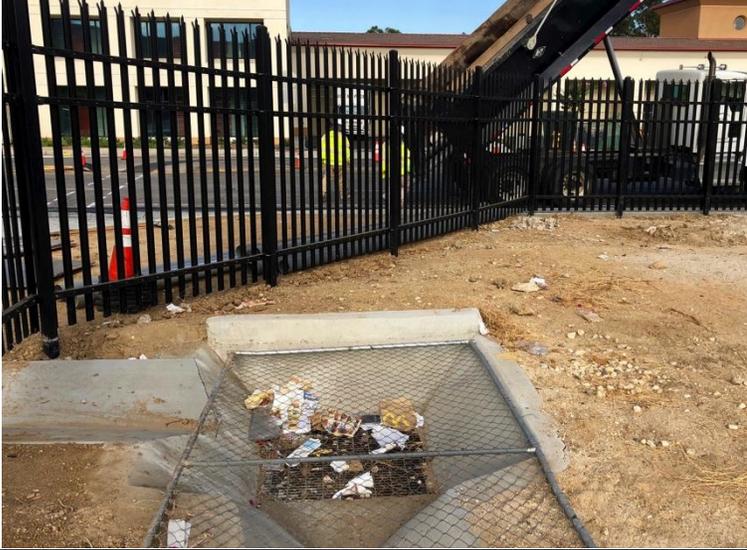
- On September 5, 2019, the CPUC Compliance Monitor observed a trash and debris accumulating in the “V” ditches. The Compliance Monitor recommended cleaning the trash and debris inside of the ditches.

<p>Photo 7 – Some work being completed within East Markland Drive; also note the significant amount of trash in the drainage channel. Photo facing west.</p>
9/05/19	Mesa Substation

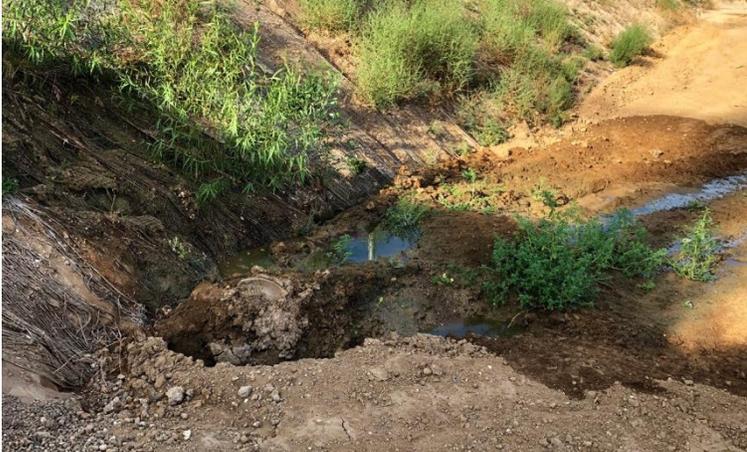
- On September 5, 2019, the CPUC Compliance Monitor noted ponded water at the base of the southeastern corner of the large detention basin and willows beginning to grow on the banks. He also noted several dragonfly nymphs in the pools. Cleaning the ponded water to minimize potential vector issues and removing the invasive Weeds before they mature was recommended.

The ponded water I had previously noted at the base of the southeastern corner of the large detention basin remained, and willows were beginning to grow on the banks – Photo 8. I saw several dragonfly nymphs in the pools.

<p>Photo 8 – Water seep noted within the southeastern corner of the large detention basin.</p>
9/05/19	Mesa Substation

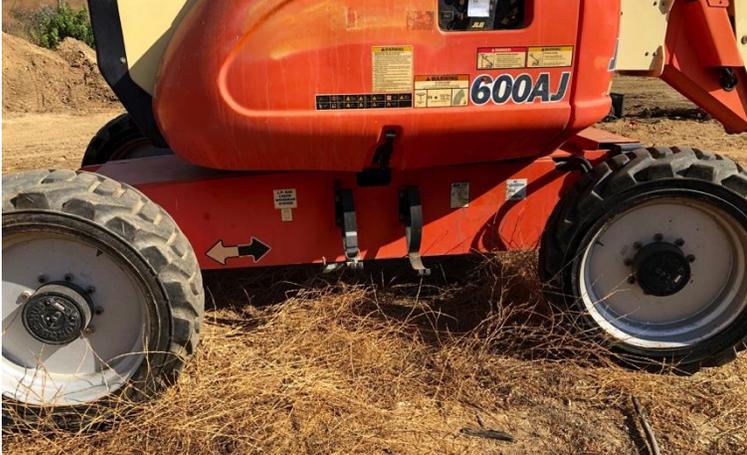
I counted three damaged drip pans around the equipment parking area. I also saw a parked manlift near the Mesa Operations Building that had no drip pan – Photo 13 – and a piece of equipment near the new staging area located east of Market Place Drive with a poorly placed drip pan – Photo 14.

Photo 13 – Manlift near the Mesa Operations Building without a drip pan.
9/05/19	Mesa Substation

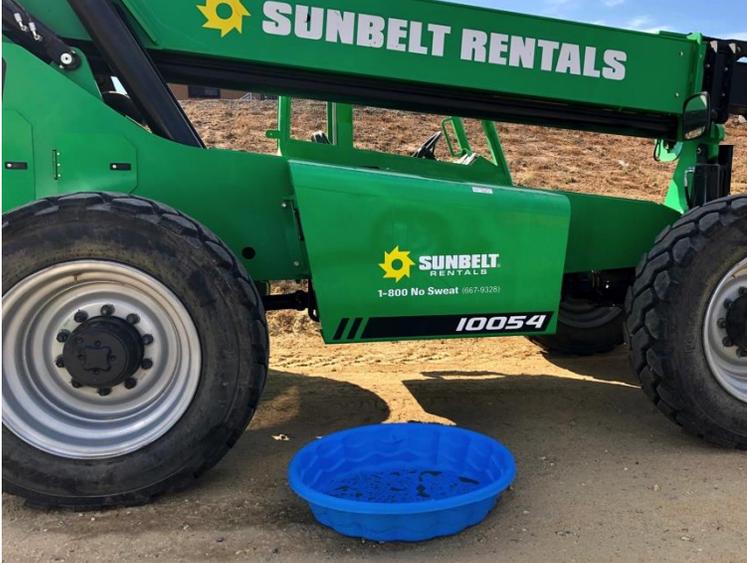
Photo 14 – Equipment parked near the new staging area, located east of Marketplace Drive, with a poorly placed drip pan.

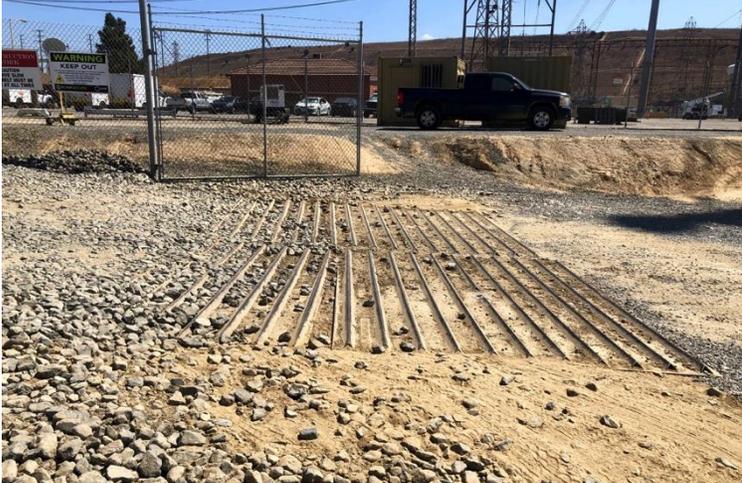
Photo 1 – Rumble plates at the main project exit/entry needed cleaning. Photo facing south.
9/18/19	Mesa Substation

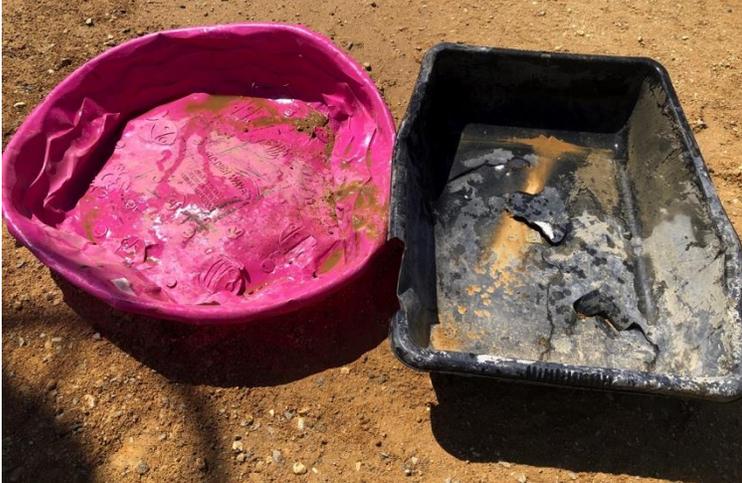
- On September 18, 2019, the CPUC Compliance Monitor indicated that at least five drip pans were broken and needed to be replaced. Additionally, the Compliance Monitor noted a large excavator parked in the staging area with missing drip pans underneath. The CPUC Compliance Monitor reported this information to the Mesa Project Coordinator and recommended that they replace the broken drip pans.

Near the northeast corner of the 220-kilovolt kV switchrack area, I counted eight drip pans, five of which were damaged and needed to be replaced – Photo 2. Other damaged drip pans were noted throughout the project site. A large excavator was parked in the staging area and did not have drip pans placed underneath – Photo 10. I reported this information to Project Coordinator Pete Lubich (ULM Services, Inc.) and recommended that they replace the damaged drip pans.

Photo 2 – Damaged drip pans.
9/18/19	Mesa Substation

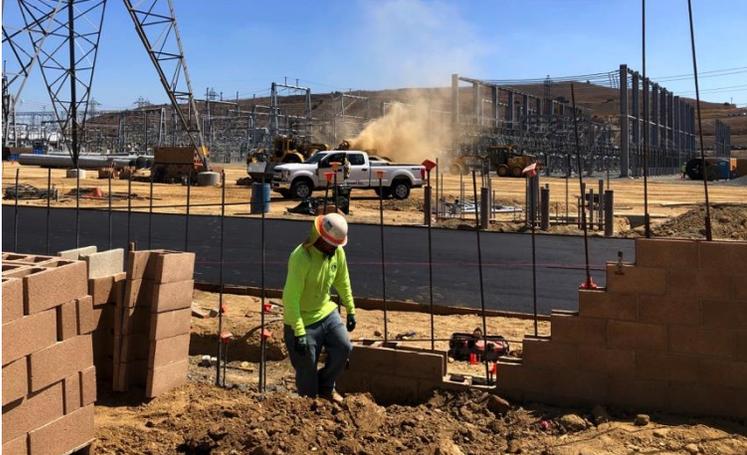
Photo 5 – Northern wall work. Note the dusty conditions created by the operating loader. Photo facing south.
9/18/19	Mesa Substation

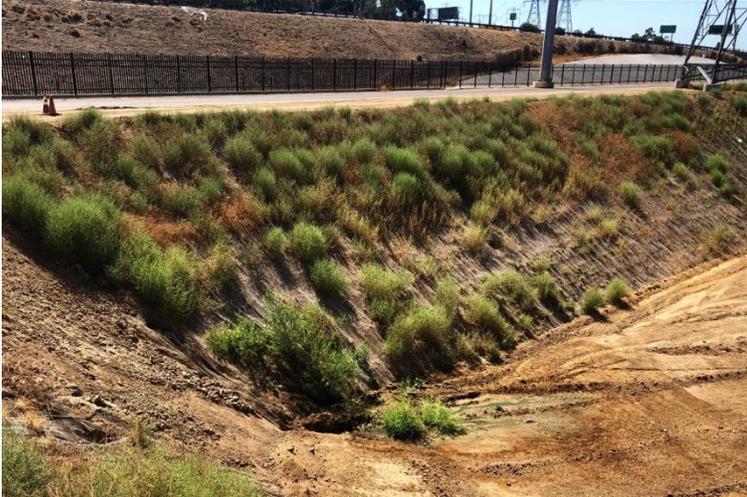
Water continued to seep from the southeastern corner of the large detention basin – Photo 6. The walls at the detention basin supported a healthy stand of Russian thistle; this invasive weed was also extensively growing within the Transmission Corridor south of the project site. I recommend that crews remove these weeds before they begin to mature.

Photo 6 – Water seep noted within the southeastern corner of the large detention basin – note the extensive amount of Russian thistle. Photo facing southwest.

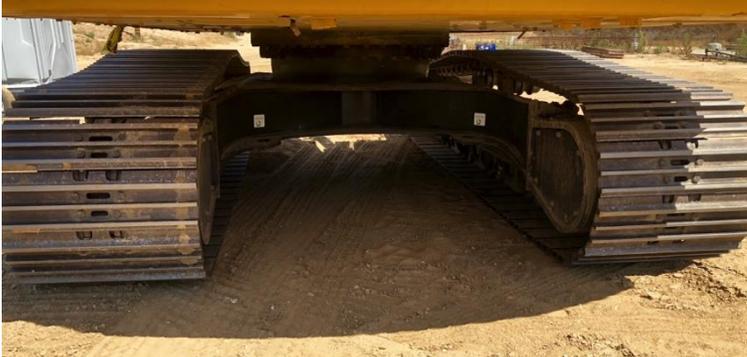
Photo 10 – No drip pan placed under this equipment.
9/18/19	Mesa Operations Building

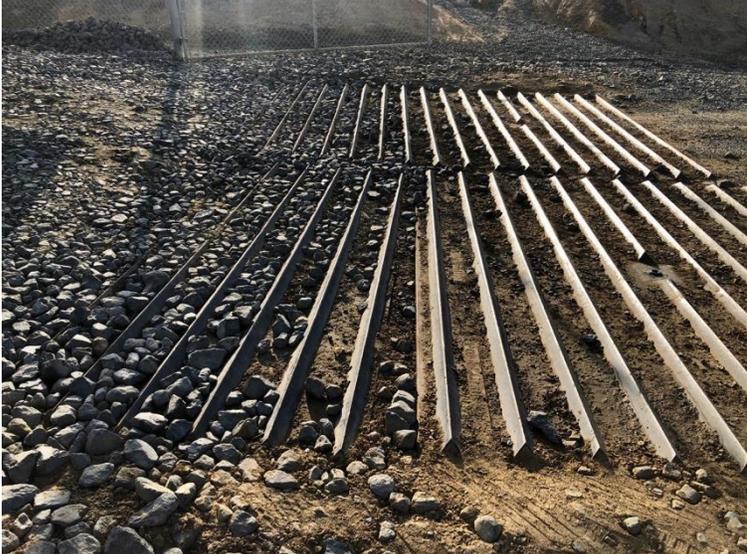
<p>Photo 1 – Rumble plates at the main project exit/entry needed cleaning. Photo facing south.</p>
9/25/19	Mesa Substation

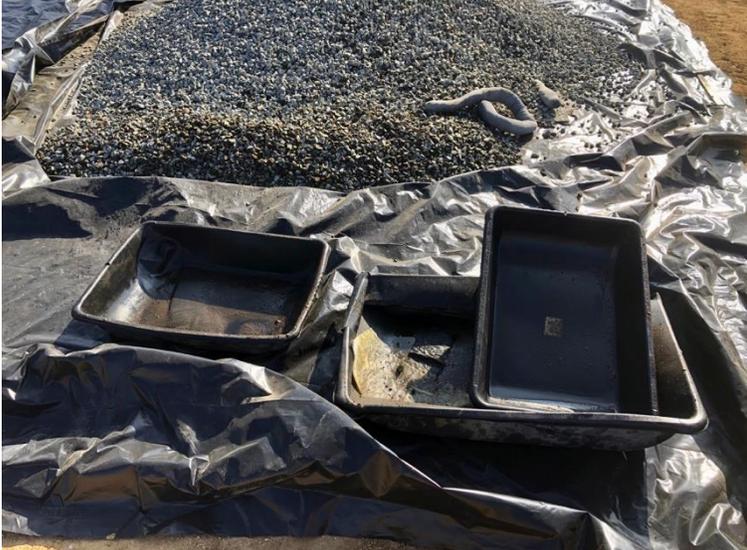
Plastic sheeting was laid out on the gravel near the 66-kV switchrack area. I noted oil-soaked drip pans and gravel stockpiled on it – Photo 9. Craig Pernot (Power Grade) was nearby and he explained that the motorgrader blew a hydraulic line and lost approximately 30 gallons of fluid. He believed crews captured most of it and they were waiting on containers to put it into.

Photo 9 – Hydraulic fluid spill cleanup.

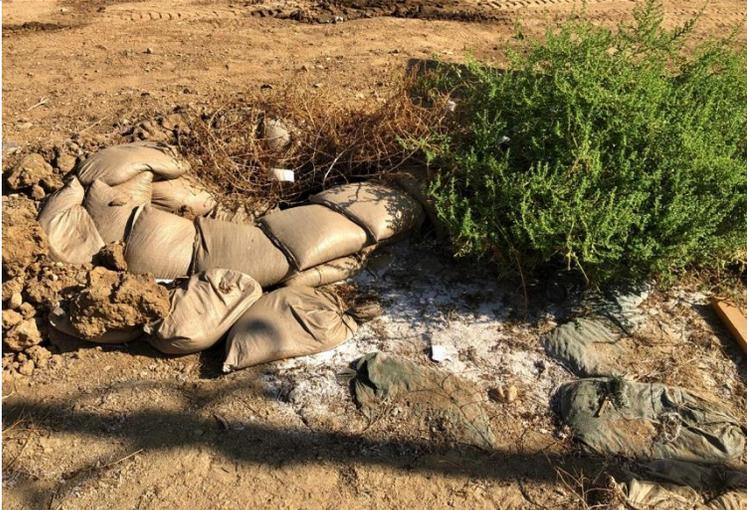
The eastern project entry way still under construction near the Mesa Operations Building – Photo 10. Conduit work continued, and excavated areas had proper climbing structures installed – Photo 11. I noted what appeared to be a washout near the site drain inlet; this area needed to be cleaned, and best management practices (BMPs) needed to be upgraded prior to the rainy season – Photo 12.

Photo 12 – Site drainage inlet with what appeared to be construction materials washout.

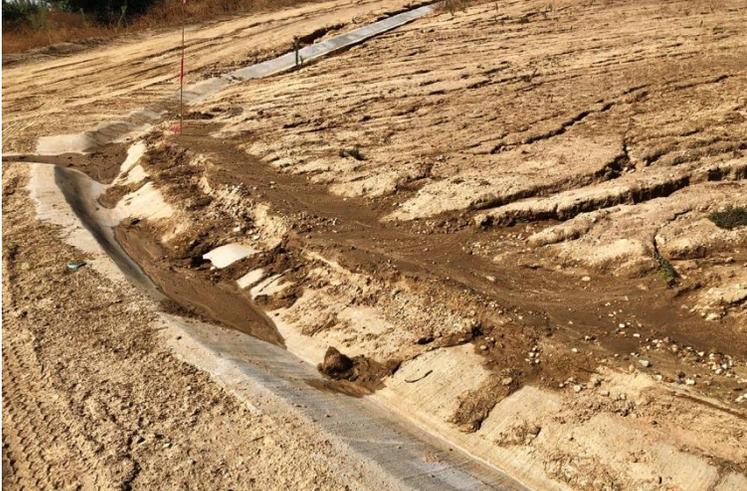
Re-grading of the Transmission Corridor north of Potrero Grande Drive continued – Photo 13. I noted ponded water and sediment flow in the central portion of the corridor – Photo 14. I notified biological monitor Matt Daniele (ICF) of my concerns.

<p>Photo 14 – New sediment flow within the Telecommunications Corridor, located north of Potrero Grande. Photo facing west.</p>
