January 15, 2020

**Re: Monthly Report Summary #26 for the Mesa 500-kV Substation Project**

SITE INSPECTION CHECKLIST (Based on monitor's observations during site visit; responses do not imply that monitor observed all staff, crews, and parts of the project during this inspection)

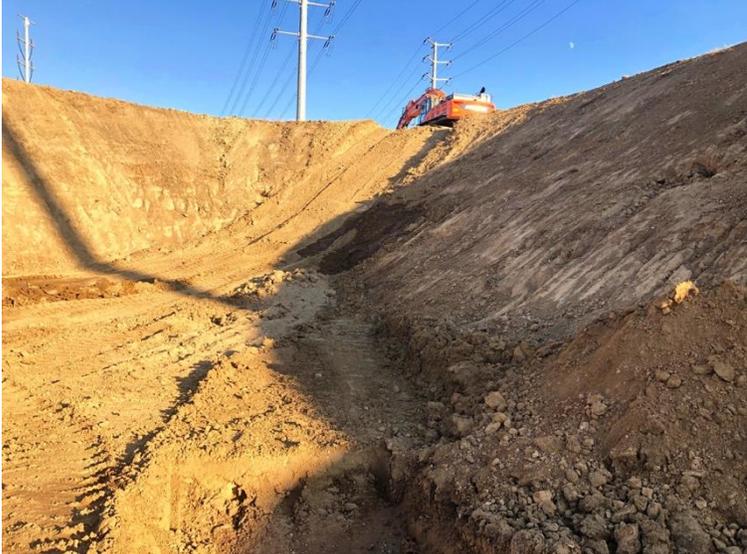
Photo 4 – Water seep in the southeastern corner of the detention basin. Photo facing east.
11/05/19	Mesa Substation

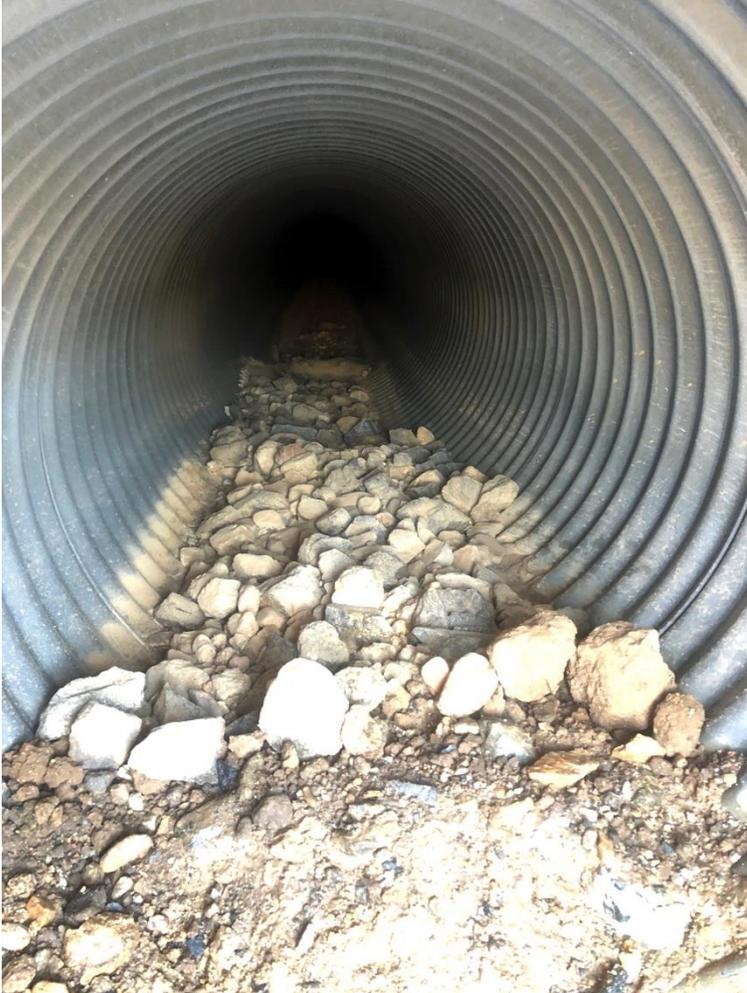
Photo 4 – Rock within the detention basin outfall pipe.
11/13/19	Mesa Substation

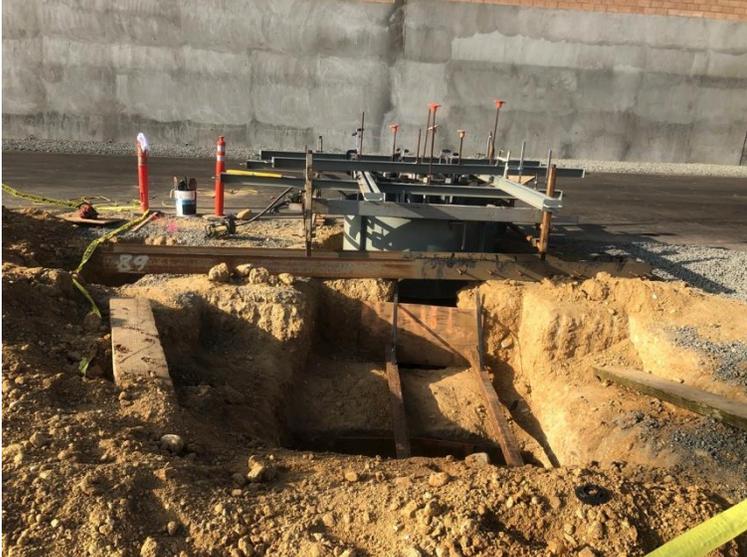
Another tower foundation was prepared, the rebar cage was installed, and concrete had been poured – Photo 5. A drill rig was parked nearby – Photo 6.

Photo 5 – Tubular steel pole (TSP) foundation work. Photo facing north.

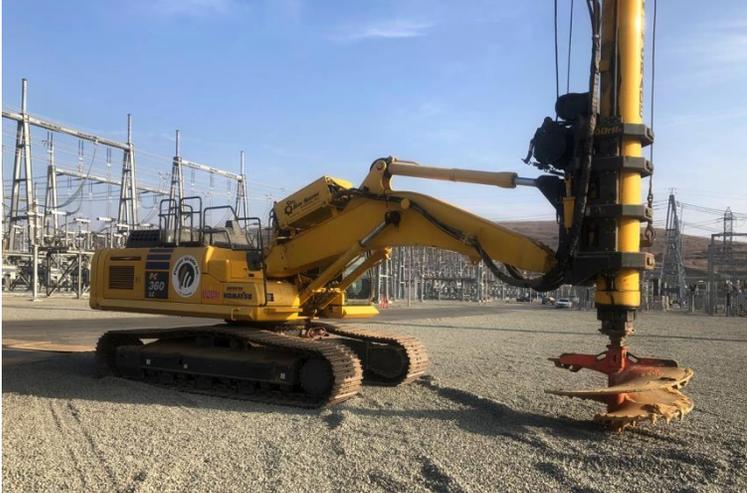
Photo 6 – Drill rig onsite. Photo facing south.
11/13/19	Mesa Substation

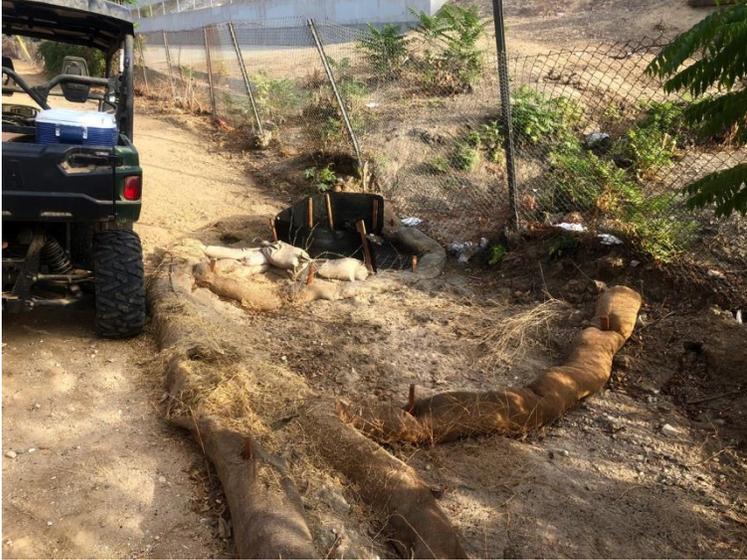
<p>Photo 10 – Old BMPs outside of the southern boundary wall, located near the drain inlet. Photo facing east.</p>
11/13/19	Mesa Substation

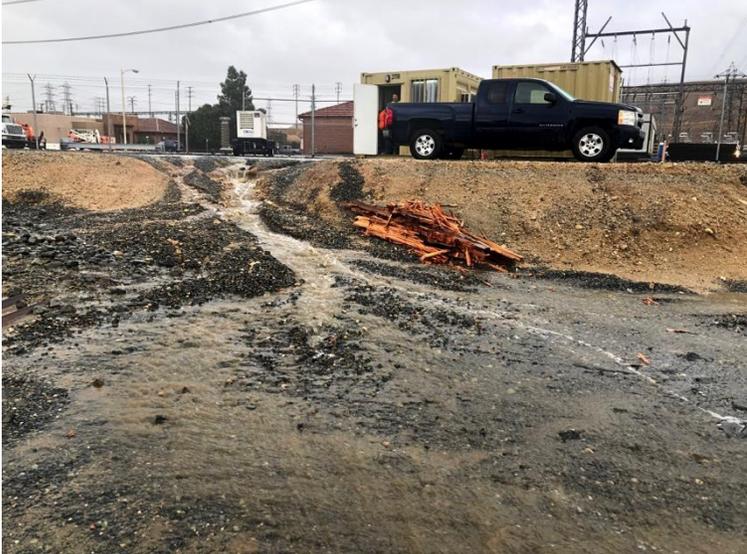
Upon entering the site, I noted runoff flowing from the Existing Mesa Substation at several locations – Photos 1 & 2. A crew was attempting to redirect the muddy flow with gravel bags – Photo 3. Filter fabric placed under the storm drain inlet grates was removed so water would flow freely into the drainage system.

Photo 1 – Stormwater runoff from the existing Mesa Substation. Photo facing south.
11/20/19	Mesa Substation

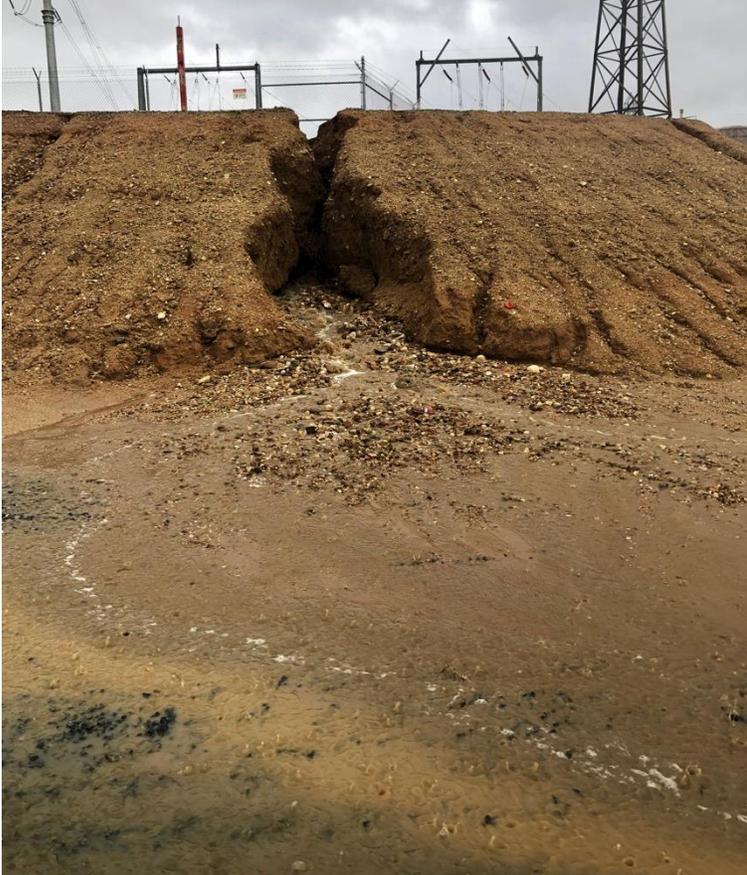
Photo 2 – Stormwater runoff from the Existing Mesa Substation. Photo facing south.

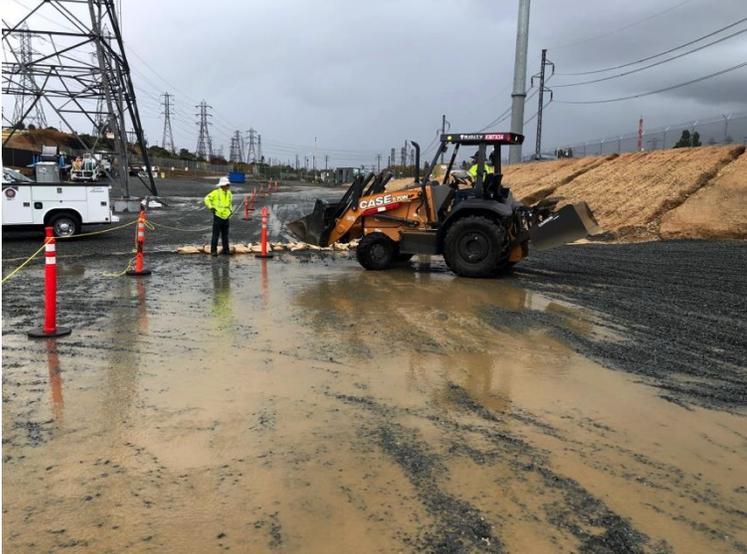
Photo 3 – Crews attempting to redirect stormwater runoff through the site. Photo facing northeast.
11/20/19	Mesa Substation

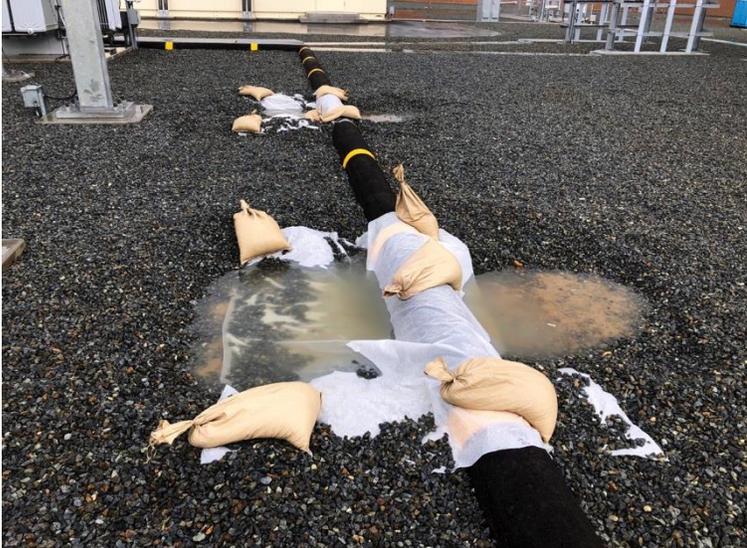
The “valves” through the 16-kilovolt (kV) containment berm were not installed; in order to seal them, crews placed visqueen sheeting and gravel bags over the holes – Photo 4. The visqueen was not sealing the holes since I noted water flowing through.

Photo 4 – Drain hole locations at the 16-kV switchrack containment berm.

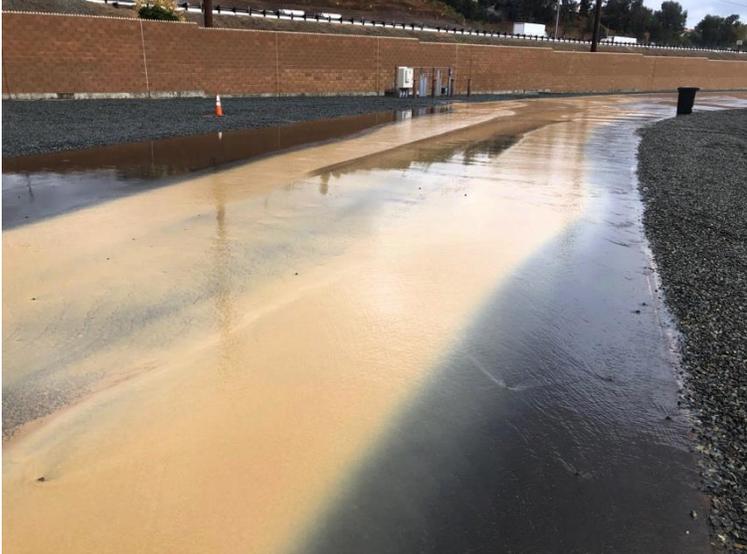
<p>Photo 5 – Rainwater runoff flowing down the paved road along the southern boundary wall. Photo facing southwest.</p>
11/20/19	Mesa Substation

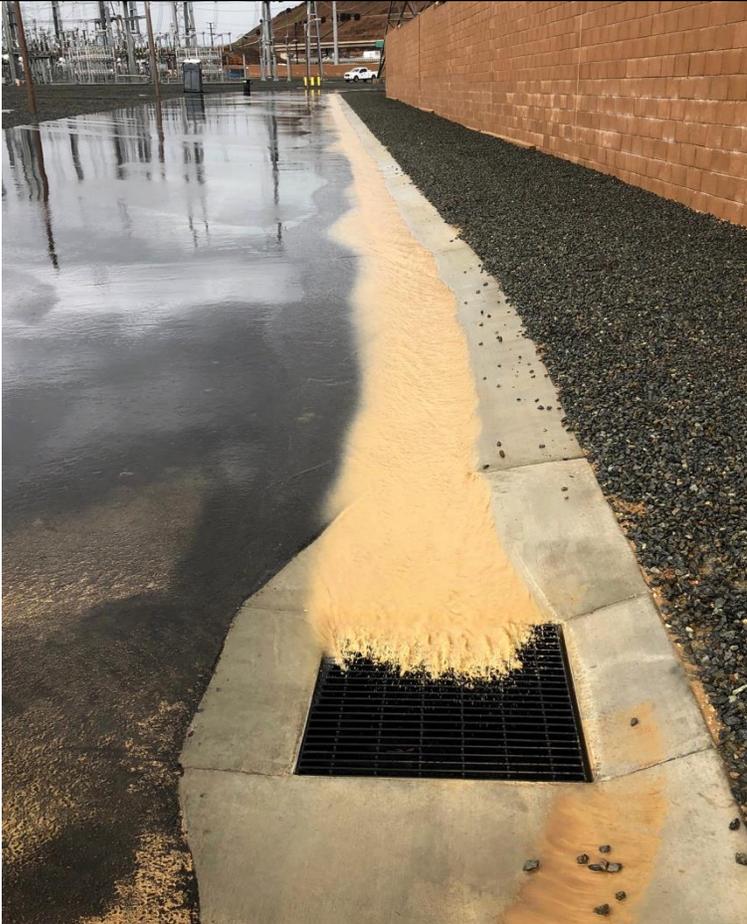
<p>Photo 6 – Rainwater runoff entering a project drain inlet. Photo facing east.</p>

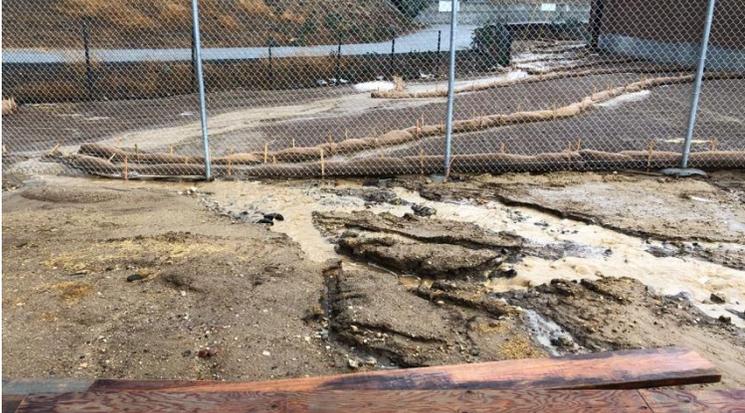
A small stream of offsite stormwater runoff flowed into the site near the outside of the southern boundary wall – Photo 7. New best management practices (BMPs) (i.e., jute netting and straw wattles) were placed along the stretch outside of the southern boundary wall; however, the amount of water overwhelmed the BMPs. The straw wattles were ruptured at several locations and were overtopped, as can be seen by the line of debris on the wattles – Photo 8. It appears that these BMPs are not designed to handle an extensive amount of flowing water. The ample amount of water was likely due to the diversion berm not being re-established prior to the storm. Photo 9 shows the location where the diversion berm was located last year.

<p>Photo 7 – Rainwater runoff flowing down the outside of the southern boundary wall. Note - the damaged BMPs. Photo facing southwest.</p>
11/20/19	Mesa Substation

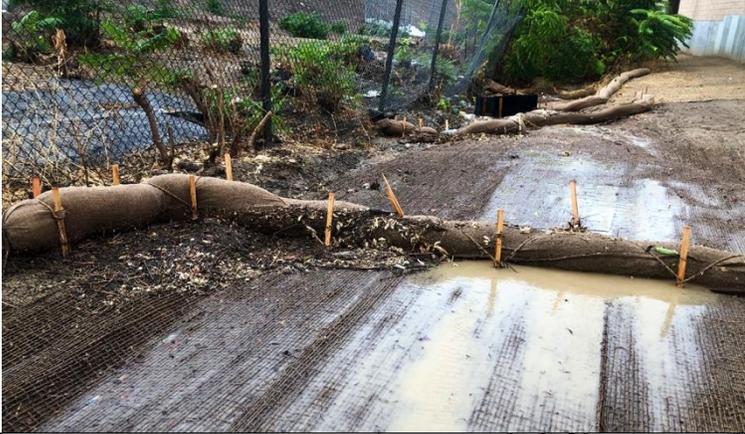
<p>Photo 8 – Rainwater runoff flowing down the outside of the southern boundary wall. Note - the debris line on the BMPs. Photo facing west.</p>
11/20/19	Mesa Substation

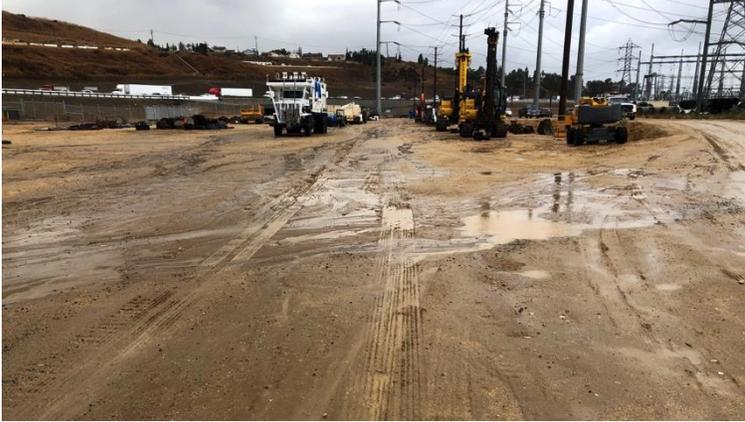
<p>Photo 9 – Diversion berm location. Photo facing southwest.</p>

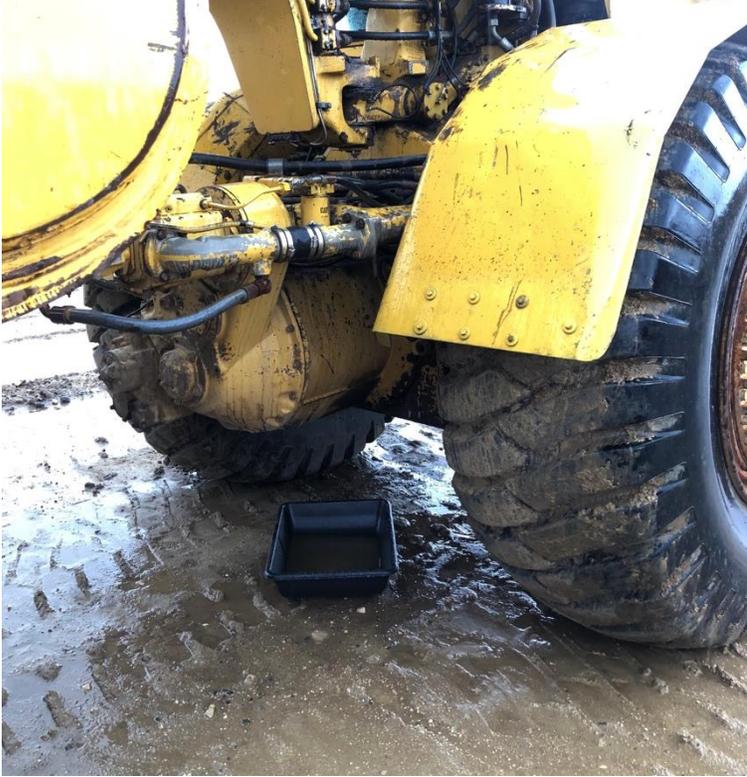
Photo 10 – A small drip pan placed underneath large equipment.
11/20/19	Mesa Substation

Drip pans need to be replaced and upgraded.

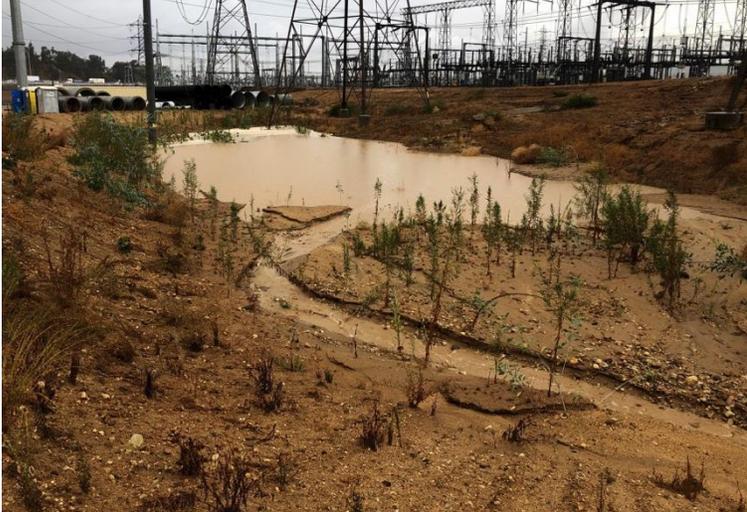
Photo 11 – Water filling a catch basin located directly south of the Existing Mesa Substation. Photo facing west.

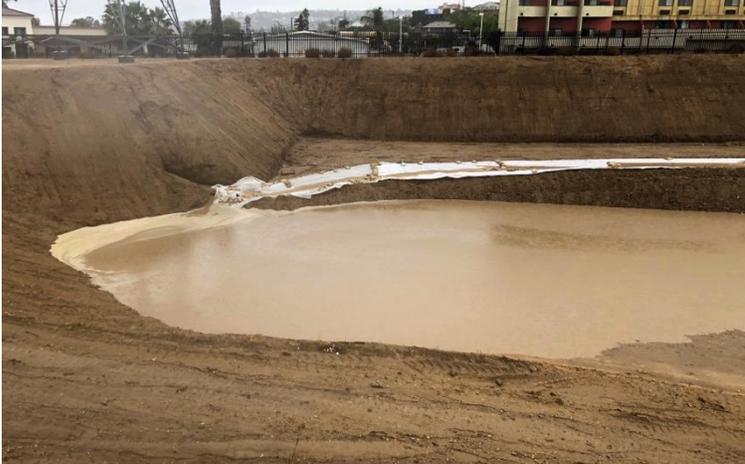
The large detention basin accumulated a pond of muddy water – Photo 12. Construction work was previously completed with removal of portions of the inlet culvert and the standpipe outlet culvert. In addition, soil was being imported to raise the bottom of the basin. Crews installed a visqueen channel through the detention basin to allow the rainwater runoff to flow between the inlet culvert and the outlet culvert – Photos 13 & 14. Several lines of gravel bag check dams were installed within the visqueen channel, but the speed of the water ruptured most of the check dams.

<p>Photo 12 – Water ponded in the detention basin. Photo facing north.</p>
11/20/19	Mesa Substation

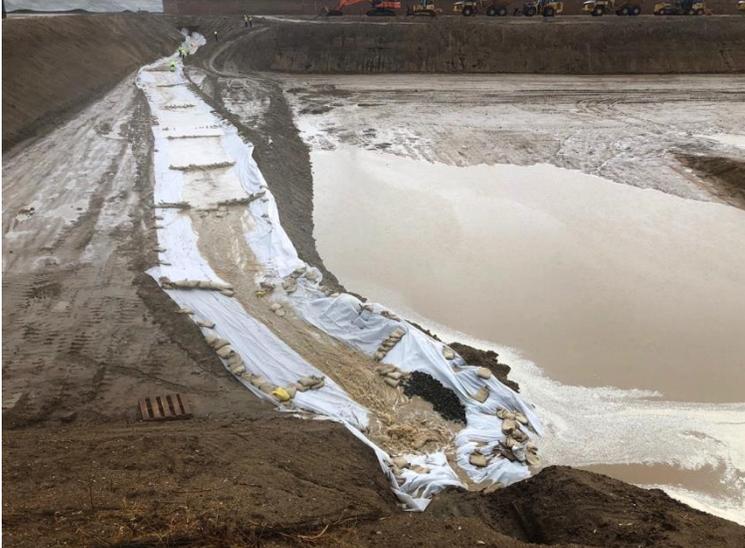
<p>Photo 13 – Detention basin with a visqueen drain channel installed. Note - rainwater runoff flowing from the basin inlet culvert directly into the outflow culvert. Photo facing east.</p>

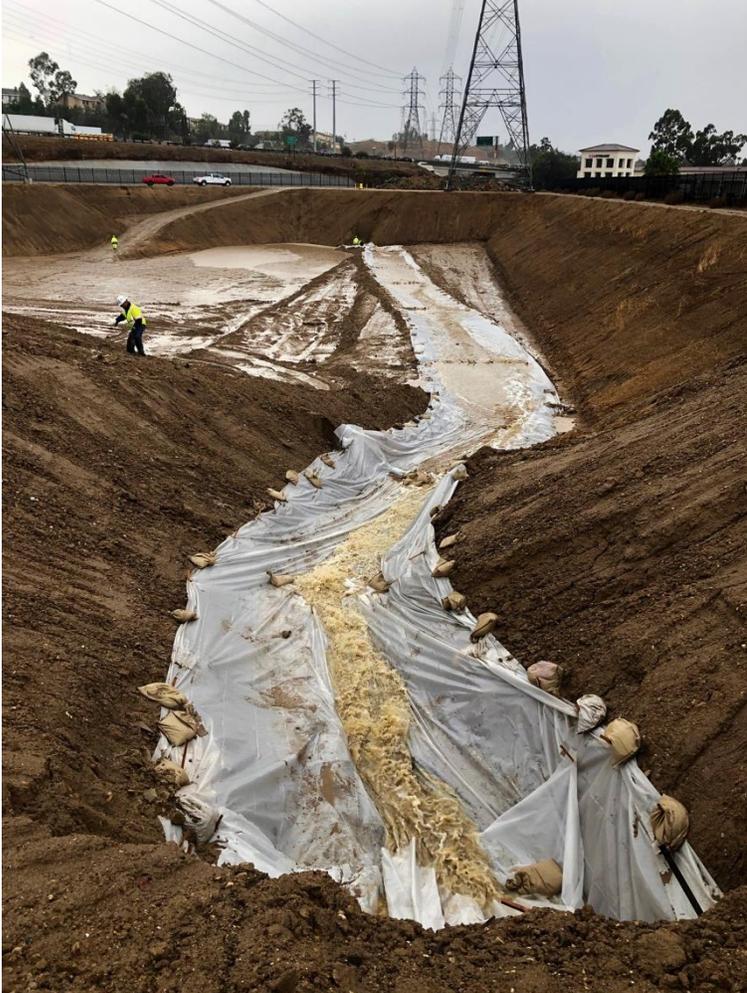
<p>Photo 14 - Detention basin with a visqueen drain channel installed. Note - rainwater runoff from the basin inlet culvert flowing directly into the outflow culvert. Photo facing west.</p>
11/20/19	Mesa Substation

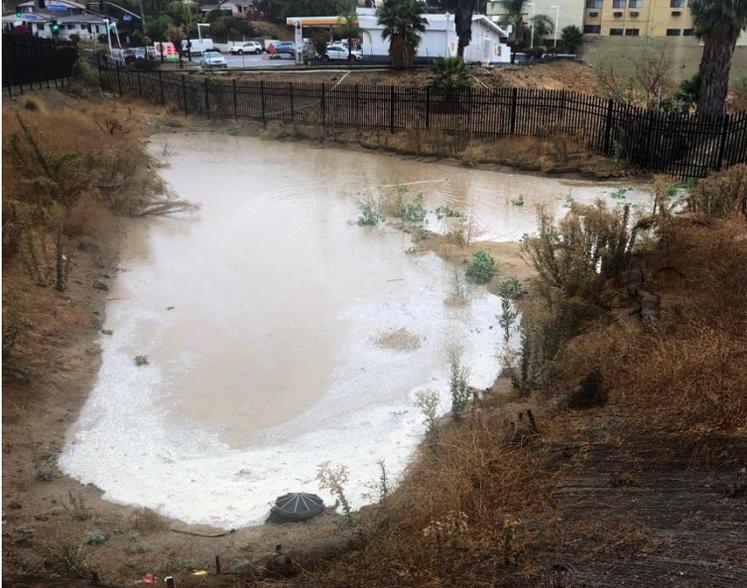
<p>Photo 15 – Small triangular detention basin full of rainwater runoff. Photo facing north.</p>

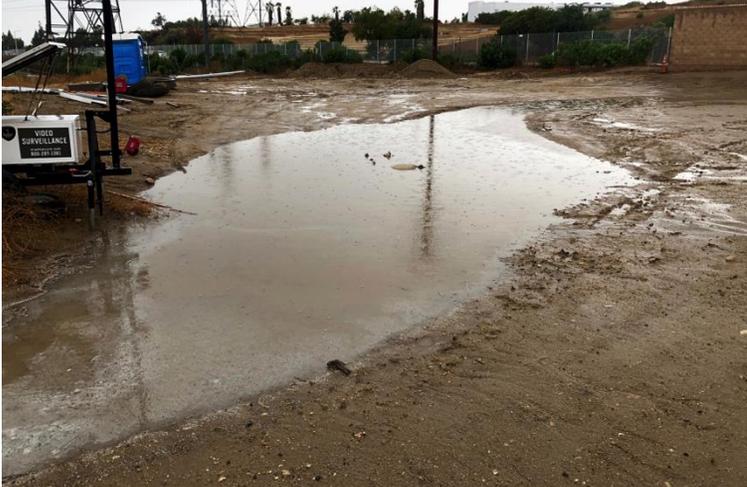
Photo 16 – Pondered water outside of the Mesa Operations Building. Photo facing north.
11/20/19	Mesa Substation

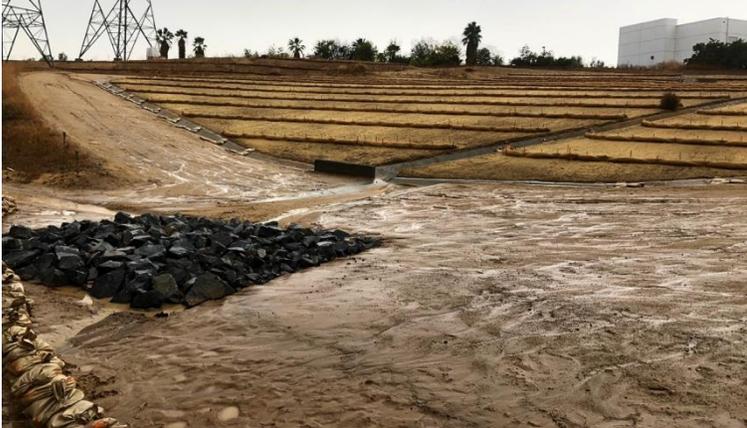
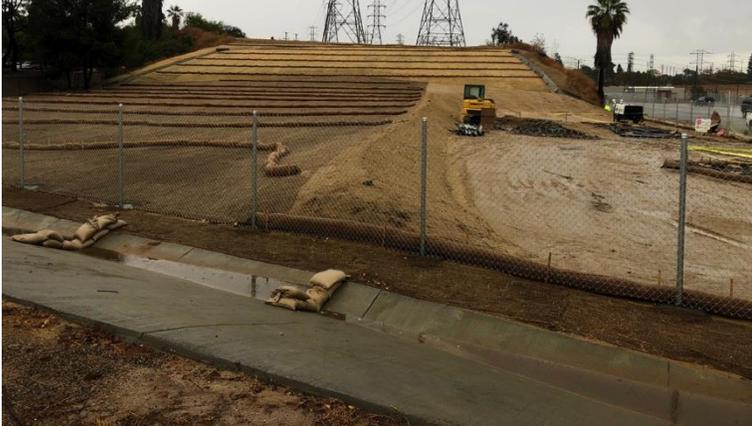
The BMP work north of Potrero Grande Drive appeared to be complete. A crew was onsite and adding gravel bags to several “V” ditches. The BMPs appeared to have held up well during the rain event – Photos 18 & 19. The Stormwater Pollution Prevention Plan (SWPPP) inspector Roberto Morales was onsite and obtaining water samples in the area north of Potrero Grande Drive – Photo 20. I saw the Power Grade foreman Craig Pernot and inquired whether water samples would be taken at the large detention basin. He mentioned that current conditions were unsafe to enter the basin.

Photo 18 – BMPs within the Transmission Corridor, located north of Potrero Grande Drive. Photo facing north.

Photo 19 - BMPs within the Transmission Corridor, located north of Potrero Grande Drive. Photo facing east.
11/20/19	Mesa Substation

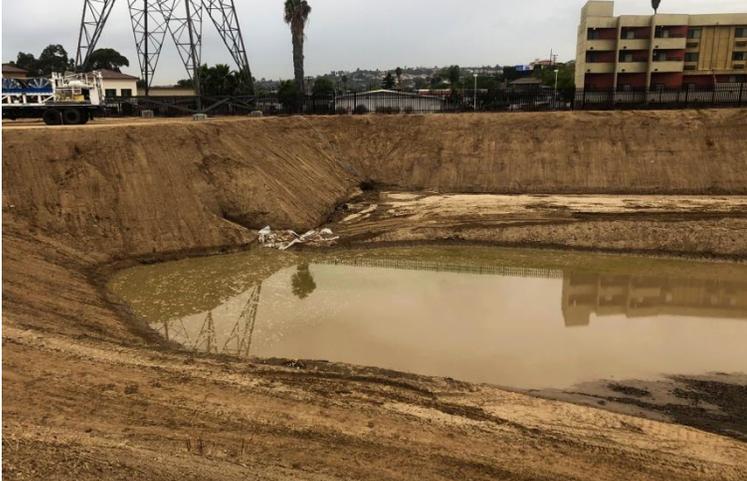
Photo 2 – The outflow culvert was sealed; therefore, the basin was holding the stormwater runoff. Photo facing north.
11/27/19	Mesa Substation

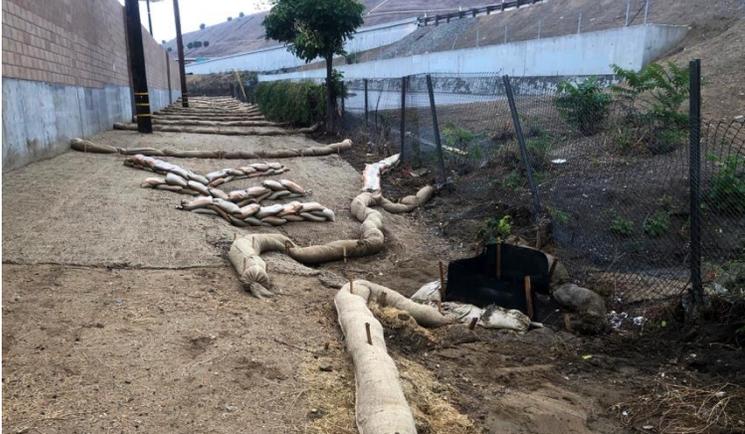
<p>Photo 4 – Upgraded BMPs outside of the southern boundary wall, located near the drain inlet. Photo facing east.</p>
11/27/19	Mesa Substation

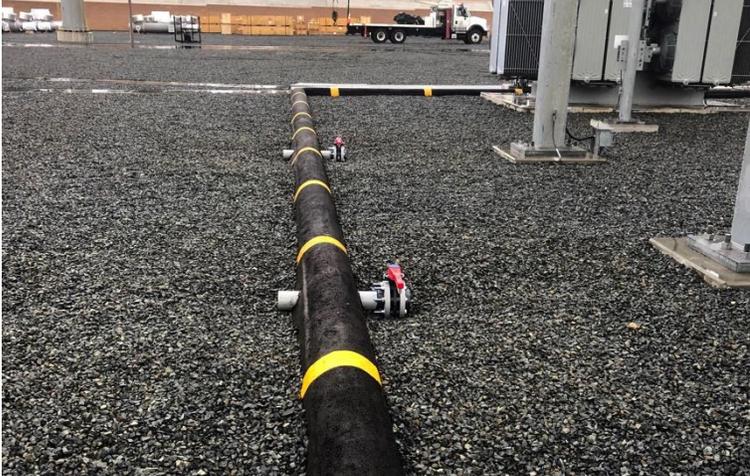
Photo 9 – Valves installed at the 16-kV containment berm. Photo facing north.
