Re: Monthly Report Summary #27 for the Mesa 500-kV Substation Project

Mesa 500–kV Substation Project CPUC Site Inspection Form

Project:	Mesa 500-kV Substation Project	Date:	December 4, 2019
Project Proponent:	Southern California Edison	Report #:	VS098
Lead Agency:	California Public Utilities Commission	Monitor(s):	Vince Semonsen
CPUC PM:	Connie Chen, Energy Division	AM/PM Weather:	Light rain and cool temperatures with a light breeze
E & E CM:	Silvia Yanez	Start/End Time:	1430 to 1600
Project NTP(s):	NTP-1, NTP-2

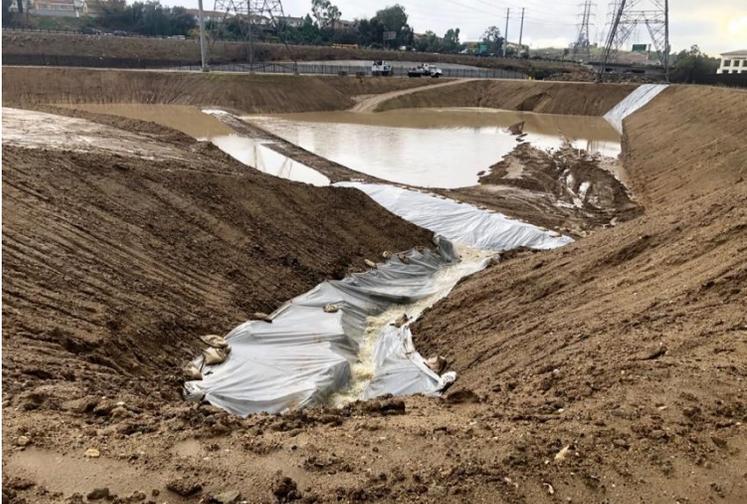
A significant amount of water was entering the large detention basin through the plastic-lined chute – Photo 1. It filled the eastern portion of the detention basin and was pouring over into the western half of the basin – Photo 2. The entire basin appeared to be about half full.

Photo 1 – Large detention basin. Photo facing southwest.
12/04/19	Mesa Substation

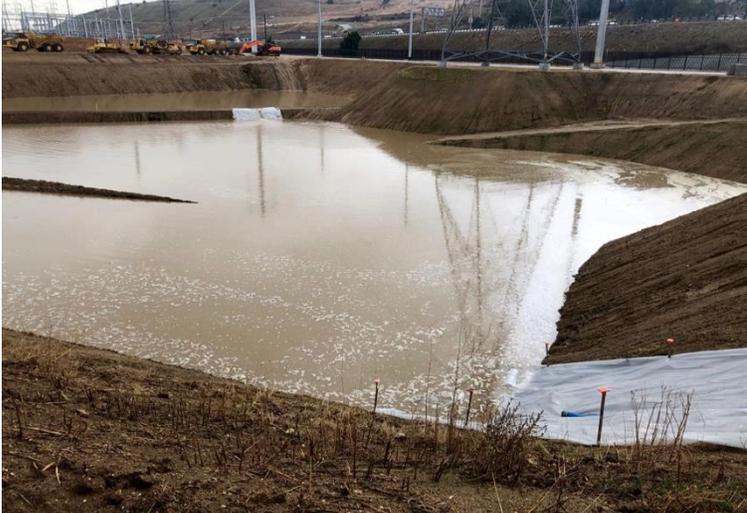
Photo 2 – The large detention basin. Photo facing southeast.
12/04/19	Mesa Substation

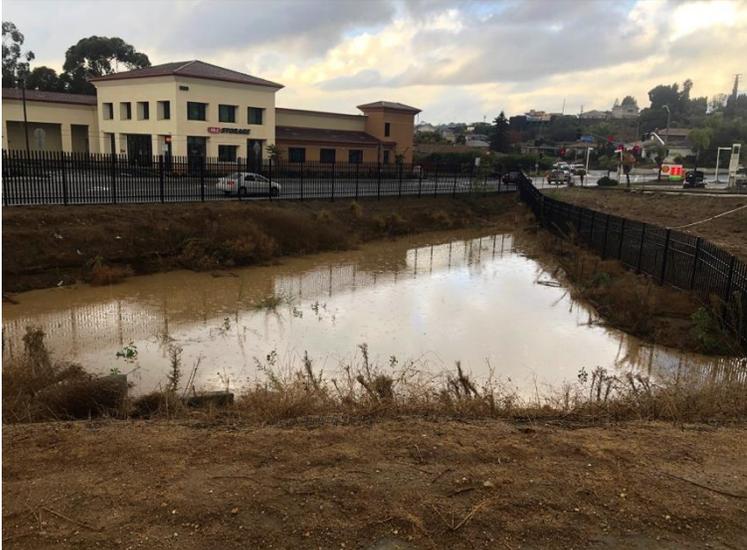
The small “triangular” retention basin appeared full – Photo 3. All hoses and plastic were in place to pump the water into the large detention basin.

Photo 3 – Small triangular retention basin. Photo facing northwest.

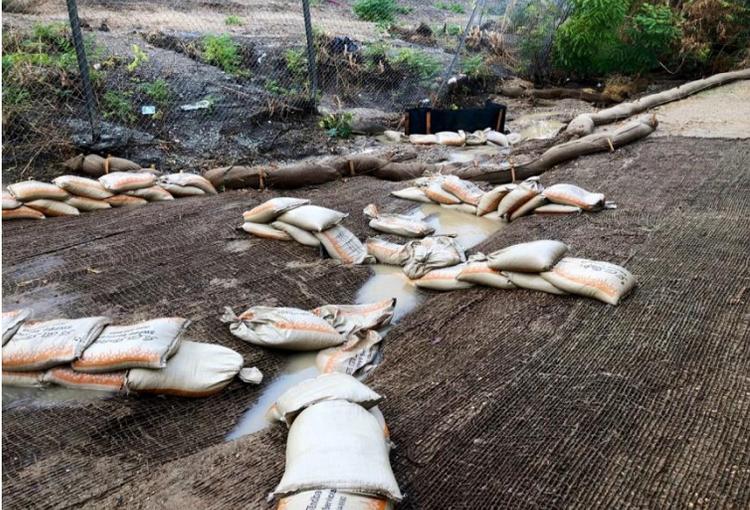
Rainwater runoff was flowing onto and through the project site from several locations. The water from the southeastern portion of the project site flowed past the Environmentally Sensitive Area (ESA) through the material staging area and the equipment parking spots. The runoff exited the project site toward the south of the southern boundary wall – Photo 4. Since my previous site visit, best management practices (BMPs) were upgraded along the wall to capture sediment before the runoff enters the drain inlet and flows offsite – Photo 5. These BMPs captured some mud – Photos 6, 7, & 8 – but it was evident that the amount of water coming through this area overwhelmed them, running under and over the wattles – Photo 9 – and rupturing the gravel bag check dams – Photo 10.

<p>Photo 10 – Upgraded BMPs outside of the southern boundary wall, note the blown-out gravel bag check dams. Photo facing southwest.</p>
12/04/19	Mesa Substation

An additional catch basin was suggested for the runoff from the southeastern portion of the project.

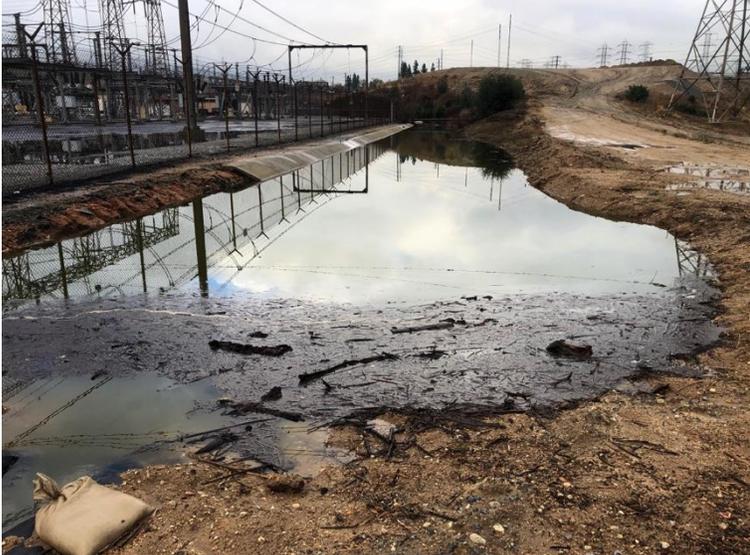
A significant amount of runoff was coming down the concrete channel along the south side of the Existing Mesa Substation – Photo 11. The crews cut and lined a small channel so water would flow through and into the project site – Photo 12. The water appeared relatively clear as it ran down the site and into a storm drain, and eventually in the large detention basin.

<p>Photo 11 – Rainwater runoff coming from the Existing Mesa Substation. Photo facing east.</p>
12/04/19	Mesa Substation

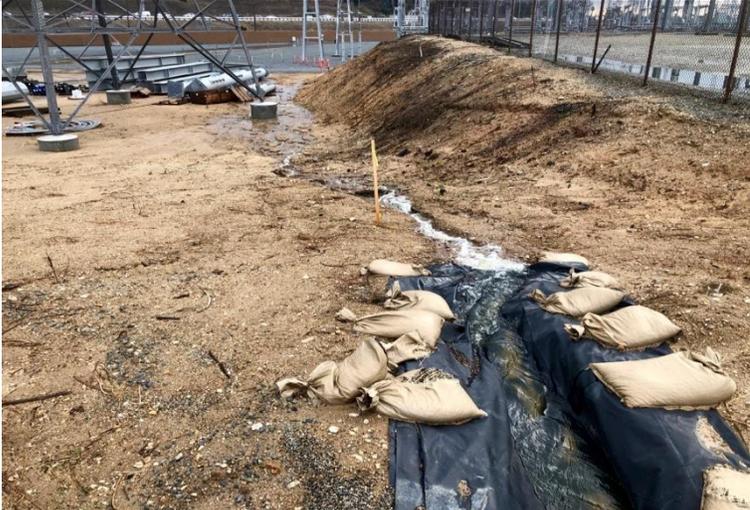
<p>Photo 12 – Plastic lined channel draining the ponded runoff that is shown in photo 11. Photo facing southwest.</p>

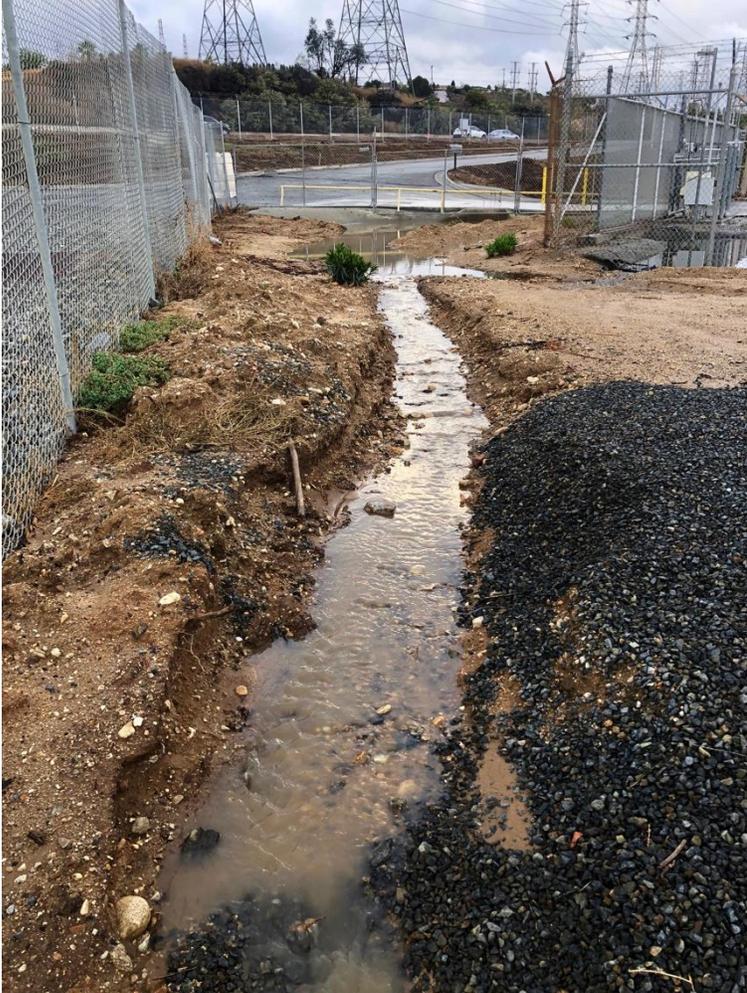
The concrete channel along the east and north sides of the Existing Mesa Substation was full, and construction crews cut a channel to direct water through the northern portion of the project site until it entered the storm drain system – Photo 13.

Photo 13 – Channel draining the concrete lined culvert located along the eastern and northern side of the Existing Mesa Substation. Photo facing northeast.
12/04/19	Mesa Substation

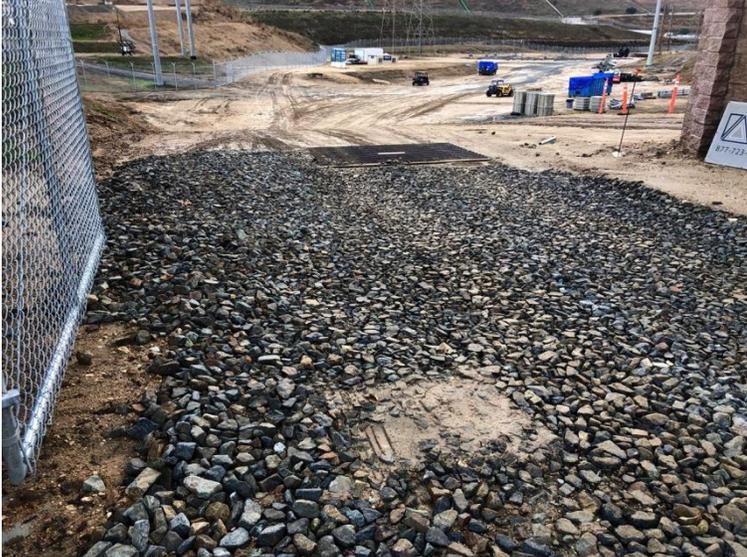
According to SWPPP inspector Alec Fera, the eastern entrance of the project site was the main exit/entry location – Photo 14. We discussed the need to upgrade the BMPs at this location, with a focus on repositioning the rumble plates and installing additional rock.

Photo 14 – Entry/exit BMPs at the eastern entrance to the project. Photo facing south.

Drip pan installation and BMP upgrades and maintenance.

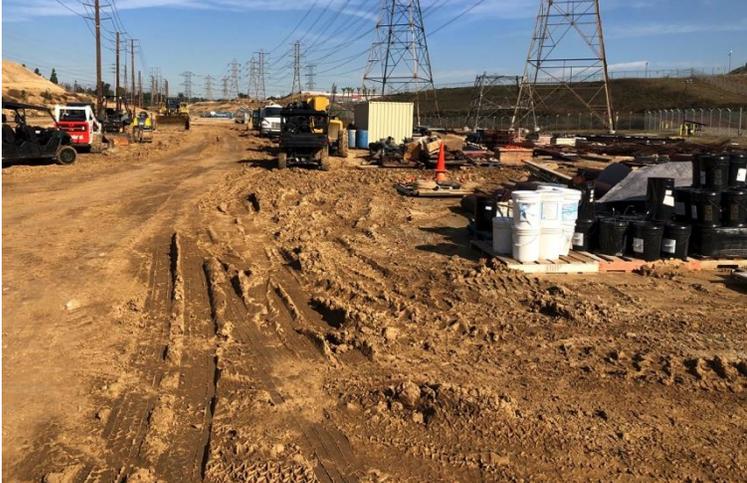
The site received rain over the weekend, and the earthen portions of the project site were muddy – Photos 1 & 2. Rainwater runoff flowed through these areas and encountered the BMPs placed along the outside of the southern boundary wall – Photos 3 & 4. Some minor upgrades to the BMPs were noted; however, the sediment-laden water overtopped the BMPs and reached the drain inlet. As mentioned previously, the drain inlet leads to drainpipes and channels.

Photo 1 – Muddy staging and equipment parking area. Photo facing east.
12/11/19	Mesa Substation

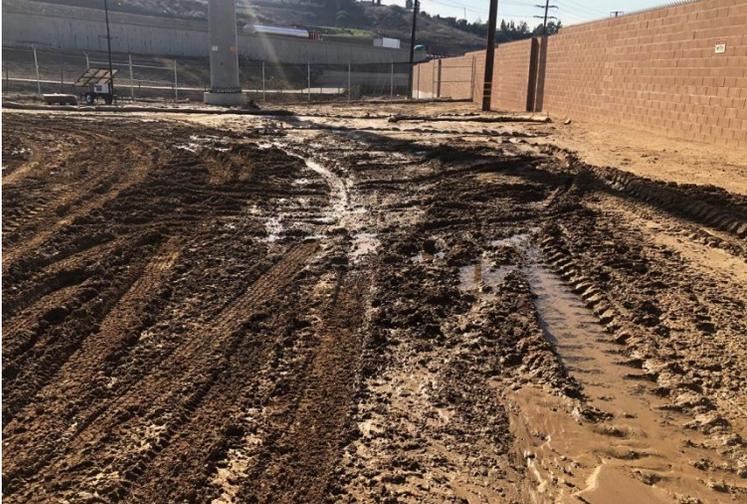
Photo 2 – Muddy portion of the site near the southern boundary wall. Photo facing southwest.
12/11/19	Mesa Substation

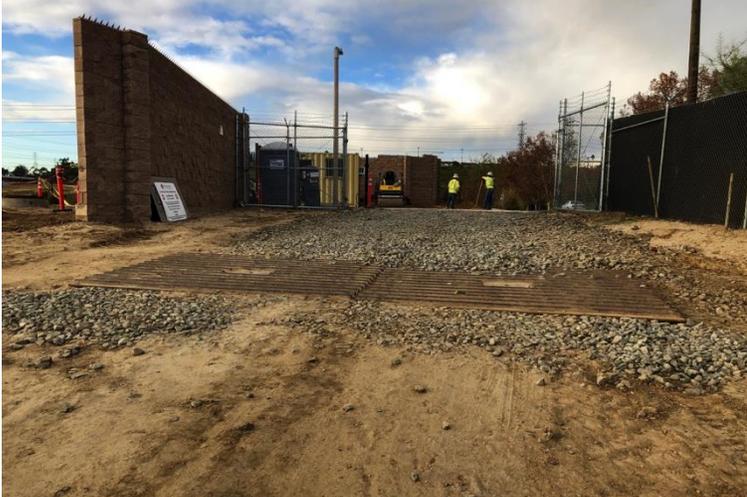
We entered through the eastern project entrance and I noted that additional rock needed to be placed at the exit/entry best management practices (BMPs) – Photo 1. I had notified personnel about this issue during my previous site visit.

<p>Photo 1 – Exit/entry BMPs at the eastern entrance, Additional rock was needed. Photo facing north.</p>
12/18/19	Mesa Substation

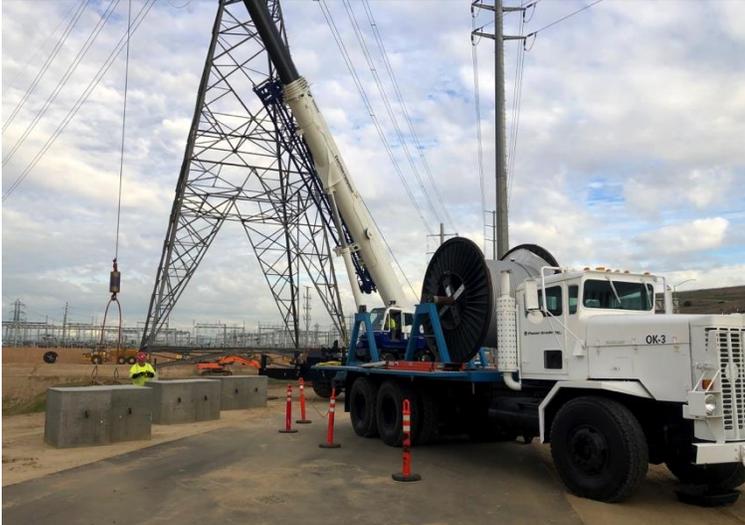
A construction crew was pulling wire. I noted several pieces of equipment being used near the detention basin – Photo 7. Another crew was installing tubular steel poles (TSPs) along the paved access road near the 66-kilovolt (kV) switchrack area – Photo 8.

Photo 7 – Wire pulling equipment. Photo facing east.
12/18/19	Mesa Substation

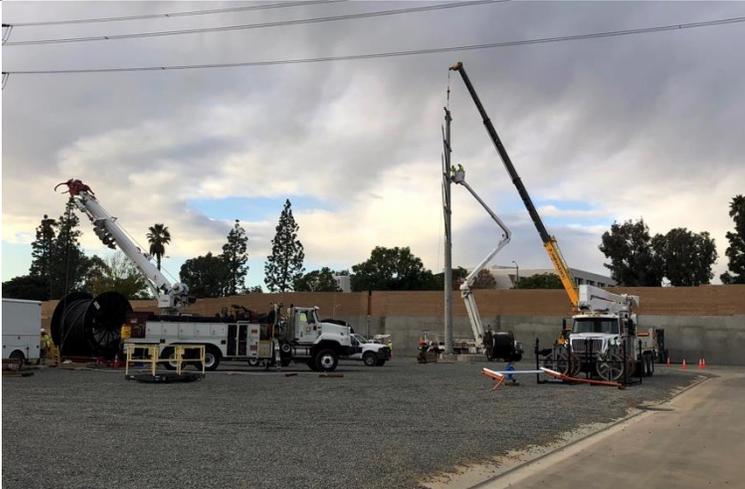
Photo 8 – Tower installation. Photo facing north.
