February 23, 2021

Connie Chen
Project Manager
California Public Utilities Commission
505 Van Ness Avenue
San Francisco, CA 94102

Re: Monthly Report Summary #28 for the Mesa 500-kV Substation Project

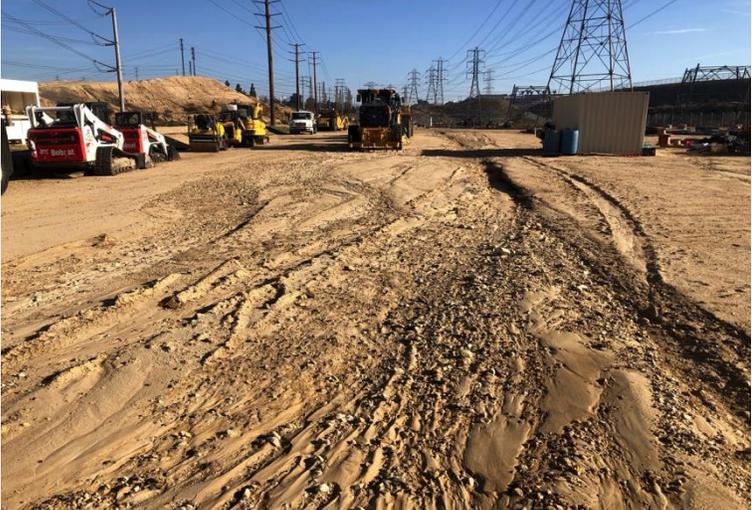
Driving in along the southern side of the project site, through the equipment parking area, I noted a dry flow line where stormwater had run down toward the outside of the southern boundary wall (Photo 1). I checked the BMPs outside of the wall where muddy sediment had filled in and overtopped all of the wattles (Photo 2). The runoff also blew out all of the gravel check dams (Photo 3). All of the runoff coming down through this area leaves the site via the California Department of Transportation concrete channel.

Photo 1 – Evidence of stormwater runoff through the southern portion of the site. Photo facing east.
1/02/20	Mesa Substation

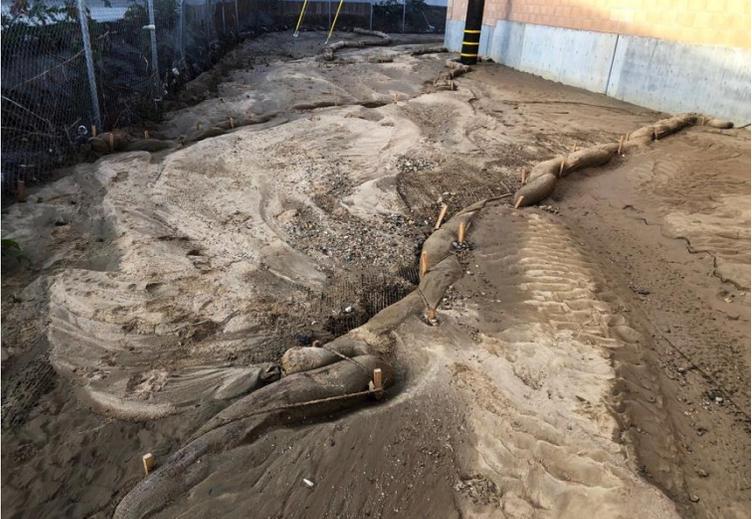
Photo 2 – Sediment captured by the BMPs along the outside of the southern boundary wall – all the wattles are full. Photo facing southwest.
1/02/20	Mesa Substation

- On January 2, 2020, the CPUC Compliance Monitor noted the site received rain over the weekend and the earthen portions of the project site were muddy. The BMPs placed along the outside of the southern boundary wall were overwhelmed from the stormwater runoff. The CPUC Compliance Monitor recommended upgrading the BMPs and cleaning the surrounding sediment.

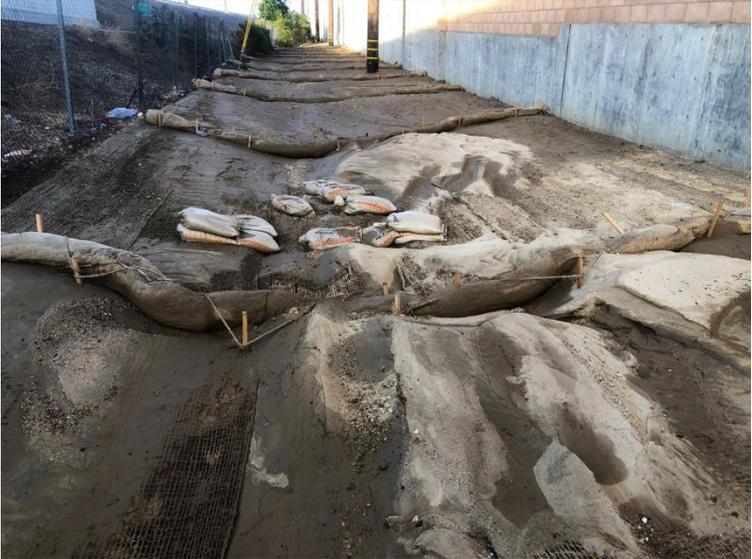
Photo 3 – Captured sediment and blown out gravel check dams indicates a large volume of water flowing through this area outside of the southern boundary wall. Photo facing west.

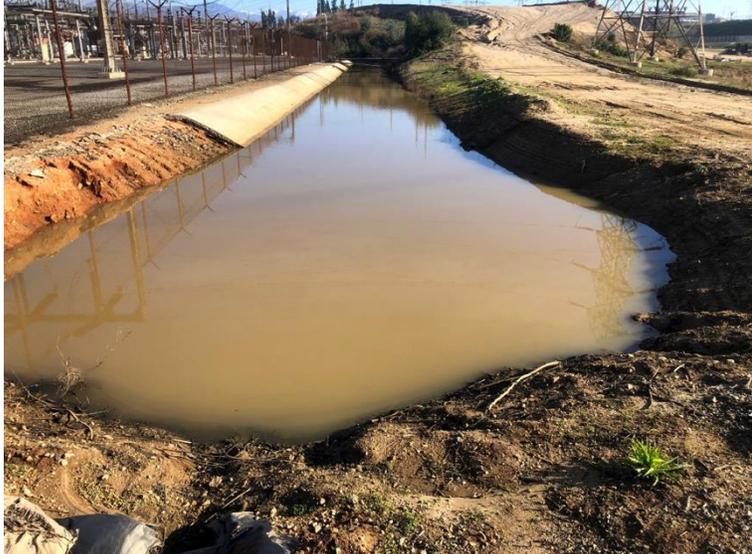
Photo 4 – Drainage channel holding water coming off of the old substation. Photo facing east.
1/02/20	Mesa Substation

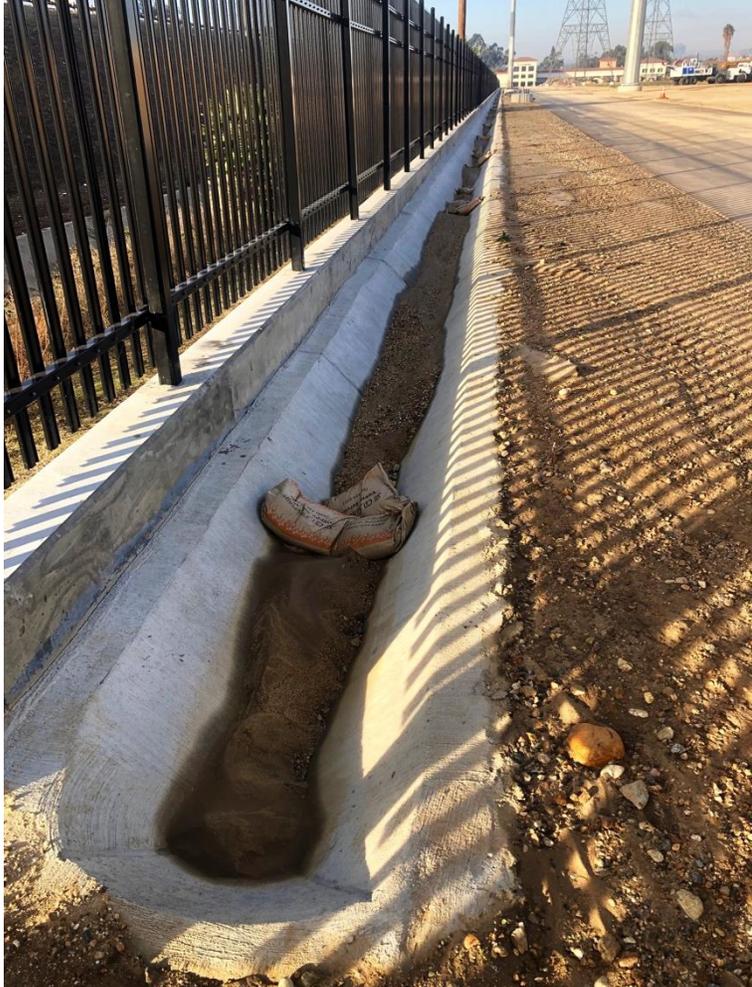
Photo 5 – “V” ditch with captured sediment, indicating rainwater runoff coming through here. Photo facing west.

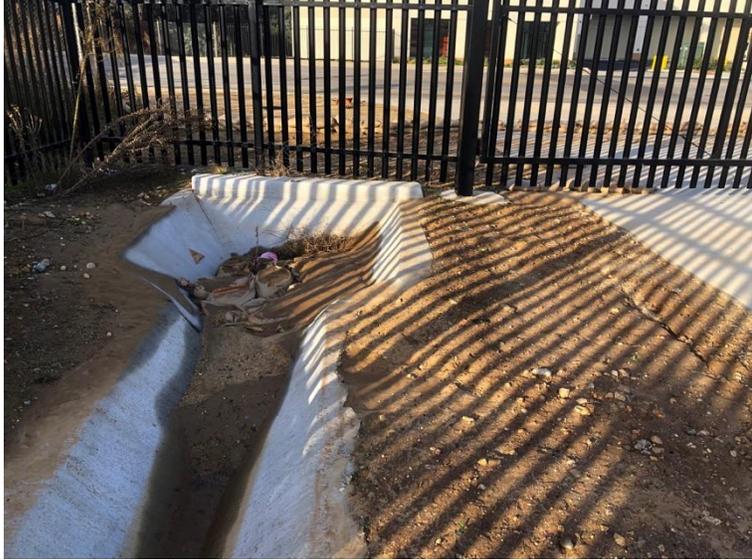
Photo 6 – “V” ditch drains are plugged at the west end of the project near Markland Avenue. Photo facing west.
1/02/20	Mesa Substation

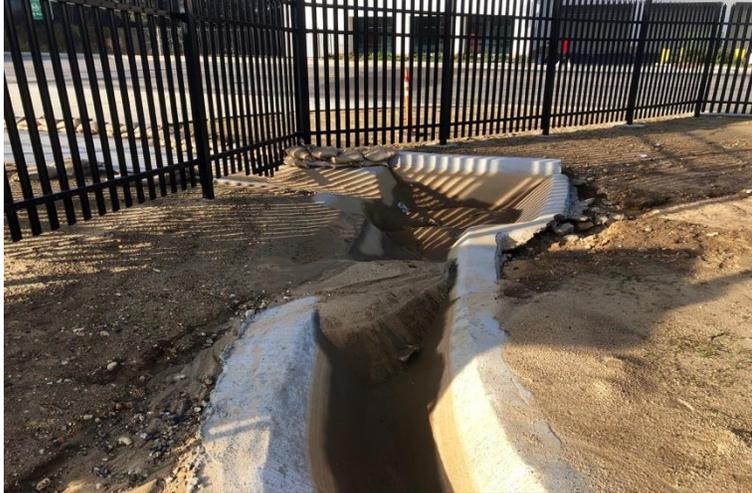
Photo 7 – “V” ditch drains are plugged at the west end of the project near Markland Avenue. Photo facing west.
1/02/20	Mesa Substation

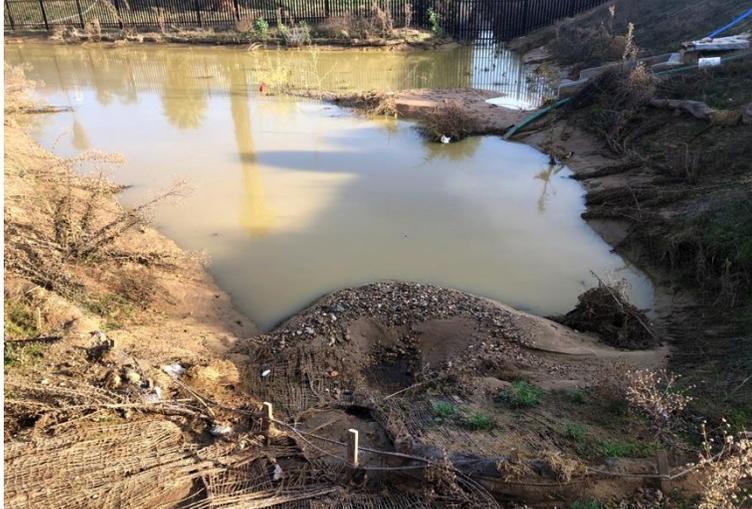
Photo 8 – Small triangular detention with sediment around the drain outlet standpipe.

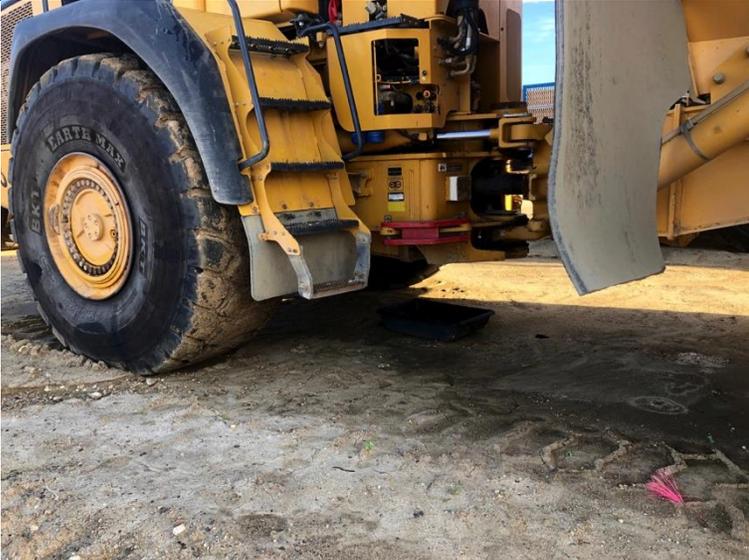
Secondary containment under the construction equipment remains tremendously inadequate (Photo 10). Equipment leaks were noted where some equipment was parked on the asphalt road (Photo 11).

Photo 10 – One small drip pan placed under a large piece of equipment.
1/02/20	Mesa Substation

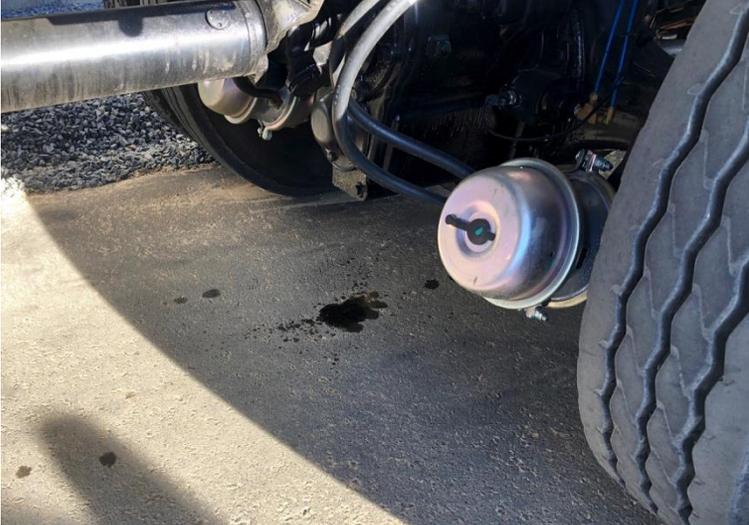
Photo 11 – Inadequate drip pan placement under this equipment.

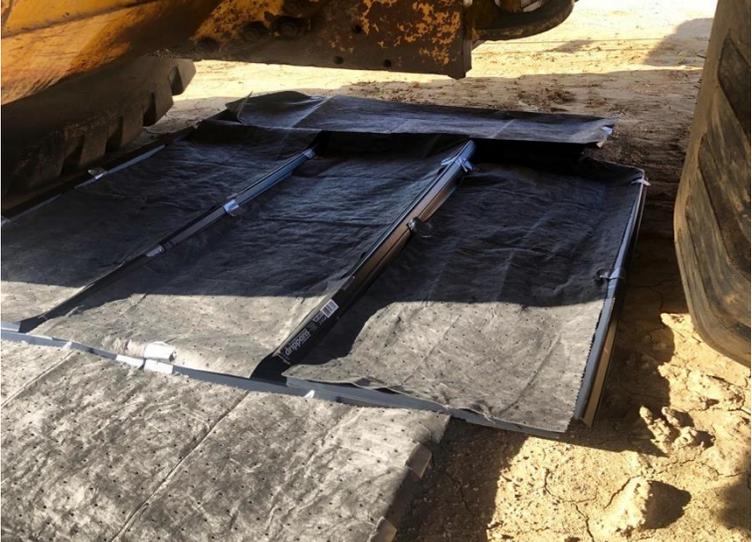
Photo 3 – New secondary containment pans.

I met with Lead Biological Monitor Matt Daniele and Power Grade Foreman Craig Pernot in order to examine the new system of secondary containment. The new drip pans can lock together to customize their size and shape depending on the equipment to be contained (Photo 3). They are also lined with absorbent pads, which can be easily removed and replaced if there are some captured leaks. Mr. Daniele's environment team will be documenting the daily installation and maintenance of these new drip pans.

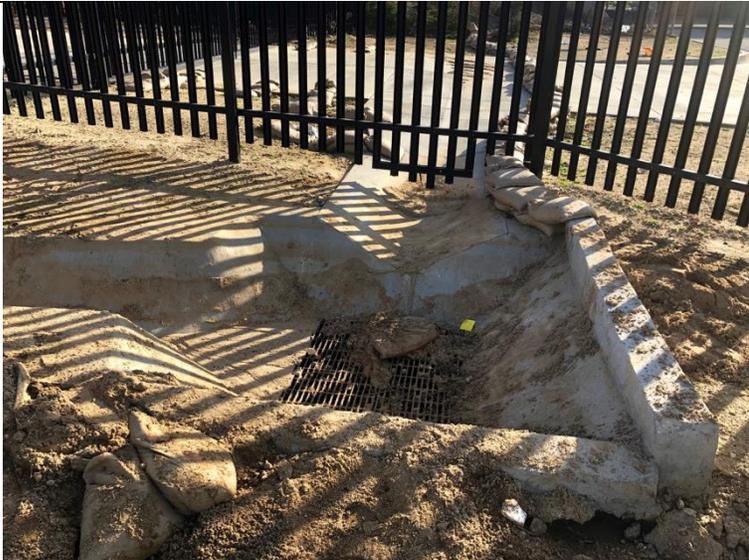
Photo 6 – “V” ditch drains are cleaned out near Markland Avenue. Photo facing south.

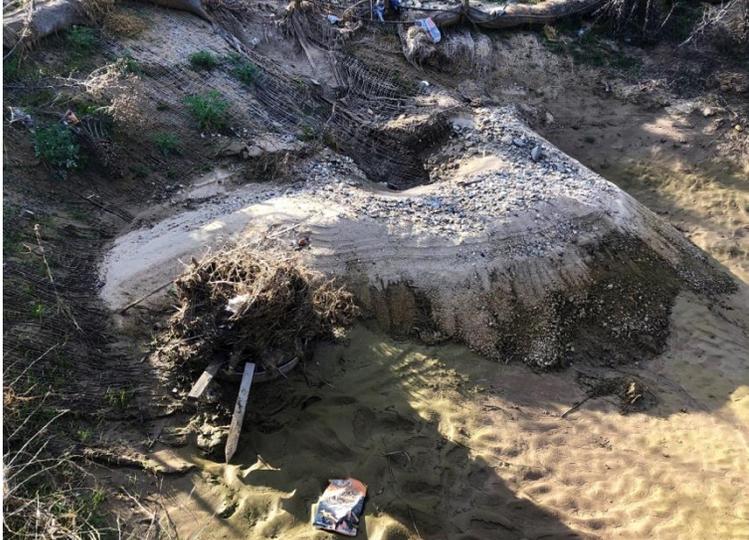
Photo 8 – Small triangular detention basin with sediment and debris around the drain outlet standpipe.
1/09/20	Mesa Substation

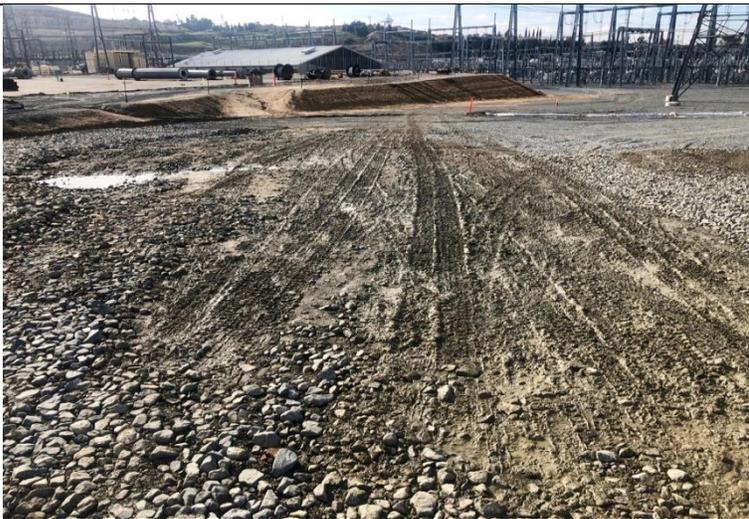
- On January 17, 2020, the CPUC Compliance Monitor noted that crews were not utilizing the entry/exit BMPs at the northern project entrance for construction equipment. It is important for crews to utilize the entry/exit BMPs to avoid trackout.

<p>Photo 1 – Vehicle are not using the entry/exit BMPs at the northern project entrance. Photo facing southwest.</p>
1/17/20	Mesa Substation

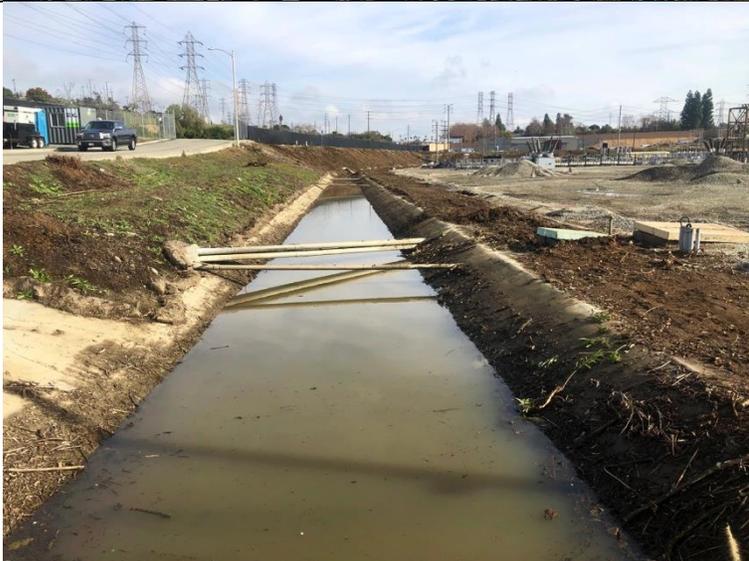
<p>Photo 2 – The concrete channel around the old substation is full. Photo facing east.</p>
1/17/20	Mesa Substation

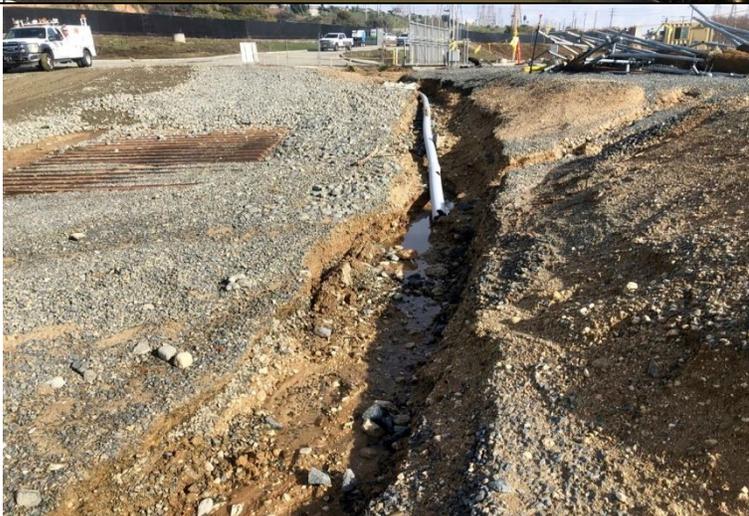
<p>Photo 3 – Overflow from the concrete channel has created a sizable rill along the entry/exit BMPs. Photo facing east.</p>

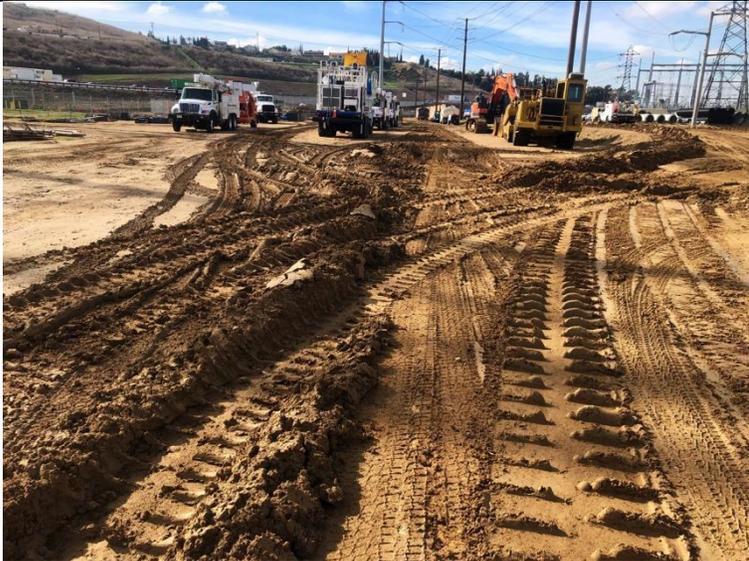
Photo 8 – Muddy conditions near the vehicle parking area. Photo facing southwest.
1/17/20	Mesa Substation

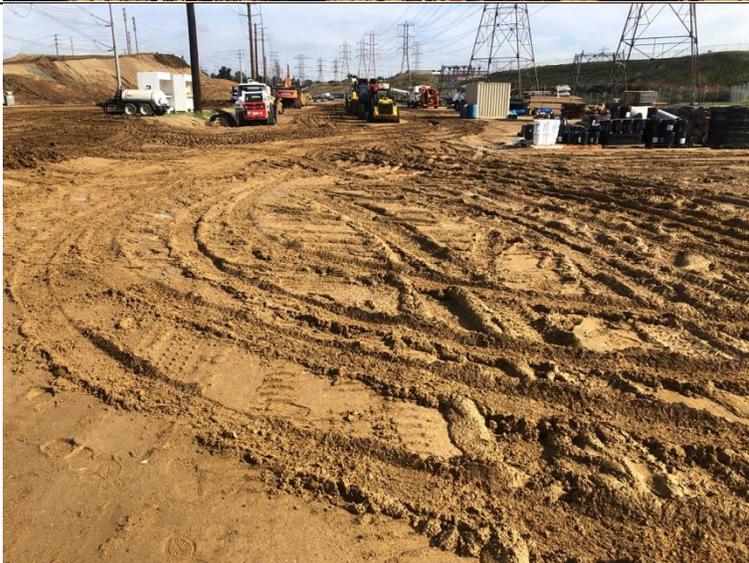
Photo 9 – Muddy conditions by the southern boundary wall. Photo facing east.

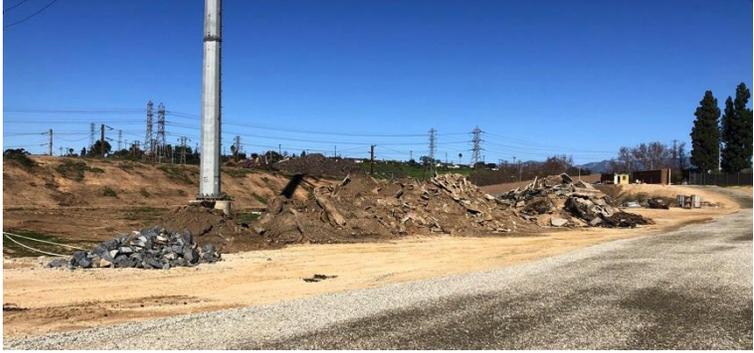
Photo 14 – Stockpiled construction debris within the southeastern portion of the project site. Photo facing northeast.
1/29/20	Mesa Substation
