Re: Monthly Report Summary #2 for the Mesa 500-kV Substation Project

This report provides a summary of the compliance monitoring activities that occurred during the period from **November 1 to 30, 2017**, for the Mesa 500-kV Substation (Mesa Substation) Project in Los Angeles County, California. Compliance monitoring was performed to ensure that all project-related activities conducted by Southern California Edison (SCE) and their contractors are in compliance with the requirements of the Final Environmental Impact Report (Final EIR) for the Mesa Substation Project, as adopted by the California Public Utilities Commission (CPUC) on February 9, 2017.

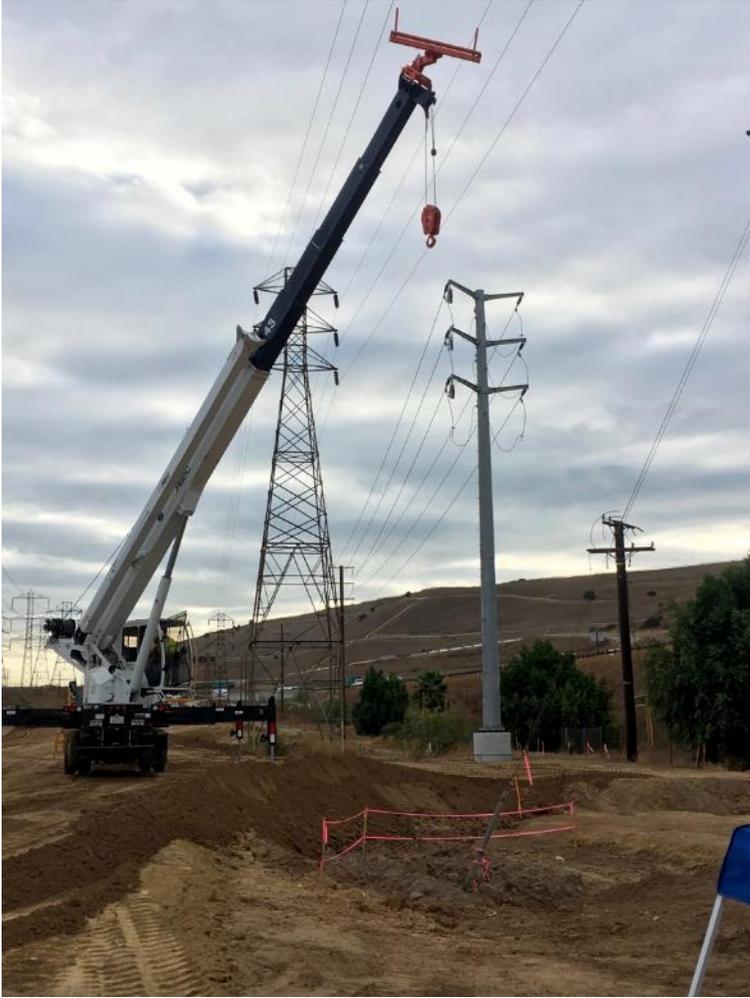
New tubular steel poles (TSPs) had been installed along the southern border of the Mesa Substation site, and I observed crews stringing wire onto the new towers and temporary wooden poles (Photo 7).

Photo 7 – Stringing the new poles. Photo facing southeast
11/03/17	Mesa Substation Site

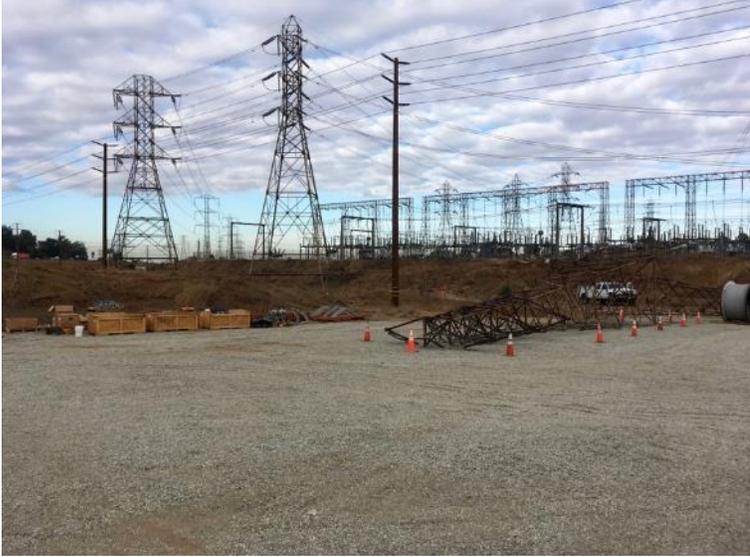
The SCE crew staging area near the southern border of the Mesa Substation site was being used to stockpile the old tower structures (Photo 8). I saw biological monitor Ben Smith (ICF) near the SCE crew staging area where he had just observed and photographed some coastal California gnatcatchers while spot-checking the various sites within the Mesa Substation site. We discussed buffers for coastal California gnatcatchers and other bird species, if and when they start nesting. Ben Smith has extensive experience with setting up buffers for bird species.

Photo 8 – SCE crew staging area. Photo facing north.

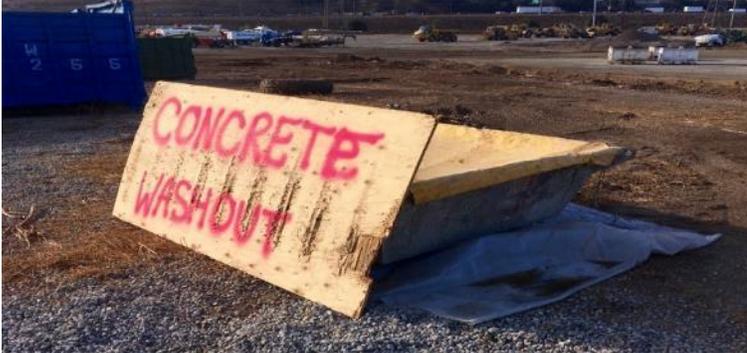
I arrived onsite at 0815 and walked to the Mesa Substation site. I noted the concrete washout near the site's entry/exit (MM HZ-3). The concrete washout was well labeled, and the plastic bin had been covered overnight to prevent birds from becoming attracted to the water (Photo 1).

Photo 1 – Labeled concrete washout area.
11/07/17	Mesa Substation Site

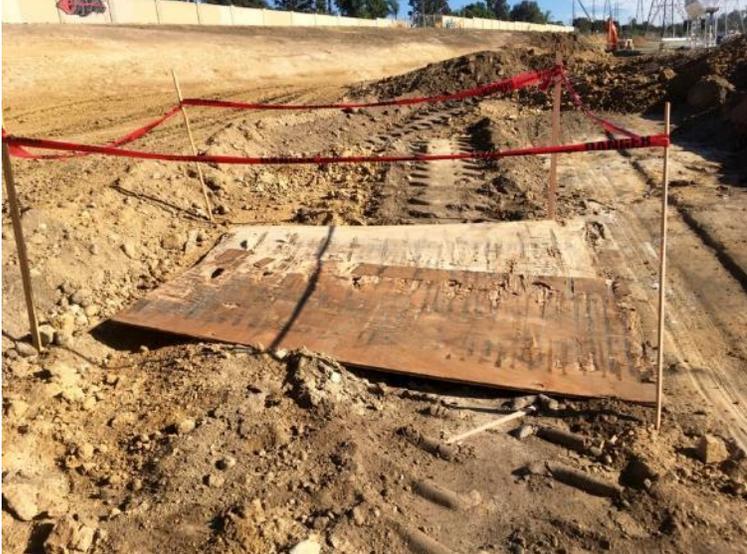
Photo 6 – A potential abandoned well that was discovered by the crew and then flagged and covered.

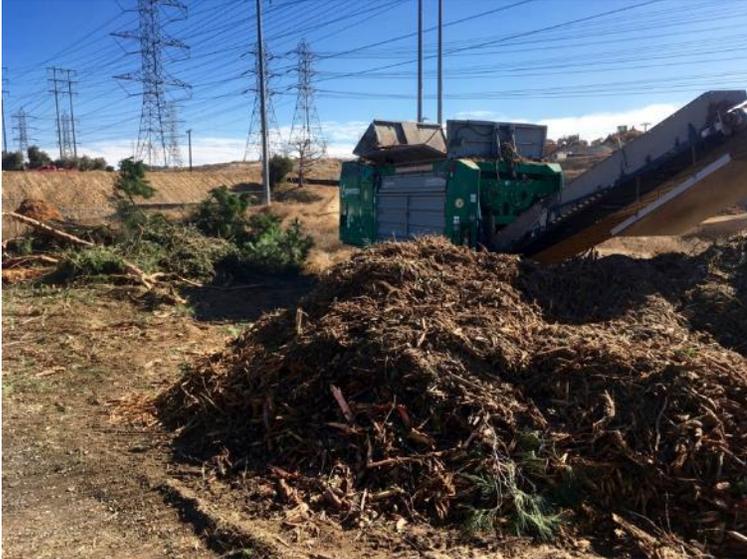
Tree removal and vegetation grinding had moved to the eastern portion of the Mesa Substation site (Photos 10 and 11). Biological monitor Eric Willems (ICF) was spot-checking the tree removal and other construction activities (APM-BIO-03, MM BR-1, MM BR-9). I asked the crew member cutting down the trees if he had observed any animals. He replied that he had seen only lizards and spiders.

Photo 10 – Chipping vegetation. Photo facing east.
11/07/17	Mesa Substation Site

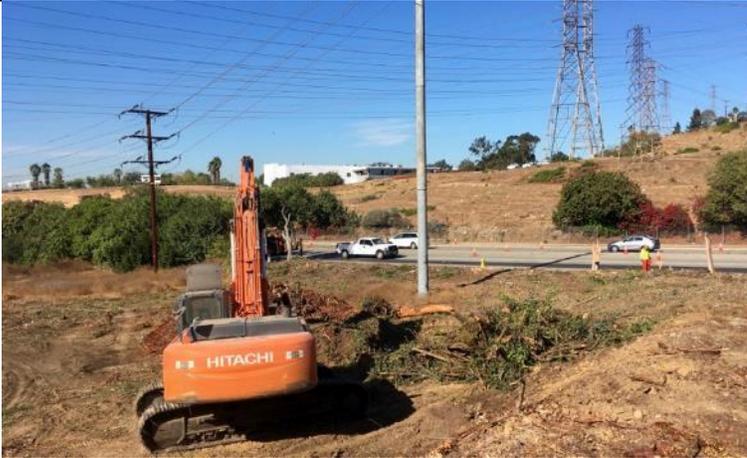
Photo 11 – Tree removal along Potrero Grande Drive. Photo facing north.
11/07/17	Kiewit Jack-and-Bore Pit Exit Hole Area

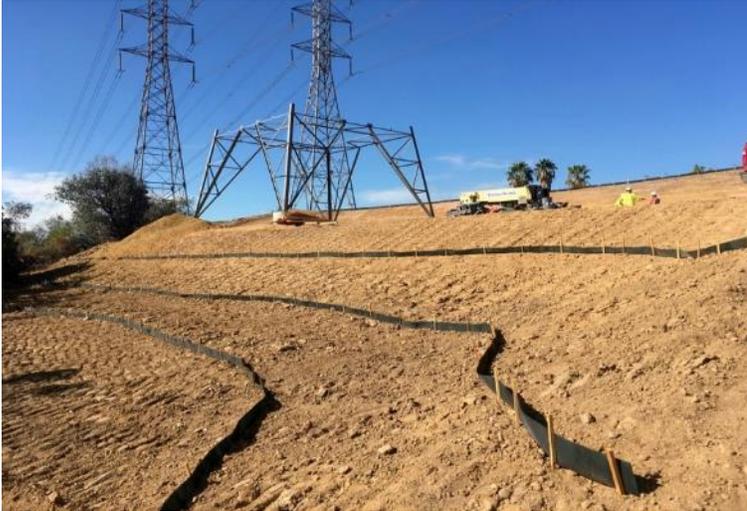
Photo 13 – A new tower being constructed. Slopes of the new pad have been stabilized with BMPs. Photo facing west.
11/07/17	Mesa Substation Site, Kiewit Jack-and-Bore Pit

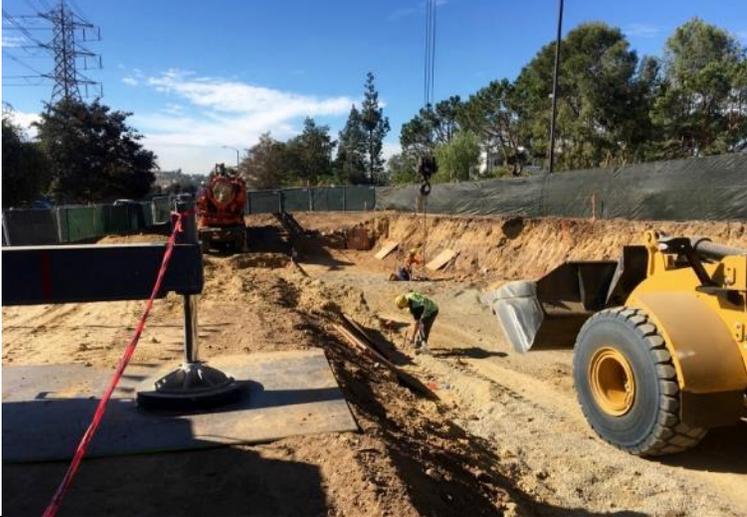
Photo 14 – Site preparation for the Kiewit jack-and-bore pit exit hole. Screening has been installed on the fencing. Photo facing west.

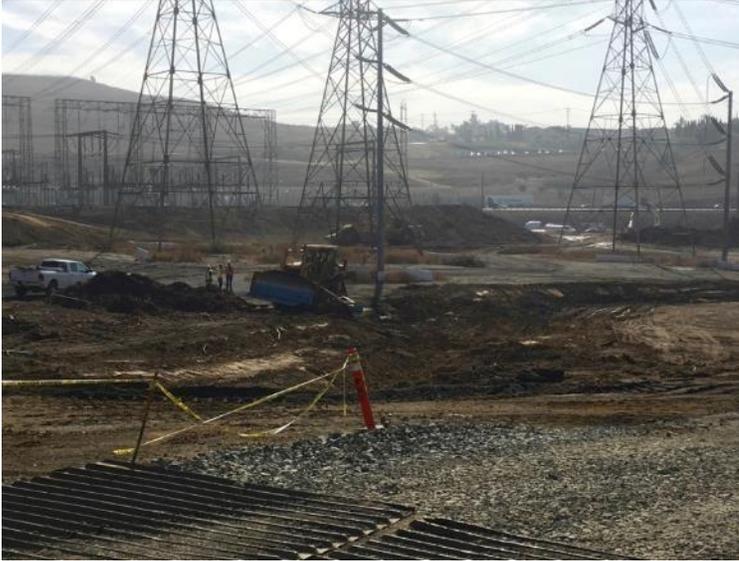
I arrived onsite at 1030 and walked to the Mesa Substation site. I observed a bulldozer clearing debris out of the old drainage channel (Photo 1). Biological monitor Eric Willems (ICF) was overseeing this work and spot-checking other construction activities (APM-BIO-03, MM BR-1, MM BR-9).

Photo 1 – Equipment continues to clear the old drainage channel. Photo facing south.
11/14/17	Mesa Substation Site

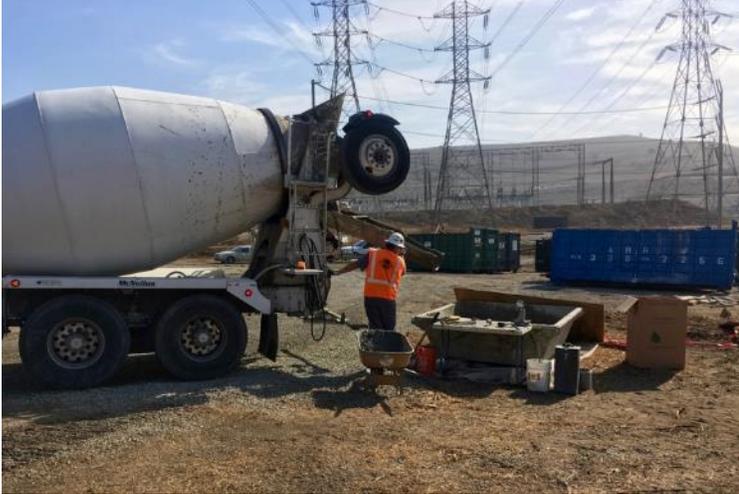
I observed a concrete truck being washed out within the designated area (MM HZ-3) (Photo 2).

Photo 2 – Concrete truck being washed out within the designated area. Photo facing south.
11/14/17	Mesa Substation Site, Kiewit Jack-and-Bore Pit

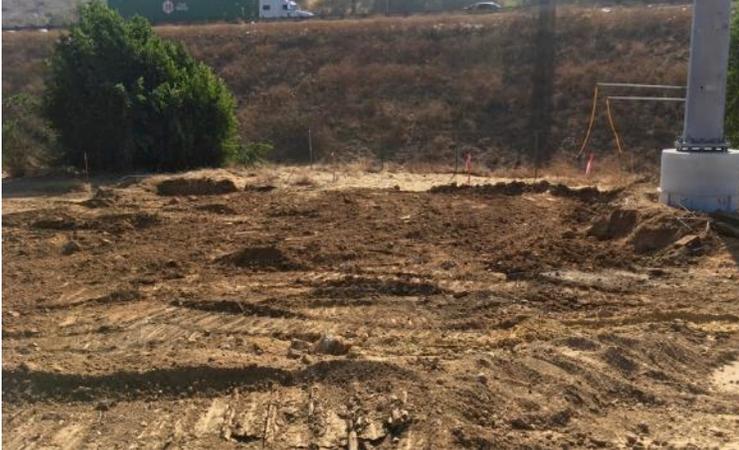
Along the southern border of the Mesa Substation site, crews had removed some of the old tower foundations (Photo 7) and continued to drill, set, and pour the new concrete foundations (Photos 8 and 9). During the pour, plastic was laid down and crews were careful not to spill concrete.

Photo 7 – Removal of the old tower foundations.
11/14/17	Mesa Substation Site

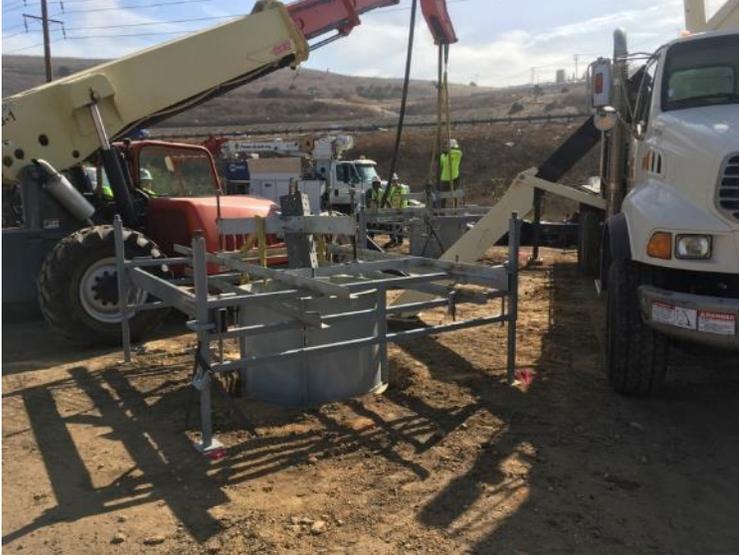
Photo 8 – Crews working on drilling and setting the forms for the new concrete foundations.

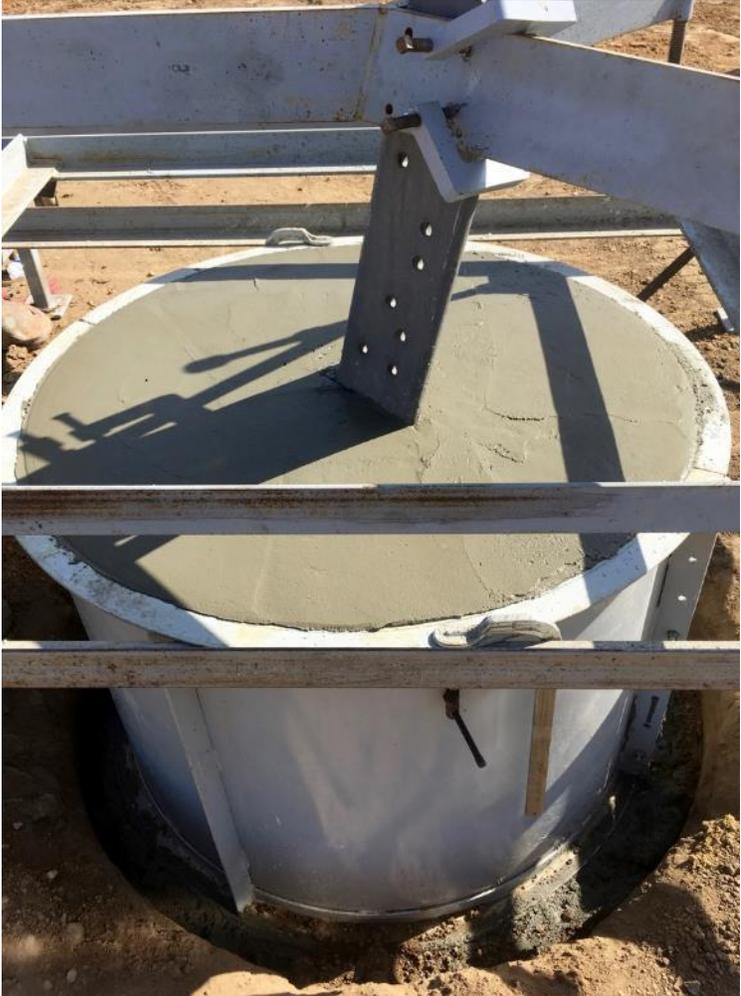
Photo 9 – A newly poured foundation leg.
11/14/17	Mesa Substation Site

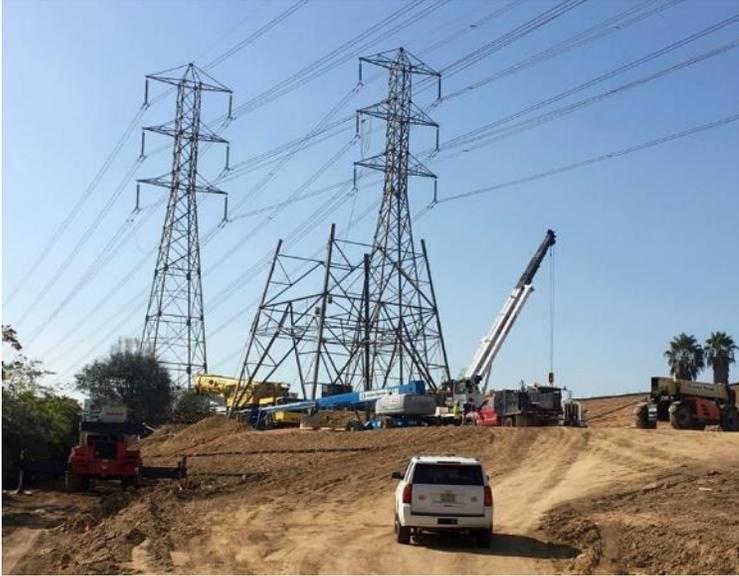
While crossing Potrero Grande Drive, I noted that a sweeper was working both the length and width of the street. The new tower within the Transmission Corridor was being erected (Photo 13). The access road to this area still did not have any exit/entry best management practices (BMPs) (APM AIR-01); however, a large sign had been painted and installed on the gate instructing vehicles not to exit the site at this location (Photo 14).

Photo 13 – New tower construction continues. Photo facing west.
11/14/17	Mesa Substation Site, Transmission Corridor

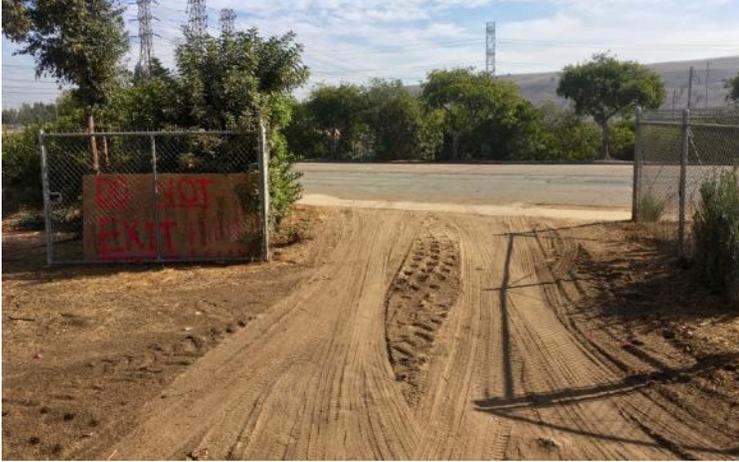
Photo 14 – The exit/entry has no BMPs; however, a sign has been posted instructing vehicles not to exit at this site. Photo facing southeast.
11/14/17	Mesa Substation Site, Kiewit Jack-and-Bore Site

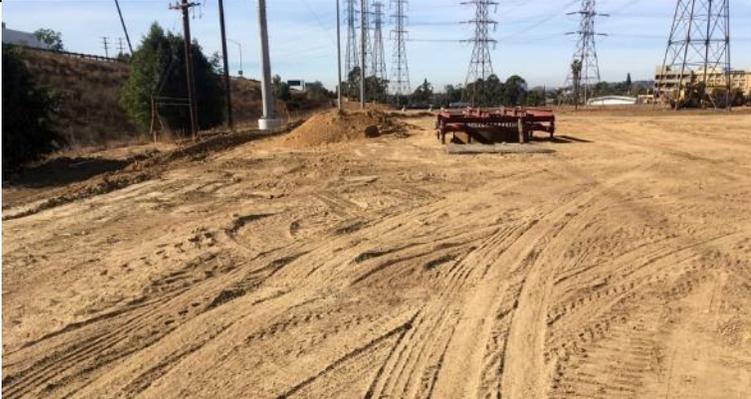
Photo 5 – Newly poured foundation; note the loose soil generating dust. Photo facing west
11/21/17	Mesa Substation Site

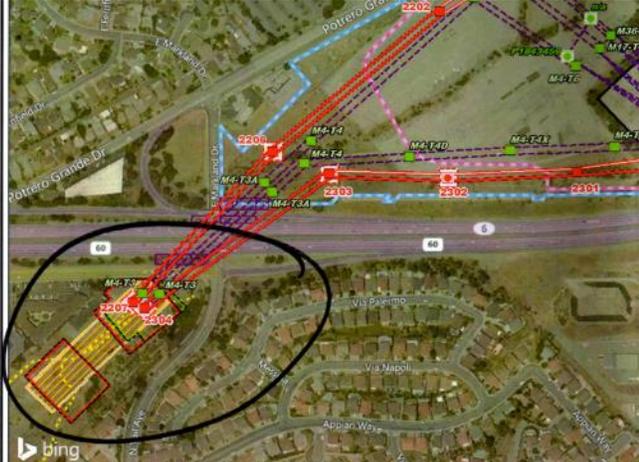
Photo 11 – Extensive construction activity is taking place in the circled portion of this photo, which is southwest of the main area of the Mesa Substation site and across Highway 60.
