February 23, 2021

**Re: Monthly Report Summary #32 for the Mesa 500-kV Substation Project**

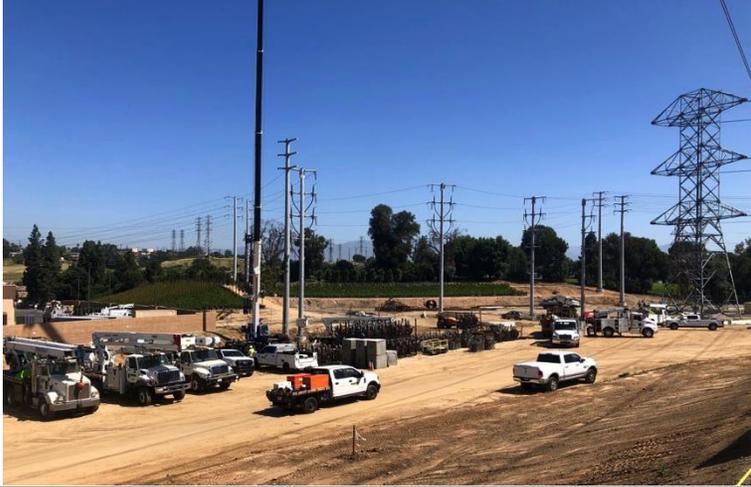
Photo 1 – Removal of existing wooden poles within the telecommunications corridor east of Market Place Drive. Photo facing northeast.
5/08/20	Mesa Substation

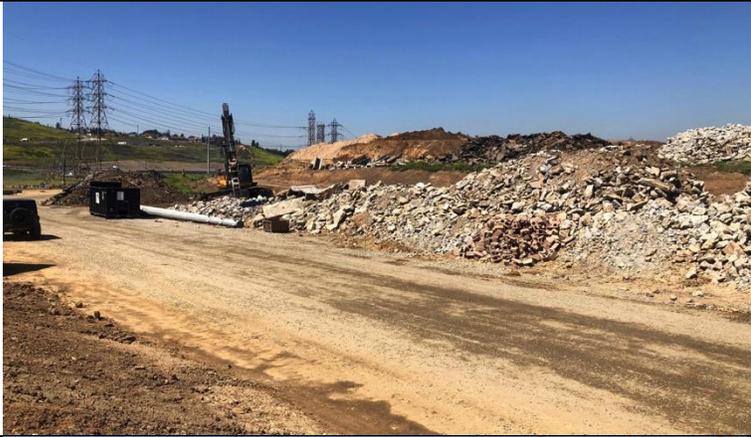
Photo 2 – Staging area for excavated concrete and asphalt. Photo facing southwest.
05/08/20	Mesa Substation

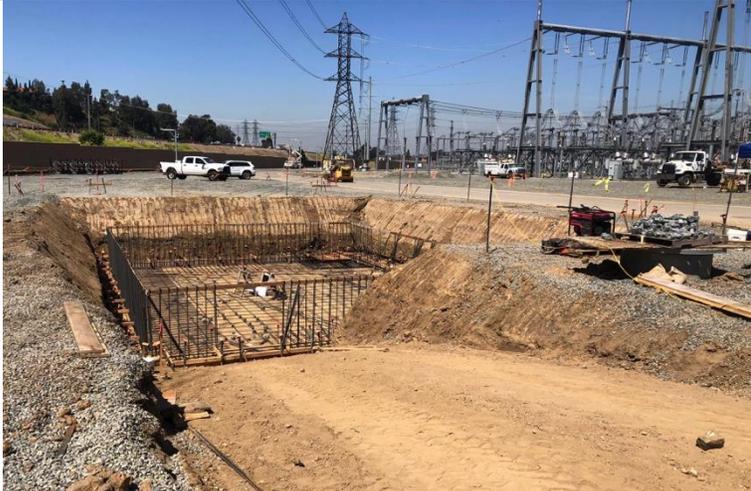
Work continued on the transformer catch basin south of the new 220-kilovolt (kV) rack area (Photo 3). Rebar was being added to the hole. The gas generator at the site had an inadequate drip pan under it. Mr. Daniele spoke with the Power Grade foreman about upgrading the secondary containment.

Photo 3 – Transformer catch basin. Photo facing southwest.

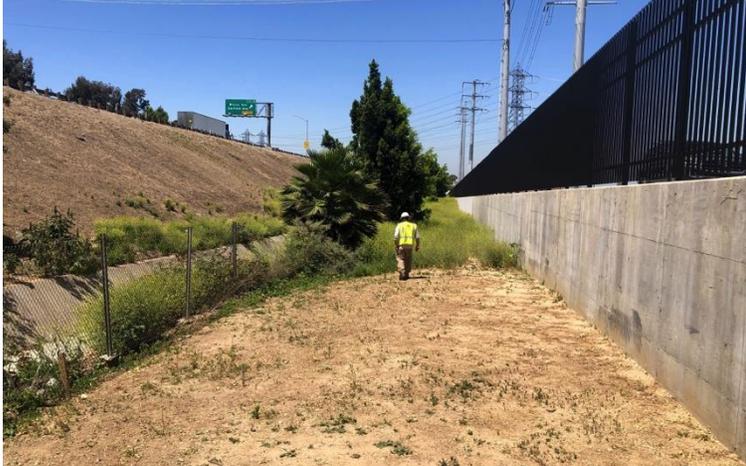
I inspected the area outside of the southern boundary wall; a small crew continued to work on weed removal. One of the biological monitors was sweeping the remaining weedy area before the weeding crew began work (Photo 9). Weedy vegetation was still growing along the drainage channel (Photo 10). I walked to the BMP area and noted that additional straw wattles had been added to the area (Photo 11). Sediment and the existing straw wattles hadn't been removed.

<p>Photo 9 – A biologist sweeping the area outside of the southern boundary fence prior to the weeding work. Photo facing west.</p>
5/08/20	Mesa Substation

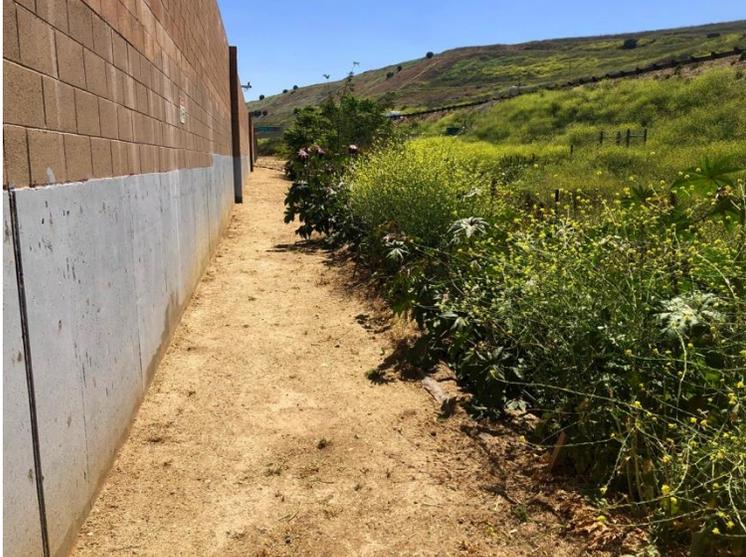
<p>Photo 10 – Some mustard and castor bean remained along the weeded area. Photo facing east.</p>
5/08/20	Mesa Substation

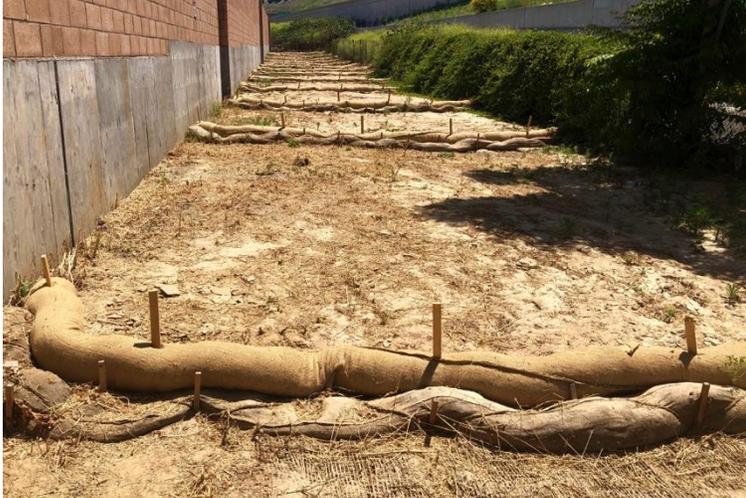
<p>Photo 11 – New straw wattles were added to the existing BMPs outside of the southern boundary wall. Photo facing east.</p>

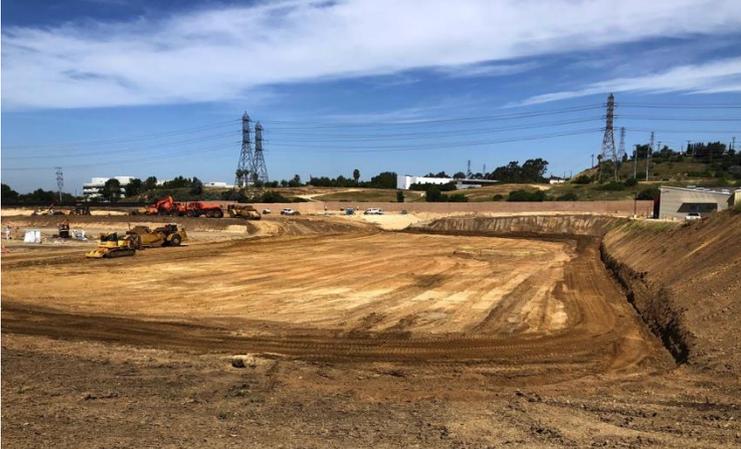
Upon entering the site through the east entrance, I noted that extensive earthwork was completed west of the entrance, near the Mesa Operations Building (Photo 1). The Phase 3 grading operation was underway. The concrete and asphalt stockpiles continued to grow with equipment working to prepare the materials for recycling (Photo 2).

<p>Photo 1 – Phase 3 earthwork at the eastern end of the project site near the Mesa Operations Building. Photo facing north.</p>
5/14/20	Mesa Substation

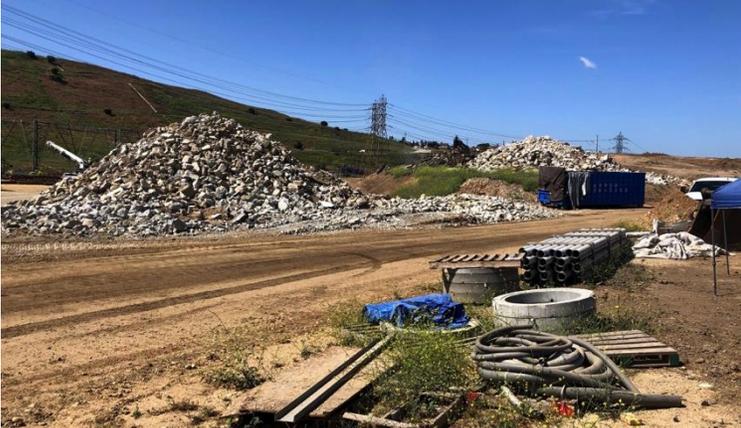
<p>Photo 2 – Staging area for excavated concrete and asphalt. Photo facing southwest.</p>
5/14/20	Mesa Substation

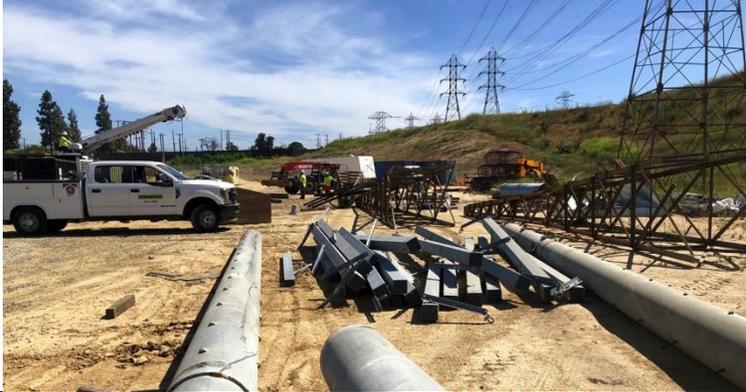
The southeastern corner of the project site was being used to demolish the existing wooden and steel poles (Photo 4). Crews were cutting the wooden poles with chain saws and were using a cutting torch on the metal poles. Several existing tower foundations remained throughout the site and would be removed and processed for recycling (Photo 5).

Photo 4 – Existing wooden and steel poles being processed for recycling. Photo facing east.
5/14/20	Mesa Substation

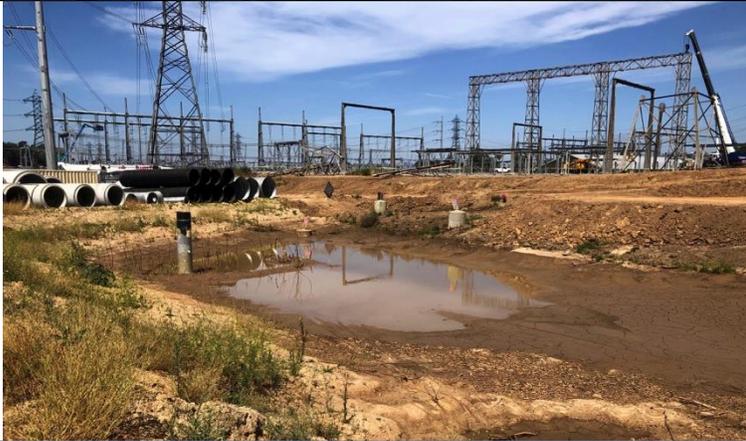
Photo 5 – Existing tower foundations remained at several locations to be removed and processed. Photo facing northwest.
5/14/20	Mesa Substation

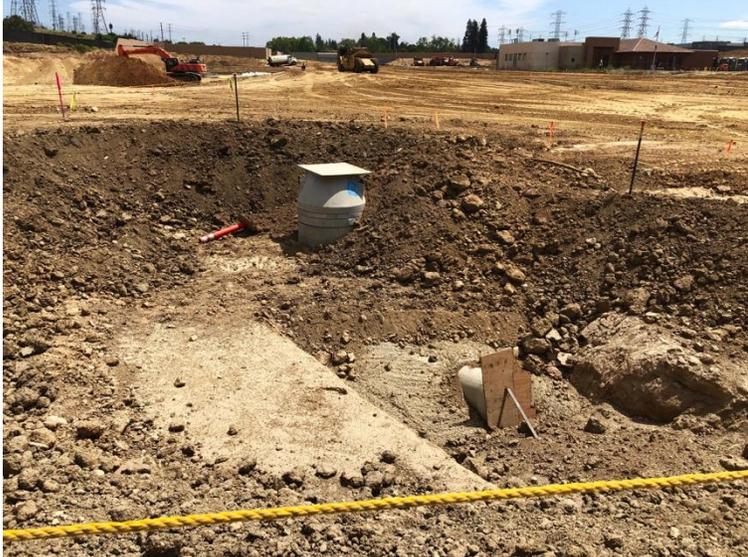
Phase 3 grading continued with the earthwork (as seen in Photo 1) and the installation of the stormwater drainage pipe system (Photos 12 and 13). Existing asbestos-coated pipe was uncovered during the demolition activities; a crew sectioned off the area and were removing the hazardous material (Photo 14). Secondary containment under the heavy equipment continued to be an issue with drip pans needing to be emptied (Photo 15) and additional pans required (Photo 16). I pointed out the leaking fluid to Power Grade Foreman Craig Pernot and the biological monitor notified Mr. Daniele. Mr. Pernot immediately added additional drip pans under the leaking equipment.

Photo 12 – Storm drain installation. Photo facing east.

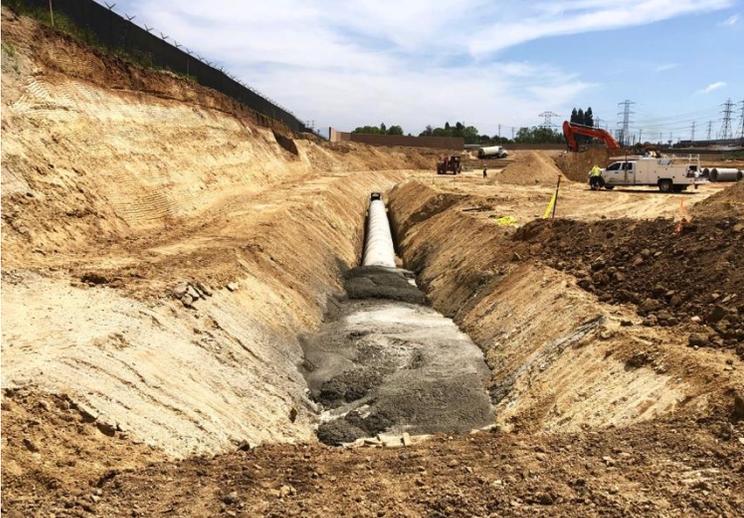
Photo 13 – Storm drain installation. Photo facing east.
5/14/20	Mesa Substation

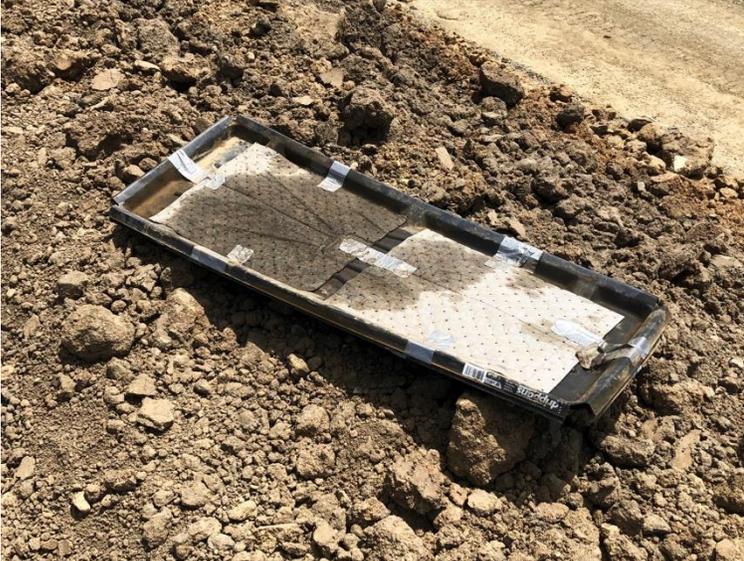
Photo 15 – Drip pan for secondary containment.

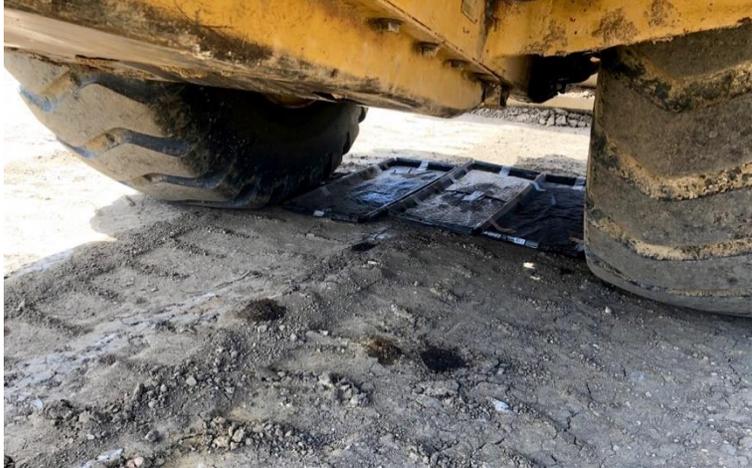
Photo 16 – Oil leaks under a large parked scraper.
5/14/20	Mesa Substation

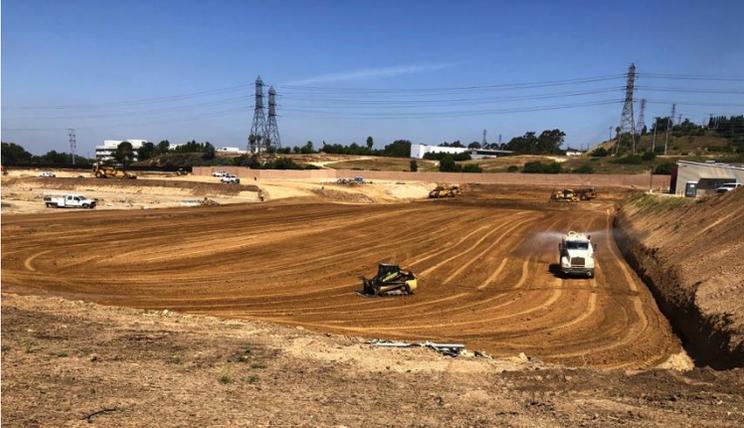
We entered the site through the east entrance and briefly observed the earthwork being performed in the area west of the entrance near the Mesa Operations Building (Photo 1). Soil was being delivered into this area with compaction tests taken at various times. The piles of concrete and asphalt continued to grow as the demolition of the existing substation was underway (Photo 2). All existing aboveground substation infrastructure was removed (Photo 3).

Photo 1 – Phase 3 earthwork at the eastern end of the project site near the Mesa Operations Building. Photo facing north.
5/22/20	Mesa Substation

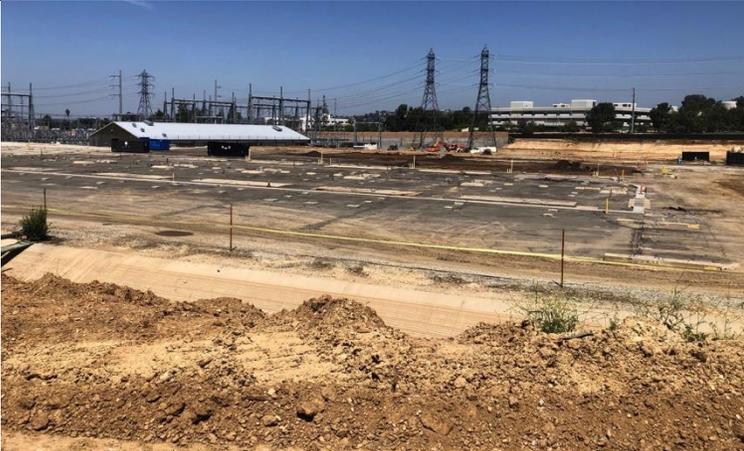
Photo 3 – Existing substation infrastructure was removed. Photo facing north.

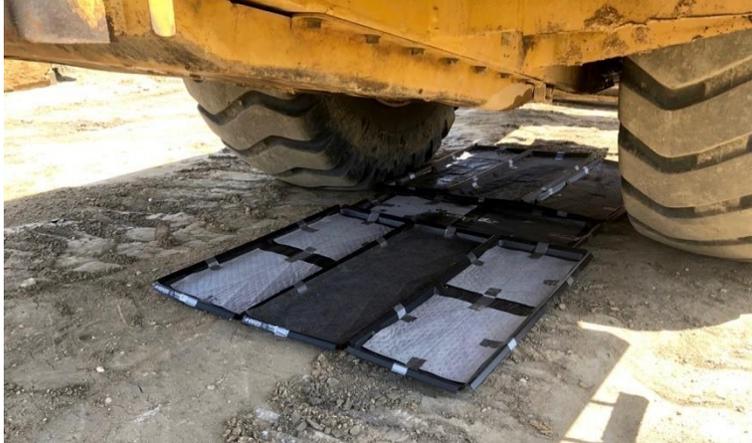
Photo 16 – Adequate secondary containment under a scraper.

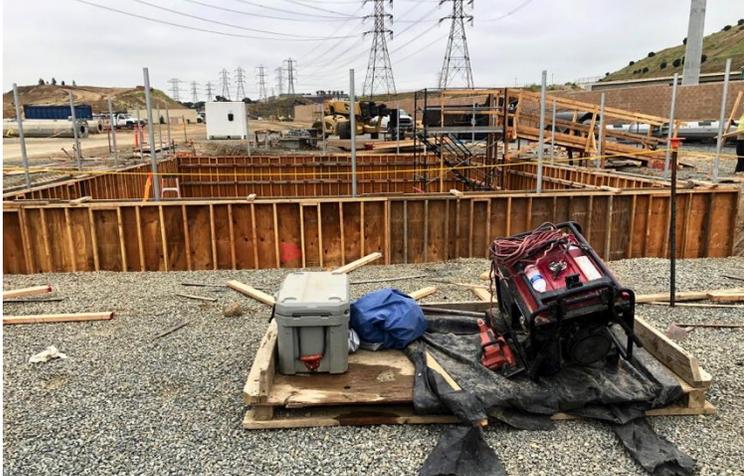
Photo 3 – Transformer catch basin construction with inadequate secondary containment under the gas generator. Photo facing east.
5/29/20	Mesa Substation

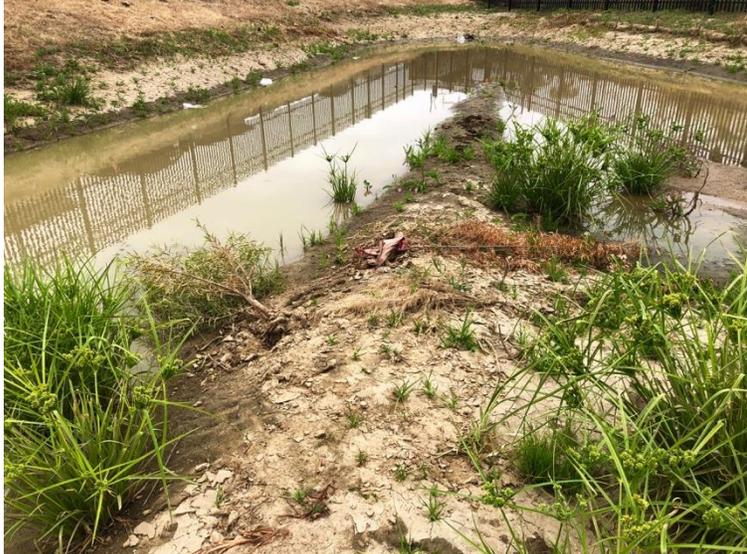
<p>Photo 6 – Small triangular detention basin holding water. Several small willow trees were removed. Photo facing north.</p>
5/29/20	Mesa Substation

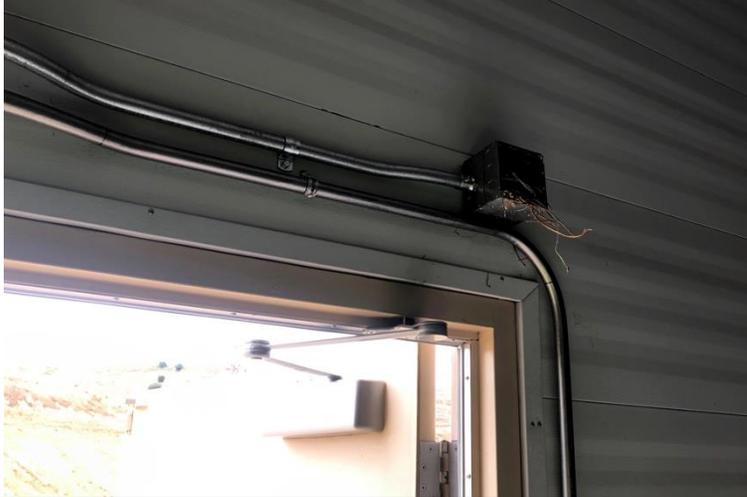
Photo 12 – House finch nest in an electrical box inside one of the remaining buildings.
5/29/20	Mesa Substation

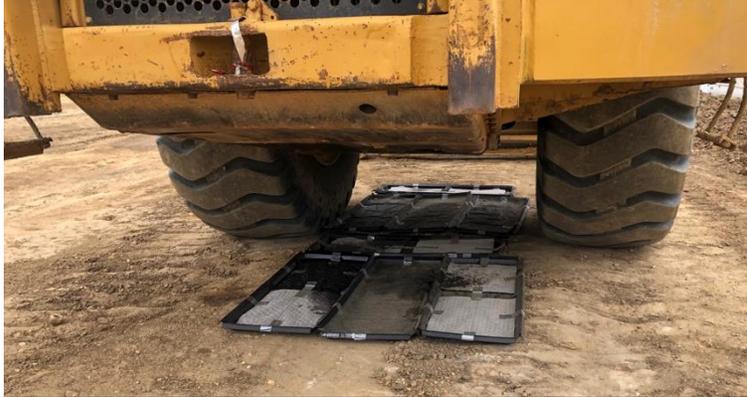
Photo 14 – Adequate secondary containment.
