March 3, 2021

**Re: Monthly Report Summary #33 for the Mesa 500-kV Substation Project**

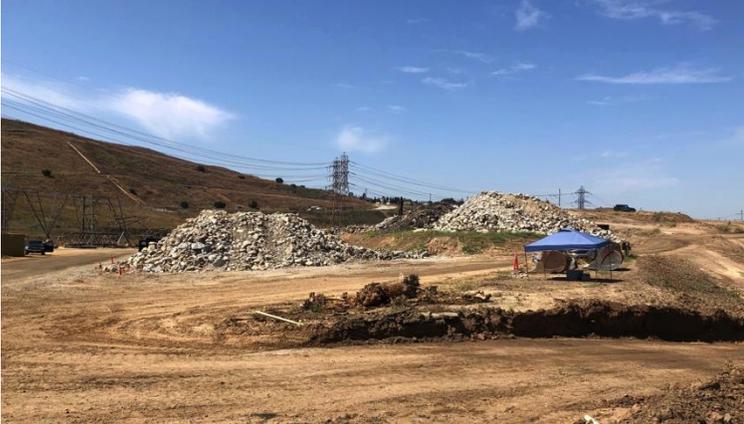
Photo 1 – Stockpiles of concrete and asphalt were being prepared for recycling. Photo facing southwest.
6/03/20	Mesa Substation

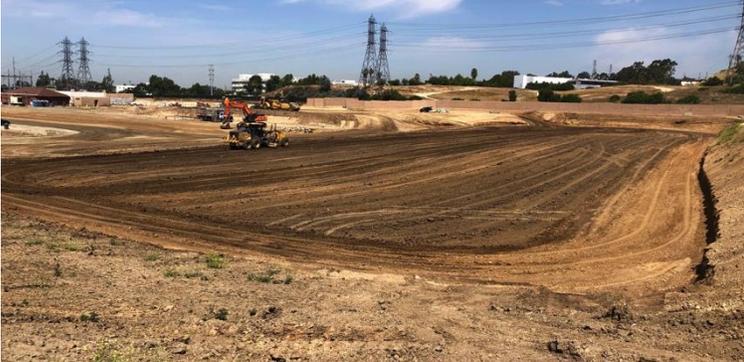
Photo 2 – Earthwork near the Mesa Operations Building. Photo facing north.
06/03/20	Mesa Substation

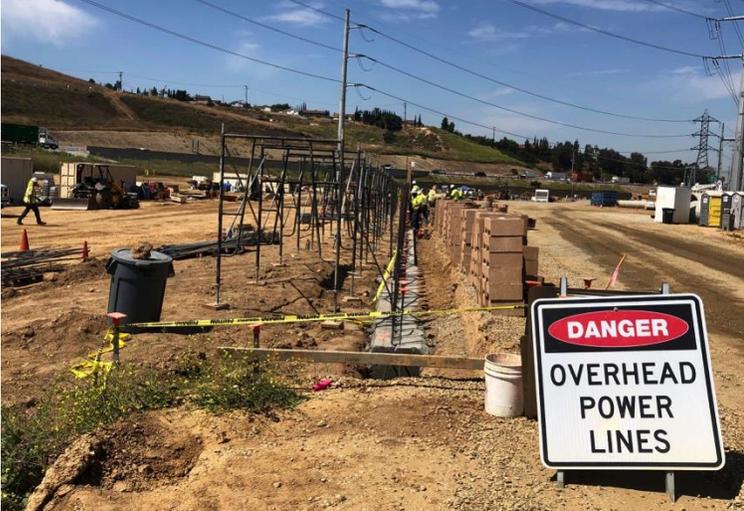
Work continued on the southern boundary wall with portions of the foundation being poured and the ongoing brick installation (Photo 3).

Photo 3 – Installation of the southern boundary wall. Photo facing west.

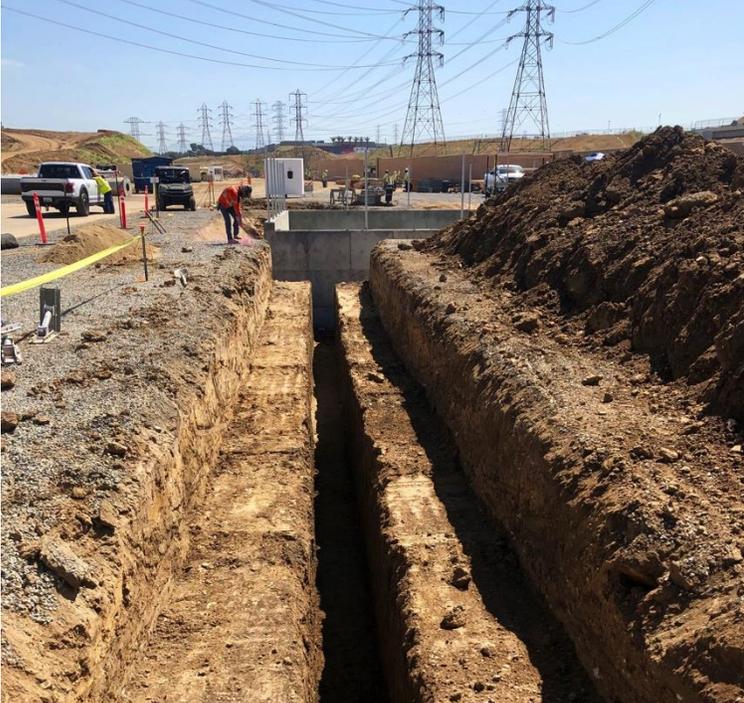
Photo 4 – Trench work around the transformer catch basin. Photo facing east.
6/03/20	Mesa Substation

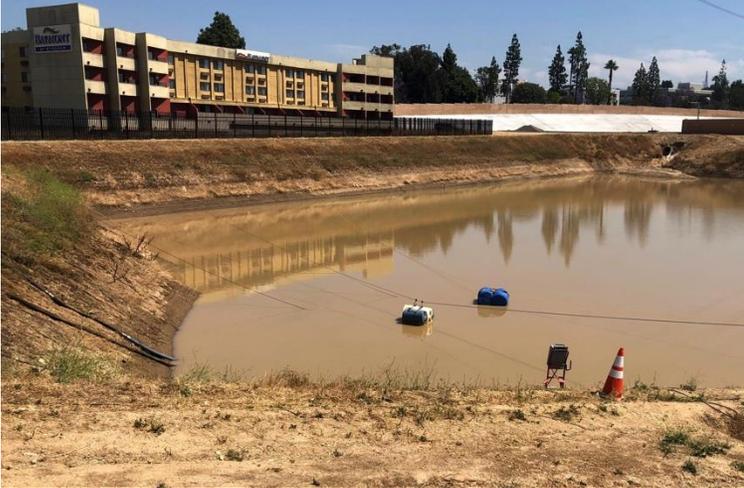
Photo 5 – The large retention basin with an estimated 5 million gallons remaining. Photo facing northeast.
6/03/20	Mesa Substation

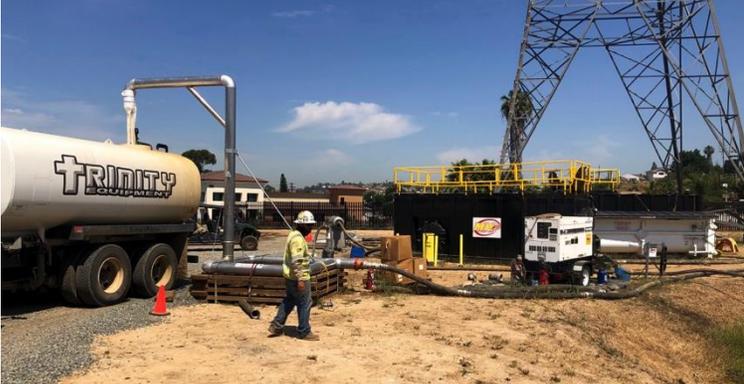
Photo 6 – The dewatering system filled a water truck. Photo facing north.

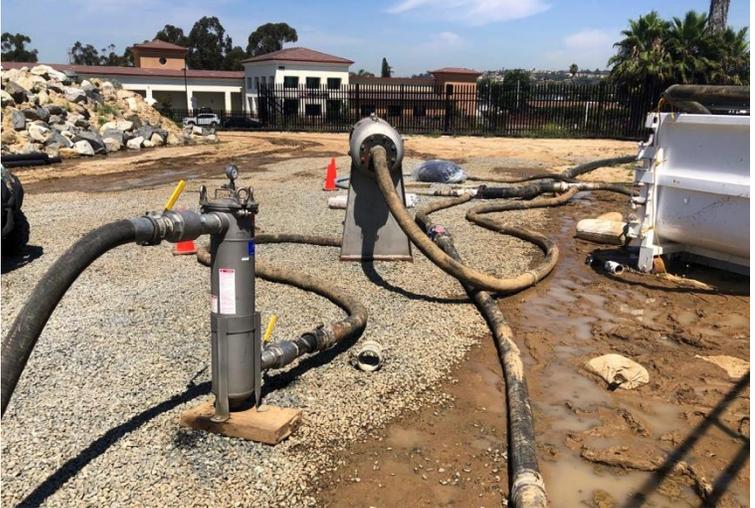
Photo 7 – Additional filtering cannisters added to the dewatering system. Photo facing west.
6/03/20	Mesa Substation

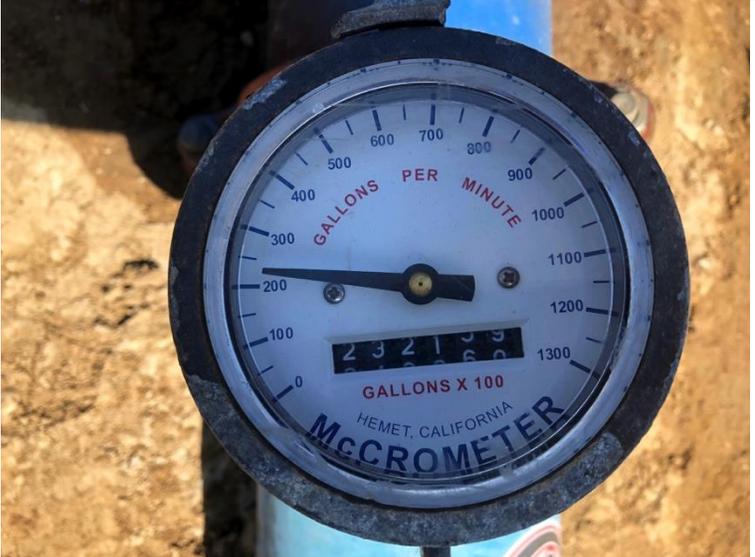
Photo 8 – Flow meter on the dewatering system.
6/03/20	Mesa Substation

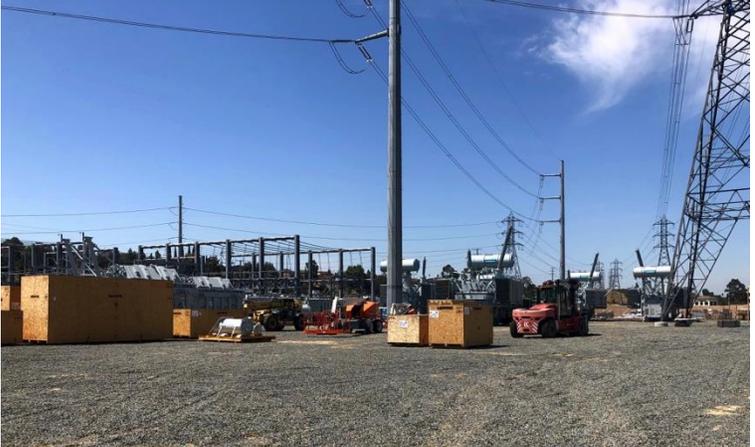
Photo 9 – Transformer assembly area. Photo facing west.

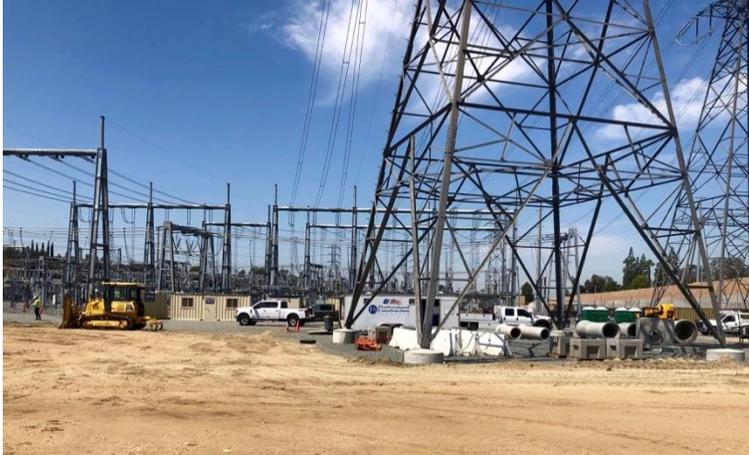
Photo 10 – Phase 4 contractor equipment being delivered onsite. Photo facing west.
6/03/20	Mesa Substation

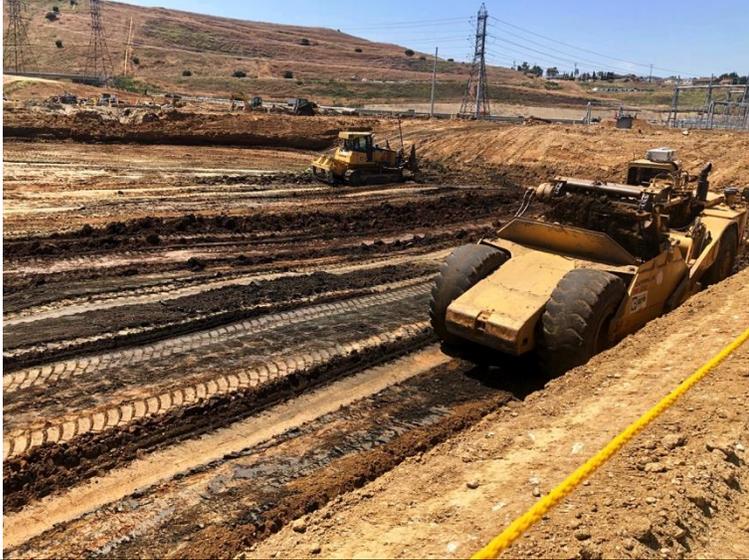
The Phase 3 grading continued with equipment moving soil (Photo 11), installing the stormwater drainage pipe system (Photo 12), and removing the various existing foundations (Photo 13). The wooden climbing structures were installed in the storm drain trench. All of the asbestos-contaminated piping was removed (Photo 14).

Photo 11 – Excavation of soil during the Phase 3 grading work. Photo facing south.
6/03/20	Mesa Substation

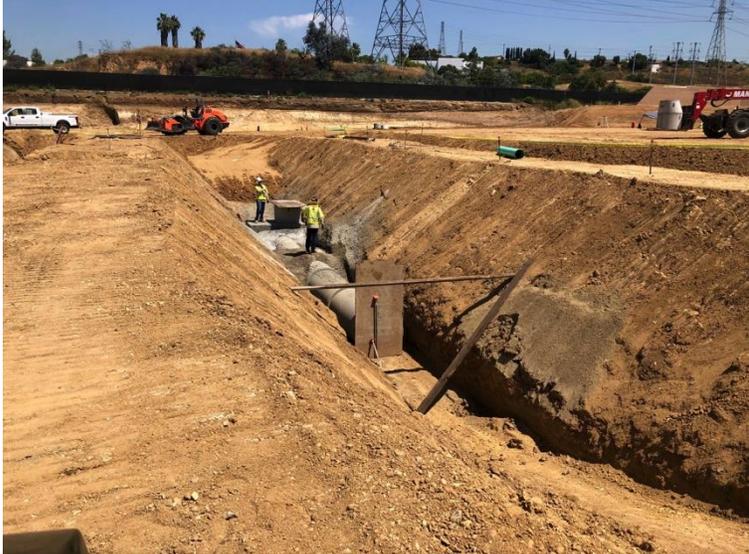
Photo 12 – Storm drain installation work with a wooden climbing structure. Photo facing north.

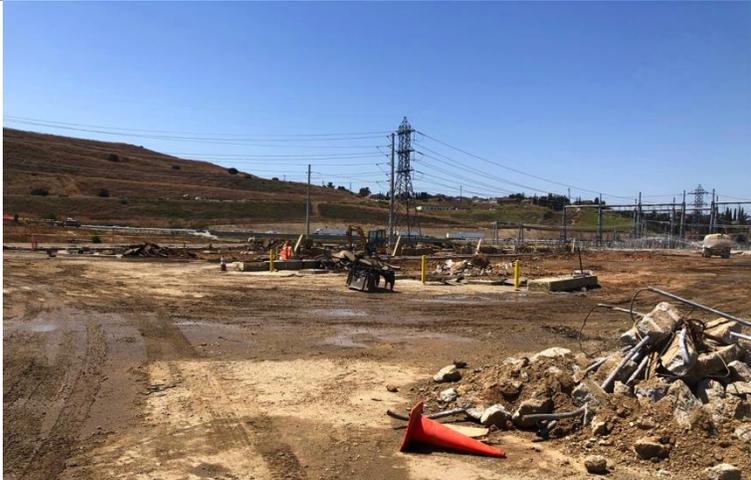
Photo 13 – Foundations were being removed and transported to the staging area. Photo facing south.
6/03/20	Mesa Substation

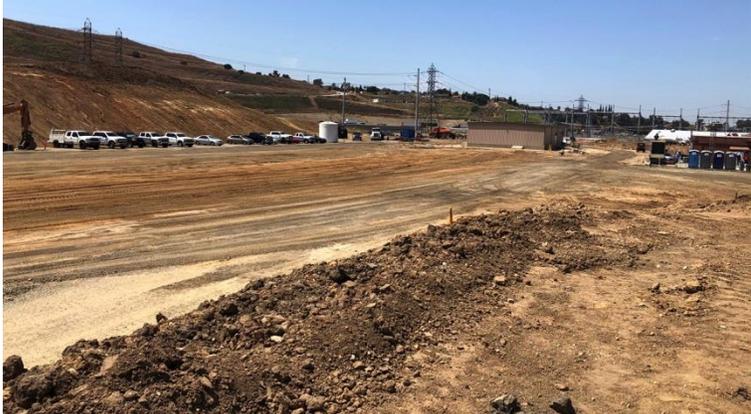
Photo 14 – The last of the contaminated piping was removed. Photo facing southwest.

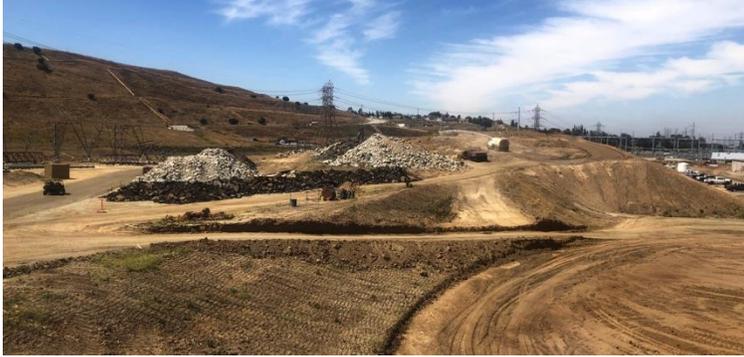
Photo 1 – Stockpiles of concrete and asphalt being prepared for recycling. Photo facing southwest.
6/12/20	Mesa Substation

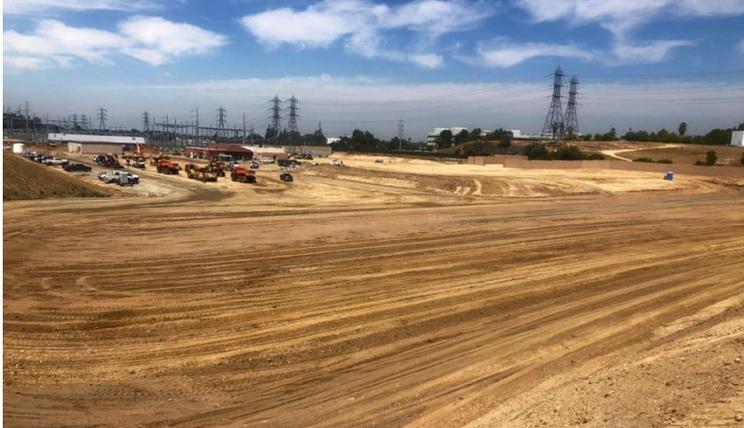
Photo 2 – Earthwork near the Mesa Operations Building. Photo facing northwest.
6/12/20	Mesa Substation

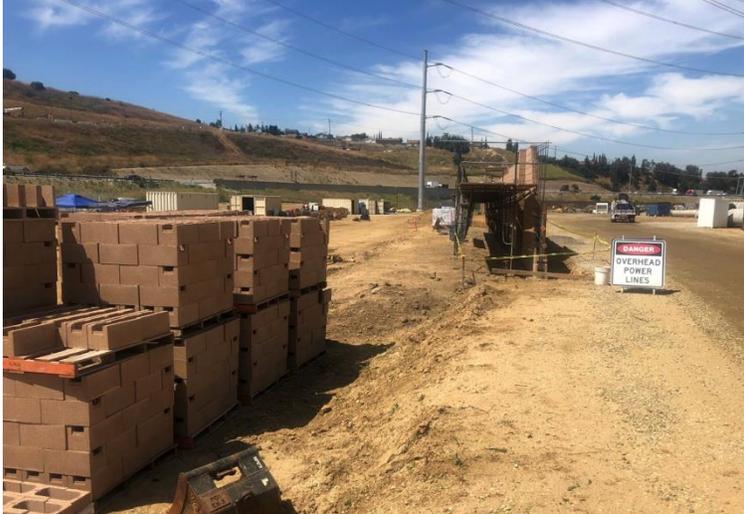
Photo 3 – Installation of the southern boundary wall. Photo facing west.

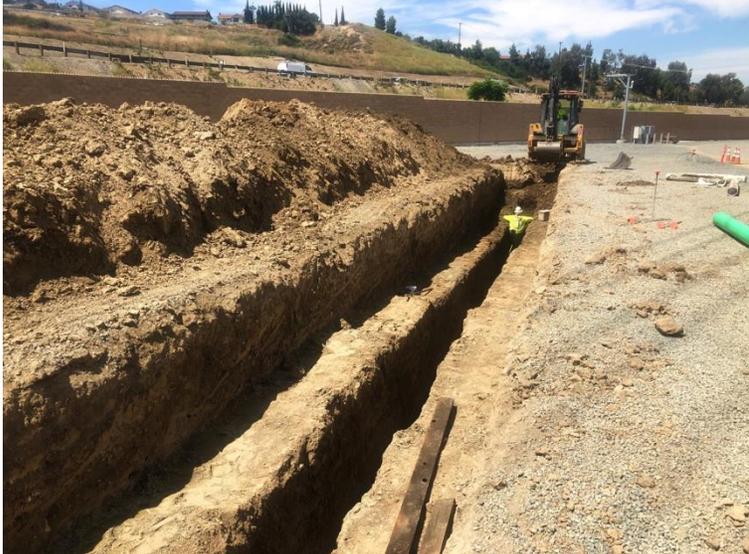
Photo 4 – Trench work around the transformer catch basin. Photo facing southwest.
6/12/20	Mesa Substation

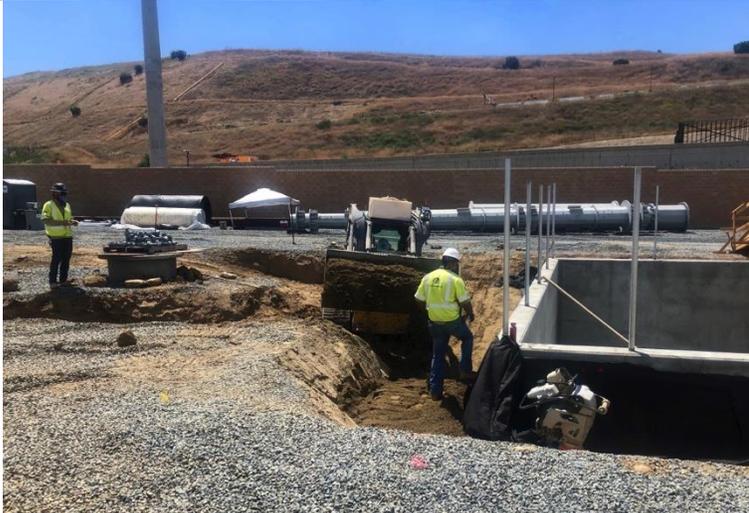
Photo 5 – Waterproofing the catch basin walls and backfilling. Photo facing south.
06/12/20	Mesa Substation

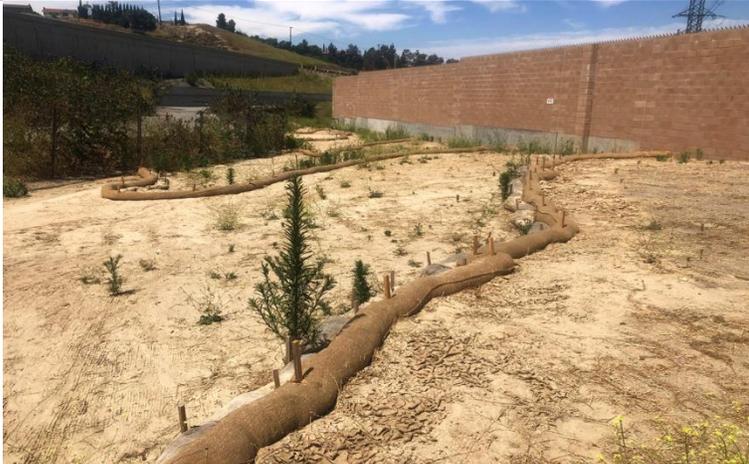
Photo 6 – BMPs around the outside of the southern boundary wall. Photo facing west.

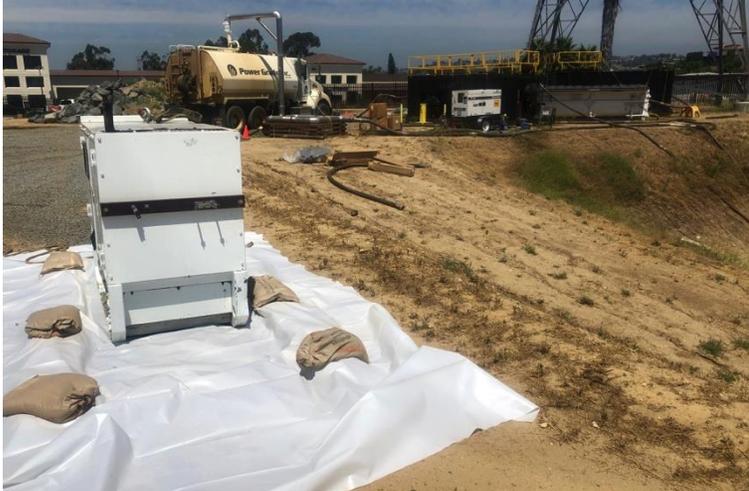
Photo 7 – Pumping and filtering work. A new generator was delivered and set up. Photo facing northwest.
6/12/20	Mesa Substation

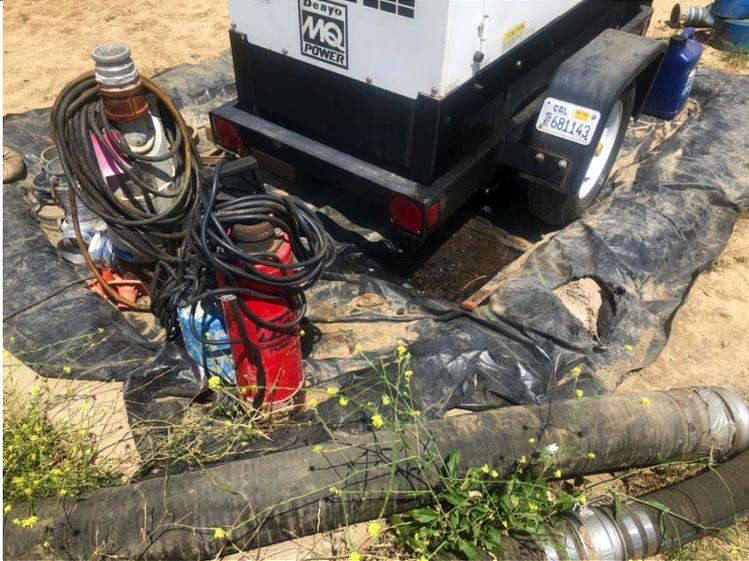
The retention basin dewatering continued with a new generator being delivered onsite (Photo 7). Oil was noted within the secondary containment under the existing generator (Photo 8). The pumping rate was around 200 gallons per minute, keeping the Nephelometric Turbidity Unit (NTU) levels within an acceptable range.

Photo 8 – Oil present in the secondary containment basin.
6/12/20	Mesa Substation

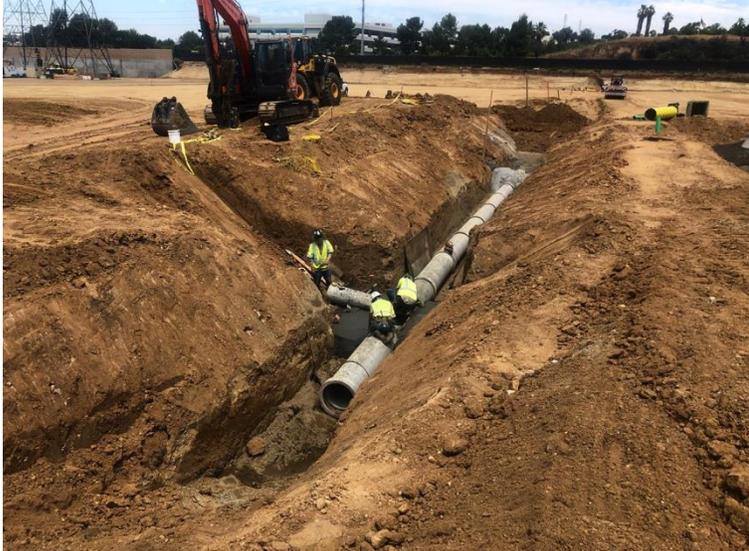
Photo 9 – Storm drain installation within the Phase 3 area. Photo facing north.

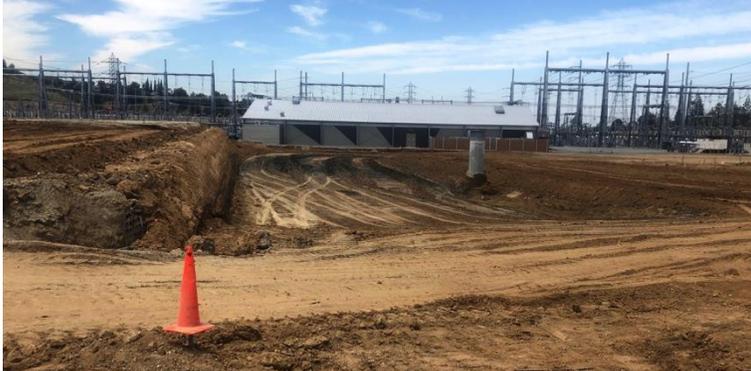
Photo 10 – Excavation work near the Mechanical Electrical Equipment Room building. Photo facing west.
06/12/20	Mesa Substation

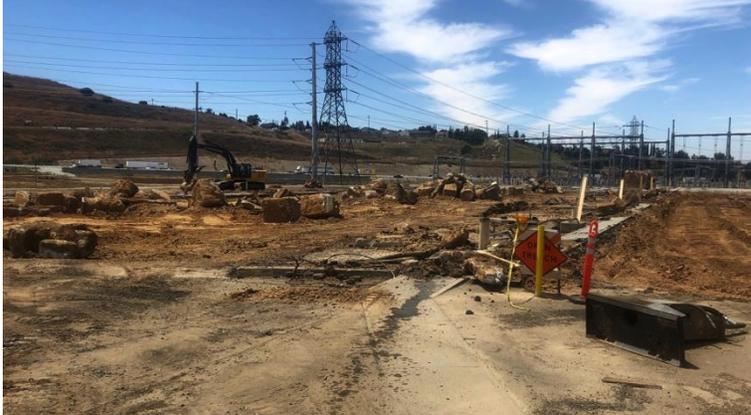
Photo 11 – Removal of the existing foundations and conduit. Photo facing south.

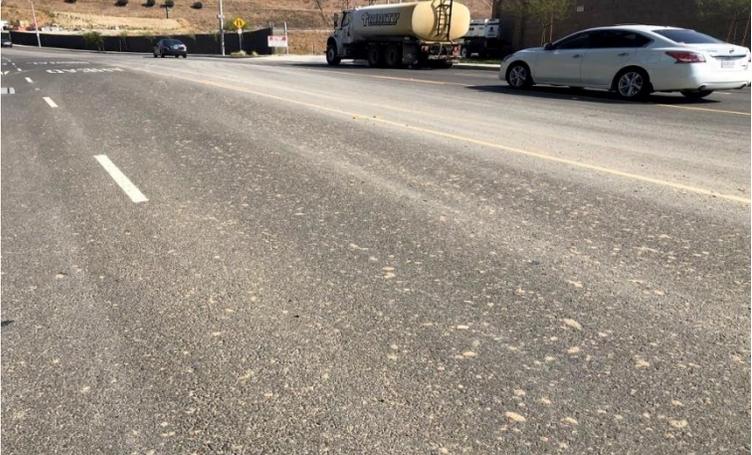
Photo 1 – Mud tracked out onto Market Place Drive. Photo facing south.
6/17/20	Mesa Substation

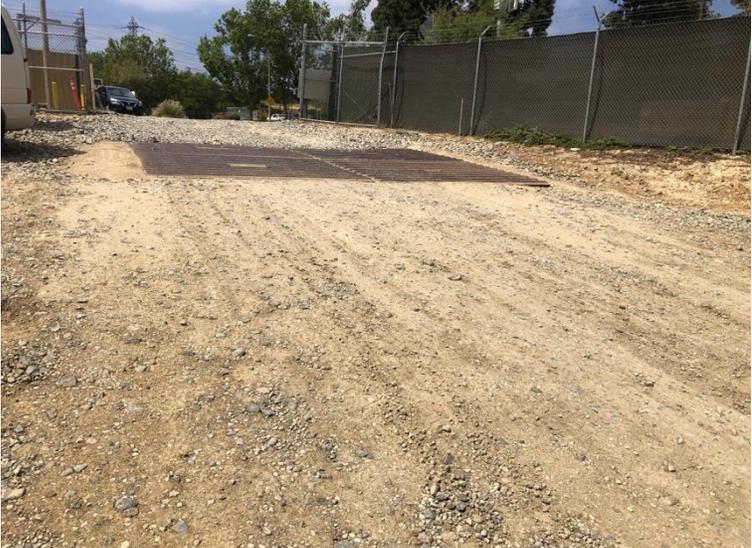
Photo 2 – Exit and entry BMP requiring upgrades. Photo facing north.
6/17/20	Mesa Substation

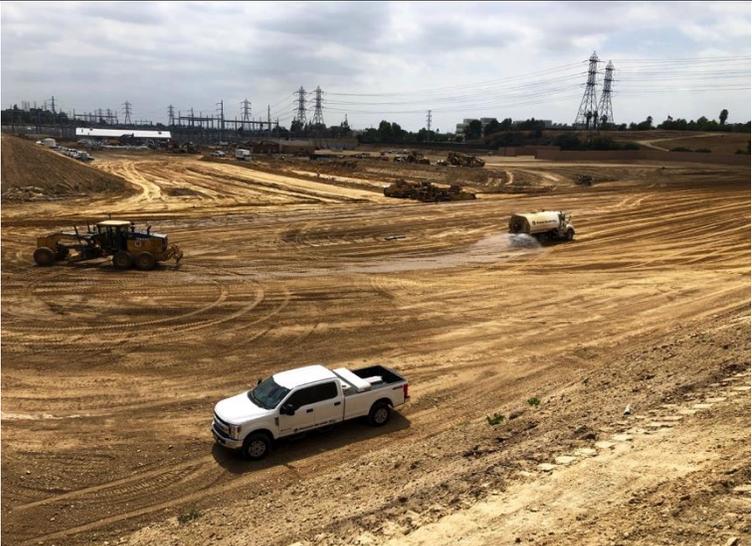
Photo 3 – Earthwork inside the eastern boundary of the site. Photo facing west.

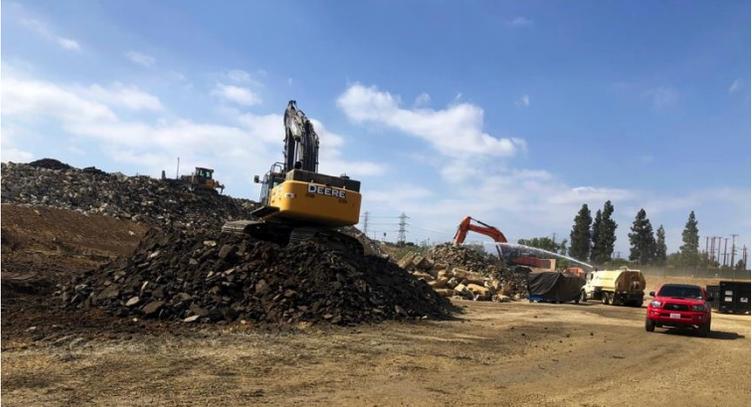
Photo 4 – Demolition and crushing of the concrete and asphalt from Phase 3 grading. Photo facing north.
6/17/20	Mesa Substation

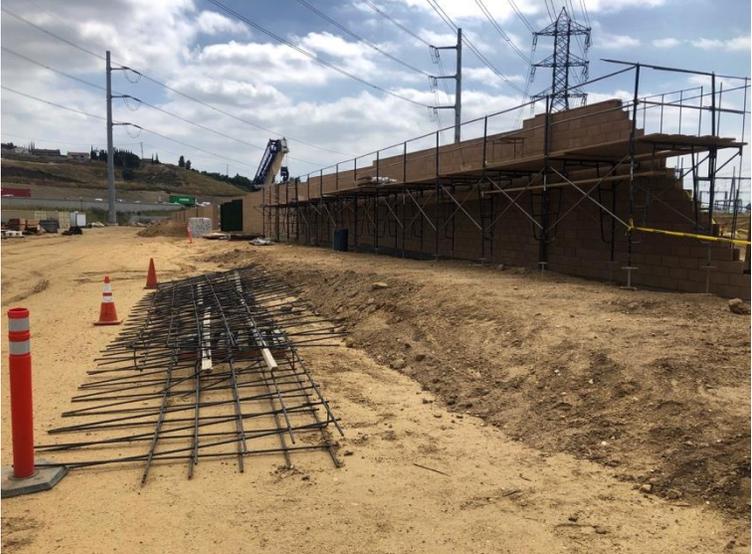
Photo 5 – Brick installation on the southern boundary wall. Photo facing west.
6/17/20	Mesa Substation

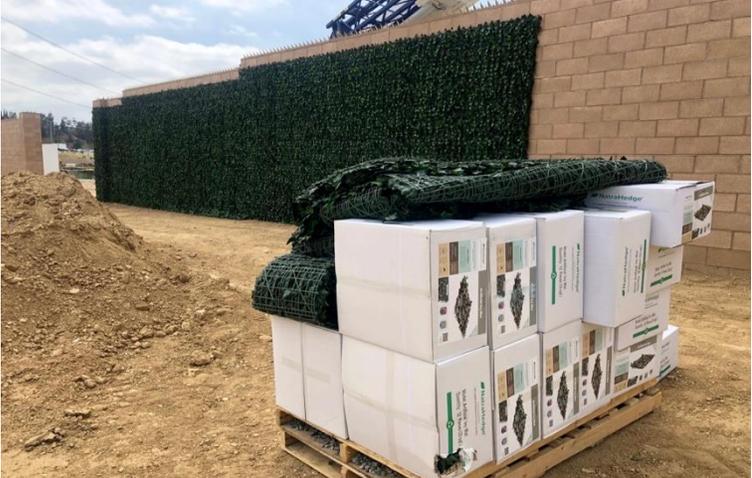
Photo 6 – Artificial ivy being applied to the south facing side of the southern boundary wall. Photo facing west.

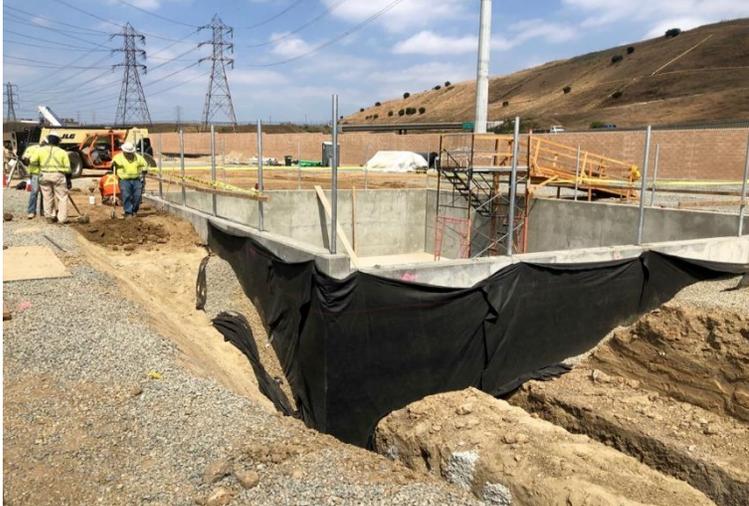
Photo 7 – Waterproofing the catch basin walls and backfilling. Photo facing east.
6/17/20	Mesa Substation

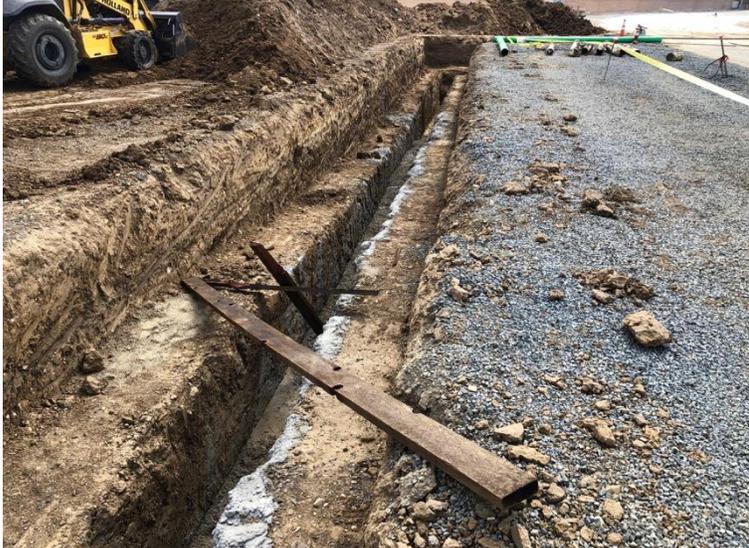
Photo 8 – Trench work west of the transformer catch basin. Photo facing west .
6/17/20	Mesa Substation

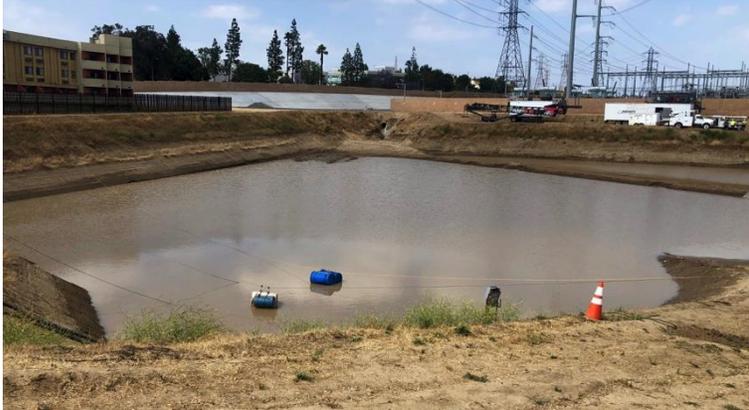
Photo 9 – Water levels continued to drop in the retention basin. Photo facing northeast.

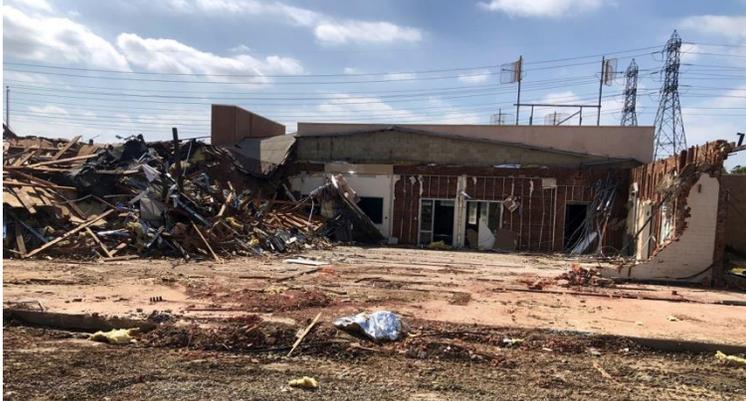
Photo 13 – Demolition of the last remaining building within the Phase 3 grading area. Photo facing north.
6/17/20	Mesa Substation

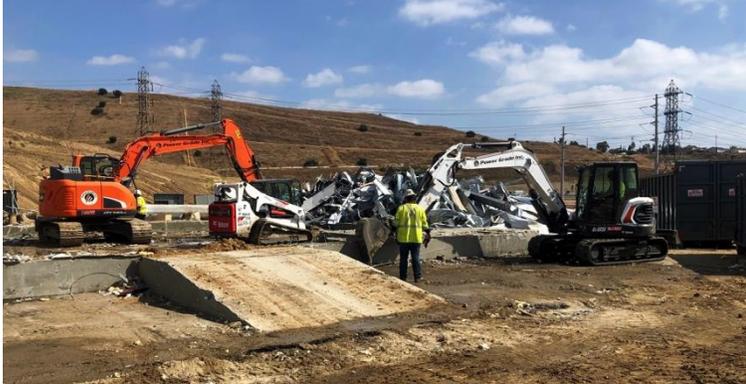
Photo 14 – Foundation demolition. Photo facing south.
6/17/20	Mesa Substation

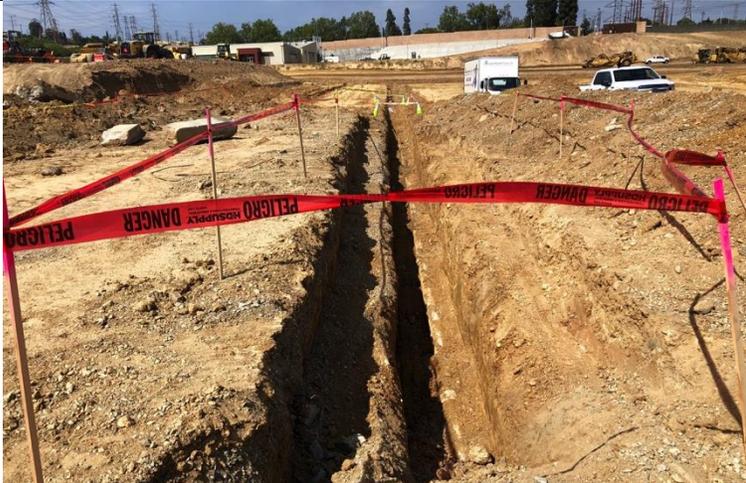
Photo 15 – Hazardous materials removal. Photo facing east.

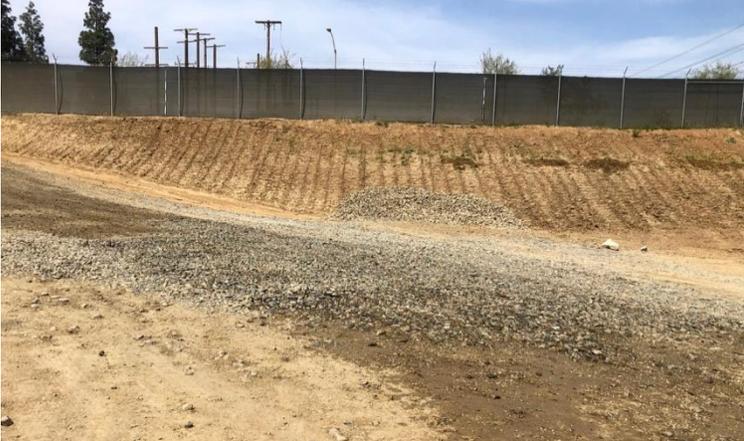
A street sweeper was working the areas in front of the construction trailers and within Market Place Drive. Upon entering the site, I noted that the BMP rock was finally spread out on the lower portion of the entry and exit (Photo 1).

Photo 1 – BMP rock was spread out on the exit and entry roadway. Photo facing east.
6/24/20	Mesa Substation

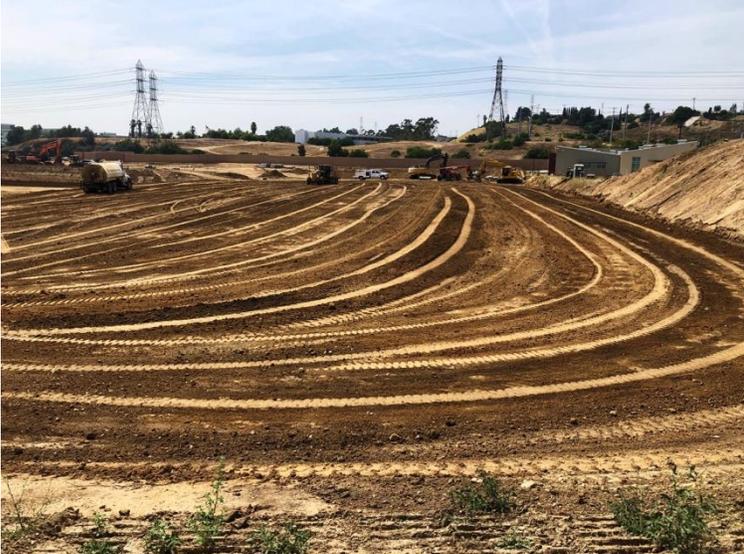
Photo 2 – Earthwork near the Mesa Operations Building. Photo facing north.
6/24/20	Mesa Substation

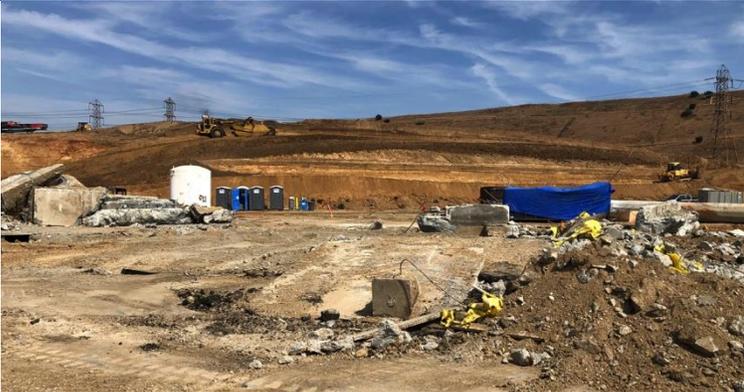
Photo 3 – Soil was being delivered from the earthen hill south of the Phase 3 grading area. Photo facing south.

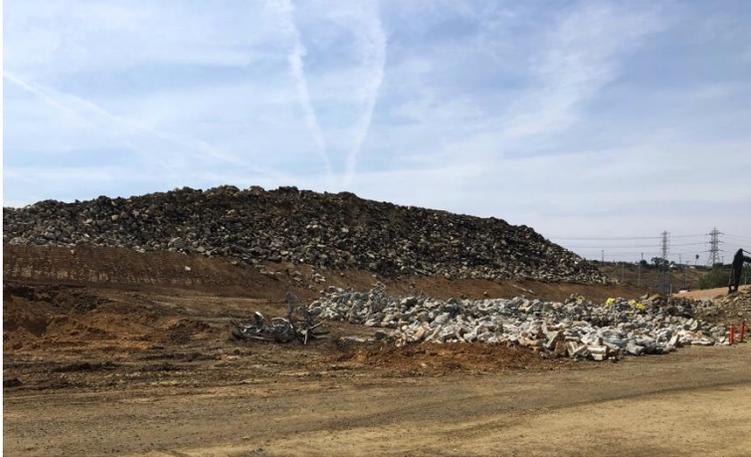
The pile of demolished concrete and asphalt continued to grow (Photo 4). According to my escort, the offsite transport was on hold due to the discovery of contaminated materials in the piles. An existing tower foundation was being excavated near the debris piles, but the work was put on hold (Photo 5).

Photo 4 – Demolition and crushing of the concrete and asphalt from the Phase 3 grading. Photo facing north.
6/24/20	Mesa Substation

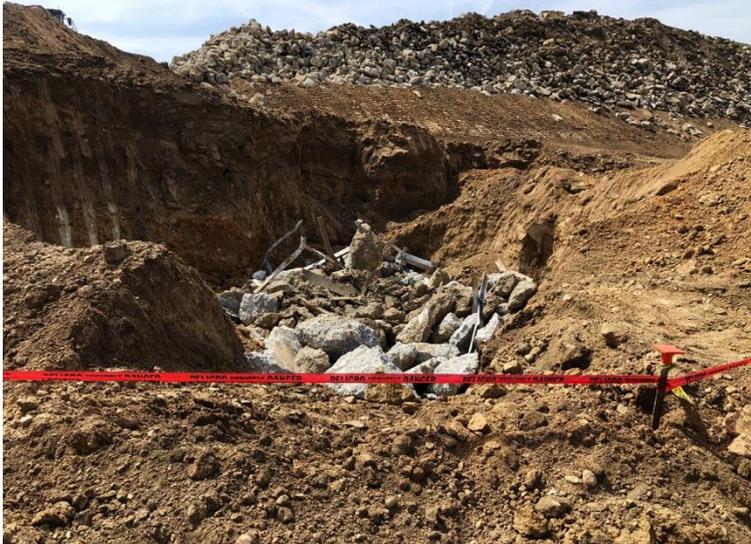
Photo 5 – Removal of an existing tower foundation. Photo facing north.
6/24/20	Mesa Substation

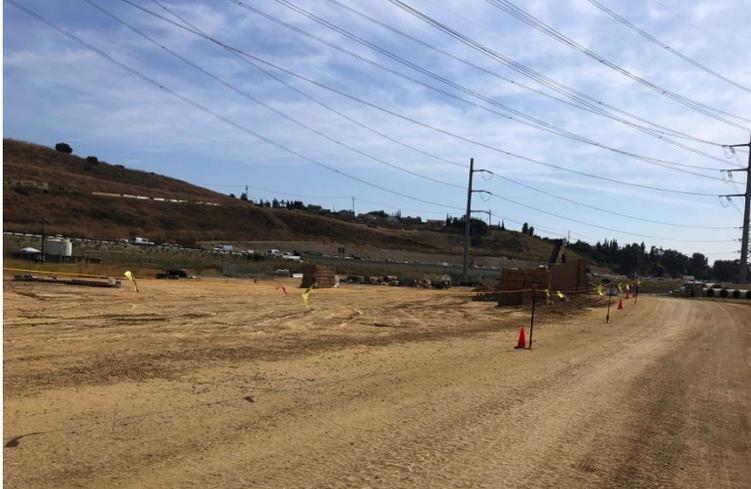
Photo 6 – Costal California gnatcatcher buffer. Photo facing southwest.

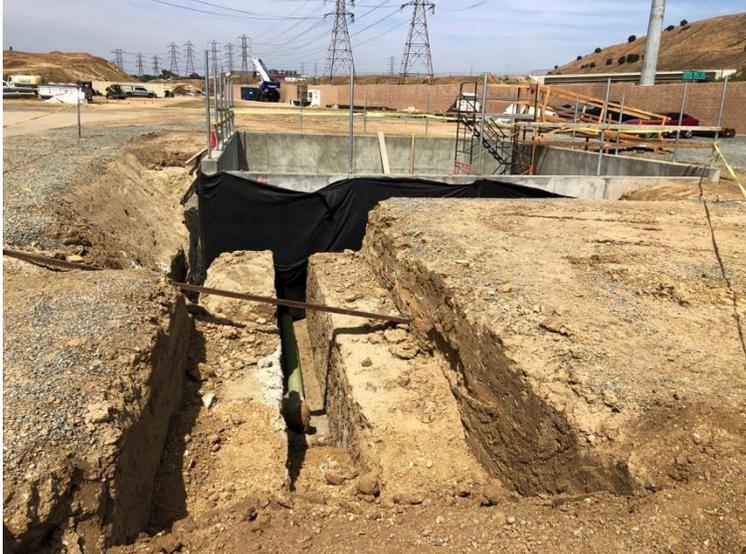
Photo 7 – Waterproofing the catch basin walls and backfilling. Photo facing east.
6/24/20	Mesa Substation

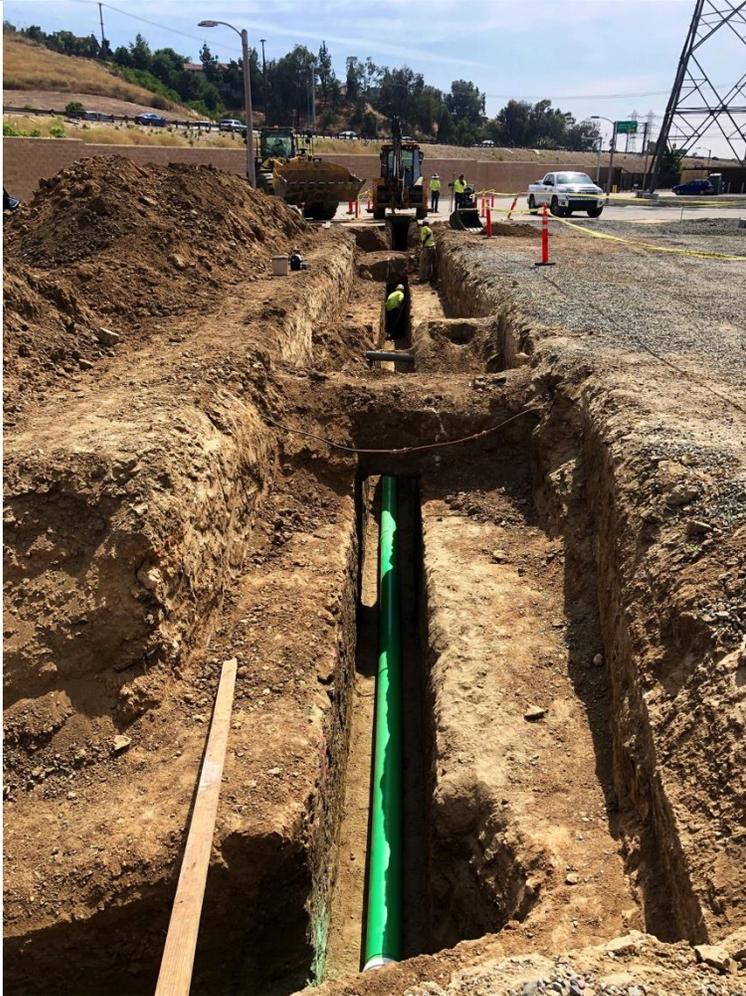
Photo 8 – Trench work and pipe installation west of the transformer catch basin. Photo facing west.

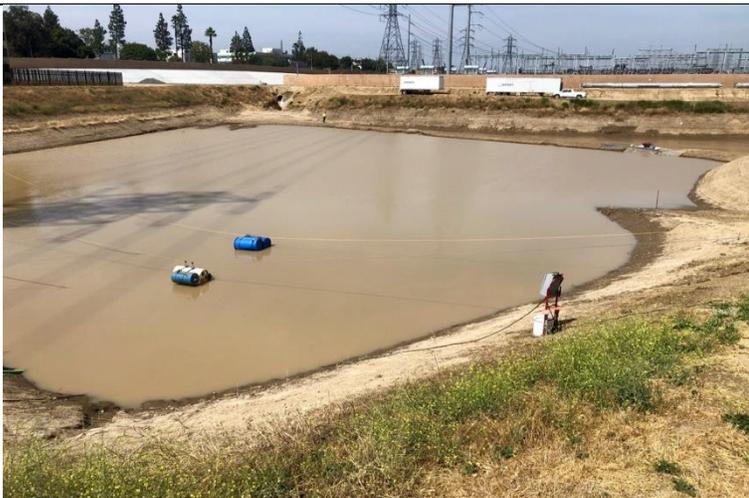
Photo 9 – Water levels in the retention basin. Photo facing northeast.
6/24/20	Mesa Substation

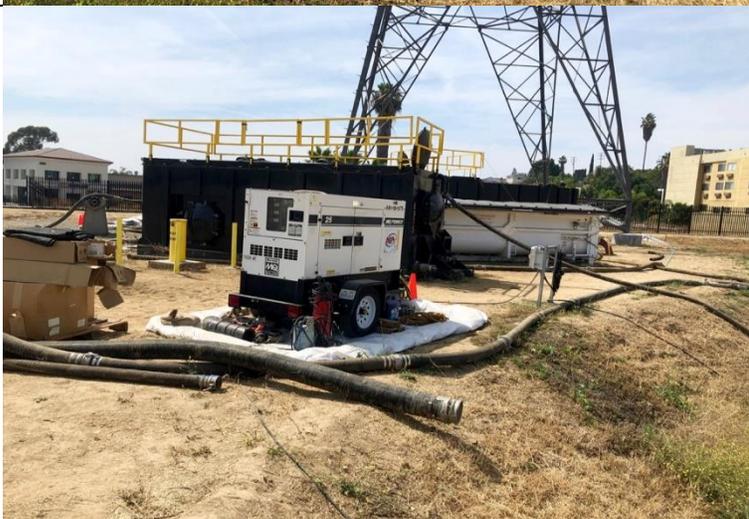
Photo 10 – Water filtering equipment. Photo facing west.
6/24/20	Mesa Substation

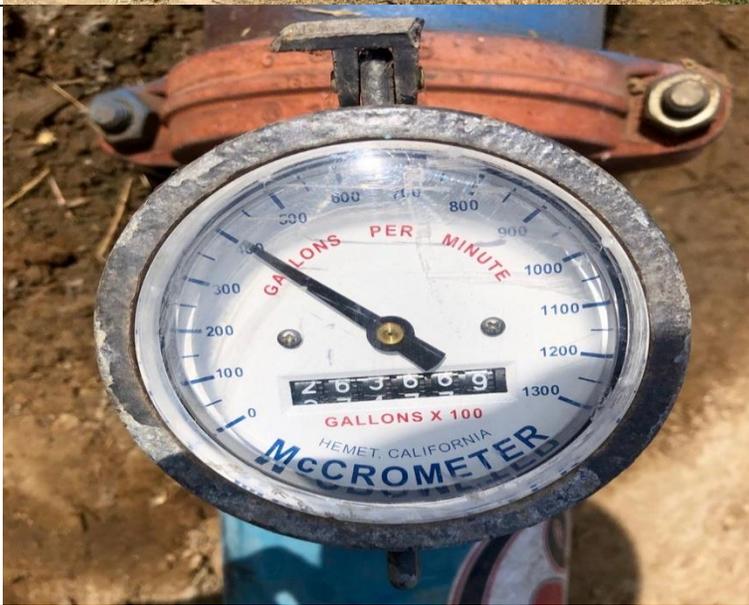
Photo 11 – Flow meter on the dewatering equipment.

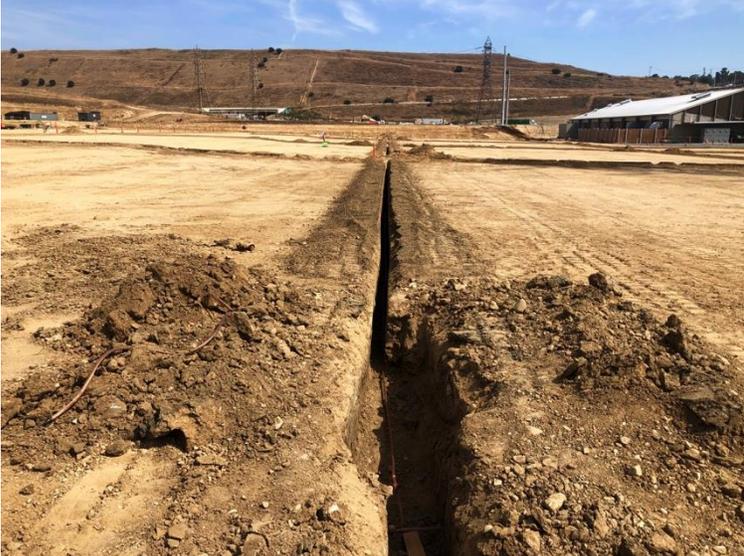
We drove through the Phase 3 grading area where installation of grounding wire was underway (Photo 12). The forms were being built and rebar was being added for some of the foundations (Photo 13). Other activities included the continued installation of the stormwater drainage pipe system (Photo 14) and the ongoing soil work (Photo 15).

Photo 12 – Installation of grounding wire. Photo facing south.
6/24/20	Mesa Substation

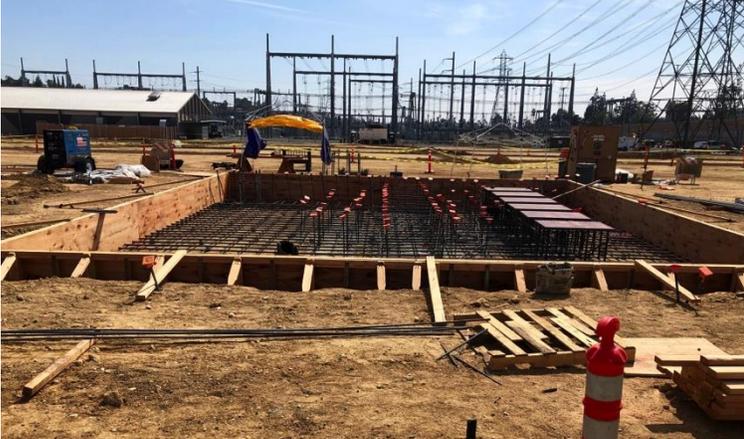
Photo 13 – Forming and rebar installation for new foundations. Photo facing west.
6/24/20	Mesa Substation

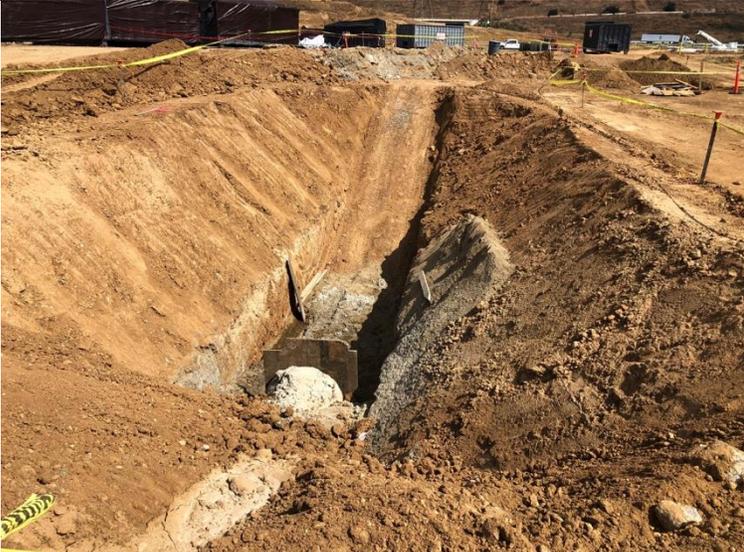
Photo 14 – Storm drain installation. Photo facing north.

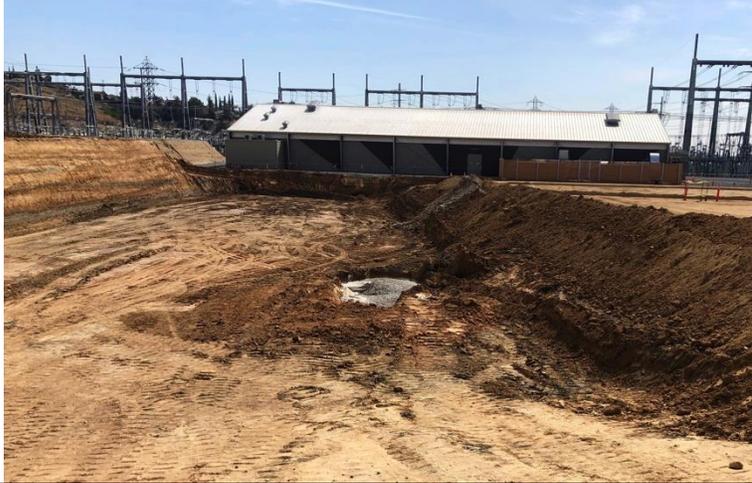
Photo 15 – Earthwork near the Mechanical Electrical Equipment Room building. Photo facing west.
6/24/20	Mesa Substation

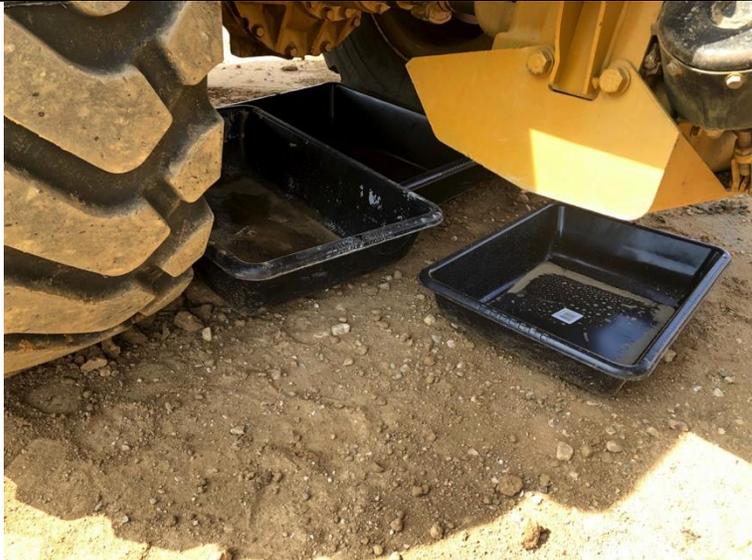
I checked the secondary containment of some of the parked earth-moving equipment and found that there were adequate drip pans underneath the engine compartments (Photo 16).

Photo 16 – Secondary containment.
