## ecology and environment, inc.

### **Re: Monthly Report Summary #3 for the Mesa 500-kV Substation Project**

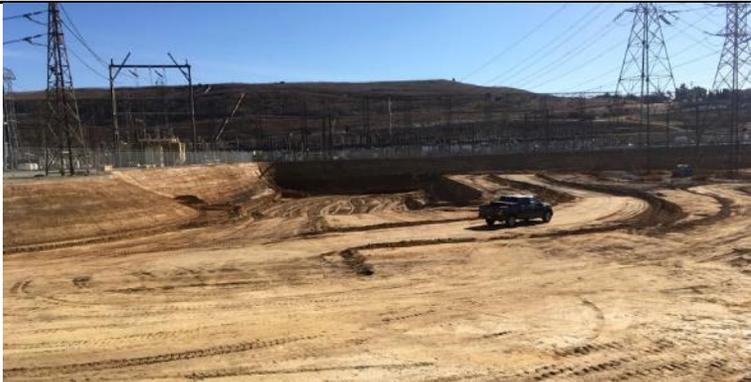
Photo 1 – Excavation area. Photo facing south.
12/15/17	Mesa Substation

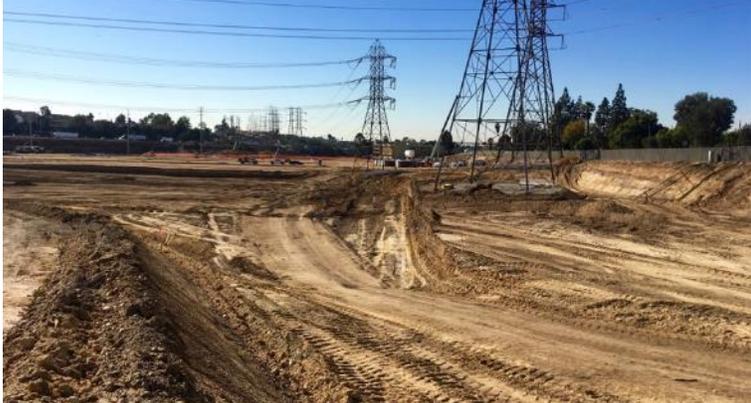
Photo 2 – Excavation area. Photo facing southwest
12/15/17	Mesa Substation – Kiewit Jack-and-Bore Pit

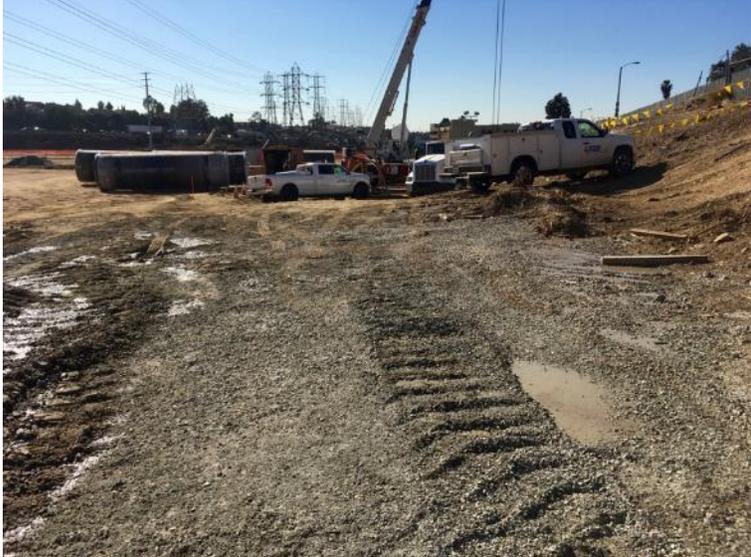
As I approached the Kiewit jack-and-bore pit (Photo 4), I noted a large wet area with some puddles of drilling mud located approximately 70 feet northeast of the bore hole; some gravel had been spread over the area (Photo 3). While this appeared to be a classic "frac-out," the Golden State foreman I spoke with said it was not a "frac-out," he explained that it was extra water and mud that the crew had deposited in this area. The foreman said they do not use drilling mud during boring operations and were only using the mud for pushing the pipe. The bore had been finished previously and the crew had installed 240 feet of pipe so far (Photo 5). Conditions around the bore site remained dusty and I spoke with the foreman about applying water for dust control (APM-AIR-01, MM HY-1).

Photo 3 – Puddles of drilling mud. Photo facing southwest.

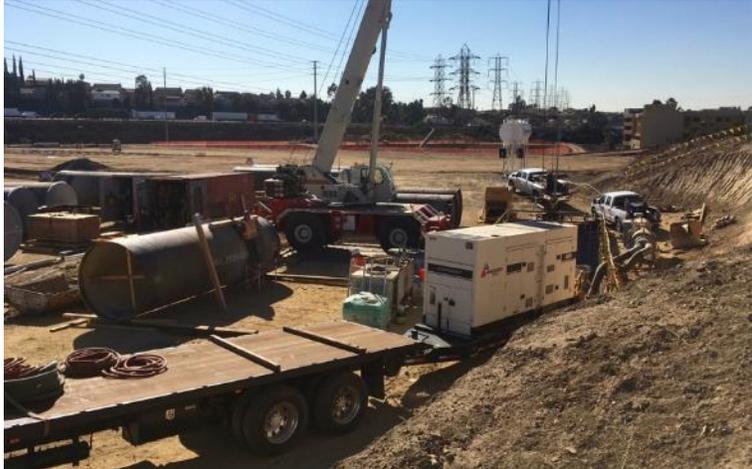
Photo 4 – Kiewit jack-and-bore pit. Photo facing southwest.
12/15/17	Mesa Substation – Kiewit Jack-and-Bore Pit

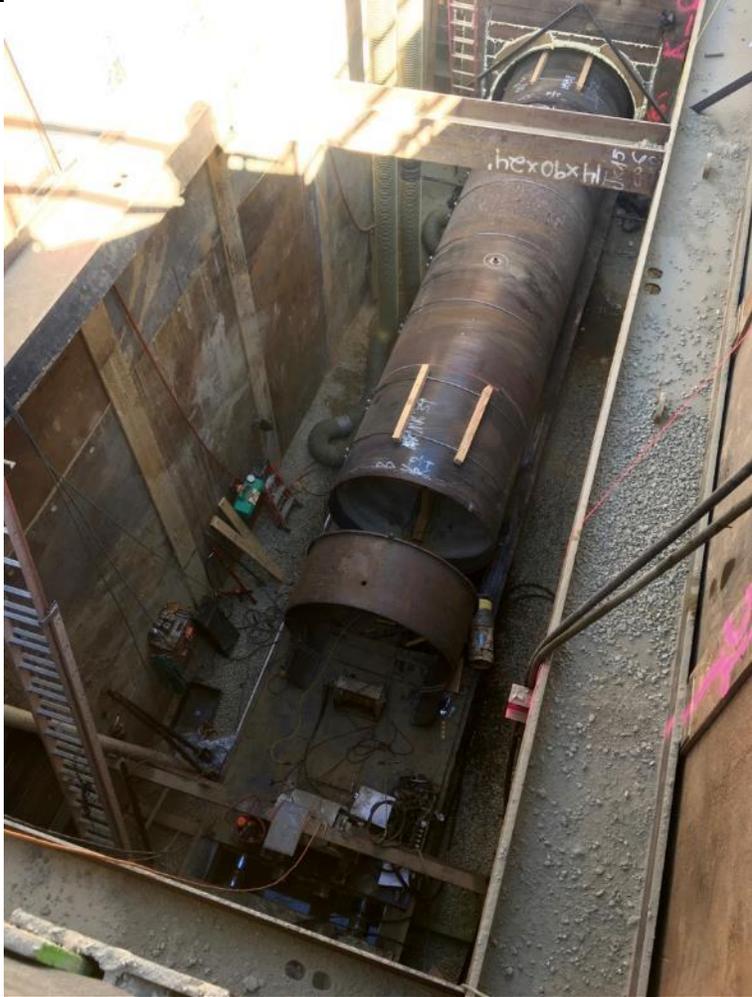
Photo 5 – Installation of water pipe.

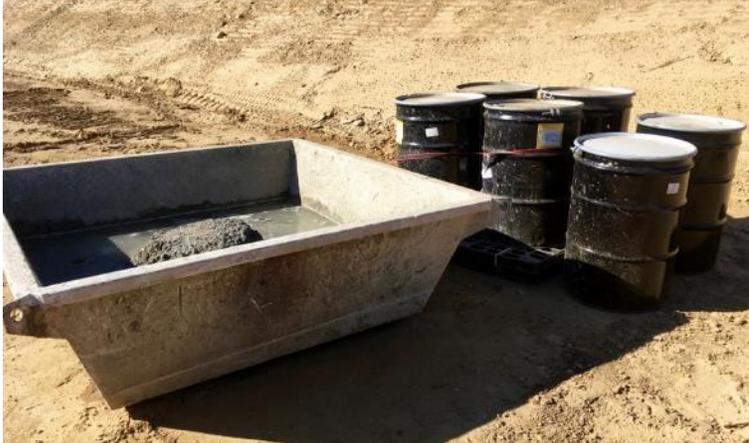
The area along the eastern border and west of the bore site was being used as a stockpile area for concrete washout and some hazardous materials labeled "soil & debris with oil" (MM HZ-3, MM HZ-4) (Photo 6).

Photo 6 – Concrete washout and hazardous material storage.
12/15/17	Mesa Substation

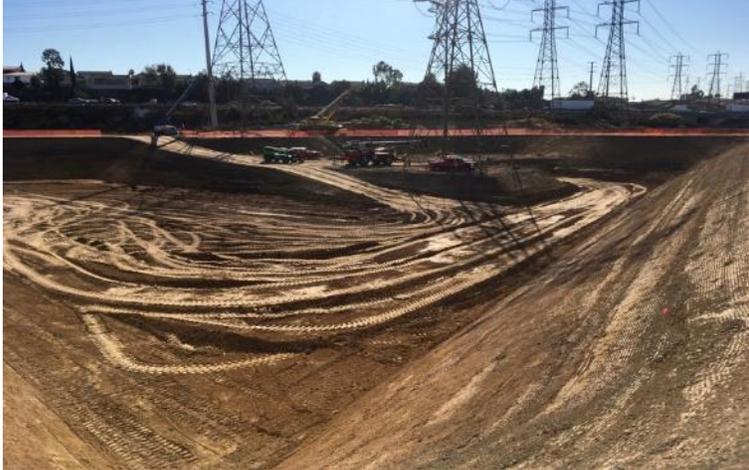
Photo 7 – Detention basin now encircled with construction fencing. Photo facing southwest.
12/15/17	Mesa Substation

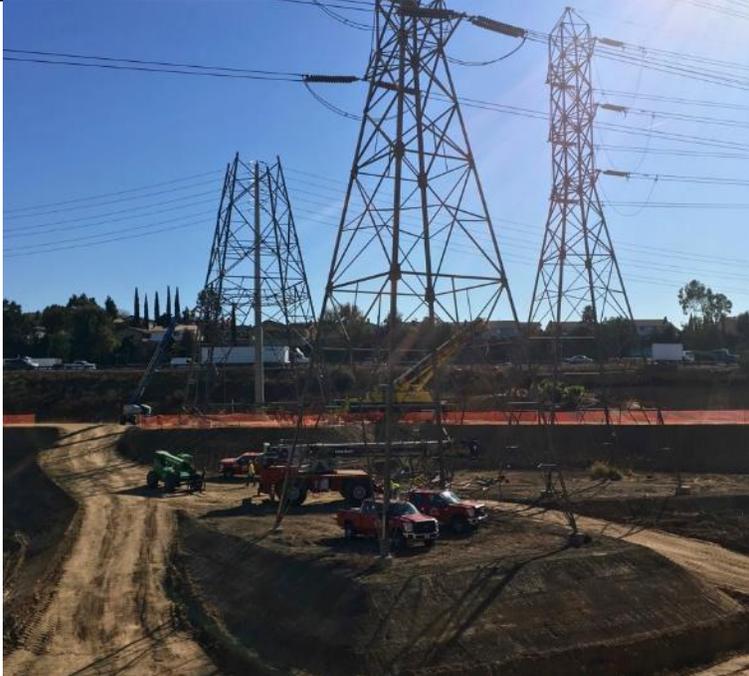
Photo 8 – Detention basin where crews are dismantling an old tower. Photo facing south.

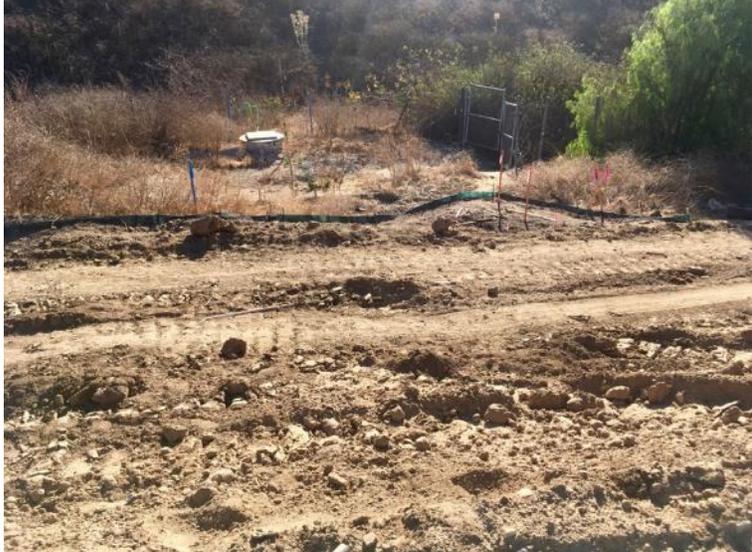
Some best management practices (BMPs) had been installed along the southern border near a drain inlet (Photo 10). The small amount of plastic wattles seemed wholly inadequate based on the amount of open soil upslope of the drain inlet.

A photograph showing a BMP installation site. The foreground is a dirt area with some rocks. In the background, there is a line of vegetation and a fence, indicating the southern border of the Mesa Substation site.	Photo 10 – BMP installation along the southern border of the Mesa Substation site.

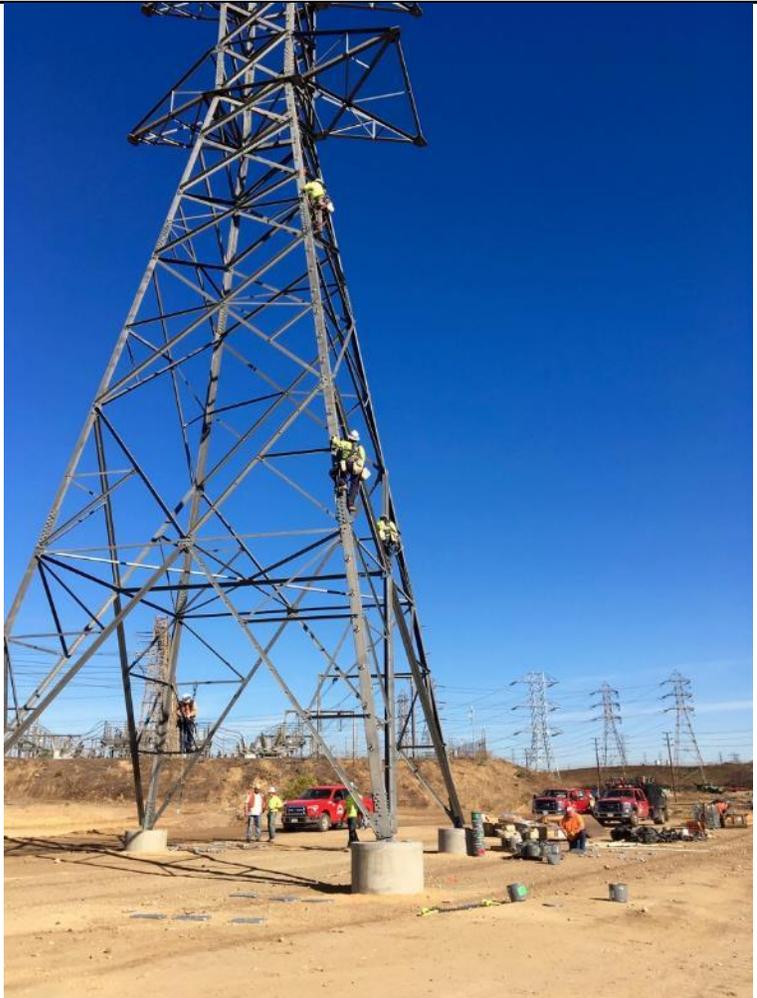
Photo 11 – Crews constructing new towers.
12/15/17	Mesa Substation

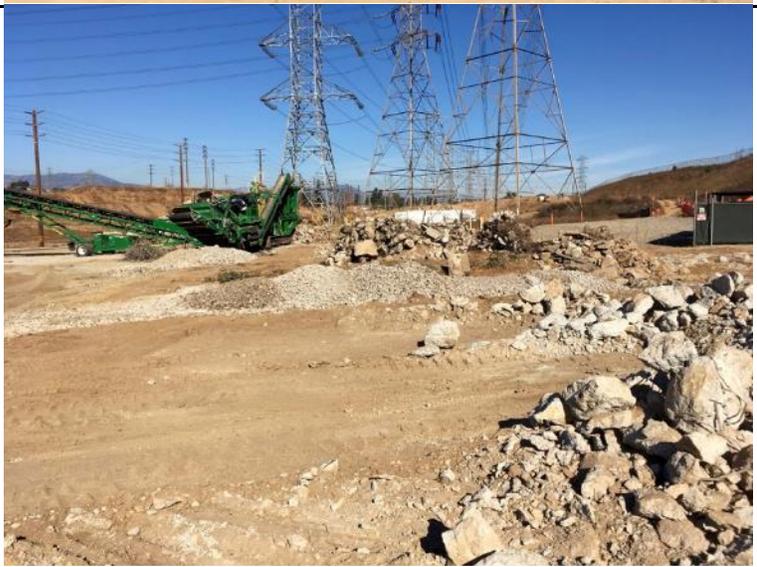
Photo 12 – Debris grinding area. Photo facing east

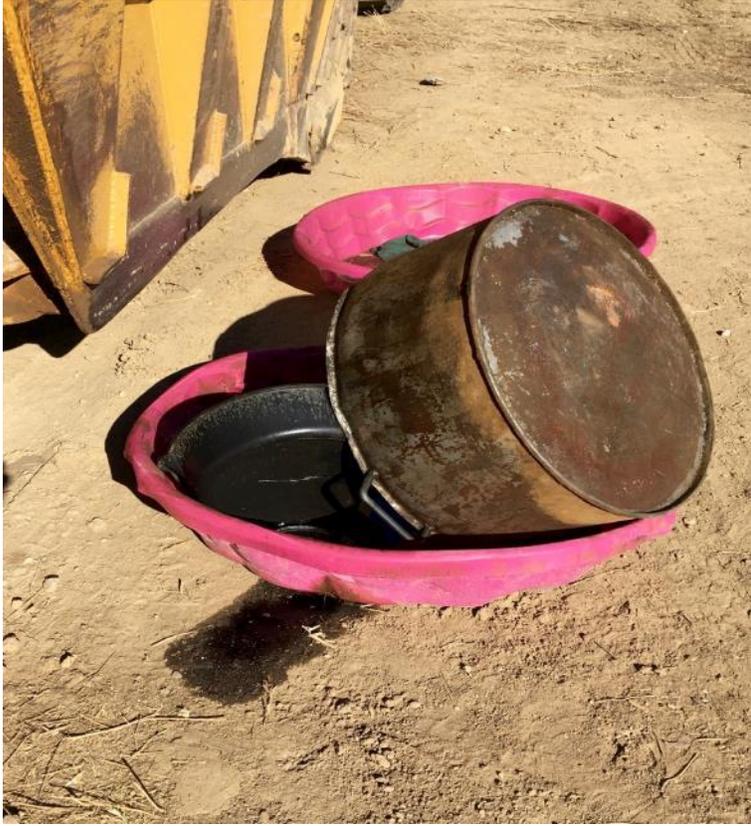
Most of the large earthmoving equipment was parked between the concrete staging area and the MarketPlace work site. Since Power Grade does not work on Fridays, all of this equipment is parked and unattended for three days. I noticed a leaking drip pan (Photo 13), a hydraulic fluid leak without a drip pan (Photo 14), and a drip pan half full of diesel fuel (Photo 15). These leaks would have become more significant during the three days without attention from a crew.

Photo 13 – Leaking drip pans.
12/15/17	Mesa Substation

I called Mesa Project Coordinator Pete Lubich (ULM Services, Inc.) about the water and the leaking equipment and he came to the site. Pete Lubich called a crew to clean up the spillage and address the leaks. We also discussed methods to control or redirect the water flow through the drainage pipes so it would not flood the equipment parking area (MM HY-3). Pete Lubich said he would recommend either damming the ditch or cutting a channel through the equipment parking area. Below the parking area, the water would flow into another section of the old drainage ditch.

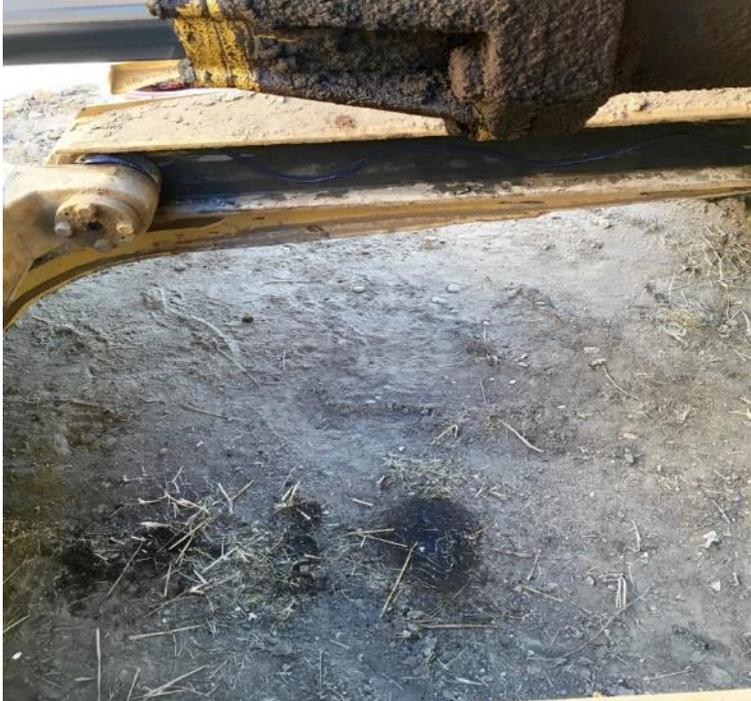
Photo 14 – Leaking hydraulic fluid.

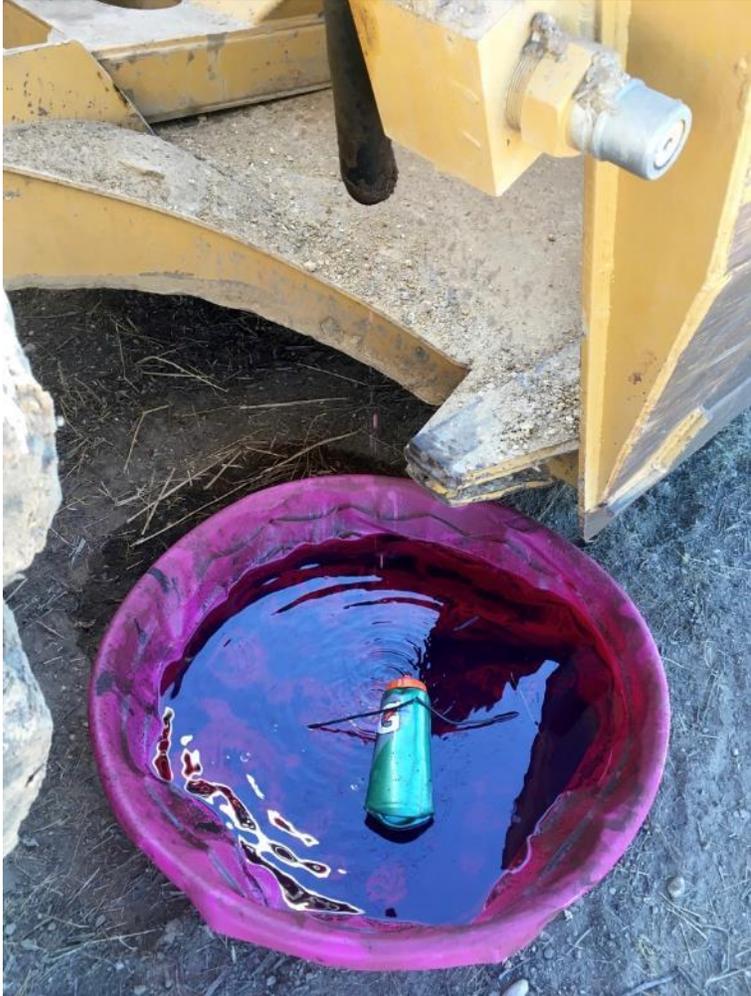
Photo 15 – Leaking diesel fuel.
12/15/17	Market Place

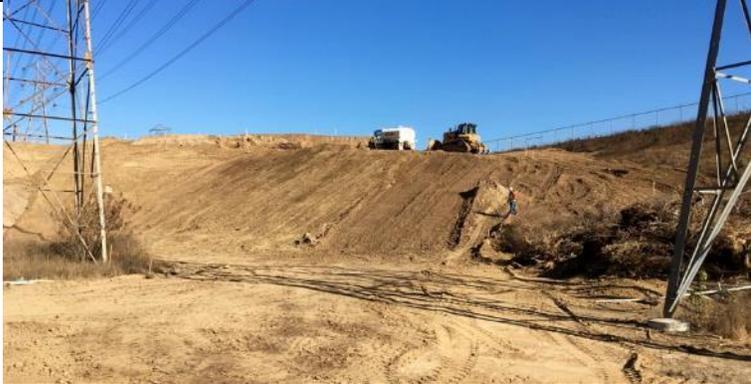
Photo 16 – Recontouring of soil over the newly installed drainage pipe. Photo facing east.

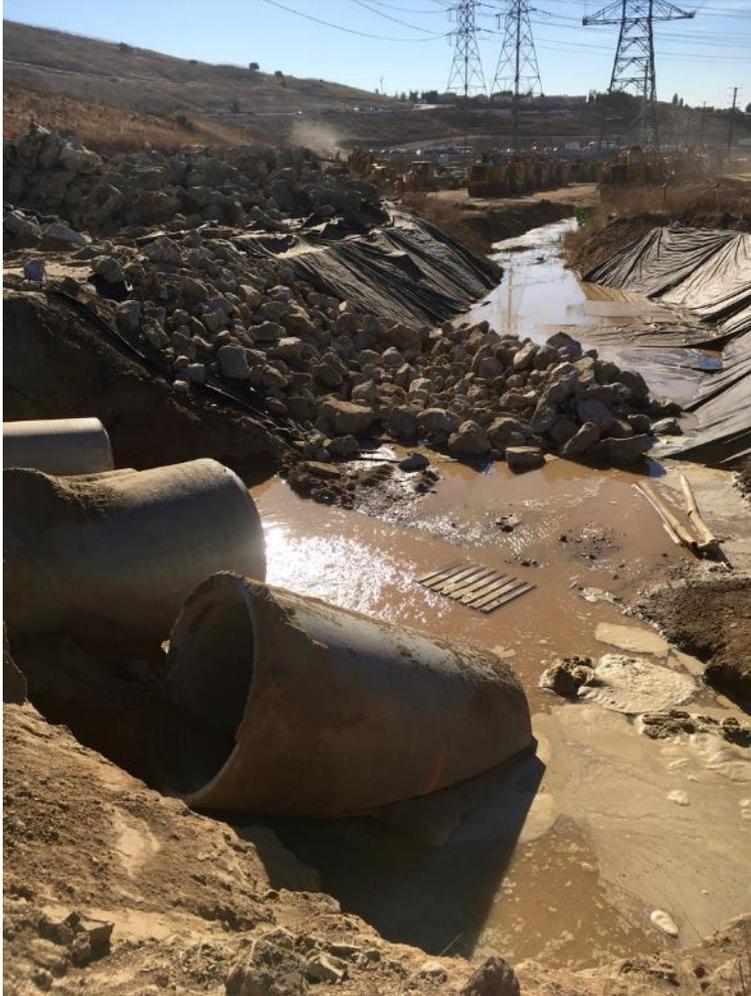
Photo 17 – Water entering the Mesa Substation site. Photo facing southwest.
12/15/17	Market Place

It is recommended to develop a plan for handling water entering the Mesa Substation site.

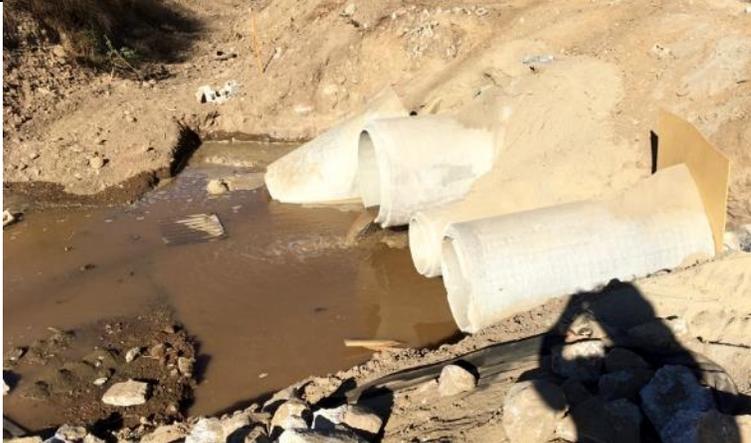
Photo 18 – Water coming into the Mesa Substation site; note the drainage pipe being undermined.

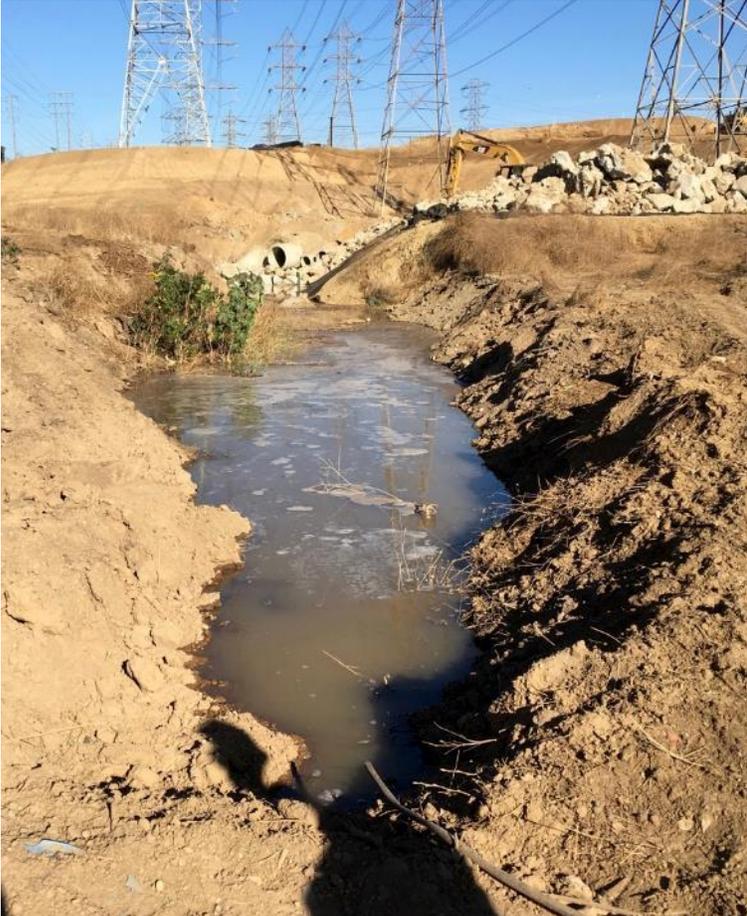
Photo 19 – Water ponded within the old drainage basin. Photo facing east.
12/15/17	Kiewit Jack-and-Bore Pit Site North of Potrero Grande Drive

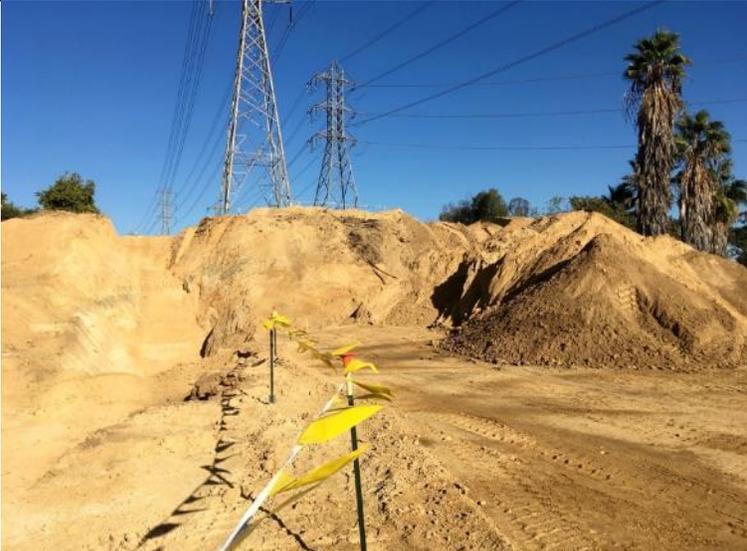
Photo 20 – Trenching for the water pipe. Photo facing east.

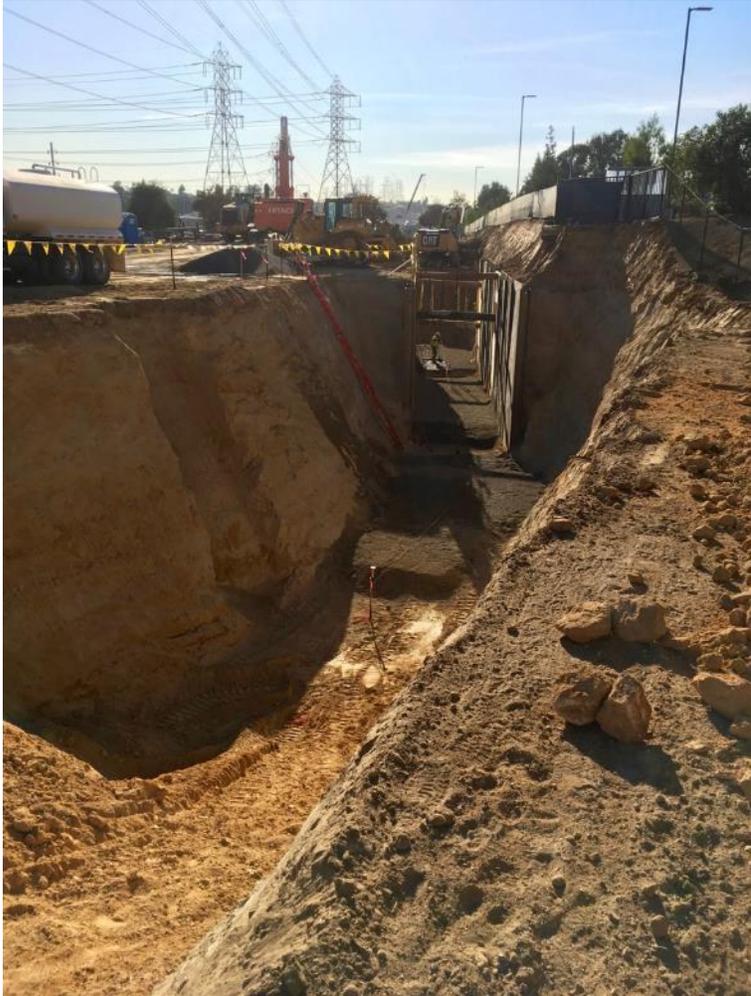
Photo 21 – Deep trench for the water pipe. Photo facing west.

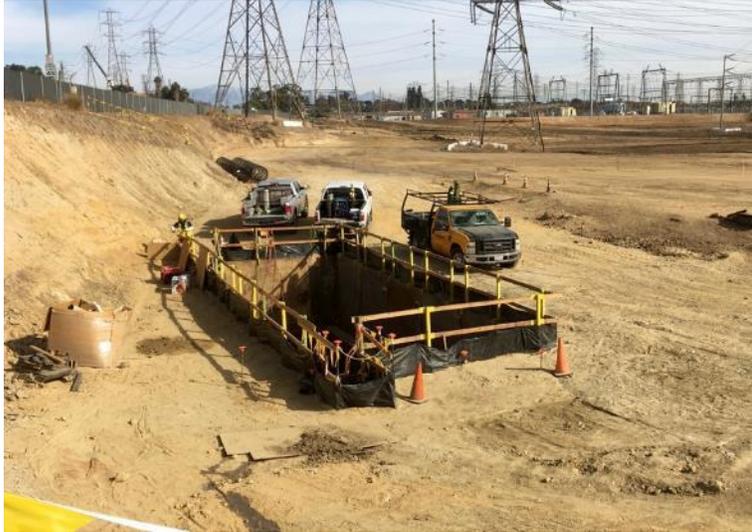
Photo 1 – Minimal work is taking place. Photo facing east.
12/22/17	Mesa Substation – Kiewit Jack-and-Bore Pit

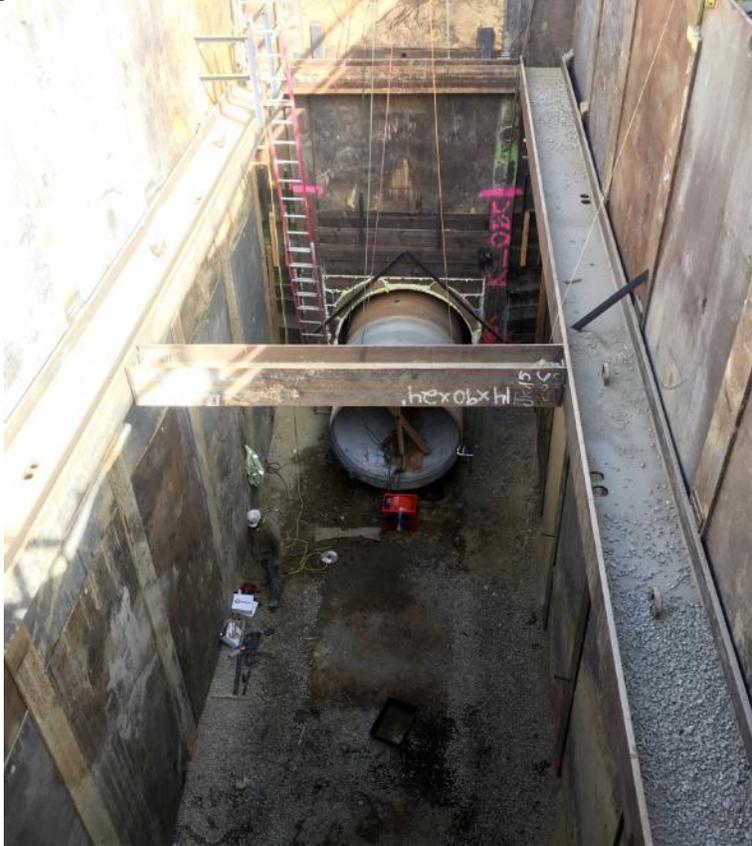
Photo 2 – Looking down into the Kiewit jack-and-bore pit; some welding is taking place.

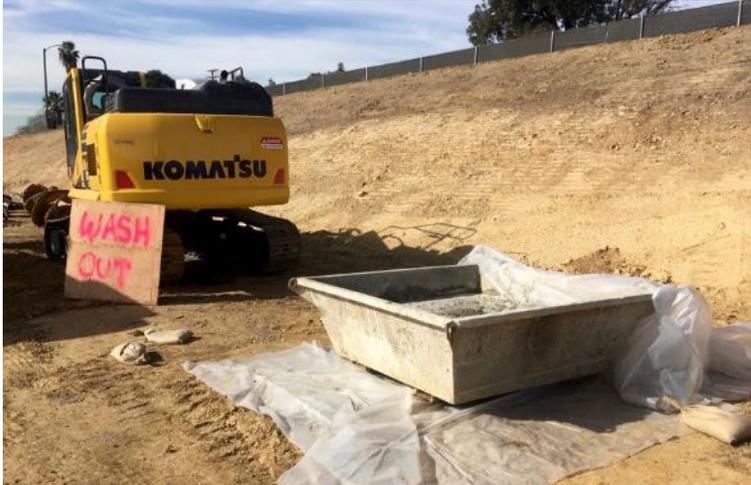
Photo 3 – Concrete washout location.
12/22/17	Mesa Substation

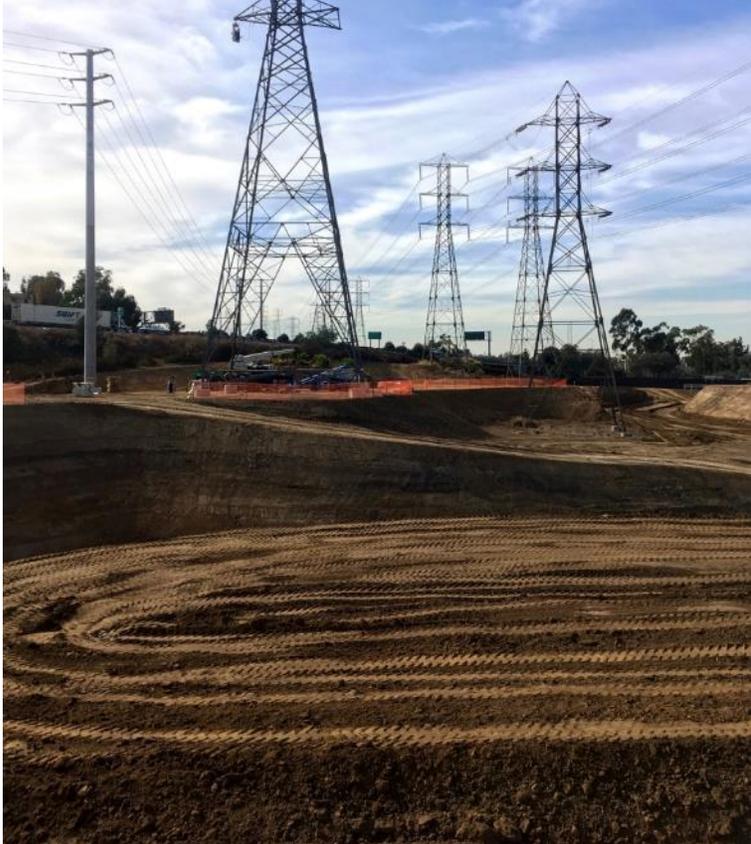
Earthmoving work continued at several locations with crews scrapers and bulldozers (Photos 4 and 5). Water trucks were providing dust control and proper moisture during the earthwork (APM-AIR-01, MM HY-1). Several scrapers were idling while parked when the crew took their lunch break. Later in the day, I spoke with the Power Grade safety lead Craig Pernot and told him about MM AQ-1 and MM NV-2 that require, "minimizing unnecessary construction equipment idling." He said he would talk with the foreman.

Photo 4 – Detention basin; soil continues to be moved in this area. Photo facing southwest.

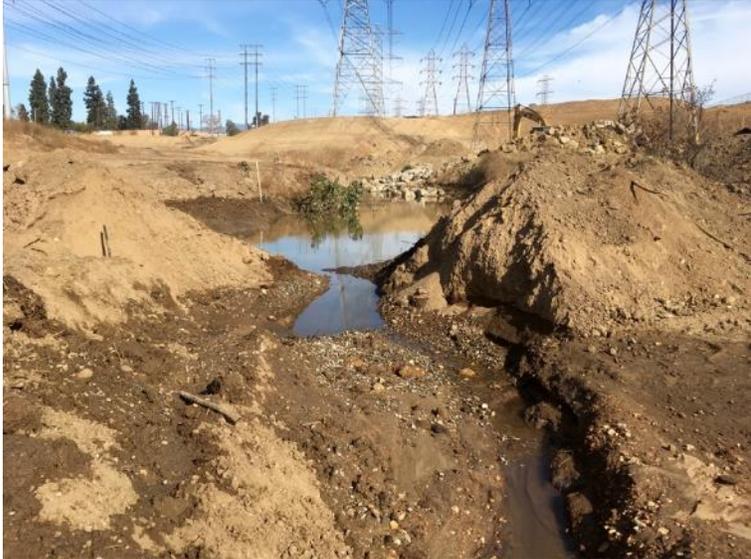
Photo 8 – Poned drainage detention basin that was opened up. Photo facing east.
12/22/17	Mesa Substation

It is recommended to develop a plan for handling water entering the Mesa Substation site.

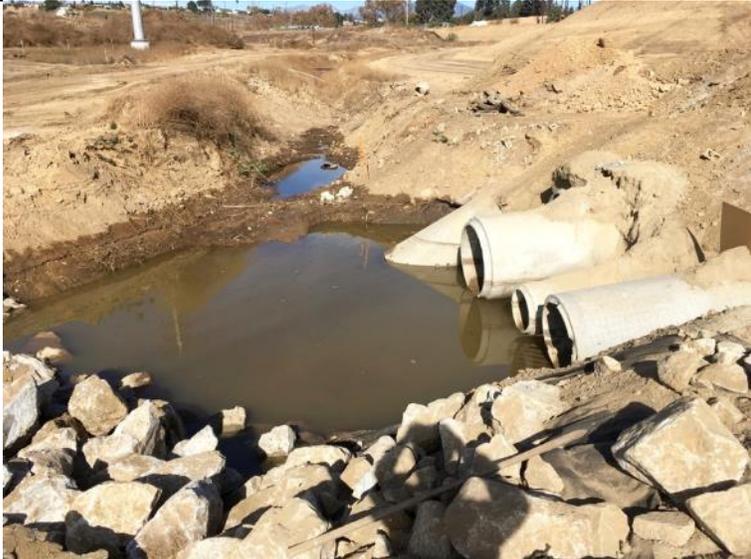
Photo 9 – Drain pipes with water coming from offsite.
12/22/17	Mesa Substation

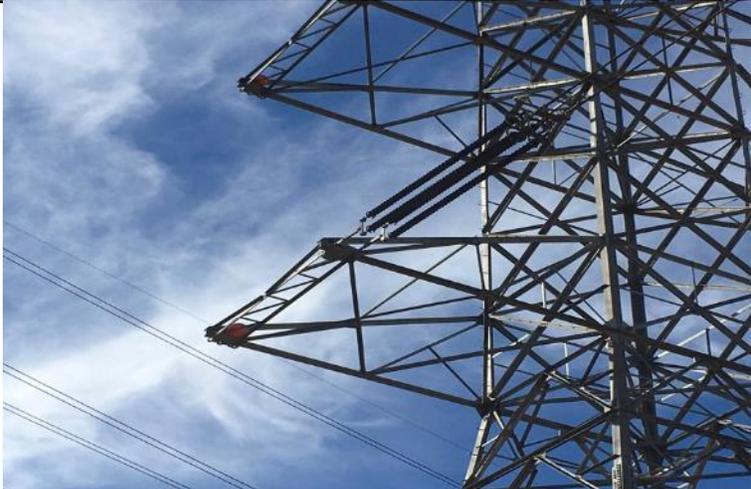
Photo 10 – Towers have had old stick nests removed and balls have been placed in the nesting locations.

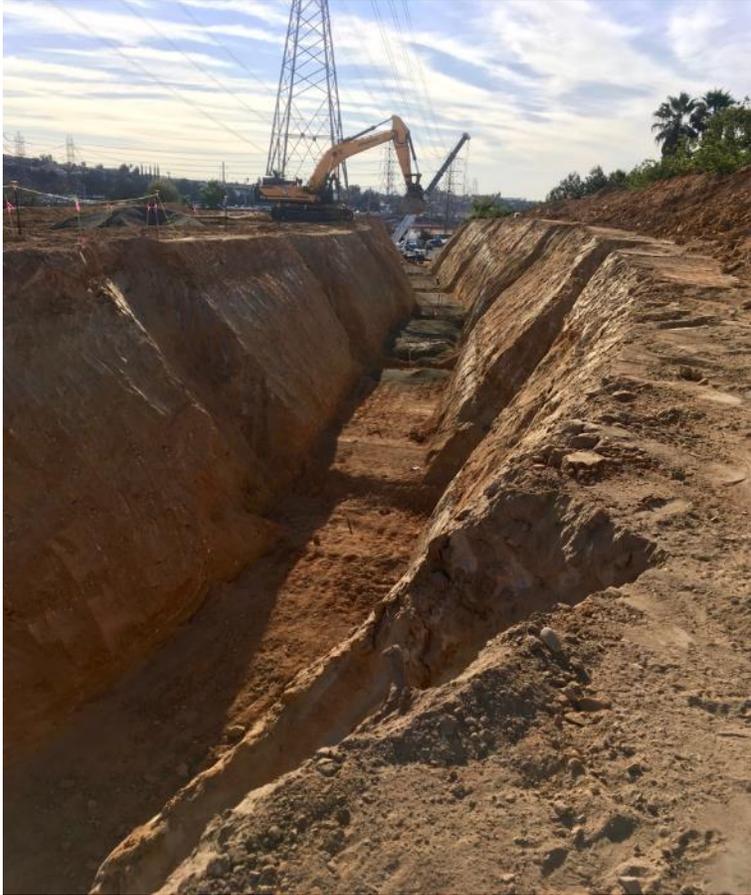
Photo 11 – Kiewit water pipe relocation trench. Photo facing west
12/22/17	Mesa Substation – Kiewit Jack-and-Bore Pit

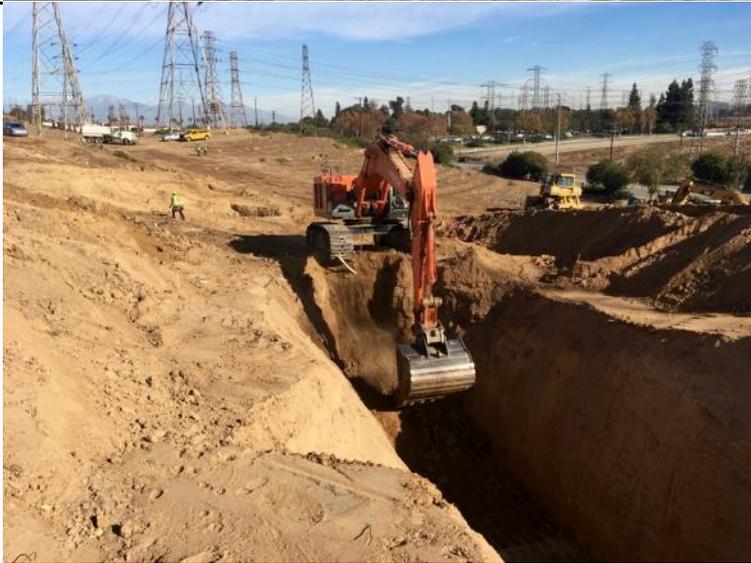
Photo 12 – Excavation of the water pipe trench. Photo facing east

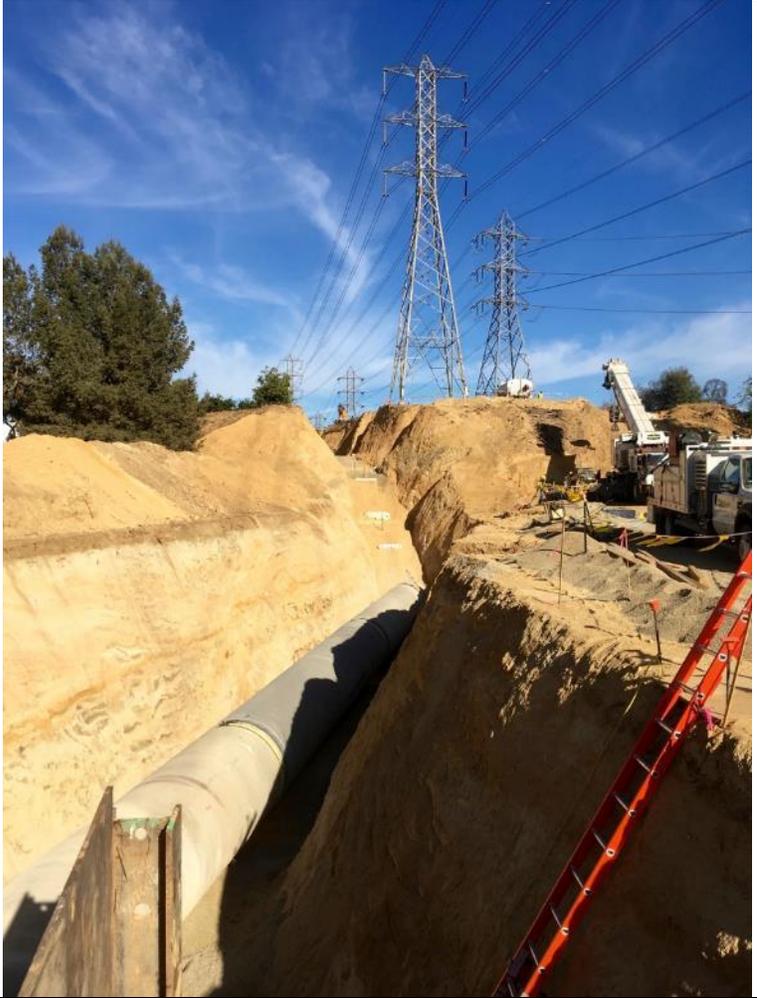
Photo 13 – Water pipe installation. Photo facing east
