August 16, 2021

Re: Monthly Report Summary #42 for the Mesa 500-kV Substation Project

This report summarizes the compliance monitoring activities that occurred during the period from **March 1 to 31, 2021**, for the Mesa 500-kilovolt (kV) Substation (Mesa Substation) Project in Los Angeles County, California. Compliance monitoring was performed to ensure that all project-related activities conducted by Southern California Edison (SCE) and their contractors comply with the requirements of the Final Environmental Impact Report for the Mesa Substation Project, as adopted by the California Public Utilities Commission (CPUC) on February 9, 2017.

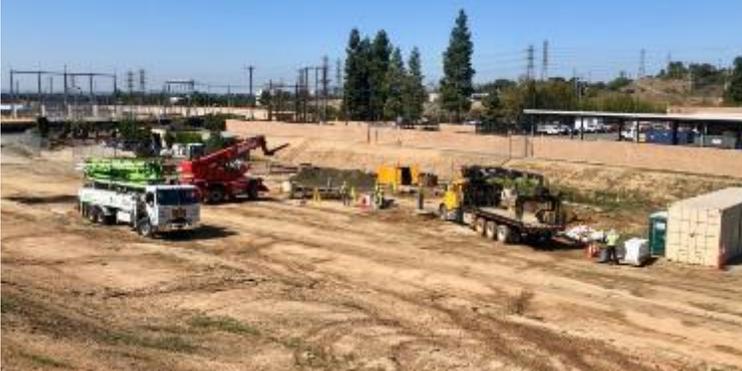
Photo 1 – Tower foundations being drilled and poured east of Market Place Drive. Photo facing northwest.
03/05/21	Mesa Substation

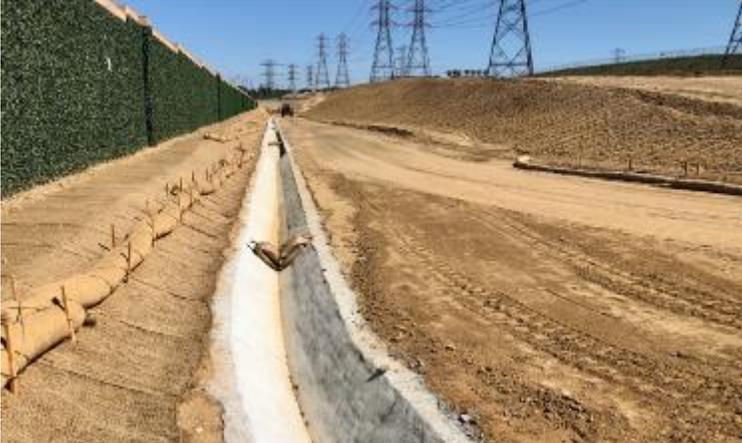
Photo 3 – Stockpiled soil and the new v-ditch with check dams. Photo facing east.

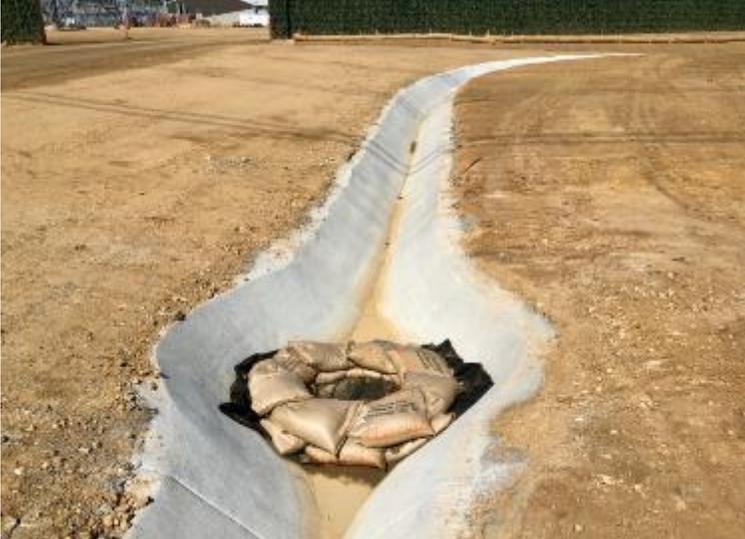
Photo 4 – V-ditch drain inlet with BMPs. Photo facing north.
03/05/21	Mesa Substation

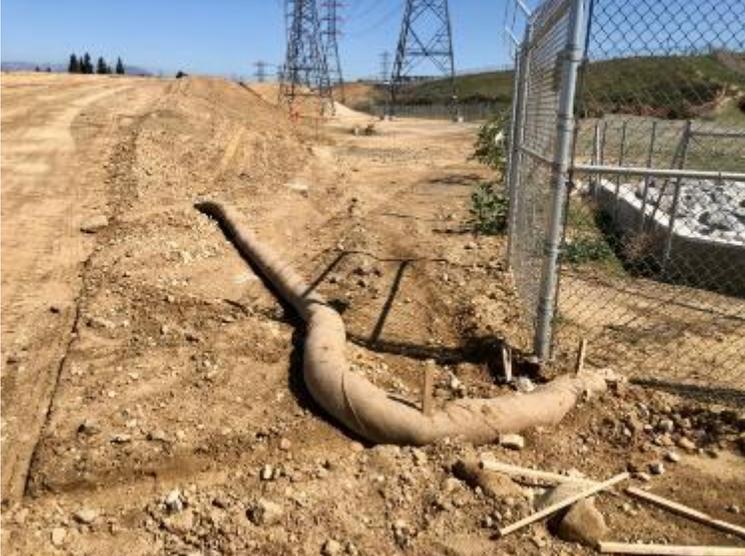
Photo 5 – Soil stockpile with one straw wattle near the riprapped drain inlet. Photo facing east.
03/05/21	Mesa Substation

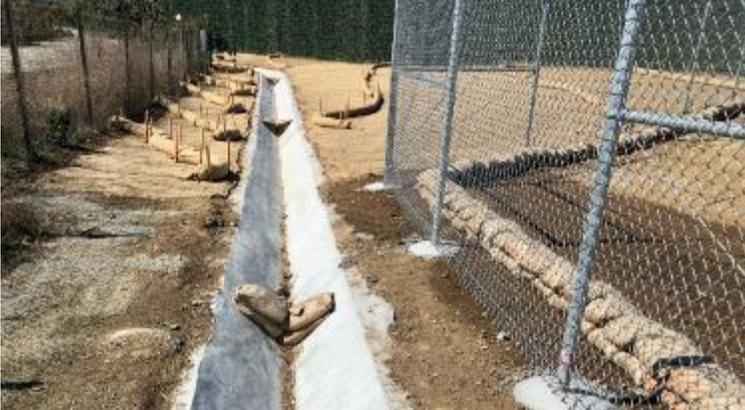
Photo 6 – BMPs installed along the outside of the southern boundary wall, with check dams in the v-ditch. Photo facing west.

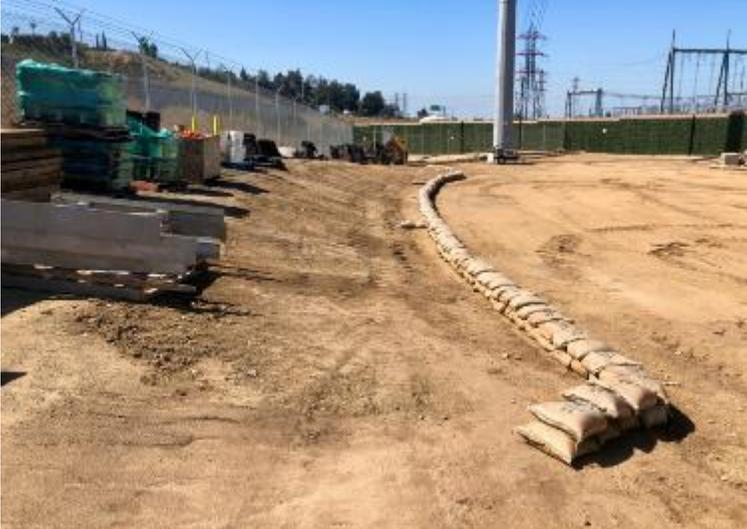
Photo 7 – Gravel bags placed where rainwater runoff may enter the site from Highway 60. Photo facing west.
03/05/21	Mesa Substation

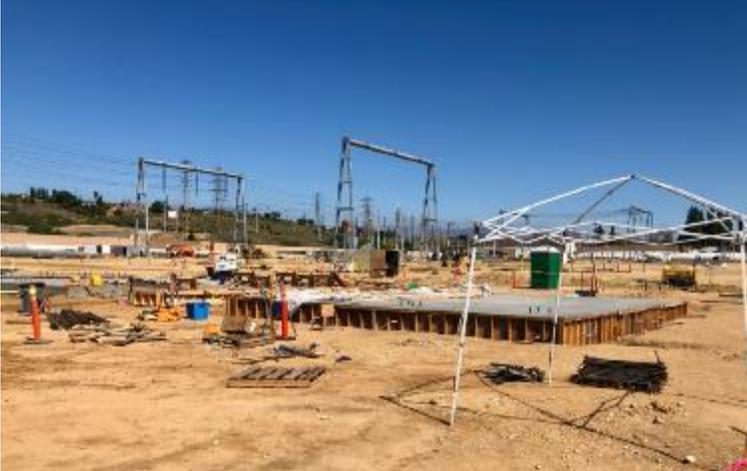
I walked through the Phase 4 construction area noting the ongoing foundation work, conduit installation, and infrastructure work (Photos 8, 9, 10, and 11). The work areas were in good condition with drip secondary containment under the equipment with minimal trash present.

Photo 8 – Transformer foundation work. Photo facing northeast.
03/05/21	Mesa Substation

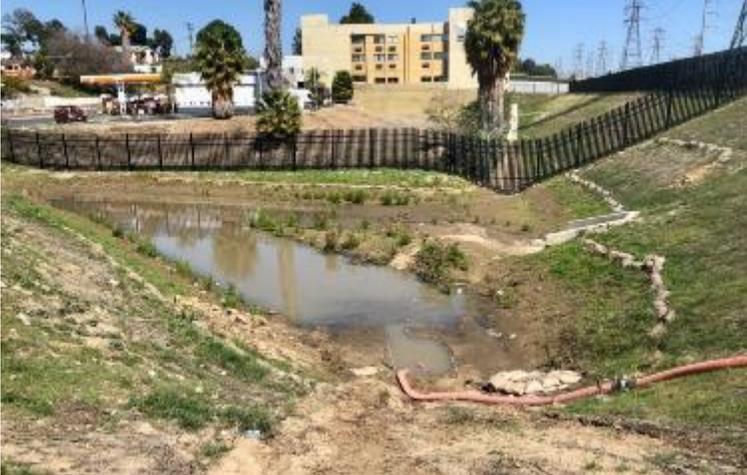
Photo 12 – Small triangular catch basin. Photo facing east.

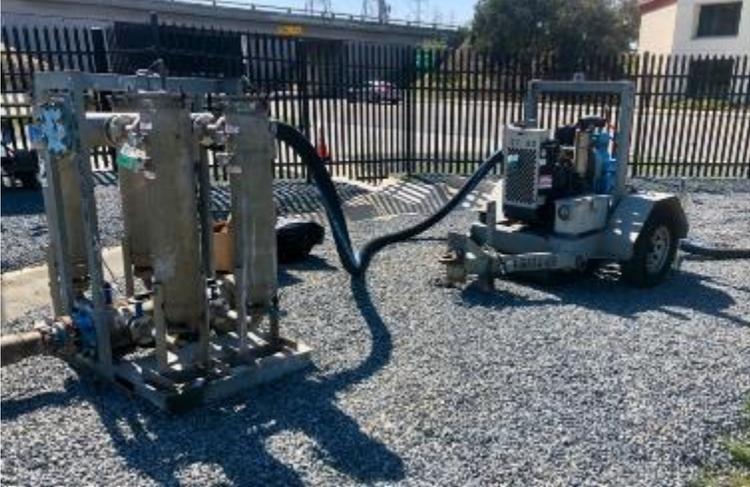
Photo 13 – Filter system for the water pumped out of the catch basin. Photo facing west.

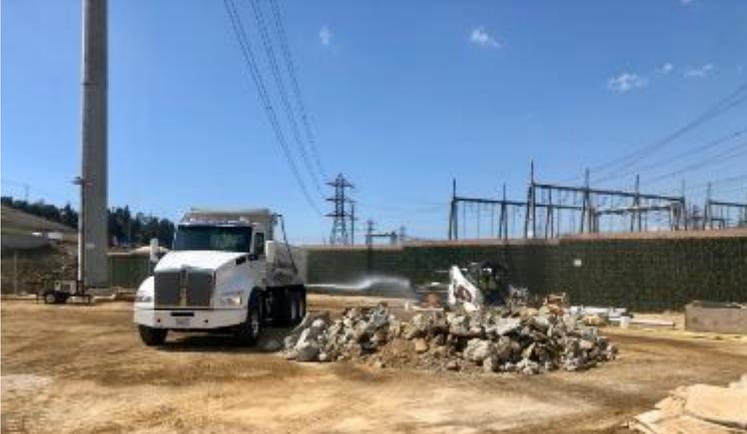
A crew was removing broken concrete from the staging area located west of the soil stockpile (Photo 4). A water truck was working with the crew to minimize dust.

Photo 4 – Removal of construction debris. Photo facing west.
03/09/21	Mesa Substation

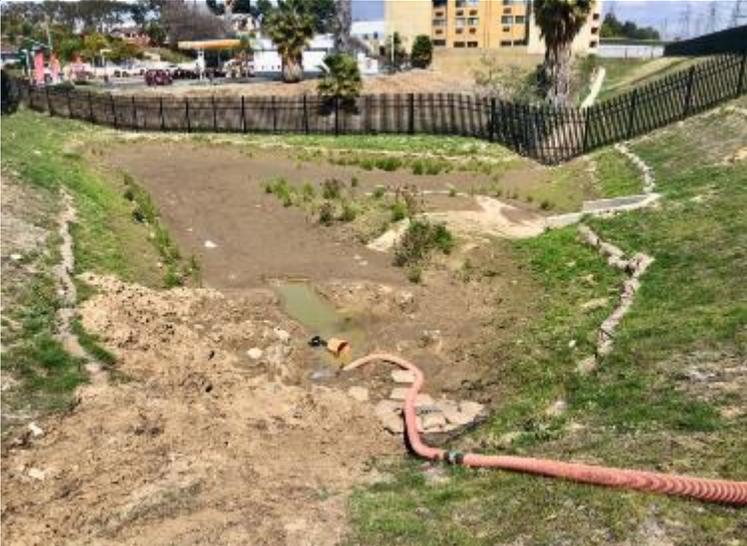
Photo 6 – The small triangular catch basin was almost dry after the water was pumped out. Photo facing northeast.

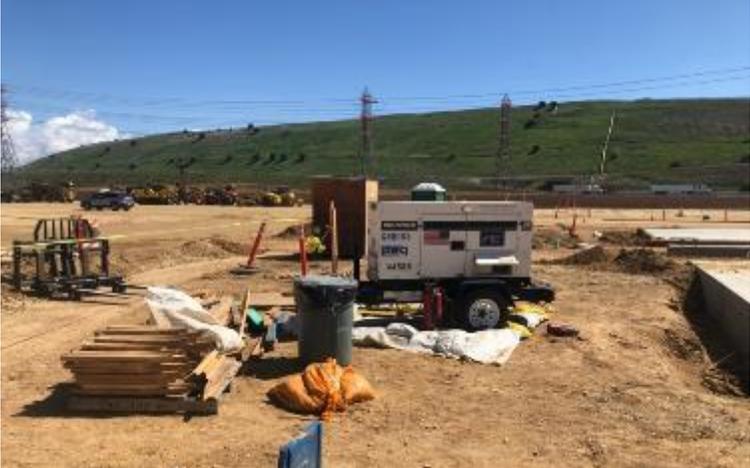
Photo 12 – Secondary containment under a diesel generator. Photo facing south.
03/09/21	Mesa Substation

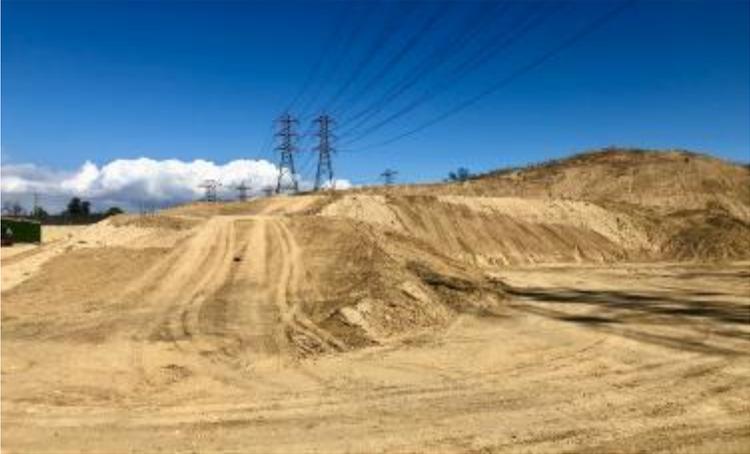
Photo 13 – Soil stockpile without BMPs. Photo facing east.

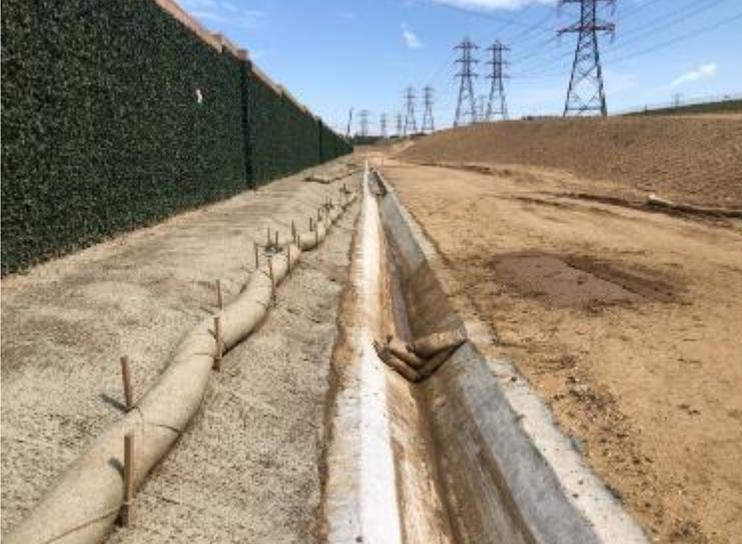
Photo 6 – The v-ditch between the southern boundary wall and the soil stockpile with mud stains visible. Photo facing east.

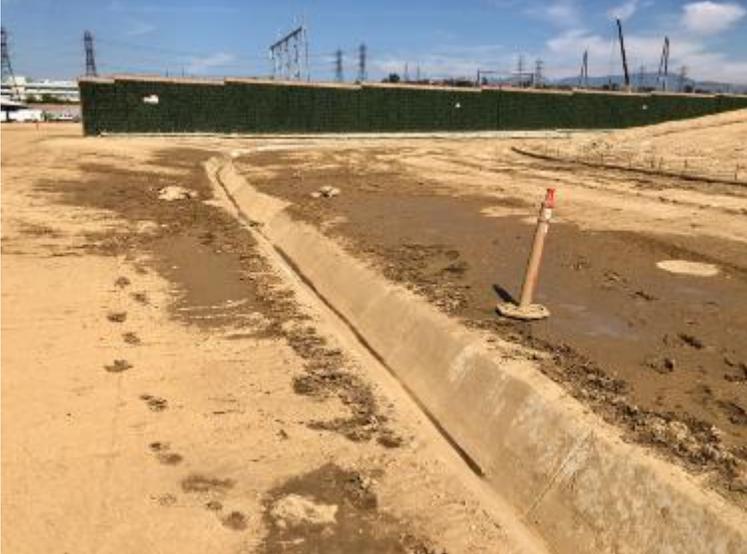
Photo 7 – The v-ditch drain inlet area at the western end of the soil stockpile with muddy areas visible from the last rain event. Photo facing north.
03/17/21	Mesa Substation

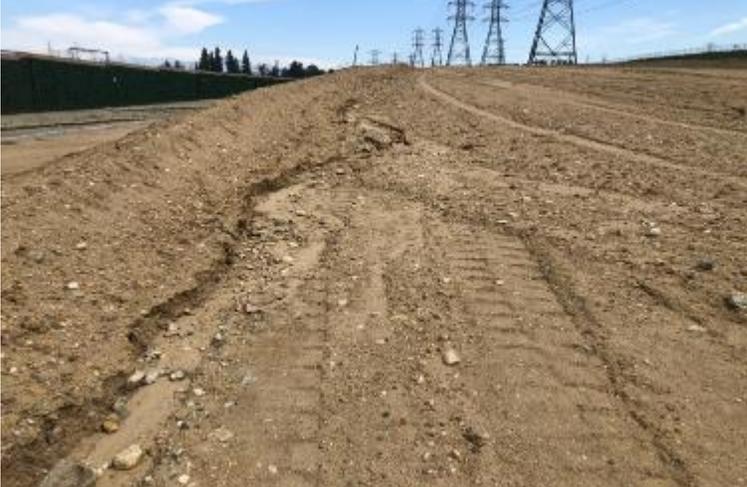
Stormwater runoff rivulets were noted coming off the top of the soil stockpile (Photo 8) and from around the southern side of the soil stockpile (Photo 9). The California gnatcatcher (*Poliioptila californica californica*) nest buffer remained in place; no additional BMPs were installed over and around the soil stockpile. Project biologists were waiting for a reduced buffer determination by the various agencies.

Photo 8 – Erosion rills coming from the soil stockpile. Photo facing north.
03/17/21	Mesa Substation

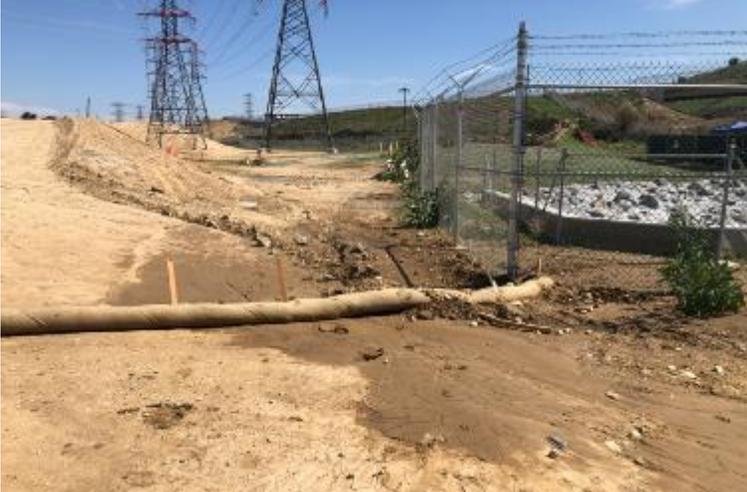
Photo 9 – Rainwater runoff from the south of the soil stockpile. Photo facing north.

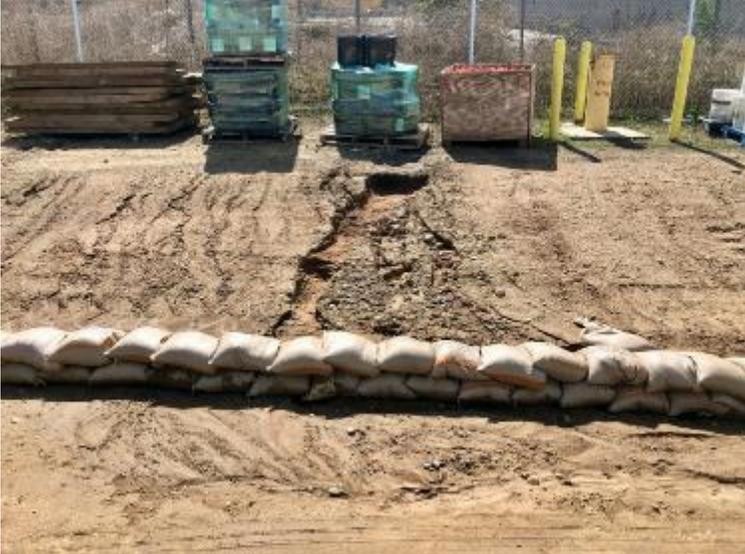
Runoff coming from the Highway 60 corridor created an erosion rill on the slope above the gravel bag BMPs (Photo 10), and rivulets were noted coming into the BMP area outside of the southern boundary wall (Photo 11).

Photo 10 – Rainwater runoff flowing into the site from the Highway 60 corridor. Photo facing south.
03/17/21	Mesa Substation

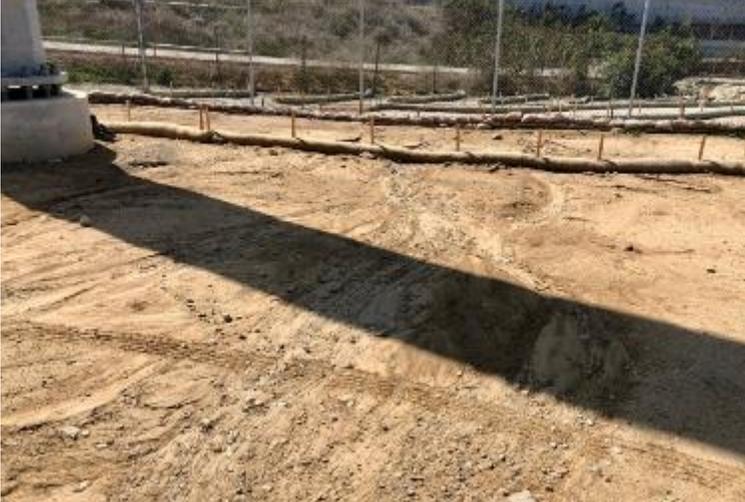
Photo 11 – Rainwater runoff rivulets flowed into the BMP area. Photo facing southwest.
03/17/21	Mesa Substation

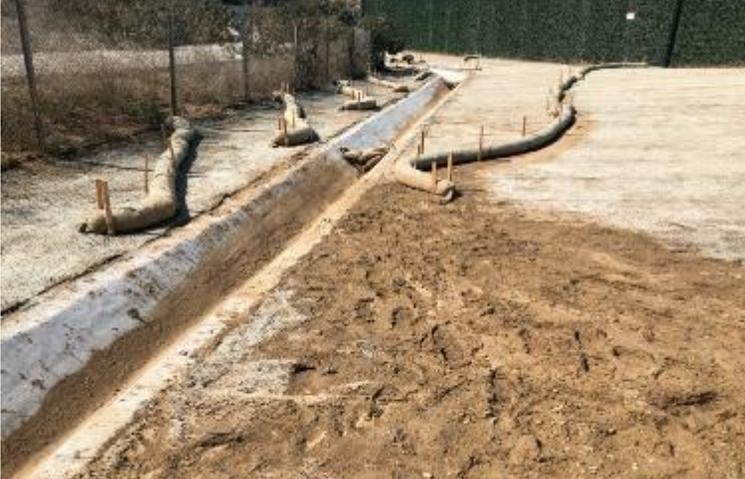
Photo 12 – Mud captured in the v-ditch. Photo facing west.

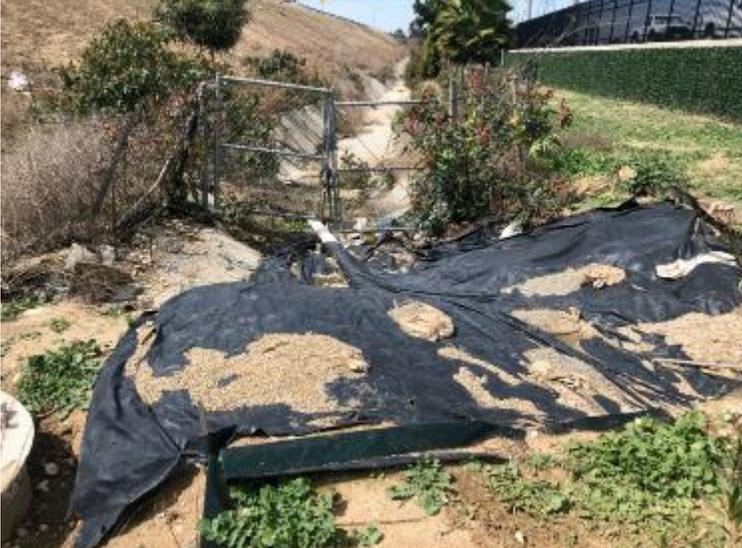
Photo 15 – Existing BMPs that needed to be removed and the area restored. Photo facing west.

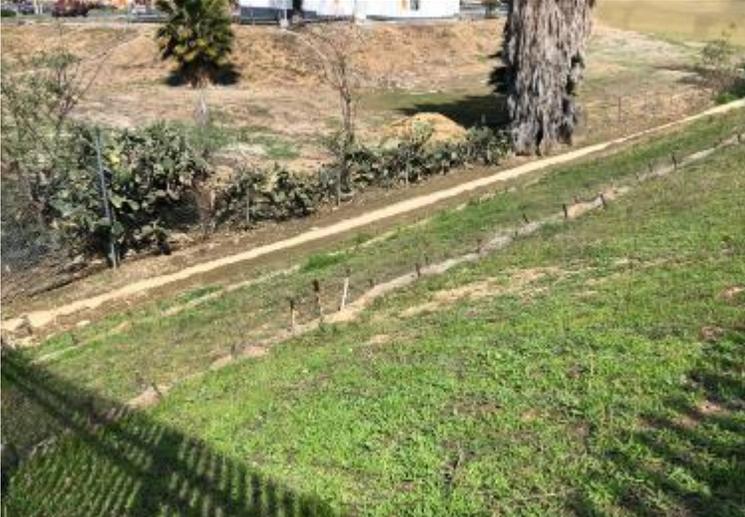
Photo 17 – The v-ditch leading into the triangular catch basin remained full of sediment. Photo facing northeast.
03/17/21	Mesa Substation

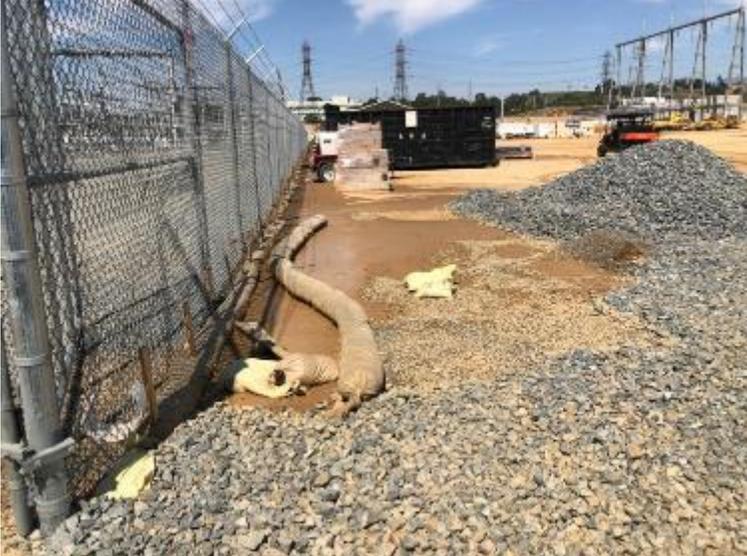
Photo 19 – Mud collected in the BMPs along the new substation fence line. Photo facing north.
03/17/21	Mesa Substation

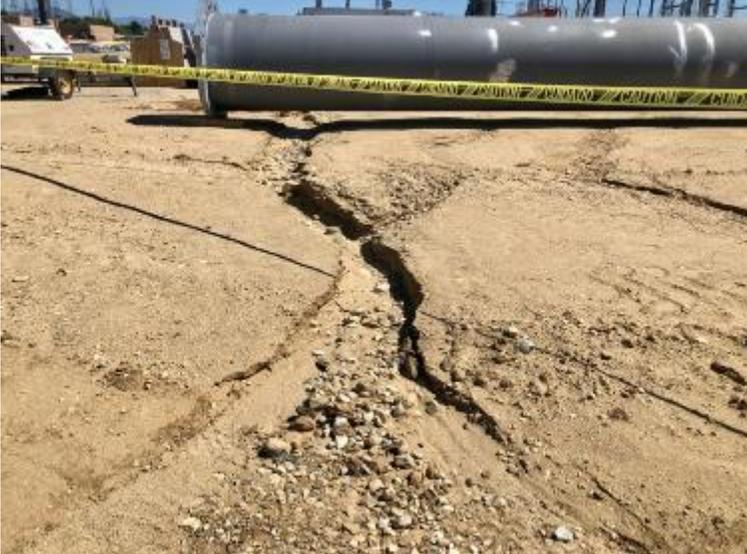
Photo 7 – Rainwater runoff rivulets flowing through the Phase 4 work area. Photo facing east.
03/24/21	Mesa Substation

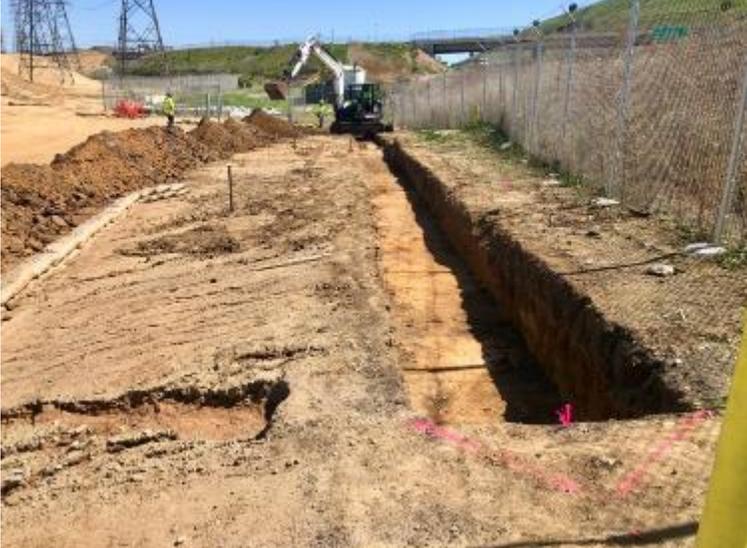
Photo 8 – Diversion ditch excavation for rainwater runoff coming into the site from the Highway 60 corridor. Photo facing east.

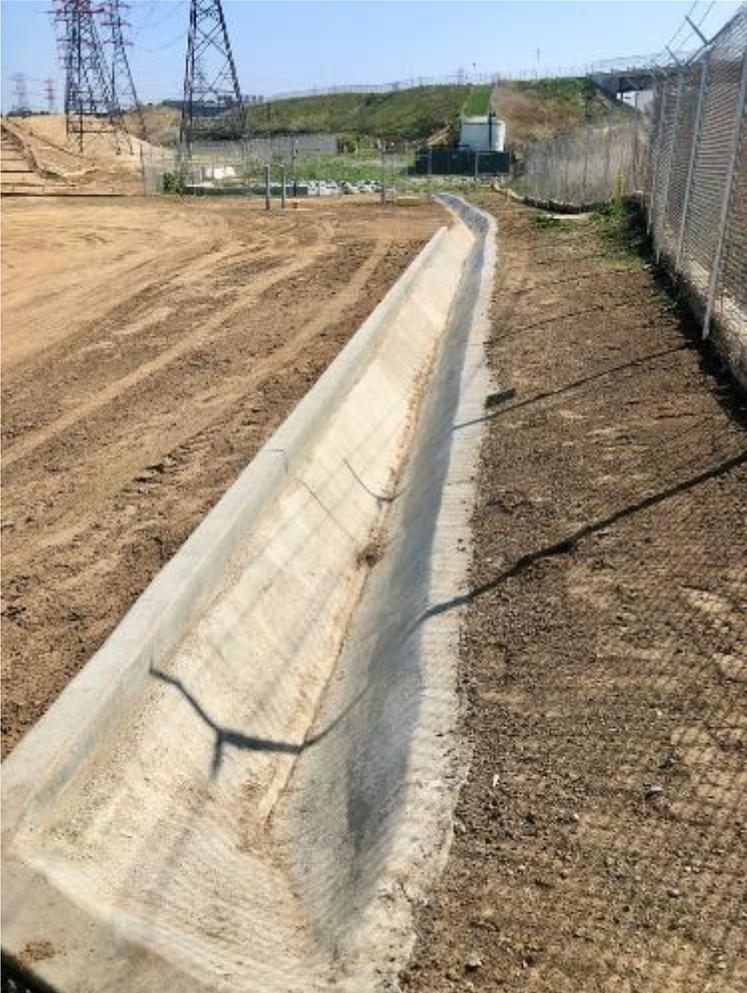
Photo 7 – Completed diversion ditch for rainwater runoff coming into the site from the Highway 60 corridor. Photo facing east.
