PUBLIC UTILITIES COMMISSION

Incident Date:	June 25-26, July 7 and 10, 2020	Report No.:	NCR-005
Date Submitted:		Location:	Project entrance on Market Place and Potrero Grande Road
Level:	Level 1 Non-Compliance	Relevant Plan/Measure:	MM HY-1; APM-AIR-01
Current Land Use:	Mesa substation	Sensitive Resources:	Public storm drain system; public roads

NCR-007 Incident Photographs

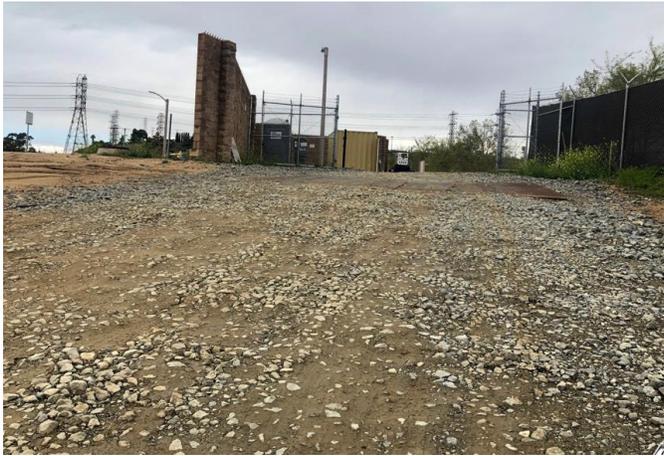
Photo 1: Rock portion of the exit/entry BMP at the eastern entrance to the project site on April 7, 2020. Photo facing north.

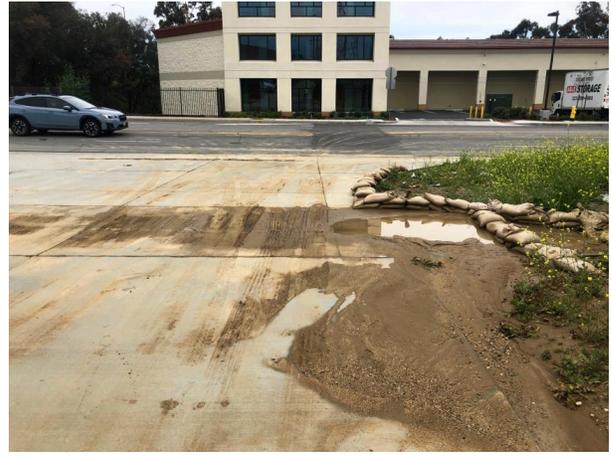
Photo 2: Muddy track out at the western project entrance on April 7, 2020. Photo facing west.

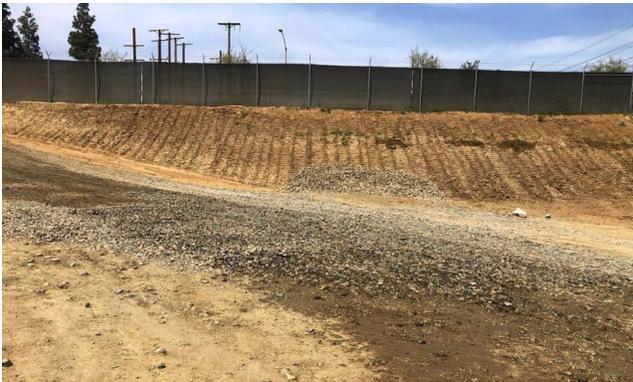
Photo 3: BMP rock spread out on lower portion of the Market Place Drive exit/entry roadway, June 24, 2020. Photo facing east.

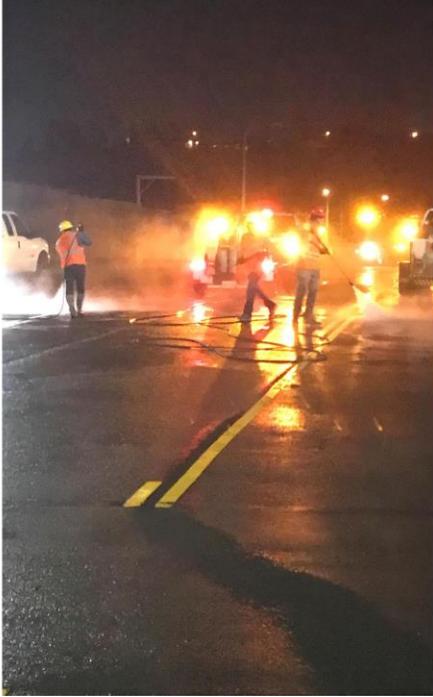
Photo 4: Market Place Drive being power washed from top (by Costco) down to Potrero Grande, July 20, 2020.

Power Grade conducted nighttime power washing of Market Place Drive on July 20, 2020. Traffic Control crews closed Market

Place Drive from Potrero Grande Road to the top of the hill near Costco to power wash the road. Three trucks were utilized to wash the street from curb to curb and hose down sidewalks. On July 20, 2020 power washing was complete on Market Place Drive and equipment was cleared.

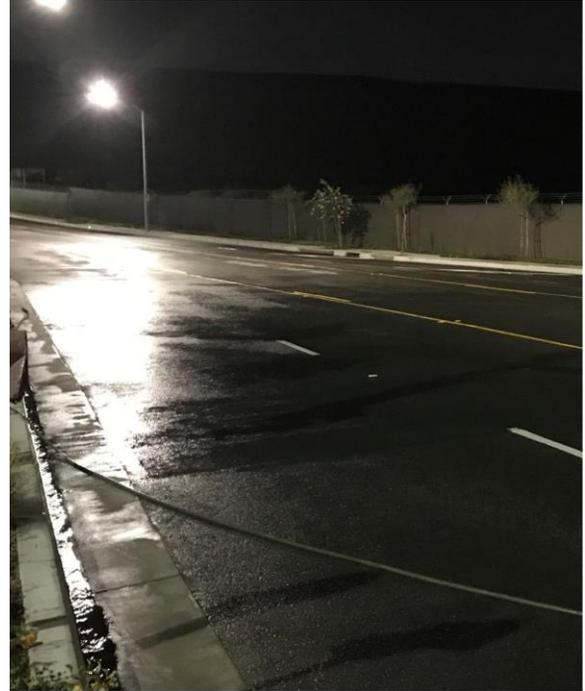
Photo 5: Market Place Drive - Looking uphill towards Costco, July 20, 2020.

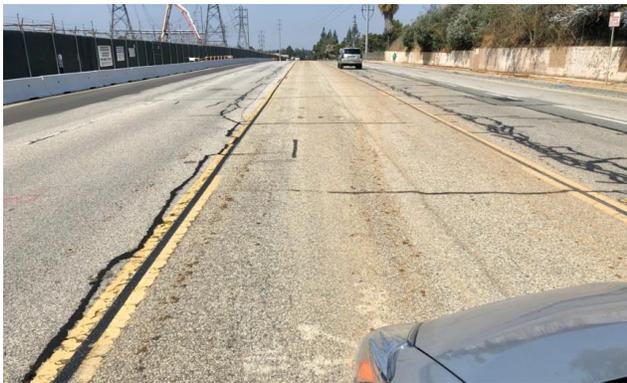
Another site inspection report from July 21, 2020 noted that a street sweeper was cleaning the roadway while a substantial amount of muddy track out was present in the road. The new northern entrance to the substation was open and the entry/exit BMPs were installed. Additional rock and another set of rumble plates were installed at the bottom of the slope.

Photo 6: Muddy track out on Potrero Grande Road on July 21, 2020. Photo facing west.

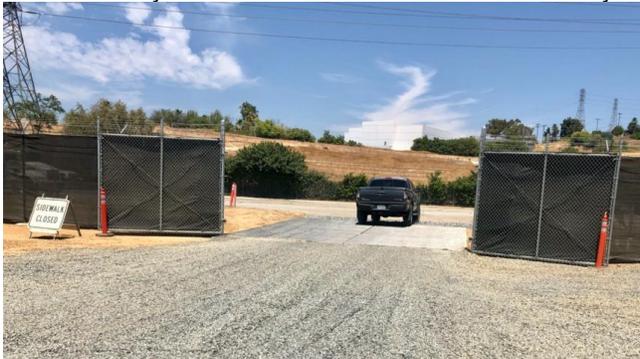
Photo 7: Northern entrance with exit/entry BMPs in place, July 21, 2020. Photo facing north.

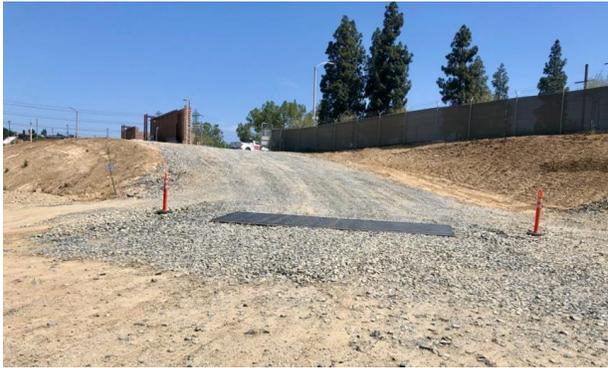
Photo 8: Additional BMPs added to the eastern project entrance, July 21, 2020. Photo facing west.

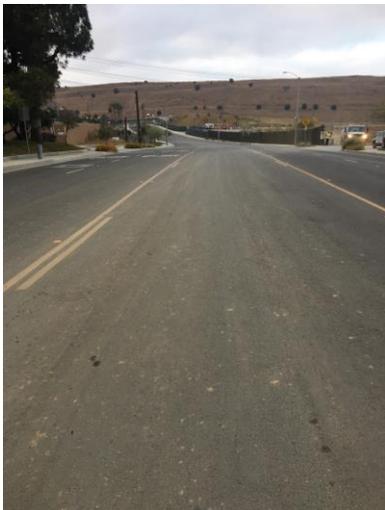
Photo 9: Track out on Market Place Drive, July 21, 2020.

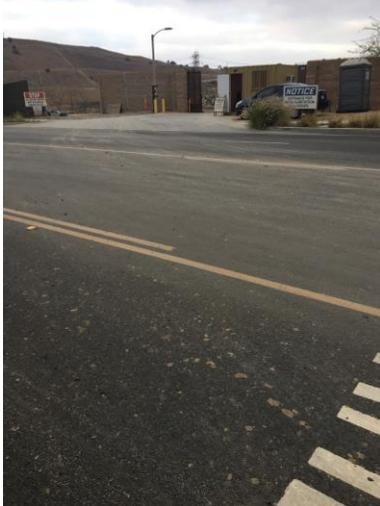
Photo 10: Track out on Market Place Drive, July 21, 2020.

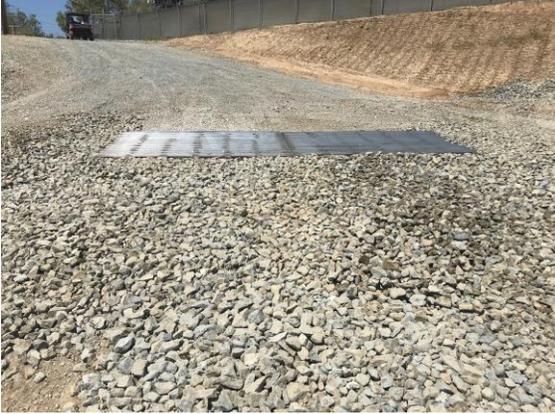
Photo 11: Market Place Drive entrance after rock was redistributed and leveled with additional plate placed over top, July 23, 2020.

SCE provided the requested information to AQMD on Tuesday, July 14, 2020. Power Grade closed down and washed Market Place Drive to Potrero Grade Road at night on Sunday, July 20, 2020 as approved by the City of Monterey Park. SCE updated the construction entrance at Market Place Drive by thoroughly cleaning the rumble plates and redistributing the rocks inside the plates on July 23, 2020.
