# Mesa 500-kV Substation Project Construction Non-Compliance Report

Incident Date:	10/17/2017-12/26/2017	Report No.:	NCR-001
Date Submitted:	1/9/18	Location:	Multiple
Level:	Level 2	Relevant Plan/Measure:	MM BR-1, MM BR-9, MM BR-10
Current Land Use:	Existing Mesa Substation; SCE right-of-way	Sensitive Resources:	Occupied coastal California gnatcatcher habitat, sensitive vegetation communities

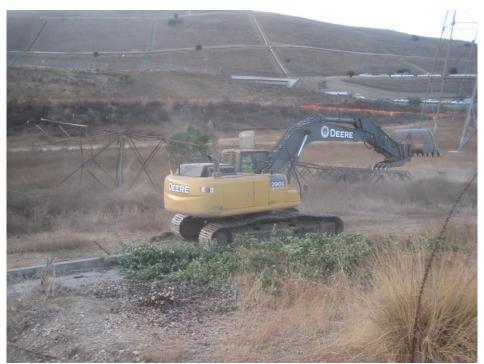
On October 17, 2017, a Power Grade excavator tracked through vegetation northeast of the transmission laydown yard and moved a downed lattice tower into vegetation prior to the required pre-construction clearance sweep. The incident occurred in occupied coastal California gnatcatcher habitat. Power Grade was reminded that they should not assume clearance from anyone onsite other than biological monitors and environmental staff.

Photo 1: A Power Grade excavator tracking through vegetation in occupied coastal California gnatcatcher habitat on 10/17/2017. The excavator moved a downed lattice tower into vegetation prior to the required pre-construction clearance sweep (Photo by SCE; FRED Incident ID #000021).

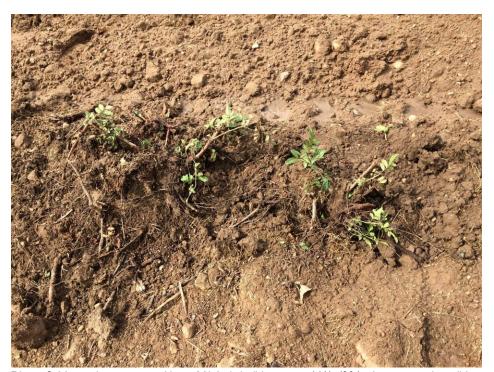
On November 15, 2017, a Michels (Power Grade subcontractor) bulldozer removed nonnative vegetation prior to a preconstruction clearance sweep at the SCE transmission area north of Potrero Grande Drive without a biological monitor present (Photo 2). The incident was not within any special status species habitat and was completely within approved disturbance limits. The biologist reminded the operator that the site had not been cleared and a biological monitor must be present during vegetation clearing activities. The operator waited until the clearance sweep had been completed and for confirmation from his supervisor before continuing vegetation removal. Power Grade reminded all crews that vegetation removal activities require a sweep prior to operations along with full-time monitoring. On November 21, 2017, a Golden State crew was observed working in the Kiewit jack-and-bore pit before a pre-construction clearance sweep. The crew had removed the wildlife exclusionary fencing. This incident was observed in Areas 1BB and 1K, but was not within any special status species habitat and was completely within approved disturbance limits. Kiewit was reminded of the requirement for pre-construction clearance sweeps and they reiterated this to the Golden State crew.

Photo 2: Vegetation removed by a Michels bulldozer on 11/15/2017 in an area that did not have a pre-construction clearance sweep and did not have a biological monitor present (Photo by SCE; FRED Incident ID #000024).

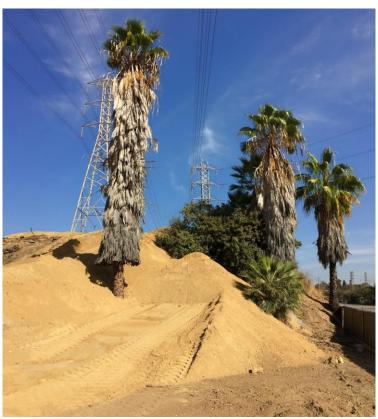
On December 4, 2017, a biologist observed a stockpile of soil that had been deposited in a Kiewit work area before a preconstruction clearance sweep had been conducted (Photo 3). The incident was not within any special status species habitat and was completely within approved disturbance limits; however, the incident impacted adjacent Mexican fan palms and a large Brazilian pepper shrub. No resolution has been documented in SCE's online database at the time of this report

Photo 3: A soil stockpile that had been placed within a Kiewit work area on 12/4/2017 prior to a pre-construction clearance sweep, impacting adjacent Mexican fan palms and a Brazilian pepper tree (Photo by SCE; FRED Incident ID #000051).

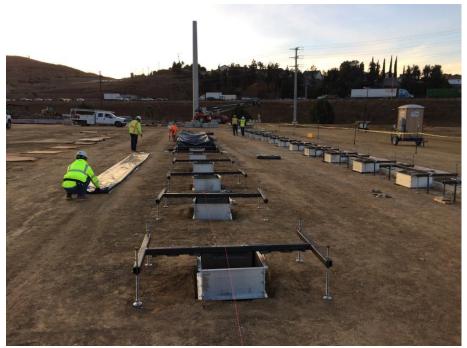
On December 11, 2017, a Power Grade crew removed wildlife exclusionary devices (tarps) from excavation pits within Area 1E before a pre-construction clearance sweep for the pits had been conducted by a biological monitor. Tarps covering more than 24 pits were in the process of being removed by the crew (Photo 4). The incident was not within any special status species habitat and was completely within approved disturbance limits, with no further impacts visible. The crew was reminded of the requirement for pre-construction clearance sweeps prior to uncovering holes/pits on construction work sites.

Photo 4: Power Grade workers removed wildlife exclusionary devices from more than 24 pits within Grading Area 1E on 12/11/2017 before the pits had a pre-construction clearance sweep by a biological monitor (Photo by SCE; FRED Incident ID #000070).
