Re: Monthly Report Summary #1 for the Santa Barbara County Reliability Project

CPUC Site Inspection Report
October 5, 13, 19, and 26, 2017

Santa Barbara County Reliability Project CPUC Site Inspection Form

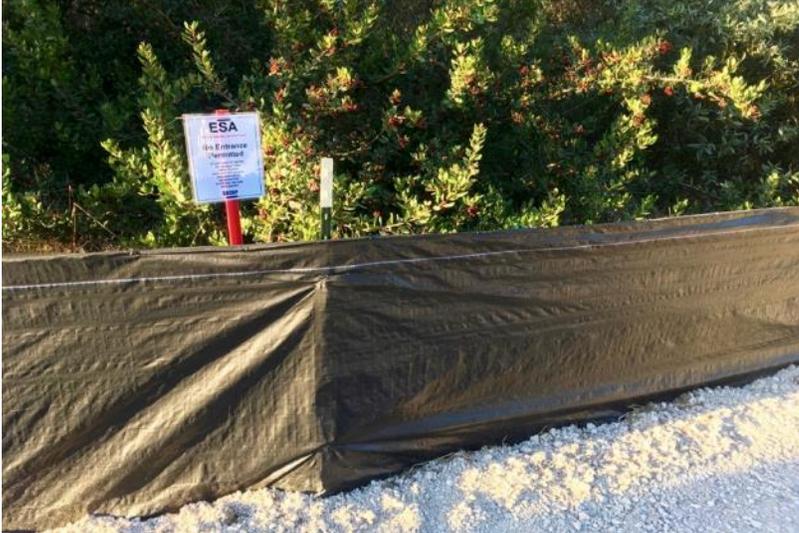
<p>Photo 1 – The staging yard is the location for the 0700 tailboard meeting. ESA signs were posted, exclusion fencing was installed, and gravel had been laid out.</p>
10/5/17	The “Y” (where Segments 2 and 3B Intersect)

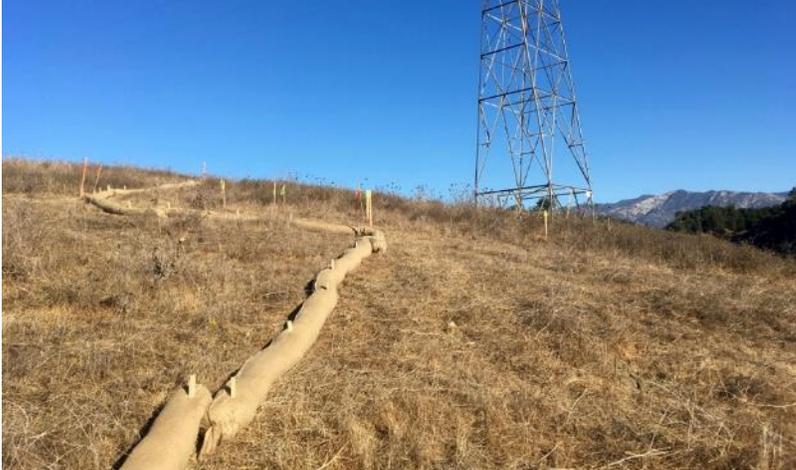
I traveled with James Rasico (Rincon) along Segment 3B. We stopped at Construct 57 where potholing and BMP installation had been completed (Photo 5). The pothole had been backfilled, which eliminated safety issues and the potential for animals to become trapped (MM BIO-6). The BMPs were installed according to the environmental maps. We checked on a number of constructs to verify ESA staking and BMP installation. We also stopped at Constructs 60 and 61 and noted large stick nests that appeared to be abandoned by red-tailed hawk (APM BIO-4). We met the ranch manager watering fruit trees planted under the transmission lines. Photo 6 shows the access roads along Segment 3B, which runs up and over Rincon Mountain.

Photo 5 – BMPs installed.

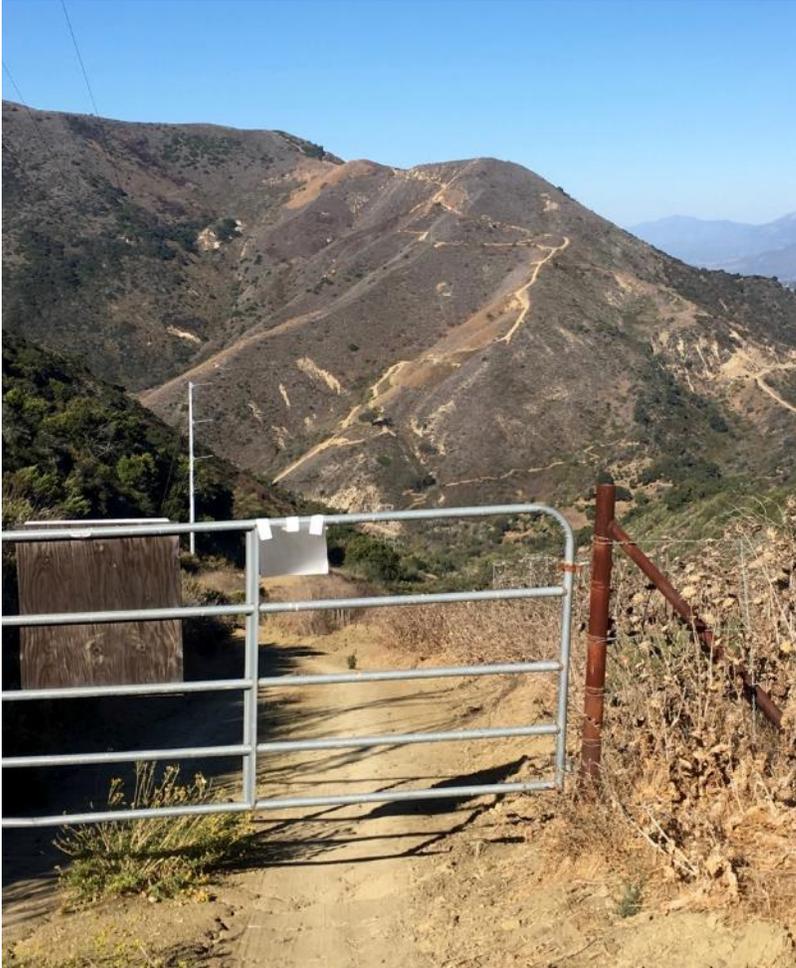
<p>Photo 6 – The Segment 3B access road is long and steep. The Segment 3B line goes up and over Rincon Mountain, which can be seen in the photo. Photo facing west</p>
10/5/17	Segment 2

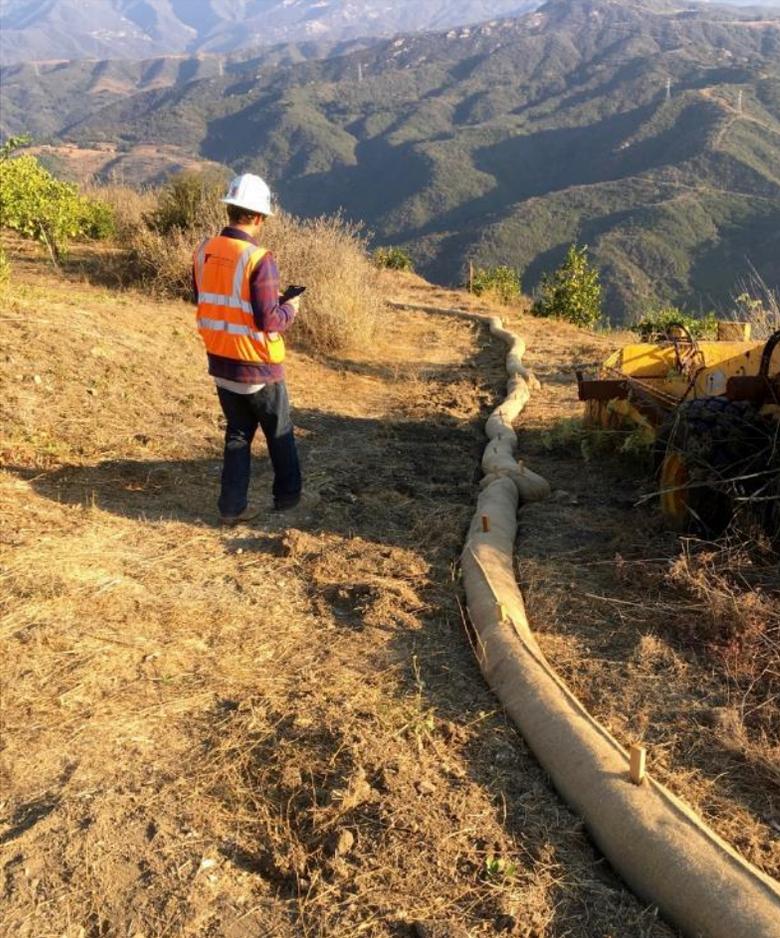
Photo 1 – BMPs being installed around the Construct 68 location. Photo facing north.
10/13/17	Segment 3B Construct 69

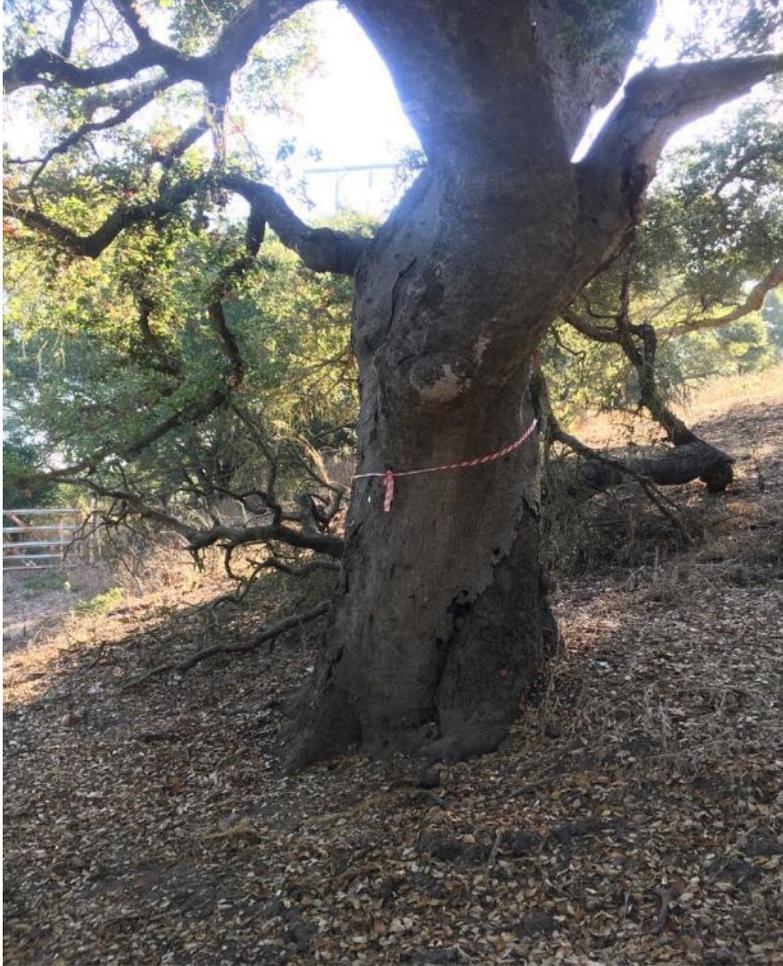
Photo 3 – Flagged oak tree within the boundary stakes.
10/13/17	Rincon Mountain on Segment 3B

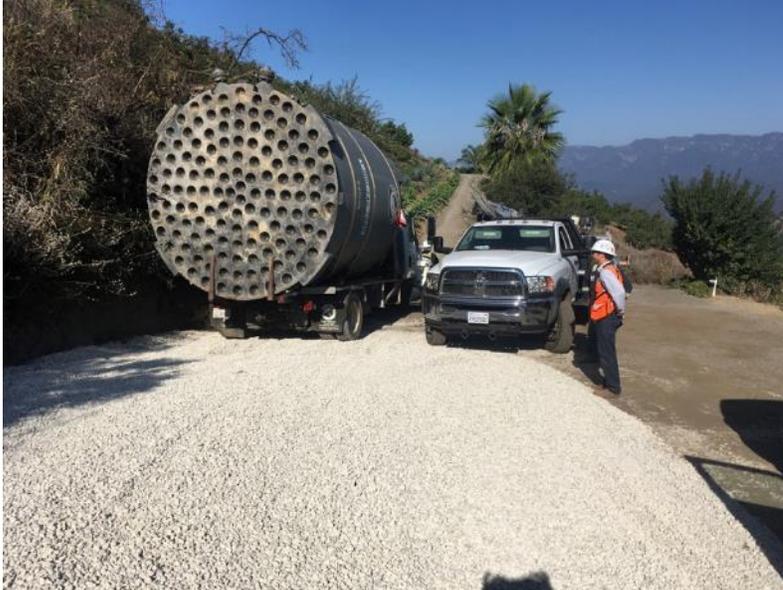
An H&M crew was installing several water tanks near the high point of Rincon Mountain along Segment 3B (Photo 4). The crew will run piping and hose from these tanks to the various construction sites to provide water for dust control and compaction. The tanks were sitting on a gravel pad, and a large diesel pump had been brought in to move the water. James Rasico (Rincon) checked the pump's horsepower to determine its compliance with condition MM AQ-1.

Photo 4 – Water tanks being brought in to provide dust control and compaction.

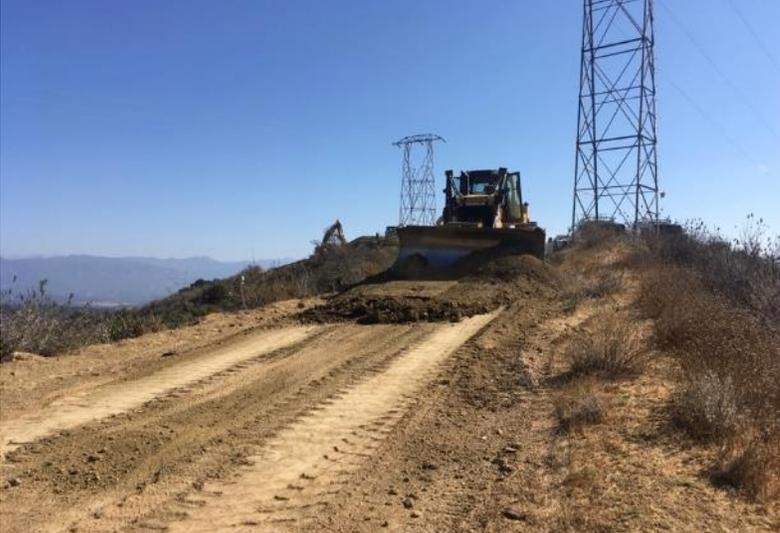
Welded wire wall excavation continues at Construct 58, with the excess soil being spread out on the access roads (Photo 6). Paleontological monitor John Minch (GANDA) was onsite with biological monitor Paulette Loubet (Rincon). At the time of my site visit, no animals had been impacted and no fossils had been found (MM BIO-6). There were numerous construction vehicles at this location, including a water truck (APM AQ-1) (Photo 7). We discussed the need for some wire-backed silt fencing below the welded wire wall excavation to keep dirt and rock from sloughing down the steep slope (MM BIO-1) (Photo 8).

Photo 6 – Excavation is ongoing at Construct 58; a dozer is spreading excess soil along the access road. Photo facing east.
10/13/17	Segment 3B Construct 58

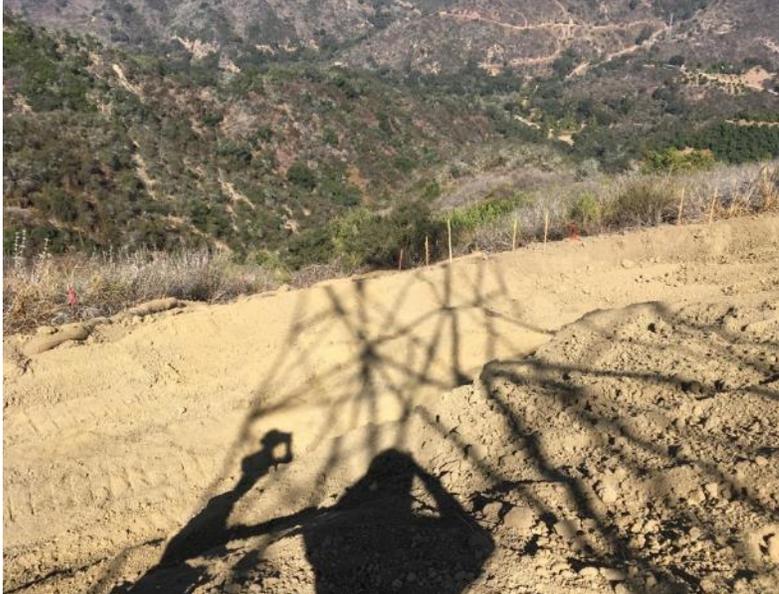
Photo 8 – The slope below Construct 58’s wall is very steep. There were discussions regarding the addition of staked silt fencing to prevent soil from running downhill.
10/13/17	Mac Brown Yard

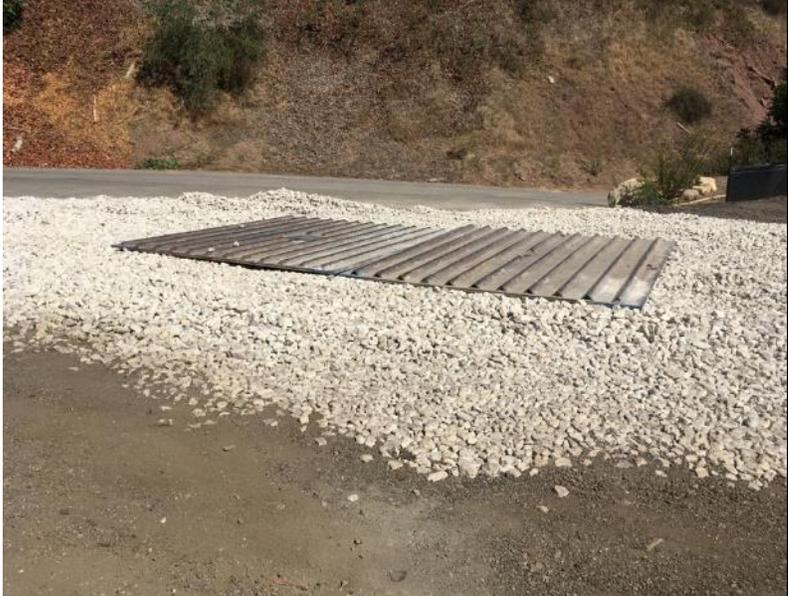
Photo 10 – Gravel and rumble plates installed at the exit/entry location.

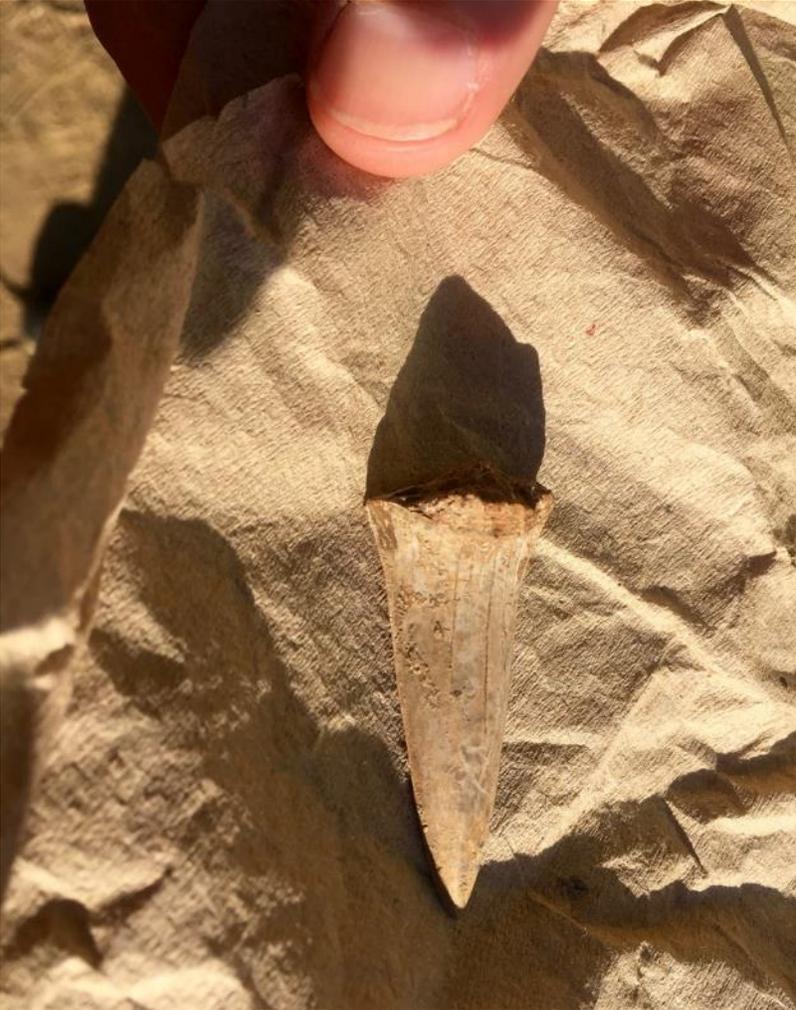
James Rasico (Rincon) and I travelled along Segment 3B up to Construct 58 where we met paleontological monitor Andrew Paden (GANDA) (MM CR-13) who showed us a fossilized mako shark tooth found along the road near Construct 58 (Photo 2). The tooth was about 1.75 inches long and still quite sharp. Andrew Paden thought it had come from the excavation area and had been dropped along the road as the soil was spread out along the access road. A number of oyster fossils had also been found.

Photo 2 – A fossilized mako shark tooth was found near Construct 58.

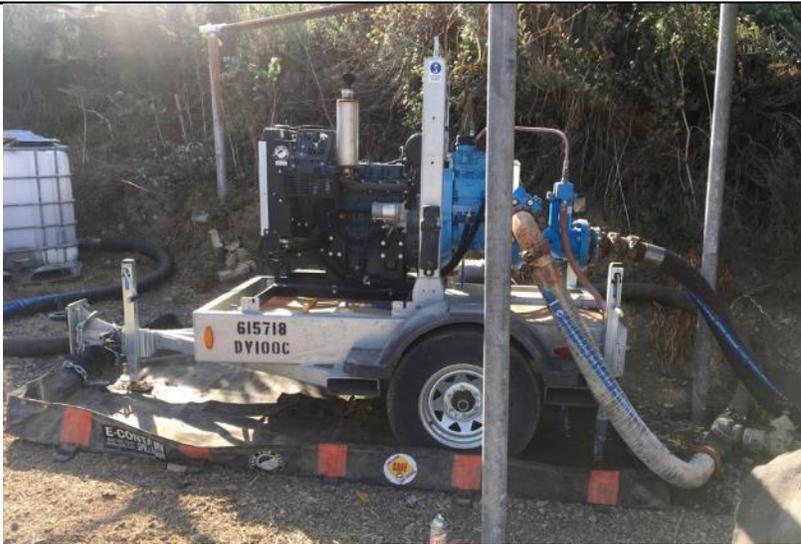
We drove to the H&M water tank/water pump area; everything had been installed and connected, so water could be delivered to the construction areas (Photo 5). The water pump was sitting in a plastic secondary containment structure, but was filling with water from a leaking hose (Photo 6). James Rasico (Rincon) pointed this out to the H&M crew and they stopped the leak. The crew was burying the water line where it crossed the road (Photo 7). While we were there, biological monitor Sarah Termondt (BRC) arrived to check in with the H&M crew.

Photo 6 – The water pump has been placed in a secondary containment structure.
10/19/17	Segment 3B, Water Line

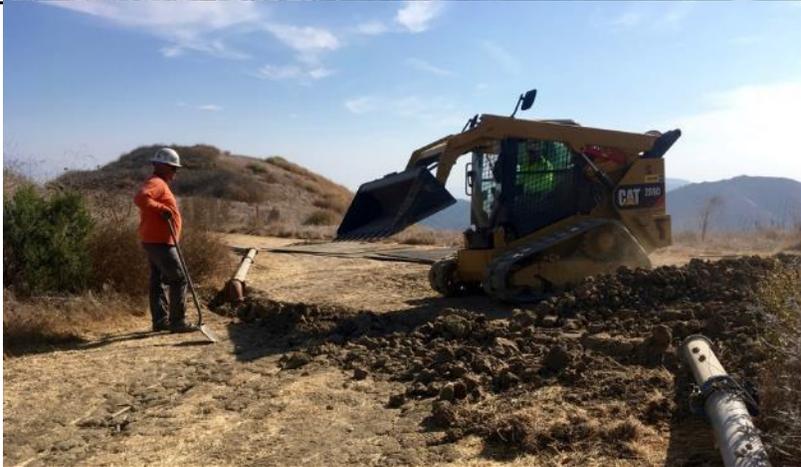
Photo 7 – Portions of the water line are buried where they cross the access road. Photo facing east.
10/19/17	Teen Challenge Yard

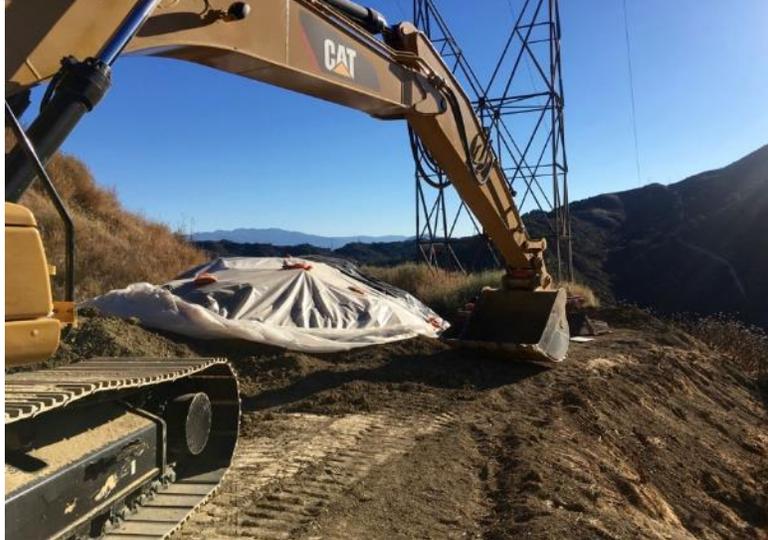
<p>Photo 2 – Soil stockpiled and covered. Photo facing east.</p>
10/26/17	Segment 3B, Construct 62

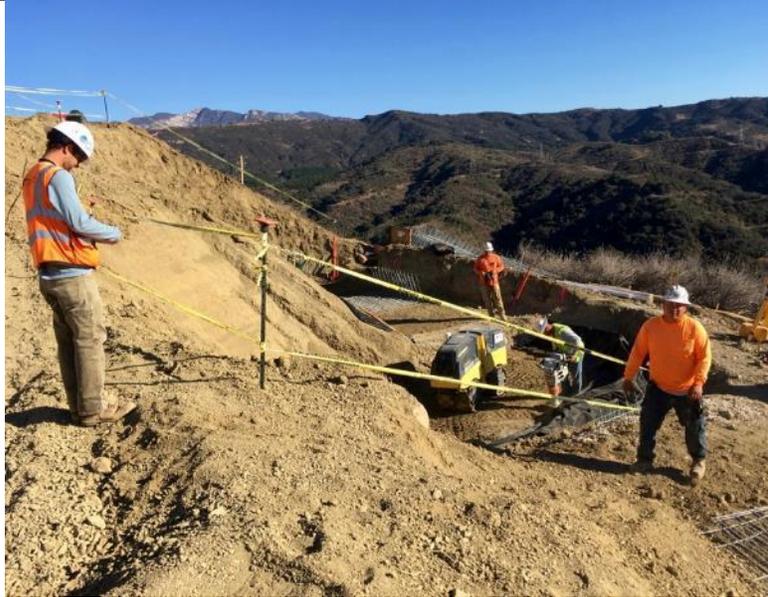
Construct 62, located immediately up the hill, was being worked on by a Henkels and McCoy (H&M) crew run by the foreman Jamie Tager (Photo 3). The crew was installing drainpipe and compacting soil in preparation for building a wire wall (Photo 4). H&M had a water hose coming down the hill from the newly installed tanks providing moisture for compaction and dust control (APM AQ-1).

<p>Photo 3 – Construction crew is backfilling and compacting the area where the wire wall is being built. Photo facing north.</p>

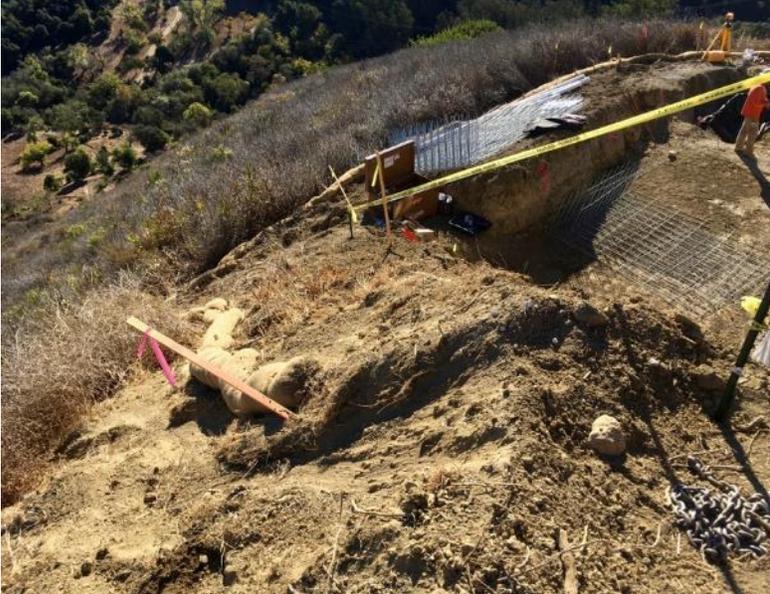
Photo 4 – Wire wall materials and BMPs at Construct 62; note how steep the hill is. Photo facing east
10/26/17	Segment 3B, Construct 58

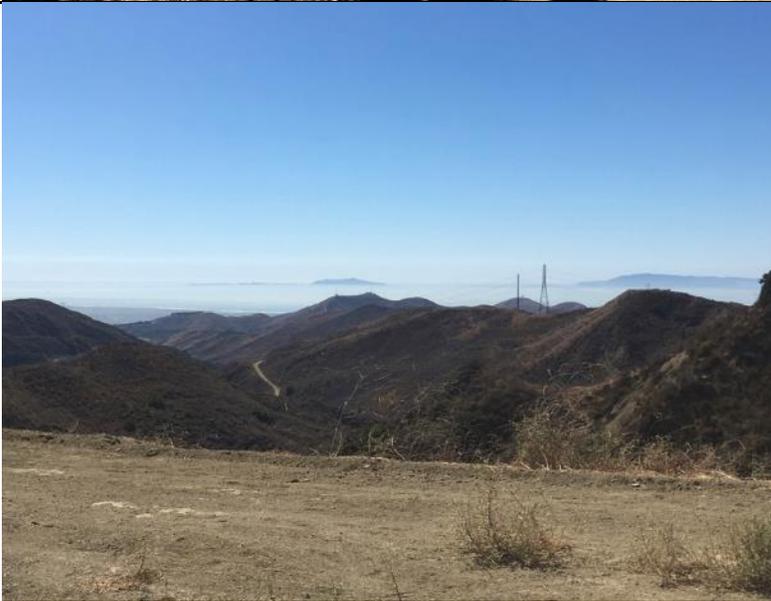
We drove to the southern end of Segment 1 and entered the access road at the Santa Clara Substation. We drove the entire Segment (Photo 7) and checked on Environmentally Sensitive Area (ESA) signs, a number which had been knocked down (APM BIO-1). We found biological monitor Asher Deitch (BRC) near the Getty Tap area where crews were conducting overhead welding on the existing poles in preparation for wire stringing (Photo 8). Fire trucks were with this crew (MM HZ-2).

Photo 7 – Overview photo looking south from the access road.
