**Re: Monthly Report Summary #60 for the South Orange County Reliability Enhancement (SOCRE) Project**

## South Orange County Reliability Enhancement Project CPUC Site Inspection Form

<b>Project:</b>	South Orange County Reliability Enhancement (SOCRE) Project	<b>Date:</b>	October 18, 2022
<b>Project Proponent:</b>	San Diego Gas & Electric (SDG&E)	<b>Report #:</b>	VS152
<b>Lead Agency:</b>	California Public Utilities Commission (CPUC)	<b>Monitor(s):</b>	CPUC/WSP Compliance Monitor
<b>CPUC PM:</b>	Louis Torres, Energy Division	<b>AM/PM Weather:</b>	Sunny, mild temps and calm
<b>CPUC CM (WSP):</b>	Fernando Guzman	<b>Start/End time:</b>	1030 – 1130 hrs
<b>Project NTP(s):</b>	Notice to Proceed (NTP)-1, NTP-2, NTP-2 Addendum 1, NTP-3, NTP-4, and NTP-5

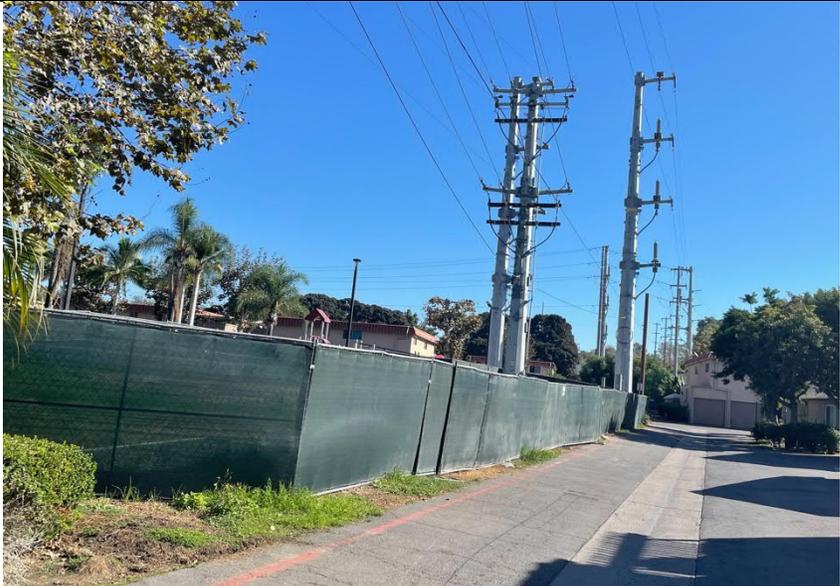
My first stop was the construction area west of the substation and across the railroad tracks. No work activities were occurring at this location, and the area was secure and clean (Photo 1).

Photo 1 – The fenced work area west of the substation and across the railroad tracks. Photo facing east.

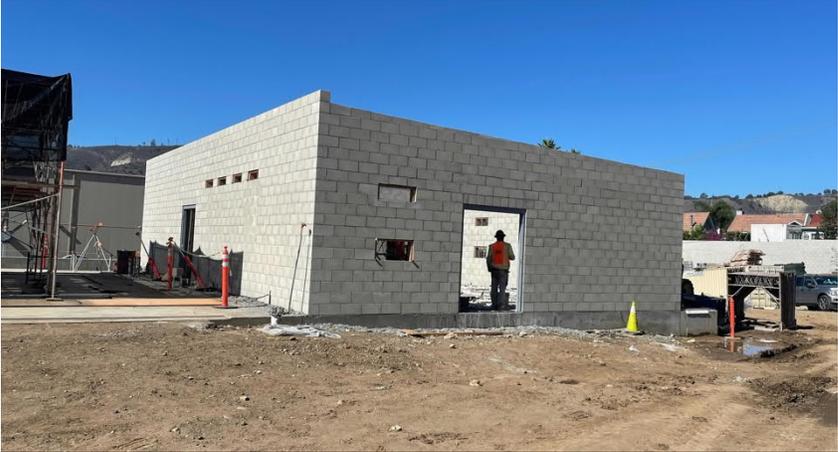
Work on the new substation was ongoing (Photo 3) and primarily focused on the construction of the control room (Photo 4). The work areas were in good condition, clear of trash, and drip pans had been placed under the heavy equipment.

Photo 4 – Work continues on the control room for the new substation. Photo facing west.
