**Re: Monthly Report Summary #9 for the South Orange County Reliability Enhancement (SOCRE) Project**

CPUC Site Inspection Reports

## South Orange County Reliability Enhancement Project CPUC Site Inspection Form

<b>Project:</b>	South Orange County Reliability Enhancement Project	<b>Date:</b>	July 19, 2018
<b>Project Proponent:</b>	San Diego Gas & Electric	<b>Report #:</b>	VS001
<b>Lead Agency:</b>	California Public Utilities Commission (CPUC)	<b>Monitor(s):</b>	CPUC/Ecology and Environment (E&E) Compliance Monitor
<b>CPUC PM:</b>	Andrew Barnsdale, Energy Division	<b>AM/PM Weather:</b>	Overcast, cool, and calm
<b>CPUC CM (E &amp; E):</b>	Joe Donaldson	<b>Start/End Time:</b>	0700 to 0915
<b>Project NTP(s):</b>	NTP-1, NTP-2, NTP-2 Addendum 1, and NTP-3

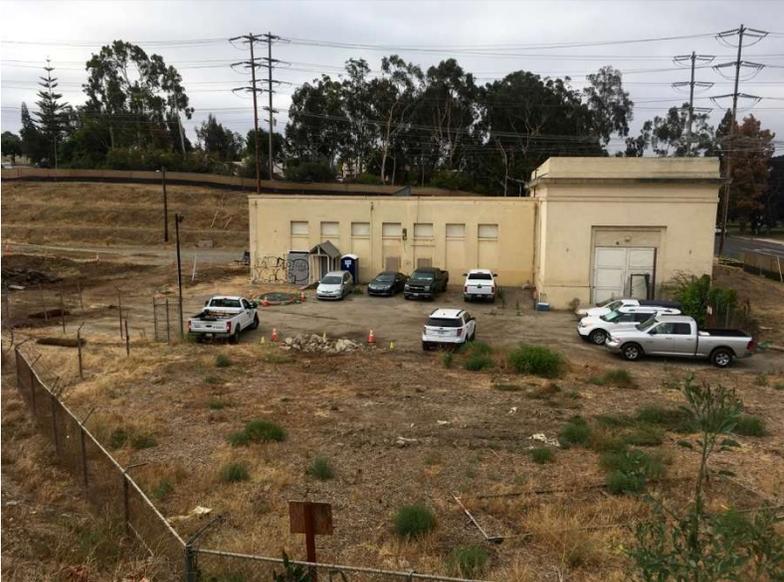
I arrived onsite at the San Juan Capistrano Substation for the 0700 tailboard meeting. A temporary parking area was available on the north side of the Capistrano Substation (Photo 1). During the tailboard meeting, I introduced myself as the California Public Utilities Commission (CPUC) onsite monitor and talked about my general inspection schedule and monitoring philosophy.

Photo 1 – Overview of the parking area and the Capistrano Substation. Photo facing south.
7/19/18	San Juan Capistrano Substation

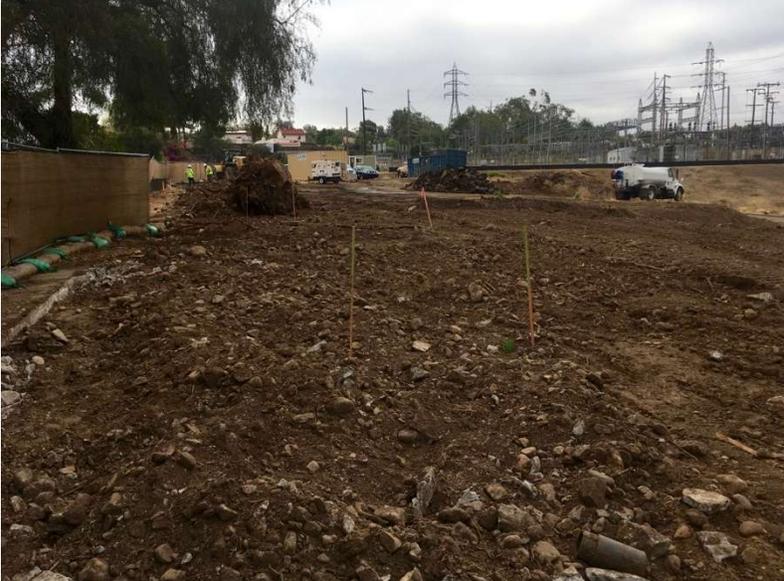
Earlier in the week, crews had started clearing and grubbing of the San Juan Capistrano Substation site and would be continuing this type of activity over the coming weeks (Photo 2). I spoke with the SDG&E Lead Environmental Inspector and we discussed the project and the upcoming construction schedule. The SDG&E Lead Environmental Inspector stated that nesting bird surveys had been conducted before the start of construction activities and no nests were found (MM BR-3, MM BR-6, MM BR-7, MM BR-8).

Photo 2 – Area of clearing and grubbing along the northern border. Photo facing east.
7/19/18	San Juan Capistrano Substation

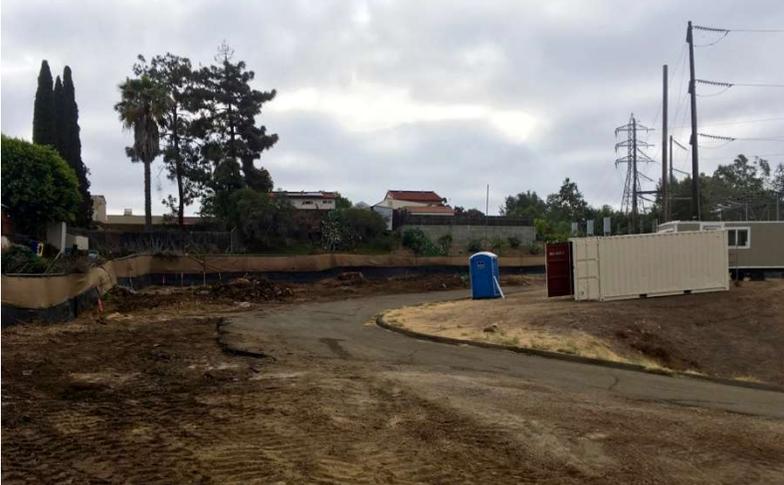
Temporary fencing and screening had been installed around most of the San Juan Capistrano Substation site (APM AEA-3) (Photo 3). The site was clear of any construction garbage and debris (APM AES-1).

Photo 3 – Northeast corner of the project site; note the fencing and screening. Photo facing east.

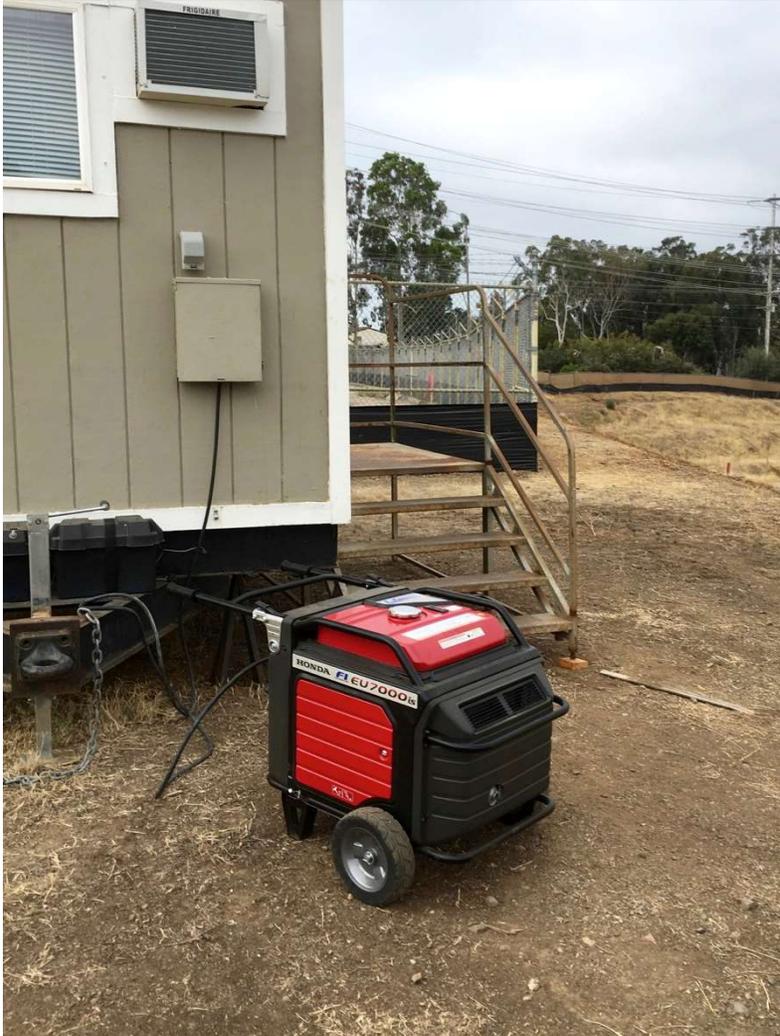
Several generators were running onsite to provide power to the construction trailers. A small generator was running near one of the trailers, and the engine appeared to be somewhat self-contained; however, I spoke with the SDG&E Lead Environmental Inspector about whether the generator should have some type of additional containment (Photo 4). He said he would speak with the contractor (MM HAZ-1).

Photo 4 – Construction trailer and generator. Photo facing south.
7/19/18	San Juan Capistrano Substation

Possible containment of gas-powered generators.

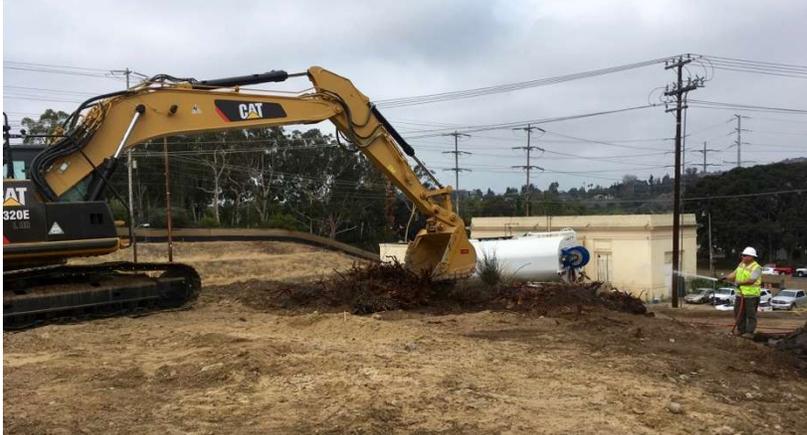
Water was being used for dust control during grubbing activities (APM AQ-1) (Photo 5). The SDG&E Lead Environmental Inspector said that, to date, they have not received any complaints from the public/neighbors.

Photo 5 – Excavator removing vegetation and a water truck providing dust control. Photo facing southwest.

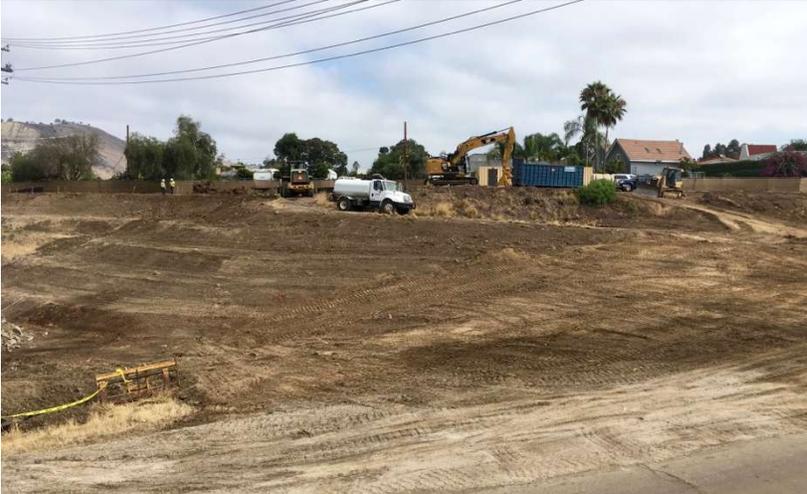
Photo 6 shows the project site looking north; at the time of my site visit, most of the vegetation had been removed.

Photo 6 – Overview of the site. Photo facing north.

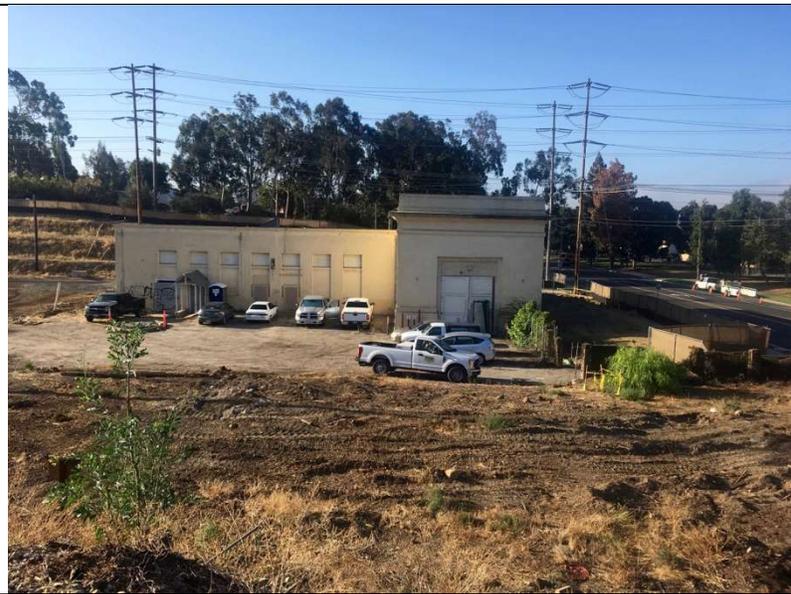
The number of onsite construction personnel remained fairly steady, with continued clearing and grubbing of the San Juan Capistrano Substation site. The temporary parking area along the north side of the Capistrano Substation remains the primary parking location (Photo 1). A small stockpile of unknown materials was in the parking area and had been covered with plastic and surrounded by wattles (Photo 6).

Photo 1 – Temporary parking area near the Capistrano Substation. Photo facing south.
7/24/18	San Juan Capistrano Substation

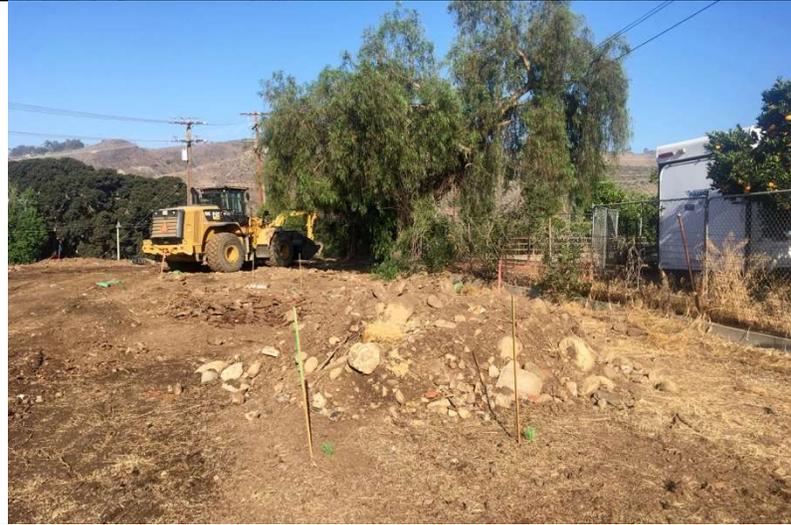
Crews had removed the temporary construction fencing along the north side of the San Juan Capistrano Substation site and were clearing out the final remnants of debris using a front loader (Photos 2 and 3). The SDG&E Lead Environmental Inspector explained that they would be focusing on putting in the permanent fencing and the barrier wall along this northern boundary. The archaeological monitor and Native American monitor were onsite and continued to oversee the earthwork activities (APM CUL-2, APM CUL-7).

Photo 2 – Clearing and grubbing continues along the northern border. Photo facing west.
7/24/18	San Juan Capistrano Substation

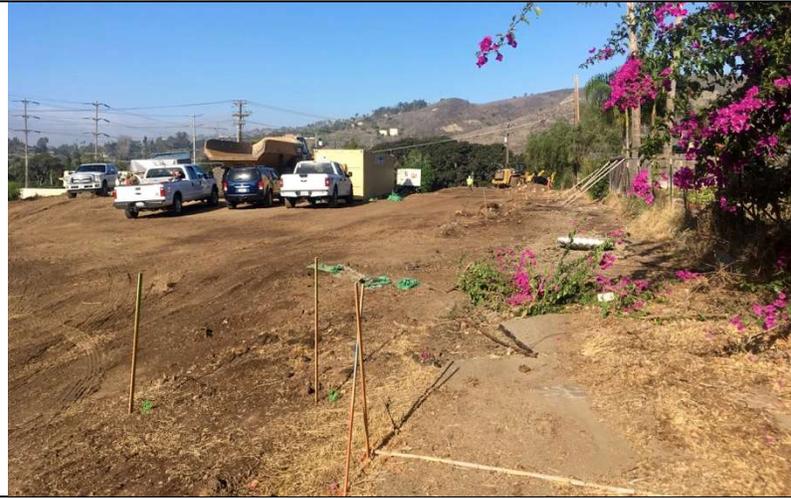
Photo 3 – Northern boundary. Photo facing west.

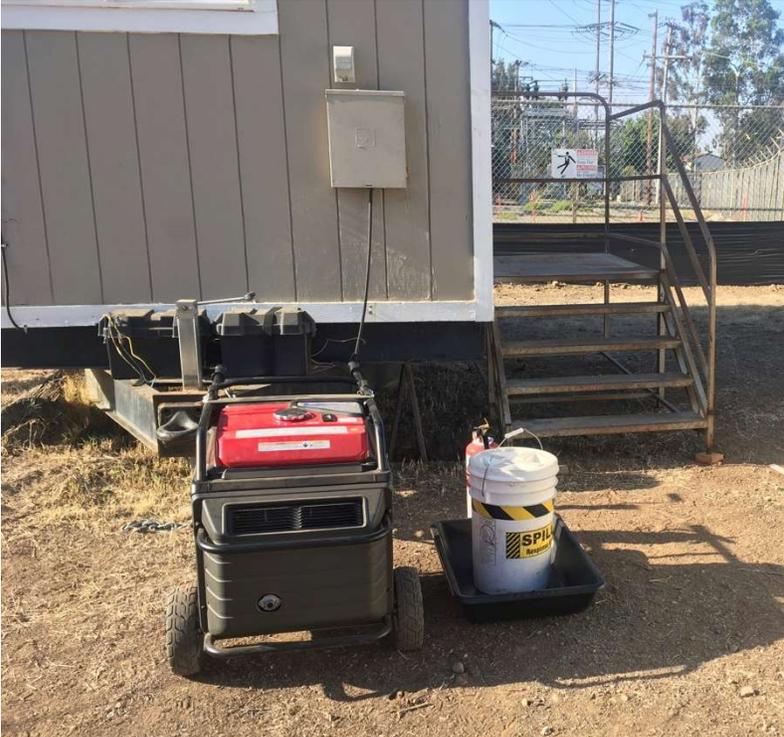
A drip pan, spill kit, and fire extinguisher had been placed next to the small generator I had noted during my previous site visit (Photo 4). The drip pan will be used during refueling of the generator (MM HAZ-1). Other drip pans were being placed under equipment that was parked overnight.

A photograph showing a portable generator with a red fuel tank and a spill kit on a black tray. The generator is positioned on a dirt surface next to a building with a metal staircase. A spill kit bucket with a yellow and black hazard label is visible on the tray.	Photo 4 – Generator with drip pan and spill kit.
7/24/18	San Juan Capistrano Substation

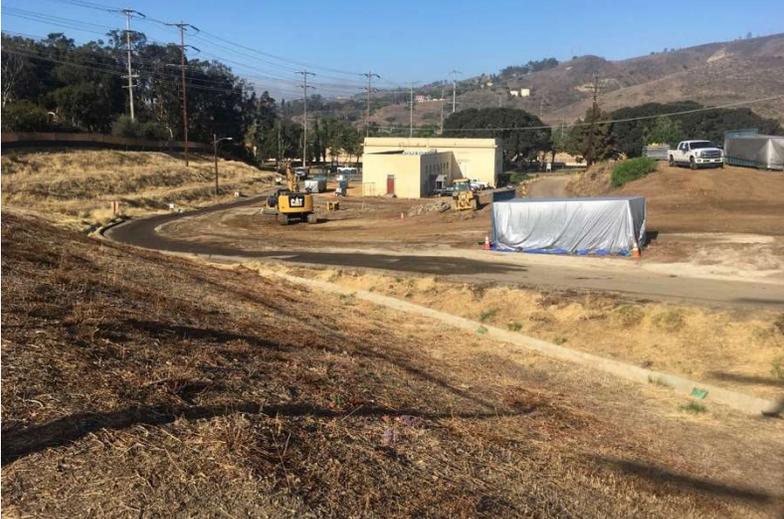
There were several dumpsters onsite and they were tightly covered with tarps. The site remained clear of any construction garbage and debris (APM AES-1) (Photo 5).

A wide-angle photograph of an asphalt road under construction or removal. The road is partially paved and curves through a dry, hilly area. In the background, there are several tarped dumpsters, a yellow building, and utility poles. The photo is facing west.	Photo 5 – Asphalt road to be removed; tarped dumpsters in the foreground and background. Photo facing west.

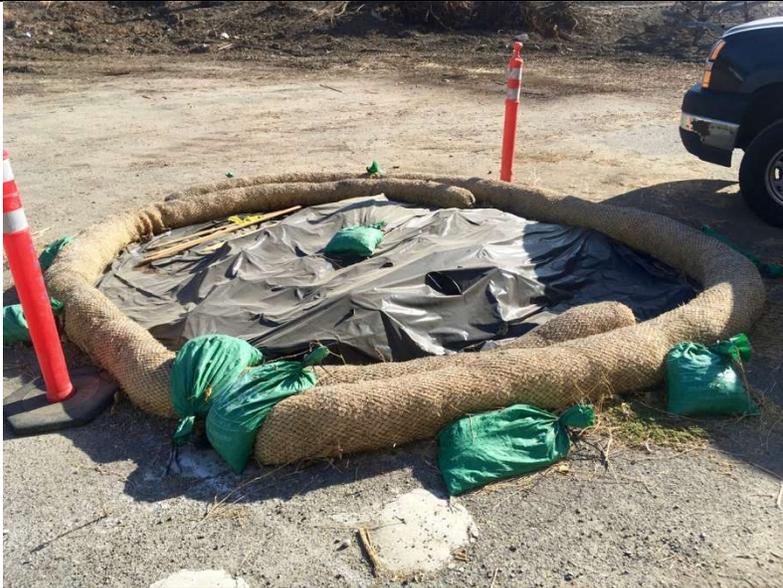
Photo 6 – Covered stockpile of unknown materials.

Inquire as to what material is being stockpiled and sealed in the temporary parking area.
