memorandum

subject MPWSP – Carmel Valley Pump Station Project Weekly Report (2/15/2021 – 2/19/2021)

CalAm Weekly Report

Daily Monitoring Log

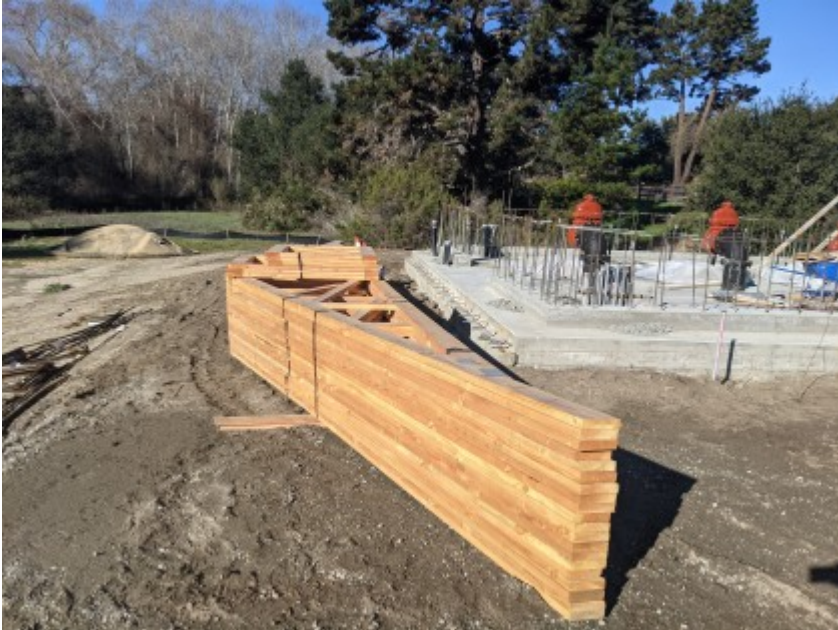
02/17/2021 - Site conditions.

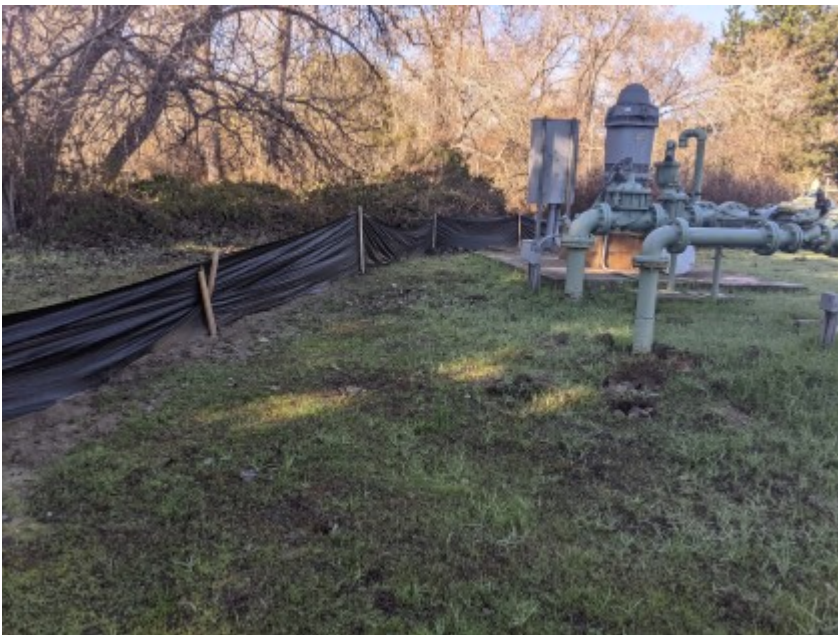
02/17/2021 - Intact exclusionary fencing surrounding work area.

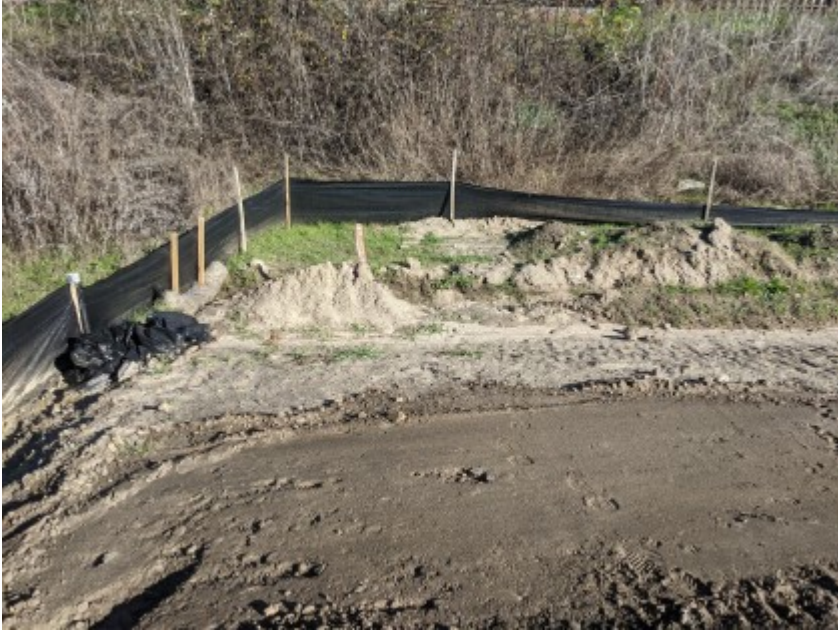
02/17/2021 - Intact exclusionary fencing surrounding work area.

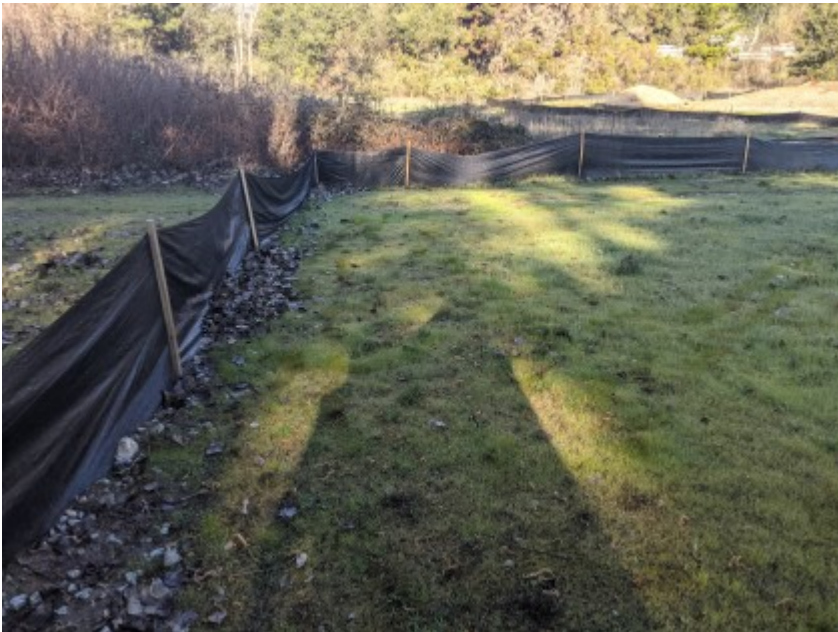
02/17/2021 - Intact exclusionary fencing surrounding work area.

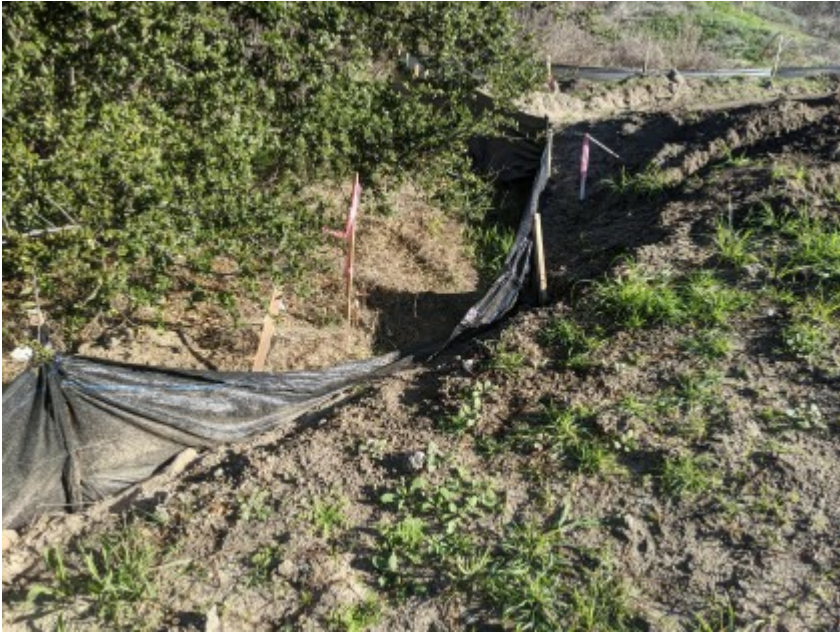
- DD&A compliance monitor inspected the status of exclusionary fencing and proper trash disposal in accordance with Mitigation Measure 4.6-1c.
- DD&A performed ongoing monitoring according to Mitigation Measure 4.6-1a.
- DD&A observed bank erosion within work area damaging exclusionary fencing in need of maintenance.
- DD&A observed section of exclusionary fencing showing signs of deterioration in need of maintenance.
- Photographed project site conditions.

02/17/2021 - Section of exclusionary fencing damaged by erosional feature.

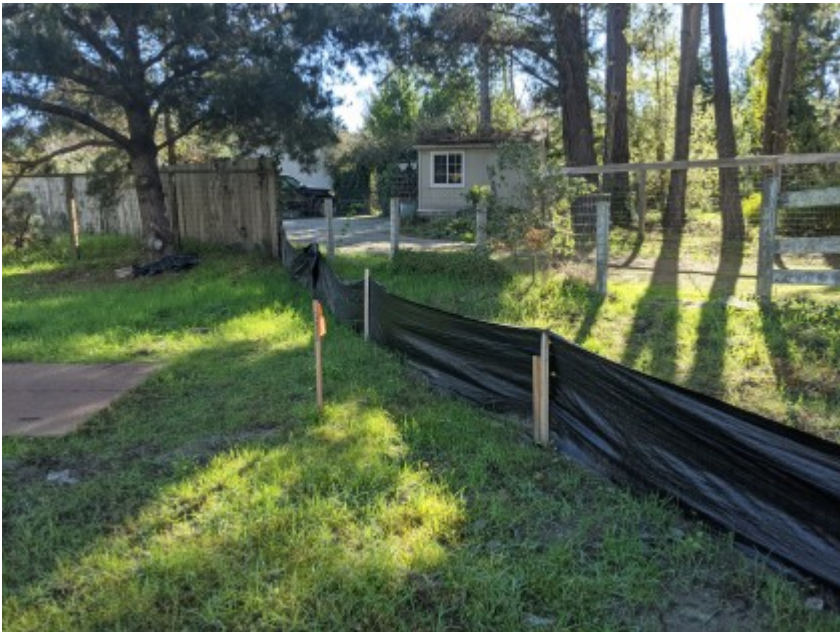
02/18/2021 - Intact exclusionary fencing surrounding work area.

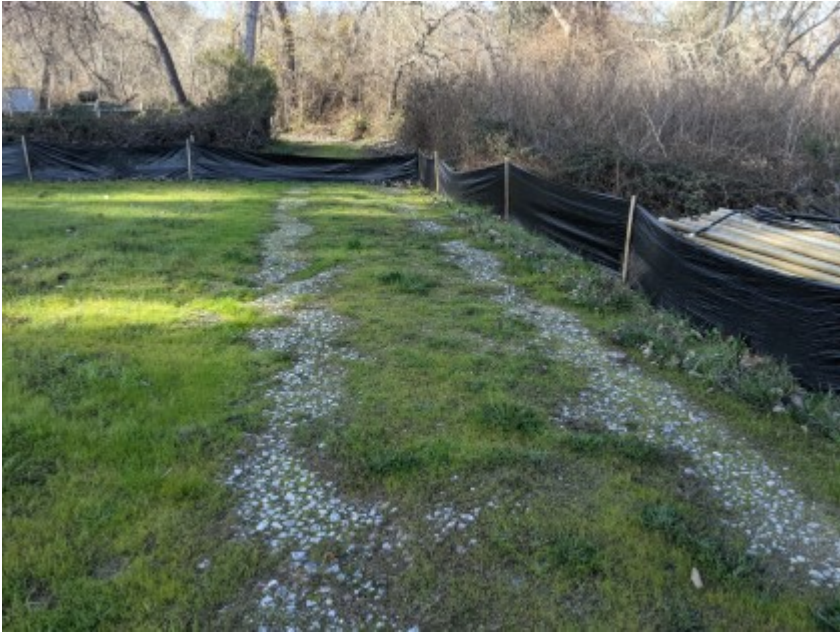
02/18/2021 - Intact exclusionary fencing surrounding work area.

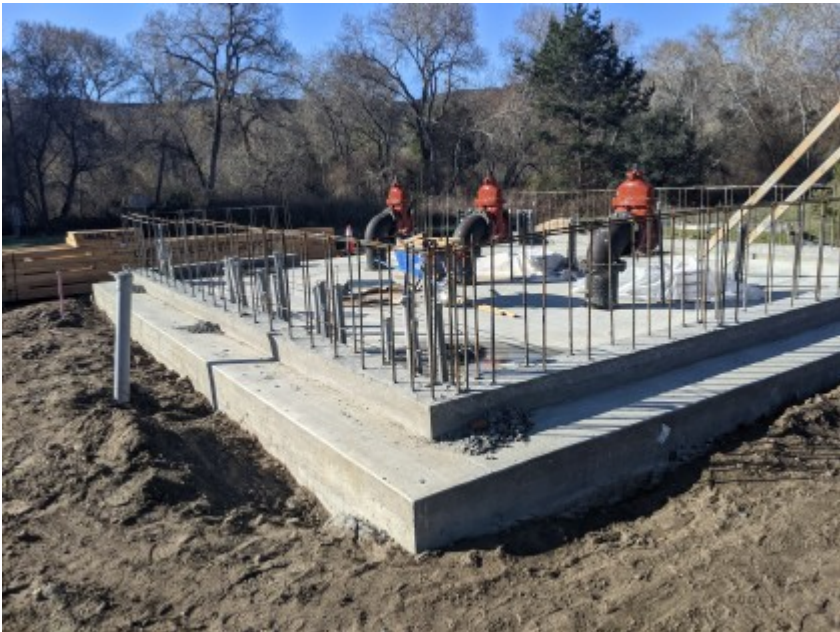
02/18/2021 - Site conditions.

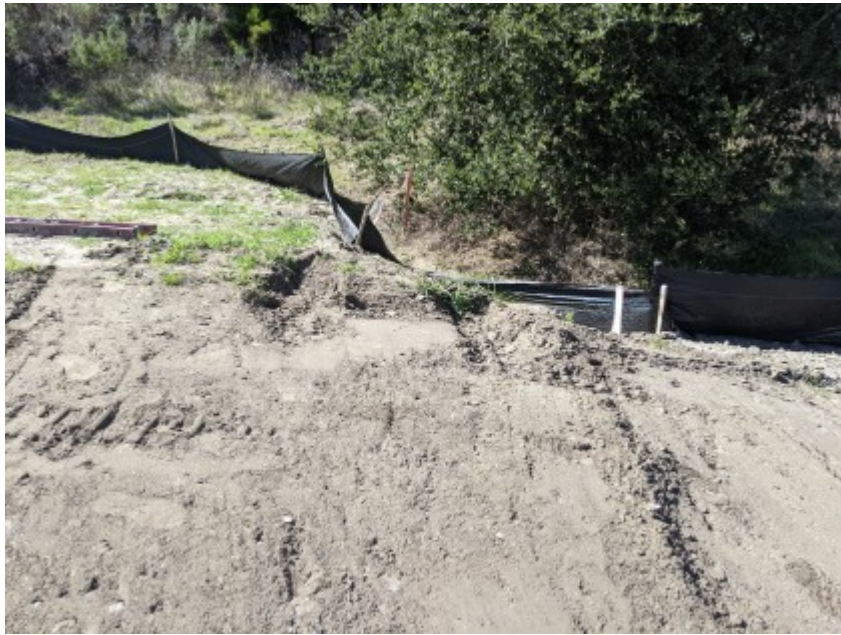
- DD&A compliance monitor inspected the status of exclusionary fencing and proper trash disposal in accordance with Mitigation Measure 4.6-1c.
- DD&A performed ongoing monitoring according to Mitigation Measure 4.6-1a.
- DD&A observed bank erosion within work area damaging exclusionary fencing in need of maintenance.
- DD&A observed section of exclusionary fencing showing signs of deterioration in need of maintenance.
- DD&A compliance monitor conducted site walkthrough with CPUC representative.
- DD&A compliance monitor communicated exclusionary fencing issues identified in the previous monitoring report to onsite inspector, crew anticipated to be onsite Monday (2/22) for maintenance.
- Photographed project site conditions.

02/18/2021 - Section of exclusionary fencing damaged by erosional feature.

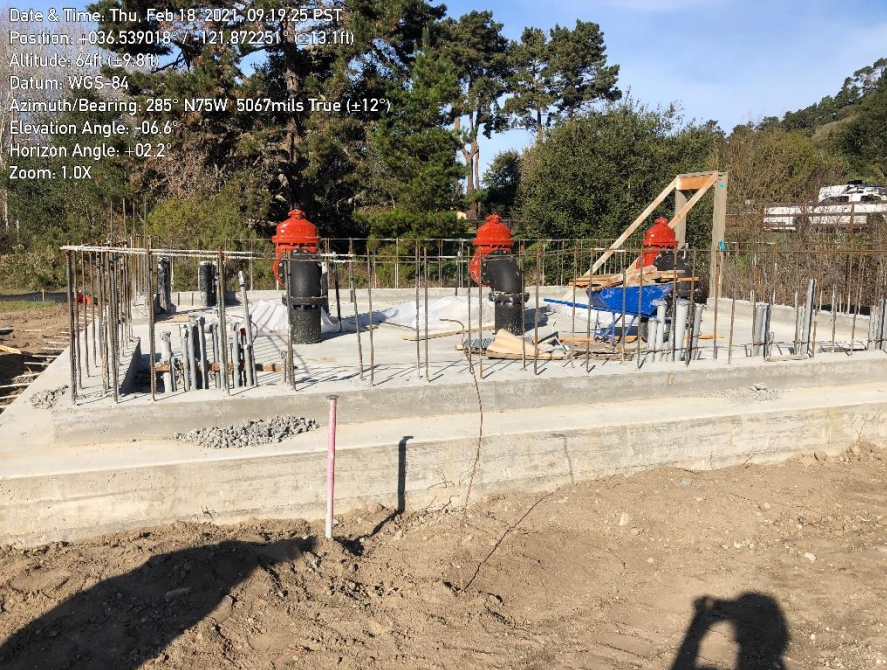
Photo 1. Foundation for pump station.

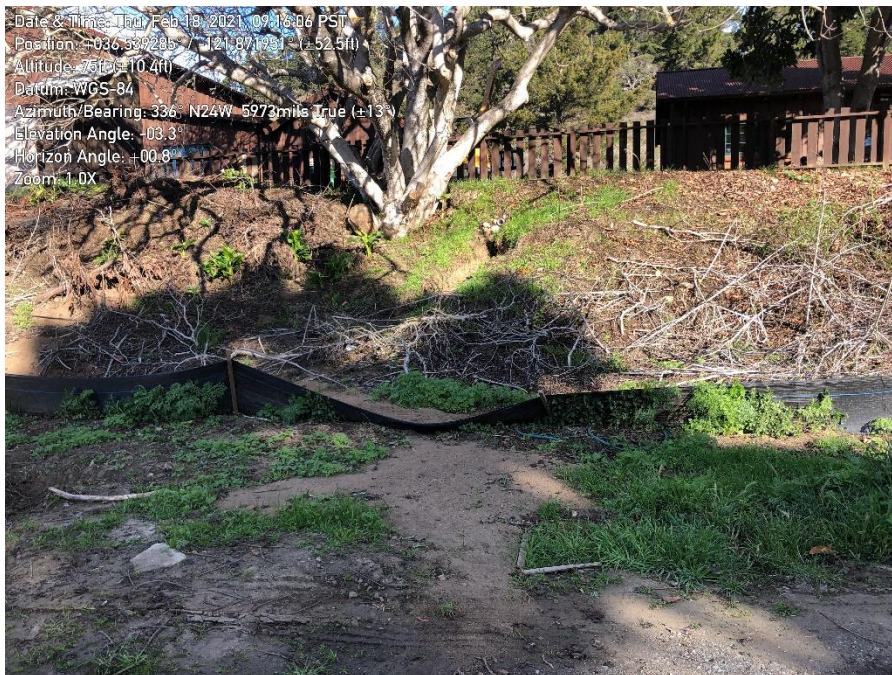
- Silt exclusion fence down in sections along north and west edges. Silt fence is compromised along west border due to a back-up of sediment near pad. Silt fence is down in section along north edge due to erosion caused by water that had flowed from a pipe coming from the neighboring property. Silt fence should be repaired to prevent special-status amphibians from entering the site (Mitigation Measure 4.6-1o). CalAm monitors have confirmed they have discussed this need with the contractor.

Photo 2. Silt fence compromised due to erosion.

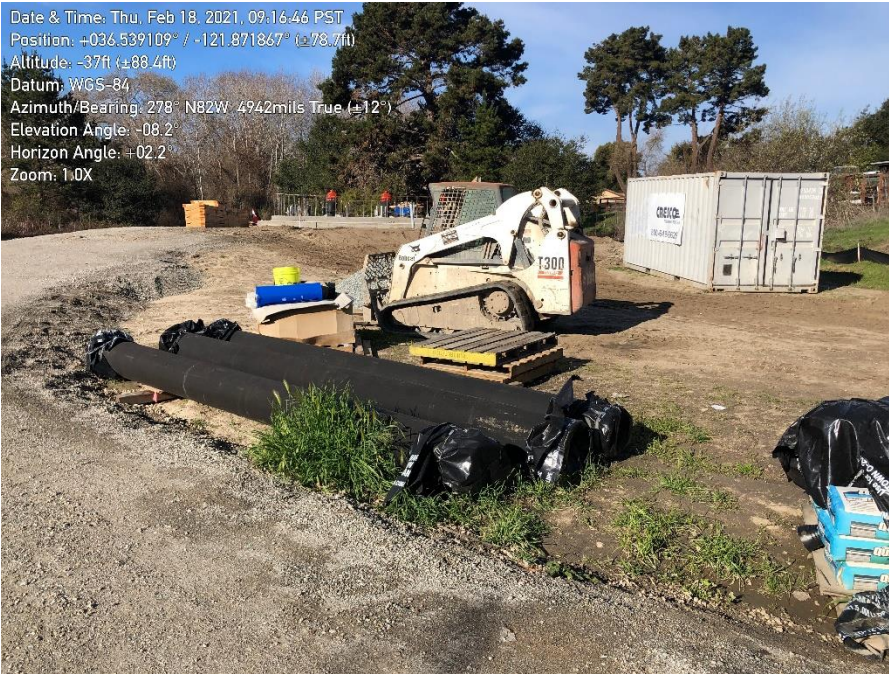
- CalAm monitor onsite to conduct weekly site inspection.
- BMPs around stock pile in place (Mitigation Measure 4.6-1o).
- Pipes in work area were capped as required by Mitigation Measure 4.6-1o.

Photo 3. Pipes capped.

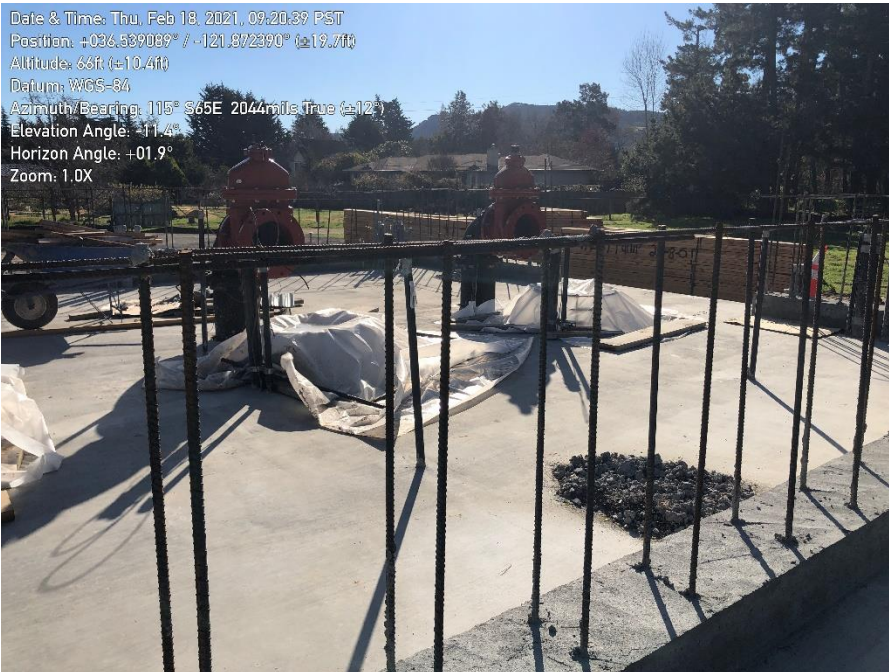
- Openings on top of slab have been covered with plastic sheeting to provide to prevent potential wildlife entrapment (Mitigation Measure 4.6-1c).
- The following compliance issues were noted by ESA on 1/27/2021 and are ongoing:

Photo 4. Openings on pump station foundation covered.

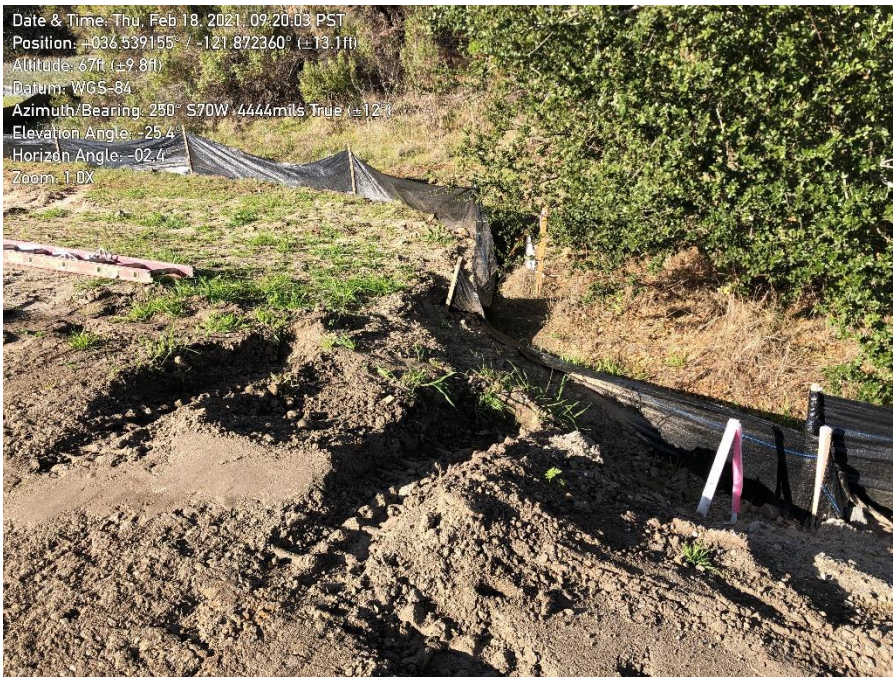
Photo 4. Silt fence down and in need of repair.
