memorandum

subject MPWSP – Carmel Valley Pump Station Project Weekly Report (3/15/2021 – 3/19/2021)

CalAm Weekly Report

Daily Monitoring Log

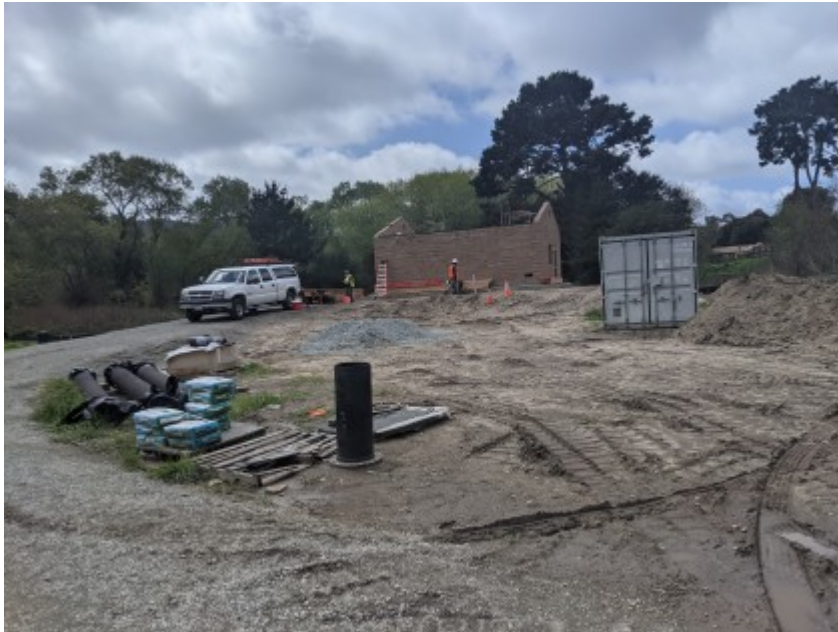
03/15/2021 - Site conditions.

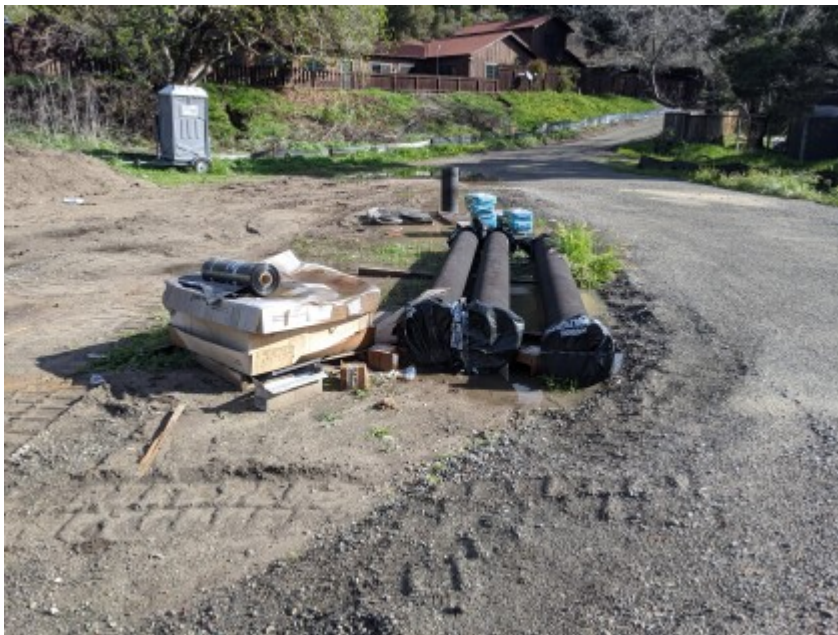
03/15/2021 - Site conditions.

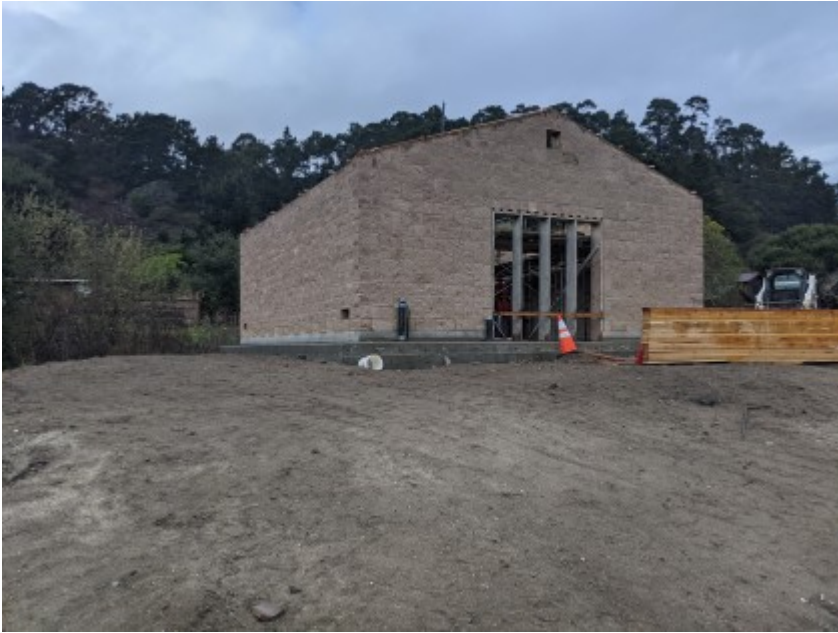
03/15/2021 - Site conditions.

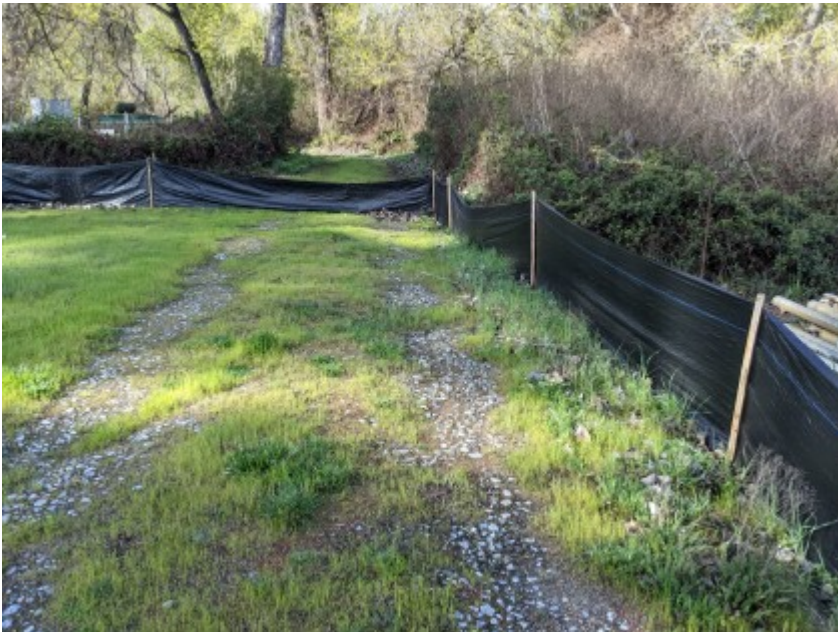
03/15/2021 - Intact exclusionary fencing surrounding work area.

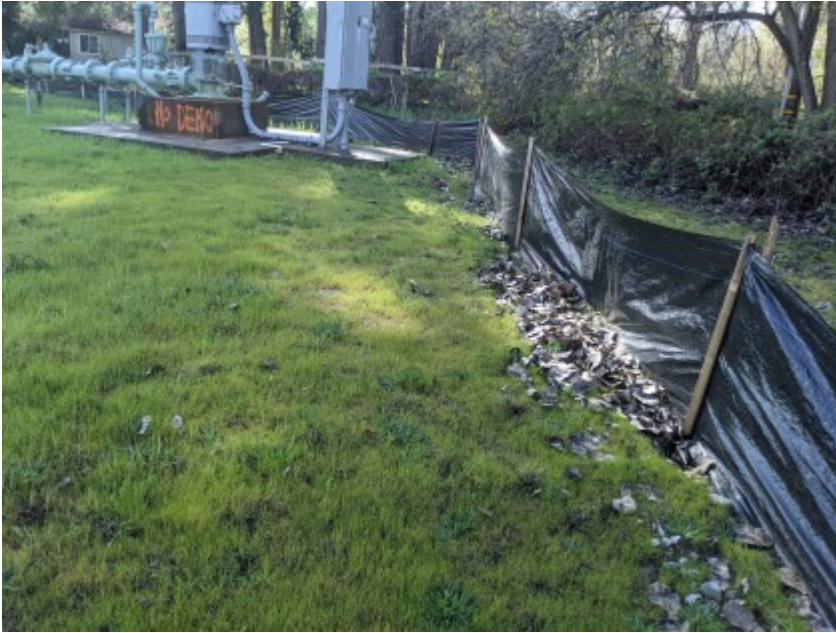
03/15/2021 - Intact exclusionary fencing surrounding work area.

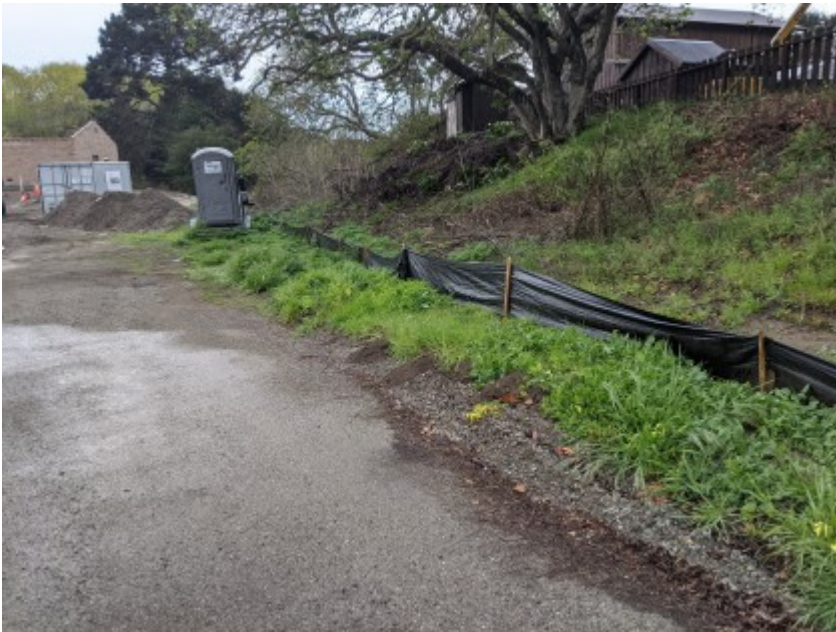
03/15/2021 - Intact exclusionary fencing surrounding work area.

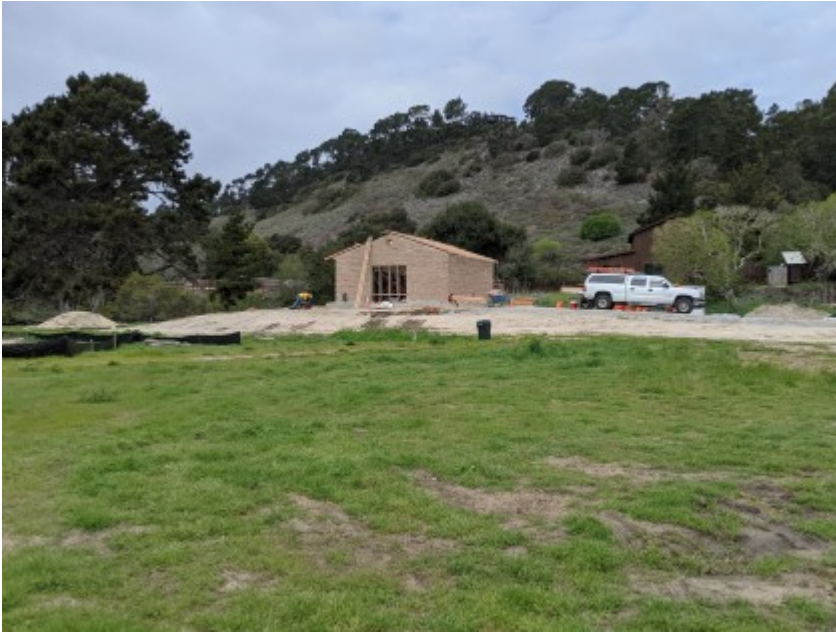
03/17/2021 - Site conditions.

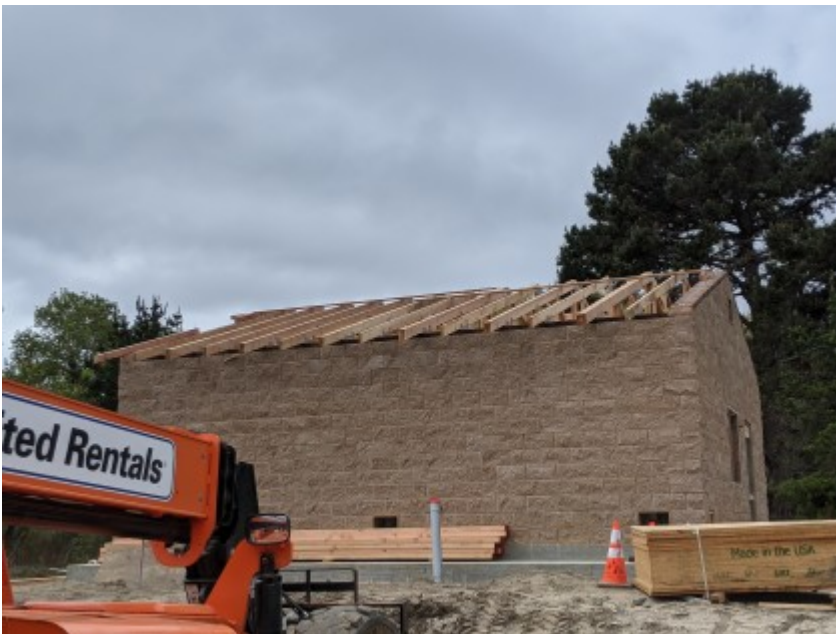
03/17/2021 - Site conditions.

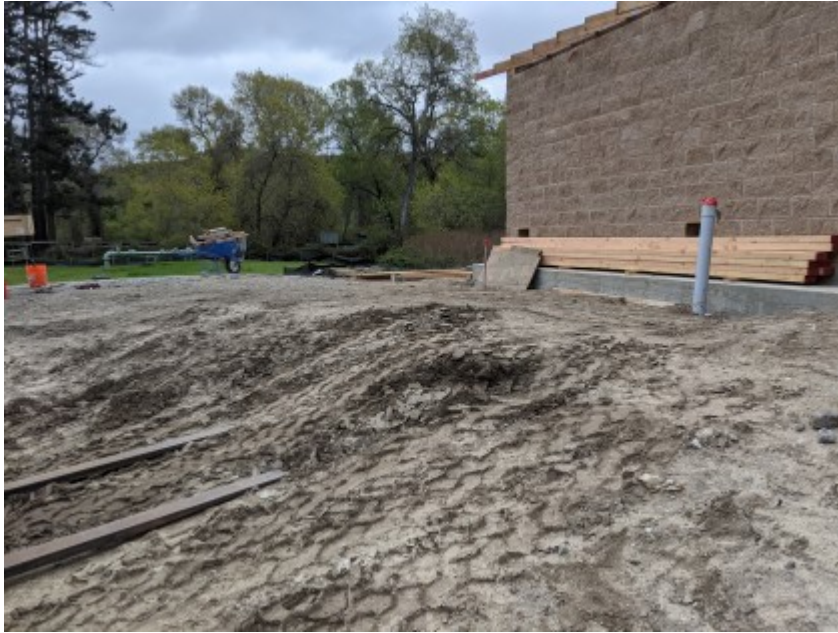
03/17/2021 - Site conditions.

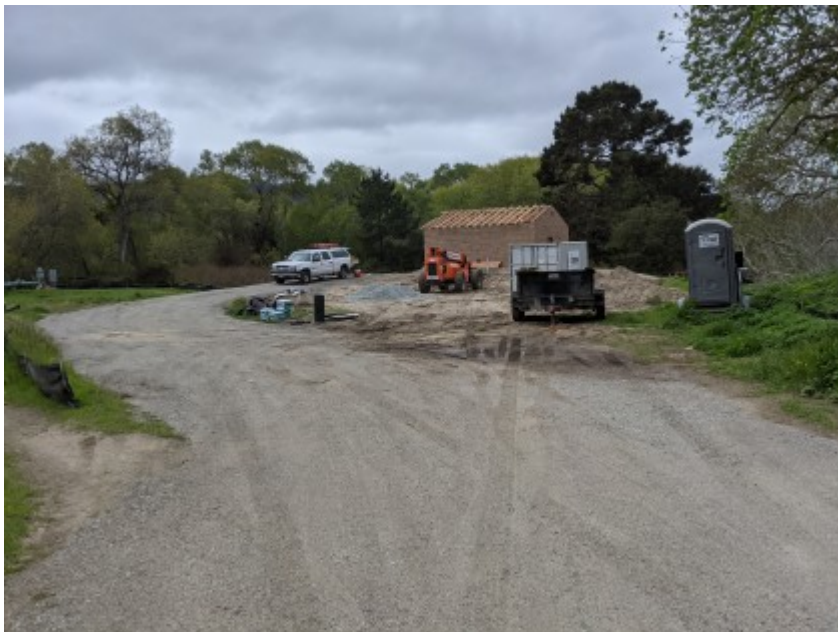
03/17/2021 - Site conditions.

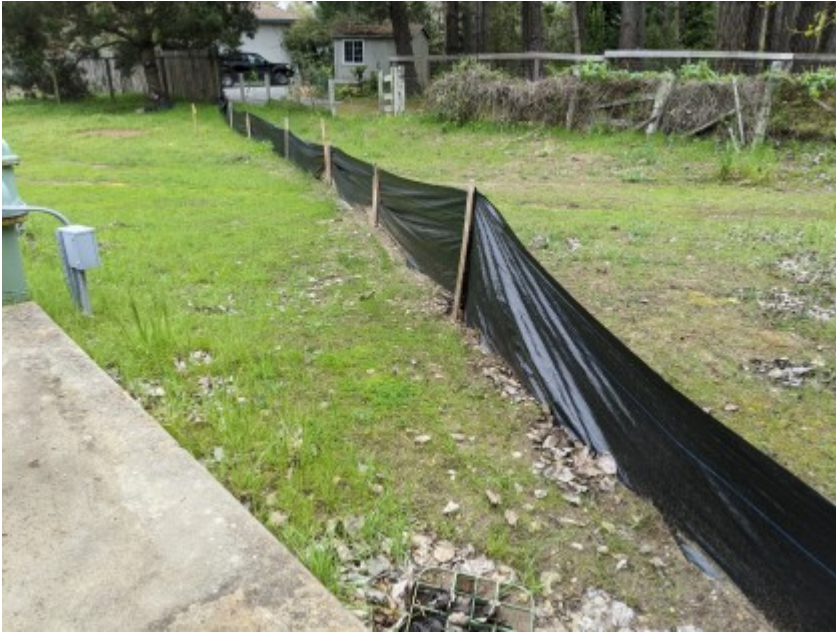
03/17/2021 - Intact exclusionary fencing surrounding work area.

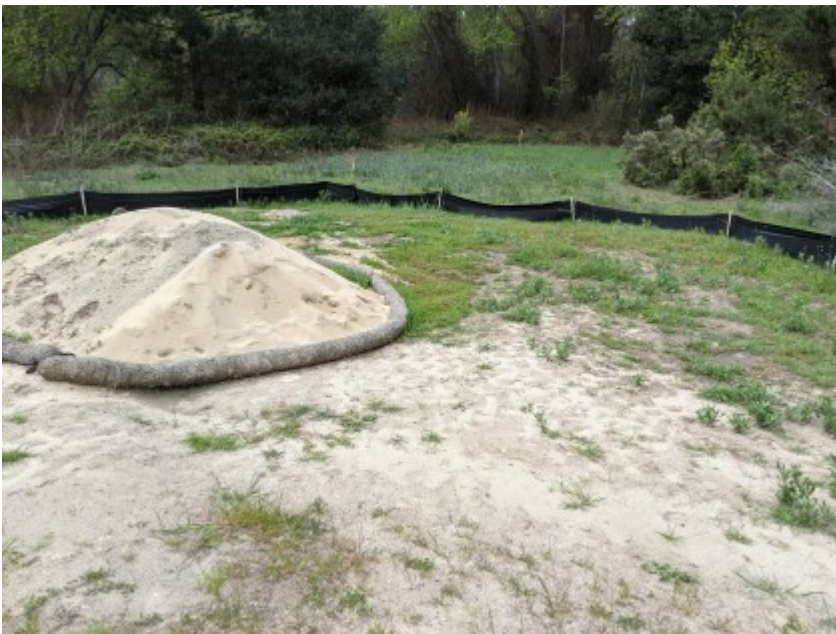
03/17/2021 - Intact exclusionary fencing surrounding work area.

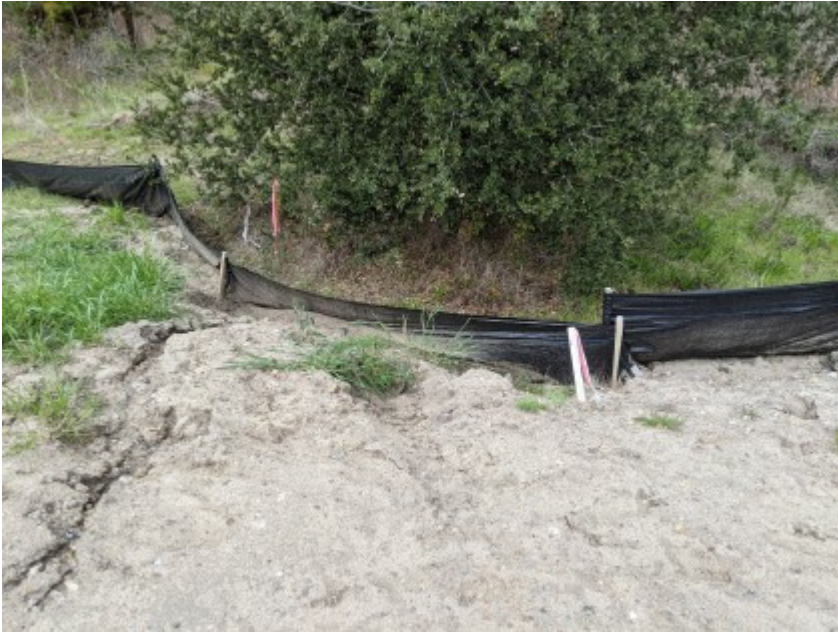
03/17/2021 - Intact exclusionary fencing surrounding work area.

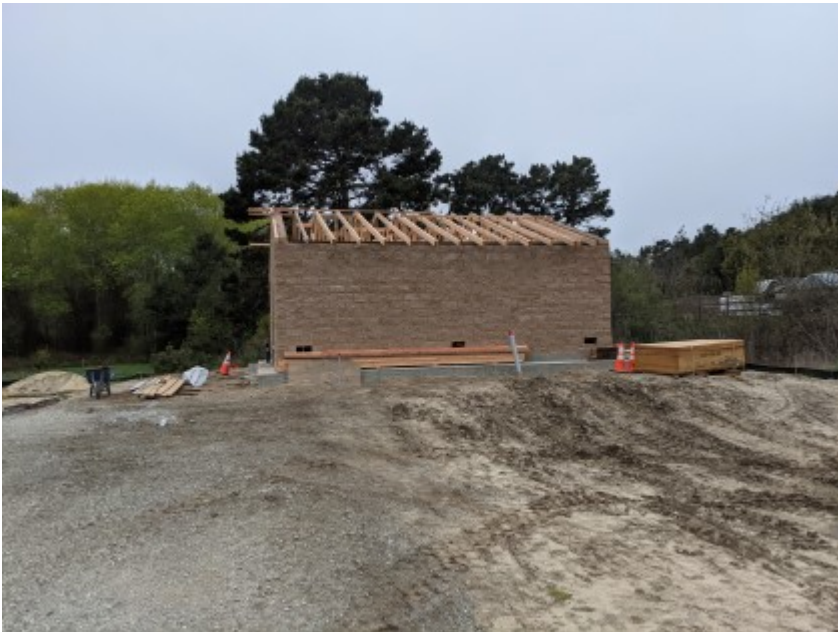
03/18/2021 - Site conditions.

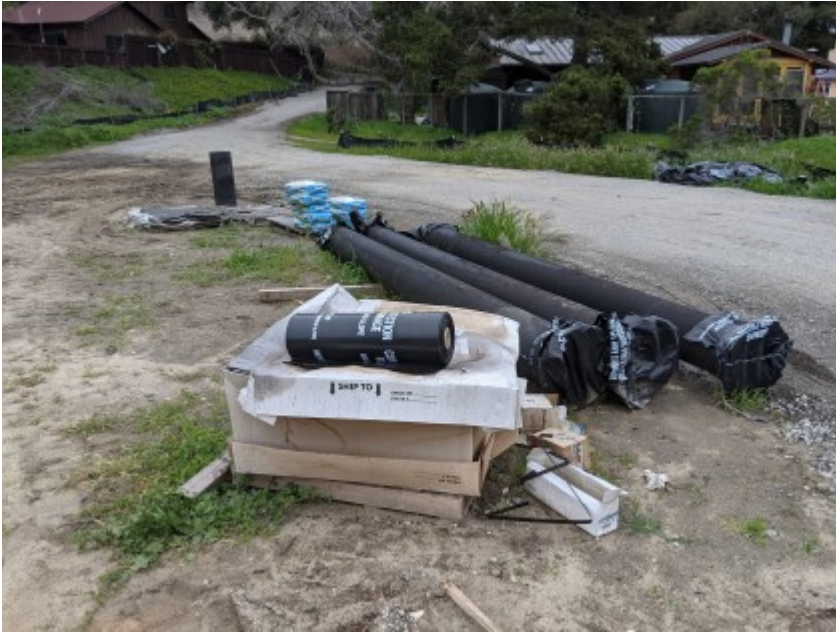
03/18/2021 - Site conditions.

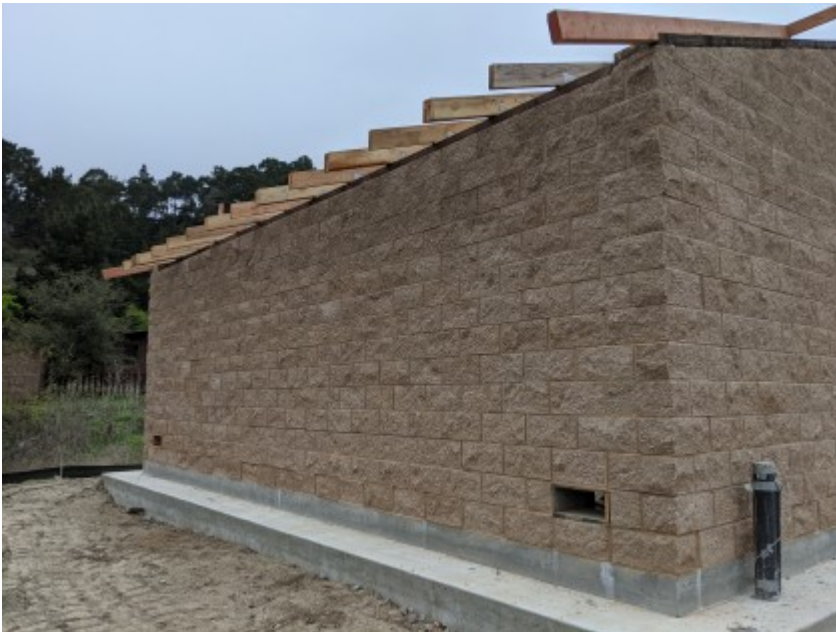
03/18/2021 - Site conditions.

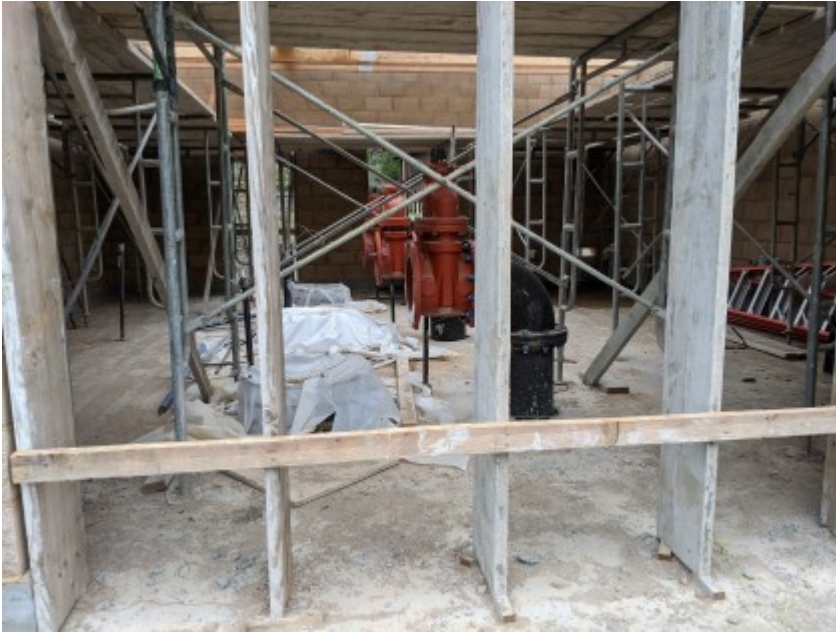
03/18/2021 - Site conditions.

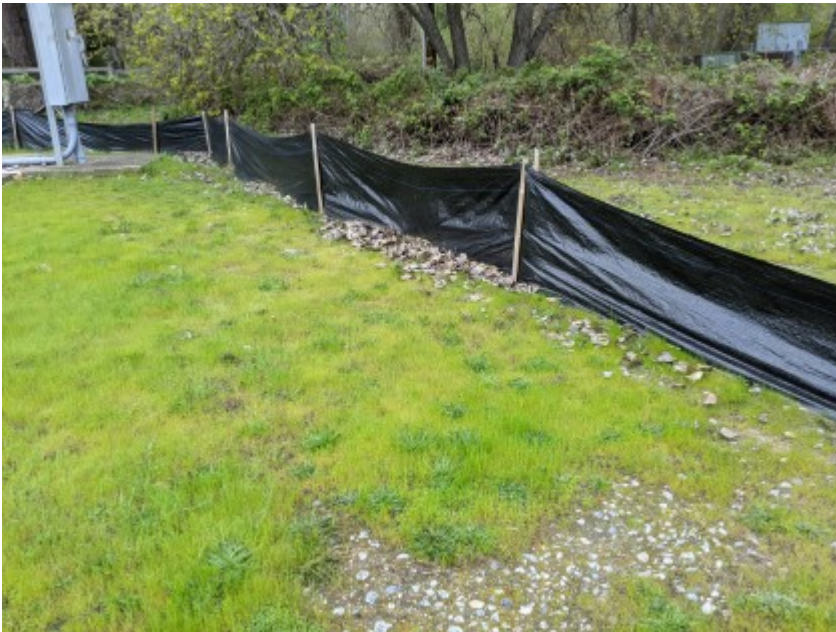
03/18/2021 - Intact exclusionary fencing surrounding work area.

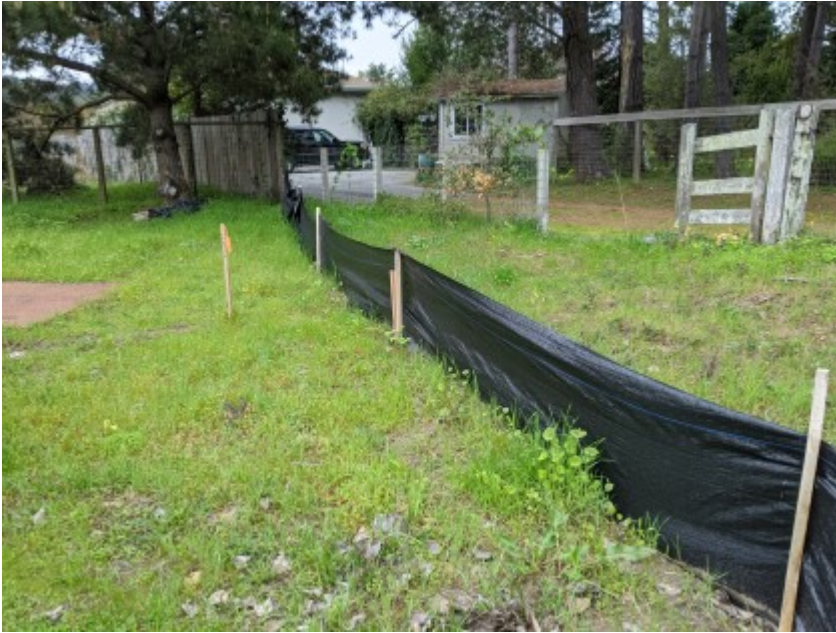
03/18/2021 - Intact exclusionary fencing surrounding work area.

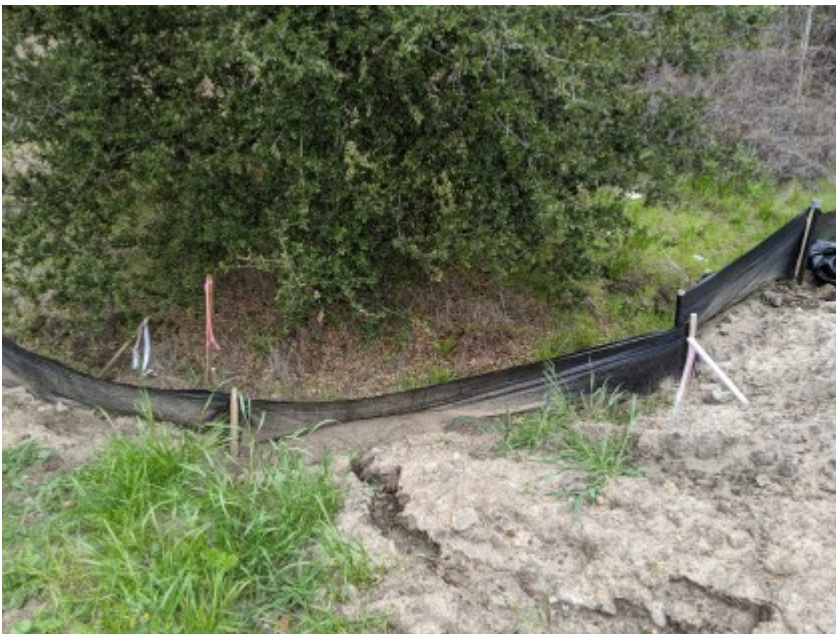
03/18/2021 - Intact exclusionary fencing surrounding work area.

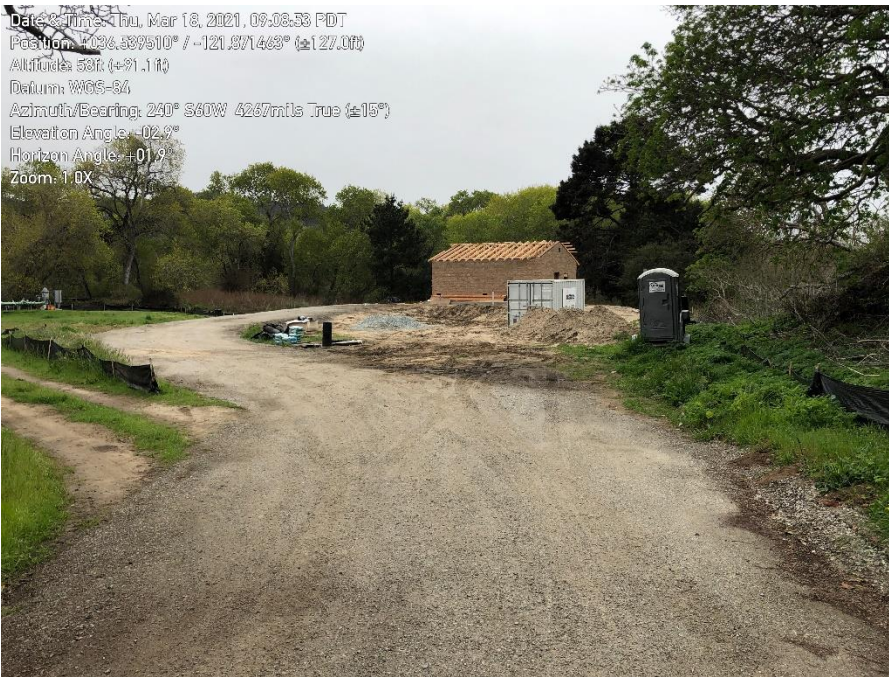
Photo 1. Pump station and overall site conditions.

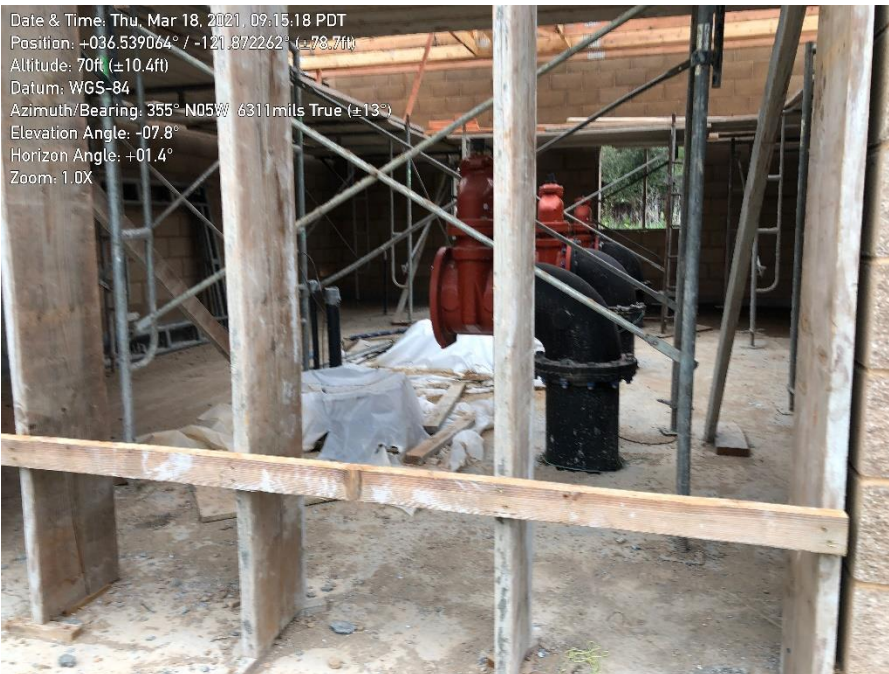
Photo 2. Interior of pump station.

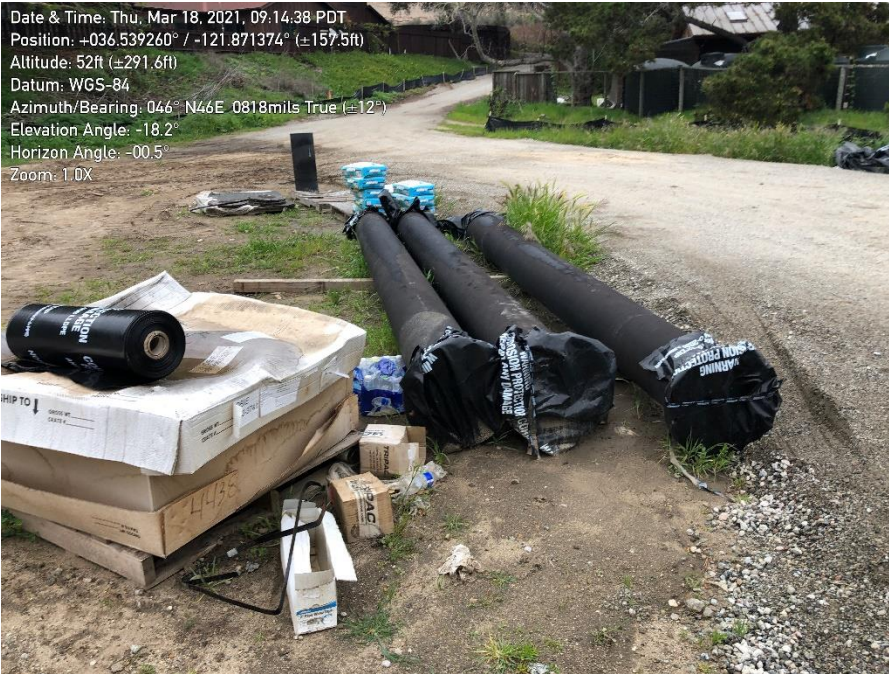
Photo 3. Pipes capped.

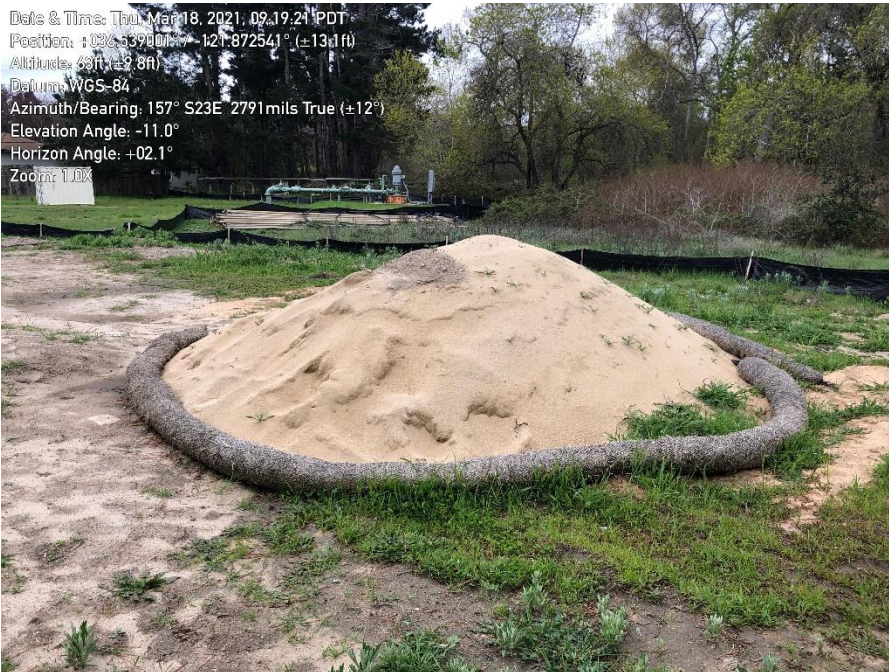
Photo 4. BMPs in place.

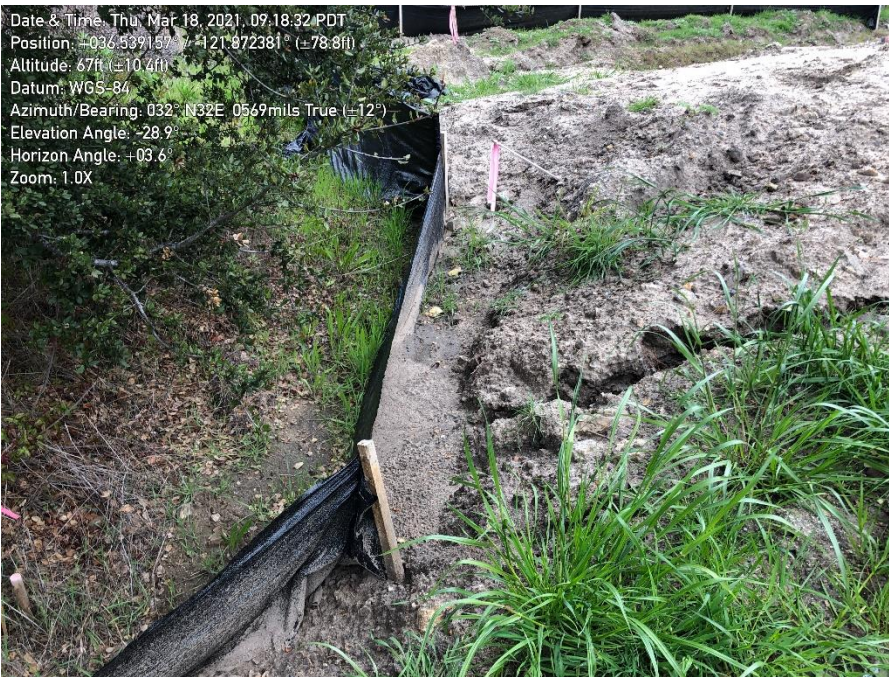
No compliance issues were observed during the week of 3/15/2021 – 3/19/2021. ESA noted that, due to recent rain events, a small amount of sediment from the building pad had backed up against a section of silt fence near the northwest corner of the site. This was originally noted during the 3/11/2021 site inspection. The silt fence was not compromised and was in adequate condition to prevent special-status amphibian species from entering the site. However, ESA recommended that any sediment observed building up against the silt fence be removed to prevent the silt fence from slumping.

Photo 5. Sediment starting to back up again silt fence due to recent rain events.

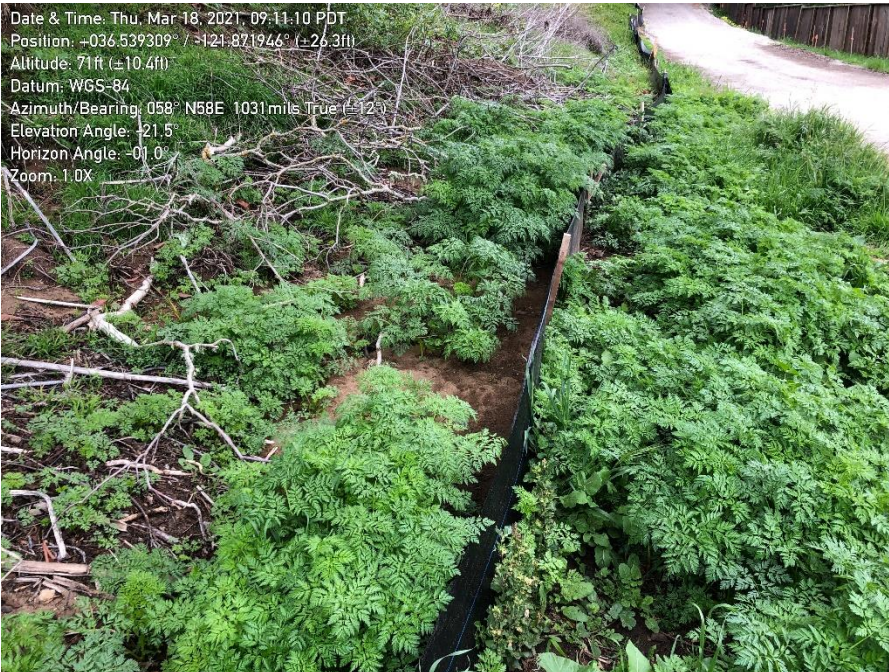
ESA also noted that invasive hemlock (*Conium maculatum*) is growing along both sides of the silt fence at the north border of the site. A Habitat Monitoring Plan was prepared for the CVPS site as required in **Mitigation Measure 4.6-1n** and specifies invasive species removal and management actions.

Photo 6. Hemlock growing up around silt fence along north border of site.
