memorandum

subject MPWSP – Carmel Valley Pump Station Project Weekly Report (3/22/2021 – 3/26/2021)

Daily Monitoring Log

Date: 3/25/2021**Time:** 09:00 – 09:30**Report Code:** MPWSP_20210325_sd**Project Site:** Carmel Valley Pump Station**Compliance Level:**Acceptable Level 0: Unanticipated Event Level 1: Minor Incident
Level 2: Moderate Incident Level 3: Major Incident **Compliance Advisory or Non-Compliance form attached** Yes
No **Photo Documentation** Yes
No **Type of Monitoring:**Full-time Spot-check SWPPP inspection
Biological Re-inspection **Construction Activity(s) Being Monitored:**

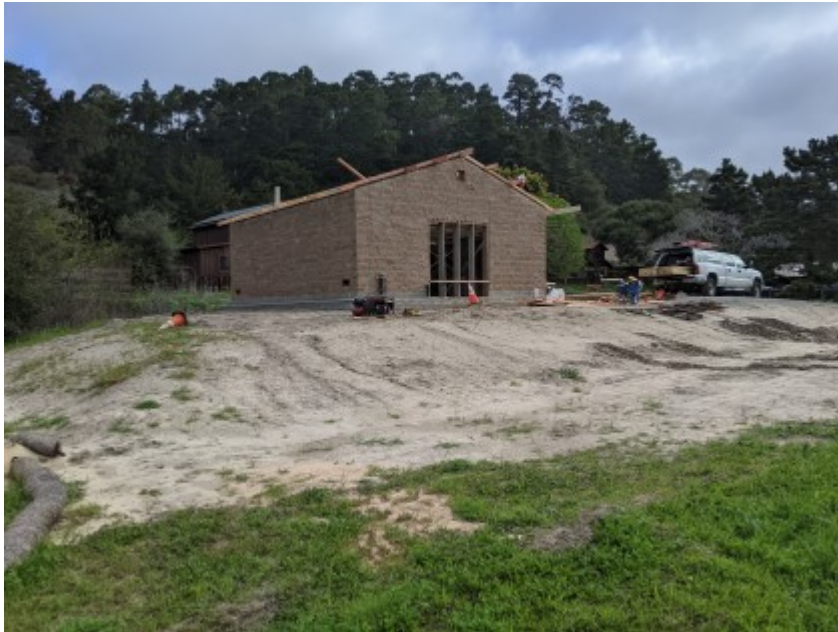
03/22/2021 - Site conditions.

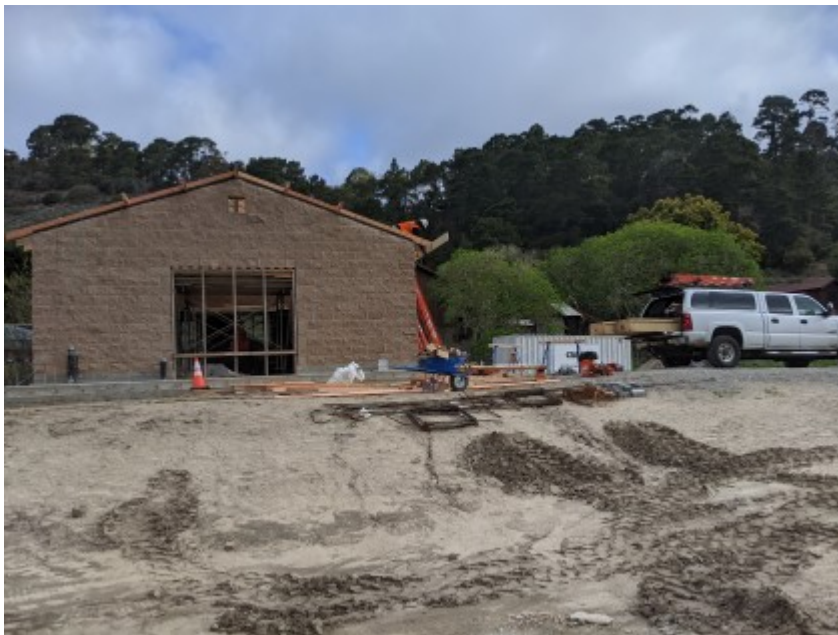
03/22/2021 - Site conditions.

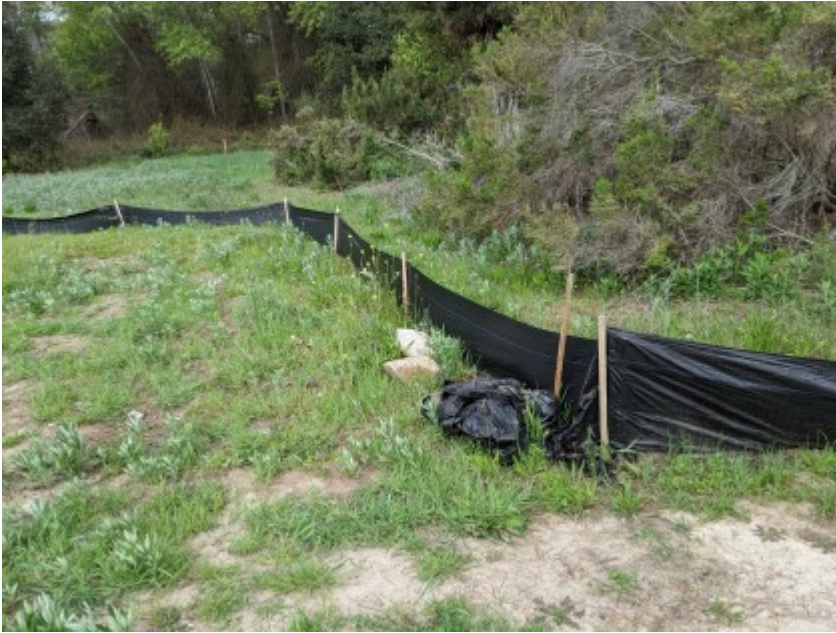
03/22/2021 - Intact exclusionary fencing surrounding work area.

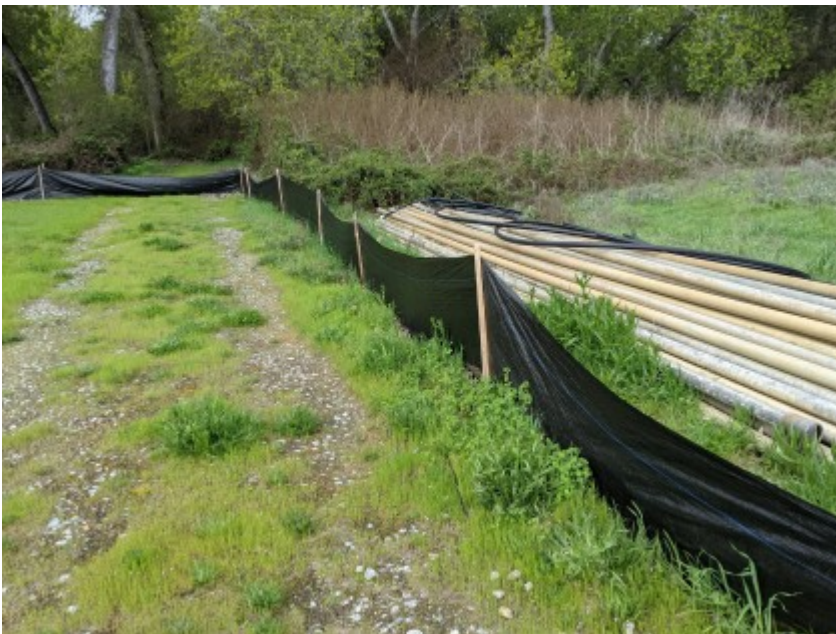
03/22/2021 - Intact exclusionary fencing surrounding work area.

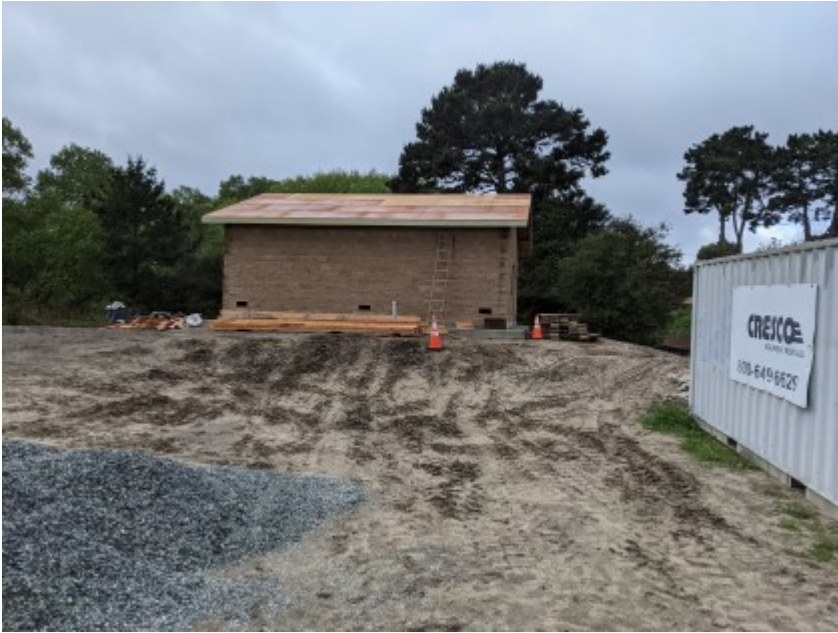
03/25/2021 - Site conditions.

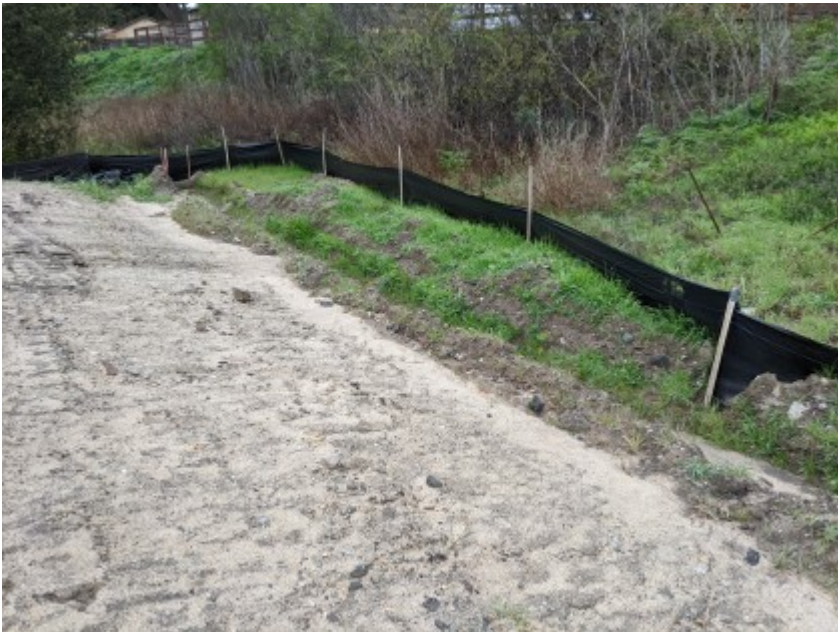
03/25/2021 - Intact exclusionary fencing surrounding work area.

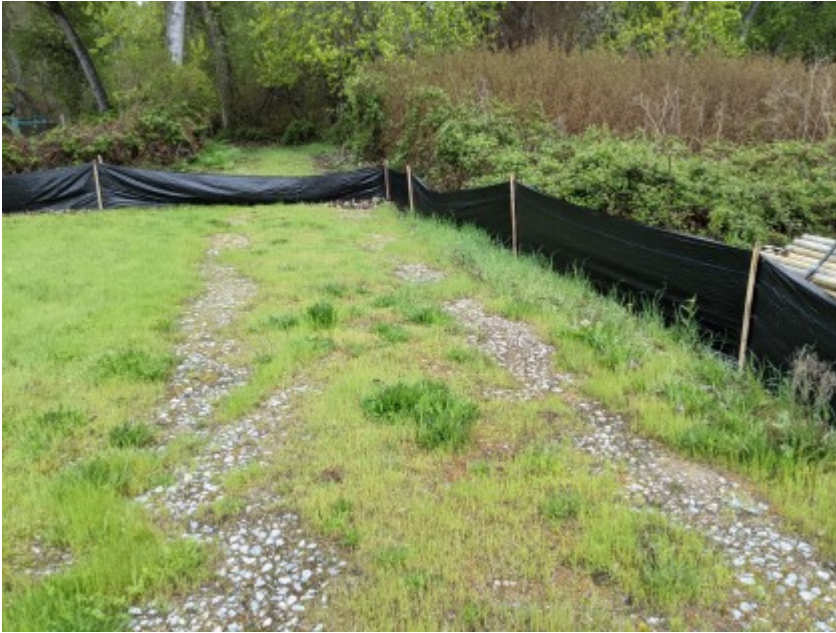
03/25/2021 - Intact exclusionary fencing surrounding work area.

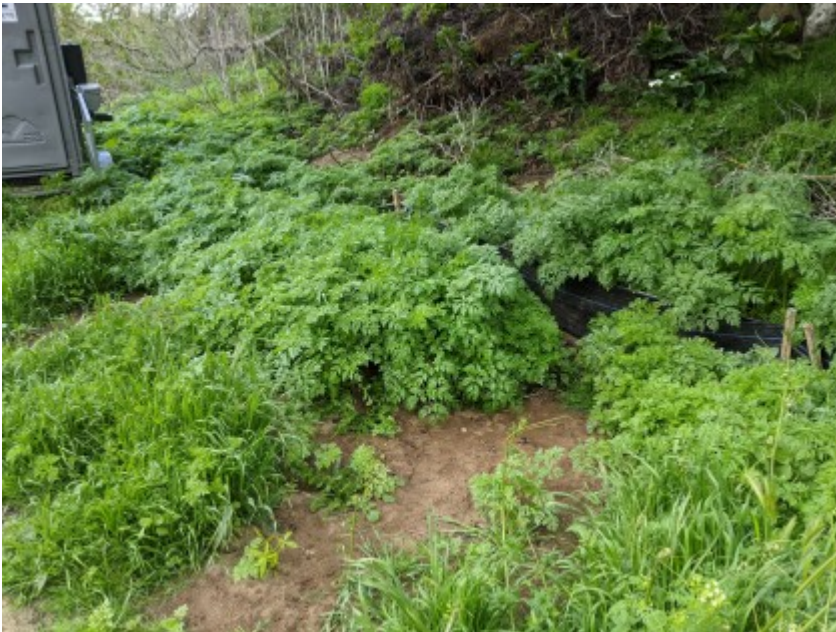
- DD&A compliance monitor inspected the status of exclusionary fencing and proper trash disposal in accordance with Mitigation Measure 4.6-1c.
- DD&A performed ongoing monitoring according to Mitigation Measure 4.6-1a.
- DD&A compliance monitor conducted site walkthrough with CPUC compliance representative.
- DD&A compliance monitor noted section of exclusionary fencing on northern side of site overgrown with invasive species in need of removal.
- Photographed project site conditions.

03/25/2021 - Invasive species overgrowing exclusionary fencing in need of removal.

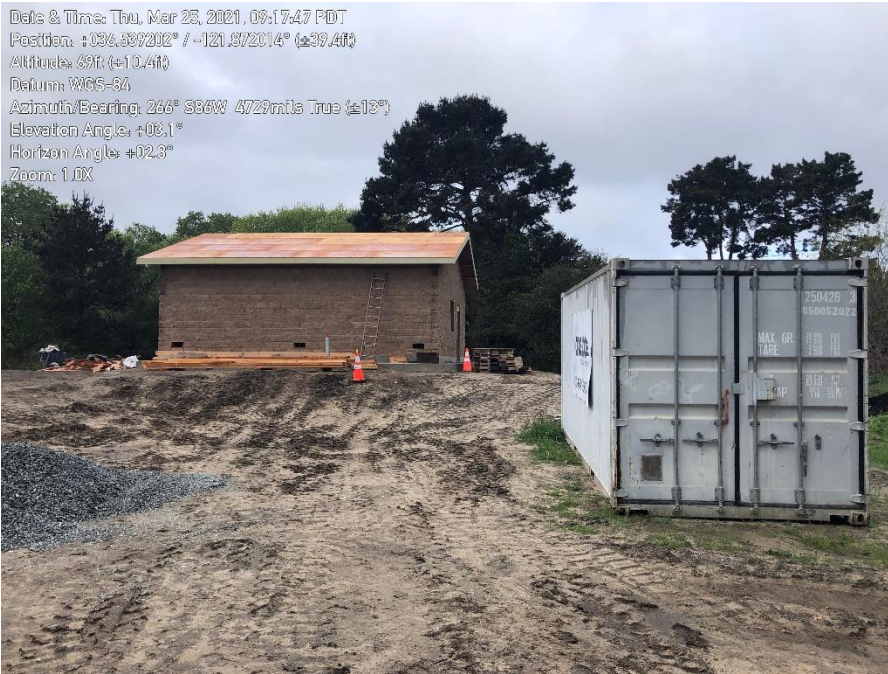
Photo 1. Pump station and overall site conditions.

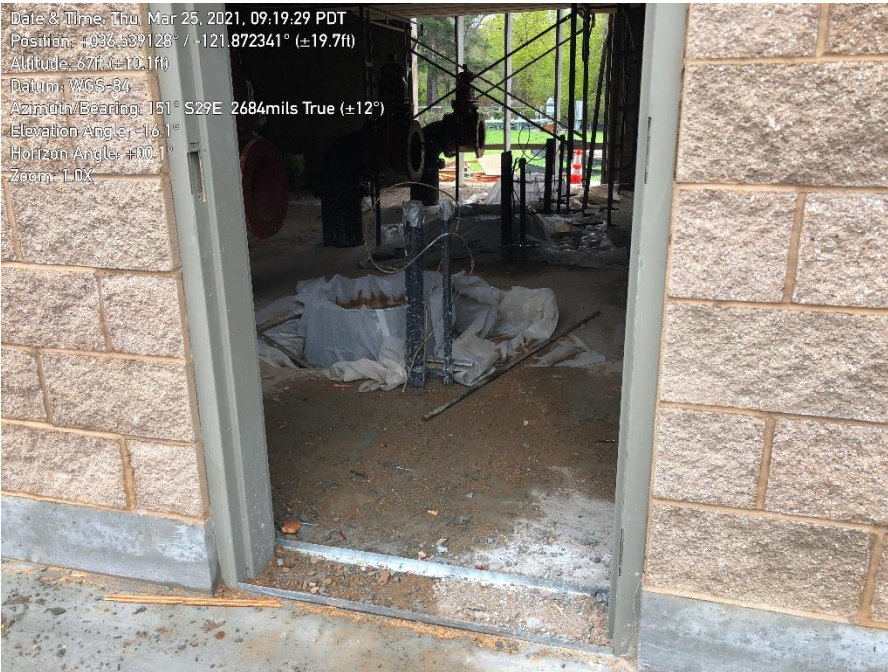
Photo 2. Interior of pump station.

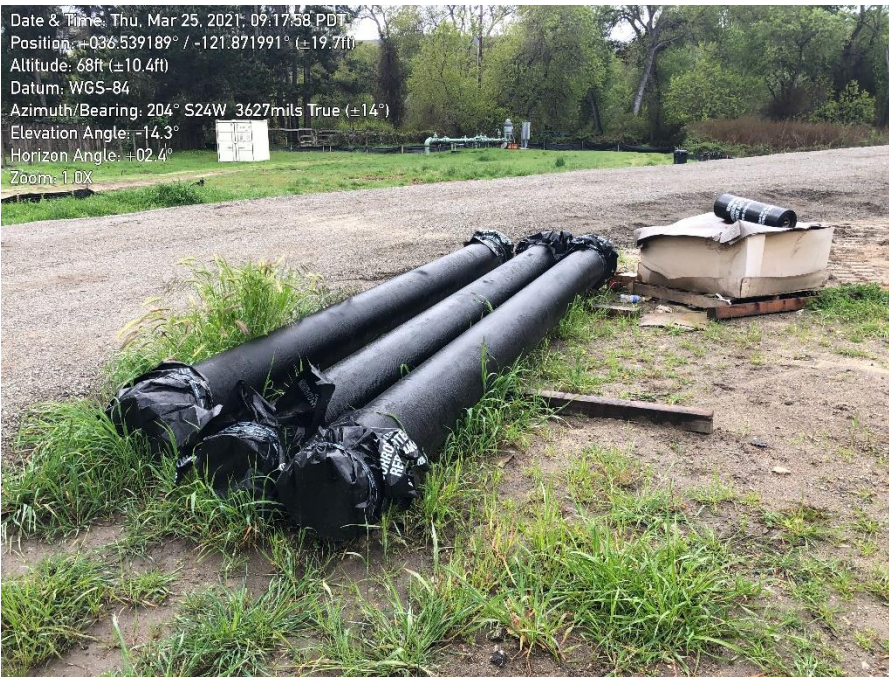
Photo 3. Pipes capped.

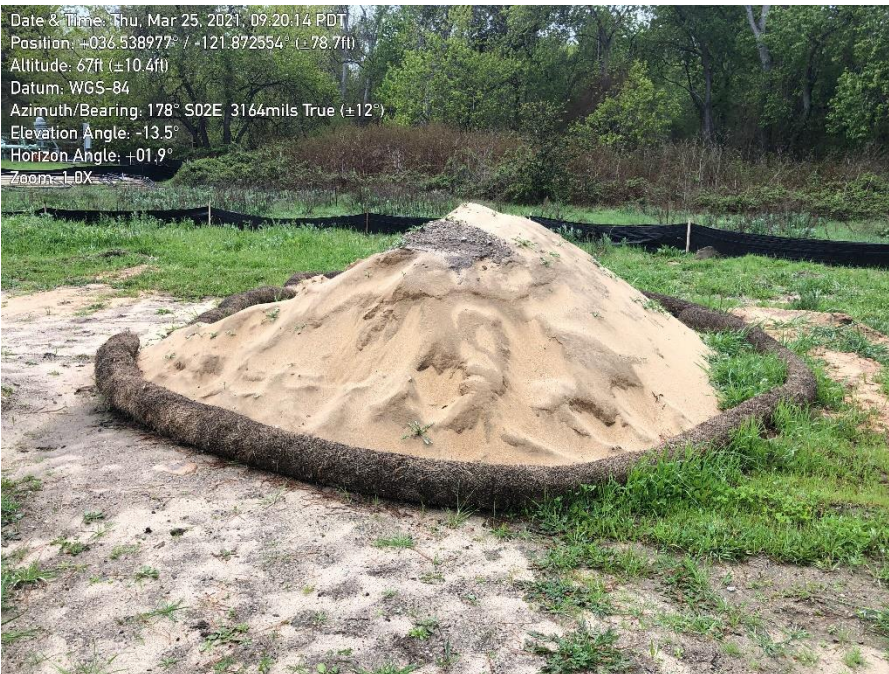
Photo 4. BMPs in place.

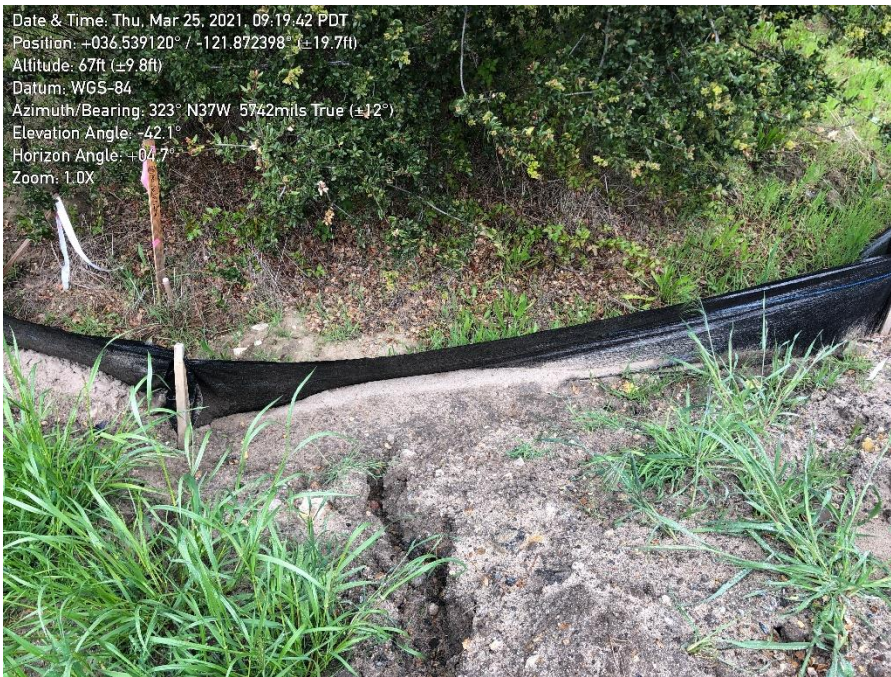
No compliance issues were observed during the week of 3/22/2021 – 3/26/2021. ESA noted that a small amount of sediment from the building pad was still backed up against a section of silt fence near the northwest corner of the site. This was originally noted during the 3/11/2021 site inspection. The silt fence was not compromised and was in adequate condition to prevent special-status amphibian species from entering the site. However, ESA recommended that any sediment observed building up against the silt fence be removed to prevent the silt fence from slumping.

Photo 5. Sediment backed up along silt fence near pad.

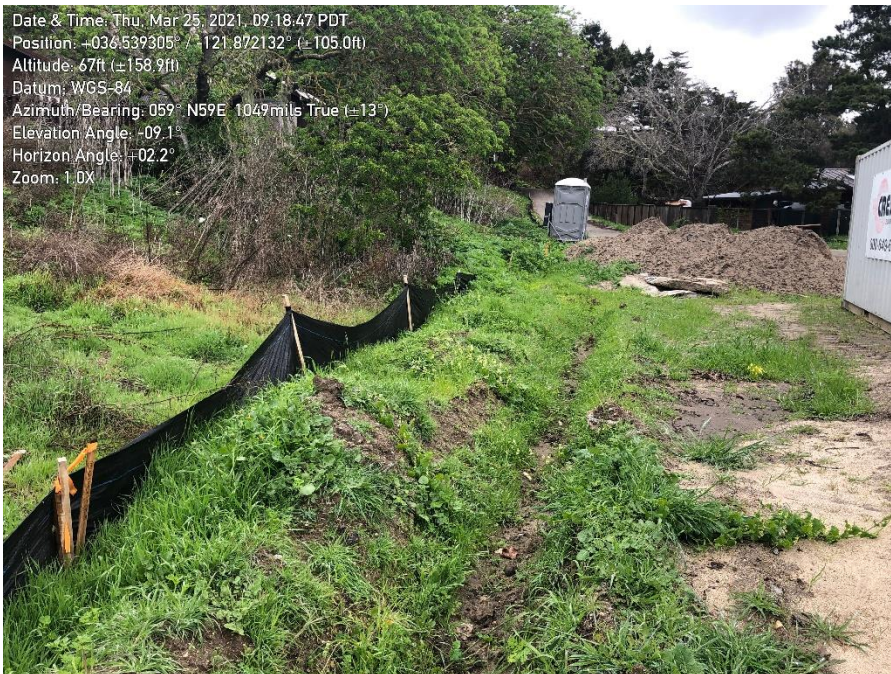
ESA also noted that invasive hemlock (*Conium maculatum*) continues to grow along both sides of the silt fence at the north border of the site. A Habitat Monitoring Plan was prepared for the CVPS site as required in **Mitigation Measure 4.6-1n** and specifies invasive species removal and management actions.

Photo 6. Hemlock growing up around silt fence along north border of site.
