memorandum

subject MPWSP – Carmel Valley Pump Station Project Weekly Report (7/30/2021 – 8/03/2021)

Monterey Peninsula Water Supply Project (MPWSP)

Daily Monitoring Log

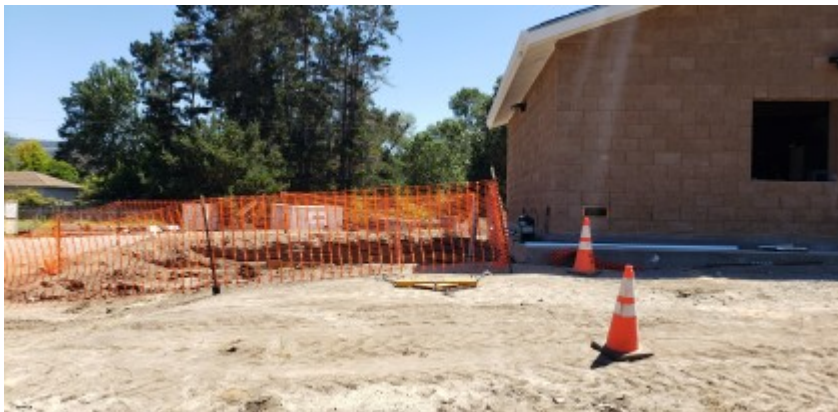
08/04/2021 - Fencing surrounding excavation.

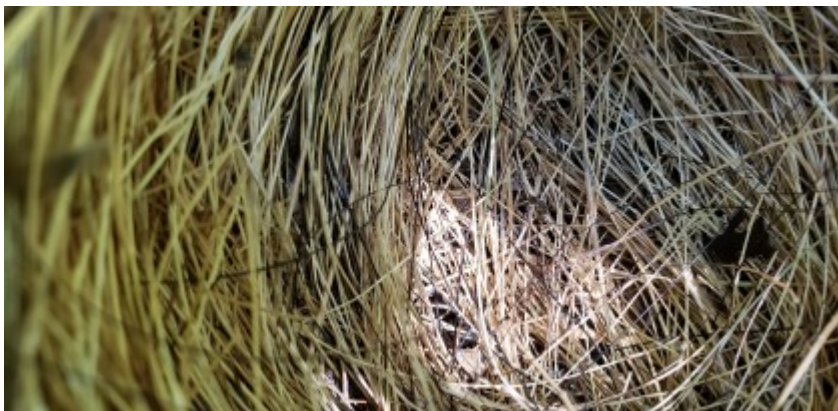
08/04/2021 - Empty CA Towhee nest adjacent to exclusion area.

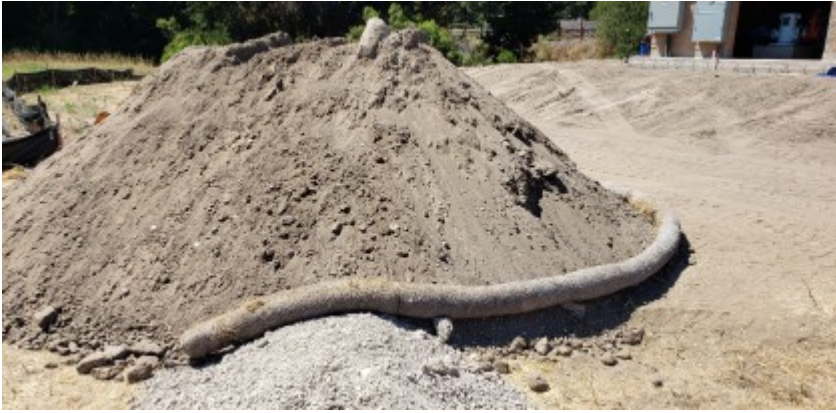
Monofilament-encased wattle was observed installed around stock piles. Per **Mitigation Measure 4.6-1p**, only certified, weed-free, plastic-free imported erosion control materials shall be used for the project. Exclusionary fencing was sagging in small sections around the site. The CalAm monitor repaired these sections during the 8/5/2021 site inspection to ensure the fence was in acceptable condition to prevent special-status amphibians from entering the work area (**Mitigation Measure 4.6-1c** and **Mitigation Measure 4.6-1o**).

08/04/2021 - Spoils pile with plastic monofilament wattle.

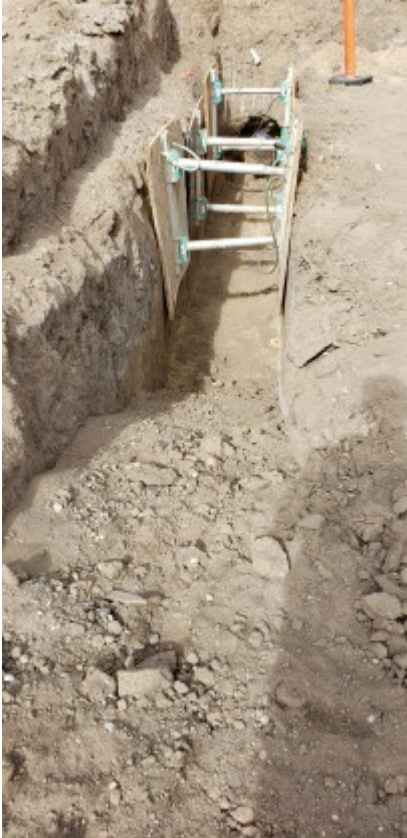
08/05/2021 - Trenches left with escape ramps at 2:1.

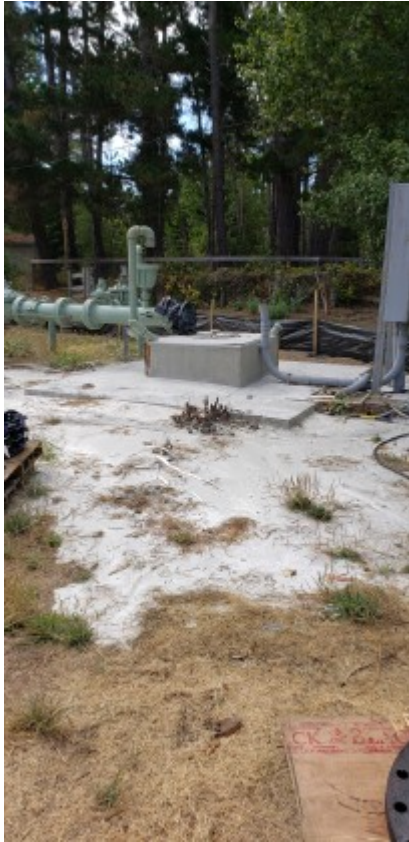
The remains of excess bentonite clay from closure of an existing well is located within the project area and is separated from the Carmel River by silt fence. Regardless, this material should be removed prior to any rain events to ensure that it cannot spread to any aquatic features.

08/05/2021 - Spilled betonite. Discuss clean up timeline with MPE. No longer liquid.

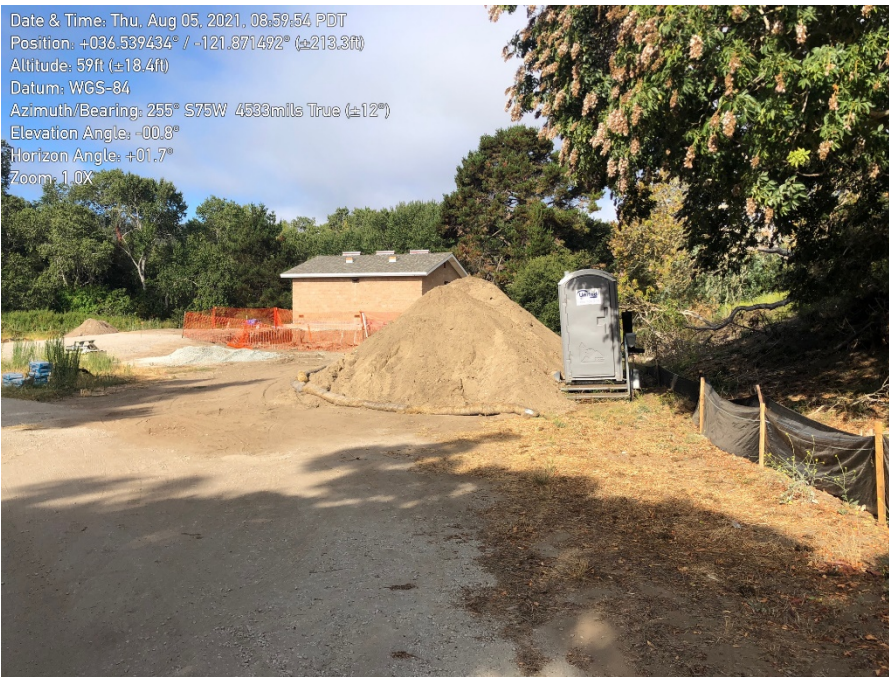
Photo 1. Site conditions. Monofilament wattle observed around stock pile.

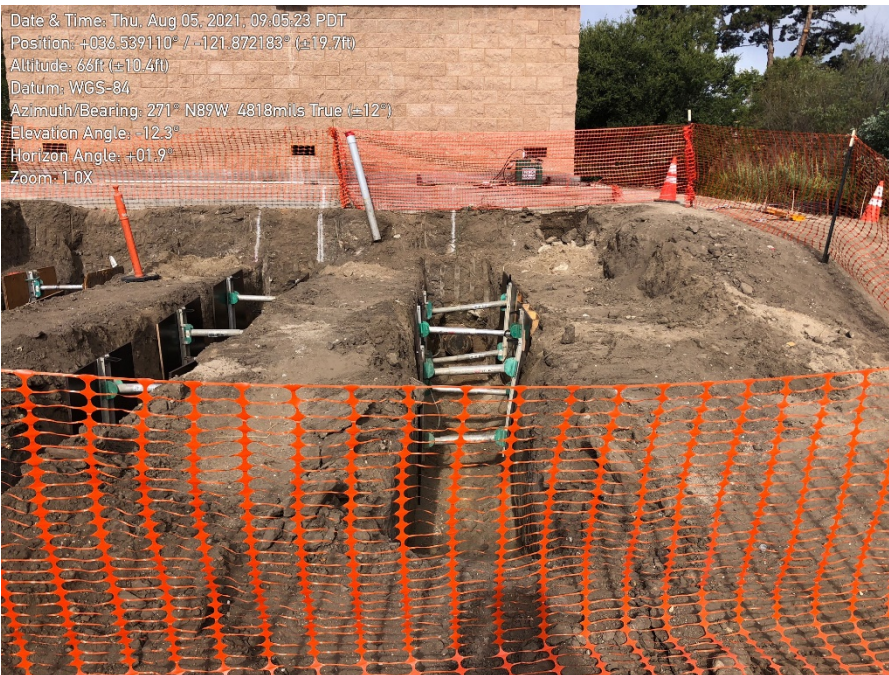
Photo 2. Trenches ramped to prevent wildlife entrapment.

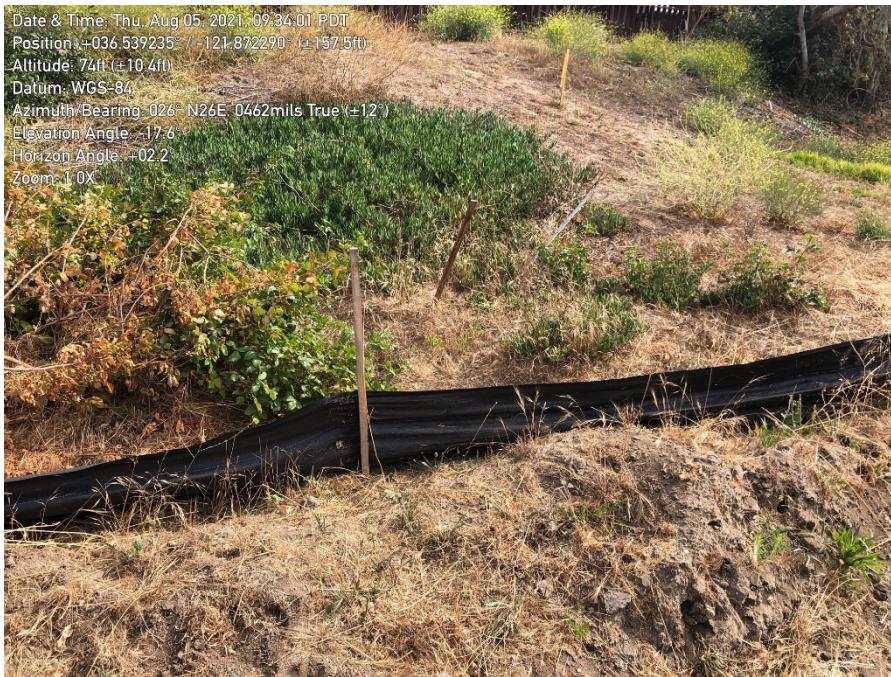
- Pipes in work area were capped as required by Mitigation Measure 4.6-1o.
- No leaking equipment or hazardous materials storage issues observed.
- Trash/food waste properly disposed of.
- Trenches ramped to prevent inadvertent entrapment of wildlife (Mitigation Measure 4.6-1c).
- The following minor compliance issues were observed:
 - Monofilament wattle observed on site installed around stock piles. This type of wattle should be removed from site.
 - Silt exclusion fence sagging in small sections along north border. DDA repaired during site visit.

Photo 3. Silt fence in need of repair along north border.
