**MEMORANDUM**

Re: SX-PQ Pre-Construction Road Condition – UG Alignment

On March 1st 2017, Icon Building Supplies conducted a pre-construction road condition video assessment of Sycamore to Penasquitos 230 kV Transmission Line Project (Project) underground alignment to satisfy the pre-construction requirements of mitigation measure TRA-3. This report and the video documents the pre-existing pavement condition along the entire underground alignment of the Sycamore to Penasquitos 230 kV Transmission Line Project. The report provides a summary of the video and includes still frame photos extracted from the video with brief descriptions of observations made along the route. The time in the video is provided along with the name of the roadway.

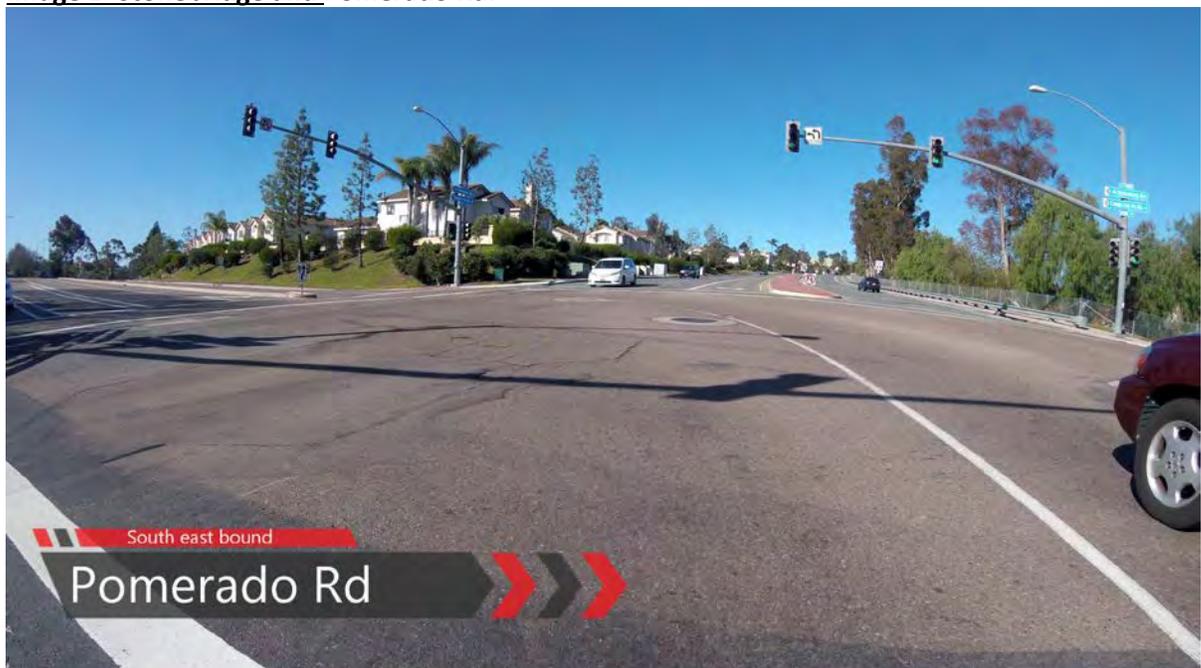
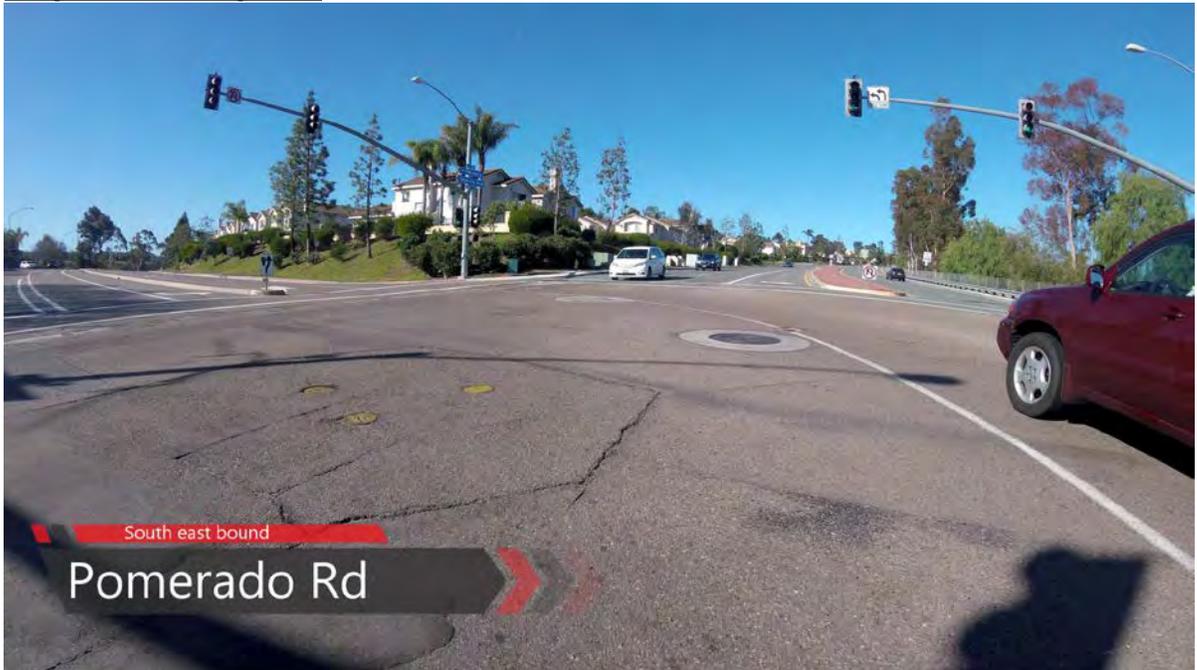
- 1) Stonebridge Parkway: very well maintained, with little to no scratching or wear seen along the route.
- 2) Stonebridge to Pomerado Rd: southwest bound at 02:43, wear and cracking of pavement in the intersection observed.

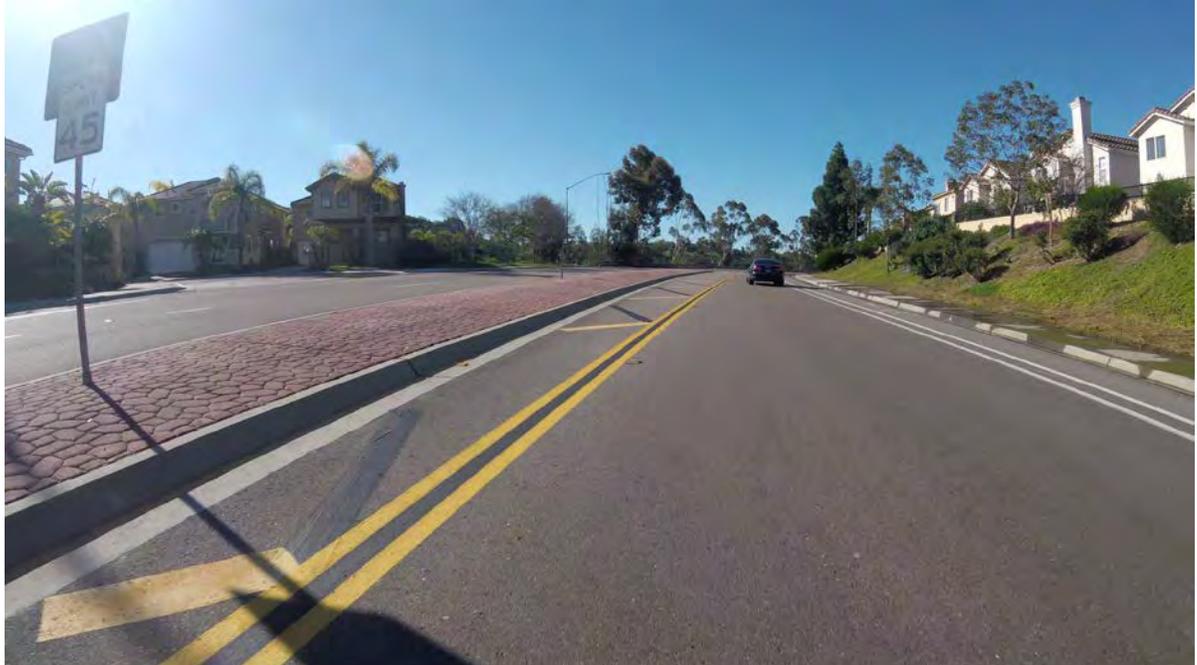
**Image 3: Pomerado Rd.**

- 3) Pomerado Rd.: the next 3 minutes of drive time show well maintained roadways.

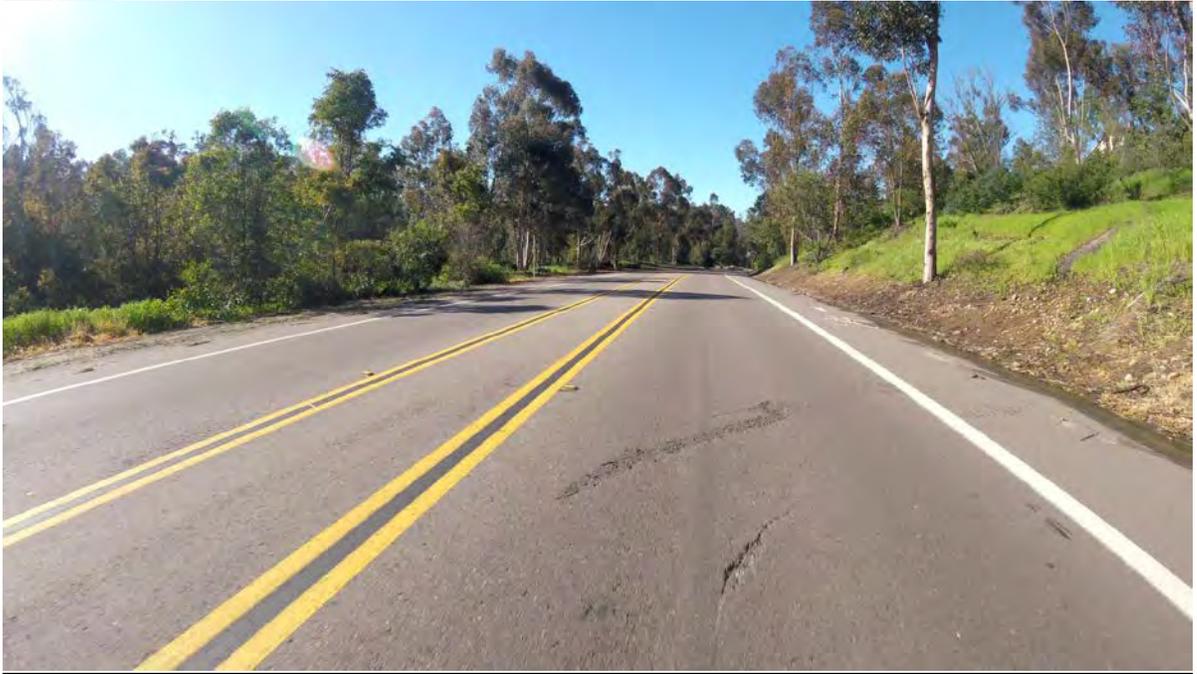
**Image 4: Pomerado Rd.**

- 4) Pomerado Rd.: Scratching is visible at 05:04.

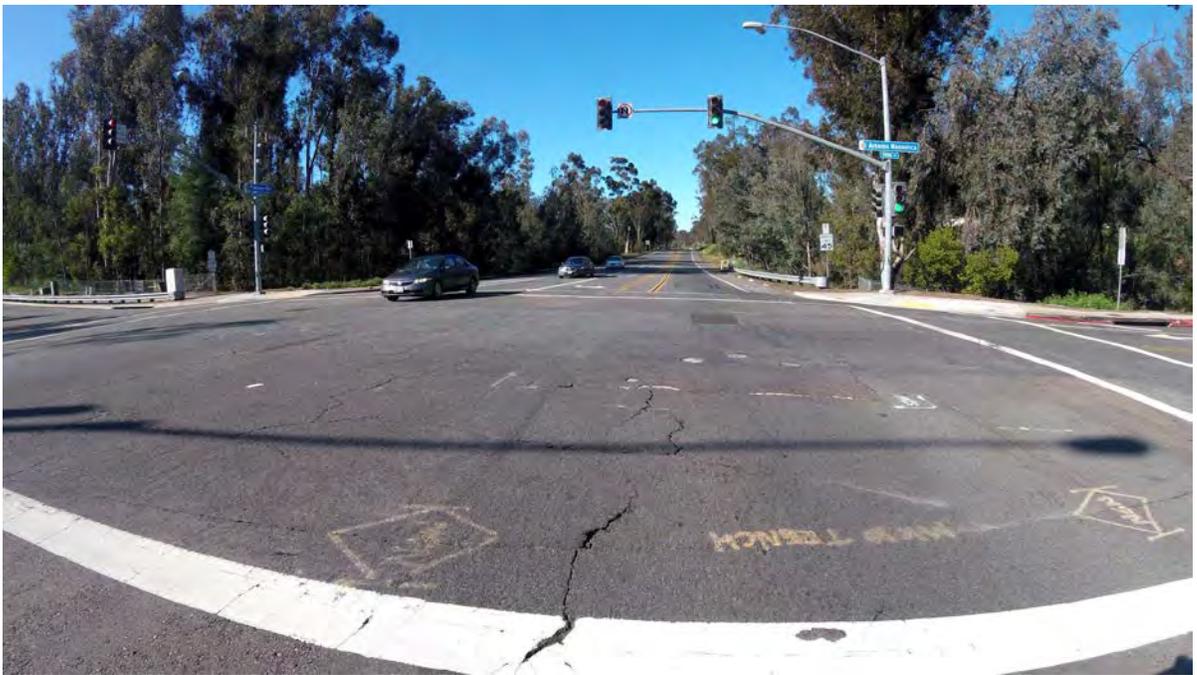
**Image 5: Pomerado Rd.**

- 5) Intersection of Pomerado Rd. and Avenida Magnifica: Cracking observed at 06:58

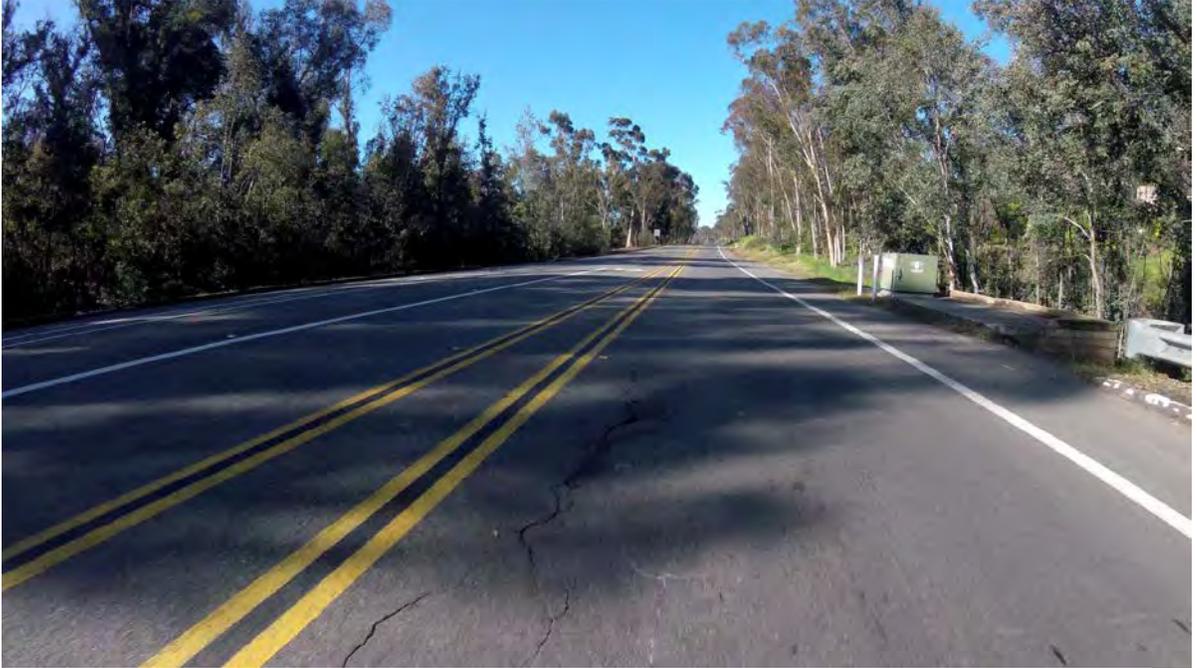
**Image 6: Pomerado Rd.**

- 6) Pomerado Rd.: Pothole at 07:04

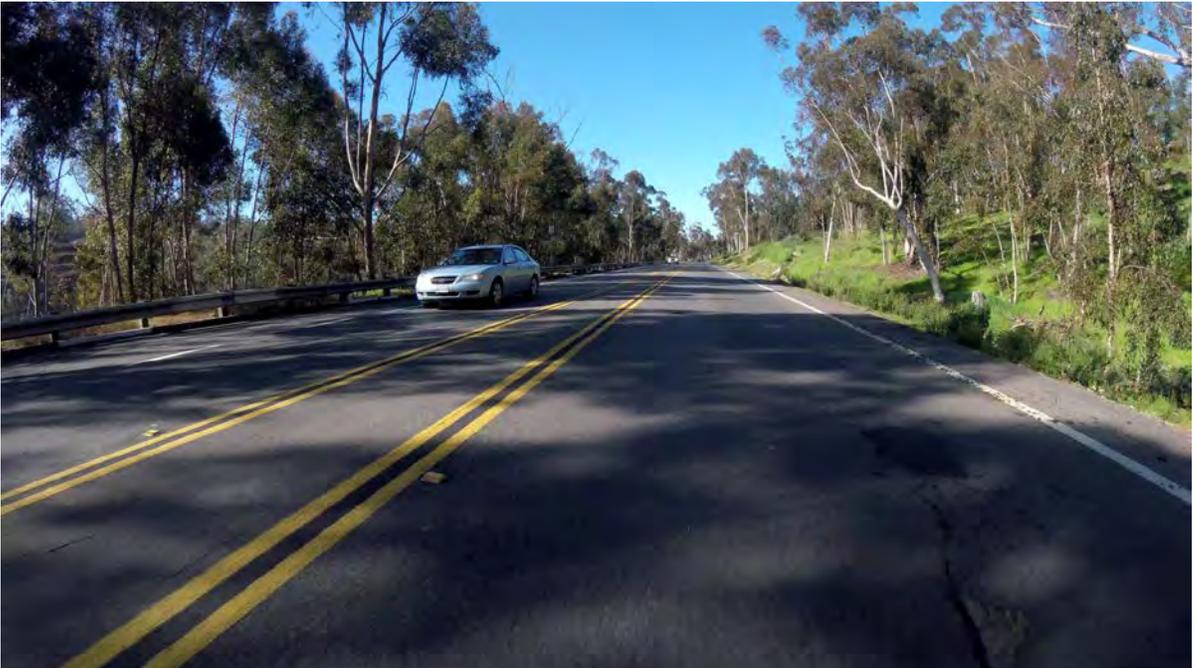
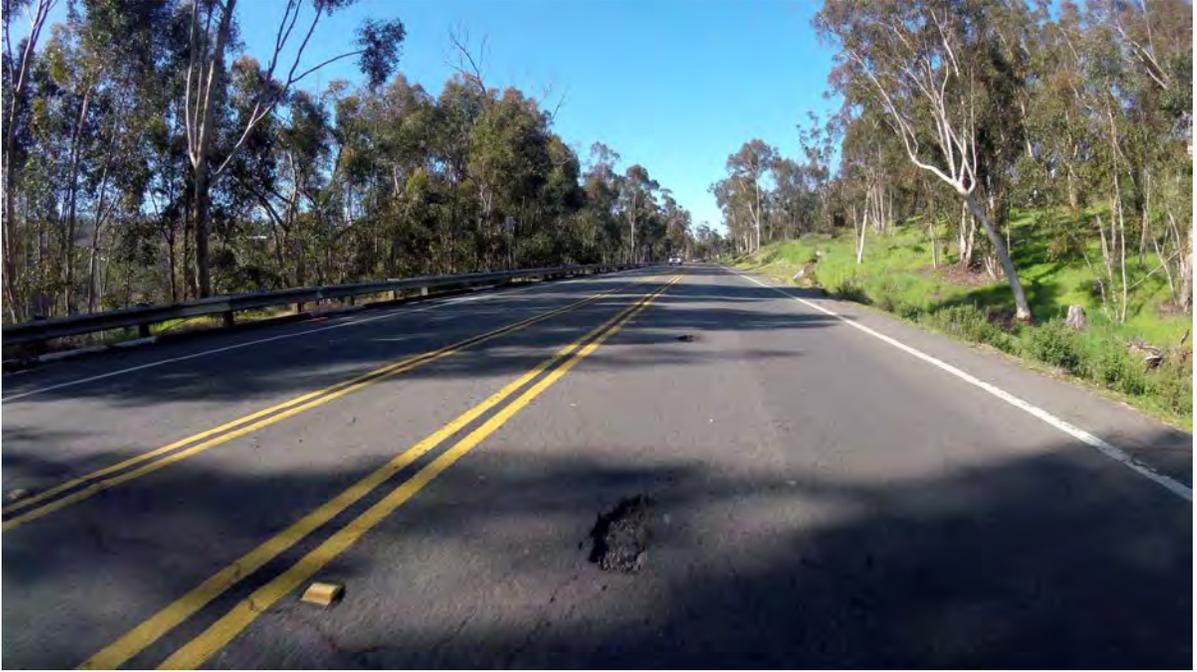
- 8) Pomerado Rd.: At 07:36 excessive wear begins with pot holes at 07:39-7:41

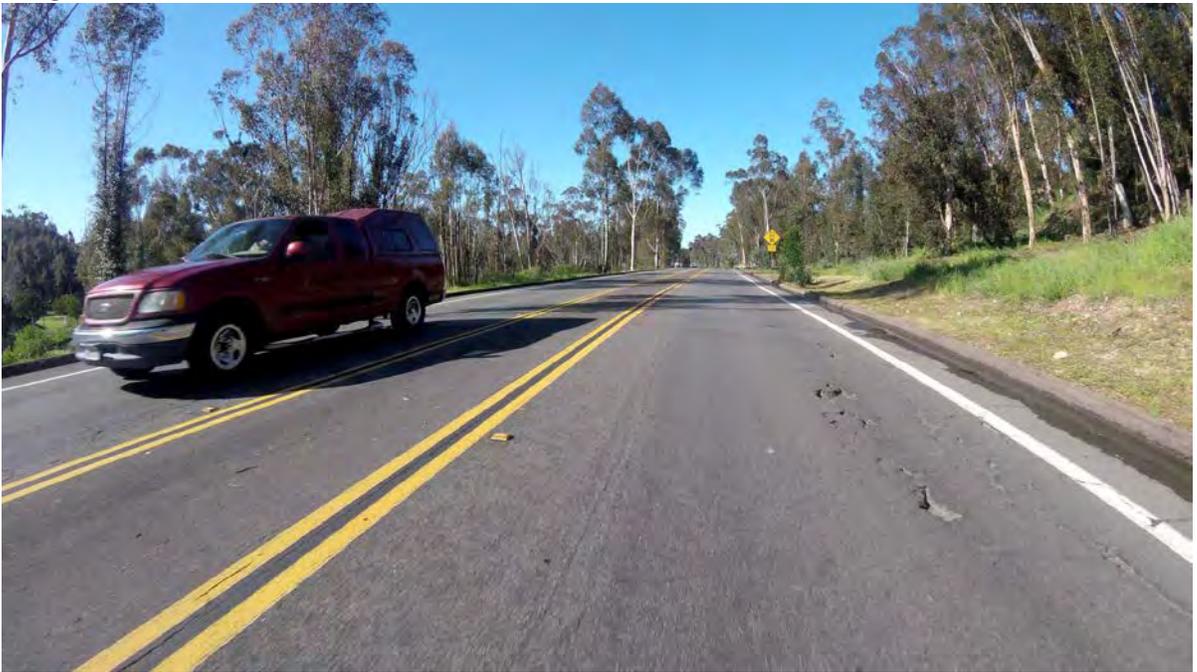
**Image 8: Pomerado Rd.**

10) Pomerado Rd.: Conditions improve until excessive cracking observed at 08:31-8:39

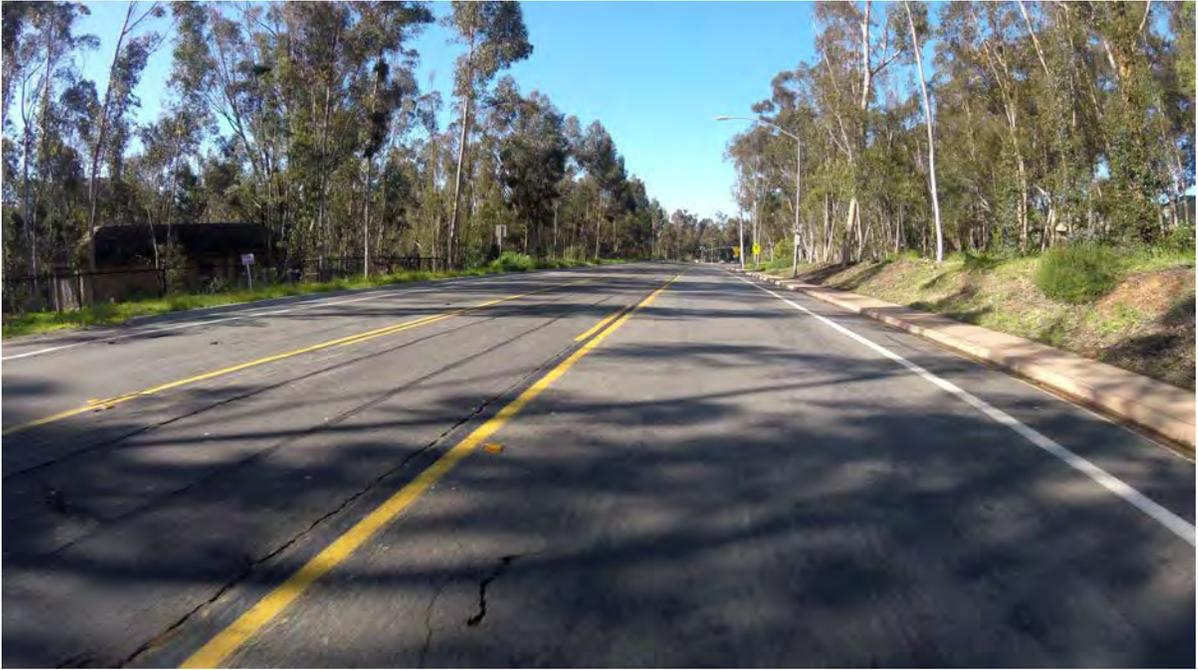
**Image 9: Pomerado Rd.**

11) Pomerado Rd.: Excessive cracking observed at 08:56

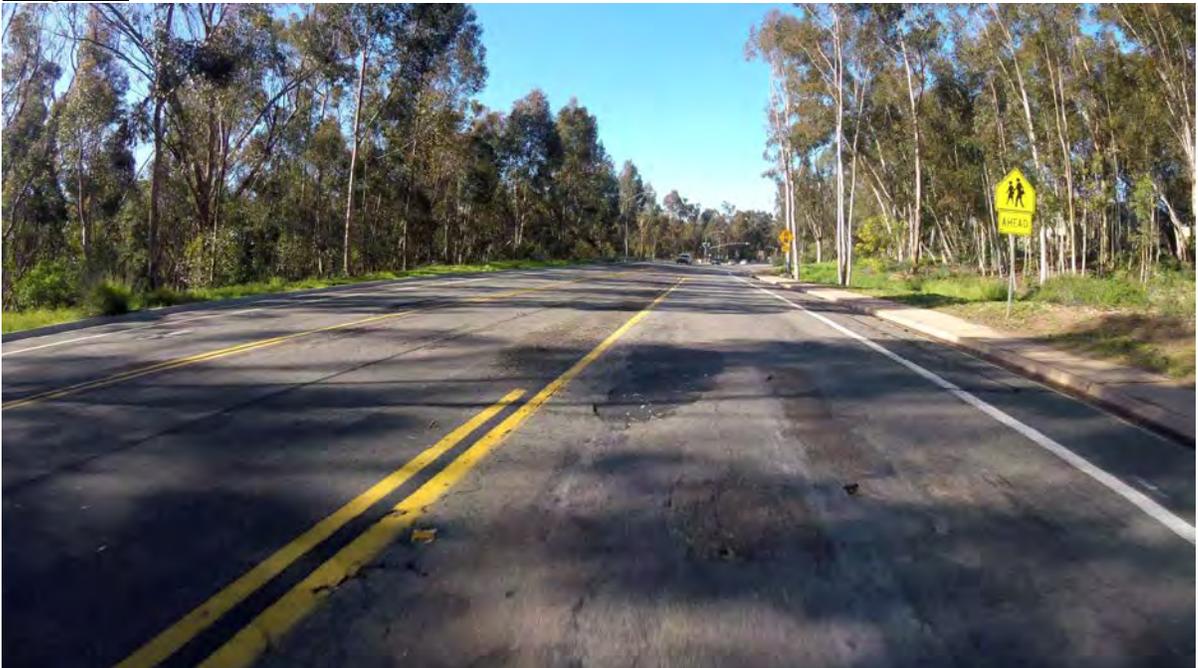
**Image 10: Pomerado Rd.**

12) Pomerado Rd.: Large hole and excessive wear observed at 09:00

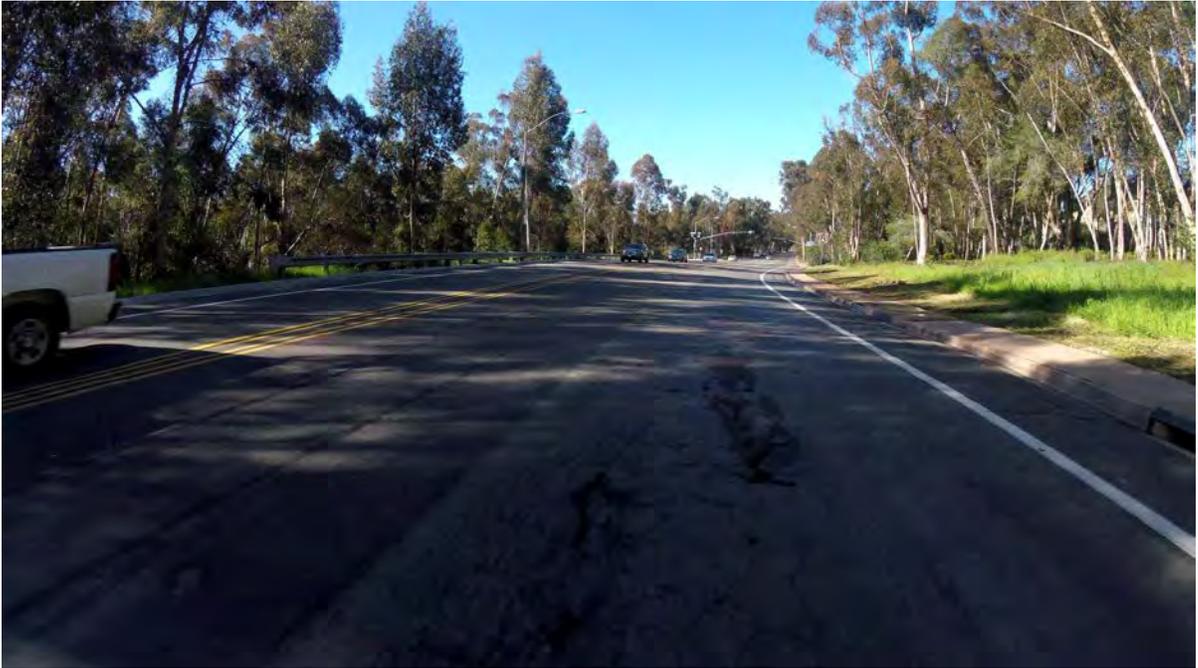
**Image 11: Pomerado Rd.**

13) Pomerado Rd.: Large hole and excessive wear observed at 09:02

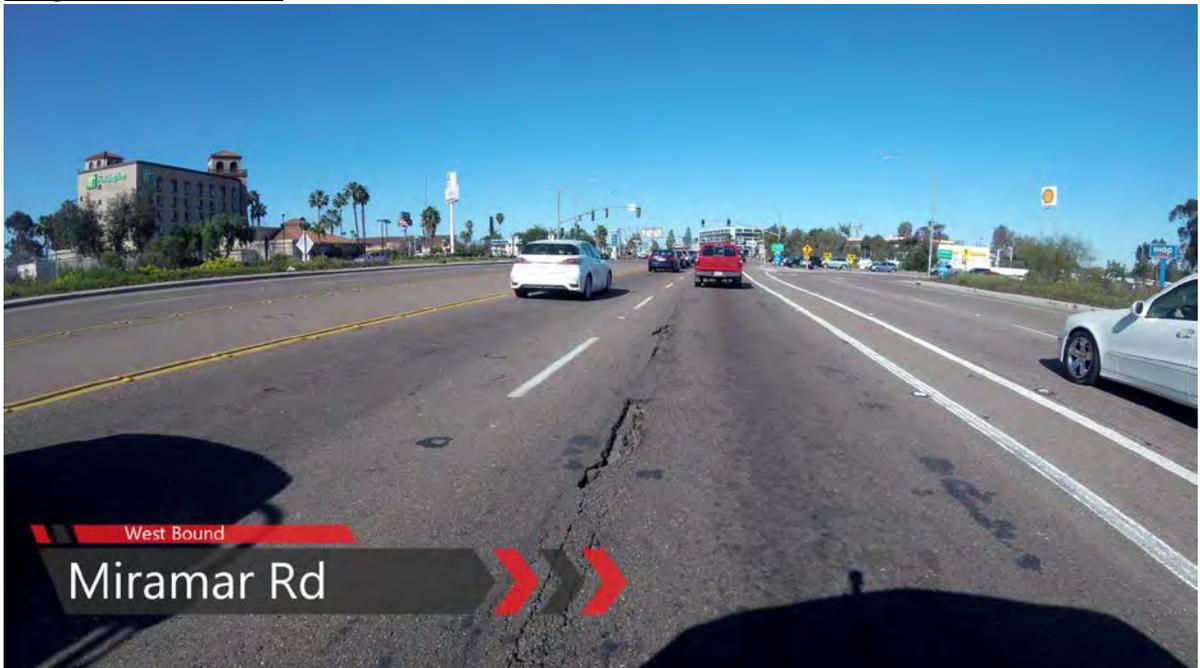
**Image 12: Miramar Rd.**

17) Miramar Rd.: 11:22 begin west bound and at 11:23 potholes and cracking are observed

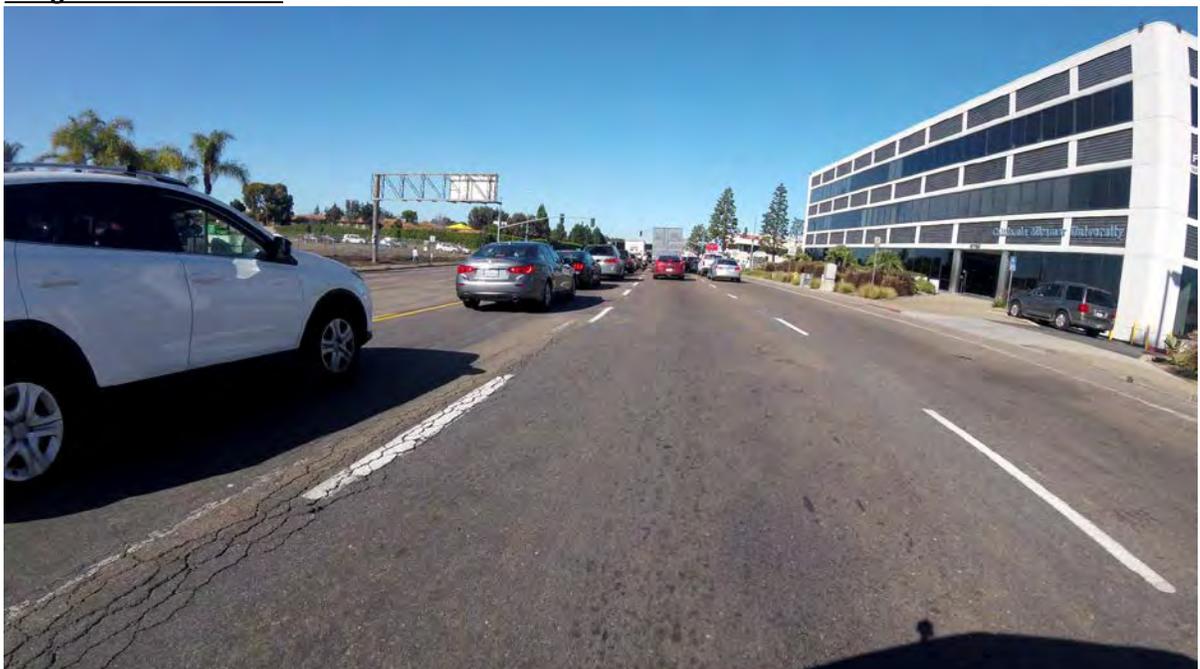
**Image 13: Miramar Rd.**

18) Miramar Rd.: Excessive cracking observed at 12:03

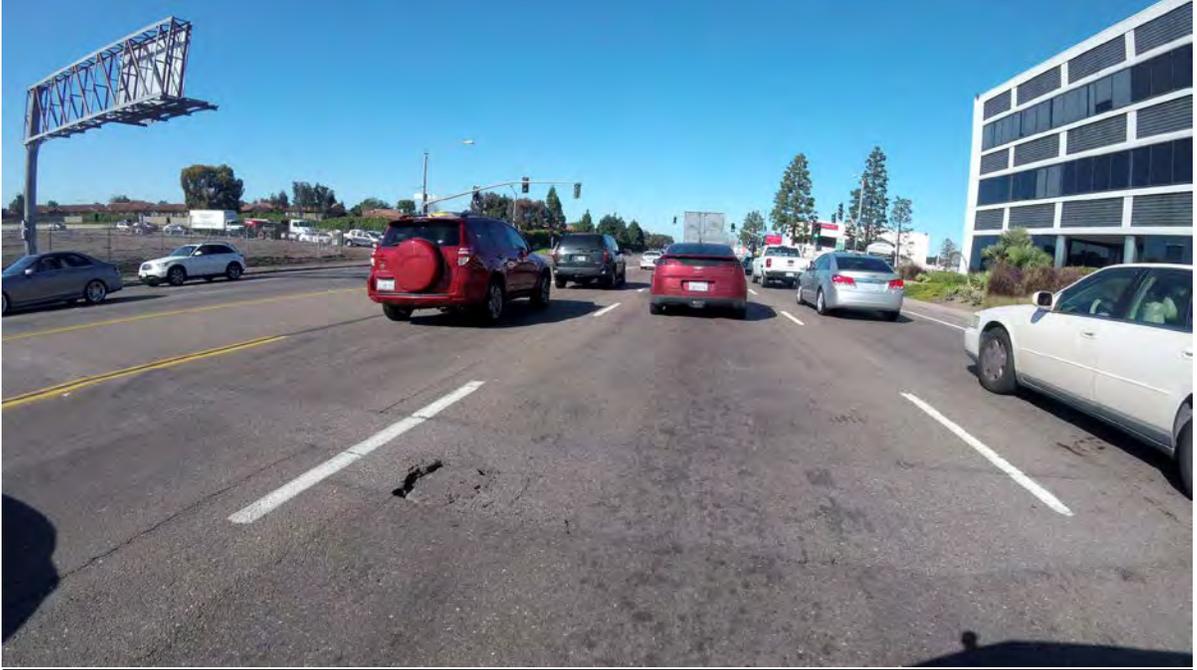
**Image 14: Miramar Rd.**

19) Miramar Rd.: Pothole observed at 12:20

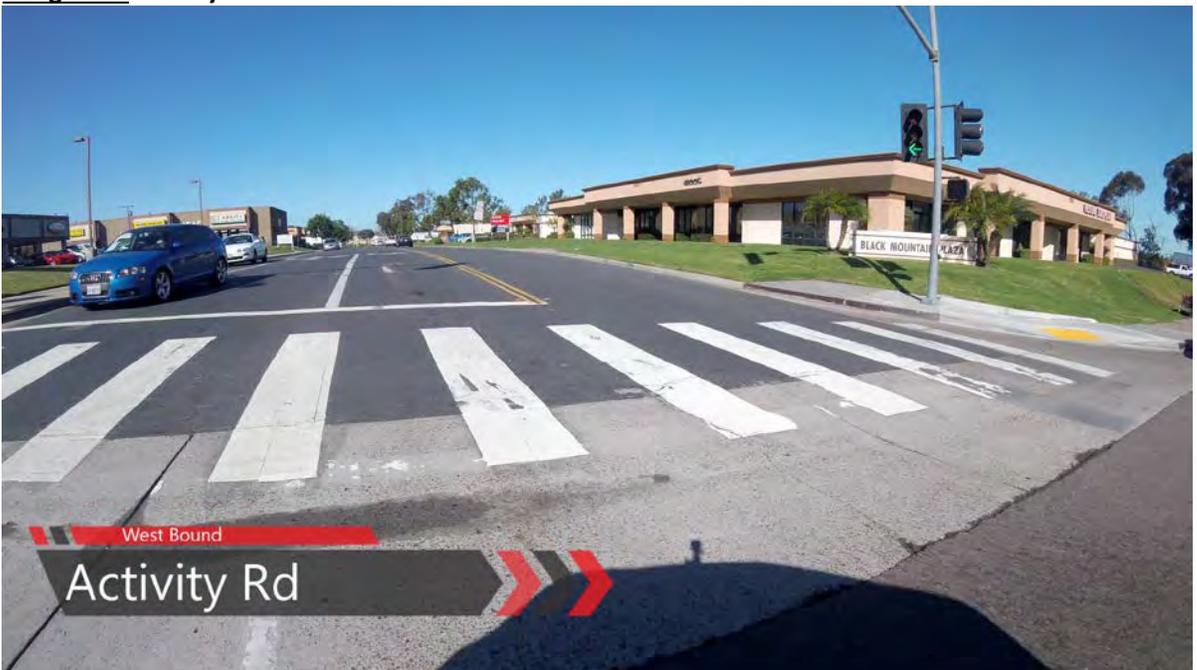
**Image 14: Activity Rd.**

22) Activity Rd.: turn west bound at 14:03, cracking in concrete drainage channel is observed.

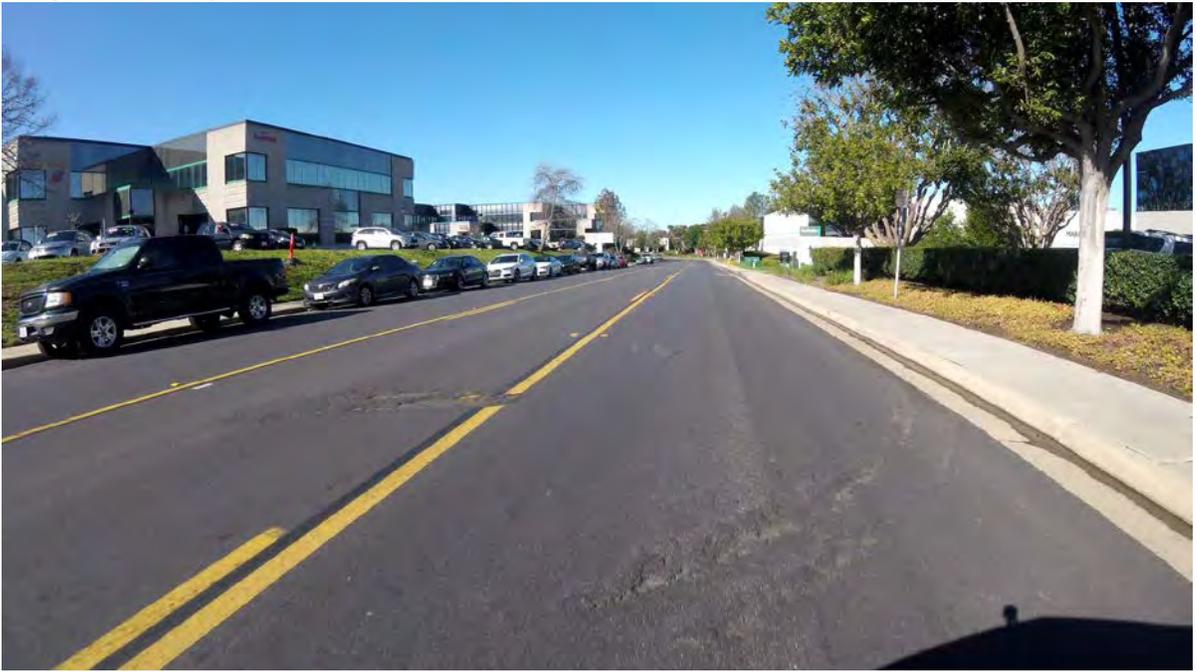
**Image 15: Activity Rd.**

24) Activity Rd.: Wear is observed at 15:27

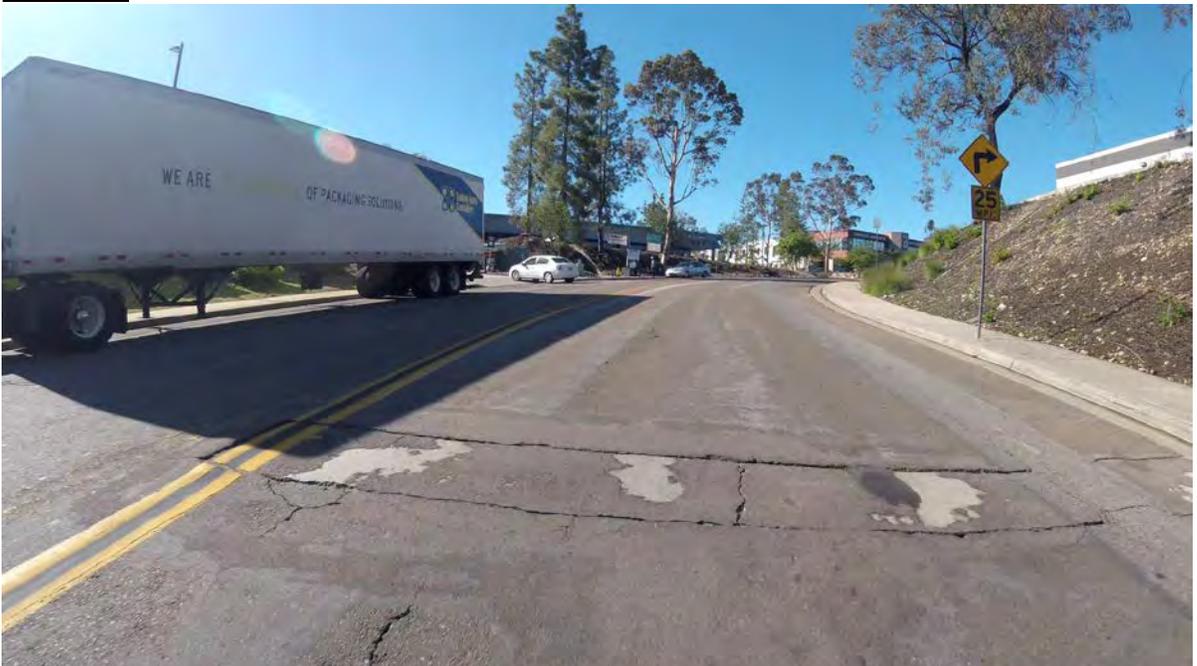
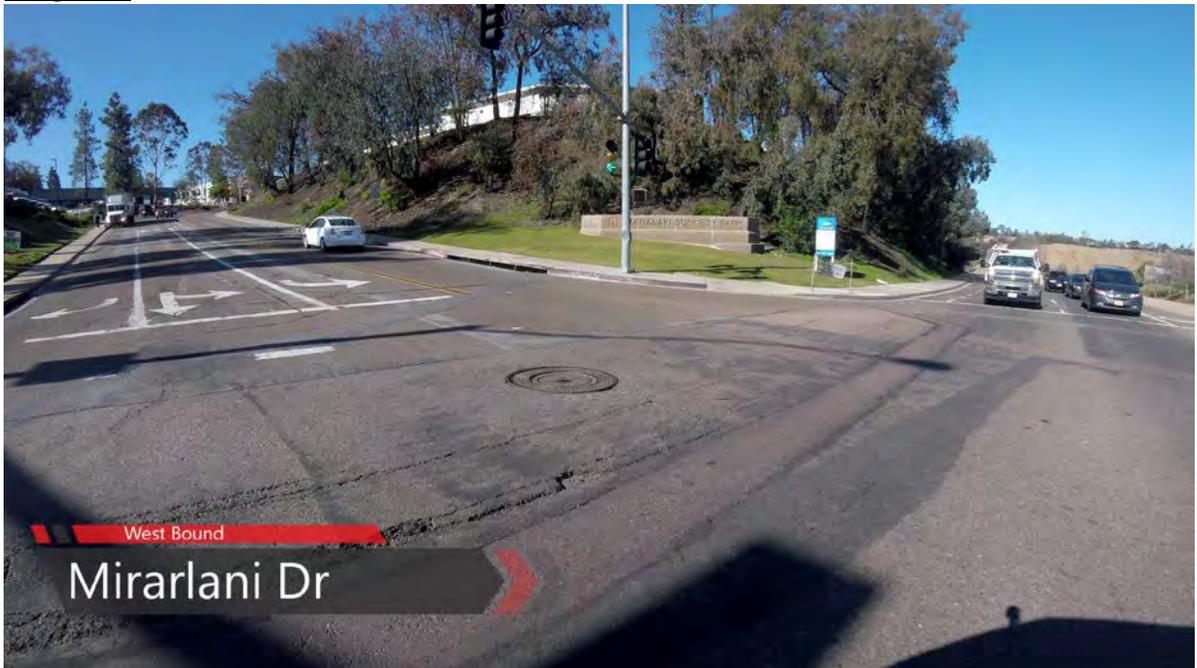
26) Miralani Dr.: turn west bound at 16:26, moderate cracking in intersection observed.

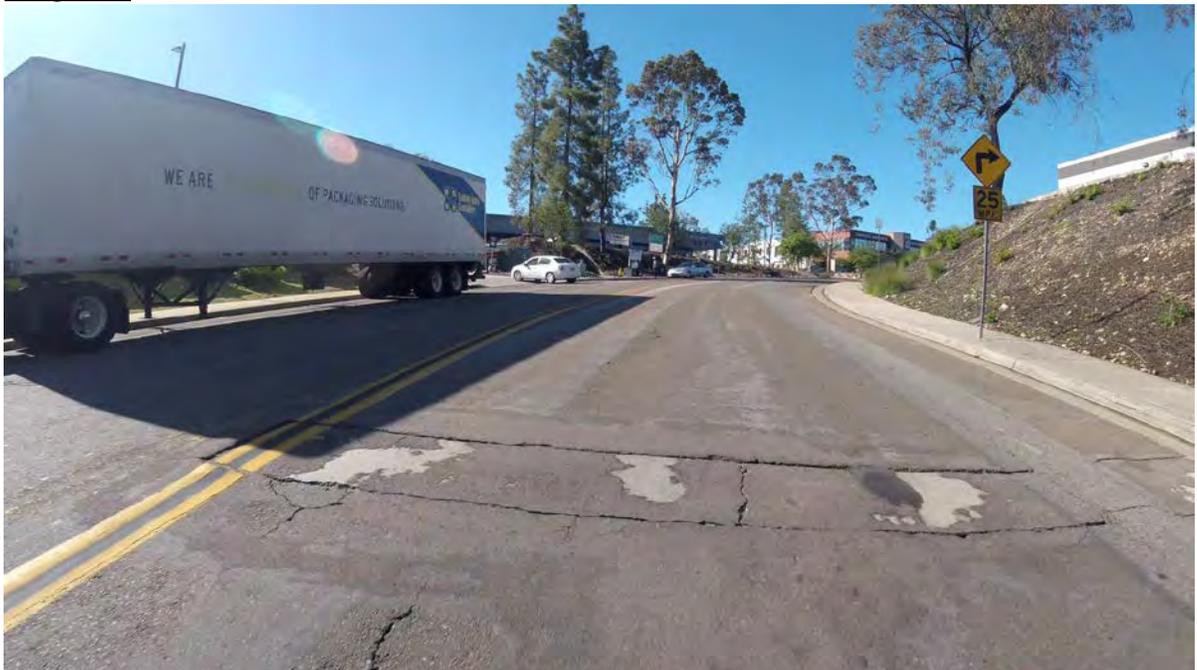
**Image 18: Miralani Dr.**

- 27) Miralani Dr.: Excessive wear observed at 16:36, 16:47, 16:50, 16:56, 16:58, 17:11, 17:21, and 17:27

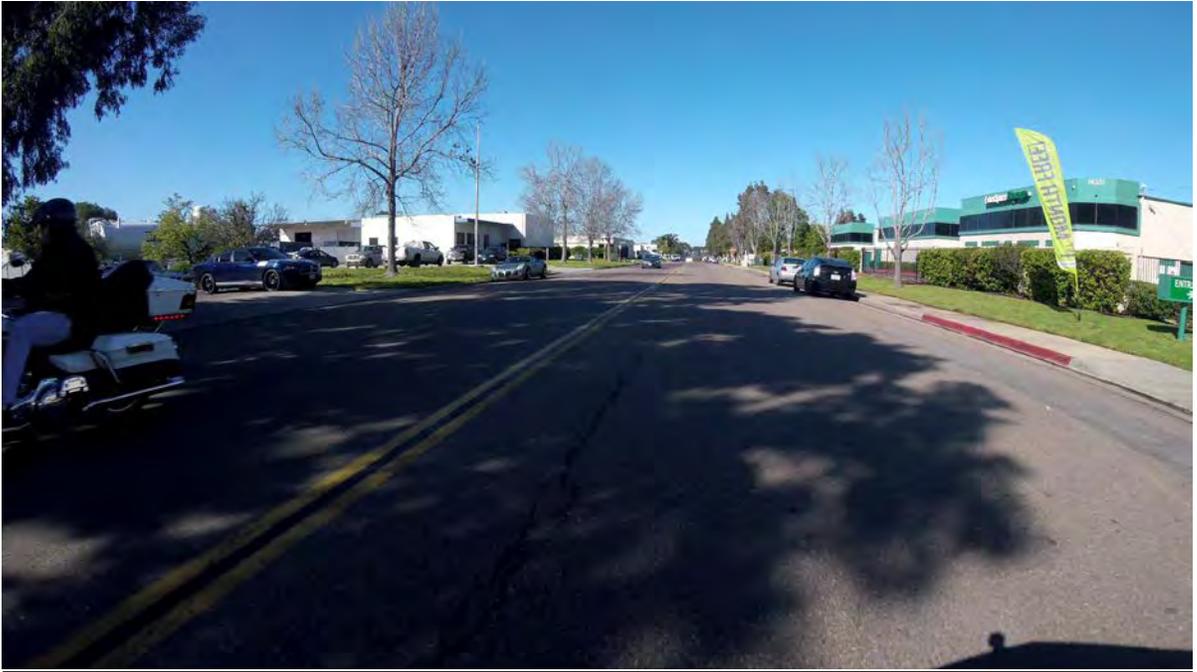
**Image 19: Arjons Dr.**

- 29) Arjons Dr.: hole observed at 18:12

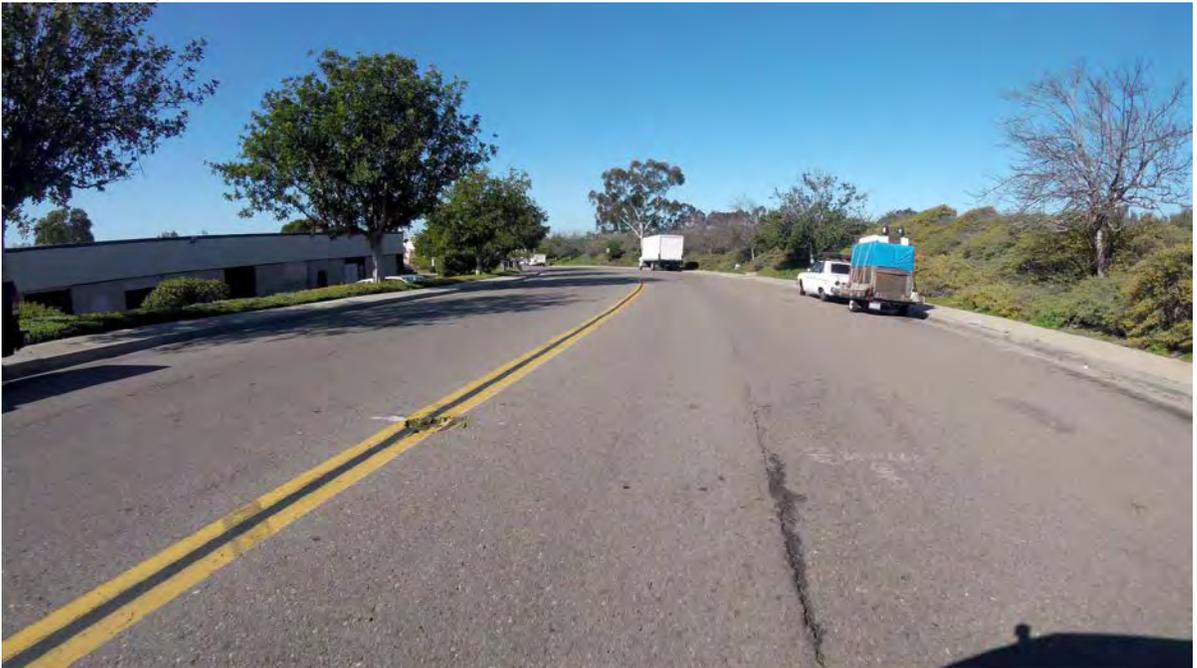
**Image 20: Arjons Dr.**

30) Arjons Dr.: Hole observed at 18:50

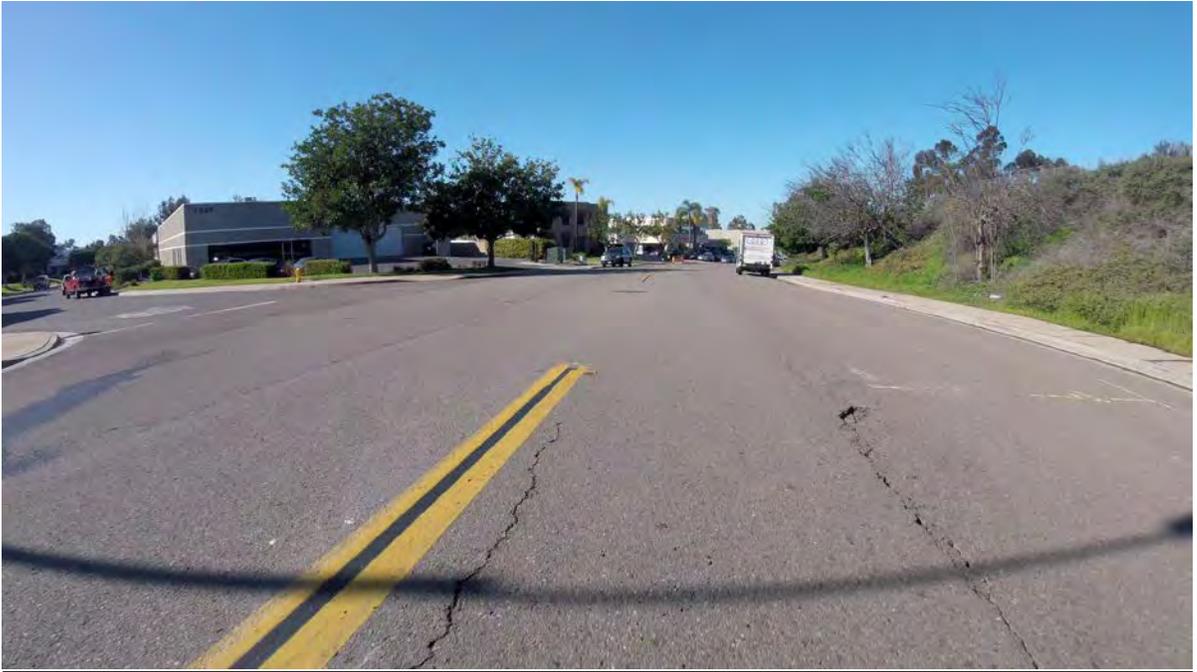
**Image 21: Arjons Dr.**

31) Arjons Dr.: Hole observed at 18:57

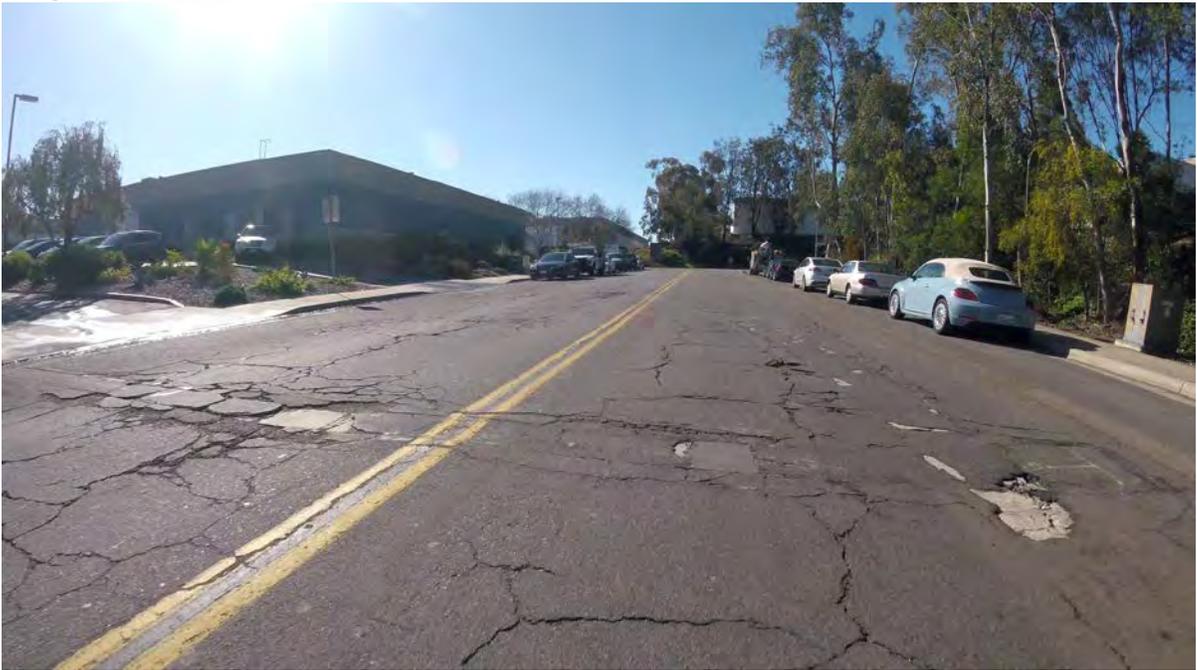
**Image 22: Trade Pl.**

32) Trade Pl.: south bound at 19:24, excessive wear, damage, cracking entire length of road.

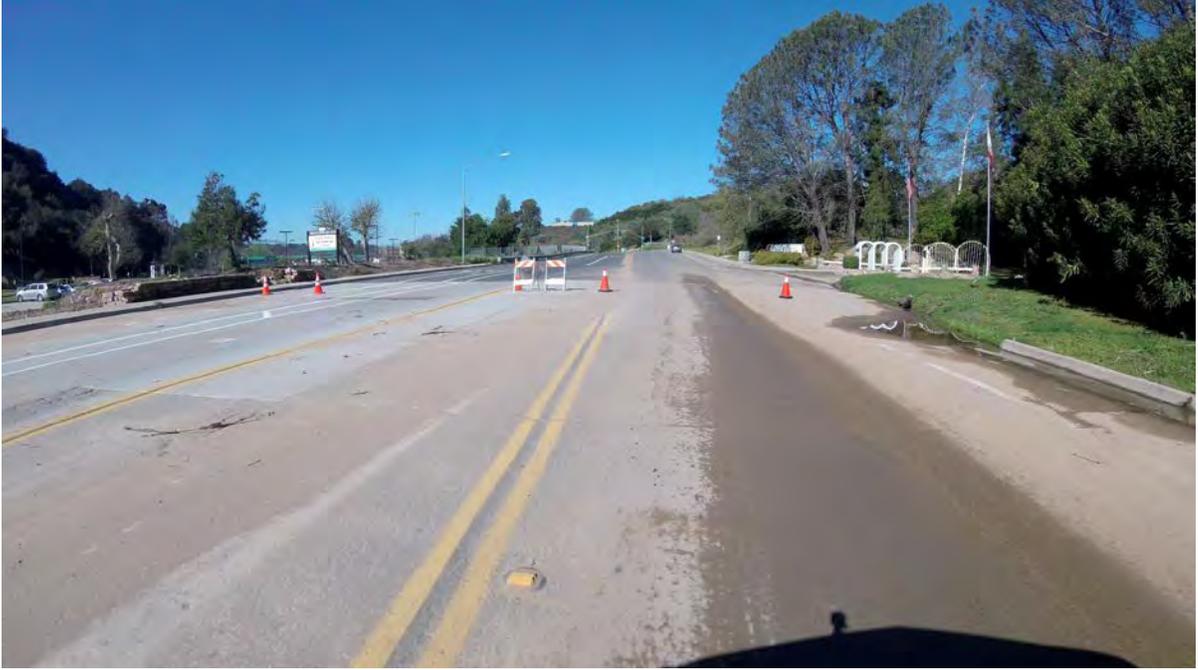
**Image 23: Carroll Rd.**

37) Carroll Rd.: At 26:30 a hole is seen.

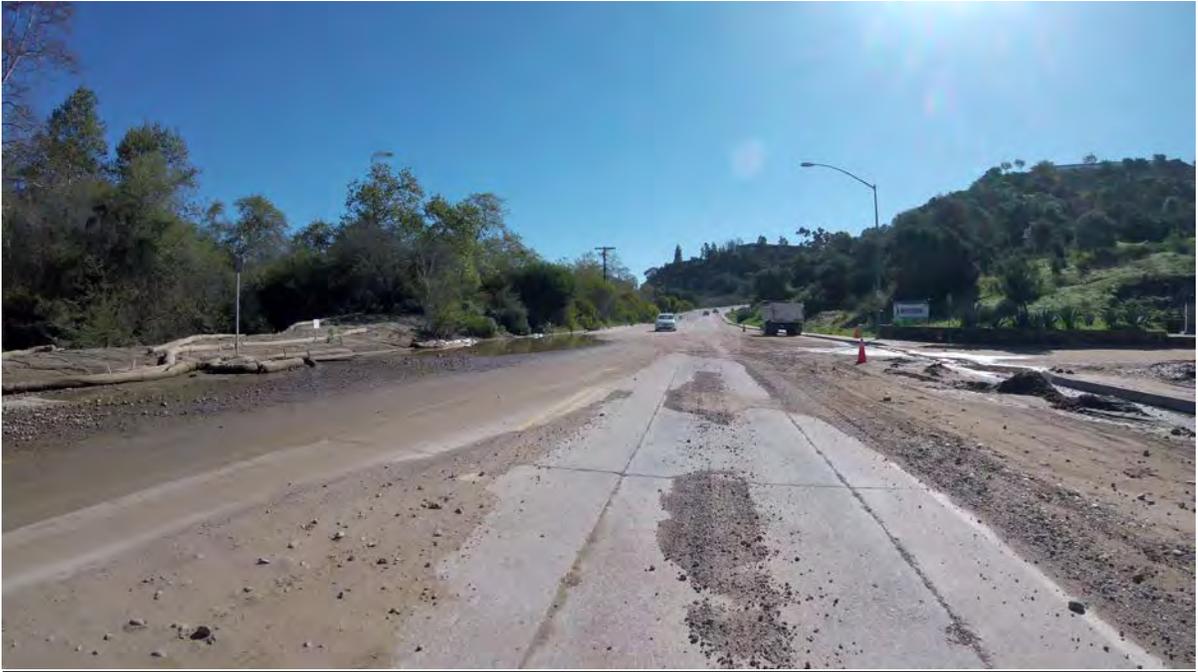
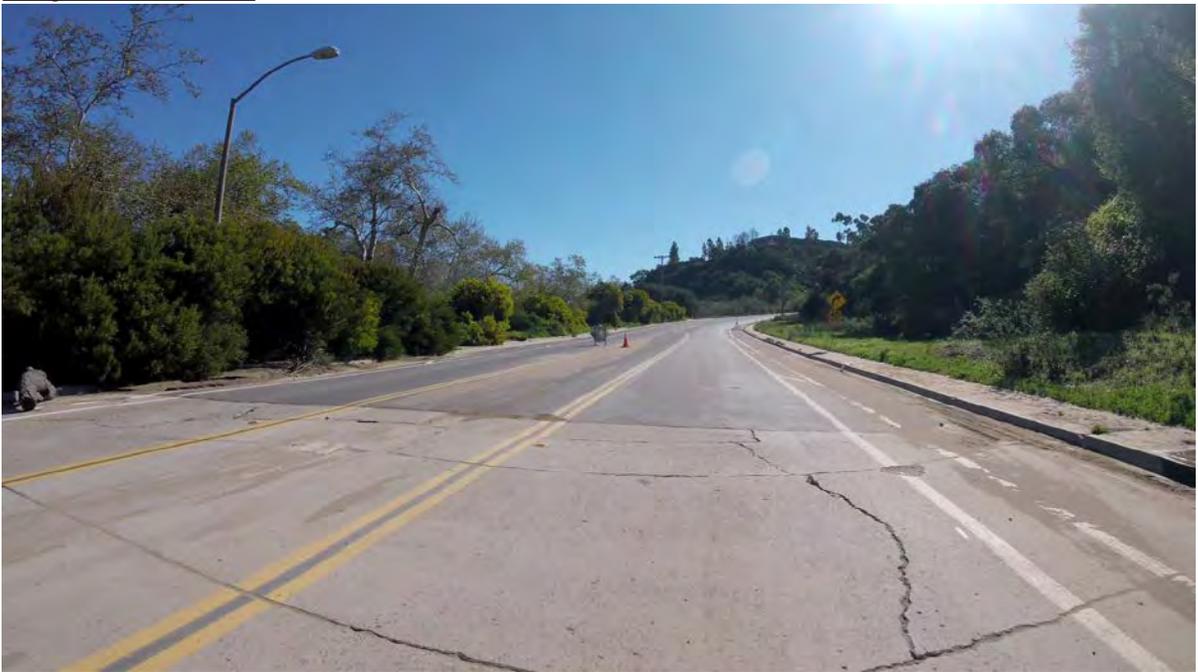
41) Carroll Rd.: major cracking and scratching on concrete portion starting at 2:05 to 2:30. Area is also flooded and muddy. After 2:30 the asphalted area resumes and is in good condition.

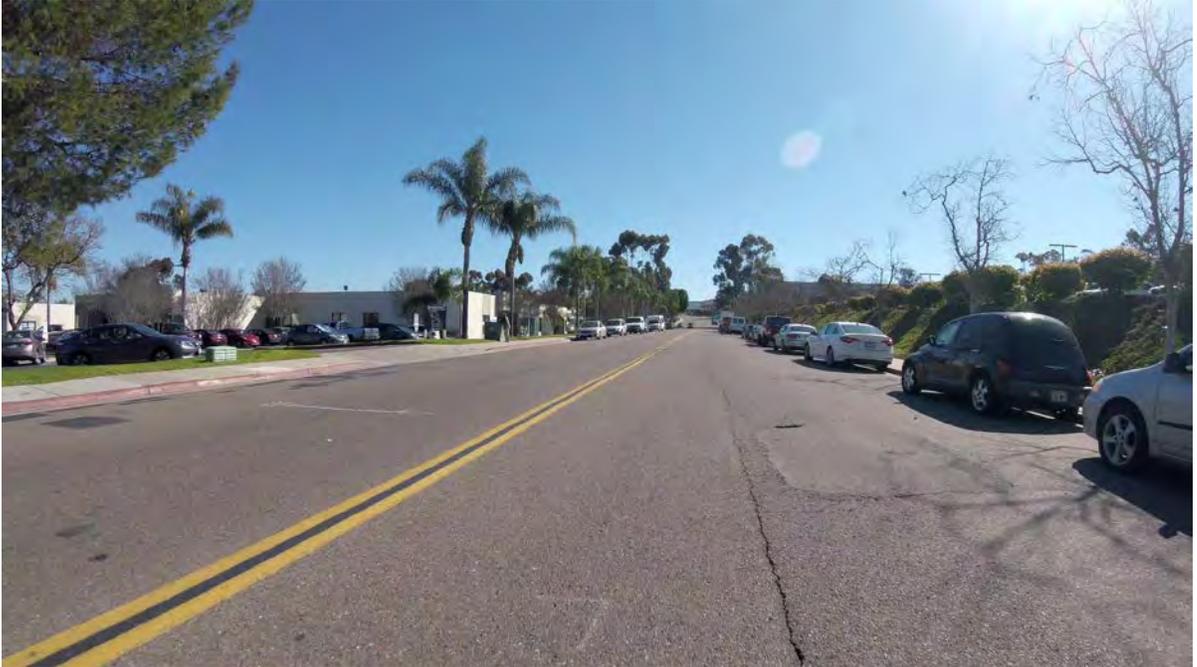
**Image 26: Trade St.**

44) Trade St.: west bound at 5:50, cracking is evident mainly at the center of the west bound lane.
