**MEMORANDUM**

Re: SX-PQ Pre-Construction Road Condition – UG Alignment

On March 1st 2017, Icon Building Supplies conducted a pre-construction road condition video assessment of Sycamore to Penasquitos 230 kV Transmission Line Project (Project) underground alignment to satisfy the pre-construction requirements of mitigation measure TRA-3. This report and the video documents the pre-existing pavement condition along the entire underground alignment of the Sycamore to Penasquitos 230 kV Transmission Line Project. The report provides a summary of the video and includes still frame photos extracted from the video with brief descriptions of observations made along the route. The time in the video is provided along with the name of the roadway.

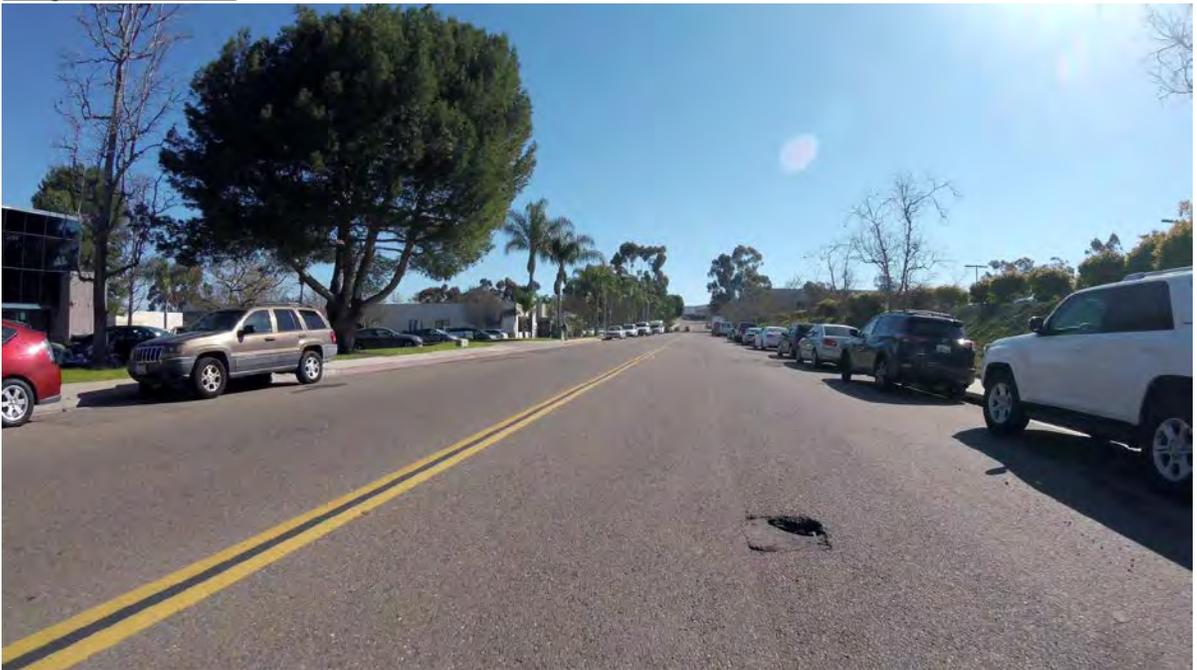
**Image 27: Trade St.**

45) Trade St.: a large pot hole is visible at 06:21.

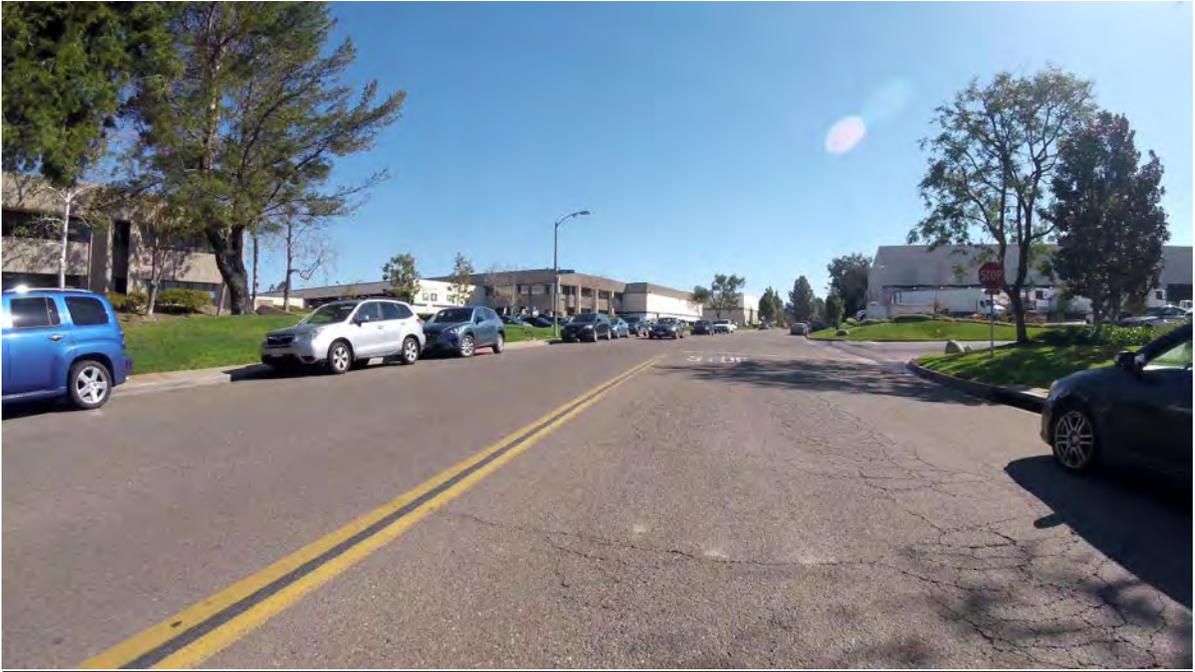
**Image 28: Trade St.**

46) Trade St.: excessive wear to the road is visible at 06:59 just before the intersection of Carroll Rd.

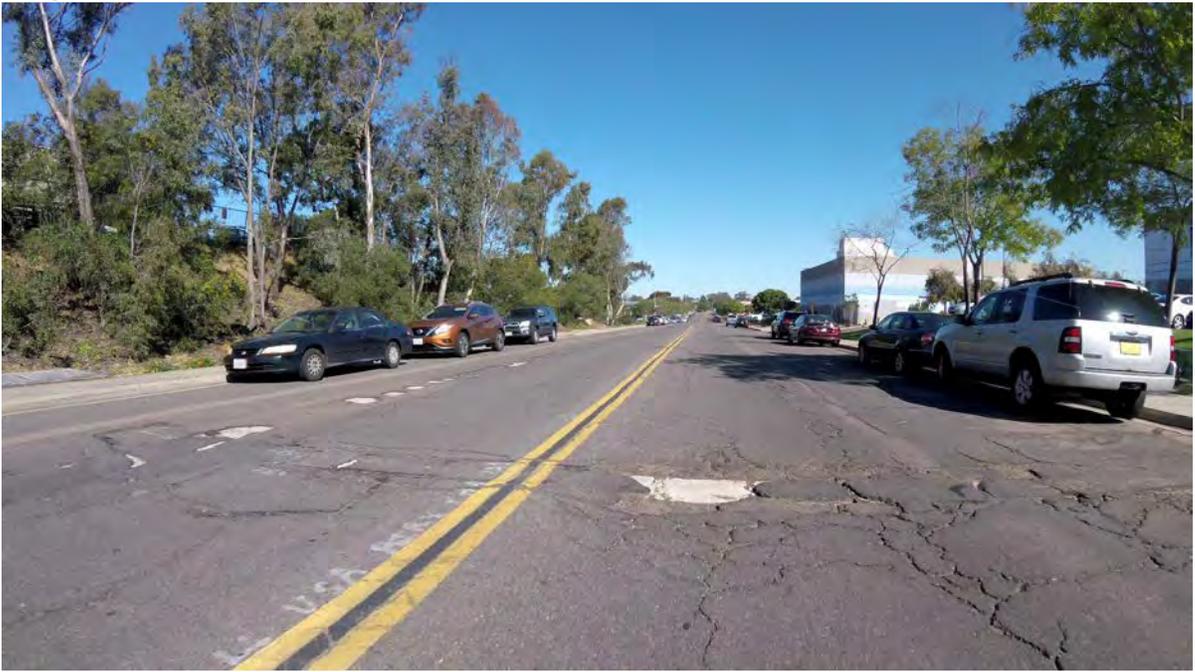
**Image 29: Trade Pl.**

- 47) Trade St.: excessive wear continues until approximately 07:16 where minor cracking only continues along Trade St. with a few sections of excessive wear seen.
- 48) Trade St. to Trade Pl.: north bound at 07:47, the entire north bound portion of Trade Pl. is excessively worn. Large cracks are visible, many potholes are present and large sections of pavement are missing.

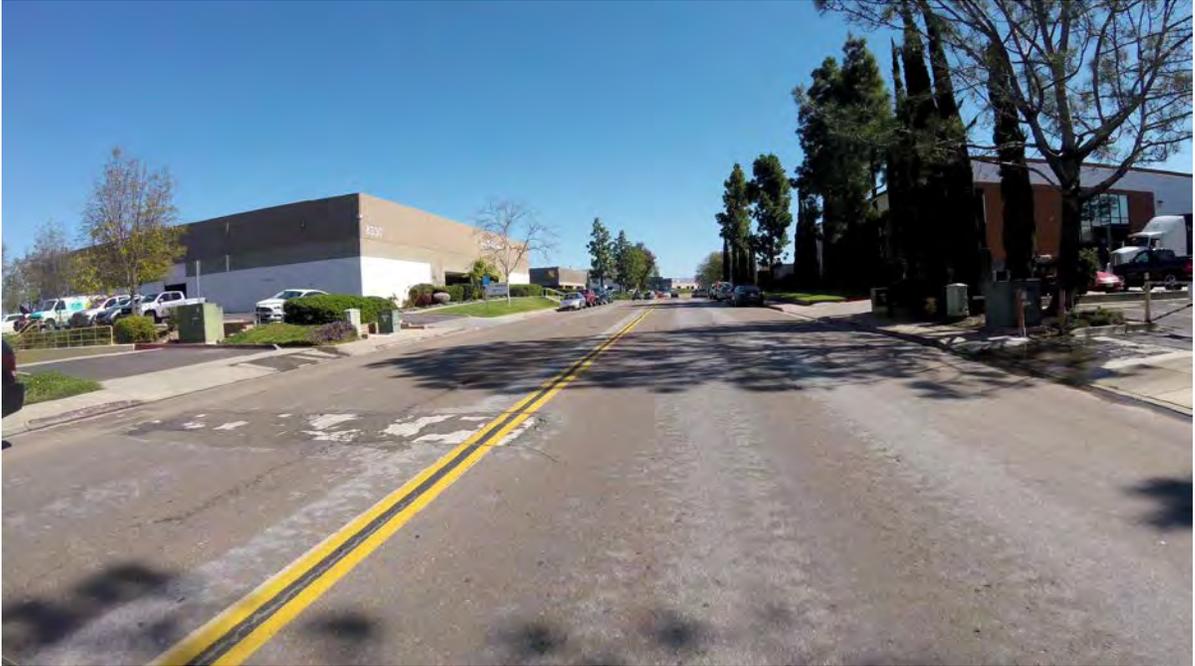
**Image 30: Miralani Dr.**

- 49) Arjon St.: west bound at 08:34, road conditions improve; however cracking is present along the center of the road.
- 50) Miralani Dr.: at 10:06 the route continues north-easterly with minor wear and cracking in many places.
- 51) Miralani Dr. Excessive wear seen at 10:32

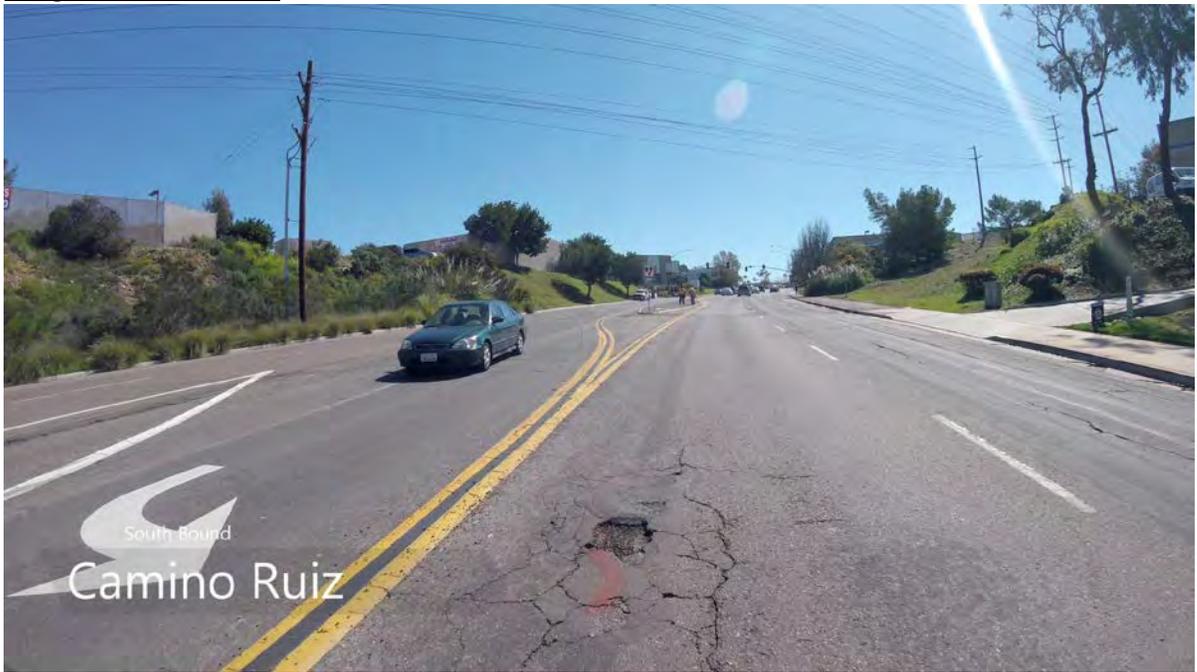
**Image 31: Camino Ruiz**

- 52) Camino Ruiz: At 11:29 the route continues south, many areas of cracking pavement and excessive wear seen at 11:36.

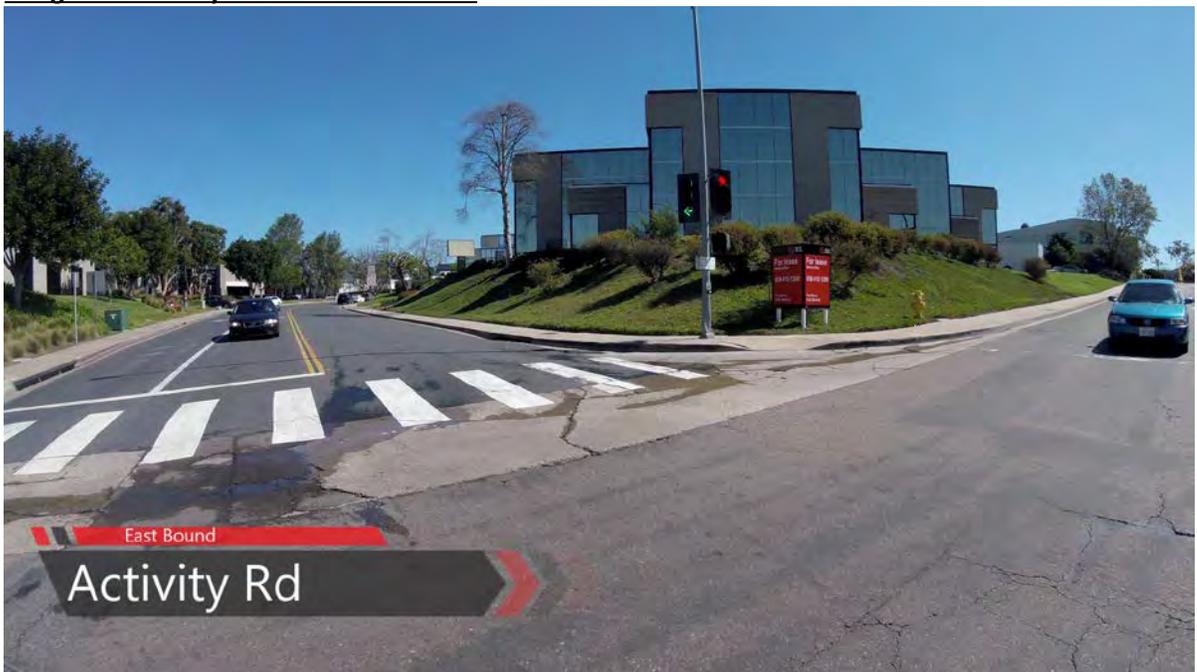
**Image 32: Activity Rd. and Camino Ruiz**

53) Activity Rd. and Camino Ruiz: west bound at 11:52, excessive wear and cracking at the intersection to the concrete drainage channel.

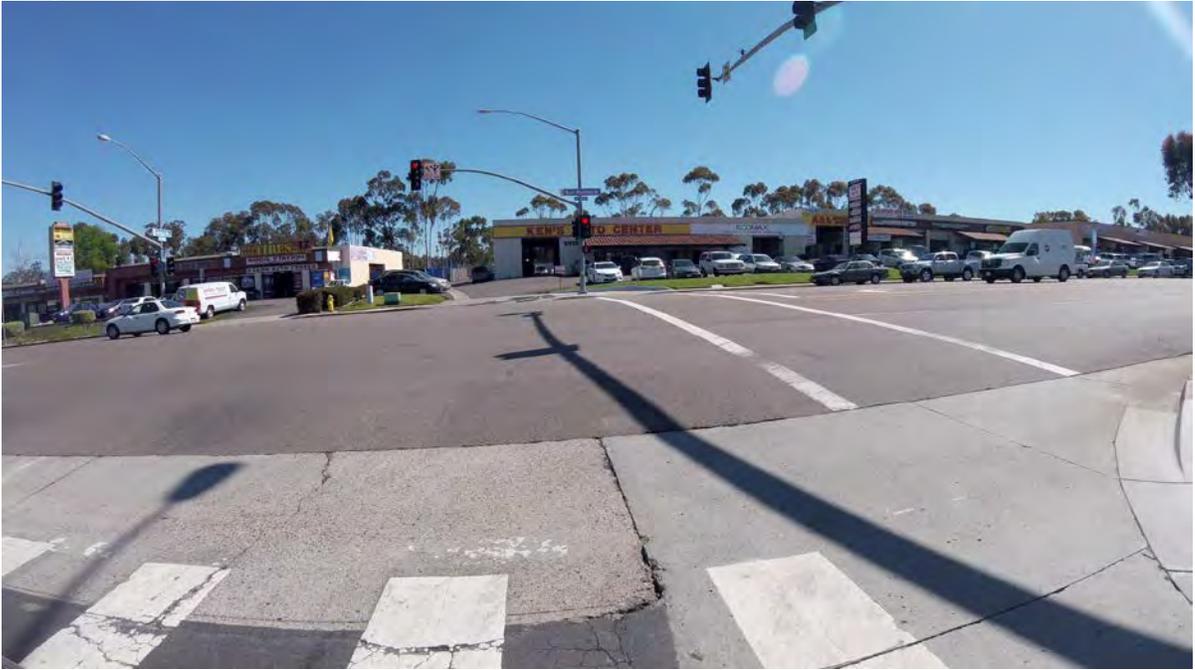
**Image 33: Black Mountain Rd.**

55) Black Mountain Rd.: at 13:30, route turn south bound, cracking is visible at the intersection in the concrete drainage channel.

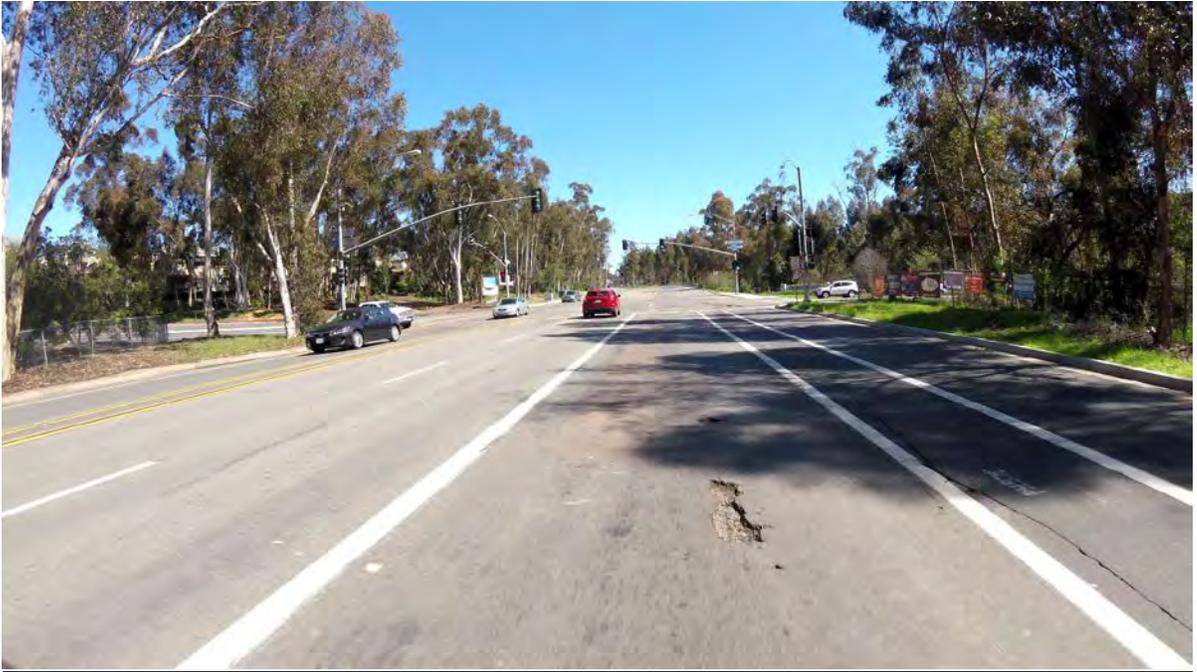
**Image 34: Pomerado Rd.**

60) Pomerado Rd.: Pothole at 17:09

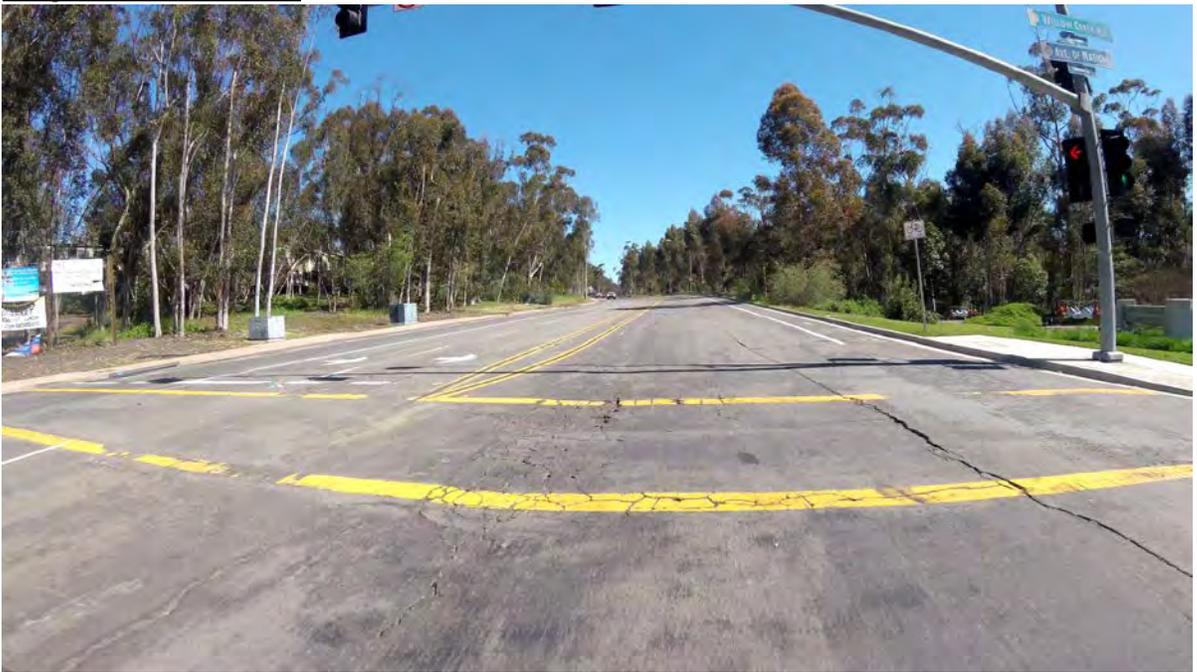
**Image 35: Pomerado Rd.**

61) Pomerado Rd.: Excessive wear continues through the intersection at Willow Creek Rd. at 17:10

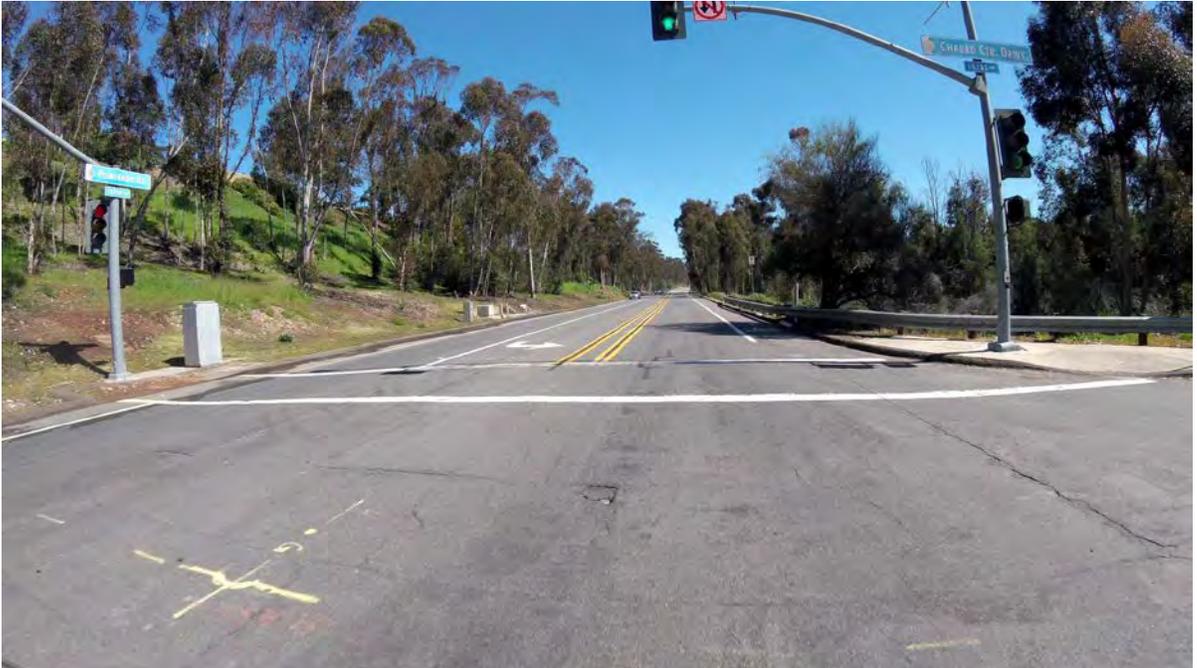
**Image 36: Pomerado Rd.**

63) Pomerado Rd.: Conditions improve at 17:52 and there is cracking at 18:56 @ Intersection of Chabad Ctr Drwy.

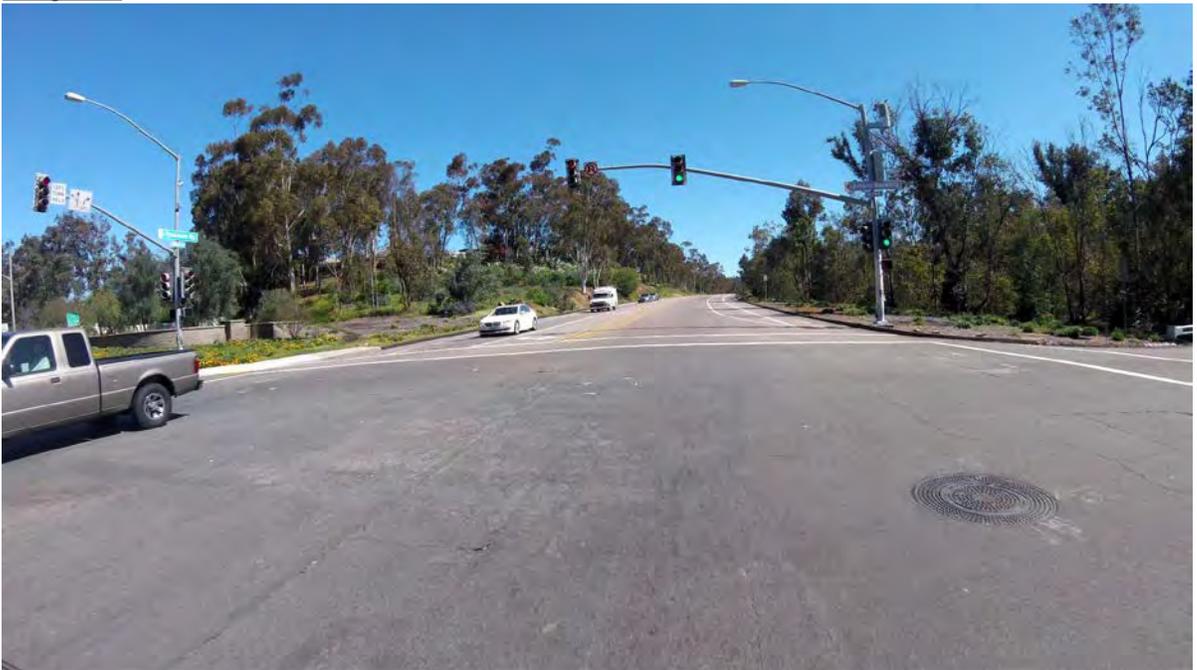
**Image 37: Pomerado Rd.**

64) Pomerado Rd.: Cracking is seen at 19:26 @ Intersection of Avenida Magnifica.

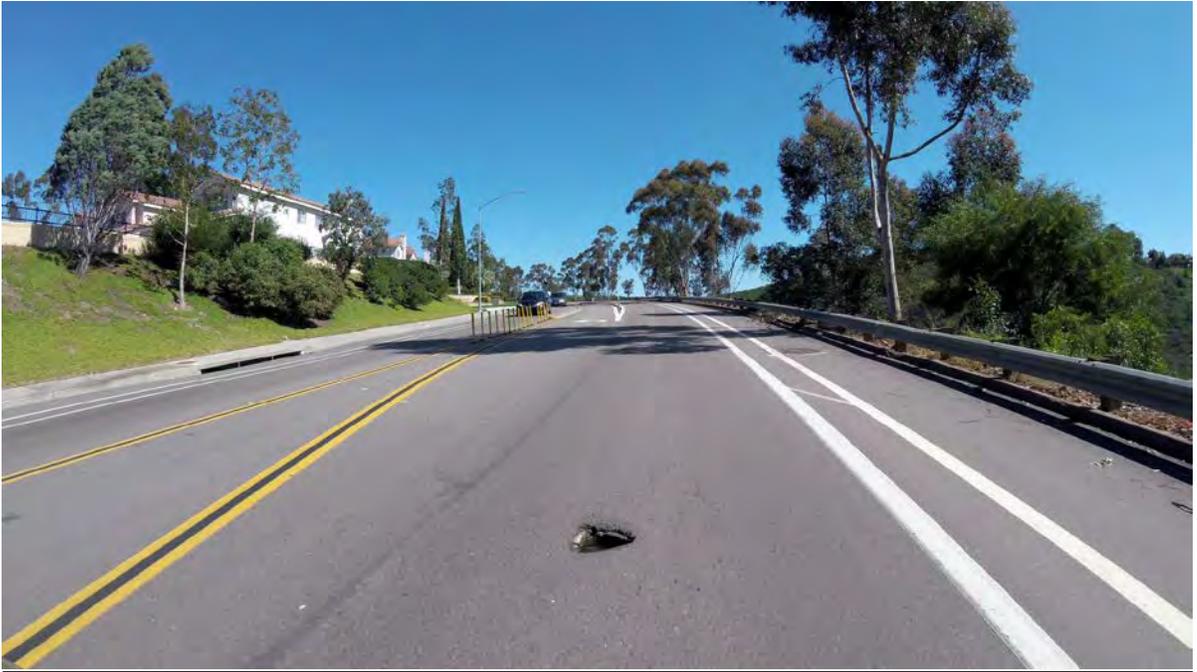
**Image 38: Pomerado Rd.**

65) Pomerado Rd.: Conditions improve after this until a hole seen at 22:25.

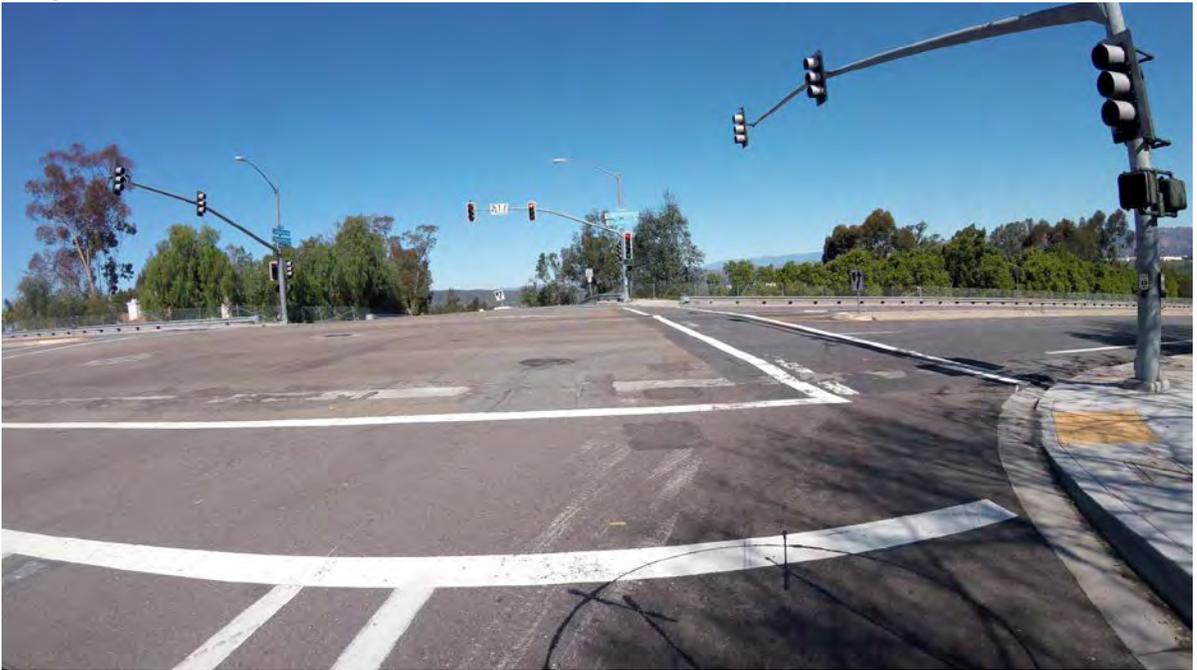
**Image 39: Pomerado Rd.**

66) Pomerado Rd.: Excessive wear at 22:58
