## PROJECT MEMORANDUM SYCAMORE-PEÑASQUITOS 230-KV TRANSMISSION LINE PROJECT

To: Billie Blanchard, CPUC Project Manager
From: Sheila Hoyer, CPUC Monitoring Supervisor
Subject: Weekly Report #14 – April 2 to April 7, 2017

#### SDG&E Sycamore-Peñasquitos 230-kV Transmission Line Project: Daily Inspection Report

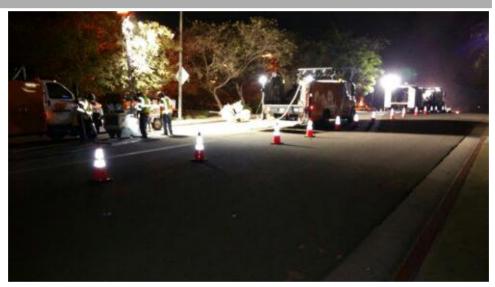
Caption Saw cutting pavement.

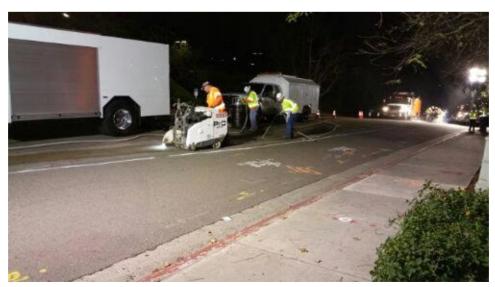
Caption Saw cutting followed by vacuum to pick up most dust.

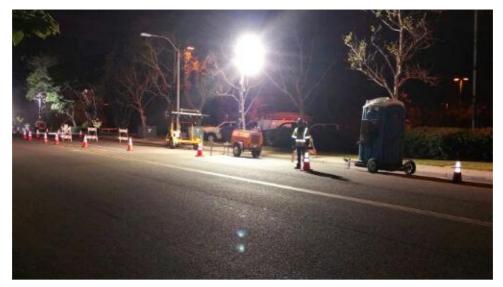
Caption Flaggers at west end of work area.

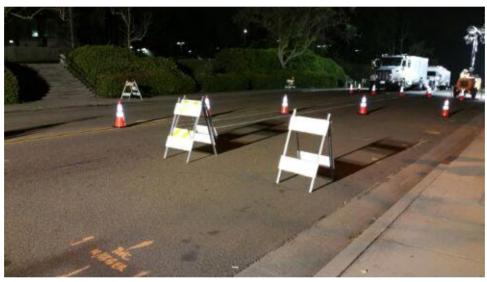
Caption Type 2 barriers.

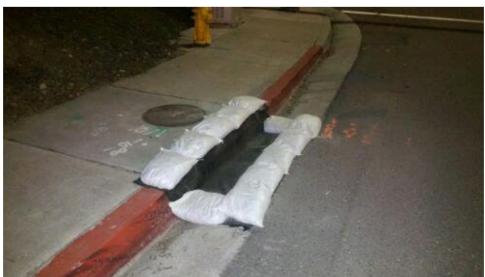
Caption Inlet protection installed.

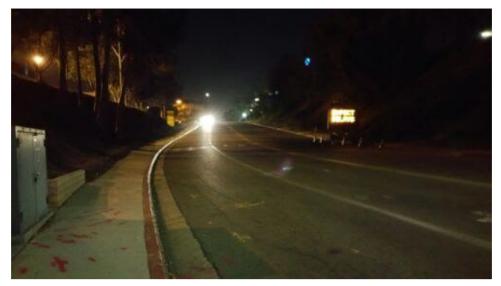
Caption Trade Street site at start of work.

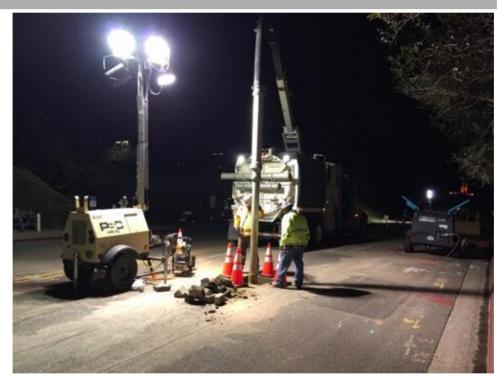
Caption Vacuum truck siphoning out debris.

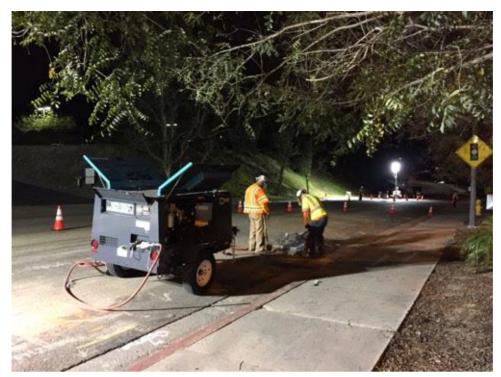
Caption Removing asphalt with jack hammer

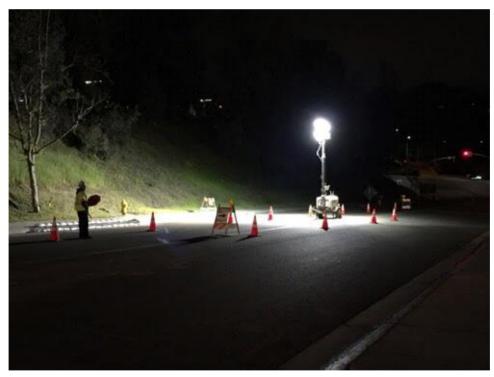
Caption Lighting, cones, traffic safety monitors in place.

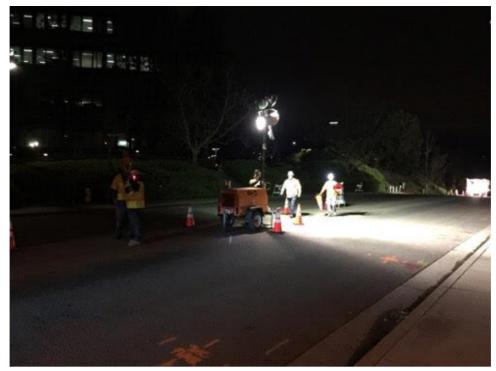
Caption Setting up lighting.

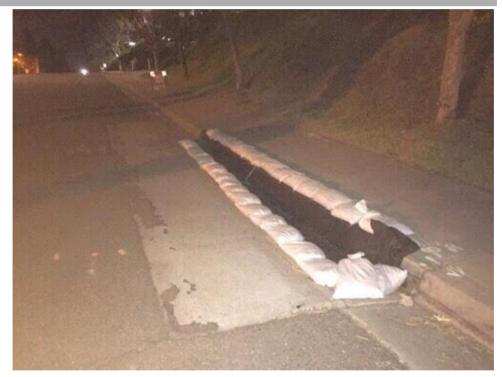
Caption BMP's were in place and in working condition

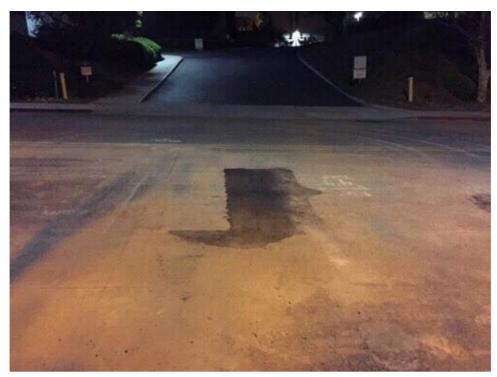
Caption Road work repaired to previous condition

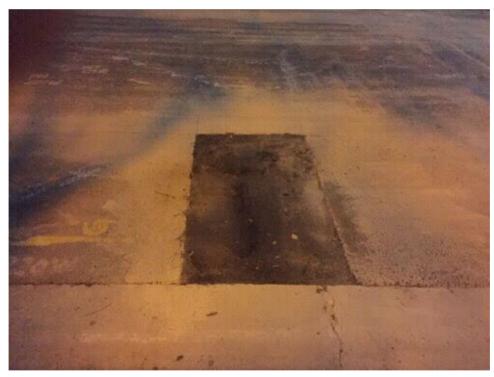
Caption Excavations restored to original condition

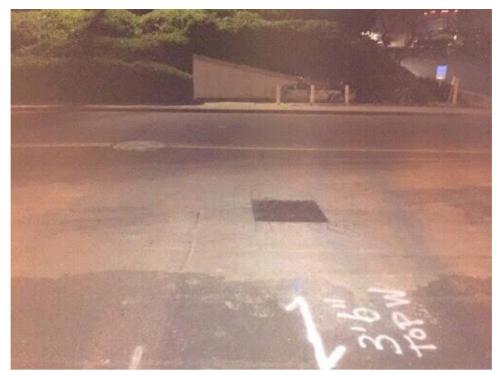
Caption Exposed areas were restored.

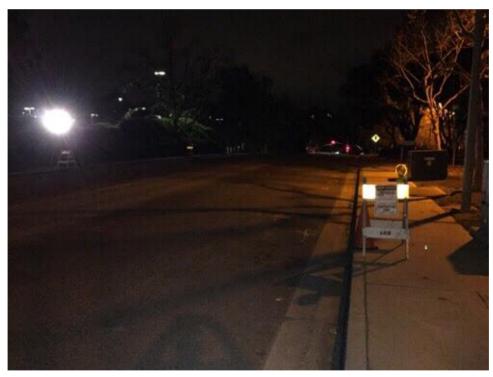
Caption Site was left clean and free of debris

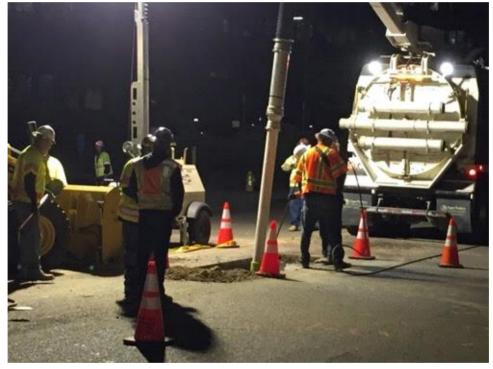
Caption Vacuum truck evacuation of trench.

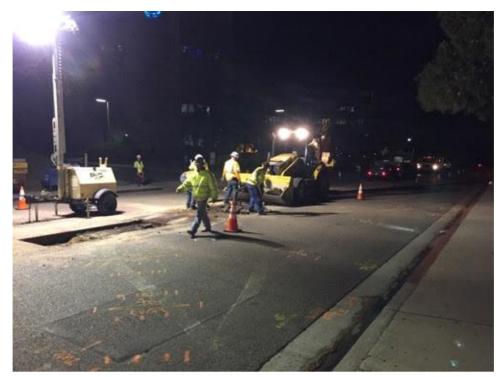
Caption Removing asphalt debris from the street

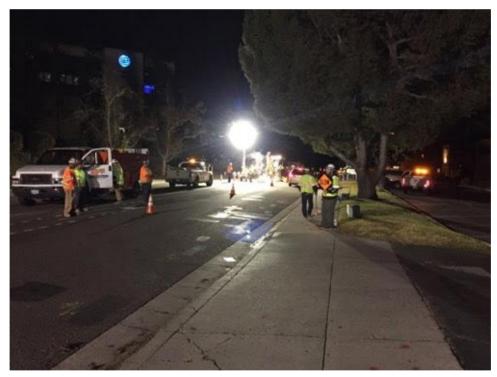
Caption Traffic flaggers directing traffic.

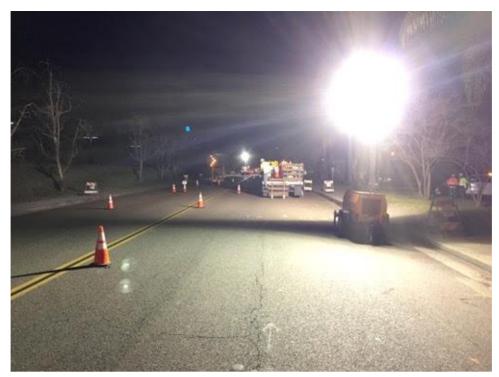
Caption Lighting was in place and work areas were well lit.

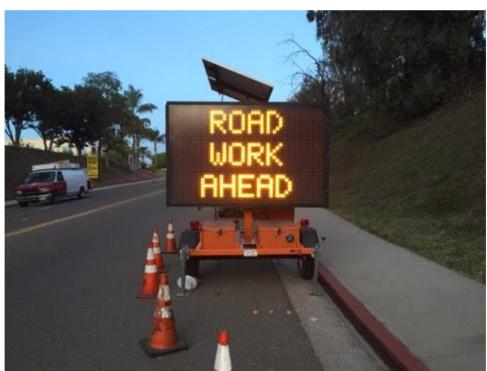
Caption Electric road construction sign

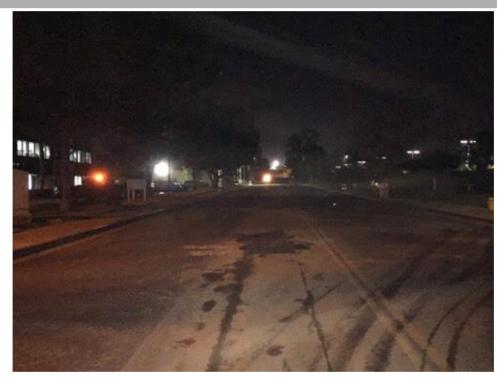
Caption Street returned to previous condition

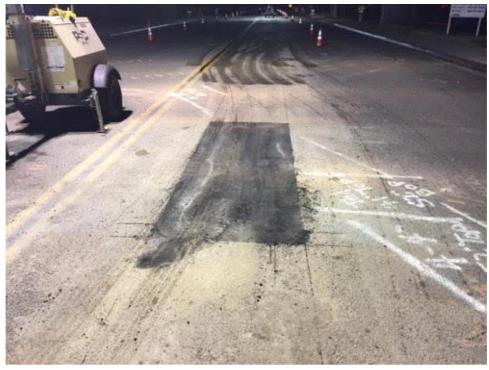
Caption Roadwork patched after completion.

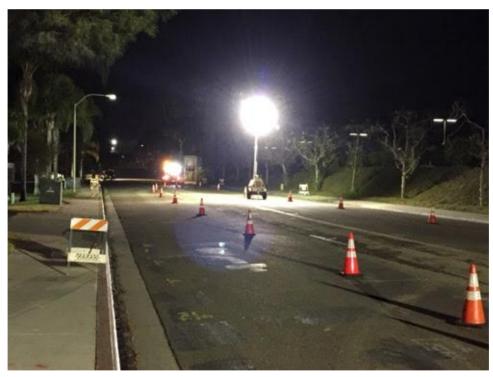
Caption Equipment being taken down.

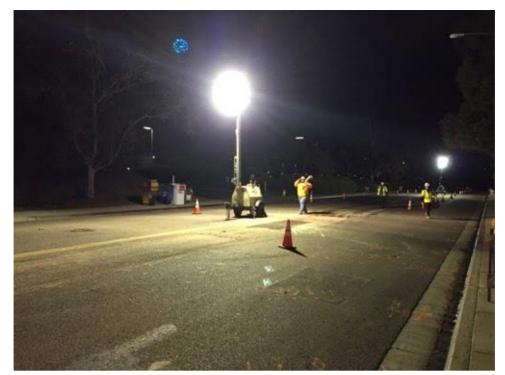
Caption Lighting being taken down

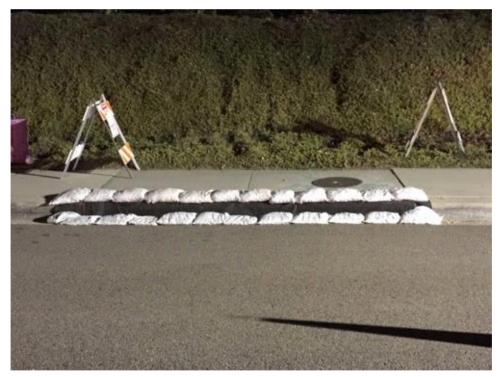
Caption SWPPP BMP's were in place

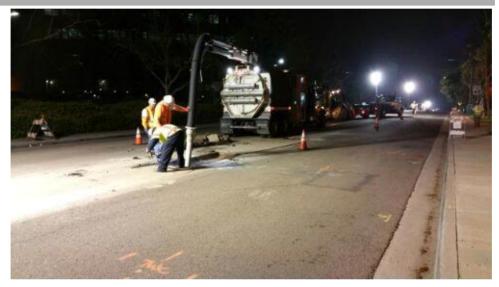
Caption Potholing.

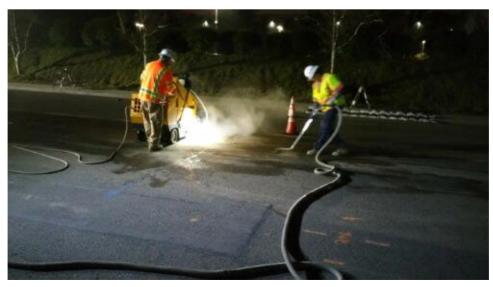
Caption Saw cutting and vacuuming.

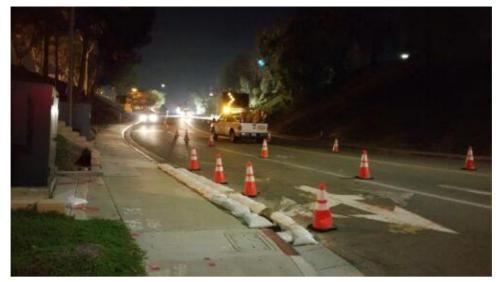
Caption Cones set up at west end of Trade St (Camino Santa Fe).

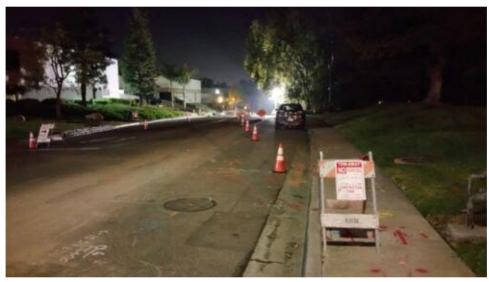
Traffic control set up at east end of Trade St site (Carroll St). Caption
