**PROJECT MEMORANDUM  
SYCAMORE-PEÑASQUITOS 230-KV  
TRANSMISSION LINE PROJECT**

Date: May 26, 2017  
To: Billie Blanchard, CPUC Project Manager  
From: Sheila Hoyer, CPUC Monitoring Supervisor  
**Subject:** Weekly Report #20 – May 14 to May 19, 2017

## SDG&E Sycamore-Peñasquitos 230-kV Transmission Line Project: Daily Inspection Report

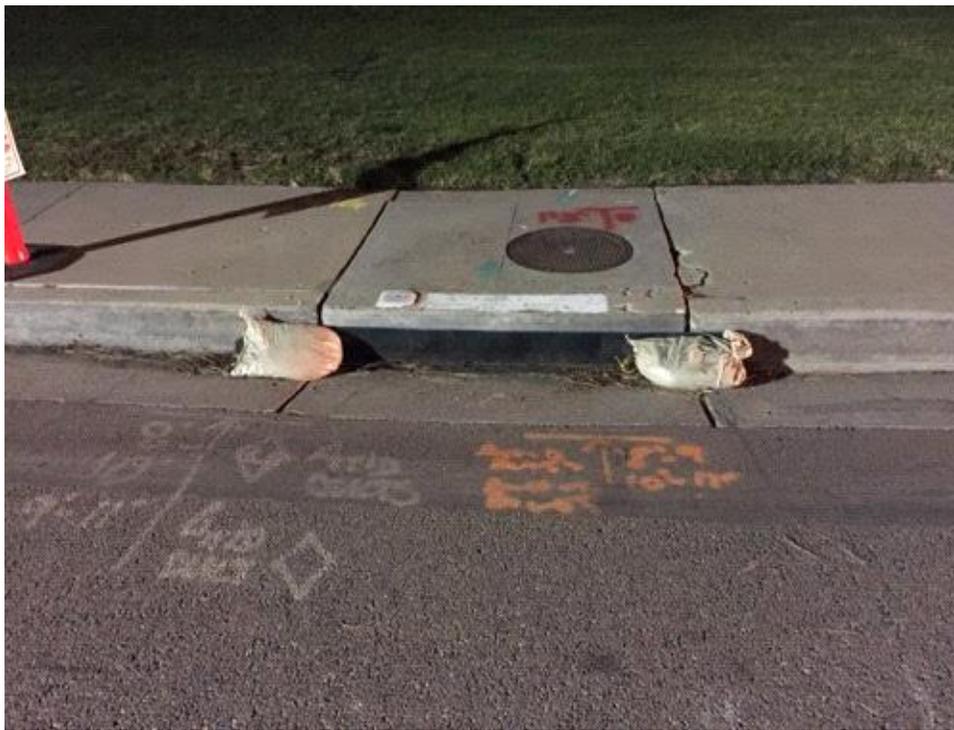
Caption BMPs in place and in good working condition.

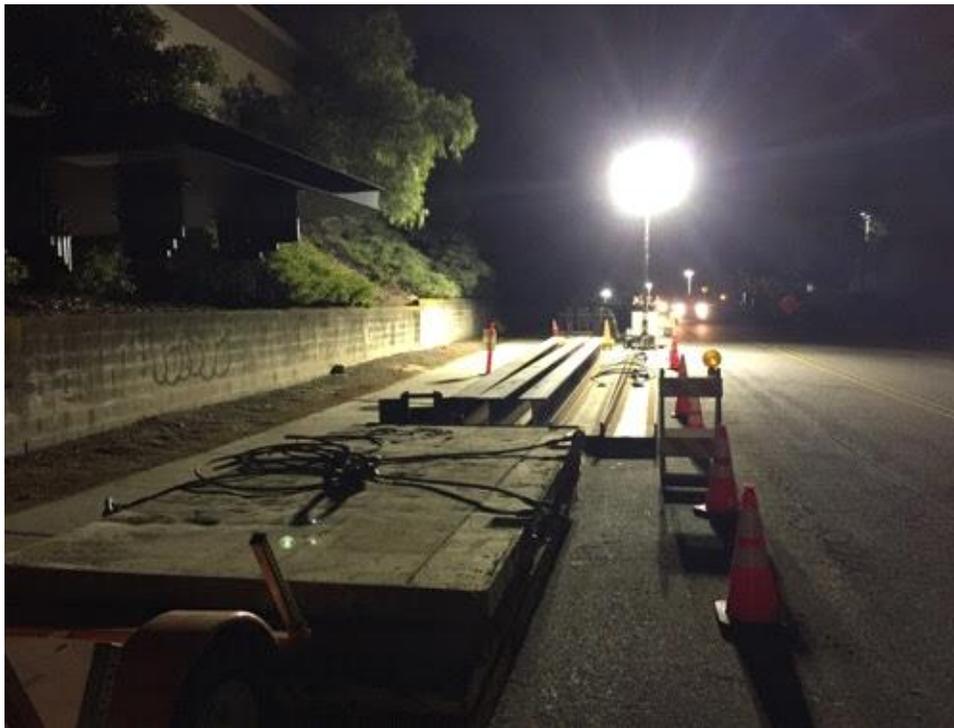
Caption I-beams and equipment stored on side of the street with cones in place.

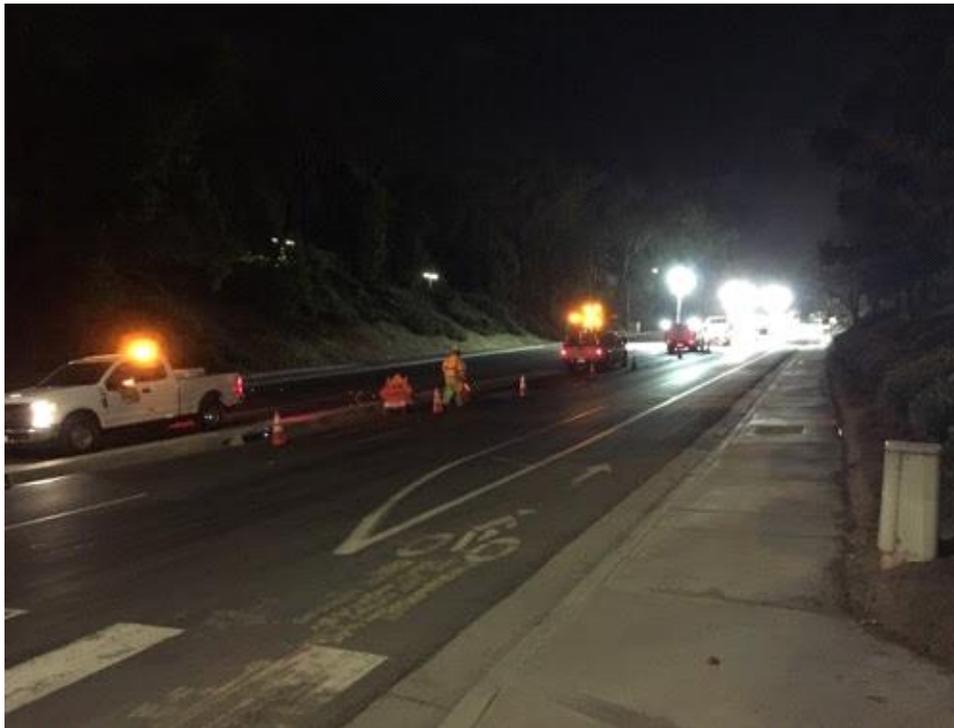
Caption Digital traffic signage in use with cones in place.

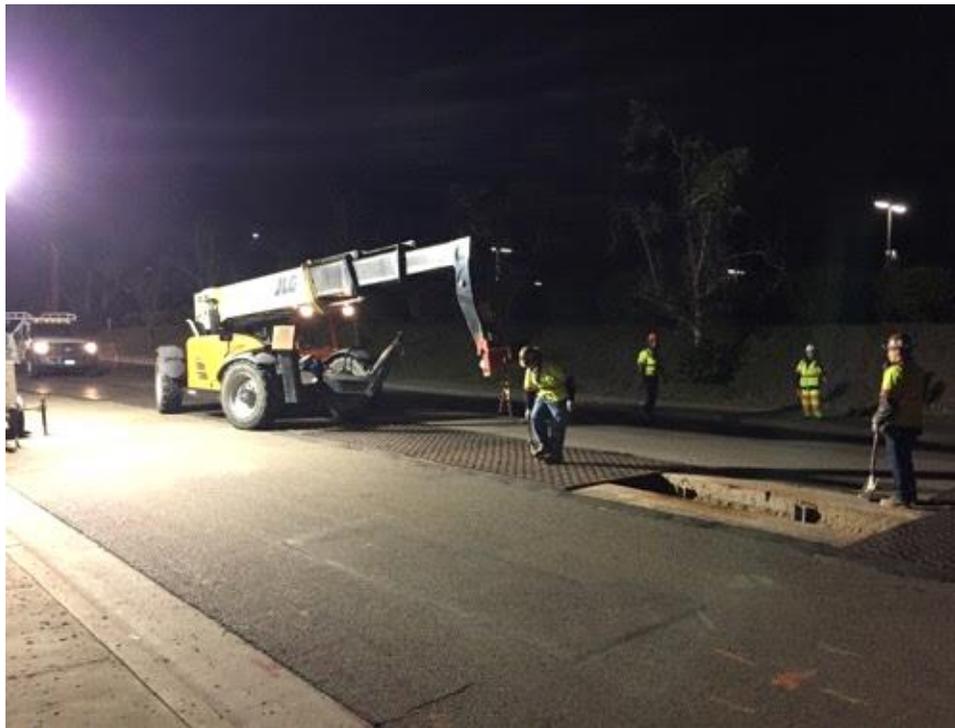
Caption Removing steel plates from over the trenches.

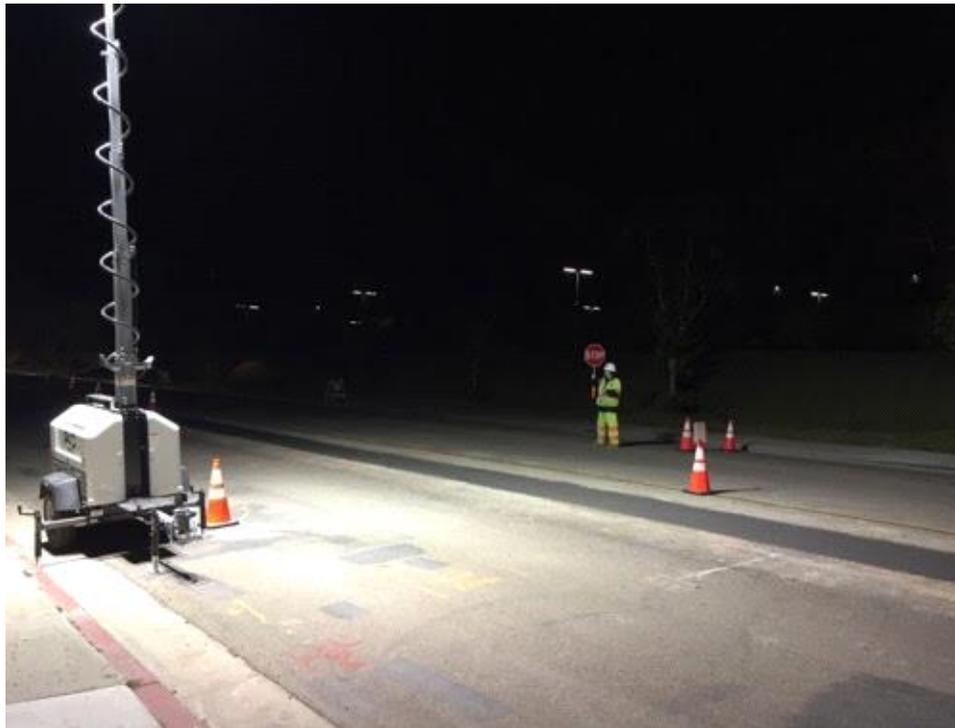
Caption Traffic flaggers in place.

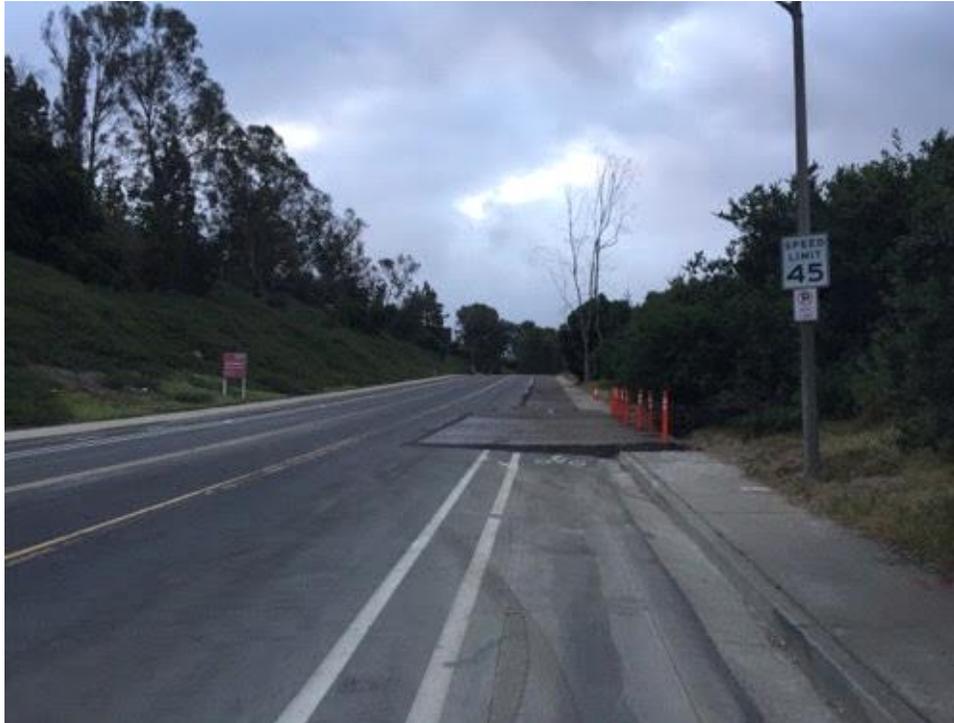
Caption Equipment returned to designated areas and streets swept.

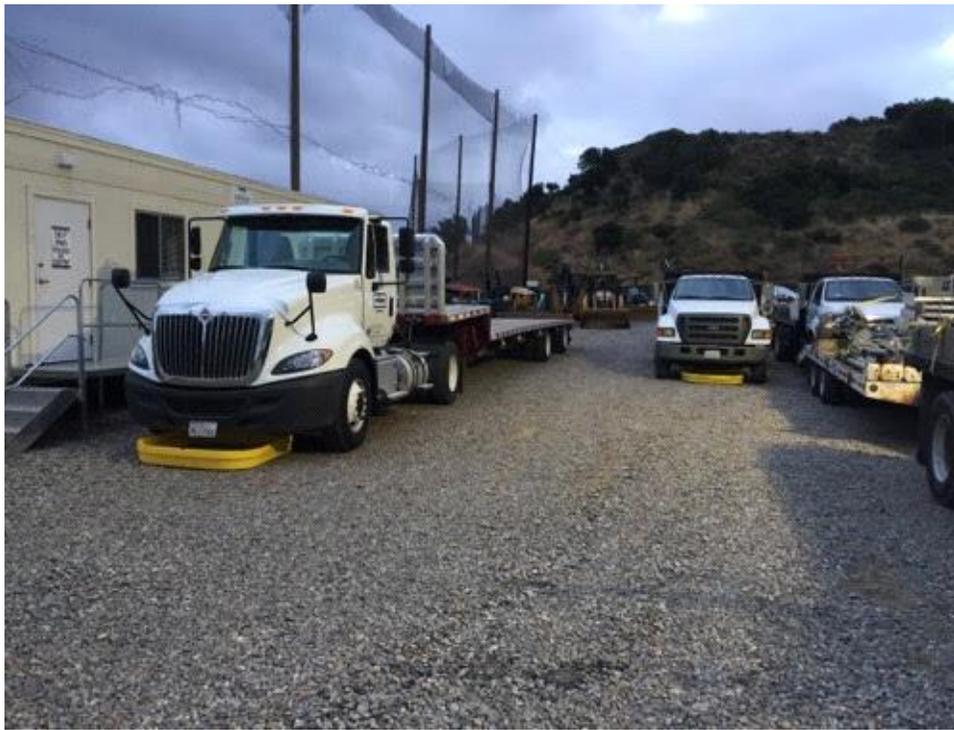
Caption Drip pans in place.

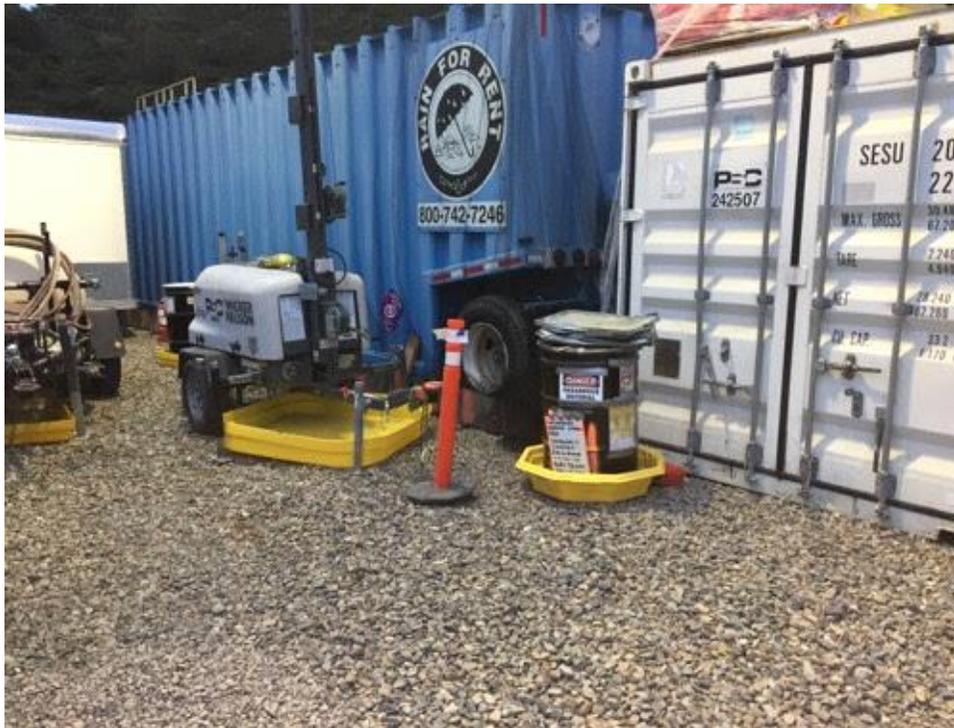
Caption Hazardous waste clearly labeled and stored in secondary containment.

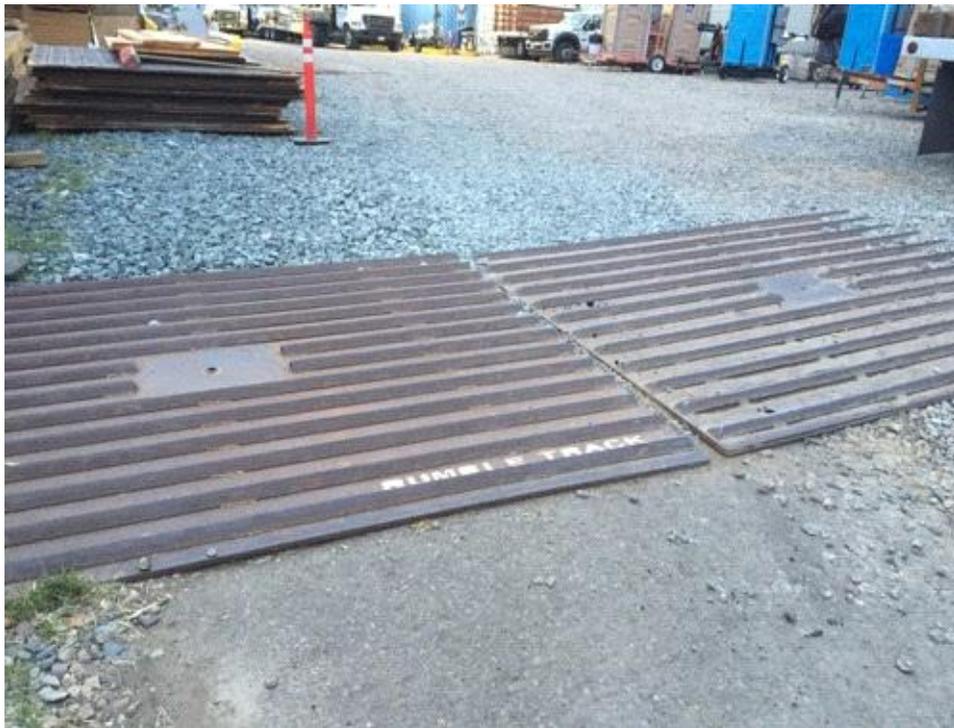
Caption Steel shaker plates installed at storage yard entrance.

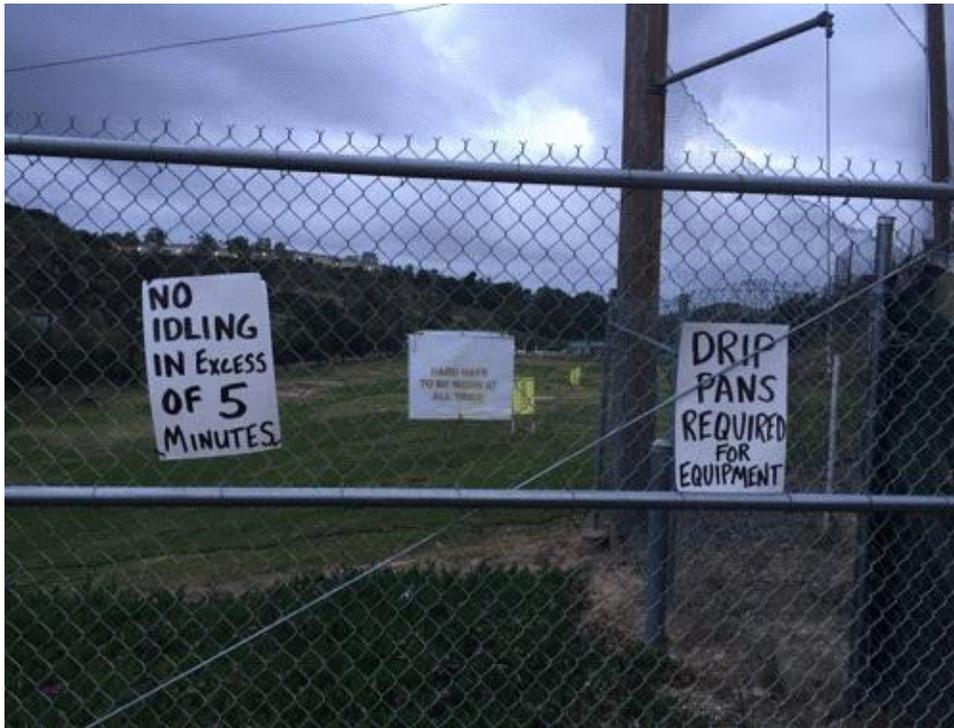
Caption Project requirement signage at storage yard entrance.

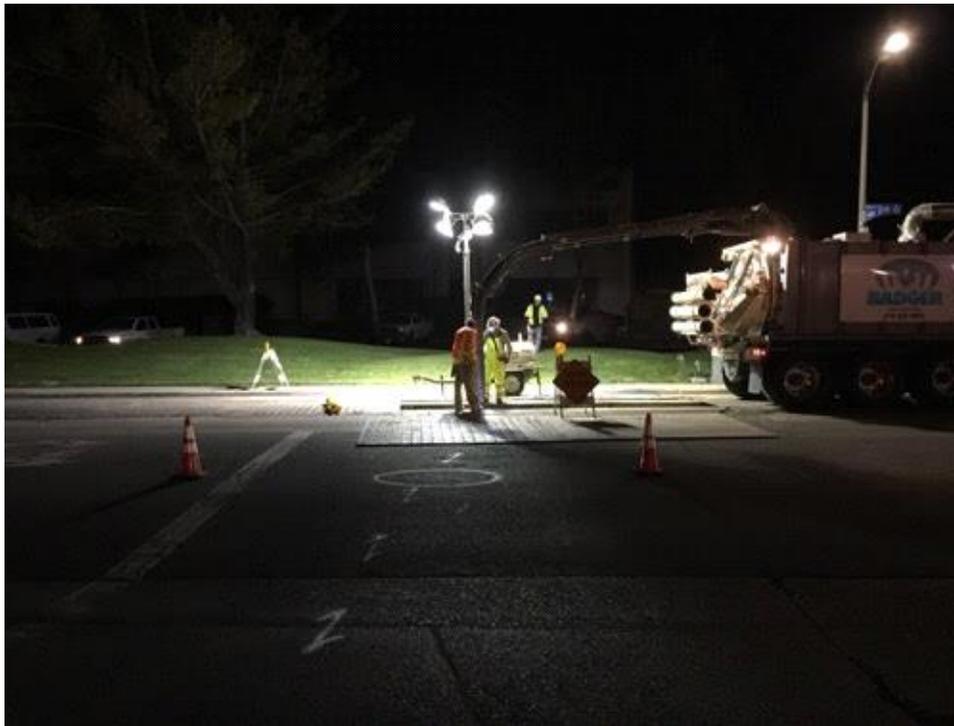
Caption Potholing on Trade Street

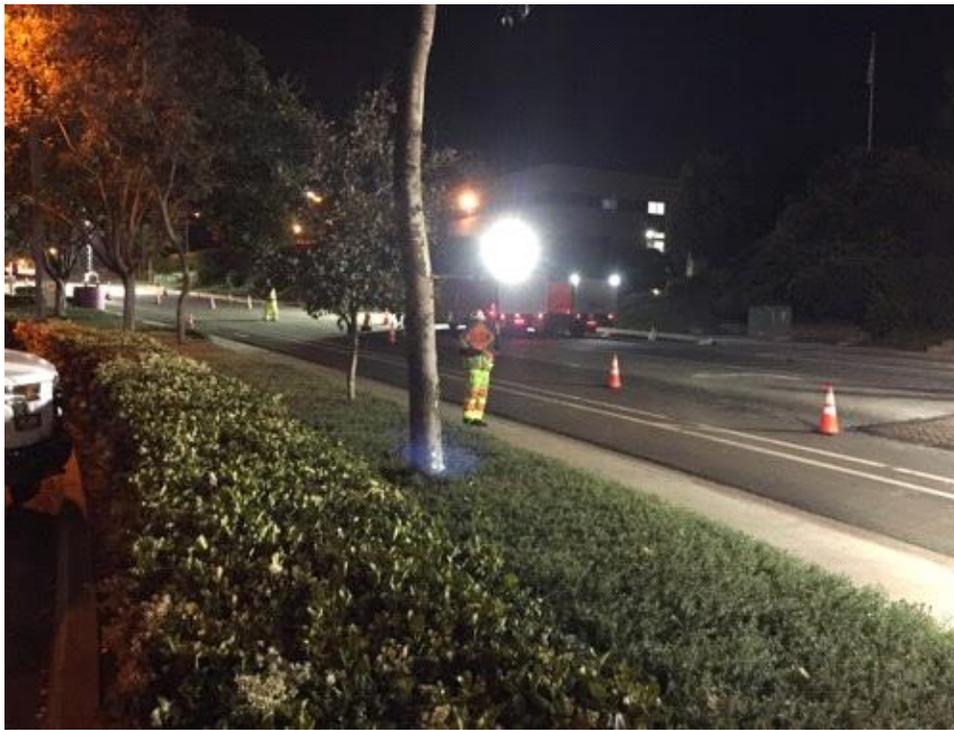
Caption Traffic flaggers at work.

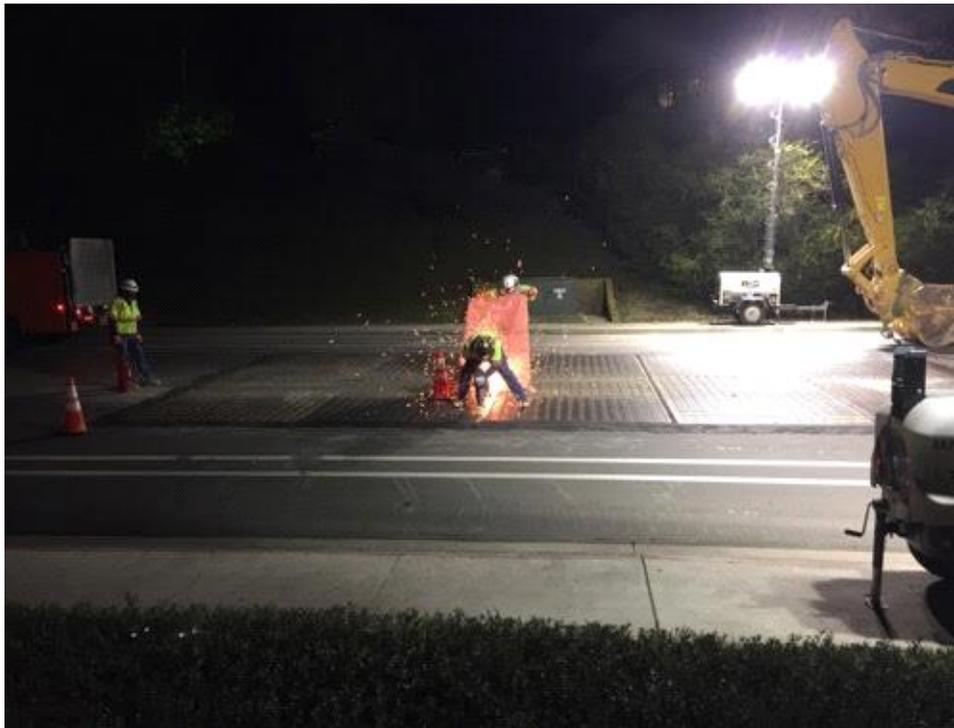
Caption Fire prevention blanket in use

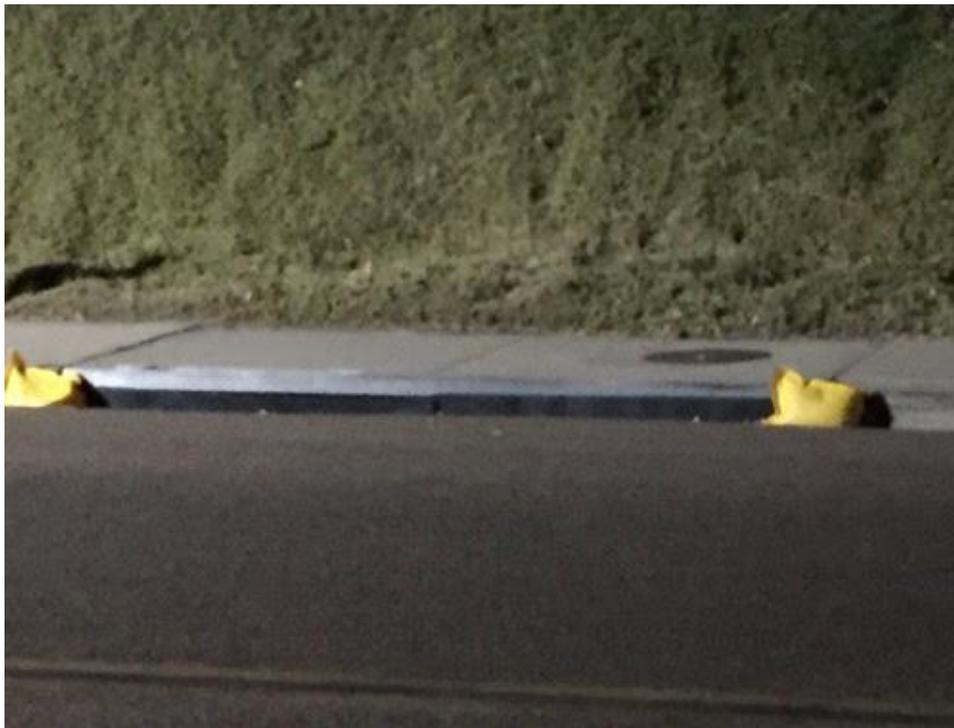
Caption BMPs in place.

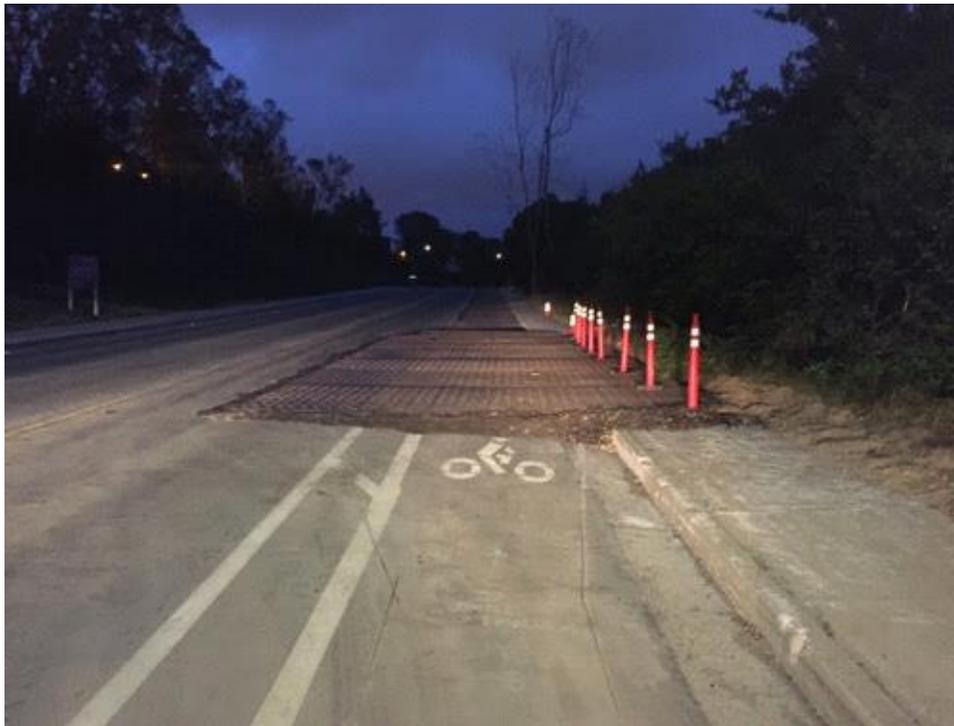
Caption Vault covered with steel plates and sealed with asphalt.

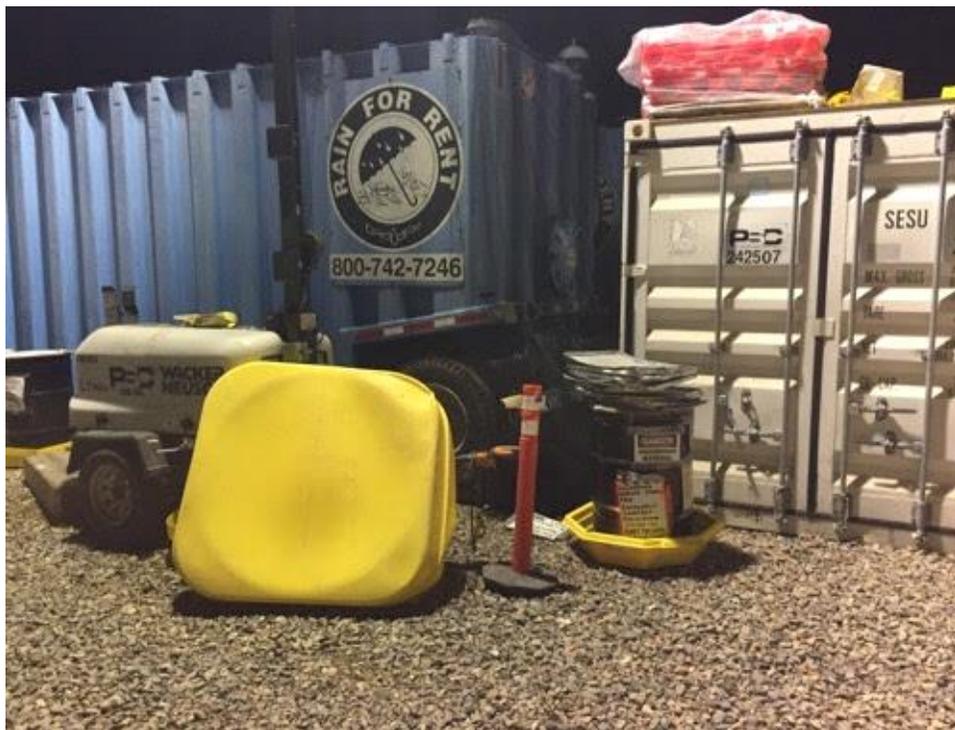
Caption Hazardous materials clearly labeled and in secondary containment.

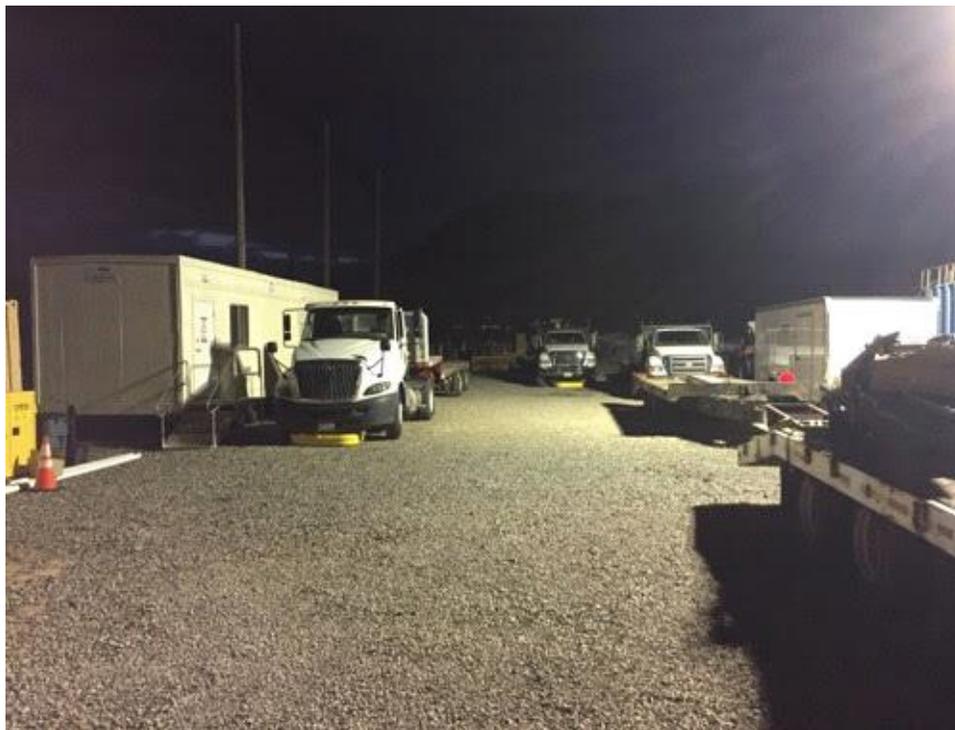
Caption Drip pans in place.

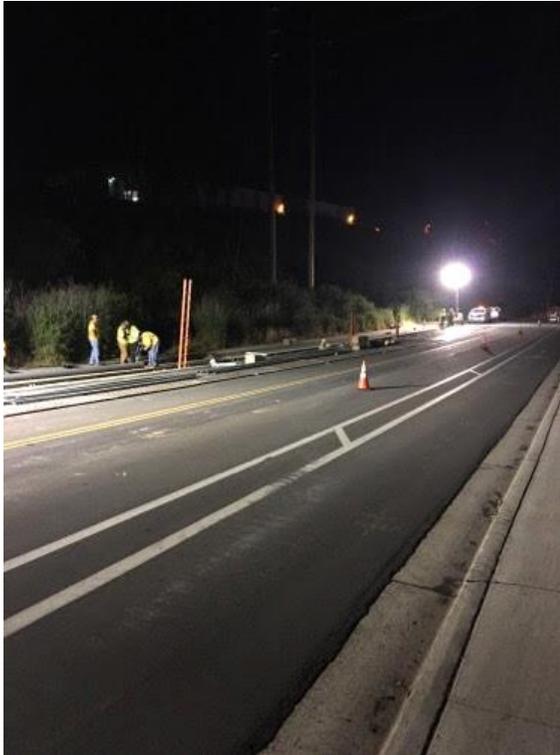
Caption Conduit installation on Carrol Road.

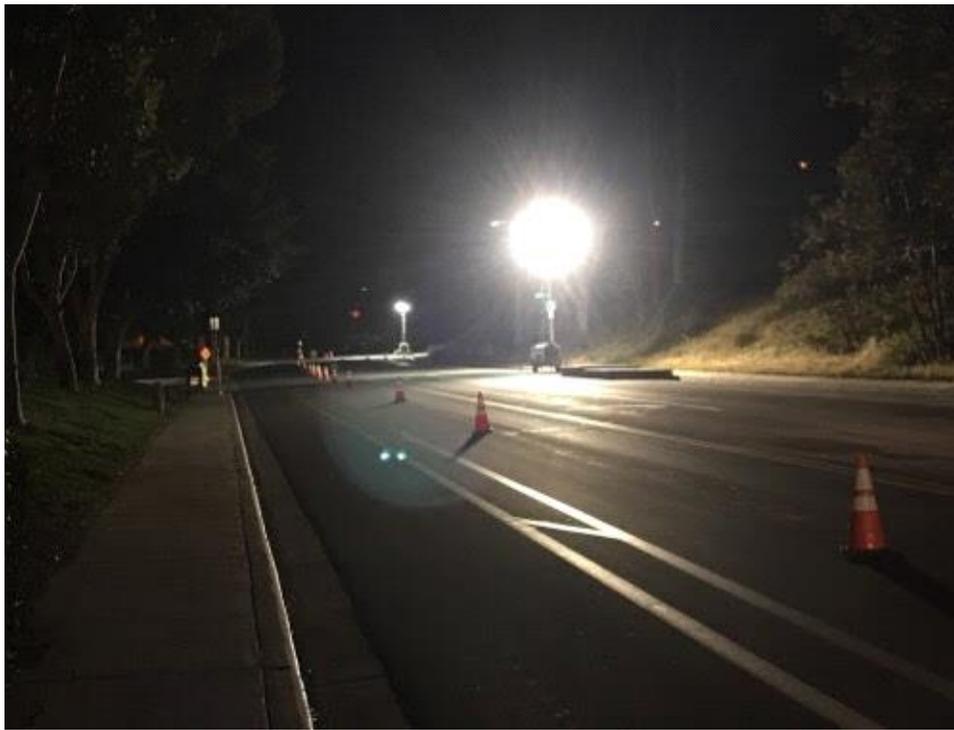
Caption Traffic control on Carrol Road.

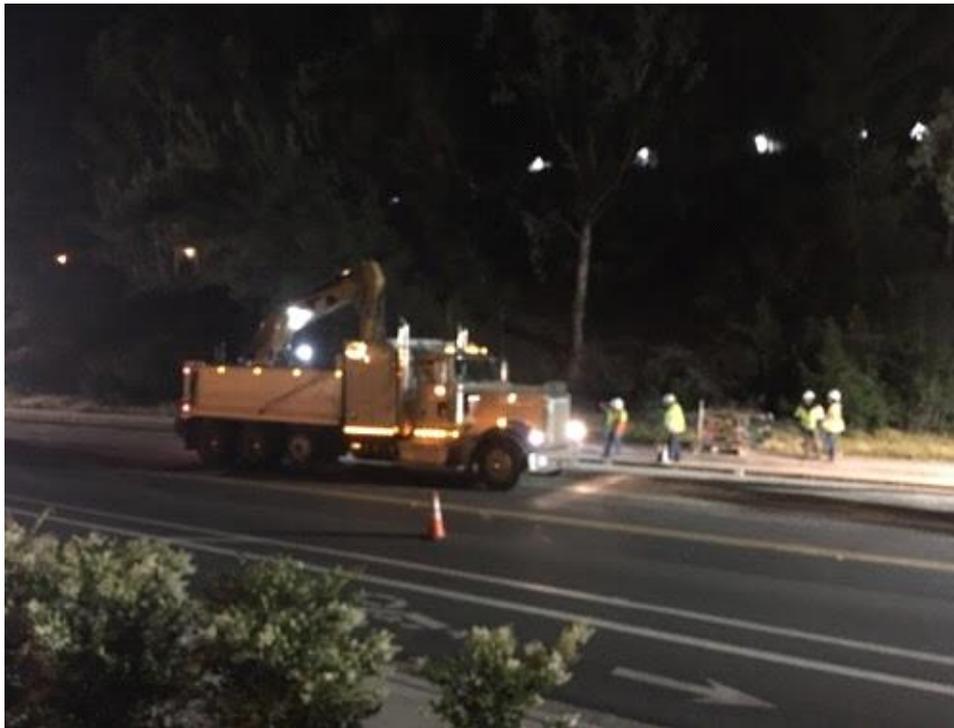
Caption Excavation on Carrol Road.

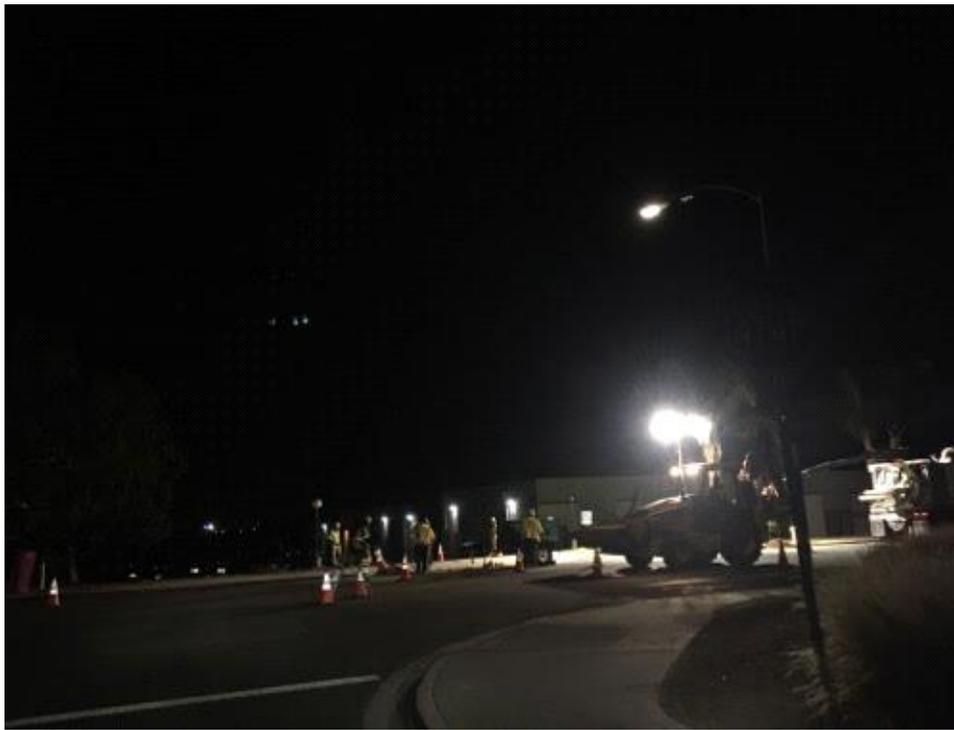
Caption Potholing on Carrol Road.

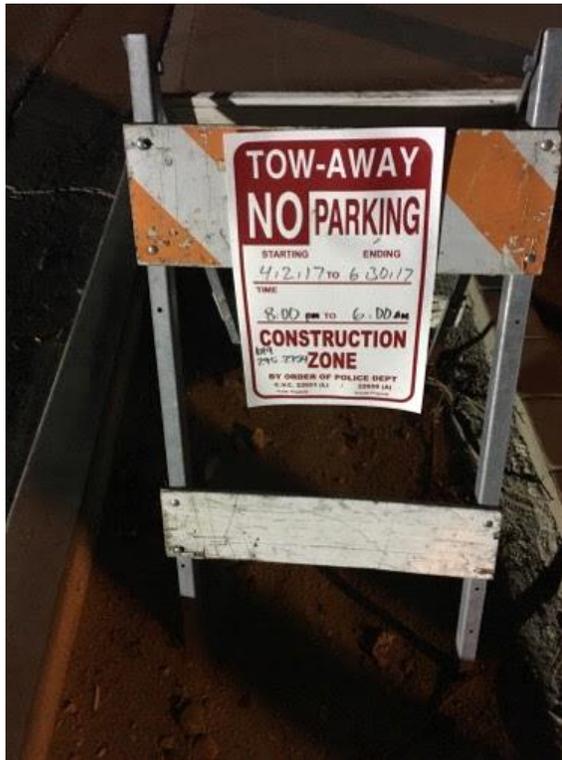
Caption Signage on Trade Street. 4 vehicles towed for parking in a no-parking zone.

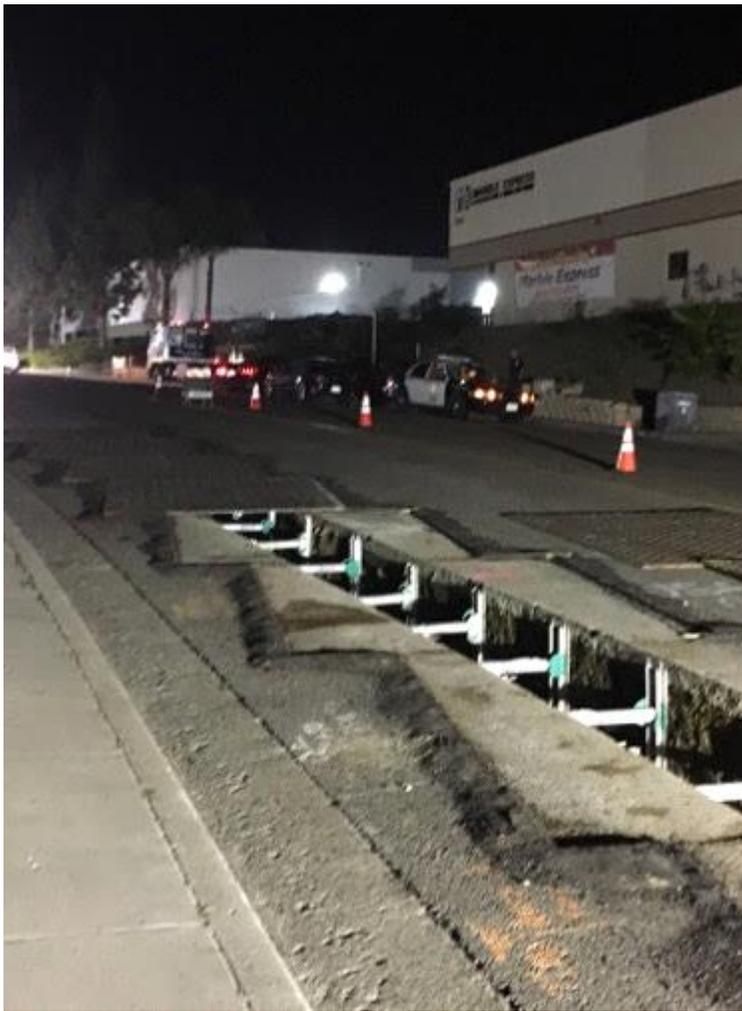
Caption Vehicle being ticketed and towed on Trade Street.

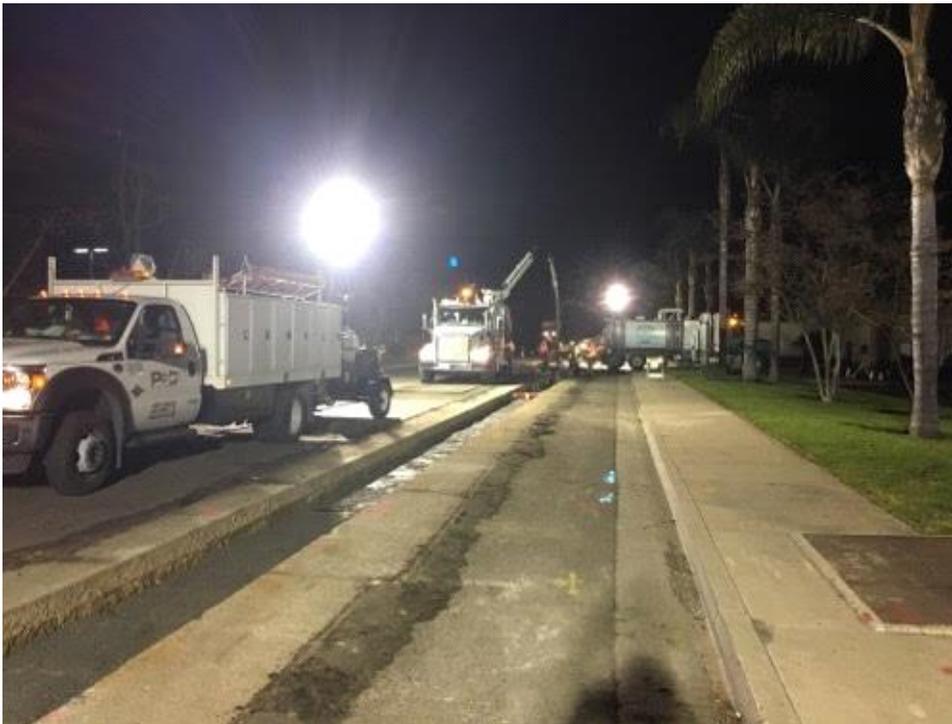
Caption Potholing on Trade Street.

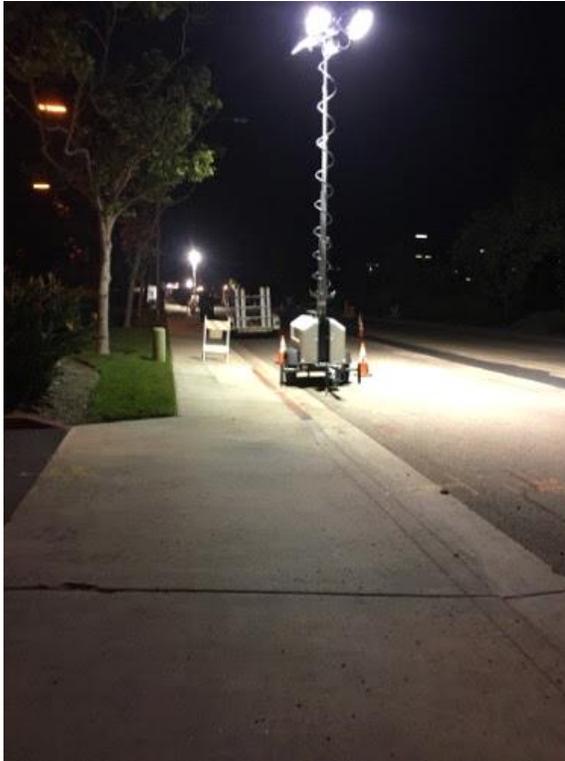
Caption Traffic control on Trade Street.
