**PROJECT MEMORANDUM
SYCAMORE-PEÑASQUITOS 230-KV
TRANSMISSION LINE PROJECT**

Date: June 2, 2017
To: Billie Blanchard, CPUC Project Manager
From: Sheila Hoyer, CPUC Monitoring Supervisor
Subject: Weekly Report #21 – May 21 to May 26, 2017

This report provides a summary of the construction and compliance activities associated with the SDG&E Sycamore-Peñasquitos 230-kV Transmission Line Project for the week of May 21 to May 26, 2017.

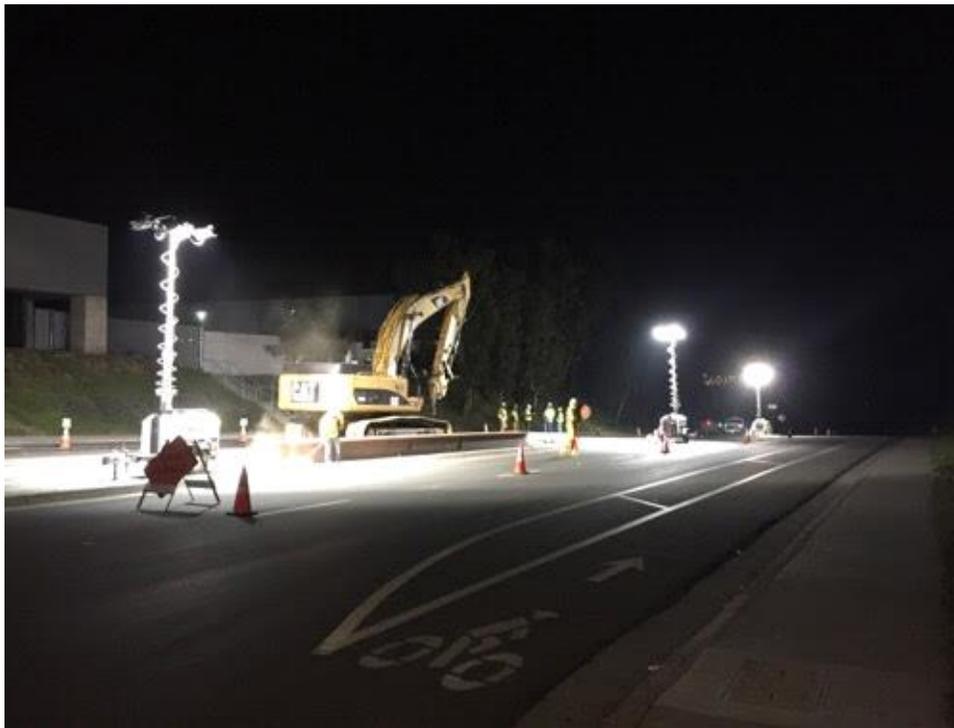
Caption Abundant lighting in place.

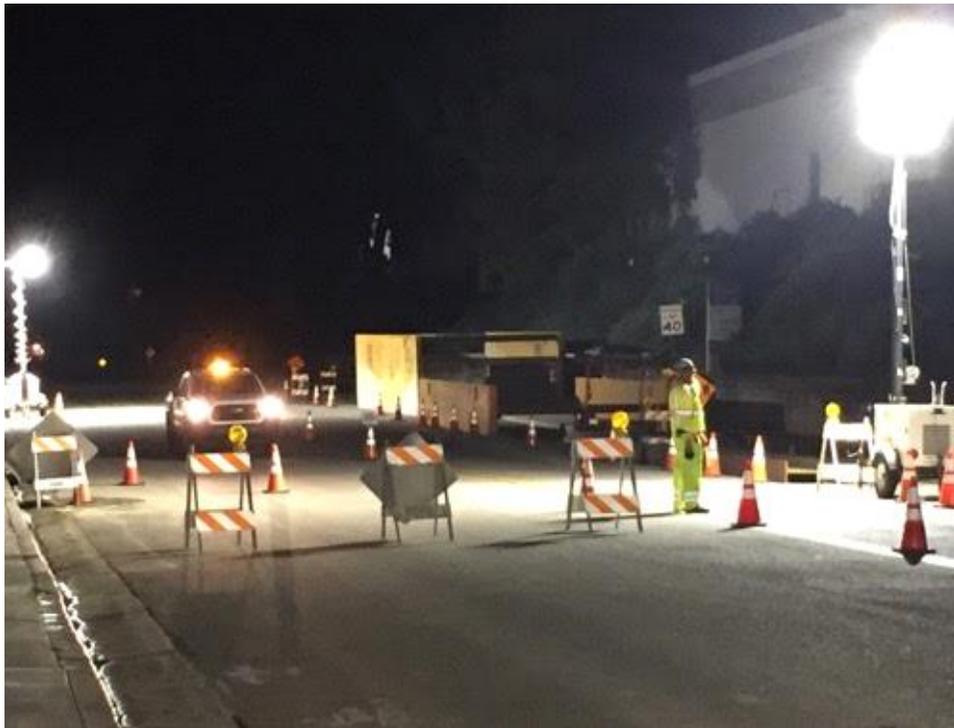
Caption Traffic flaggers at work.

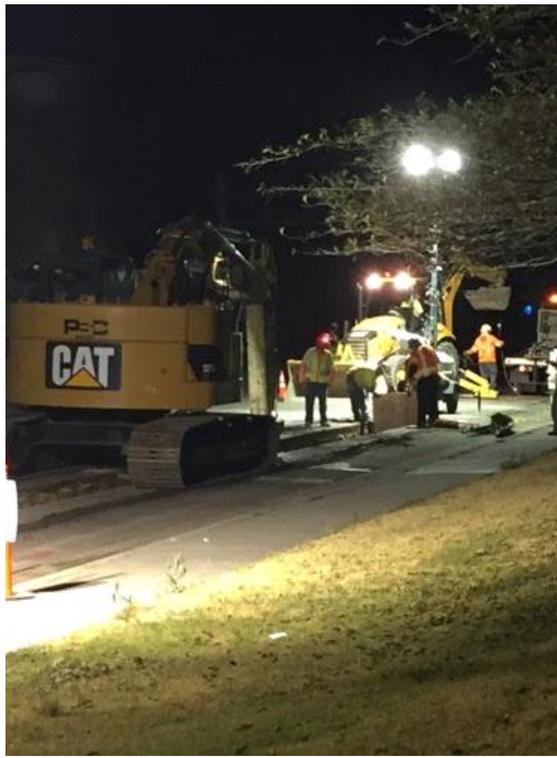
Caption Excavation in progress.

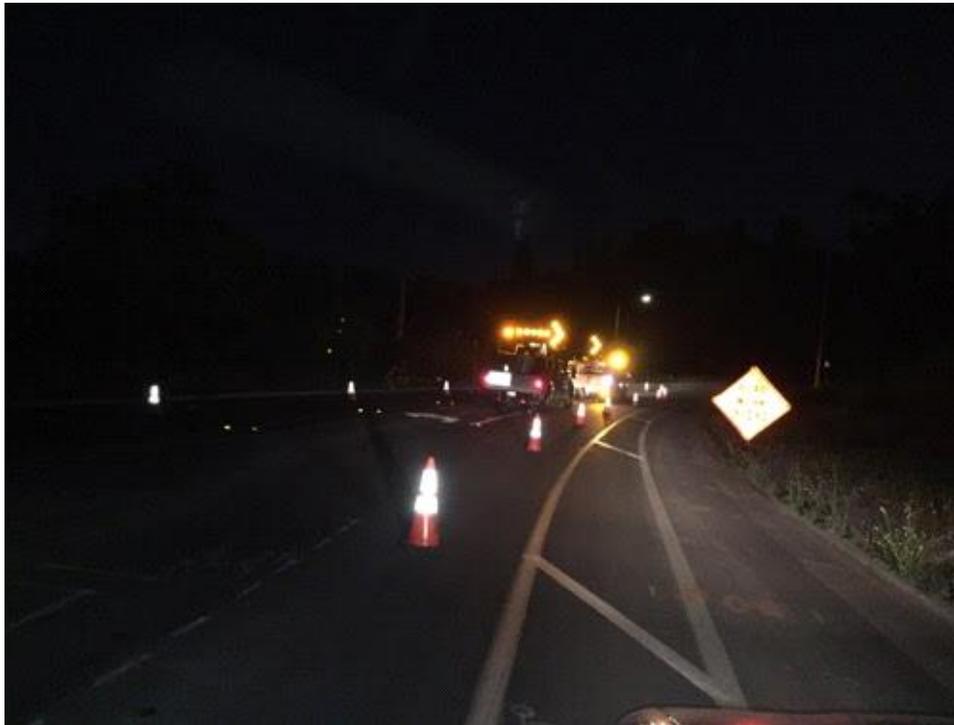
Caption Digital traffic safety signage during set up.

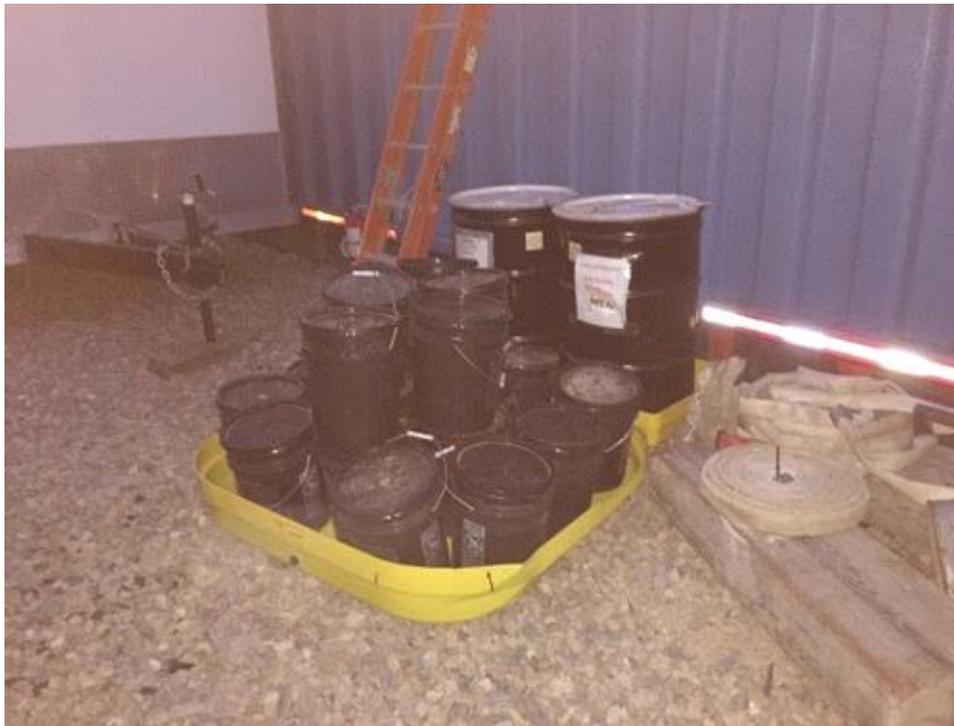
Caption Hazardous materials clearly labeled and stored in secondary containment.

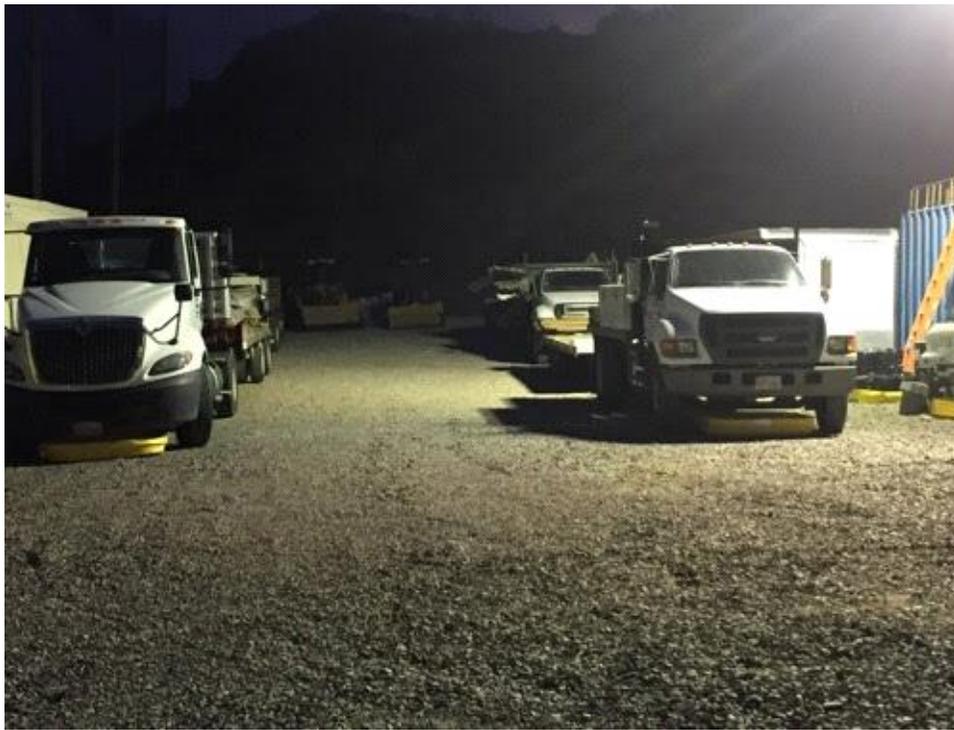
Caption Drip pans in good condition and in place.

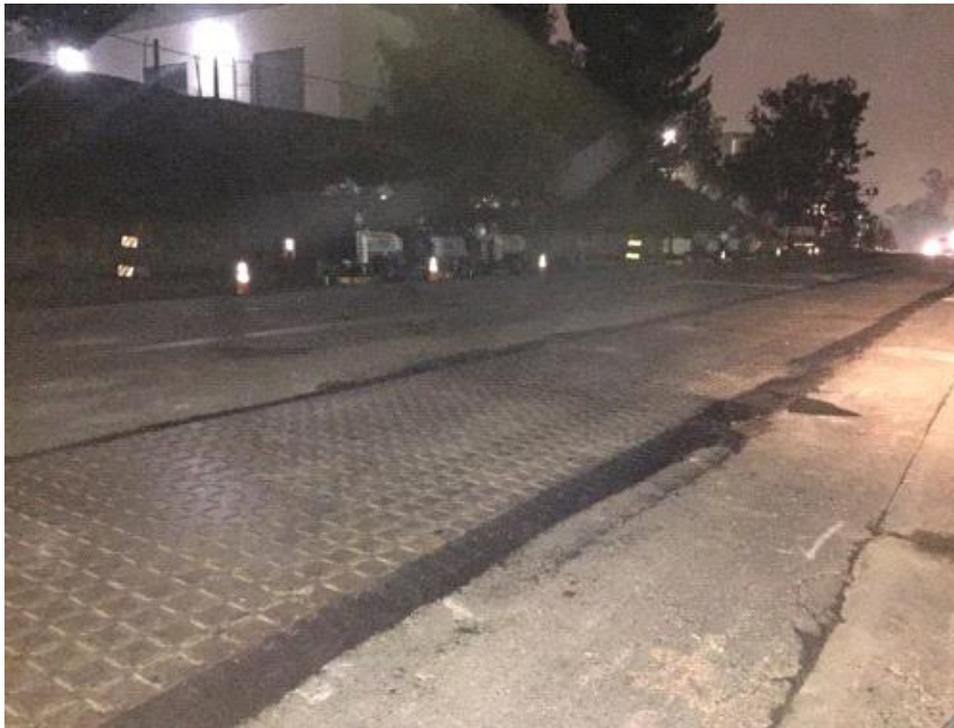
Caption Steel plates installed to cover trenches and capped with asphalt.

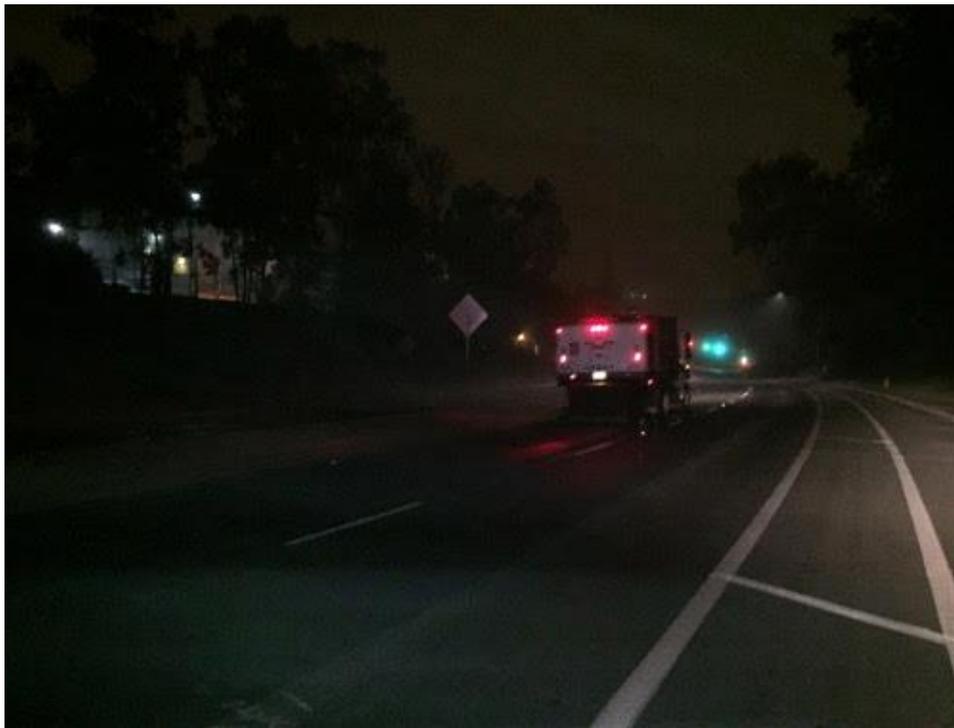
Caption Street sweepers doing clean up.

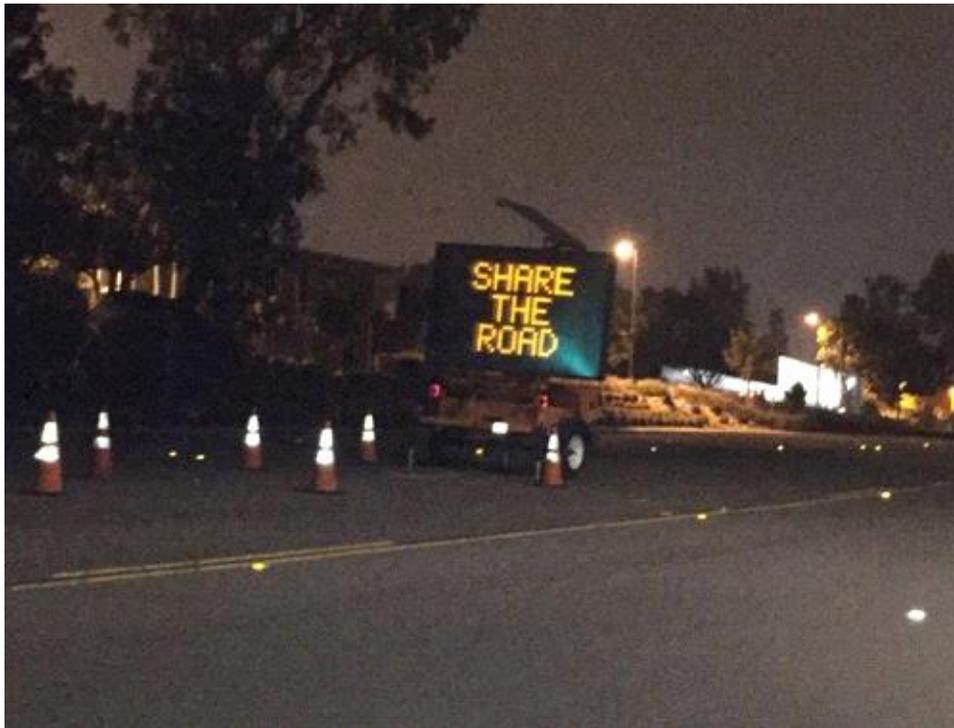
Caption Digital signage for traffic safety.

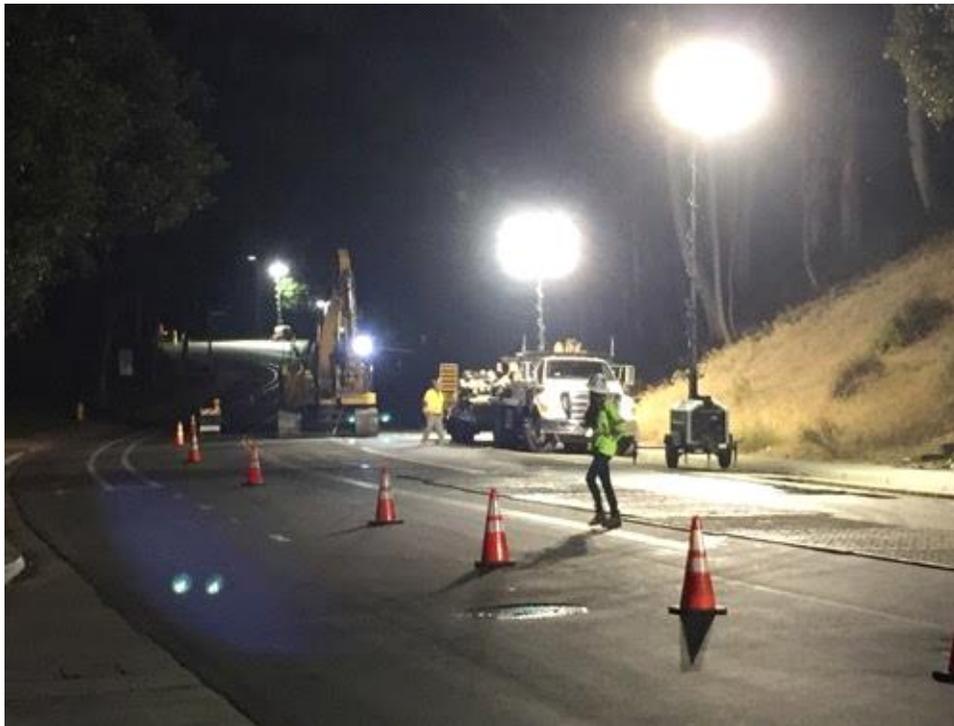
Caption Abundant lighting in place for night work.

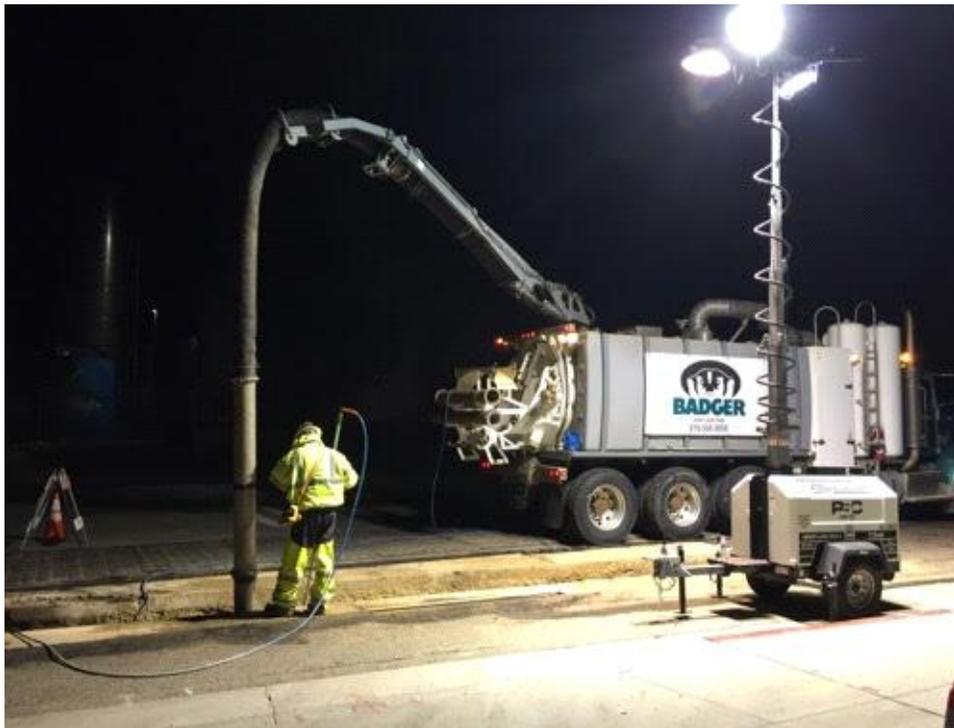
Crews potholing in the trenches.

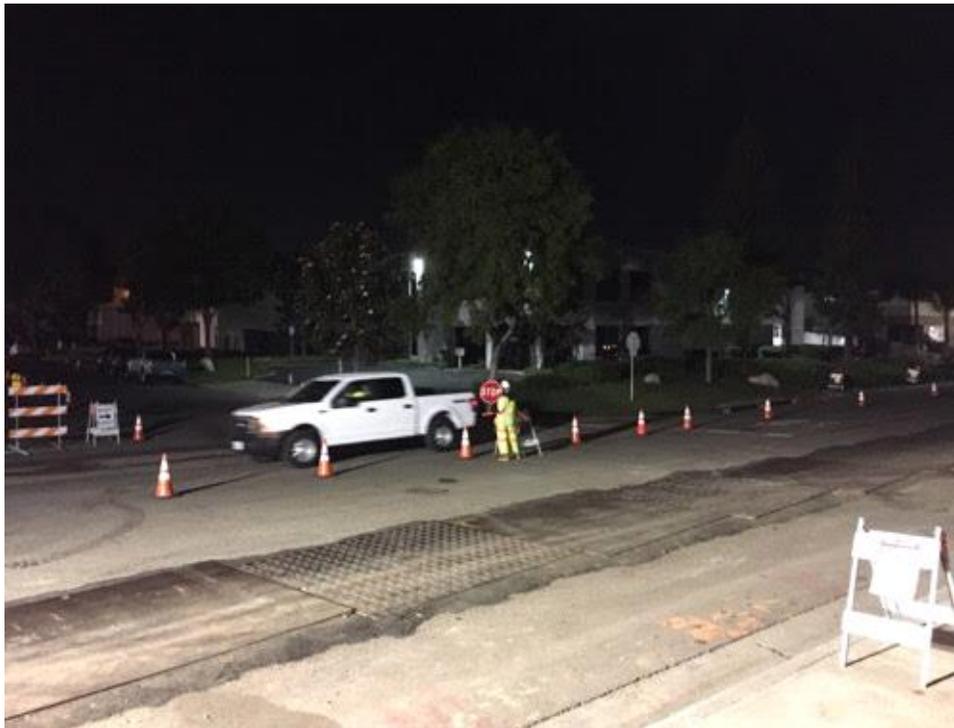
Traffic flaggers at work.

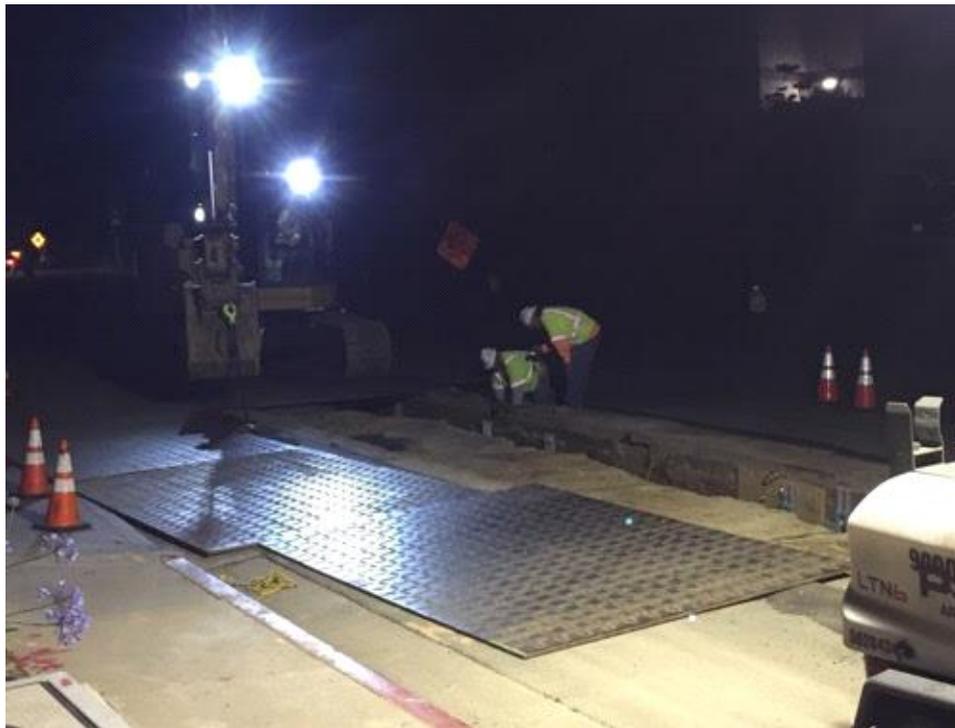
Caption Steel plates being removed for access to work to be done this evening.

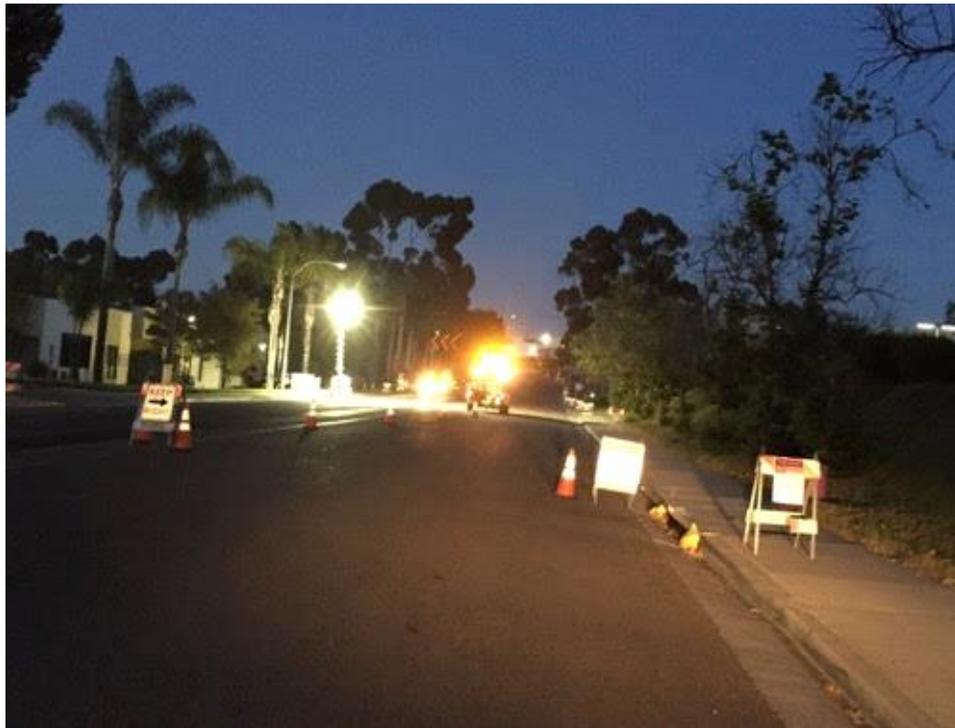
Caption Nightly set up.

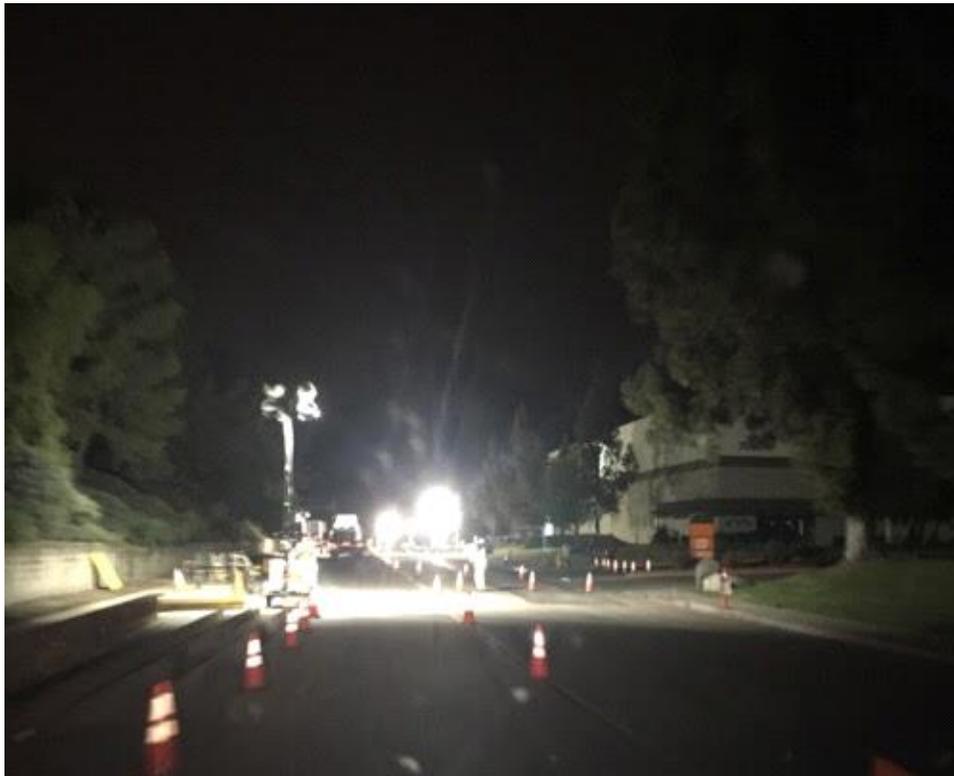
Caption Traffic control on Trade St.
Photo Attributes Capture Date/Time: Thu May 25 2017 23:35:28 GMT-0700 (PDT)
Coordinates: 32.888707, -117.180152
View Direction: West

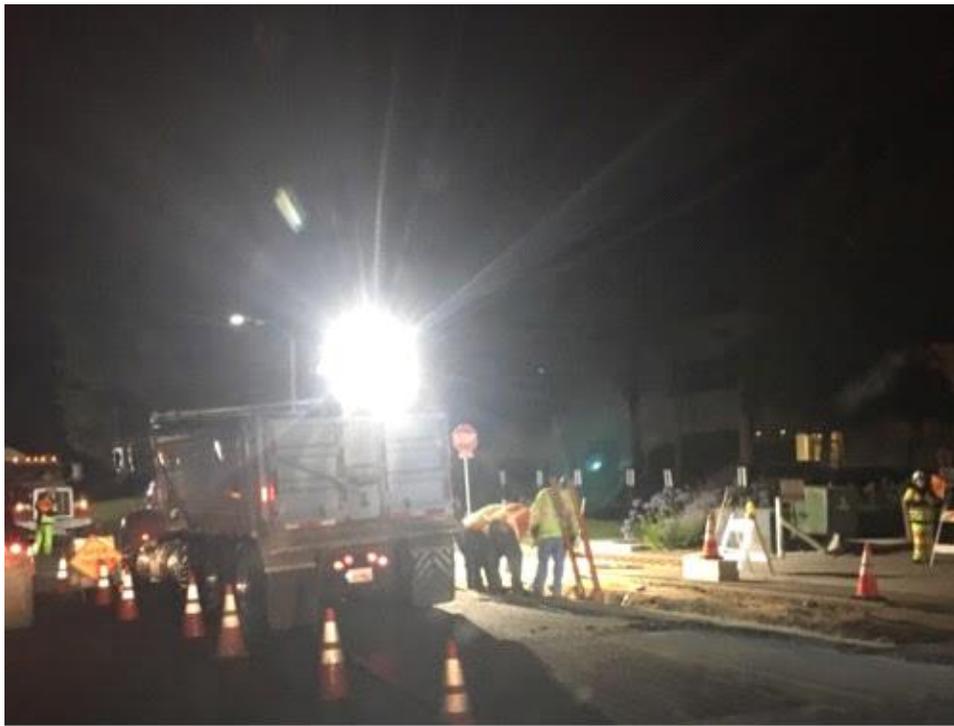
Caption Trench work on Trade St,
Photo Attributes Capture Date/Time: Thu May 25 2017 23:35:03 GMT-0700 (PDT)
Coordinates: 32.888707, -117.180152
View Direction: West

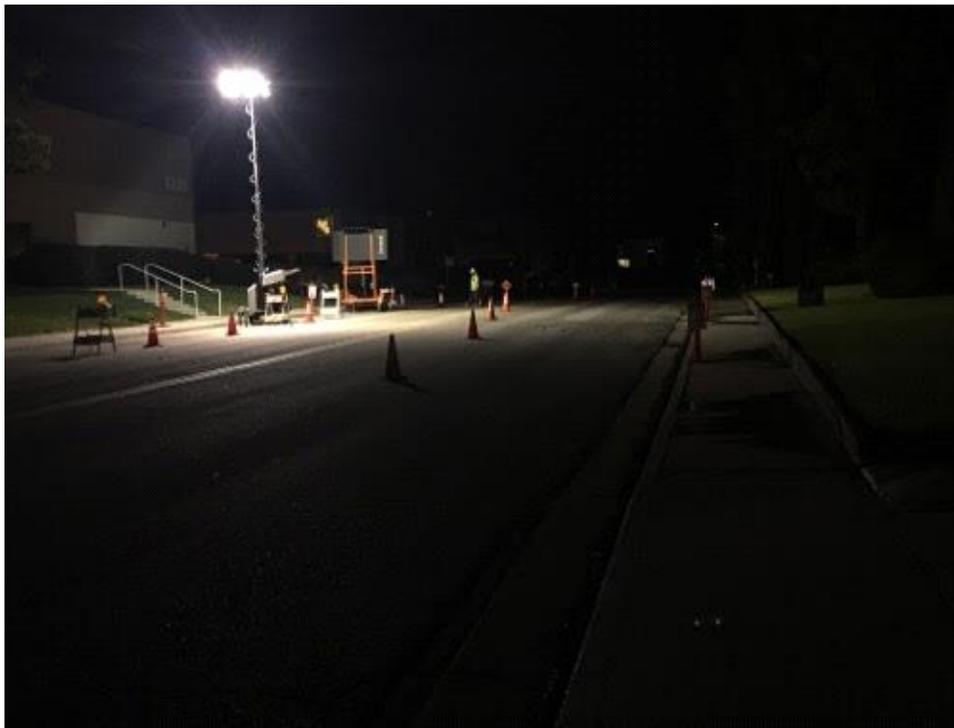
Caption Traffic control Miraloni Dr.
Photo Attributes Capture Date/Time: Thu May 25 2017 23:12:16 GMT-0700 (PDT)
Coordinates: 32.888707, -117.180152
View Direction: East

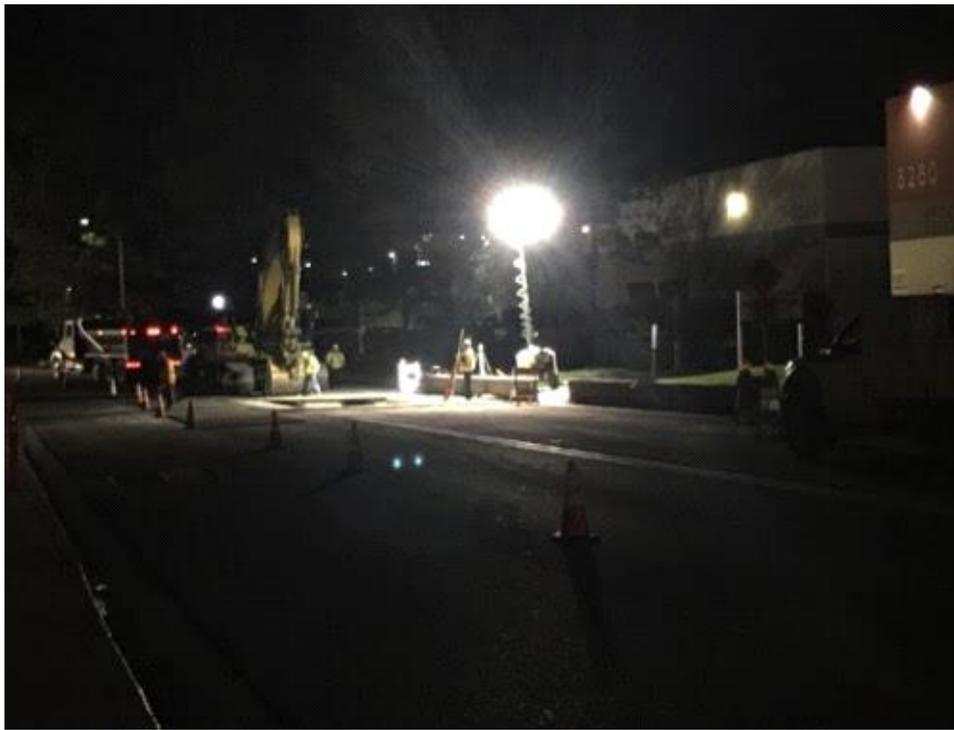
Caption Vault work in Miraloni Dr.

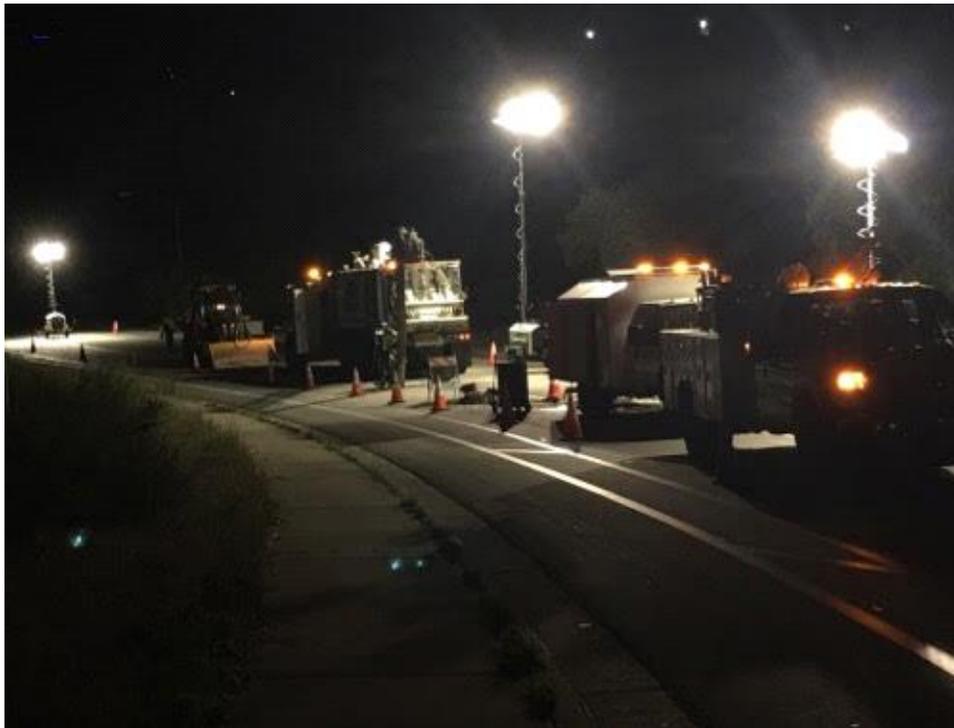
Caption Potholing in Carroll Rd

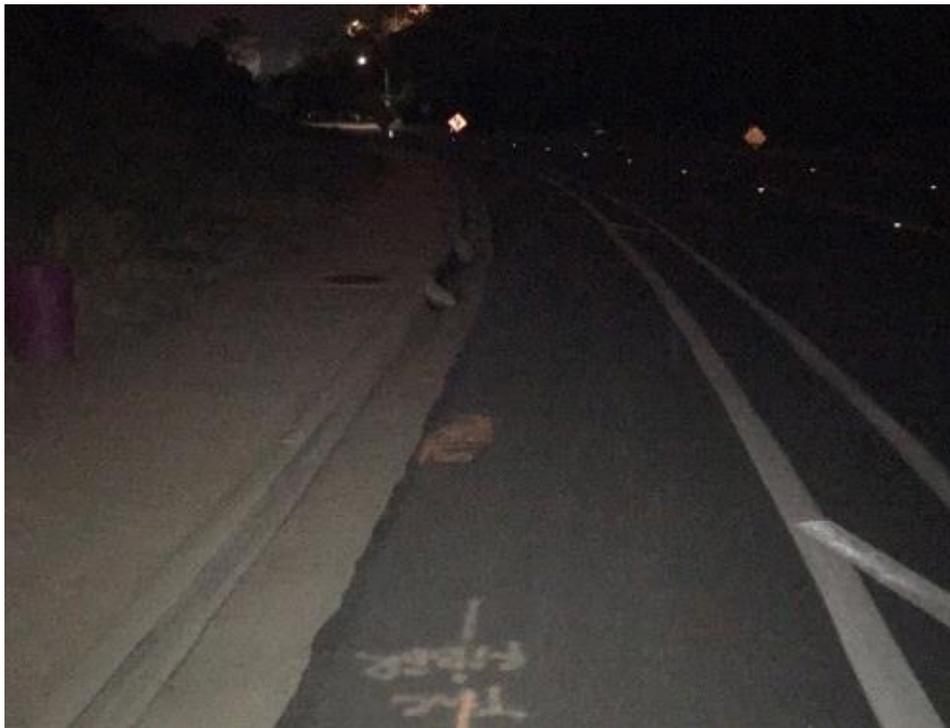
Caption BMPs on Carroll Rd.

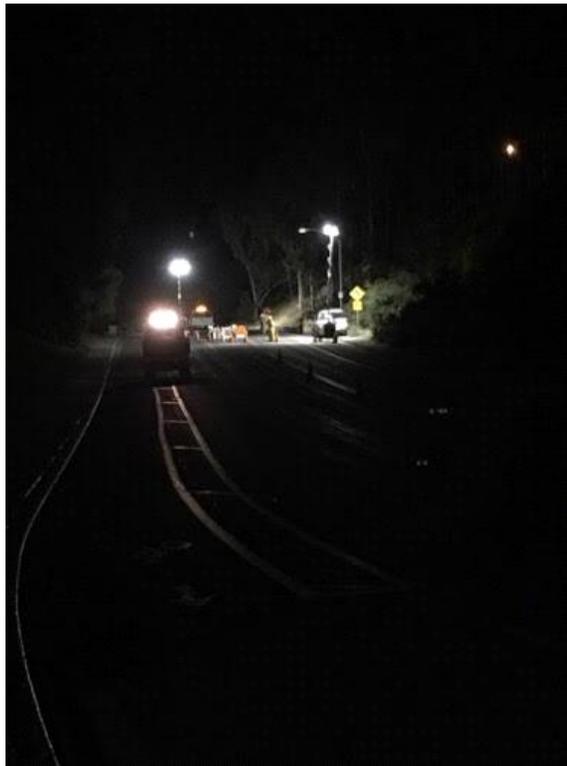
Caption Conduit installation at Carroll Rd.

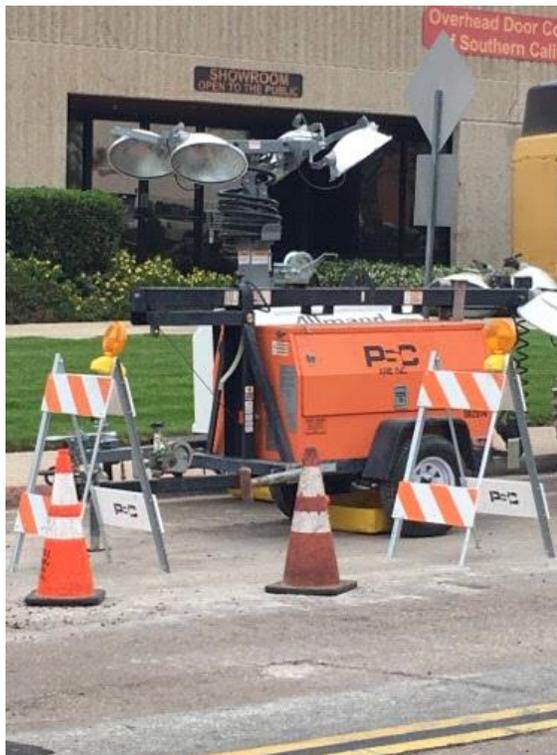
Caption Equipment storage

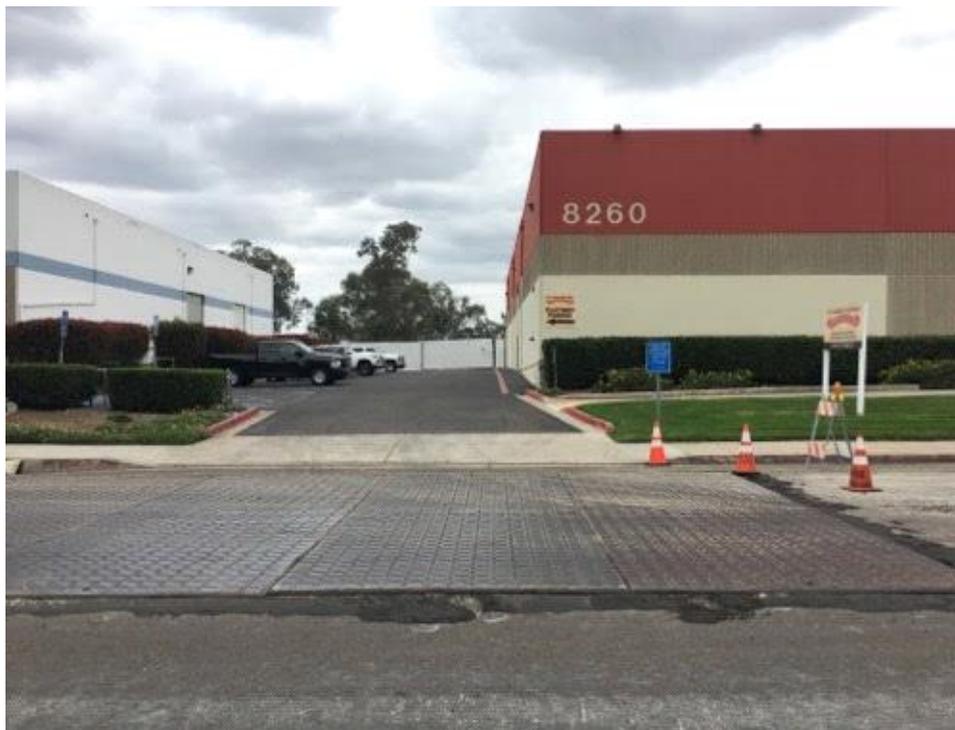
Caption Miralani Dr. vault site
