**PROJECT MEMORANDUM
SYCAMORE-PEÑASQUITOS 230-KV
TRANSMISSION LINE PROJECT**

Date: June 12, 2017
To: Billie Blanchard, CPUC Project Manager
From: Sheila Hoyer, CPUC Monitoring Supervisor
Subject: Weekly Report #22 – May 30 to June 2, 2017

This report provides a summary of the construction and compliance activities associated with the SDG&E Sycamore-Peñasquitos 230-kV Transmission Line Project for the week of May 30 to June 2, 2017.

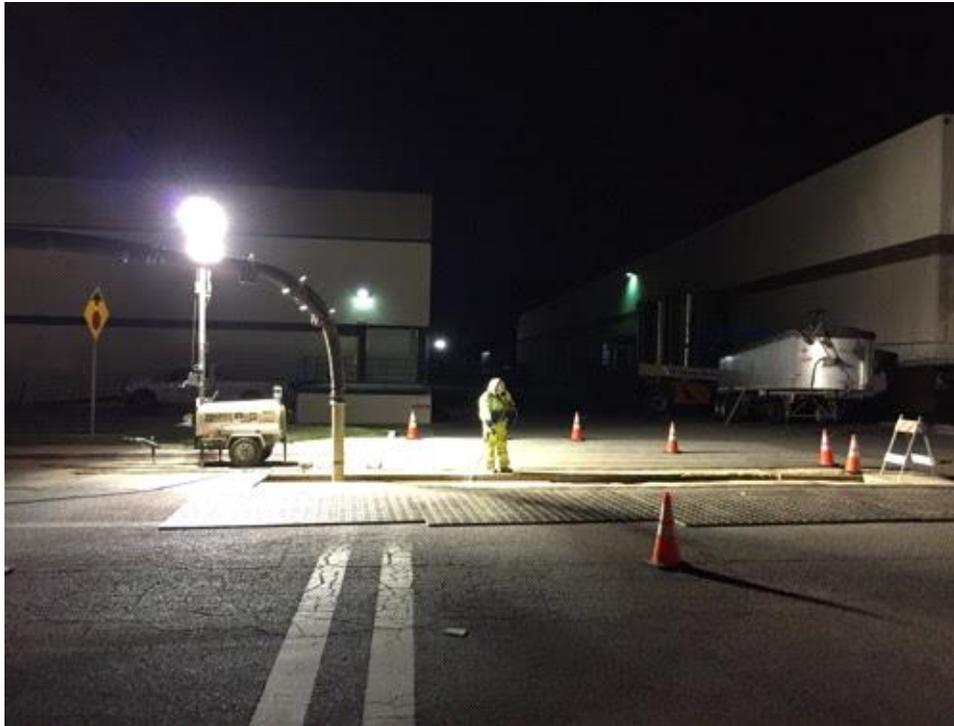
Caption Potholing.

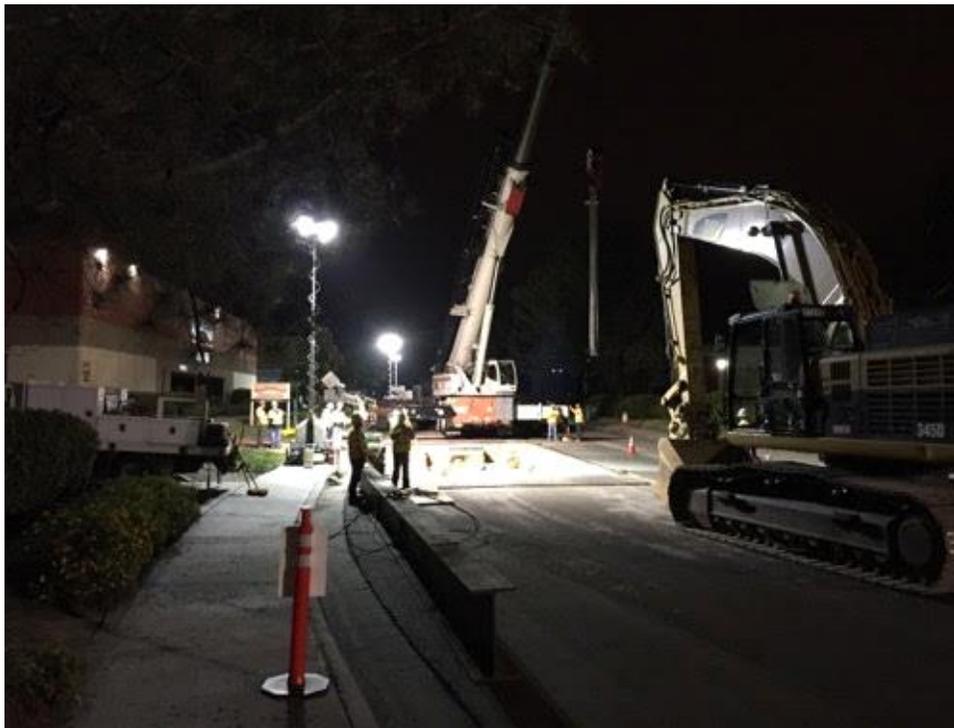
Caption Vault work being done.

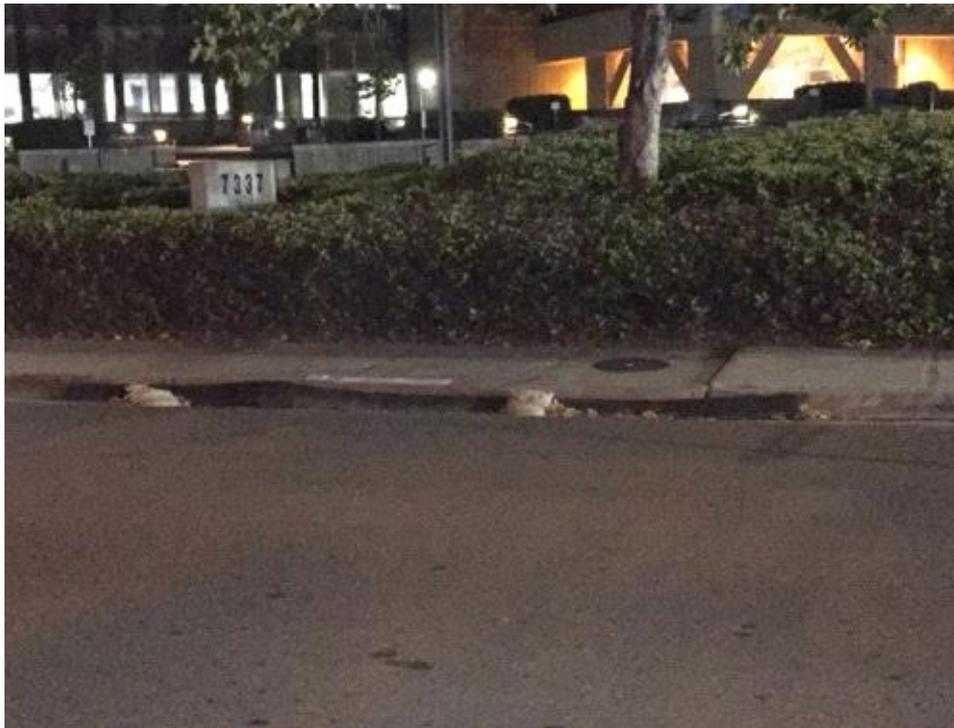
Caption All BMPs in place and in good working order.

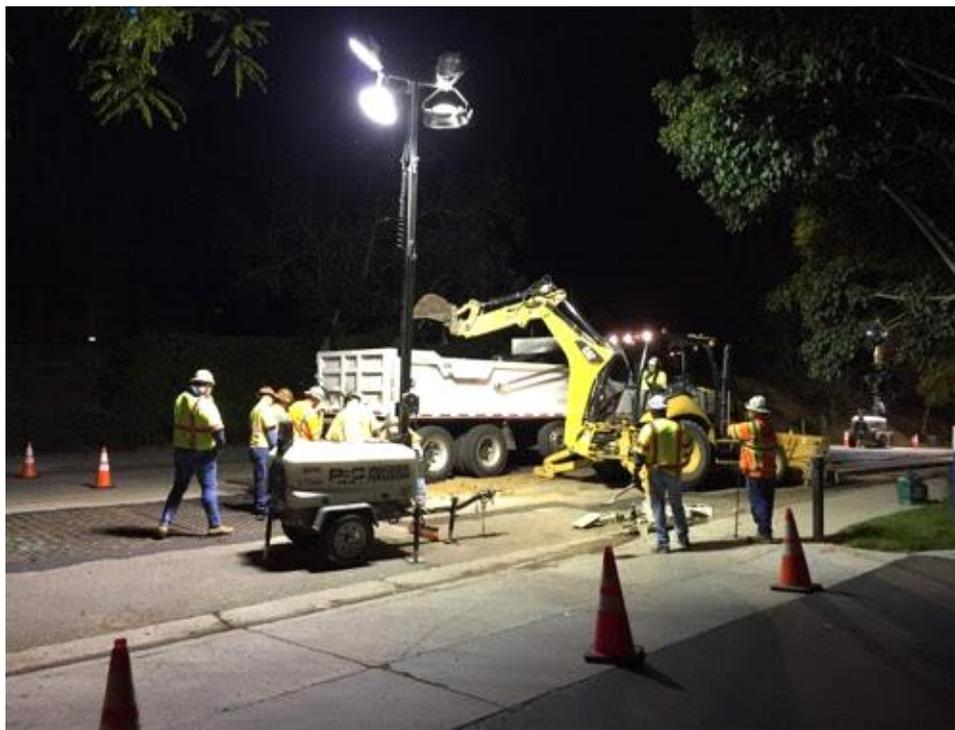
Caption Excavating with no dust being created.

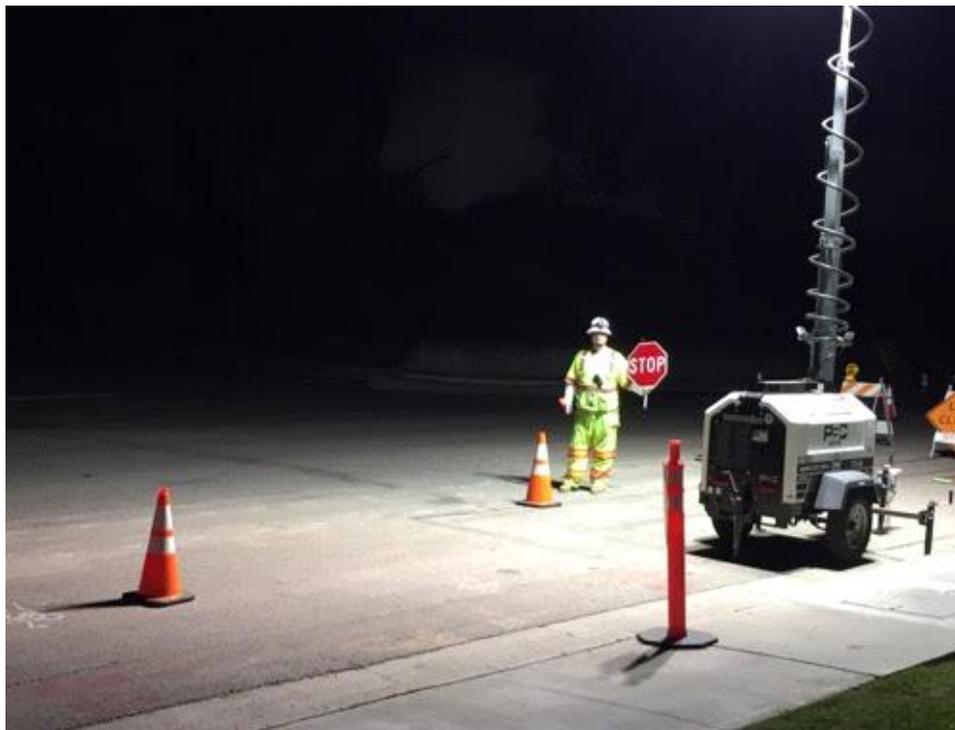
Caption Traffic flagger at work with ample lighting in place.

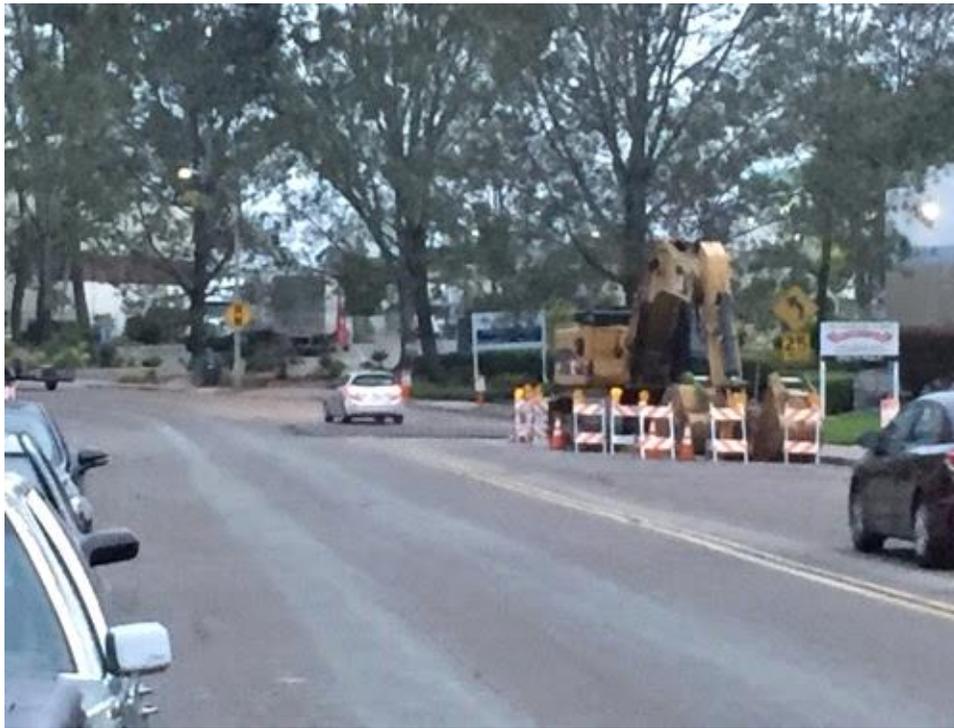
Caption Vault construction cleared and street returned to public use.

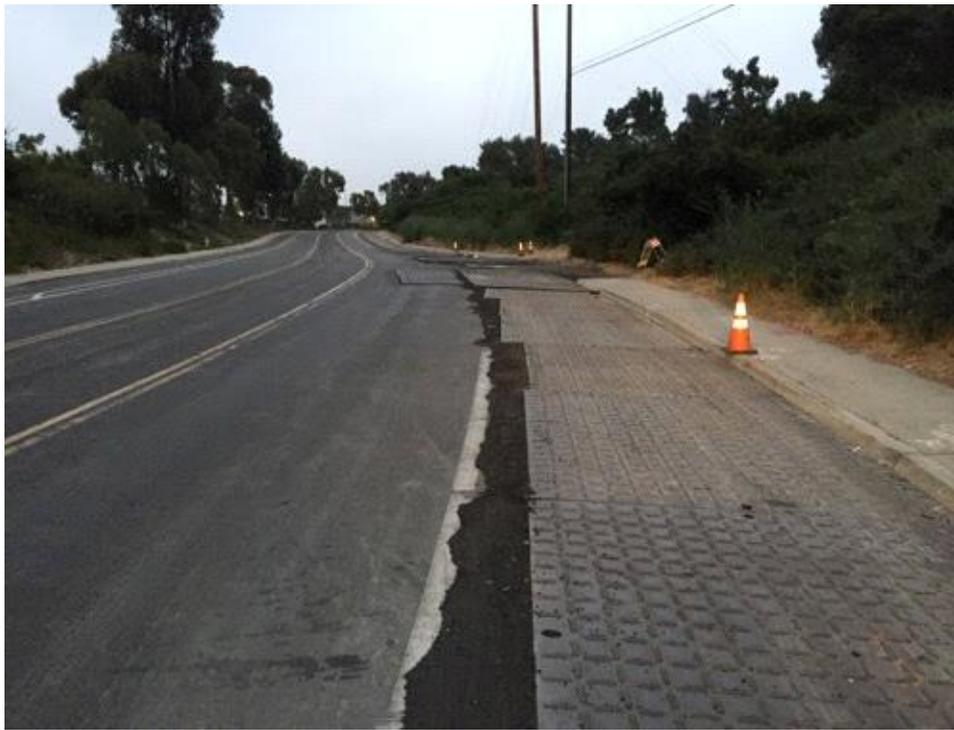
Caption Steel plates covering trenches.

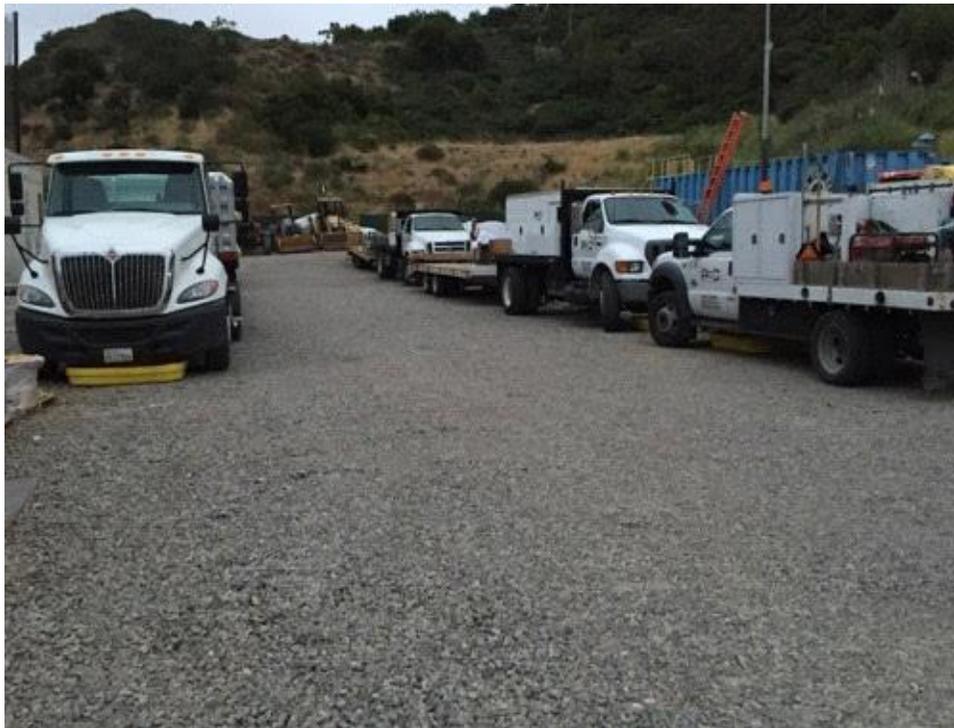
Caption Drip pans in place.

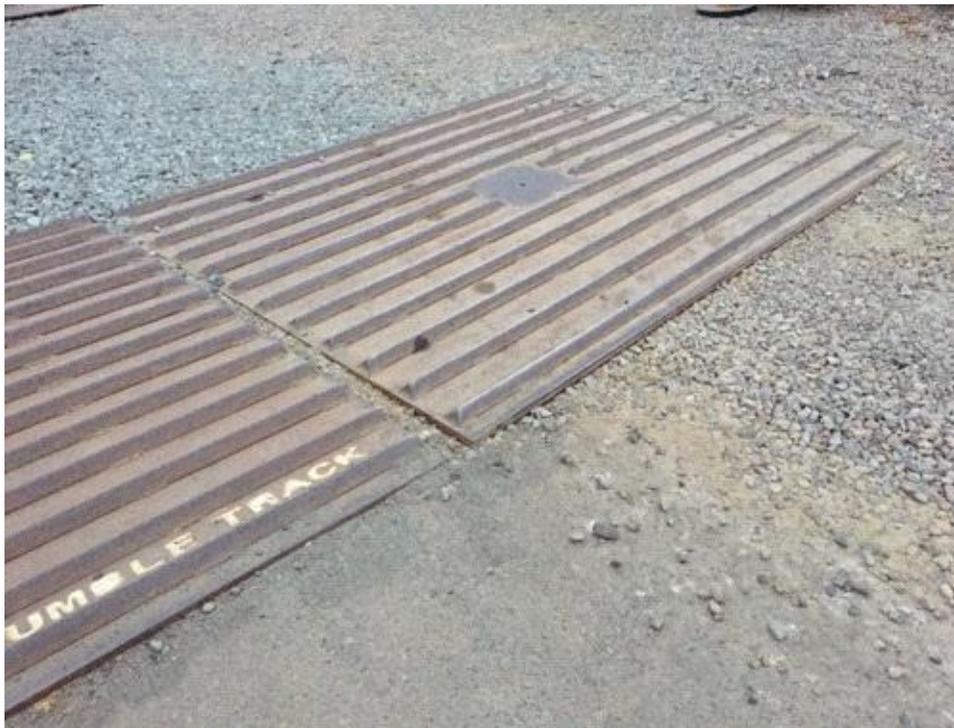
Caption Steel shaker plates at construction yard entrance.

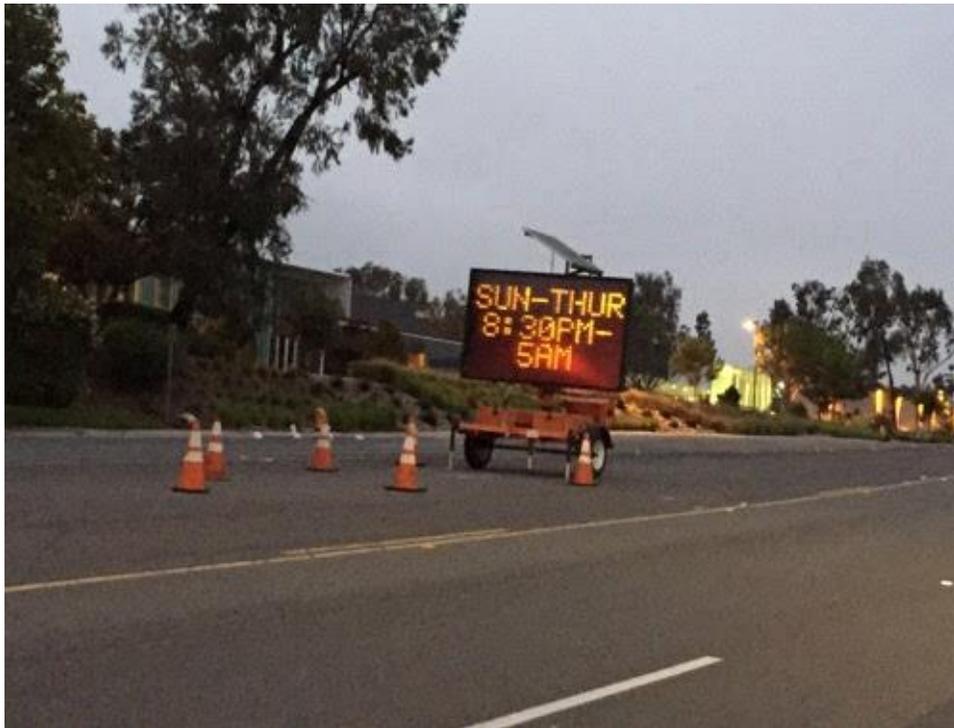
Caption Digital signage.

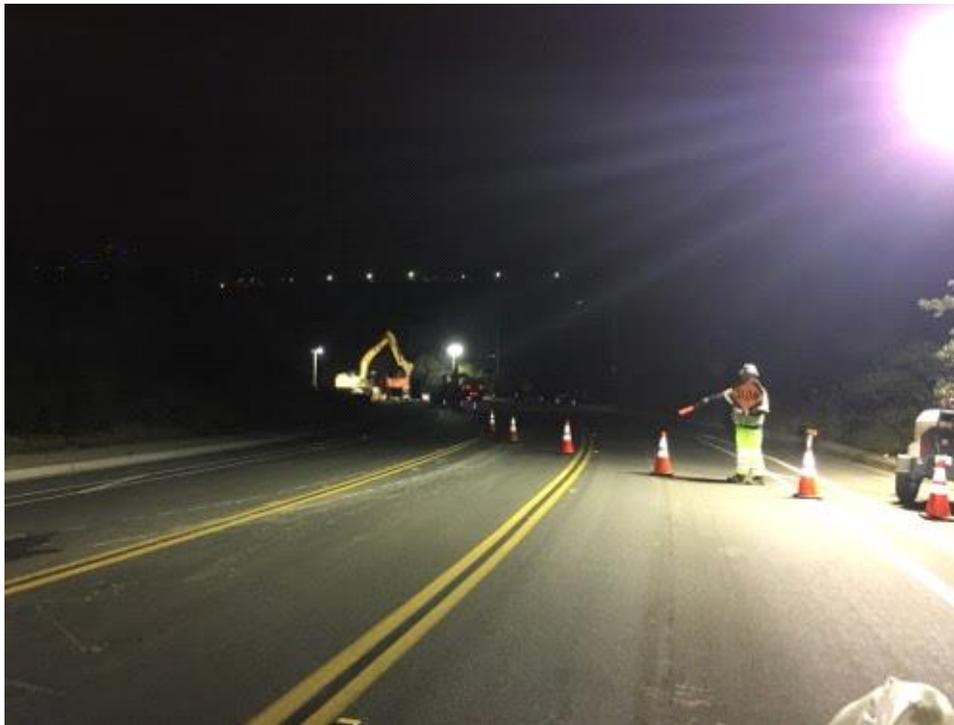
Caption Excavation on Carroll Rd. (western edge)

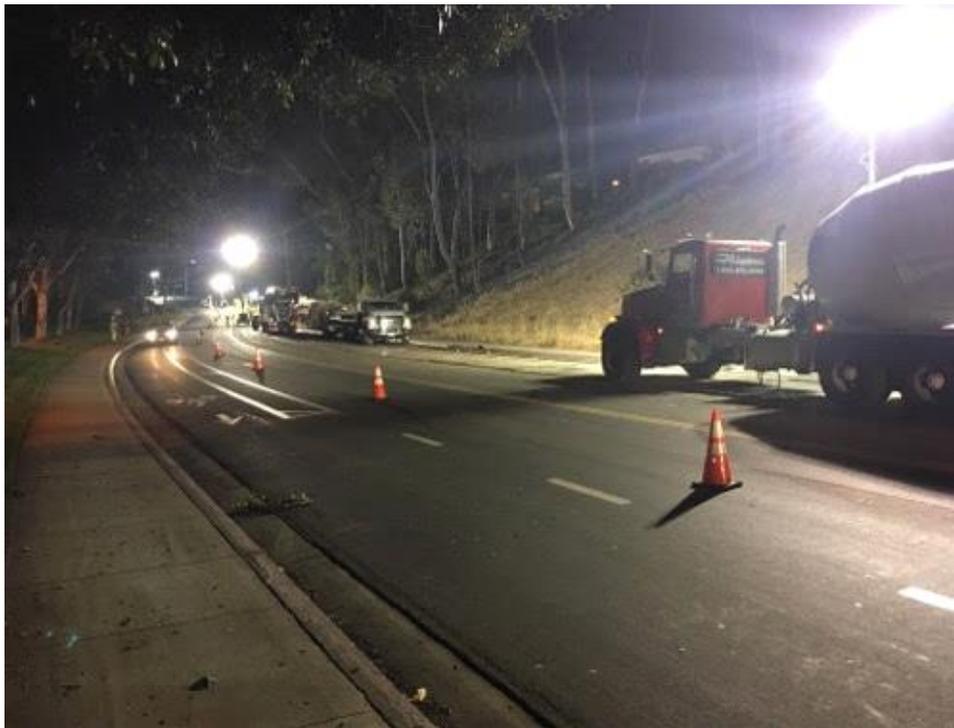
Caption Work along Carroll Rd.

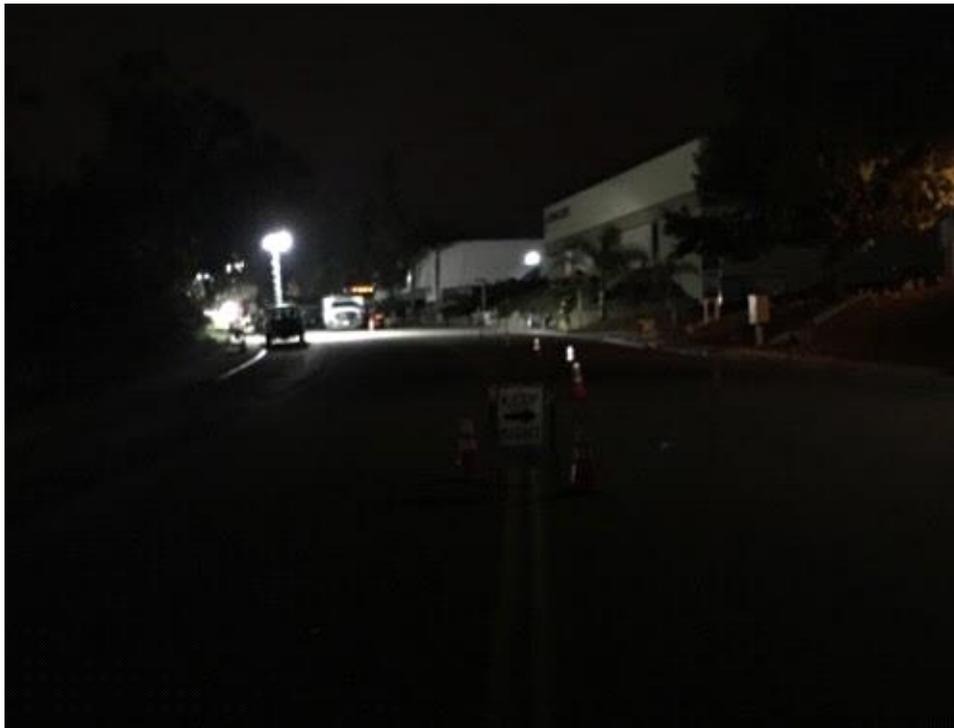
Caption Western edge of Trade Place.

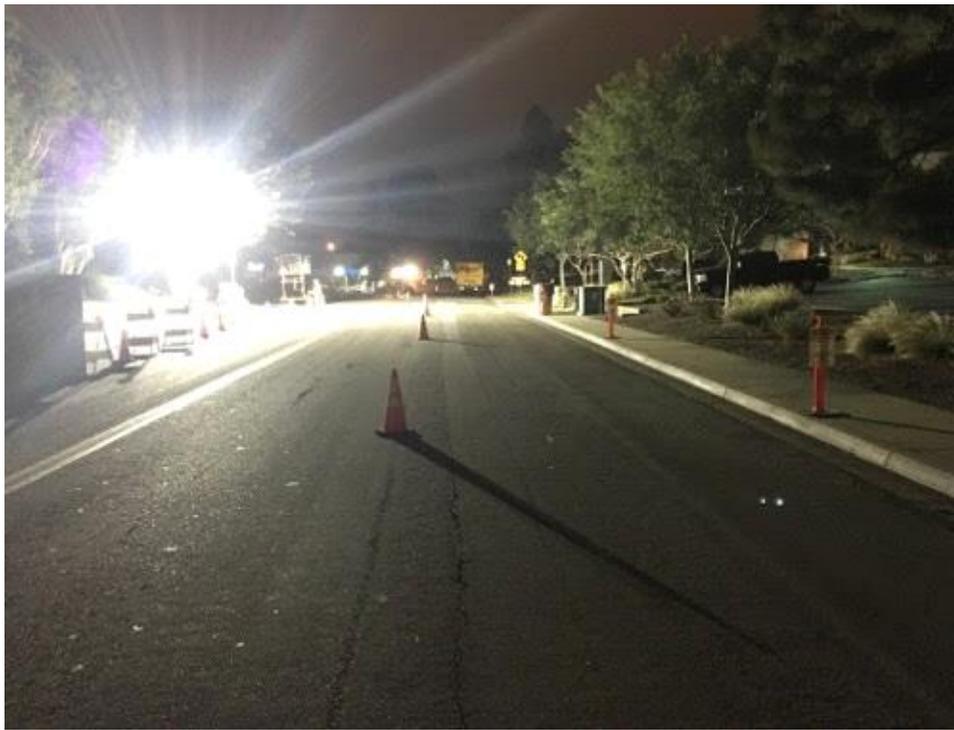
Caption Two lanes now clearly marked at Miralani Dr.

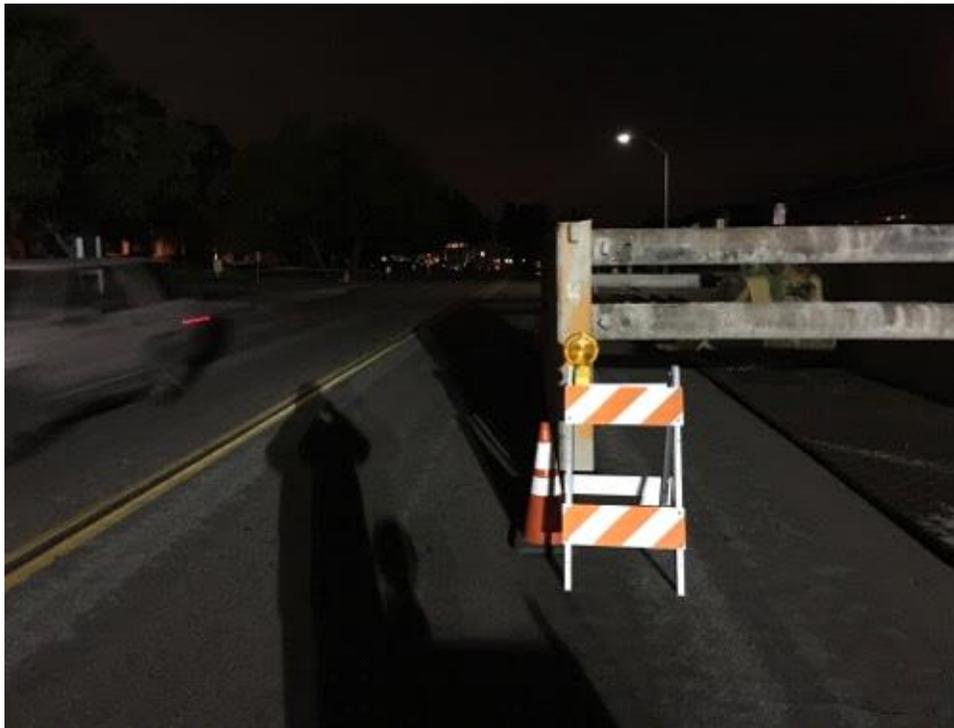
Caption Westward traffic is crossing over the center divide. Tight lane west bound, approximately 10 feet wide next to shoring.
