PROJECT MEMORANDUM
SYCAMORE-PEÑASQUITOS 230-KV
TRANSMISSION LINE PROJECT

Date: June 23, 2017
To: Billie Blanchard, CPUC Project Manager
From: Sheila Hoyer, CPUC Monitoring Supervisor
Subject: Weekly Report #24 – June 11 to June 16, 2017

2017-06-12 PM Inspection Report

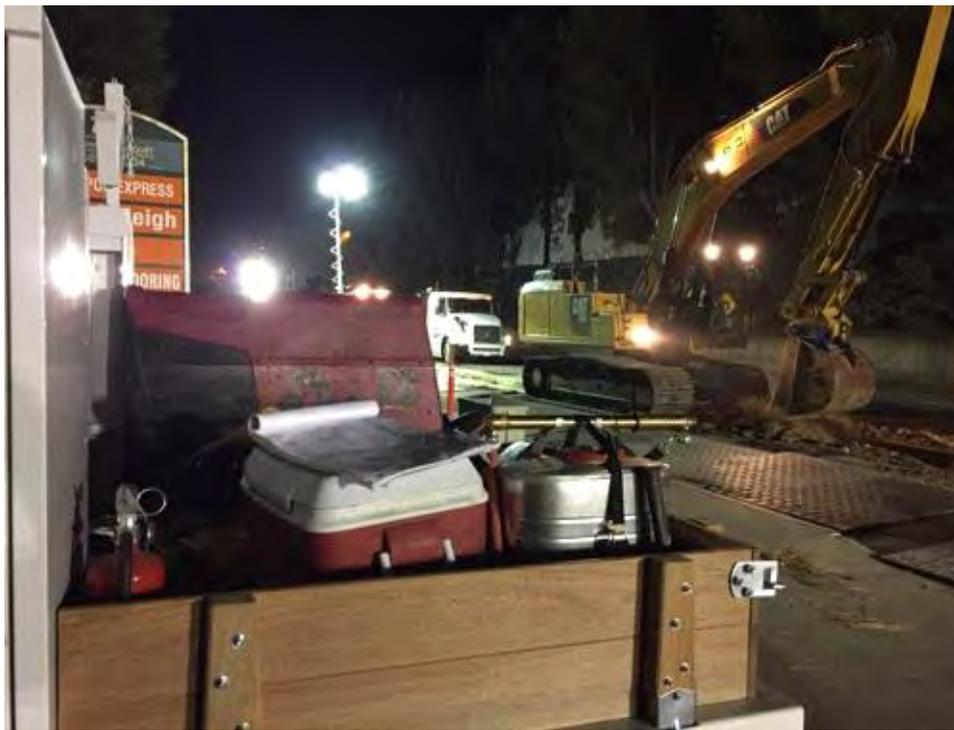
Caption Fire prevention equipment and full water sprayer within 50'of work site.

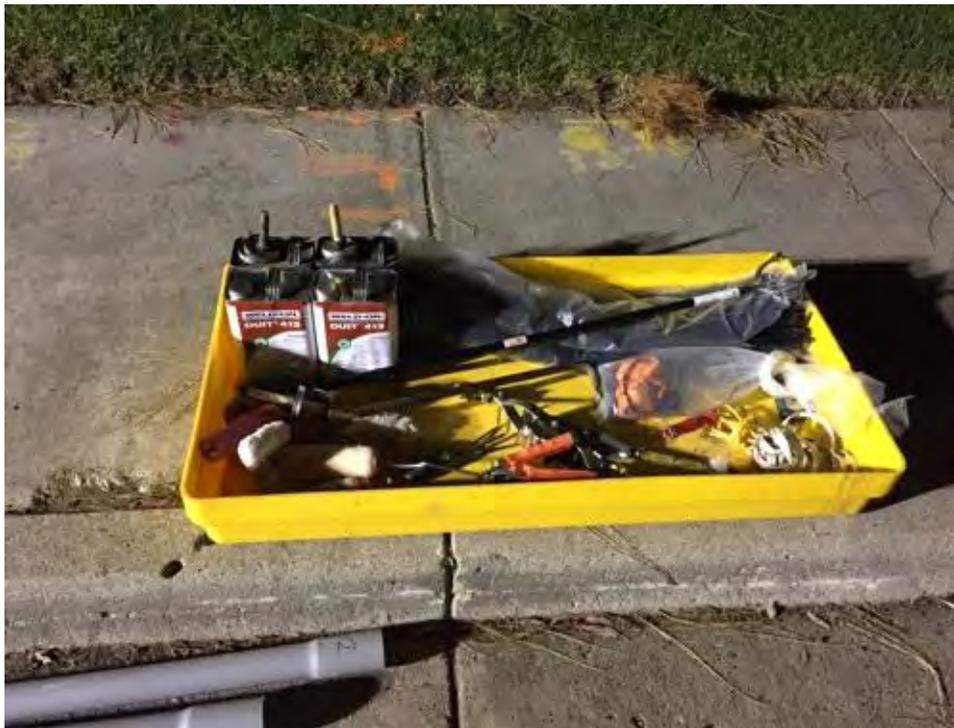
Caption Hazardous materials on site stored in secondary containment.

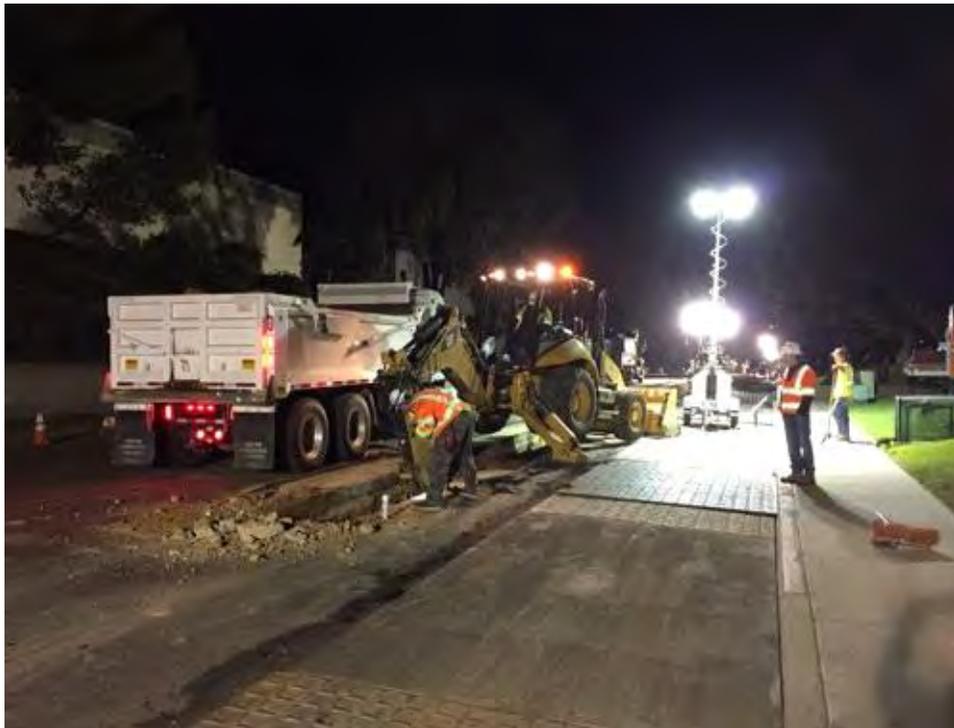
Caption Excavating, well lit and monitors present.

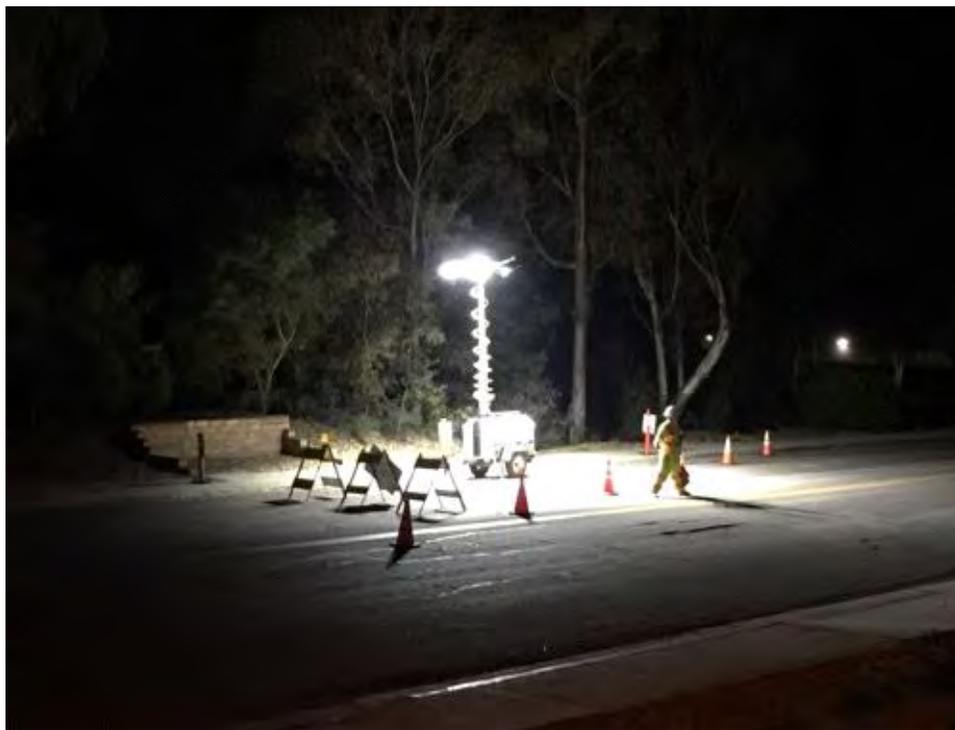
Caption Lighting and traffic flagger on duty.

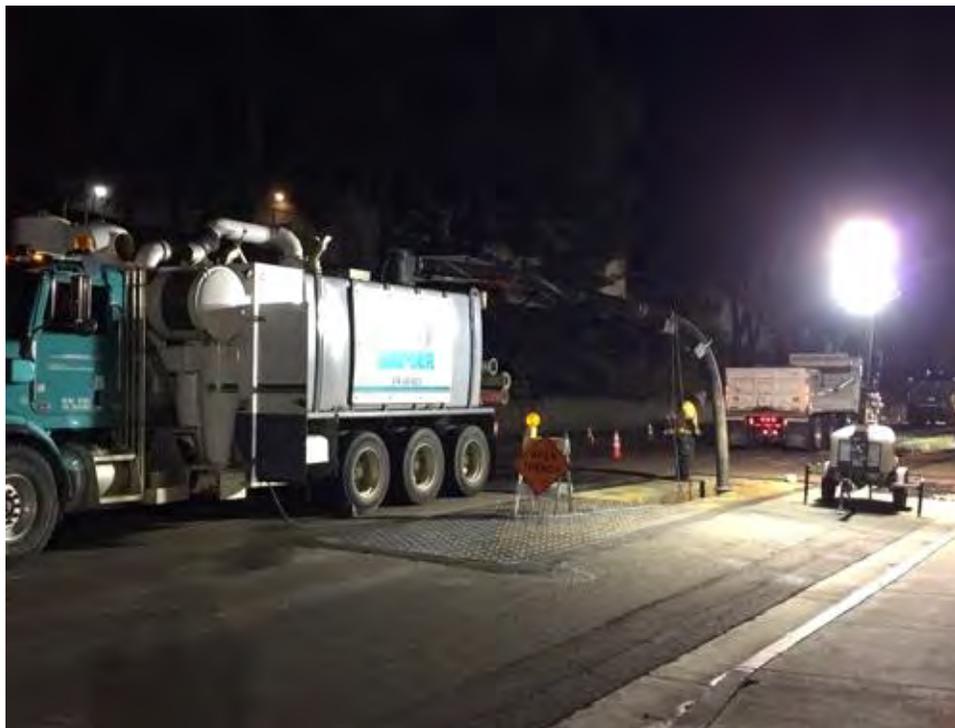
Caption Potholing

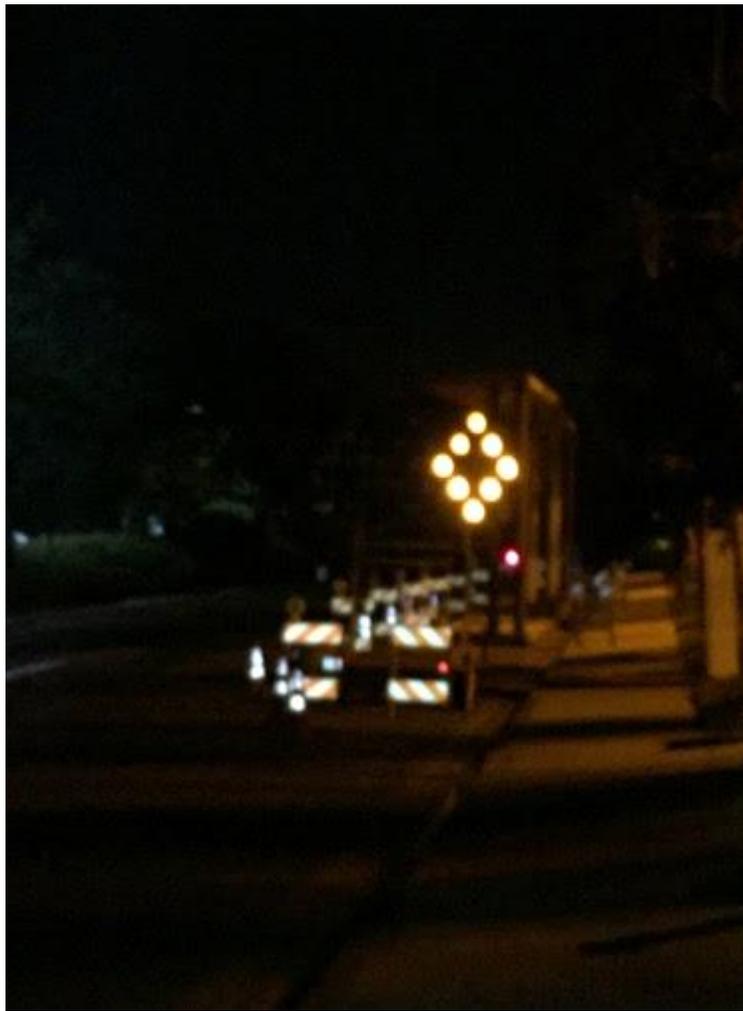
Caption Digital signage in place.

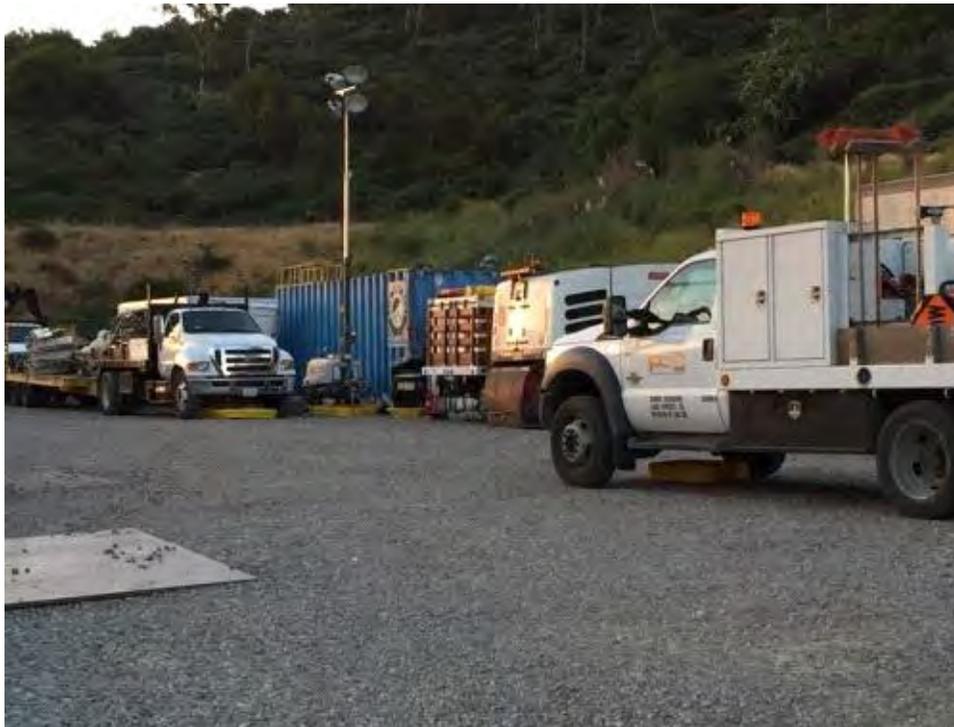
Caption Drip pans in place.

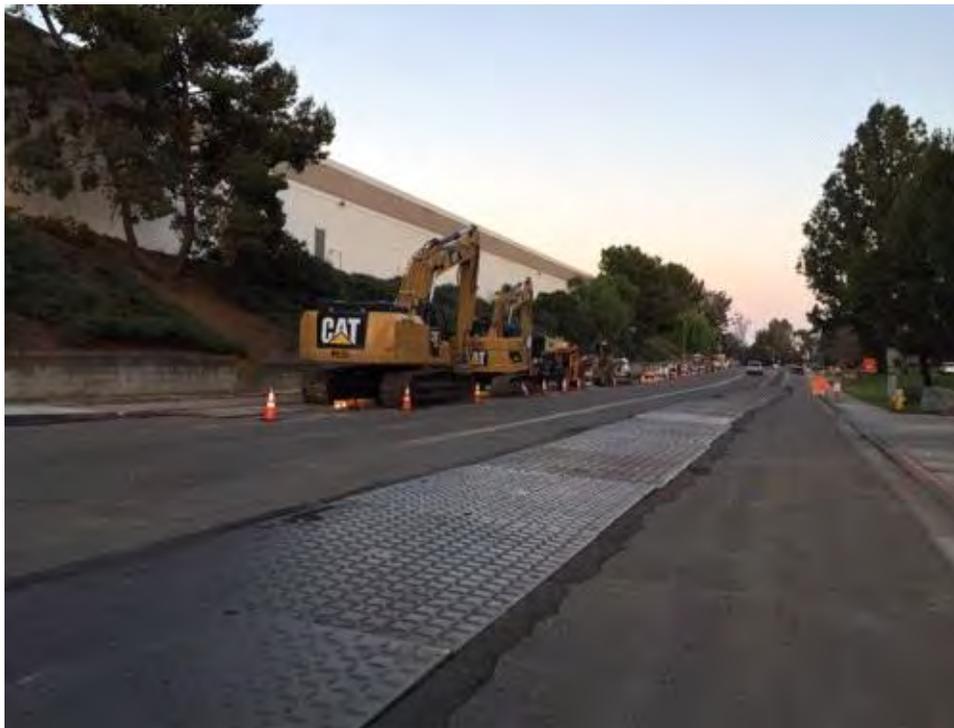
Caption Streets cleared and equipment safely stored.

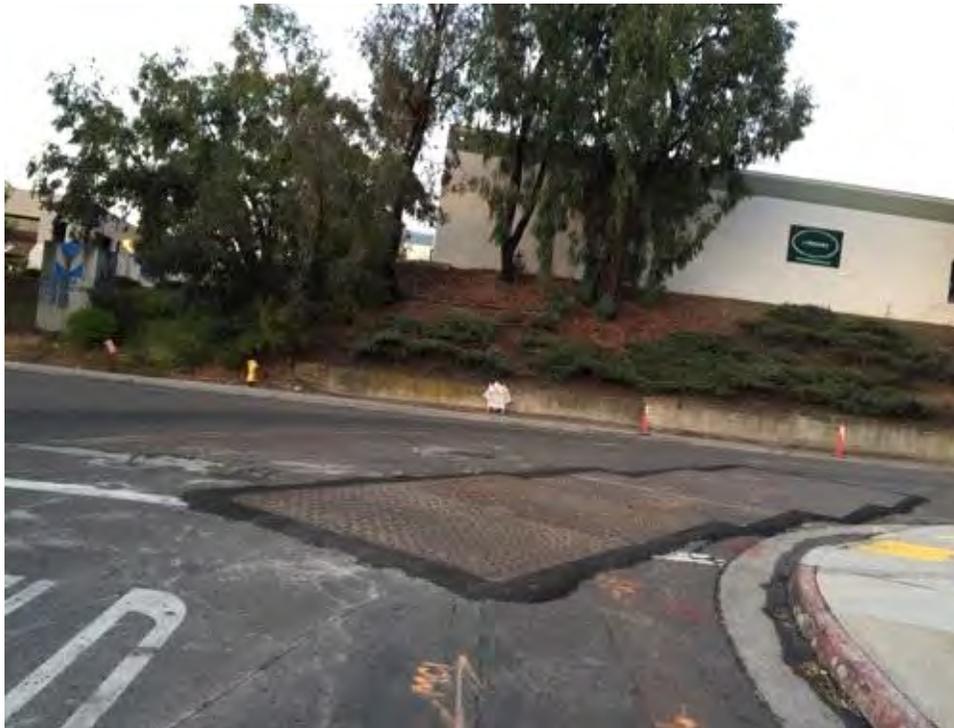
Caption Trenches covered with steel plates and sealed with asphalt.

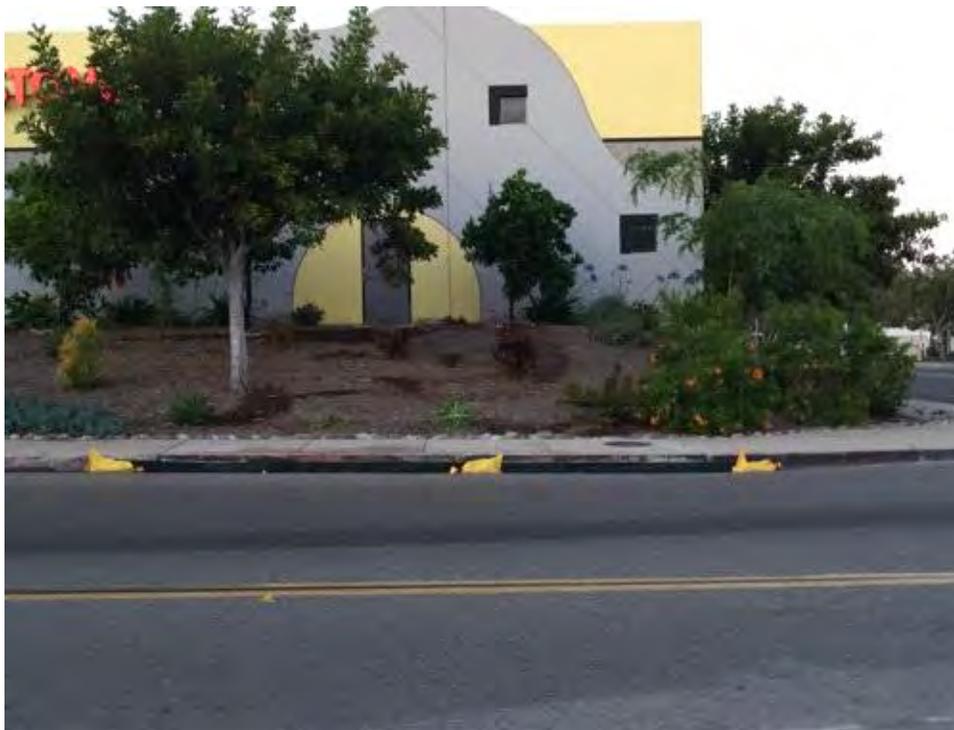
Caption BMP's in place and in good working order.

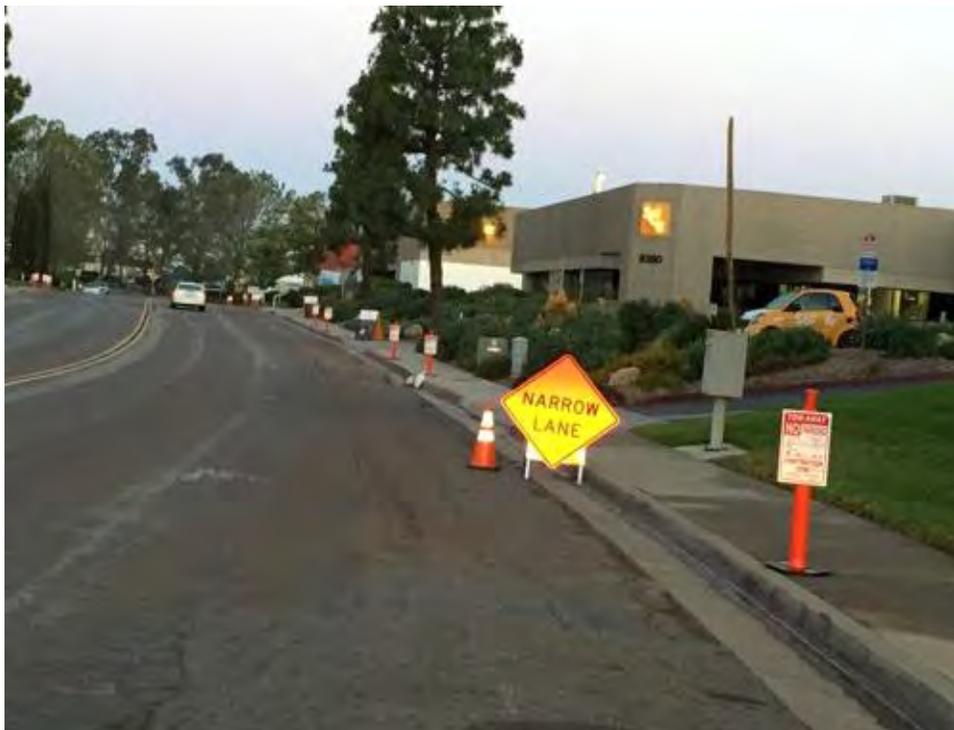
Caption Construction signage in place.

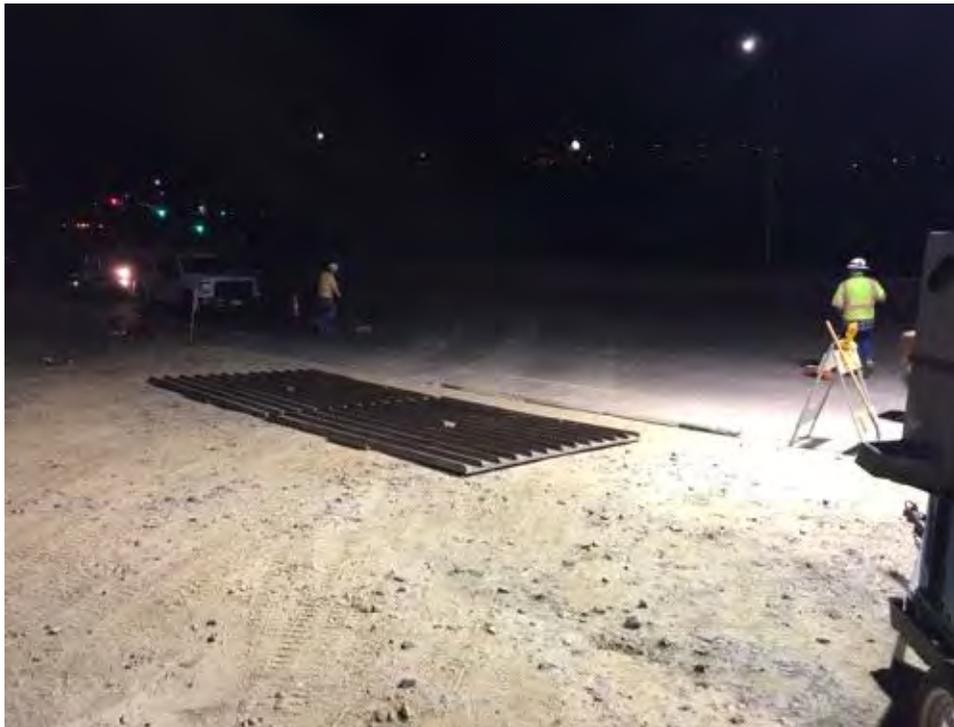
Caption Steel shaker plates installed at vault entrance at the 805.

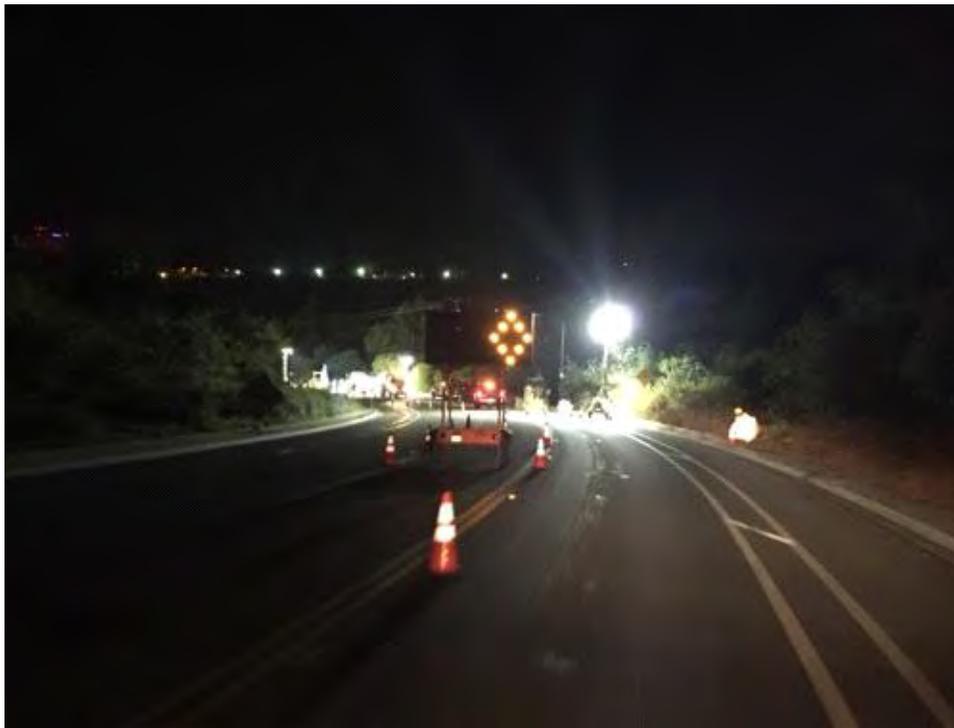
Caption Digital signage and cones in place.

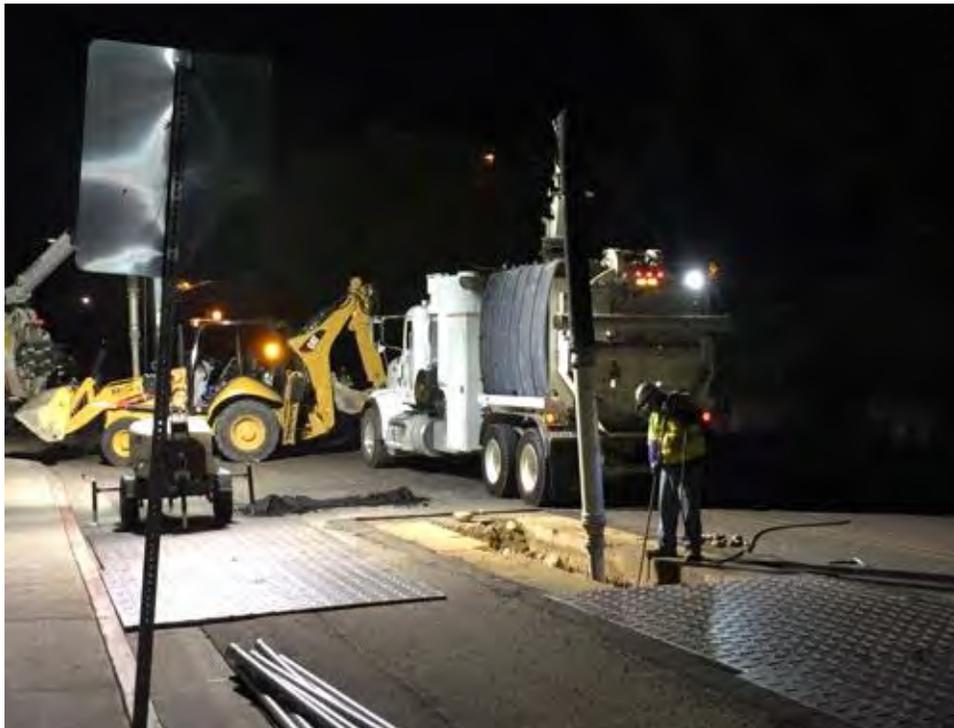
Caption Well-lit potholing in progress.

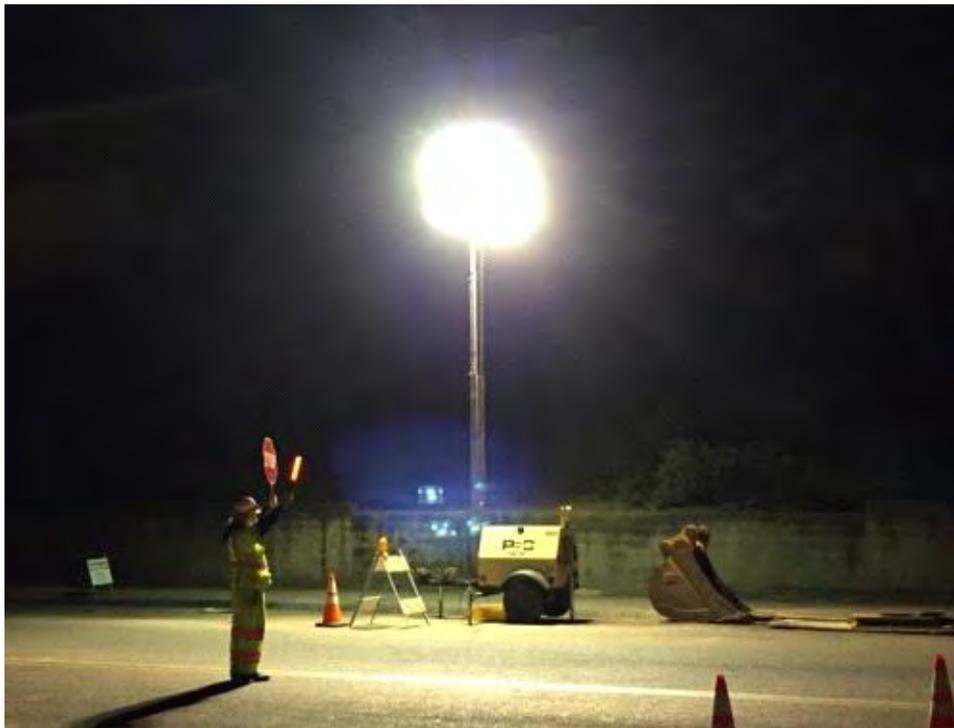
Caption Traffic flaggers in place.

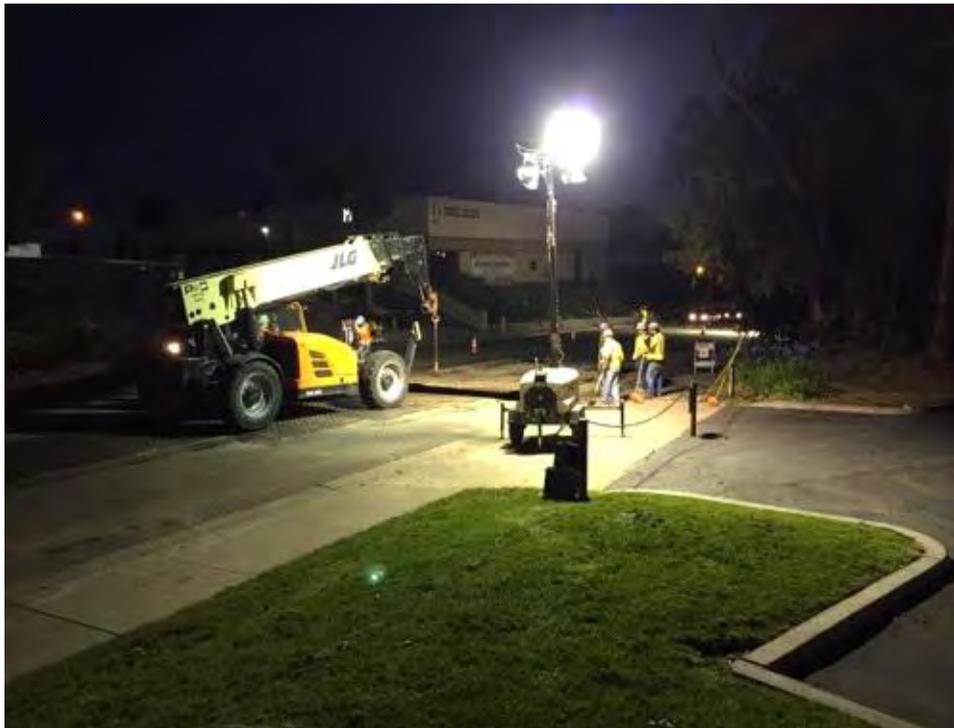
Caption Removing steel plates to commence work.

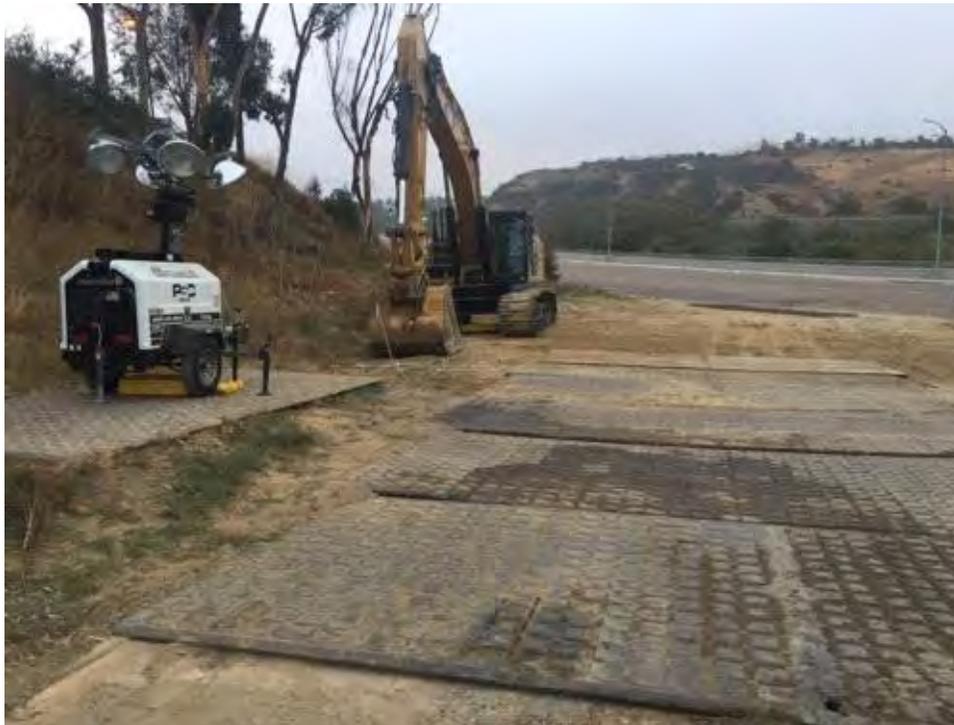
Caption Steel plates in place over vault.

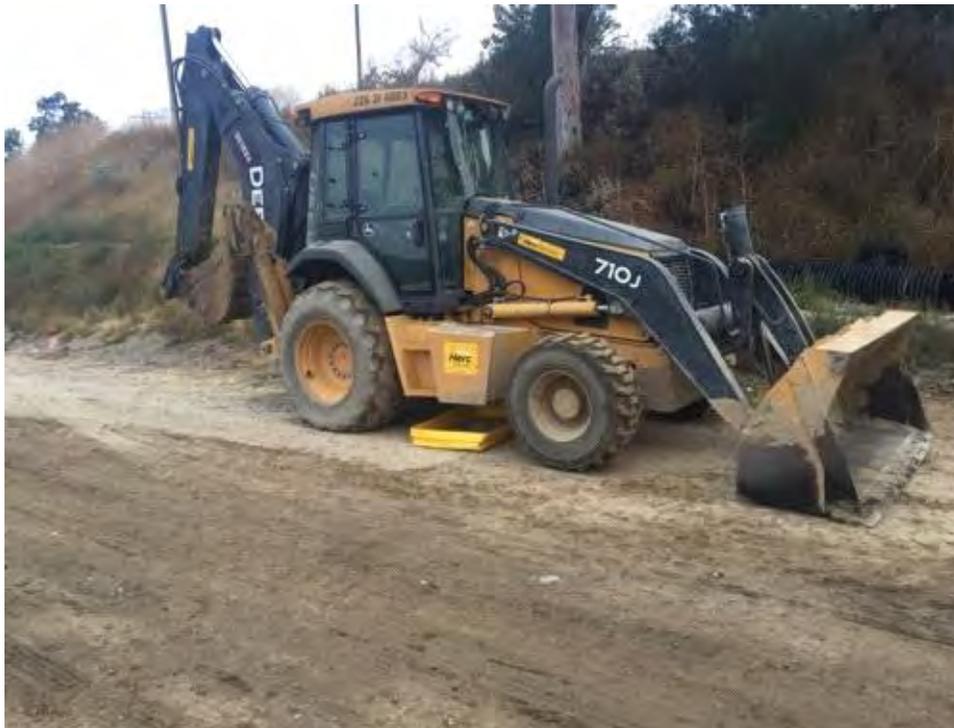
Caption Drip pans in place.

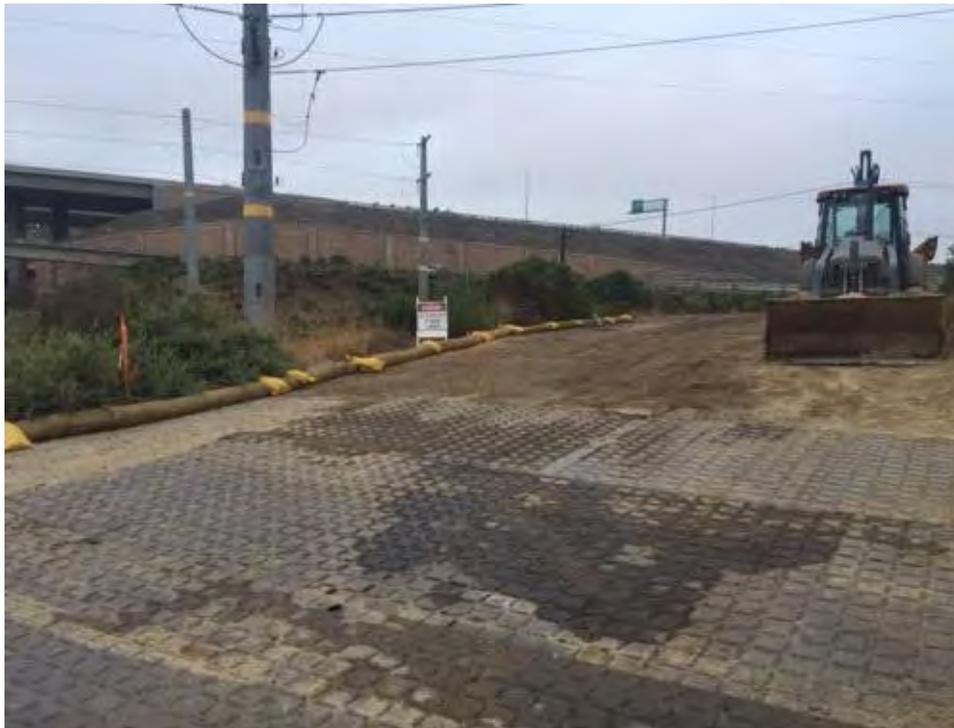
Caption BMPs in place and in good working condition.

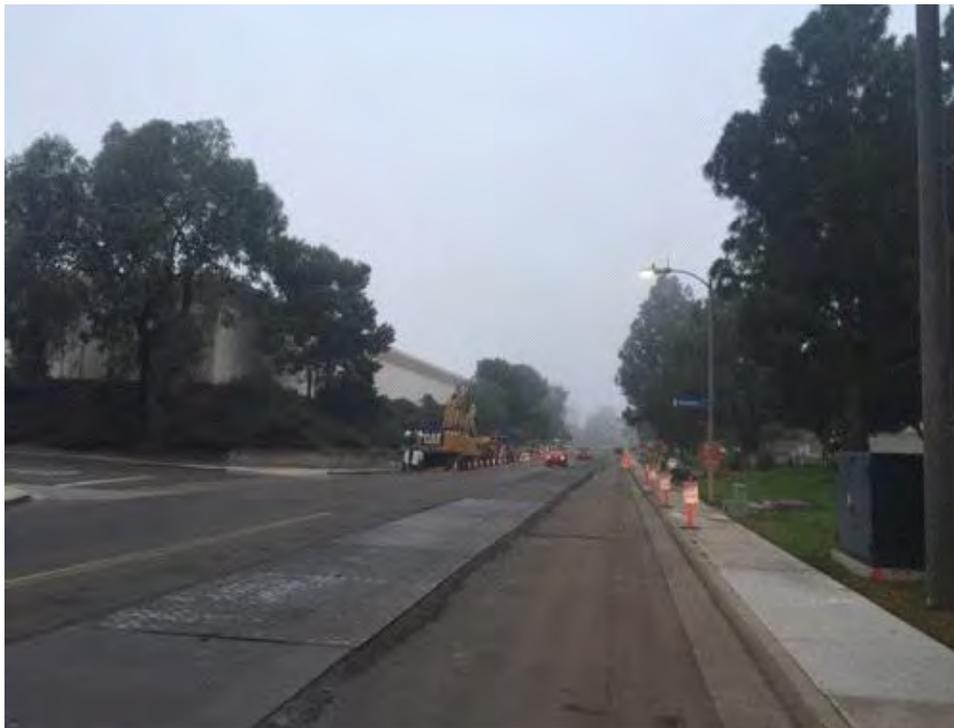
Equipment safely stored to the side of the road and street returned to unrestricted public usage.

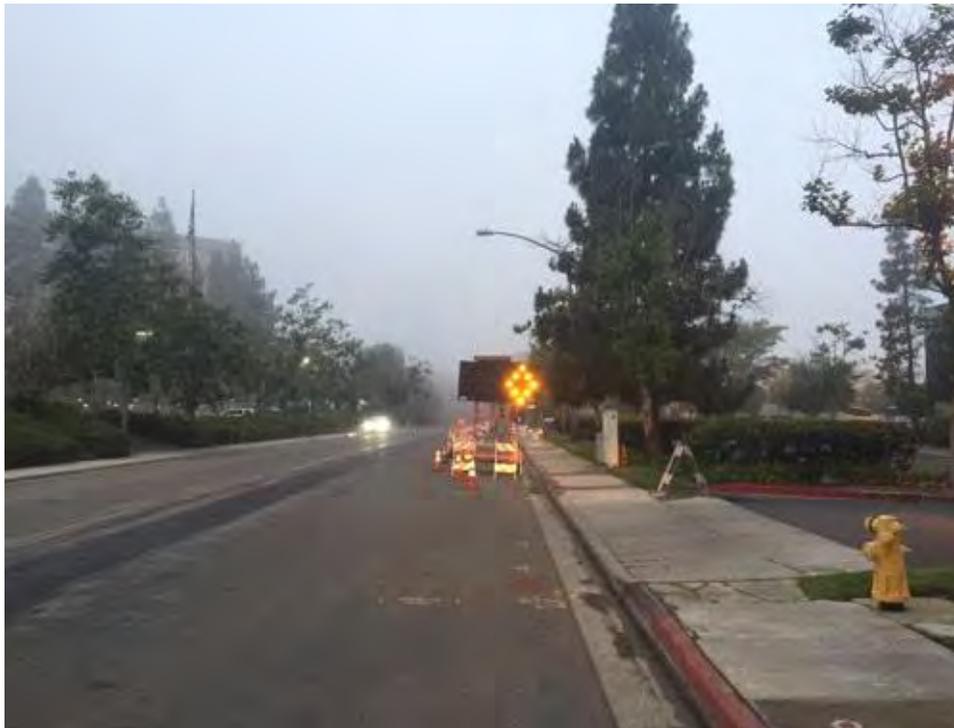
Digital signage in place.

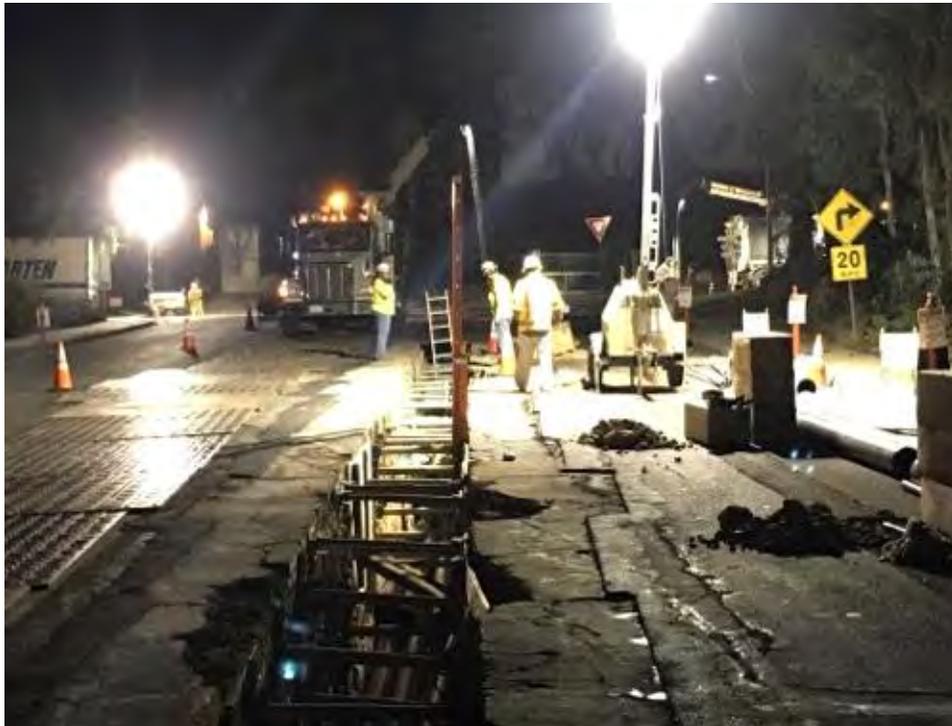
9. On June 16, 2017, the CPUC issued a Level 2 Compliance Deviation to SDG&E for a compliance deviation from the Fire Plan. The Notification stated that "During night work on June 15, 2017, the CPUC field inspector observed three vehicles and one work area on Trade Place were missing the required fire tools per the Fire Plan. The deviations from the Fire Plan were as follows:

- a. Not all vehicles and equipment (such as forklifts and light plants) were equipped with a full complement of fire tools (one round-point, long-handled shovel, one Pulaski and one 5-gallon back pump).

- b. Not all work areas had required tools and pumps within a 50-foot distance."
 This constitutes the third incident of non-compliance with the Fire Plan. The CPUC monitor had previously recorded observations related to not conforming to the Fire Plan on May 18, and SDG&E reported a Level 1 Compliance Incident on June 8, 2017. As a result of these non-compliance incidents, SDG&E submitted an email on June 19, 2017 describing corrective actions being taken, including a Safety Stand-down on that took place on June 19, 2017.

Caption Trade Street - no fire tools for personnel.

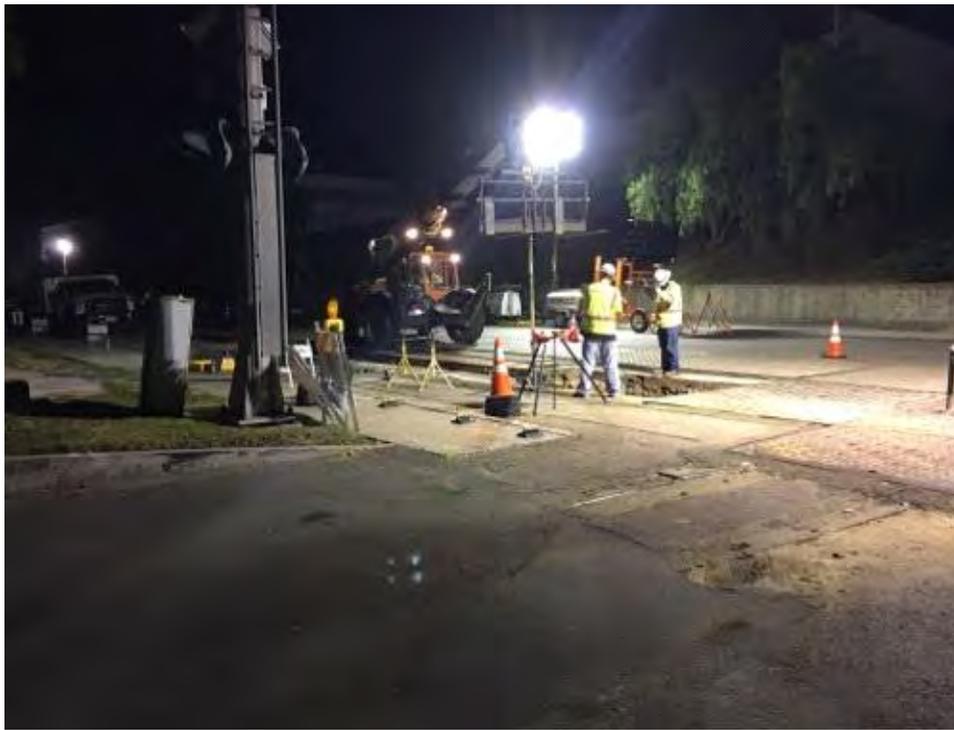
Caption Fire tools missing from work site - Trade Street

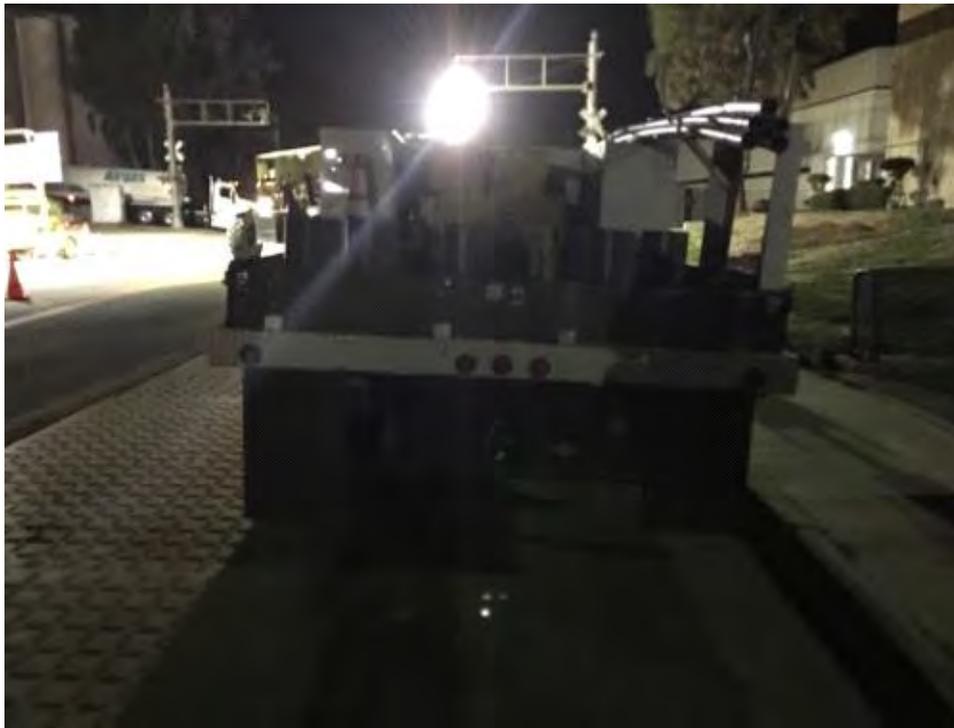
Caption Vehicle with partial fire tools Trade Street.

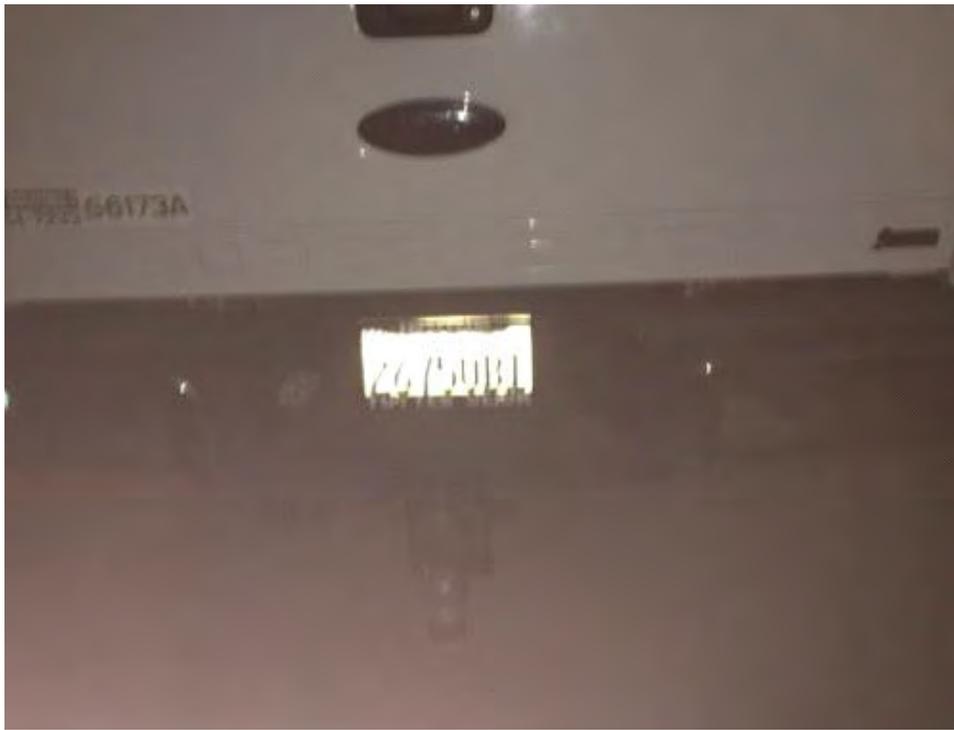
Caption Truck without fire tool.

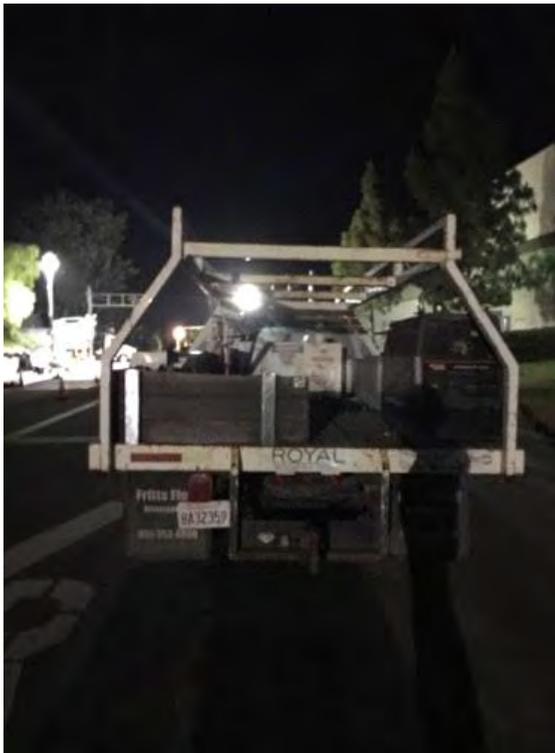
Caption Vehicle without fire tools.

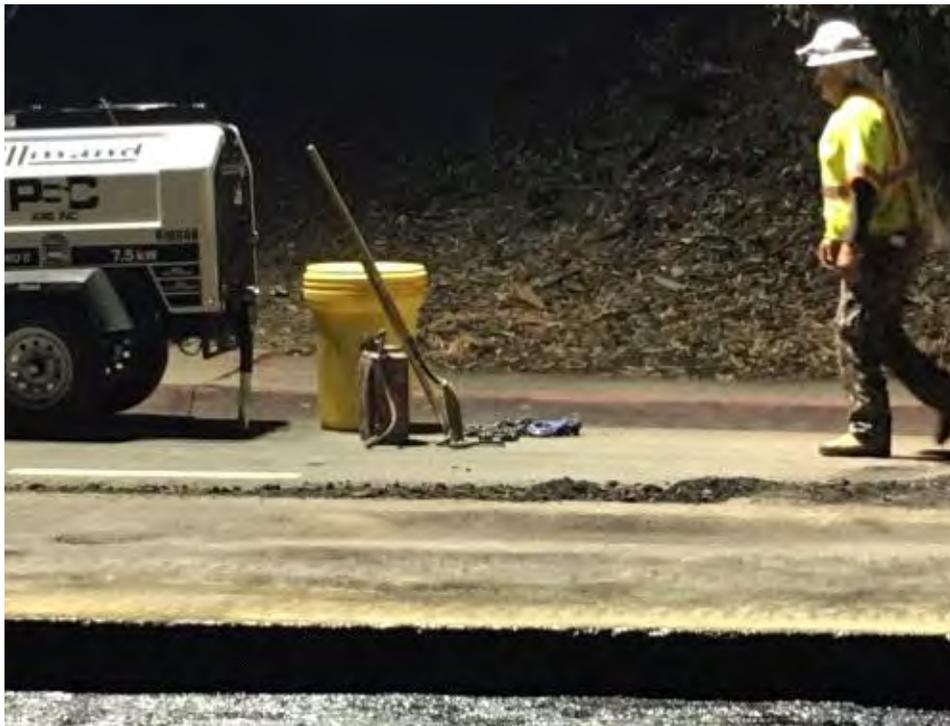
Caption Fire tools Carroll Street.

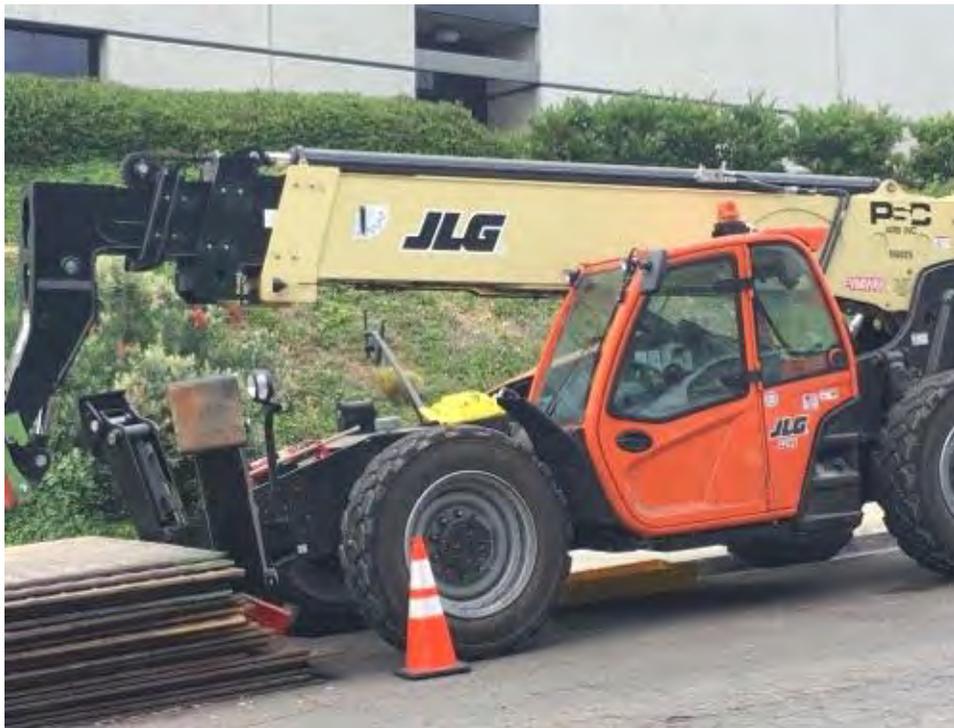
Caption Equipment storage.

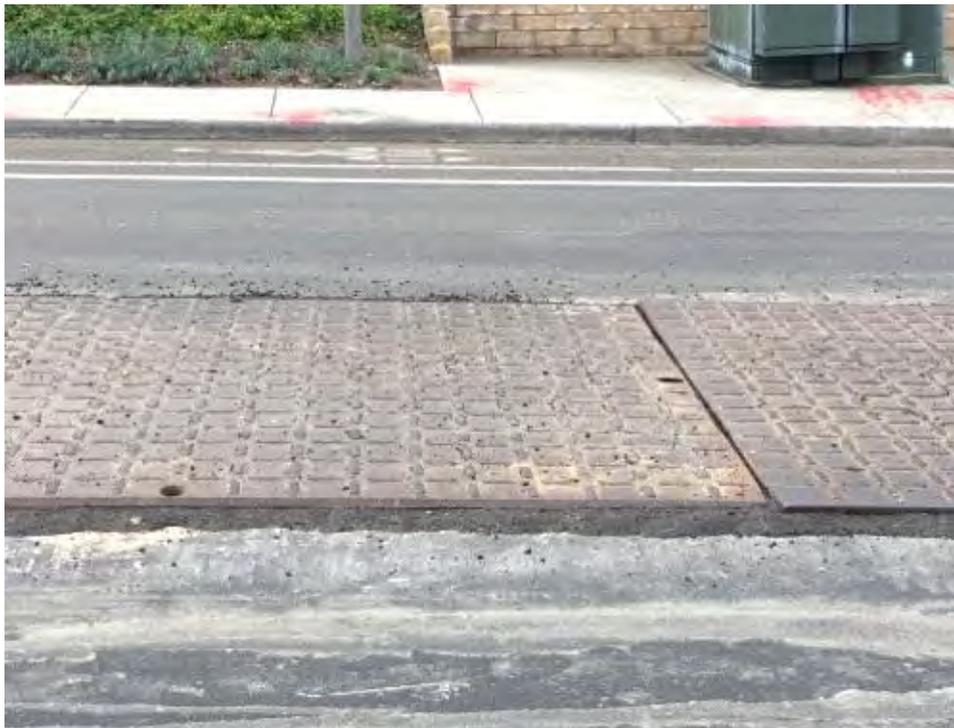
Caption Debris on Carrol Rd.
