PROJECT MEMORANDUM SYCAMORE-PEÑASQUITOS 230-KV TRANSMISSION LINE PROJECT

Date: August 10, 2017
To: Billie Blanchard, CPUC Project Manager
From: Sheila Hoyer, CPUC Monitoring Supervisor
Subject: Weekly Report #31 – July 31 to August 5, 2017

SDG&E Sycamore-Peñasquitos 230-kV Transmission Line Project: Daily Inspection Report

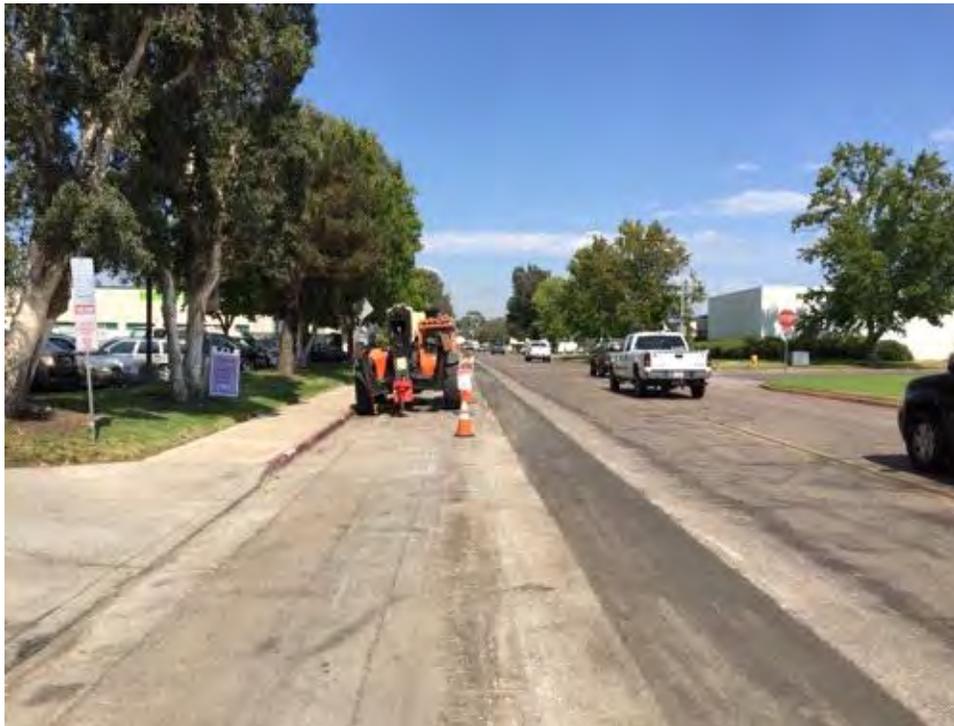
Caption Equipment properly staged on Arjons Drive.

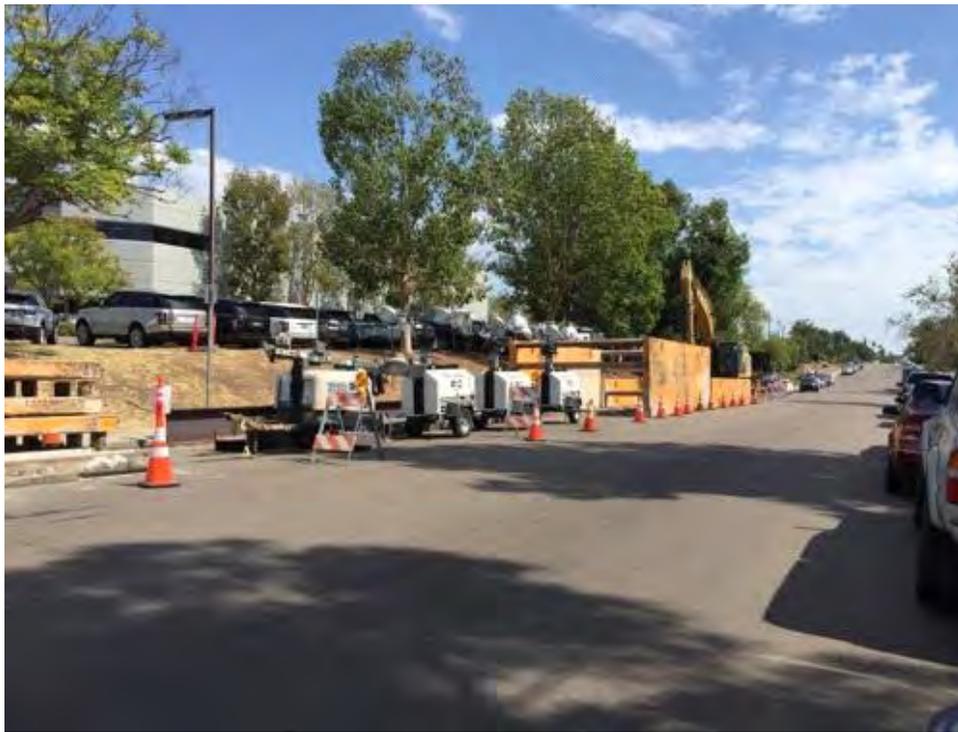
Caption Equipment staged on Clayton Drive.

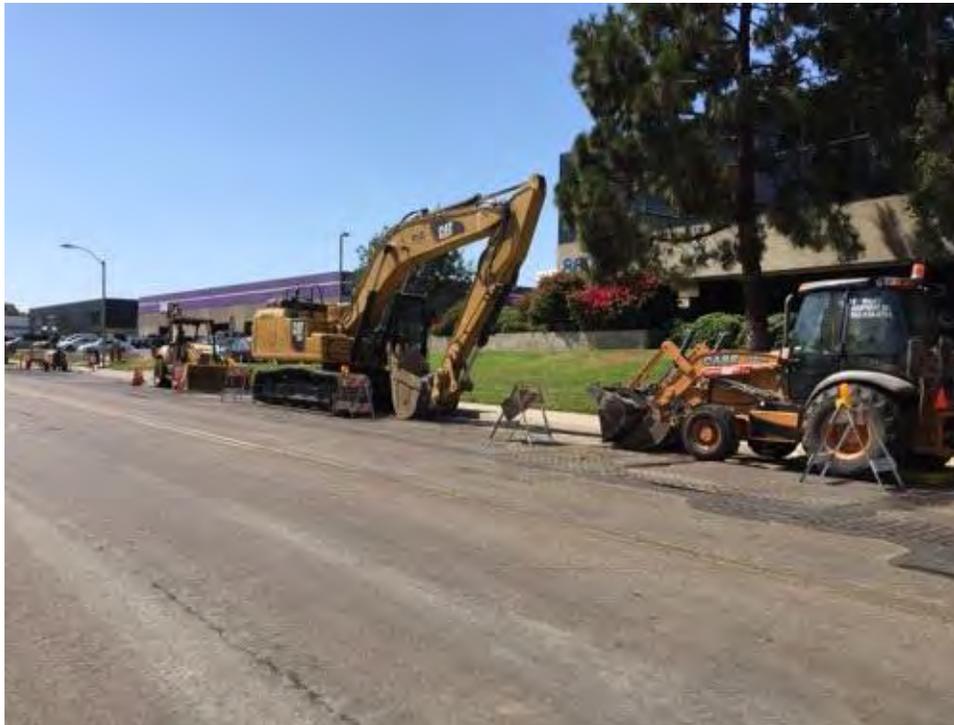
Caption Equipment properly staged on Miralani Drive.

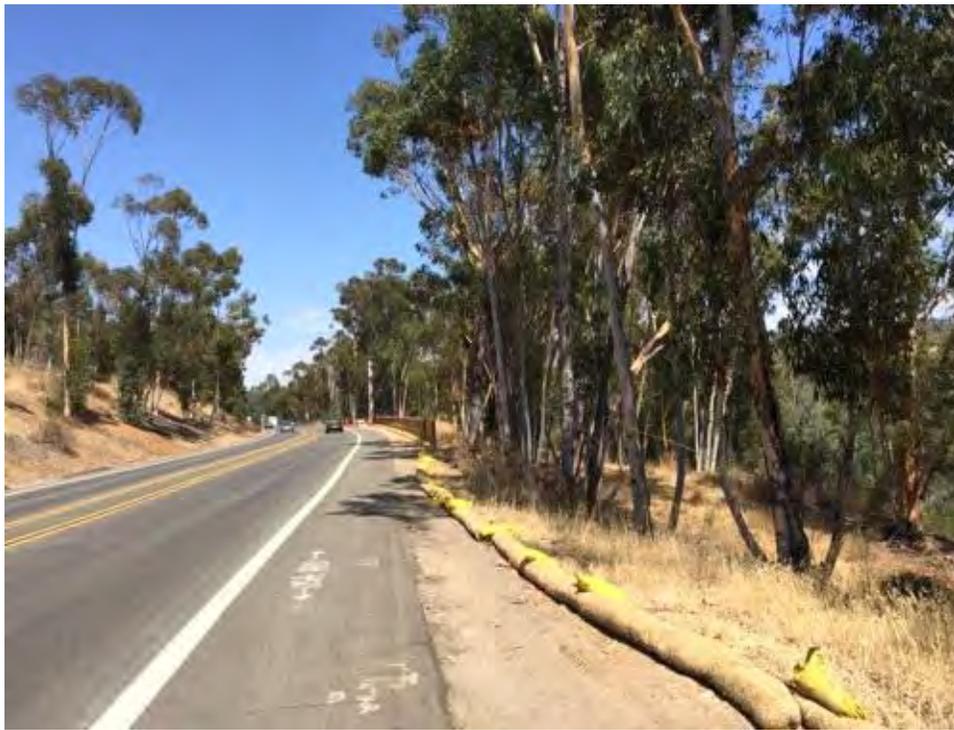
Caption Wattles in place on Pomerado Road.

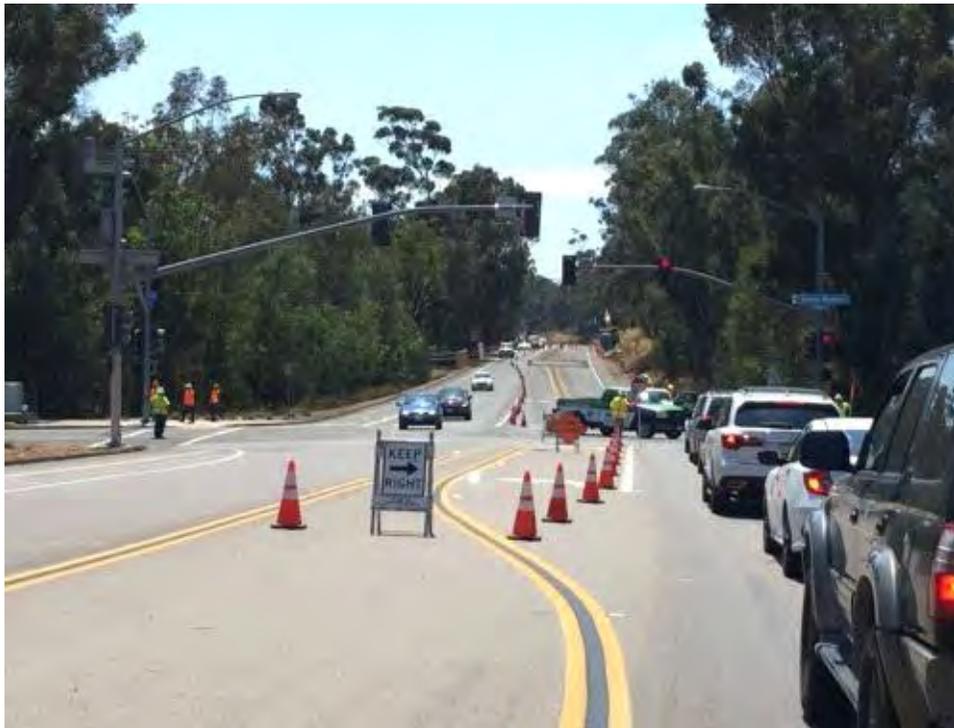
Caption Flaggers in place on Pomerado Road at Avenida Magnifico.

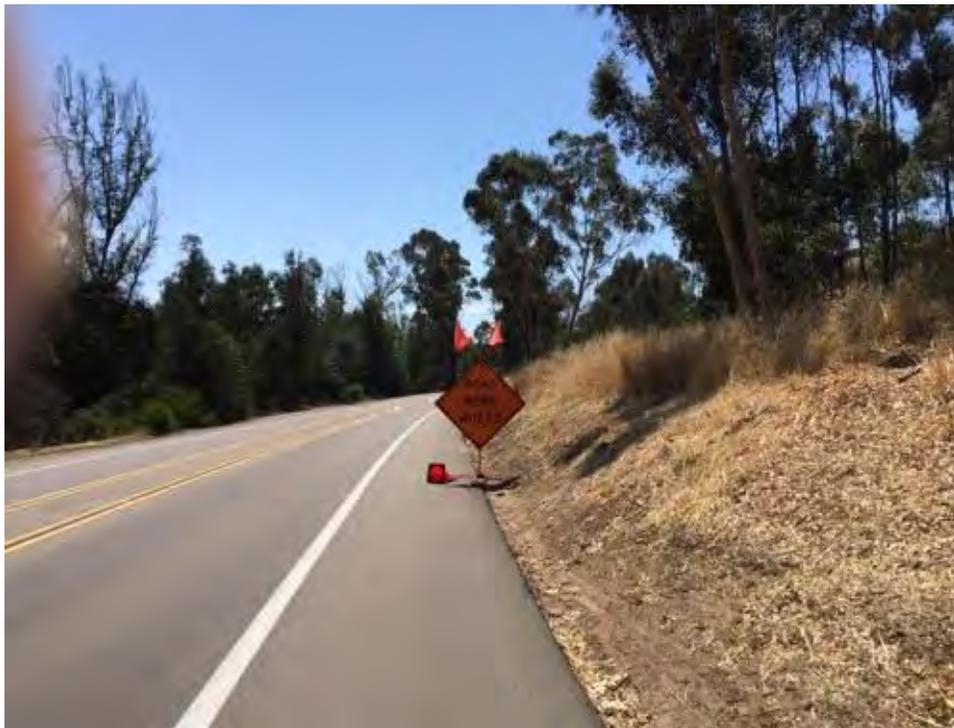
Caption Signage in place on north end of Pomerado Road.

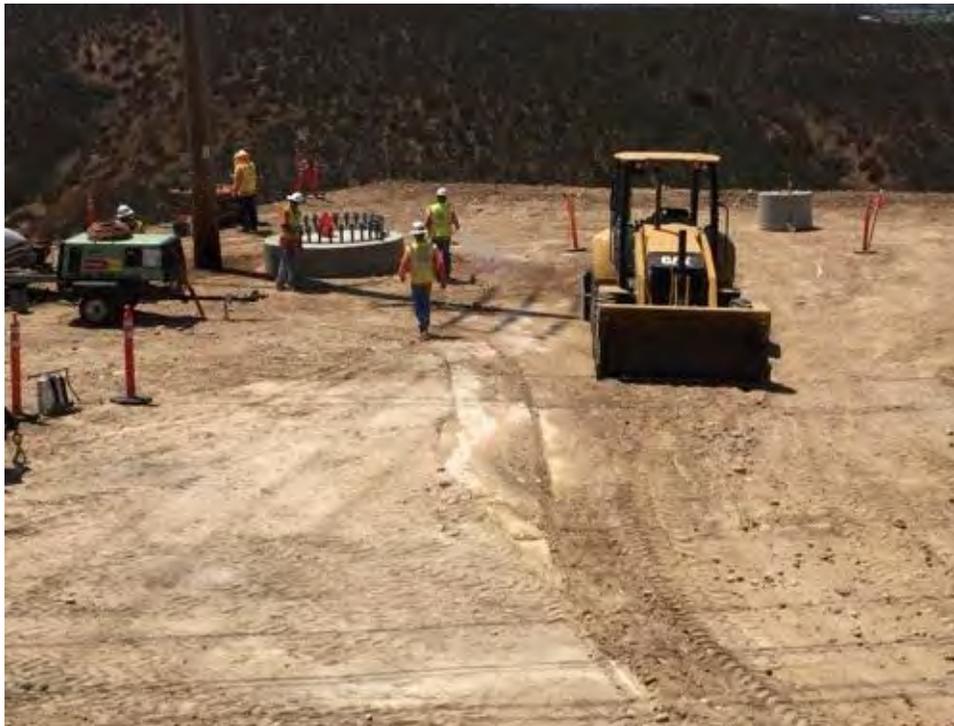
Caption Dust control in practice at Pole site 03.

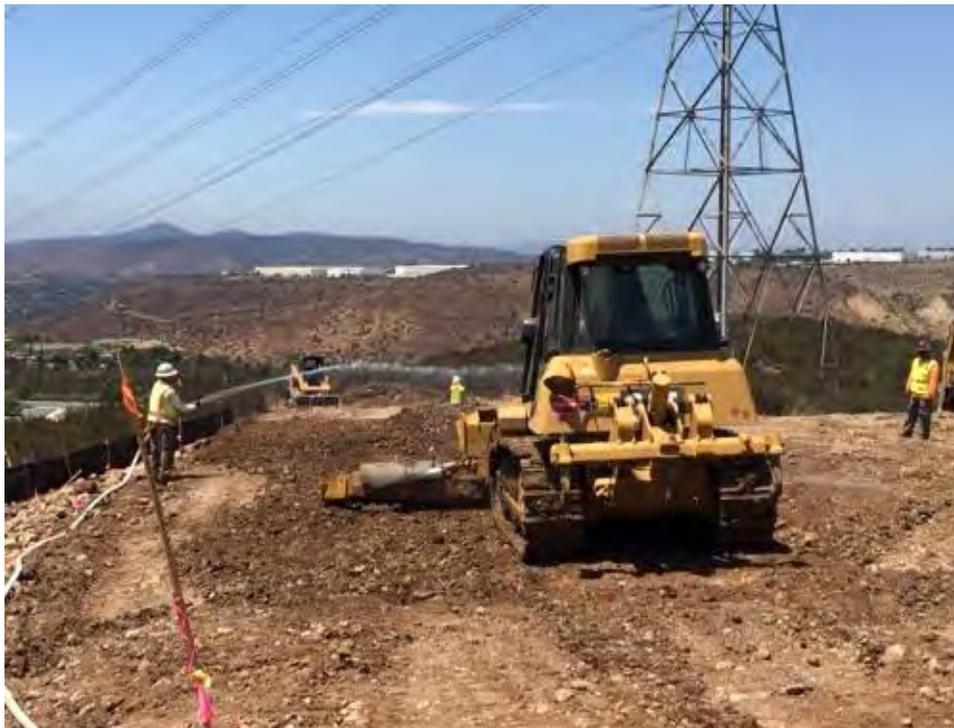
Caption Dust control in practice at Pole site 04.

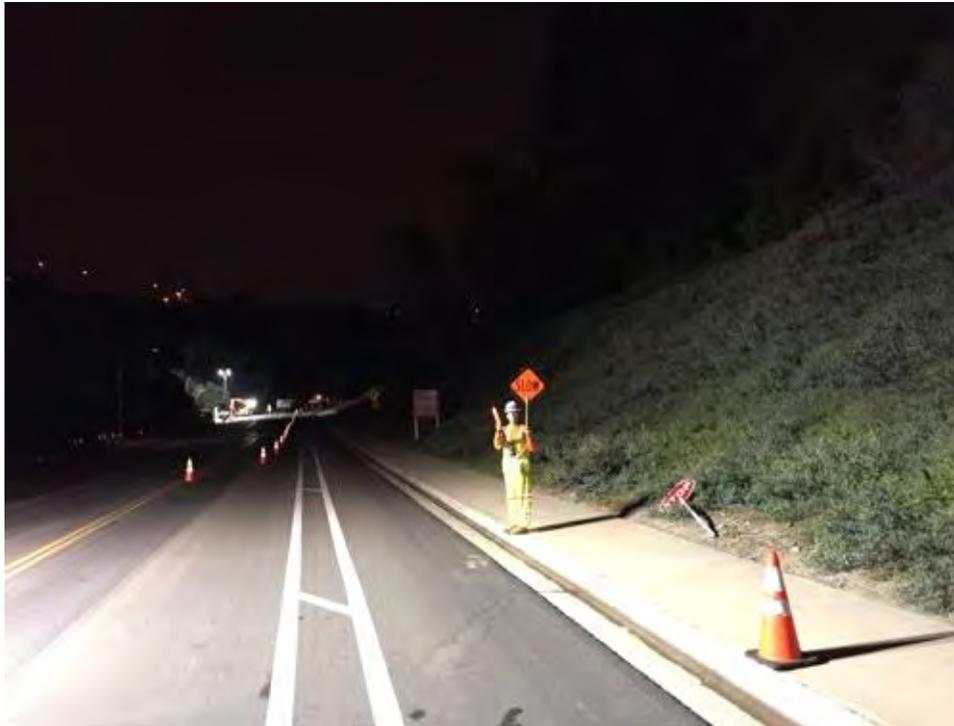
Caption Traffic flagger in place on Carroll Road.

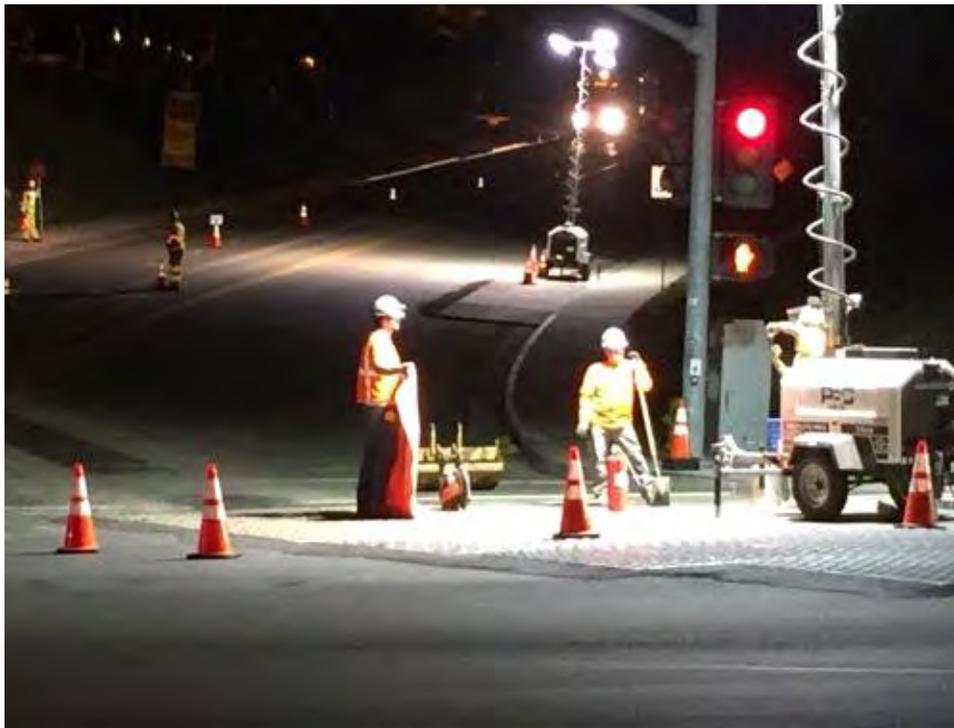
Caption Fire prevention practices in place on Camino Ruiz.

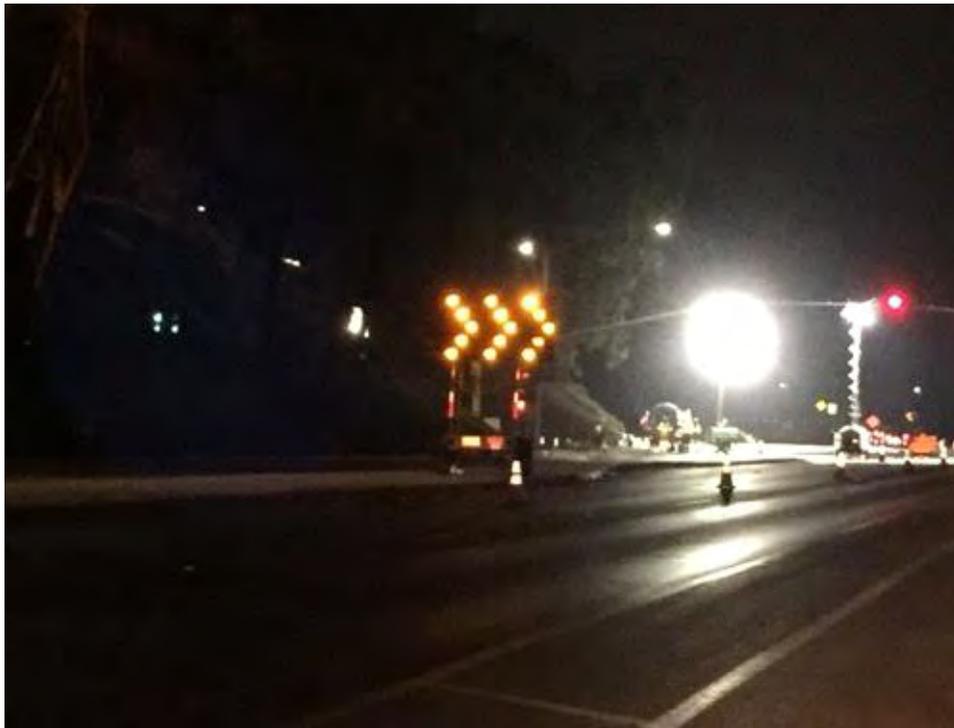
Caption Construction signage in place on Camino Ruiz.

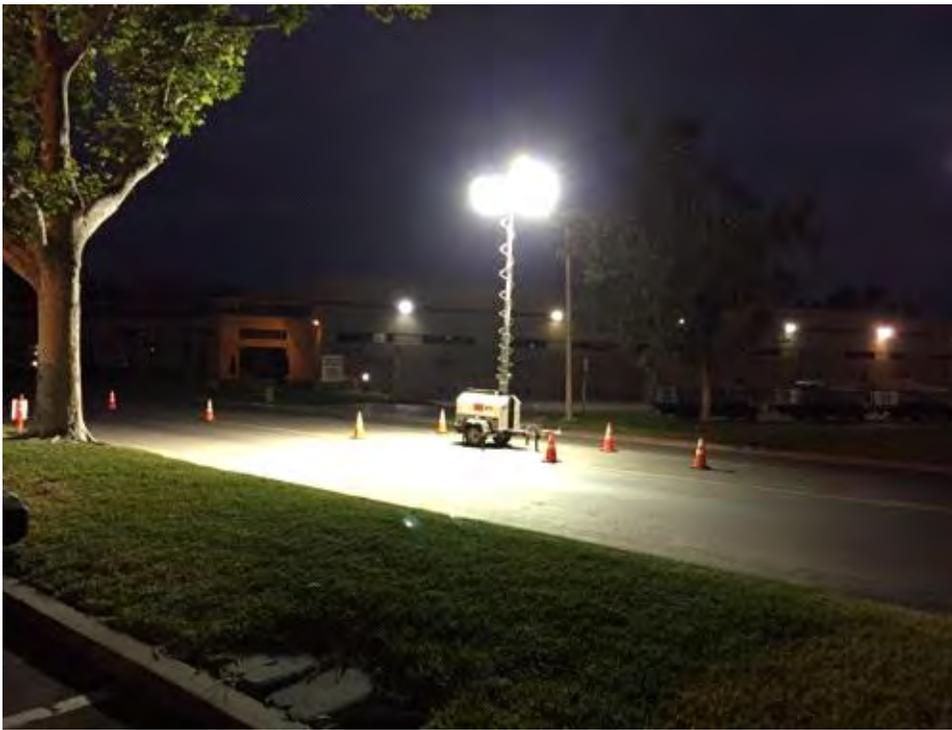
Caption Downward facing lighting in place on Activity Road.

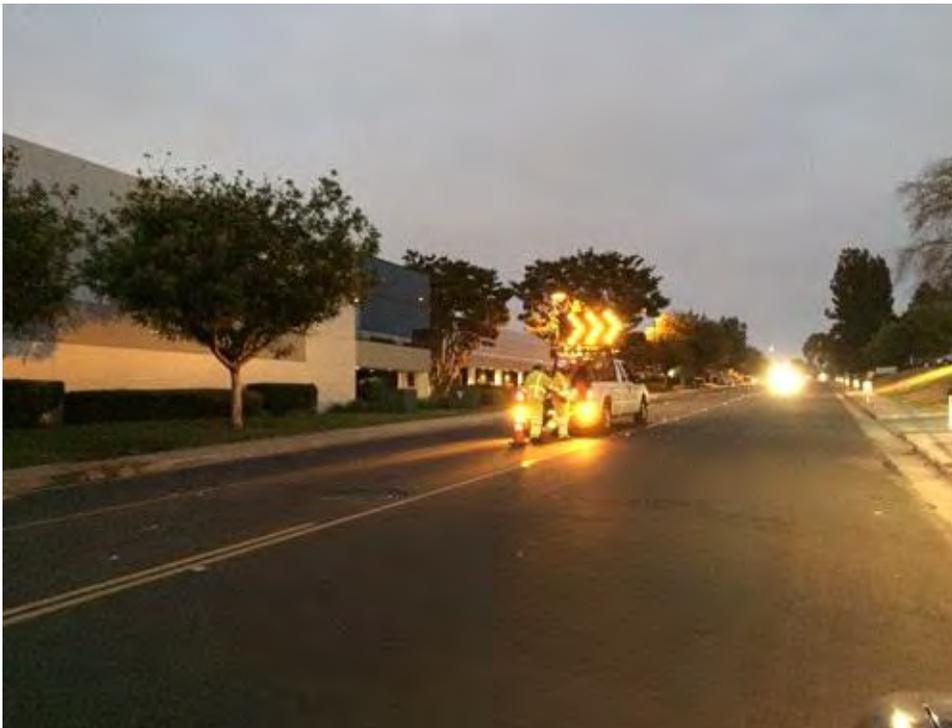
Caption Placing cones on Activity Road.

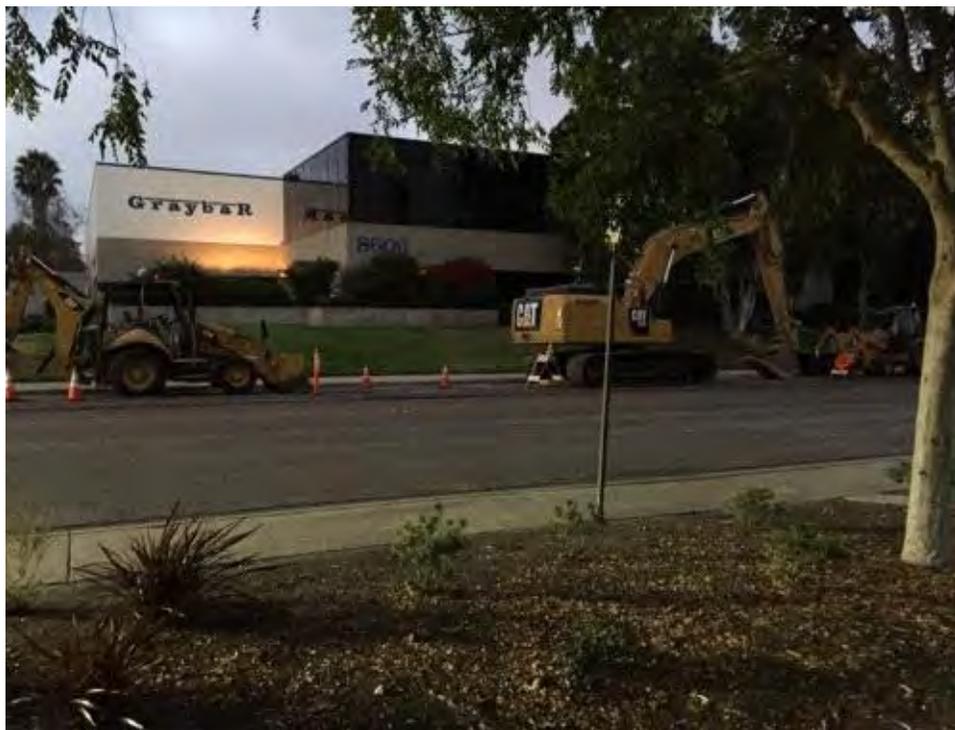
Caption Drip pans in place under equipment on Miralani Drive.

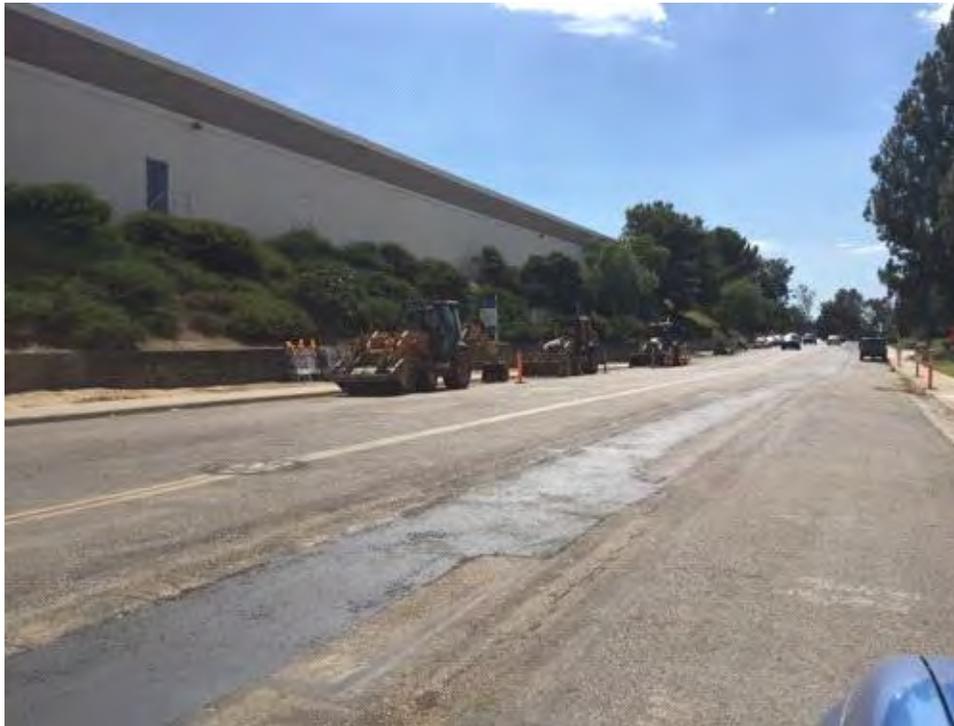
Caption Equipment properly staged on Trade Street.

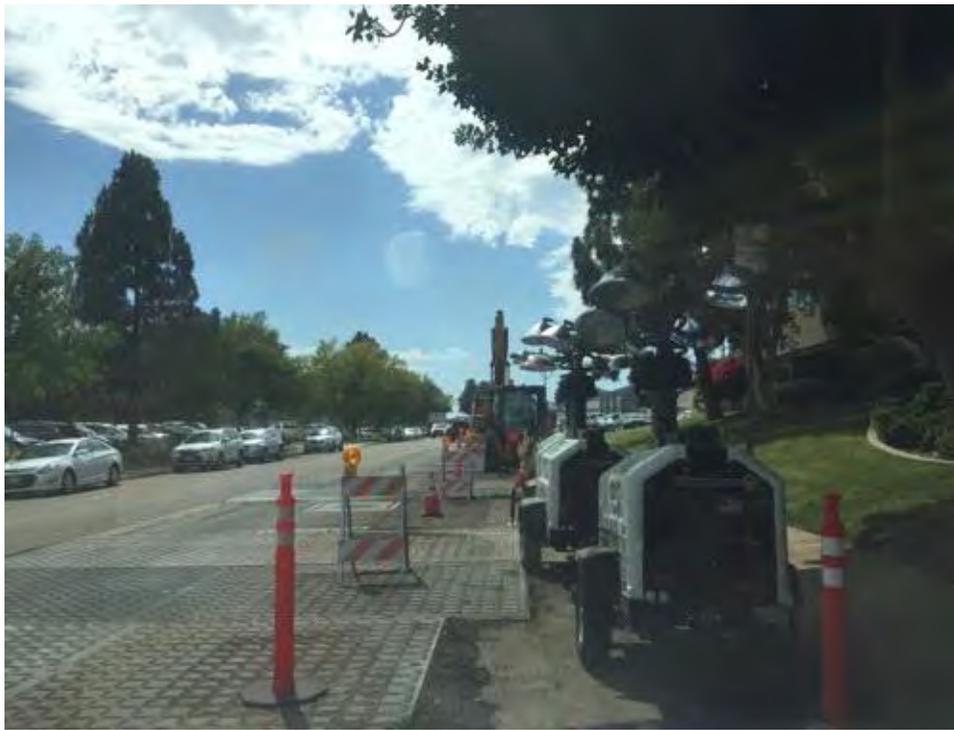
Caption Equipment properly staged on Miralani Drive.

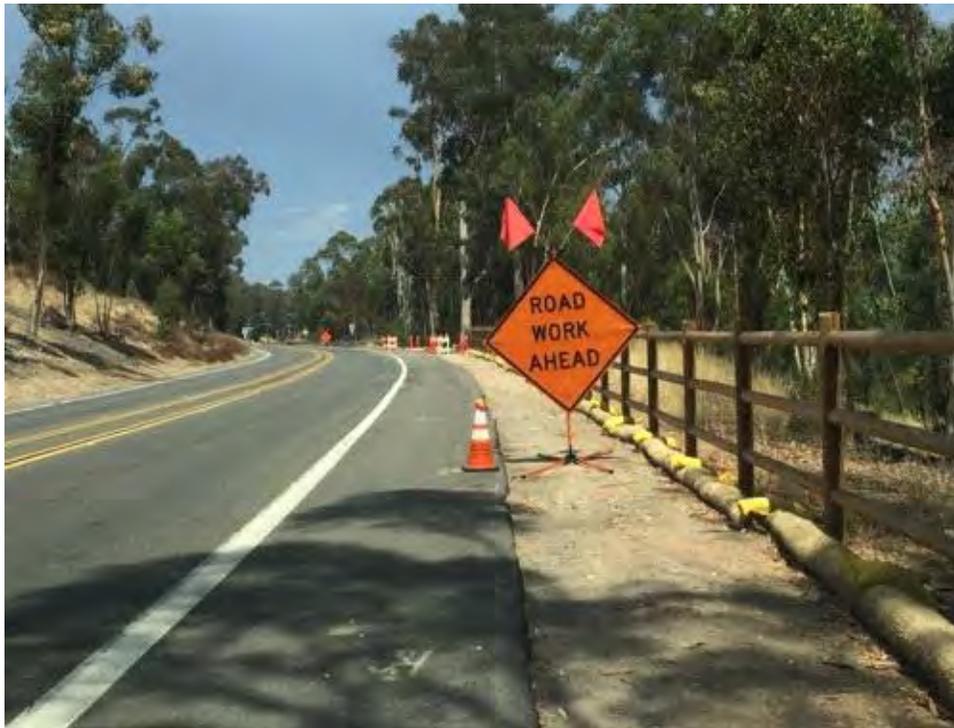
Caption Construction signage in place on Pomerado Road.

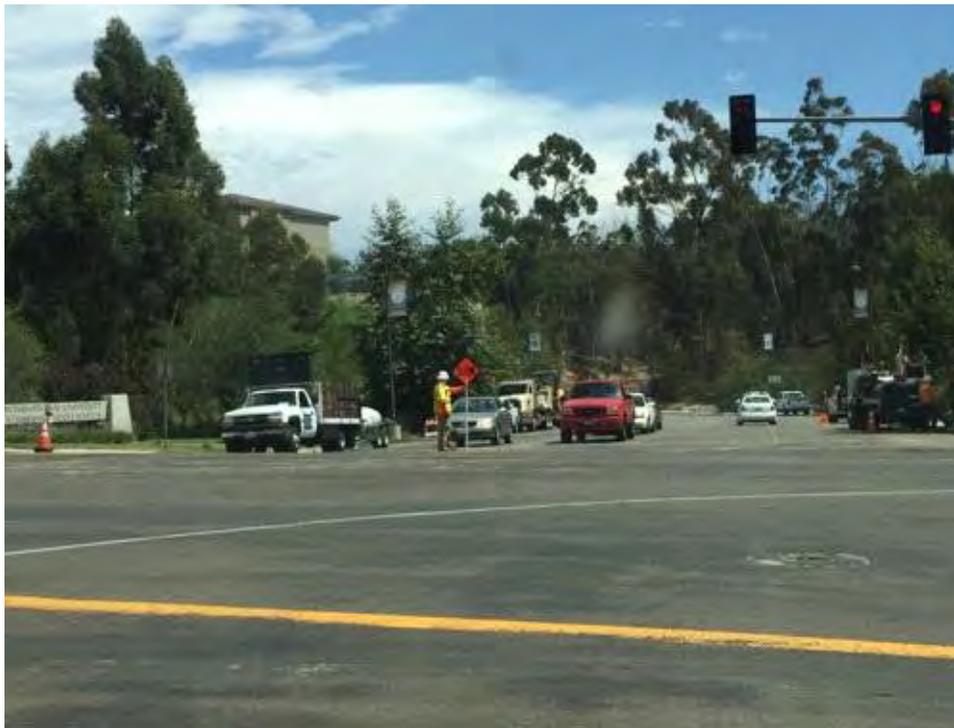
Caption Flaggers on site on Pomerado Road.

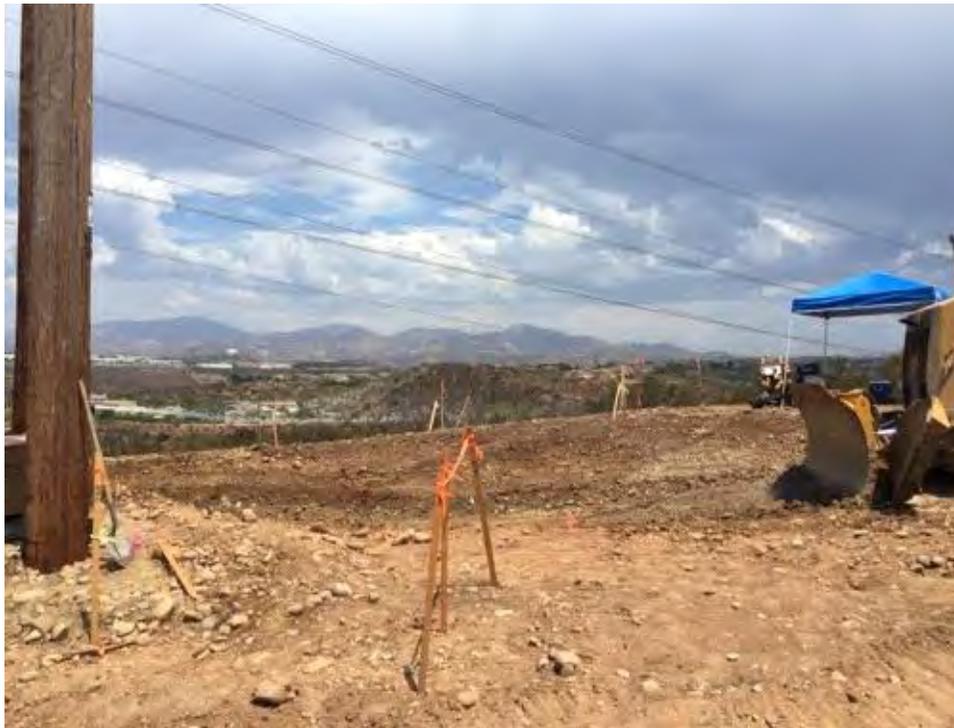
Caption Dust control practices in use at Pole site 04.

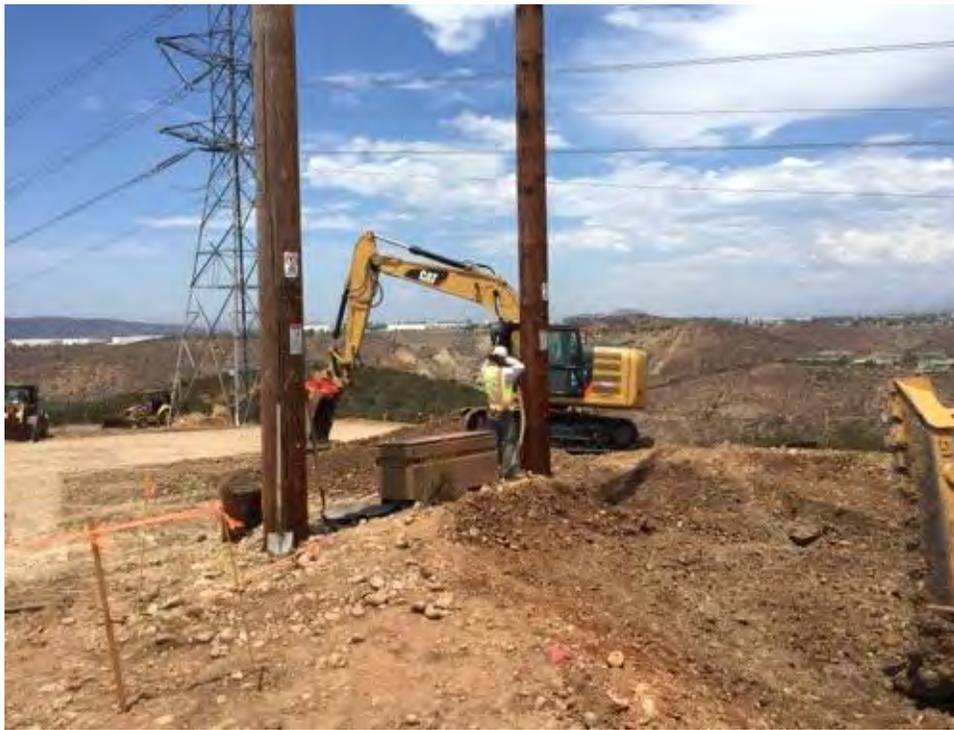
Caption Grading and excavation at Pole site 04.

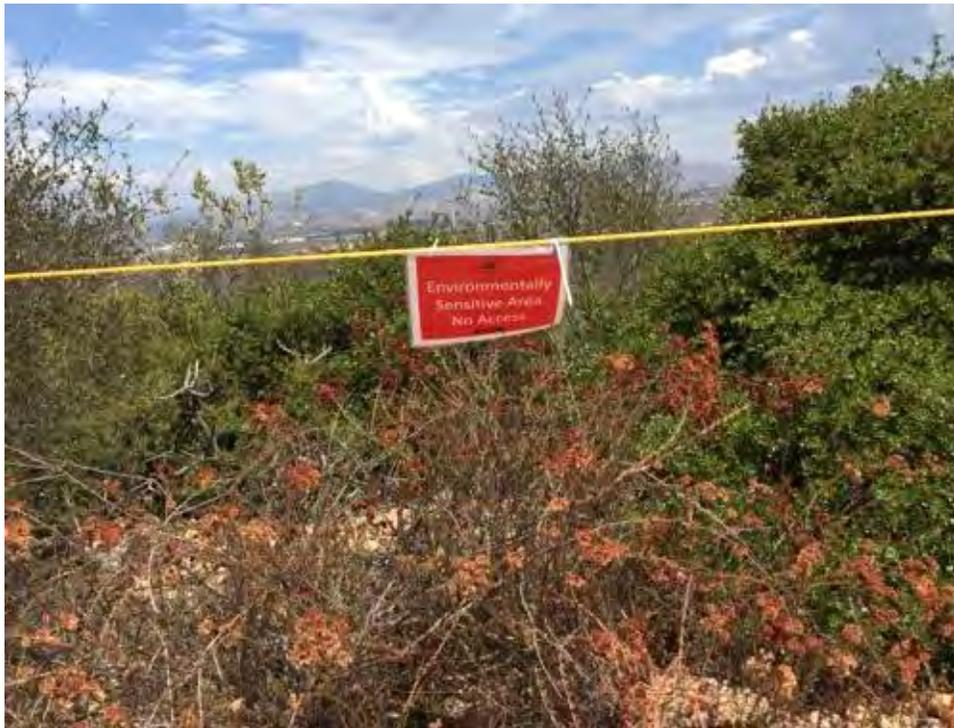
Caption Sensitive areas clearly marked at entrance to Pole site 04.

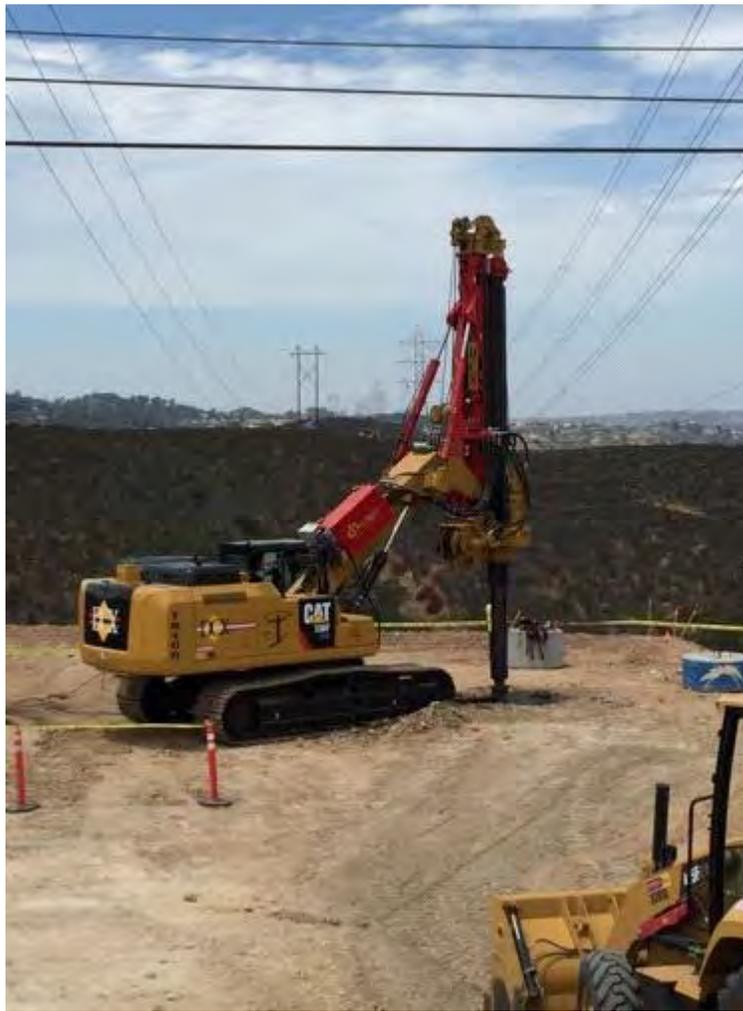
Caption Drilling at Pole site 03.

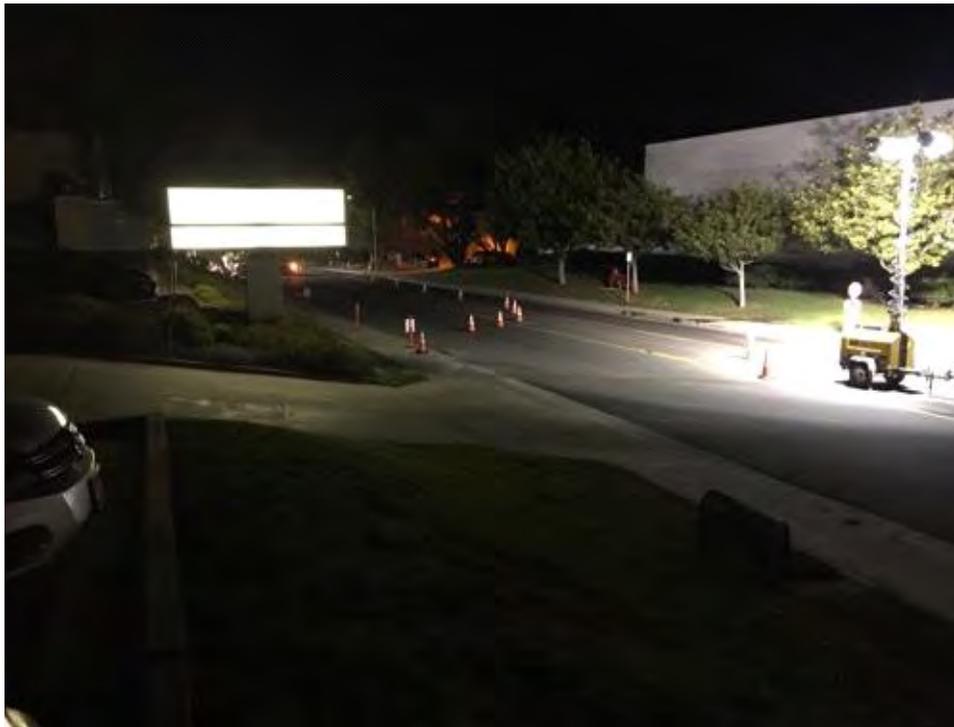
Caption Access to driveways and local businesses were maintained.

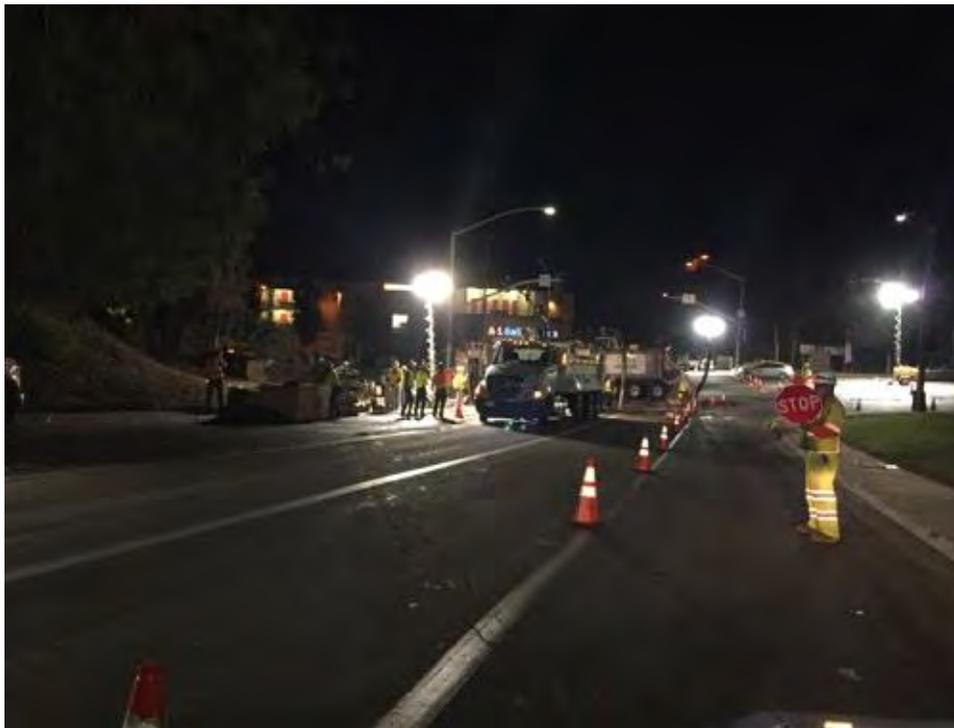
Caption Crews were potholing and excavating on Miralani Drive.

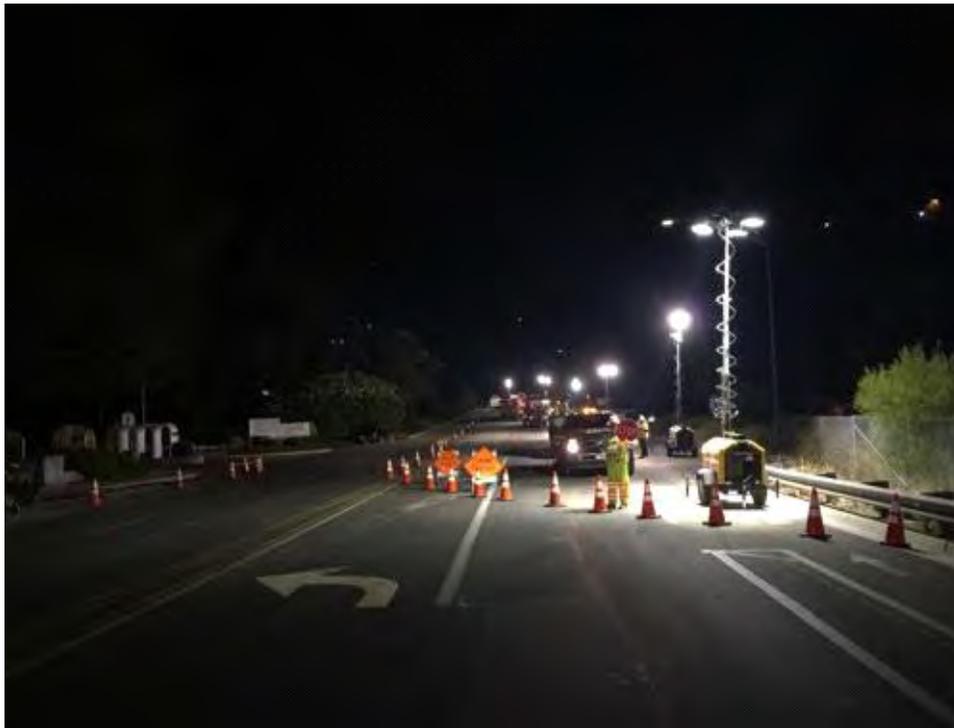
Caption Work site on Carroll Canyon Road.

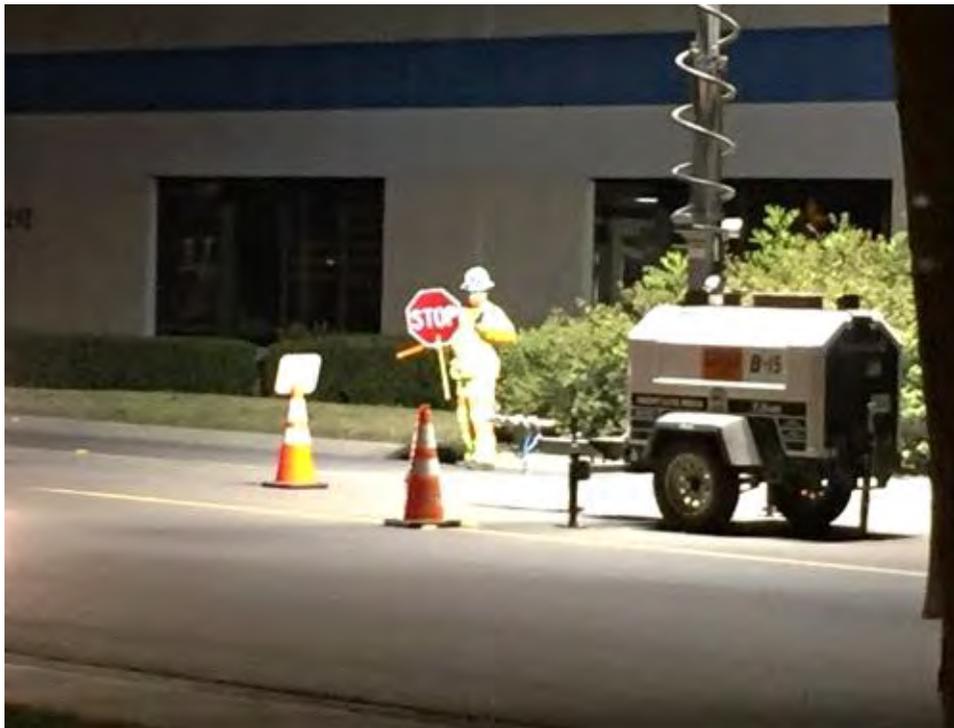
Caption Traffic flaggers in place on Activity Road.

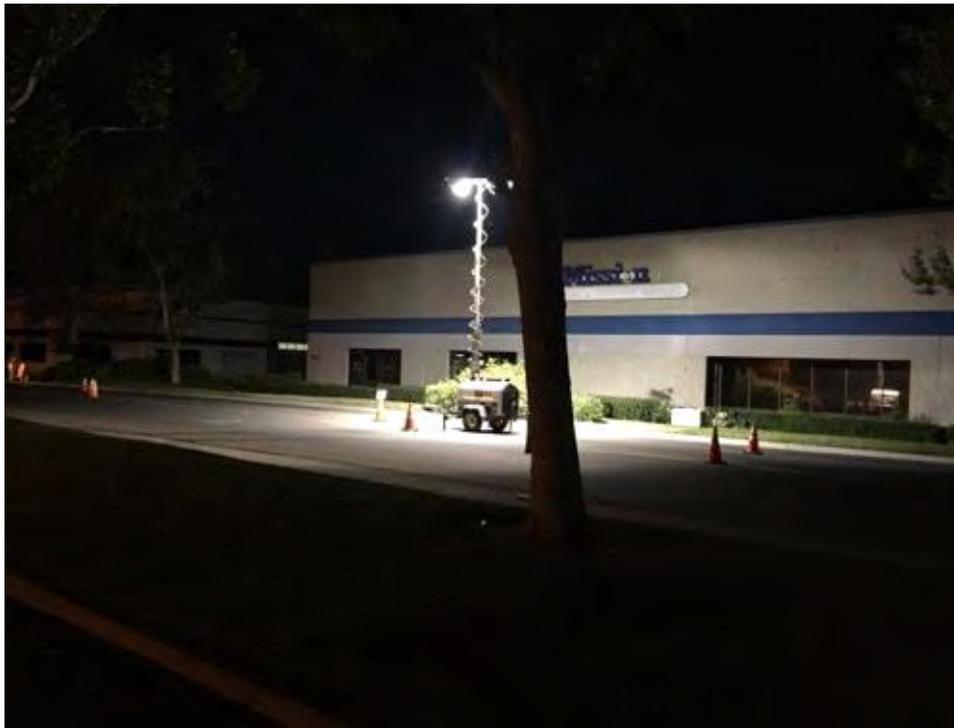
Caption Downward-facing lighting in place on Activity Road.

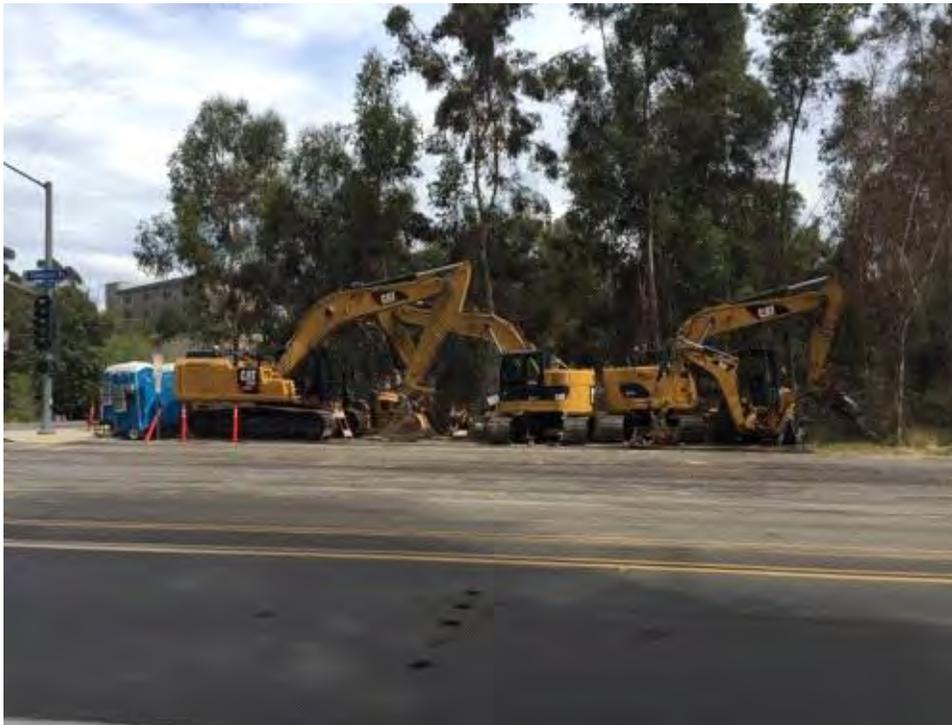
Caption Equipment stored with drip pans and street returned unrestricted to public use on Pomerado Road and Avenue of Nations.

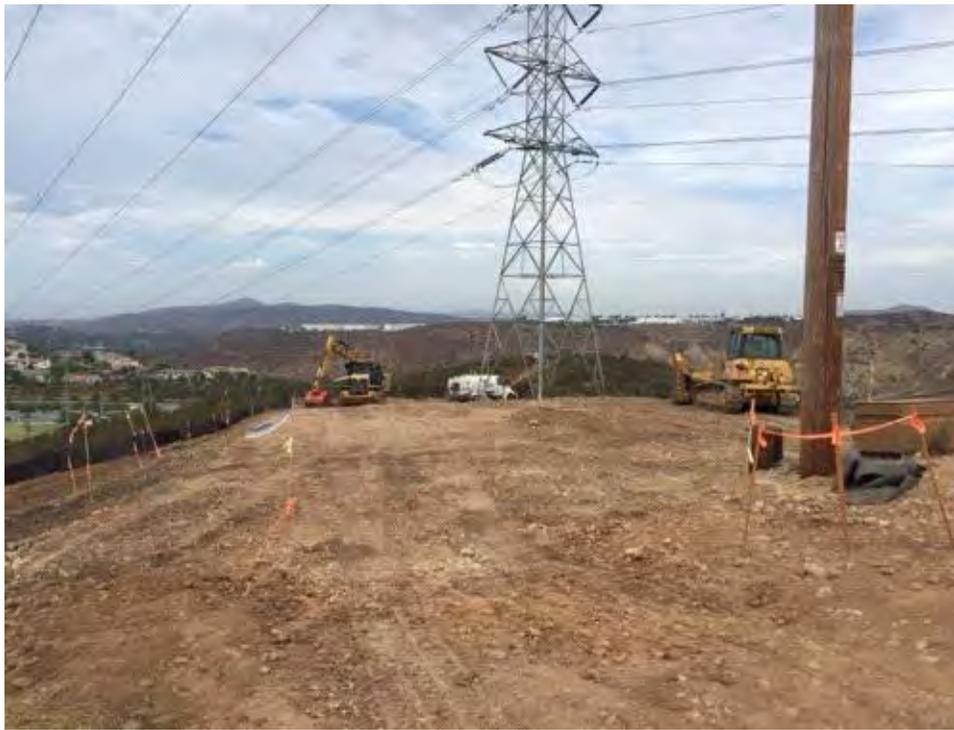
Caption No work being done a tPole site 04.

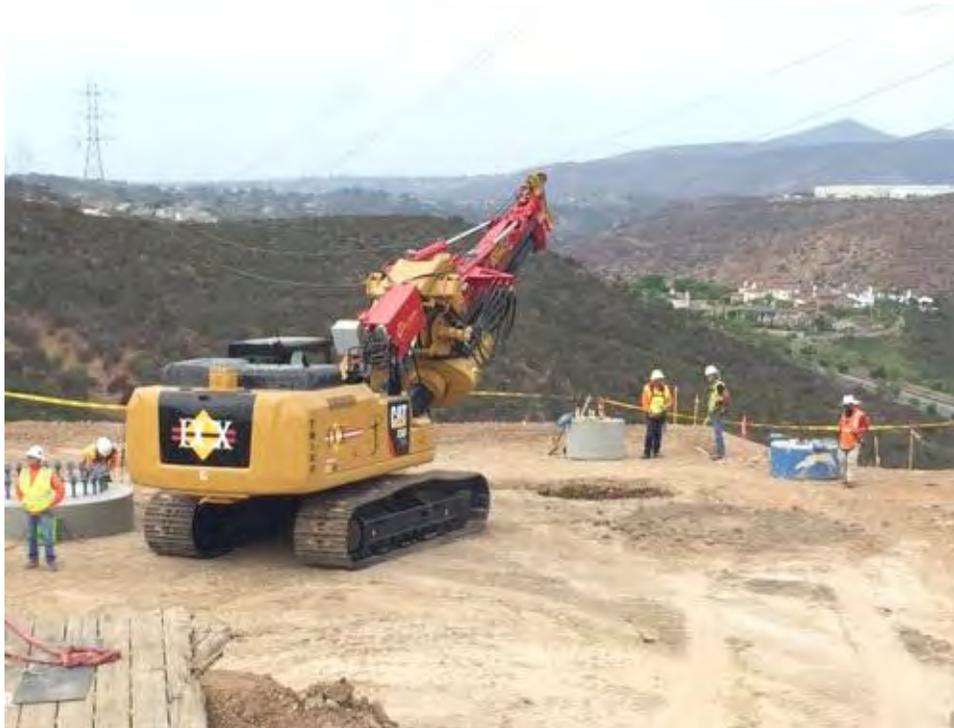
Caption Finished drilling foundation hole at Pole site 03.

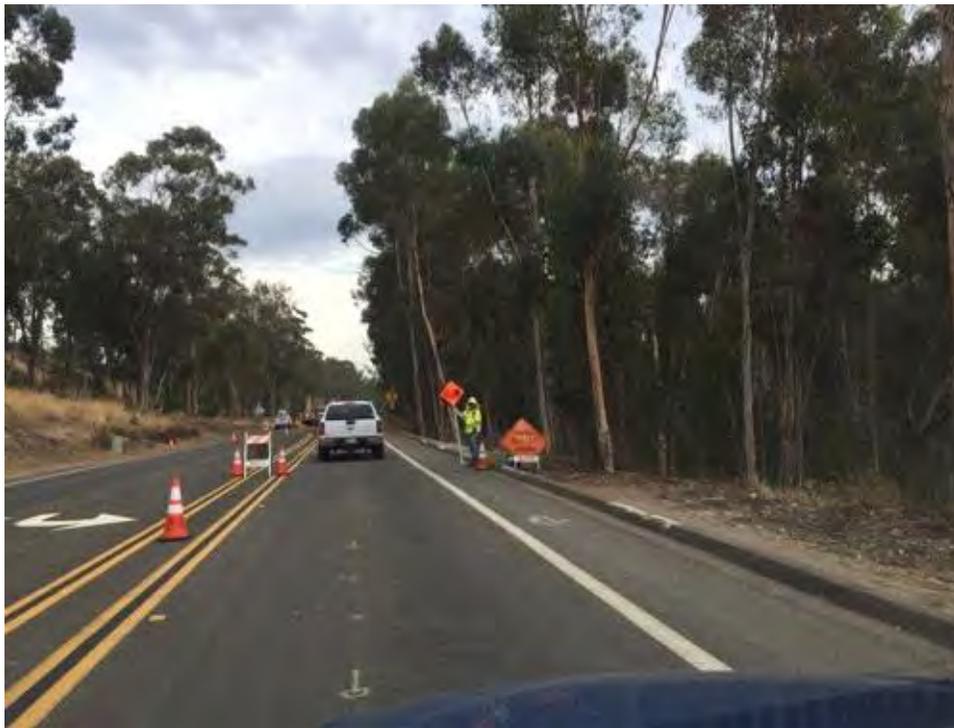
Caption Flaggers in place on Pomerado Road.

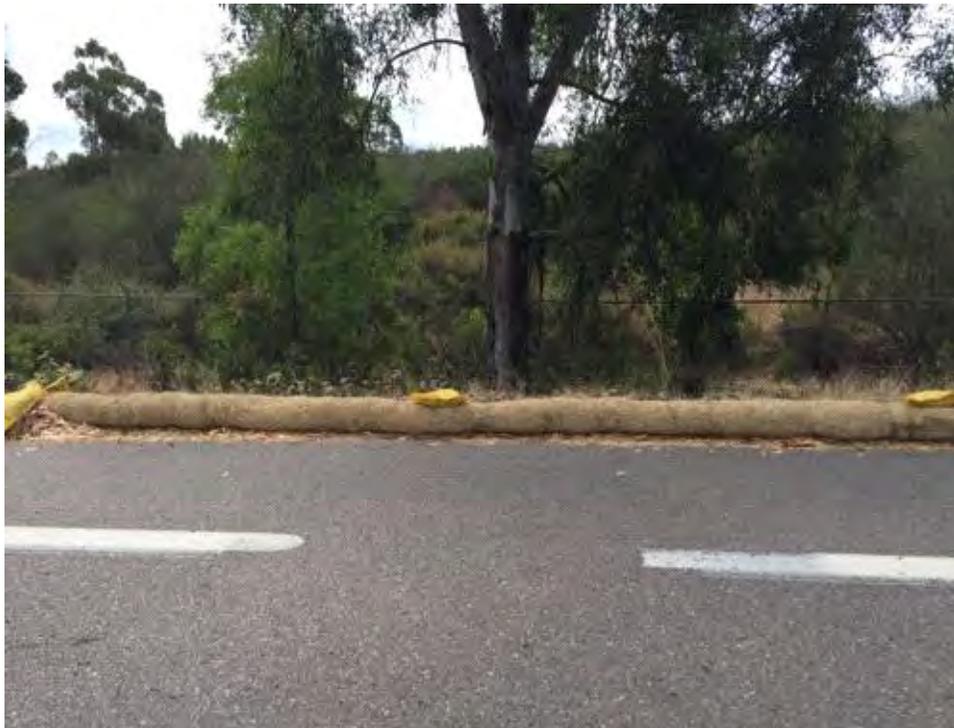
Caption Wattles in place on Pomerado Road.
