PROJECT MEMORANDUM SYCAMORE-PEÑASQUITOS 230-KV TRANSMISSION LINE PROJECT

Date: August 10, 2017
To: Billie Blanchard, CPUC Project Manager
From: Sheila Hoyer, CPUC Monitoring Supervisor
Subject: Weekly Report #31 – July 31 to August 5, 2017

SDG&E Sycamore-Peñasquitos 230-kV Transmission Line Project: Daily Inspection Report

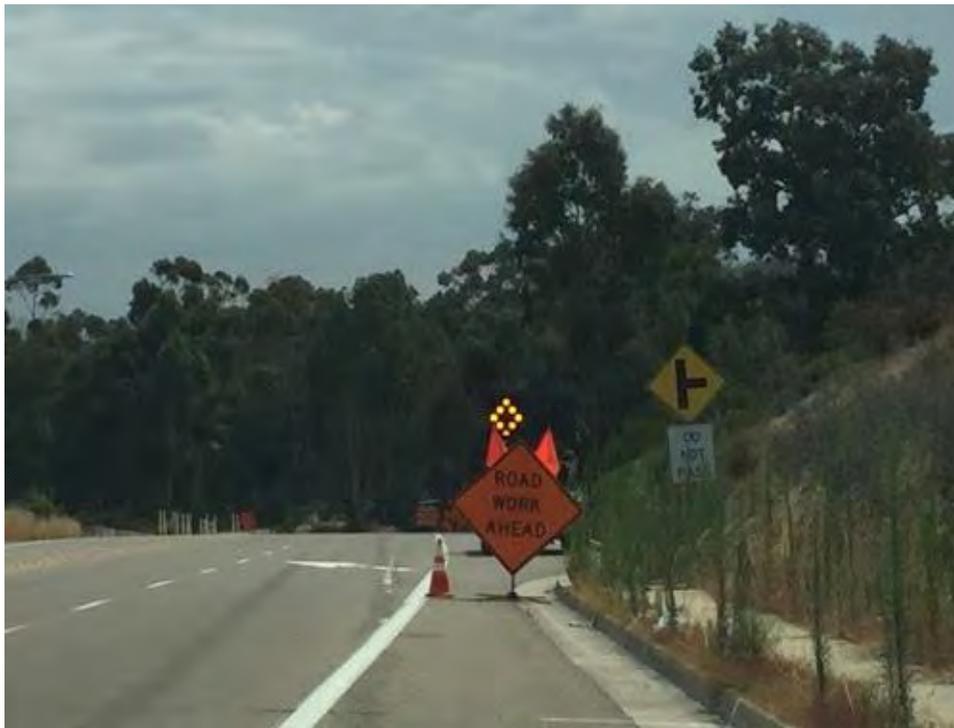
Caption Construction signage on Pomerado Road entrance to work area.
Photo Attributes Capture Date/Time: Wed Aug 02 2017 11:06:36 GMT-0700 (PDT)
Coordinates: 32.893653, -117.112033
View Direction: East

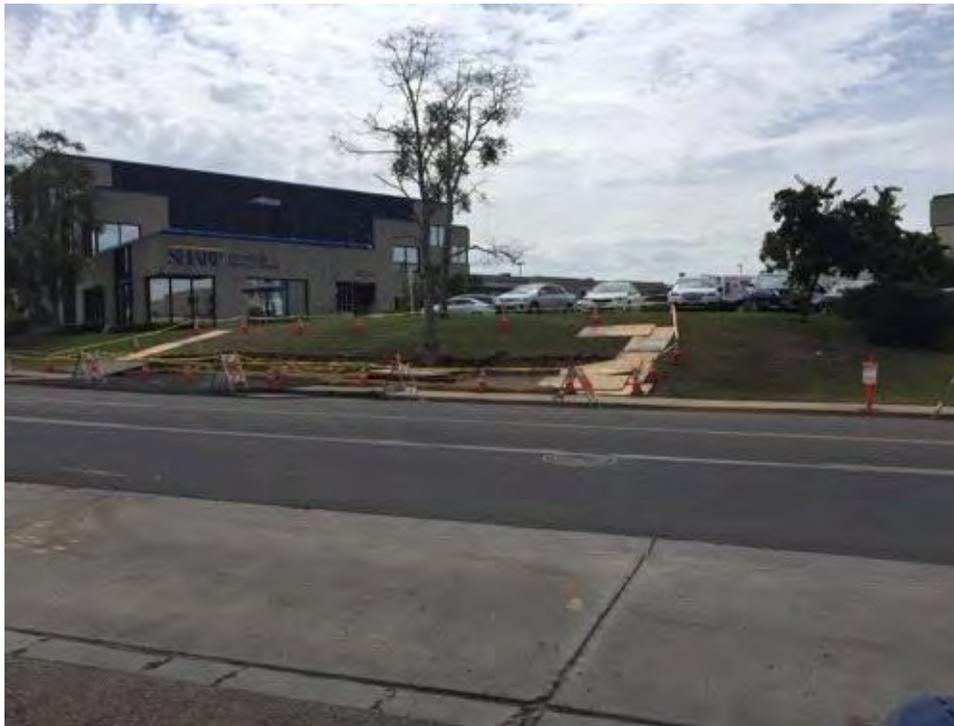
Caption Night work area on Activity Road.
Photo Attributes Capture Date/Time: Wed Aug 02 2017 10:52:07 GMT-0700 (PDT)
Coordinates: 32.896340, -117.134390
View Direction: Southeast

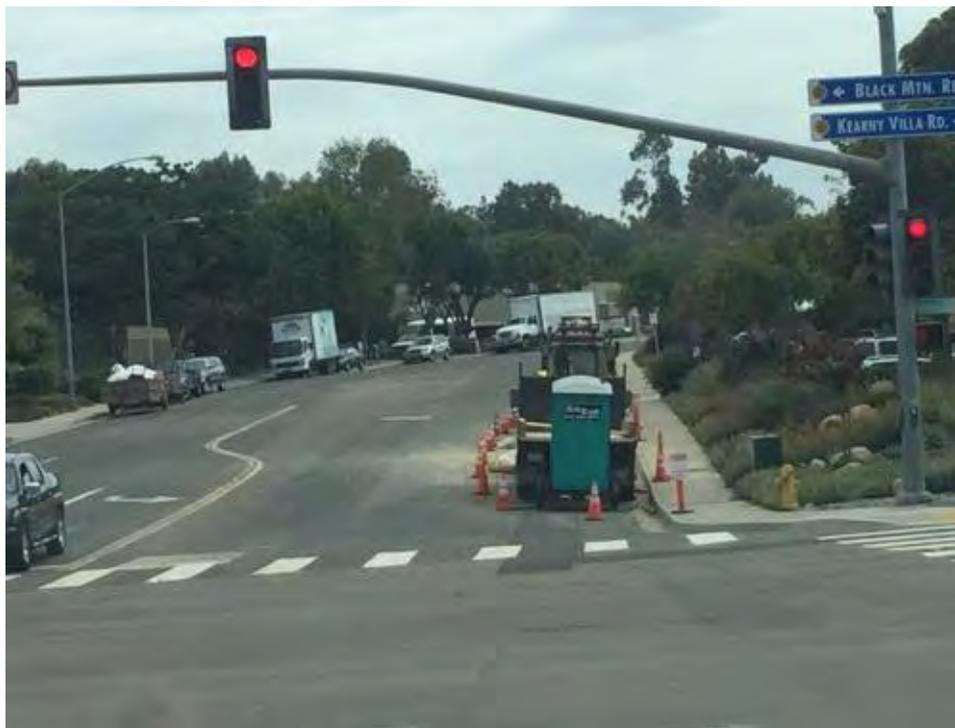
Caption Equipment staged for night work on Carroll Centre Road.

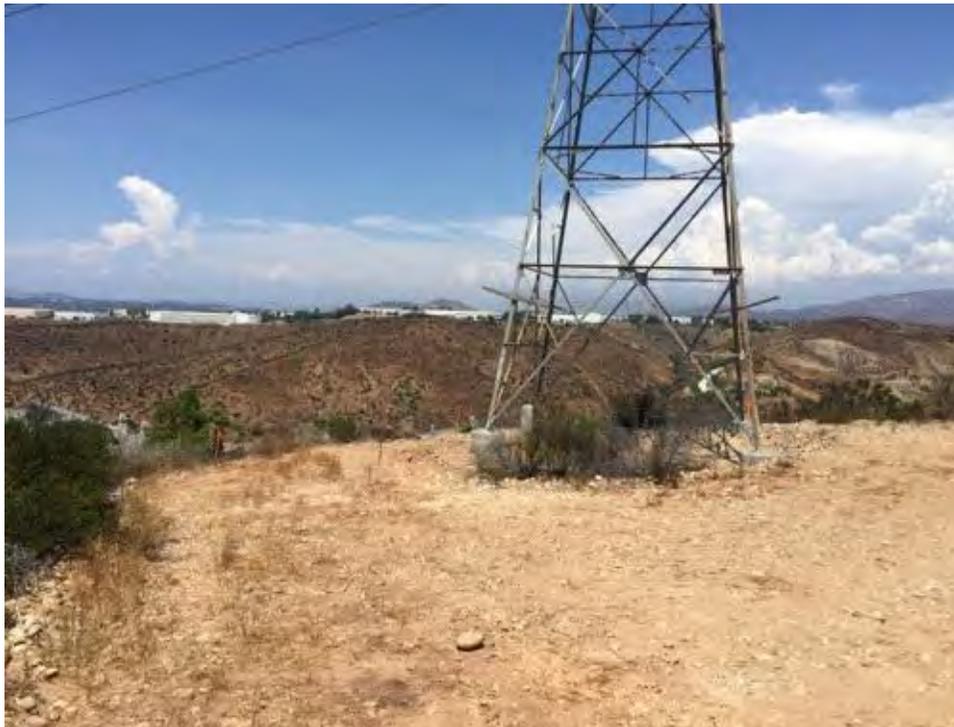
Caption Pole site 06 staked off.

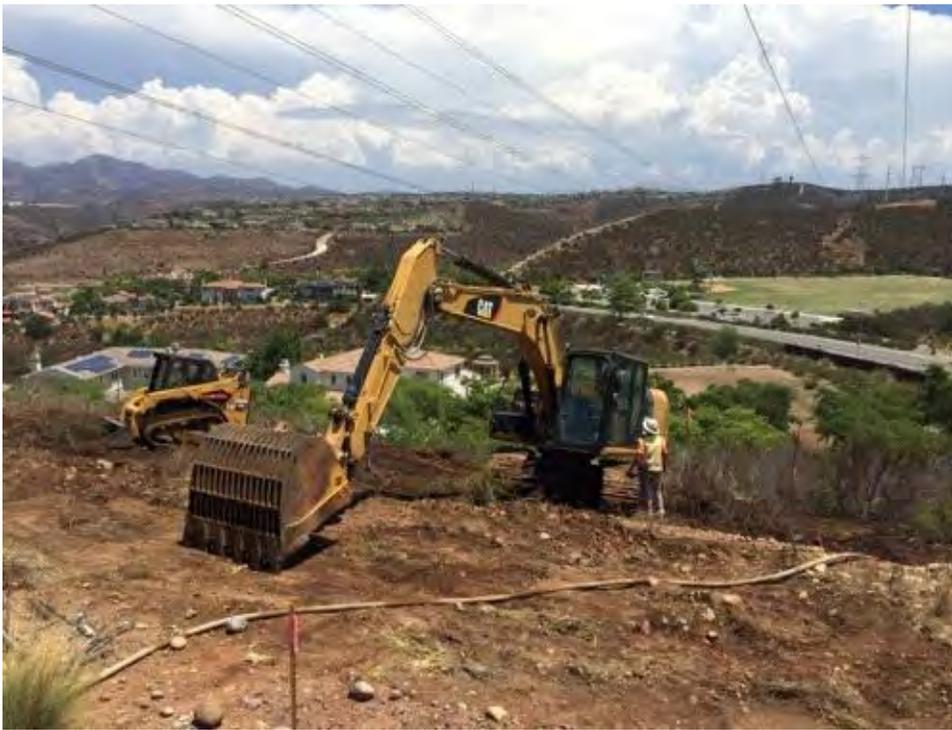
Caption Grading and dust control at Pole site 05.

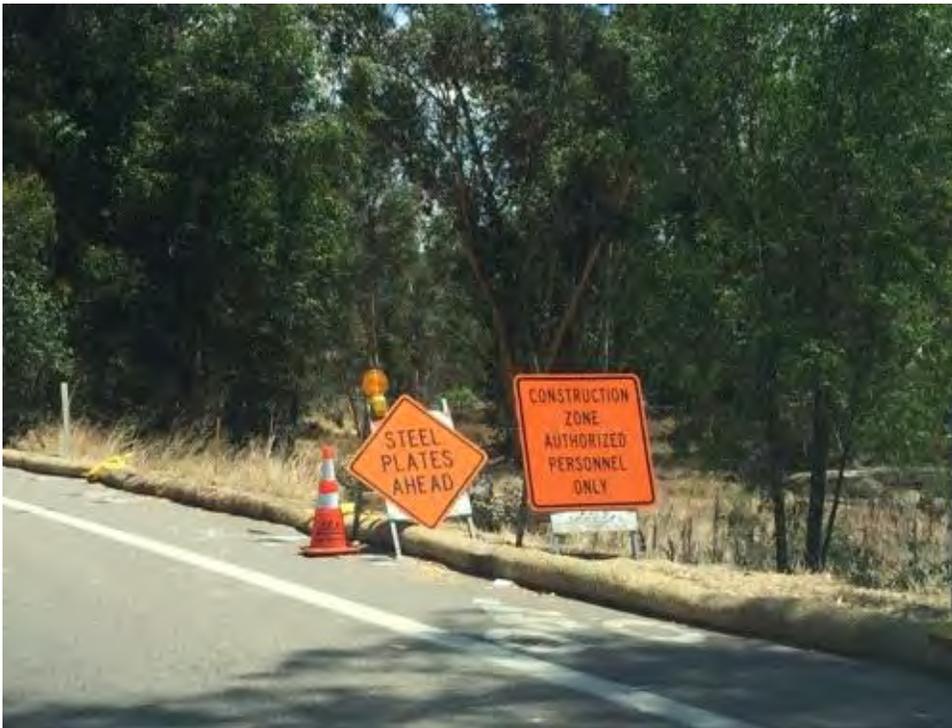
Caption BMPs and signage in place on Pomerado Road.

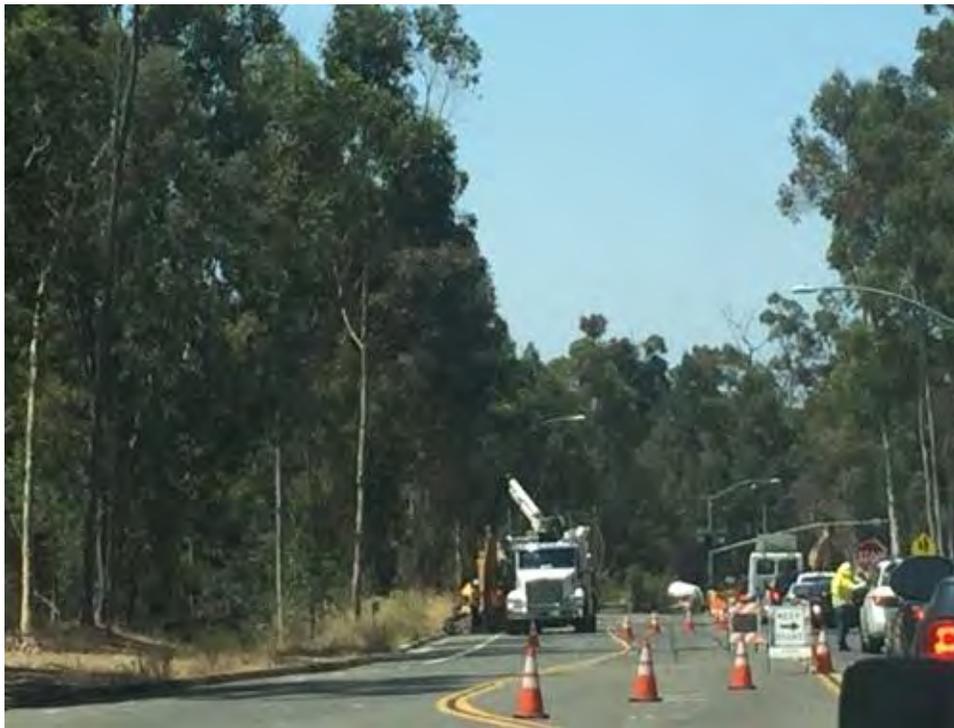
Crews potholing on Pomerado Road.

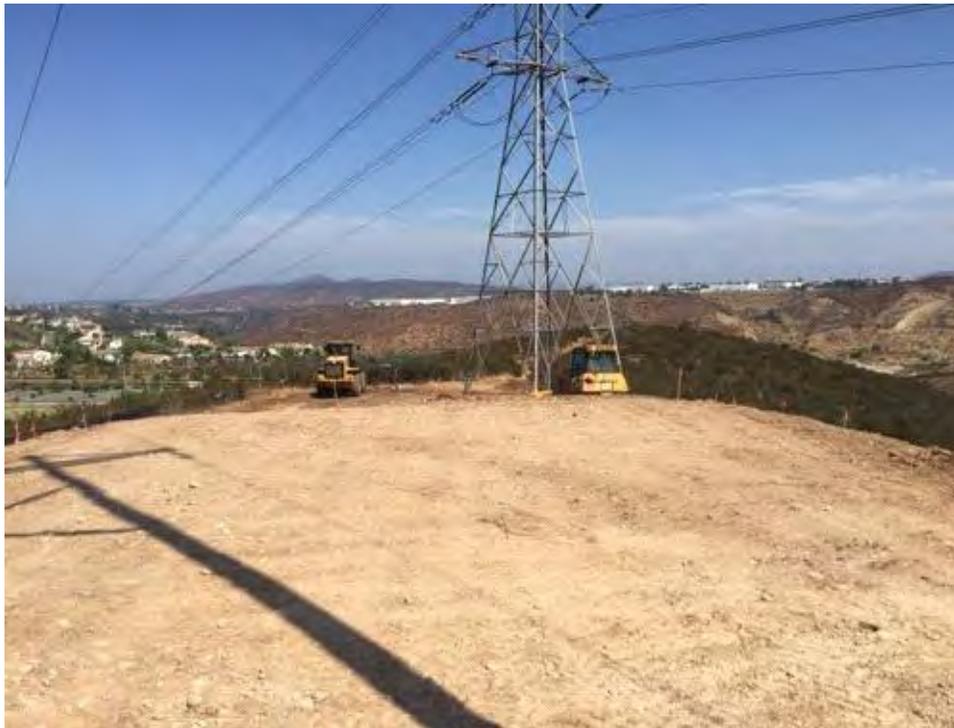
No construction work observed today at Pole site 04

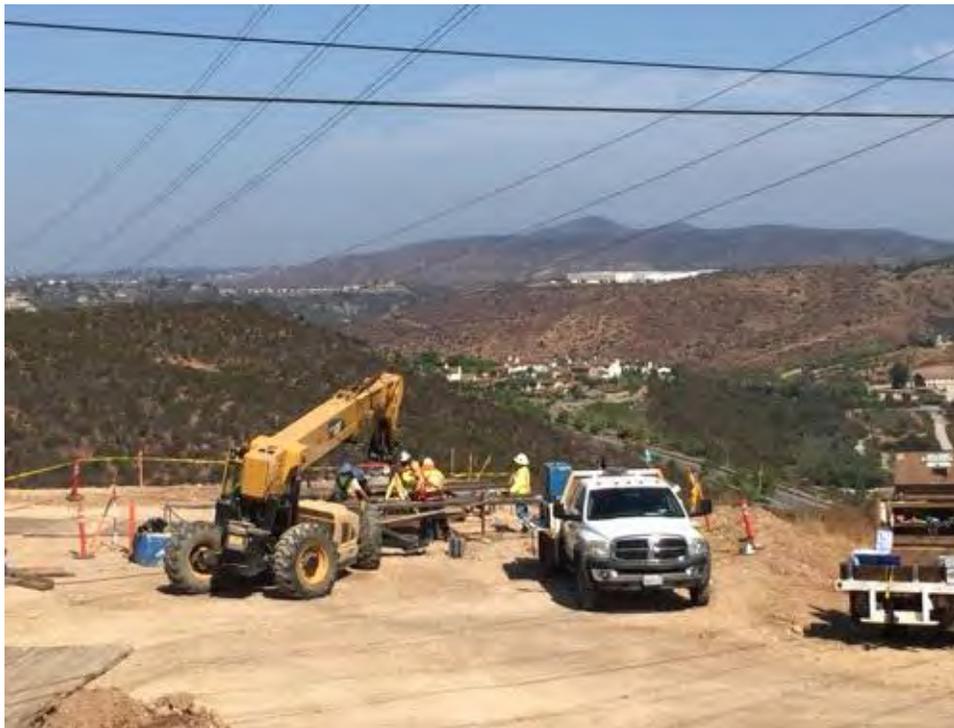
Crews setting can at Pole site 03.

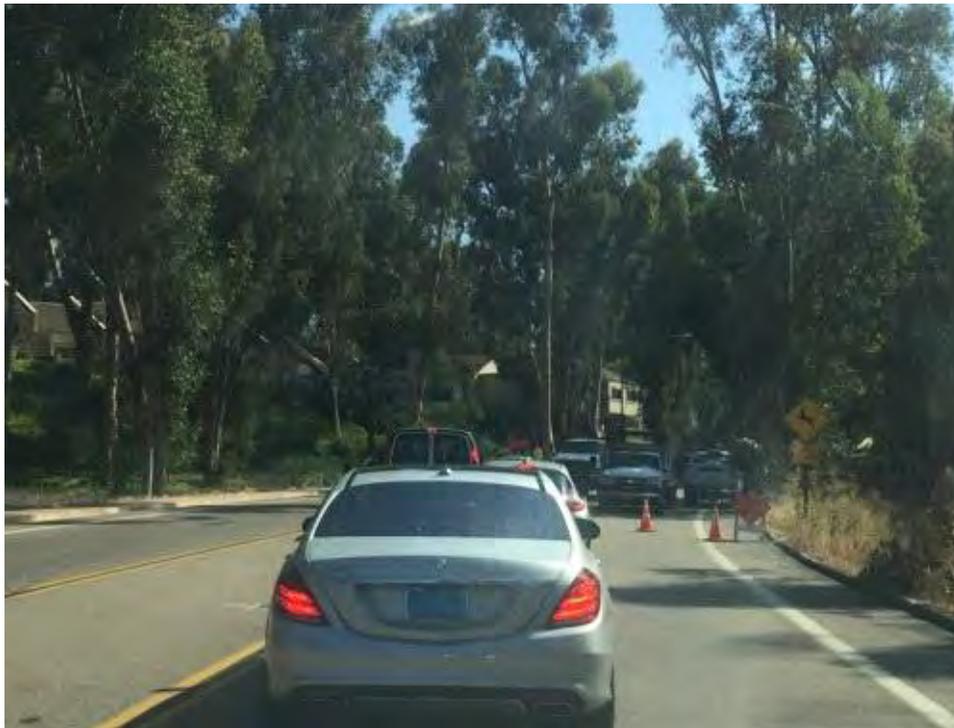
Flaggers in place on Pomerado Road.

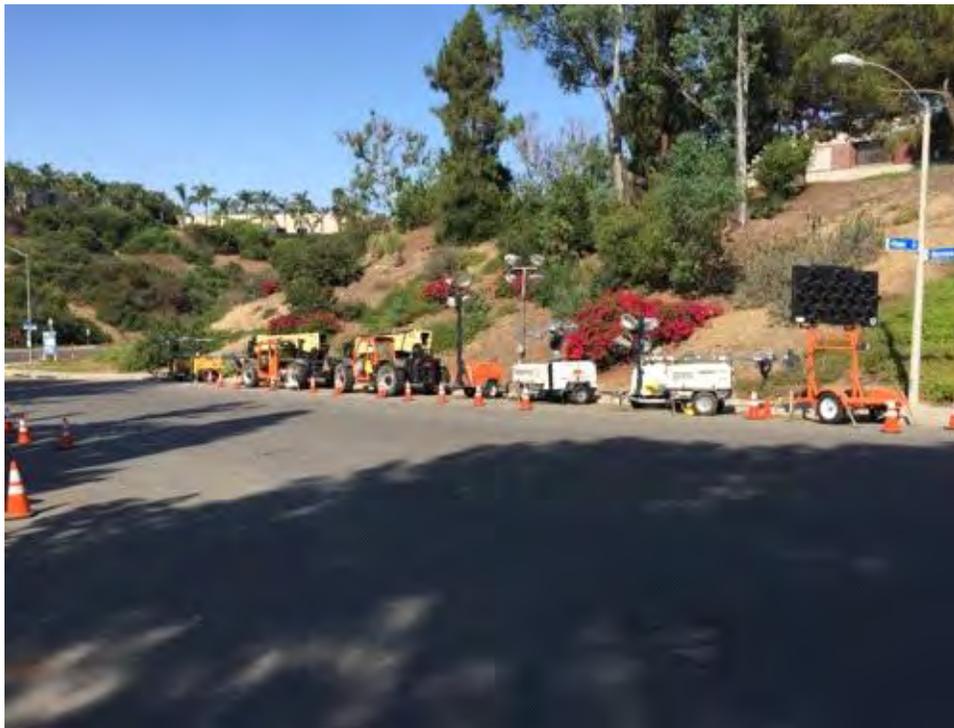
Caption Night work equipment staged on Brown Deer Road.

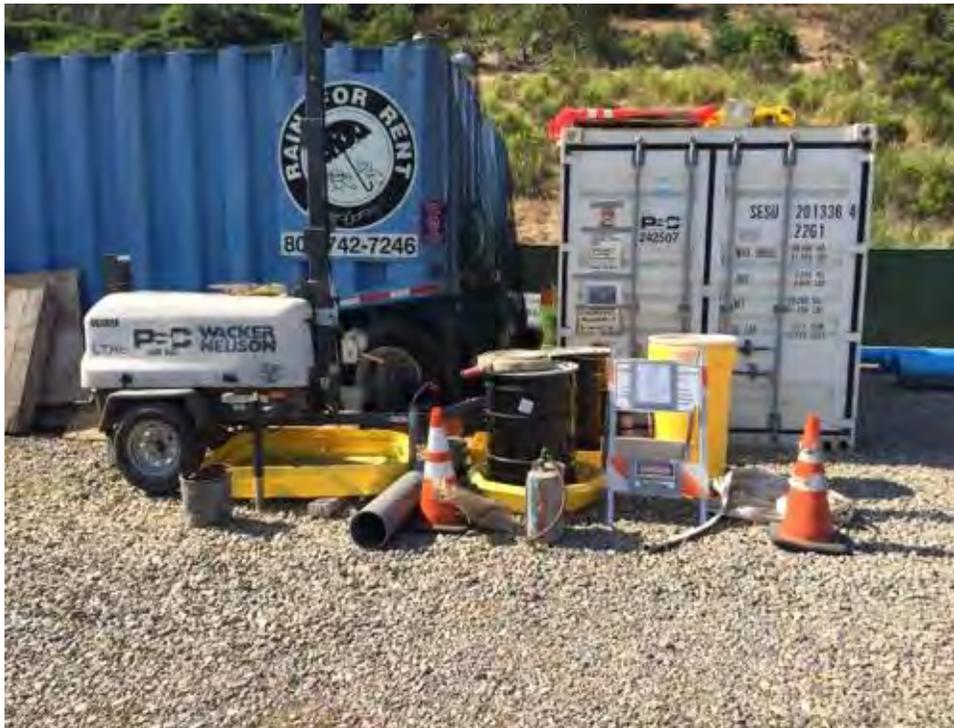
Caption Hazardous waste properly stored at Driving Range staging yard.

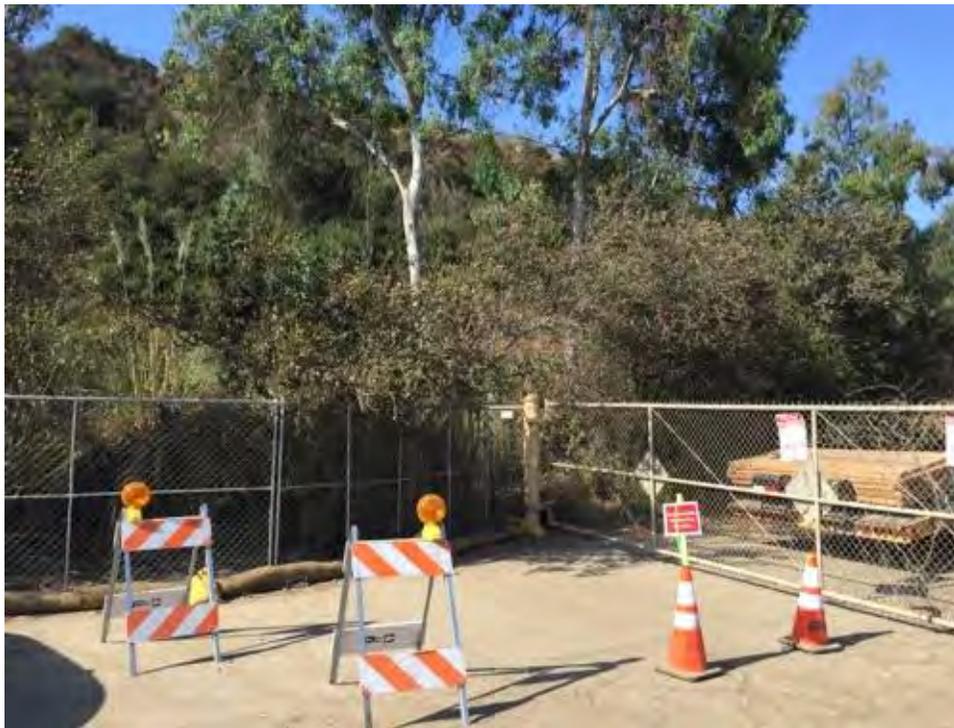
Caption Gold finch nest buffer at Hanson construction yard.

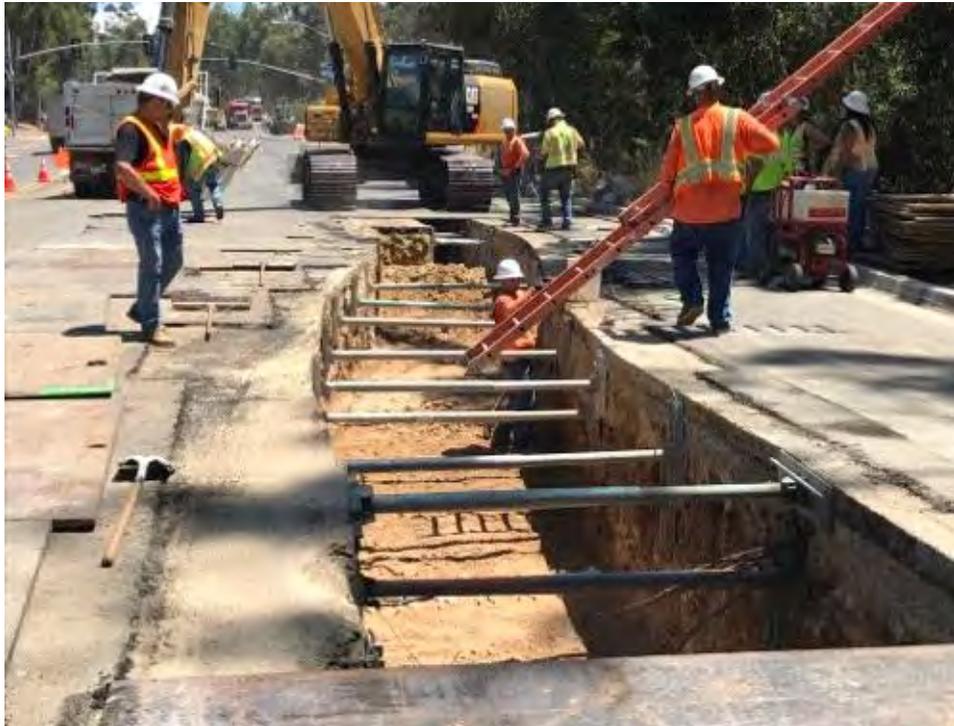
Caption Trench on Pomerado Road.

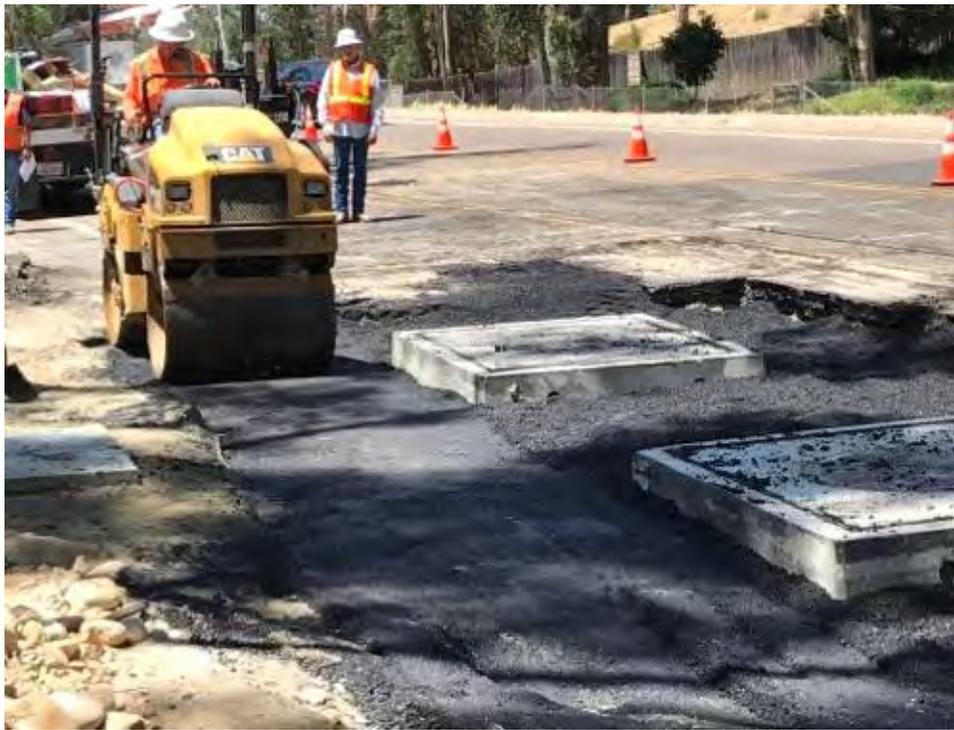
Caption Vault on Pomerado Road.

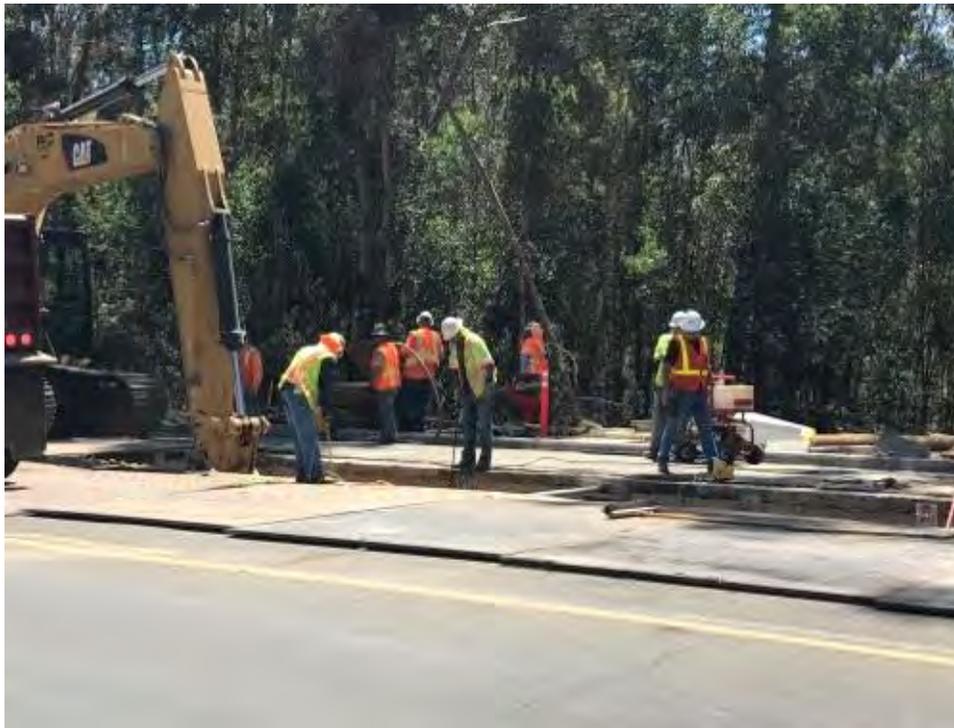
Caption Trenching on Pomerado Road.

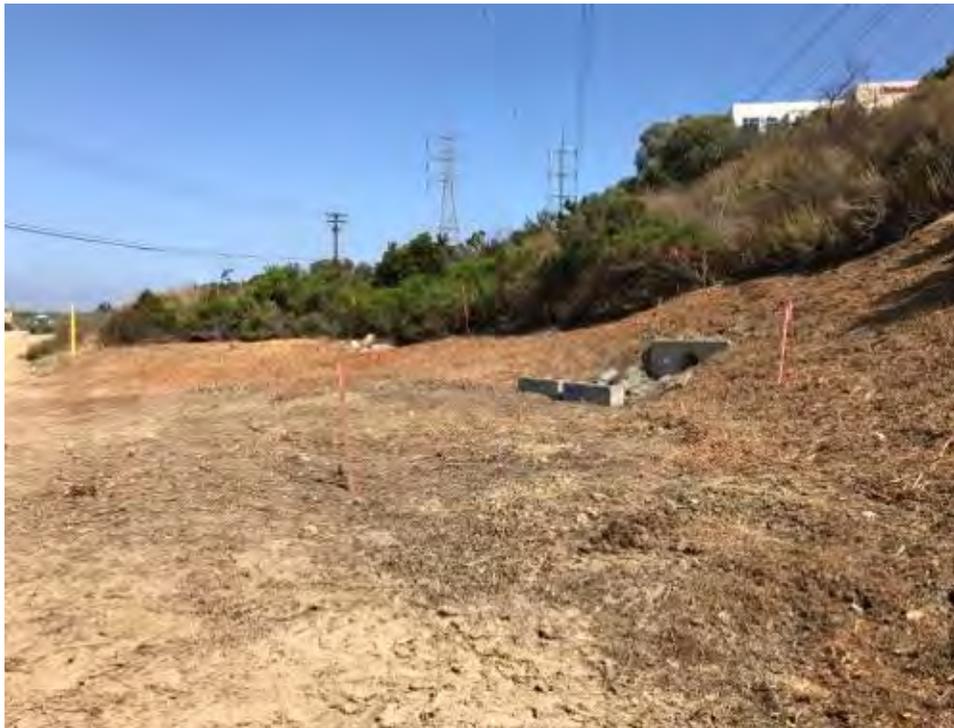
Caption CC MM CP Pole site has been cleared.

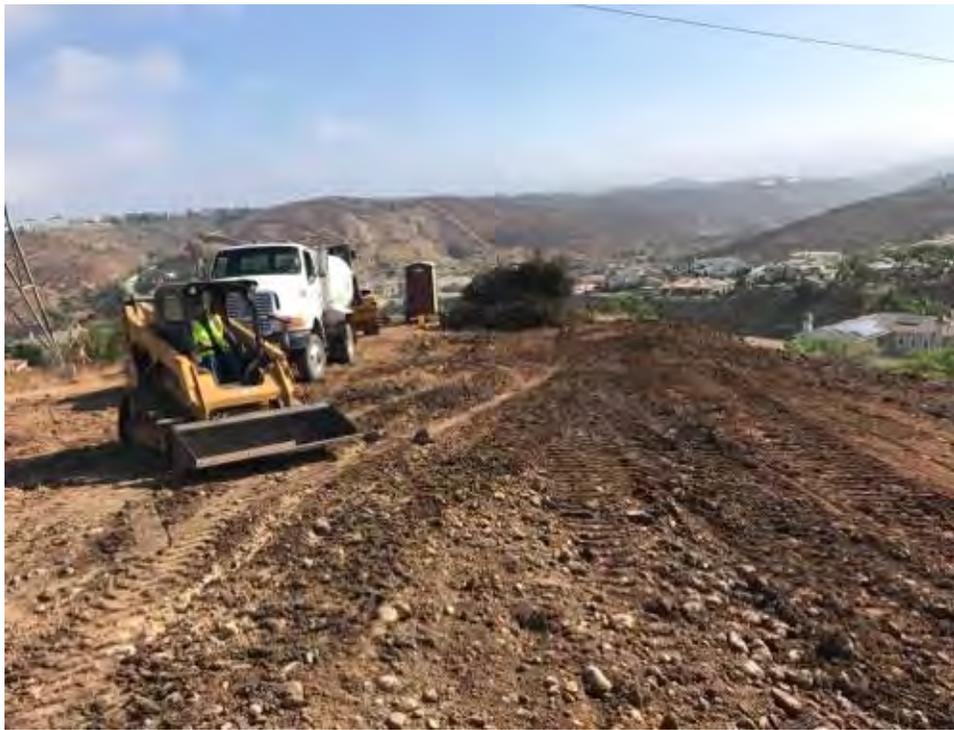
Caption Vegetation clearing complete at P05.

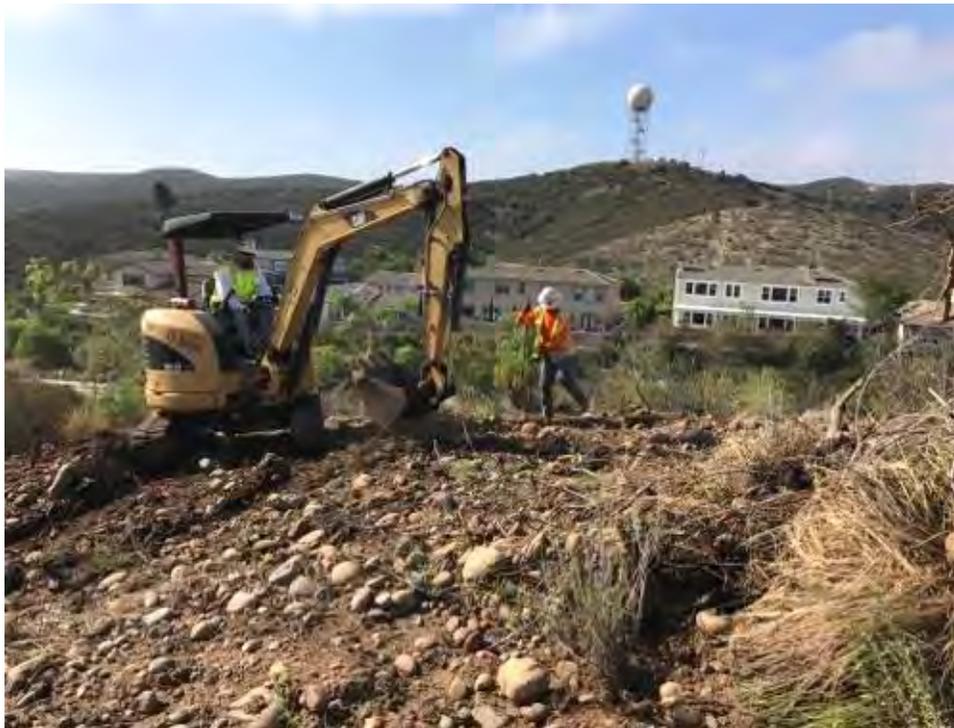
Caption Excavating to locate irrigation lines at P05.

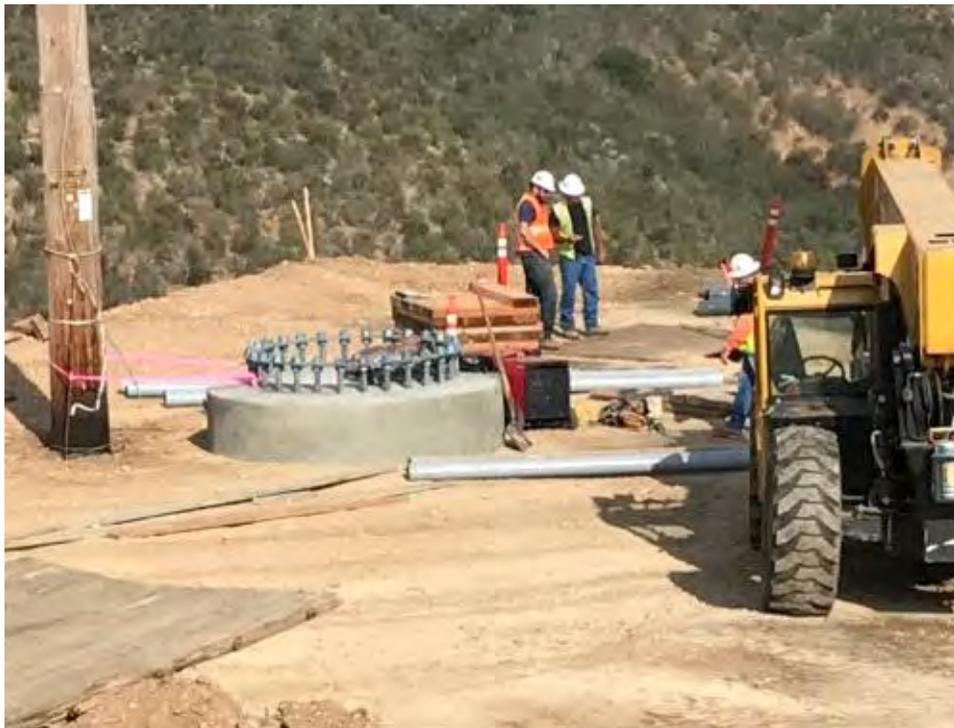
Caption P04 foundation.

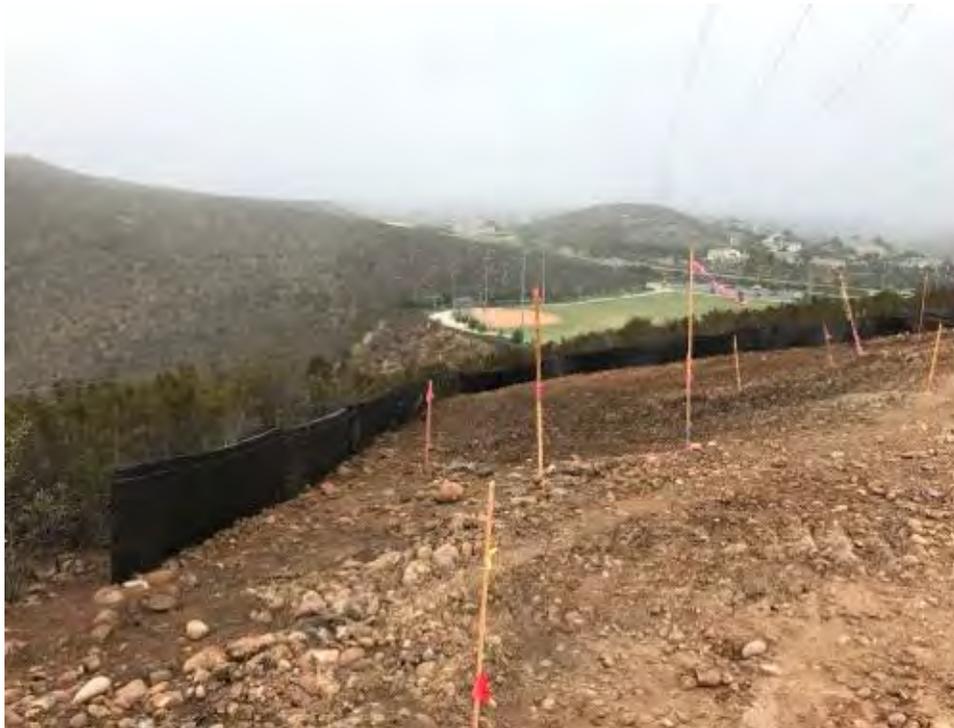
Caption Silt fence at P04.

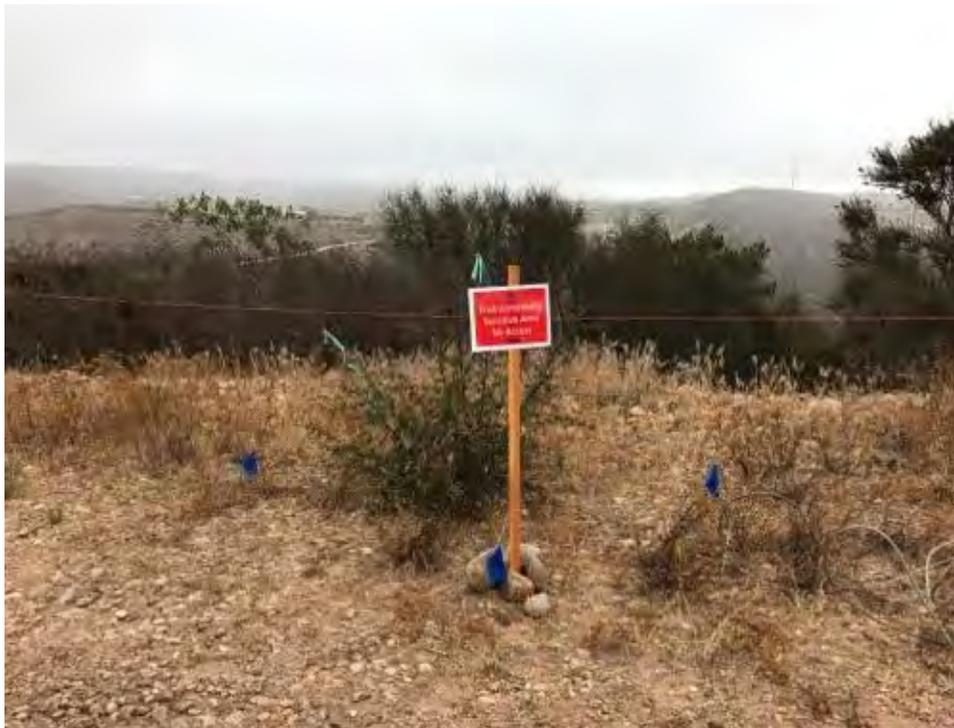
Caption Protected Nuttalls Scrub Oak at P04

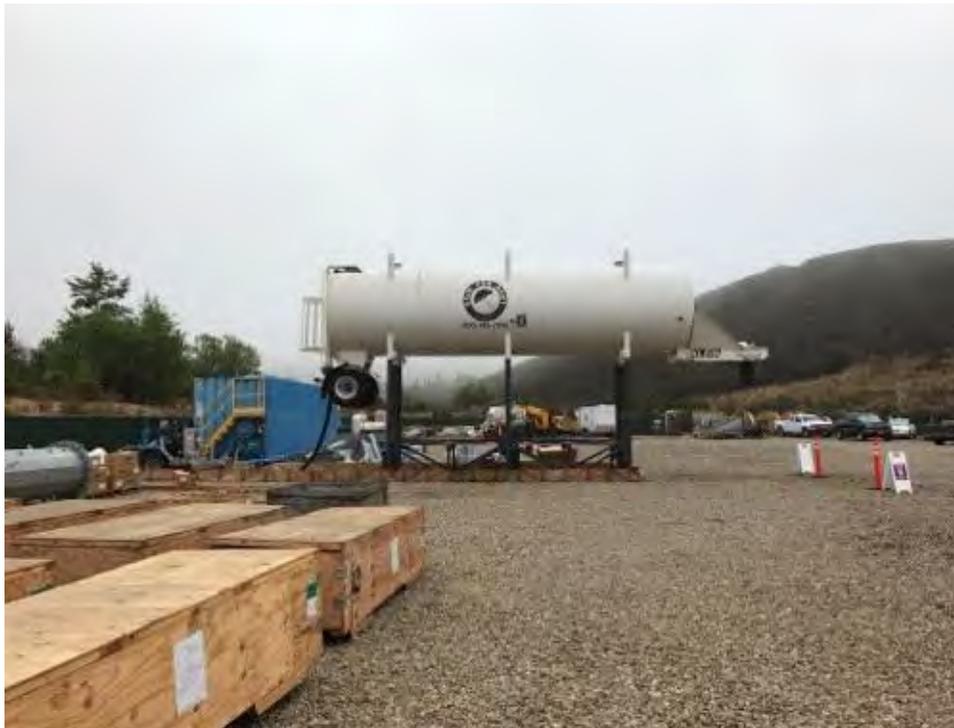
Caption Stonebridge Staging Yard water tank.
