## PROJECT MEMORANDUM SYCAMORE-PEÑASQUITOS 230-KV TRANSMISSION LINE PROJECT

Date: August 22, 2017  
To: Billie Blanchard, CPUC Project Manager  
From: Sheila Hoyer, CPUC Monitoring Supervisor  
Subject: Weekly Report #32 – August 6 to August 12, 2017

## SDG&E Sycamore- Peñasquitos 230-kV Transmission Line Project: Daily Inspection Report

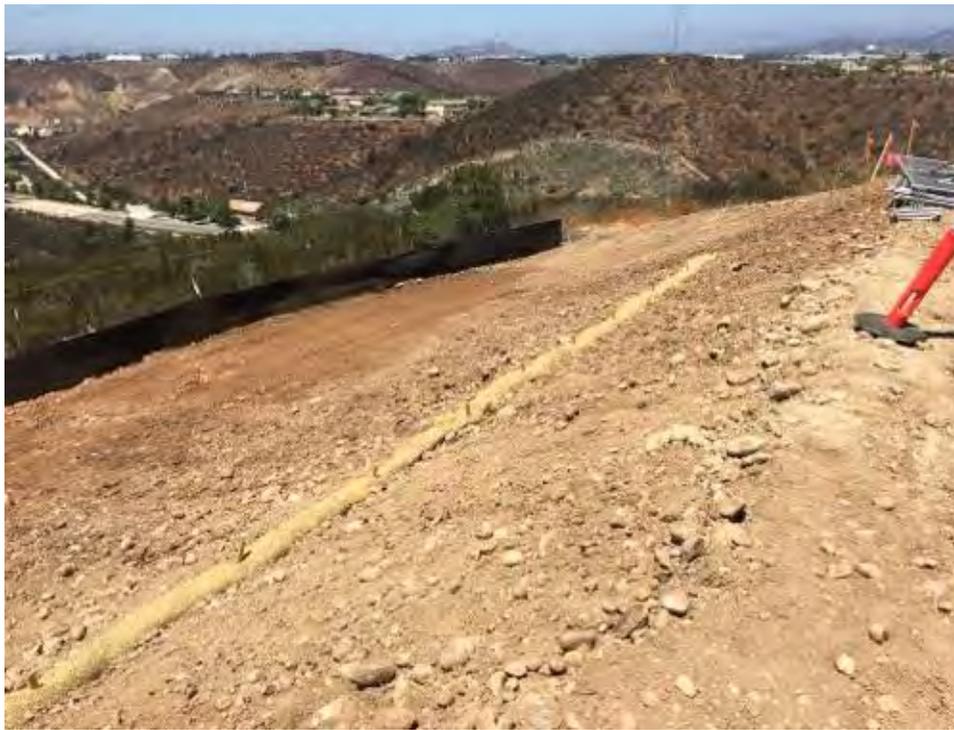
Caption P03 site, asked LEI what the long-term plan was for the new slope. Will it get BFM applied?

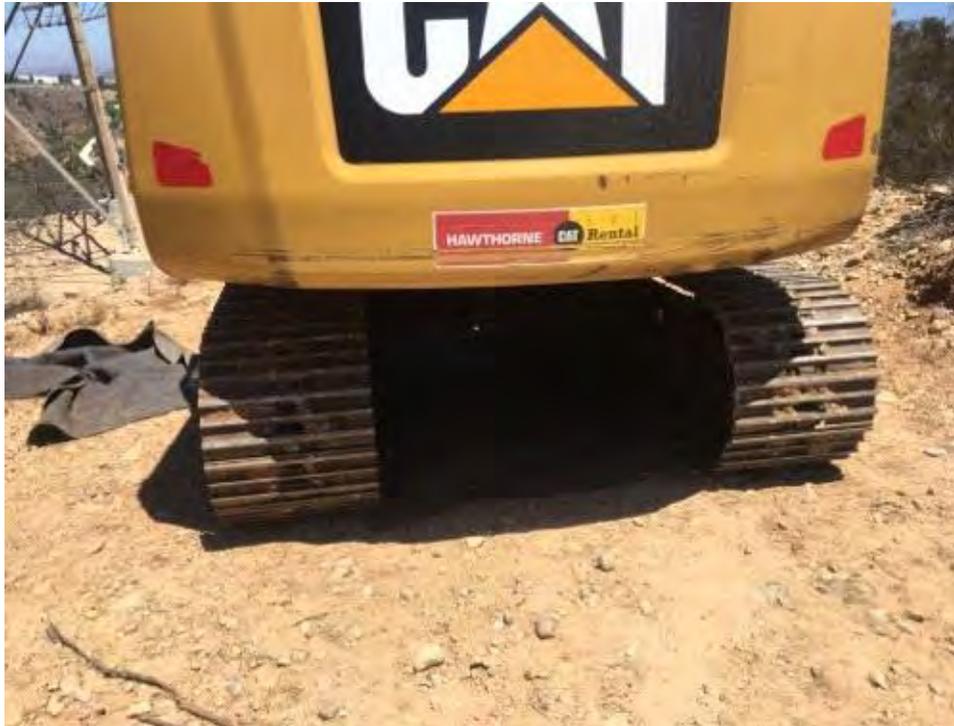
4. On August 9, 2017, a small release was detected along the access road to P06 from a skid steer. The skid steer was immediately staged atop plastic and a diaper was applied directly to the leak. The contaminated soil was shoveled up and stored in the on-site hazardous waste storage drums. No other releases occurred during this reporting period.

Caption DCX excavator with haz mat absorber.

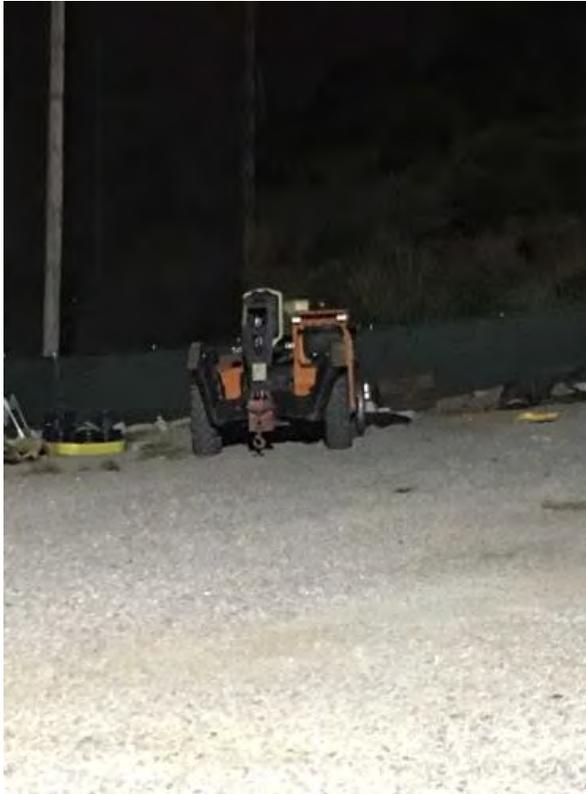
Caption Vehicle parked without drip pan at Driving range yard. I placed the pan adjacent to it under the engine.

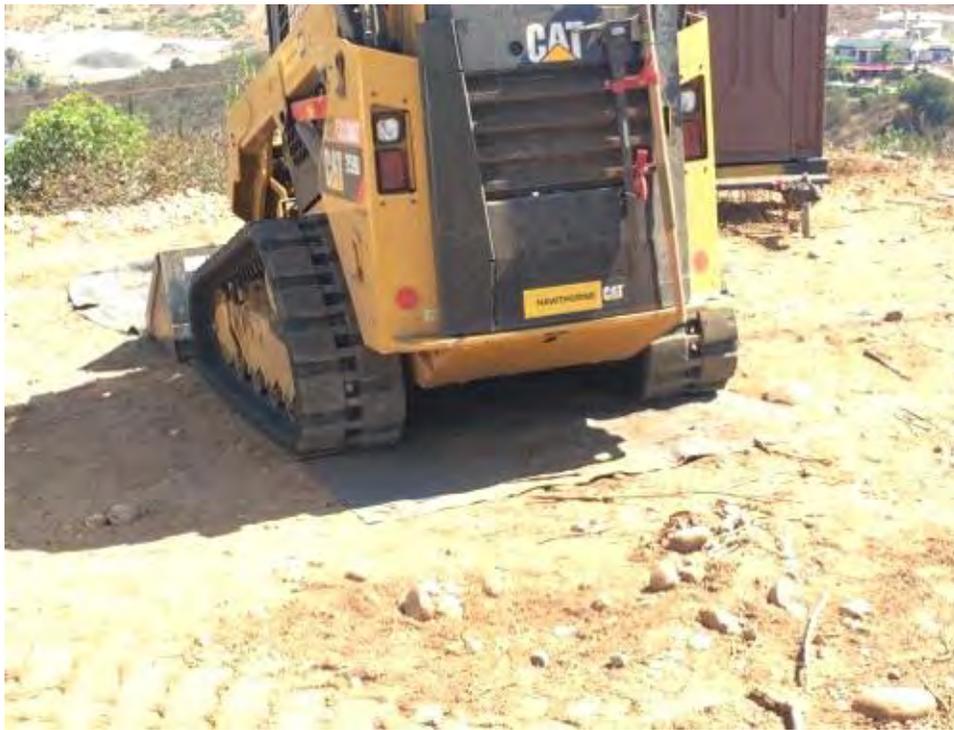
Caption Mini dozer staged with fabric haz mat absorber pad at P05 .
