## PROJECT MEMORANDUM SYCAMORE-PEÑASQUITOS 230-KV TRANSMISSION LINE PROJECT

Date: August 25, 2017  
To: Billie Blanchard, CPUC Project Manager  
From: Sheila Hoyer, CPUC Monitoring Supervisor  
Subject: Weekly Report #33 – August 13 to August 19, 2017

# 2017-08-14 AM Inspection Report

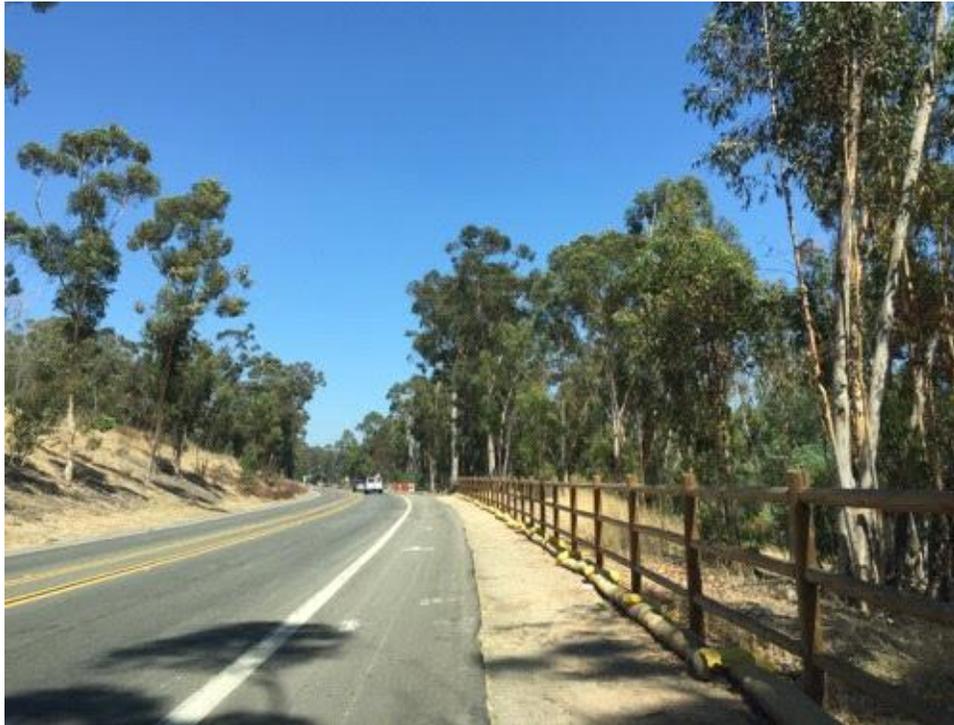
Caption Straw wattles in place on Pomerado Road.

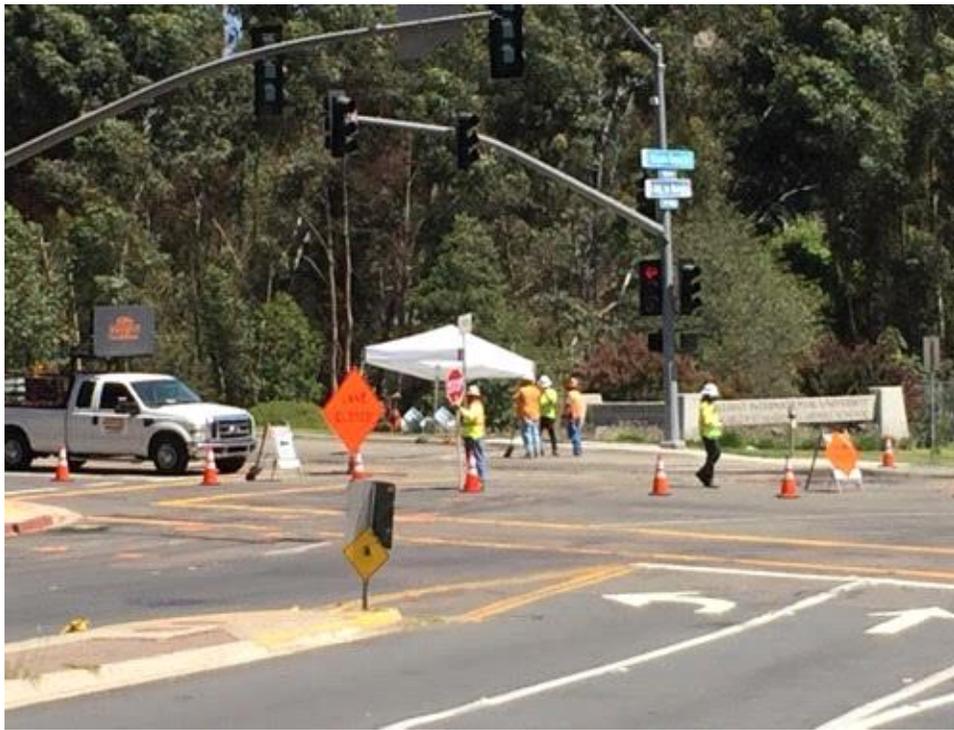
Caption Traffic flaggers on site on Pomerado Road at Avenue of Nations.

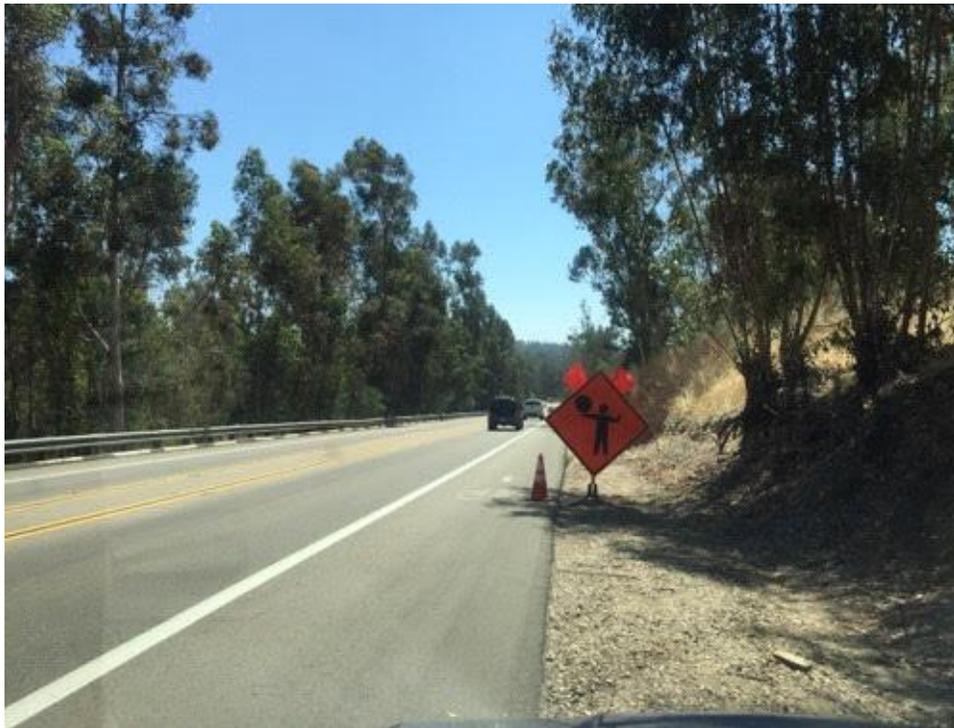
Caption Signage in place southbound on Pomerado Road.

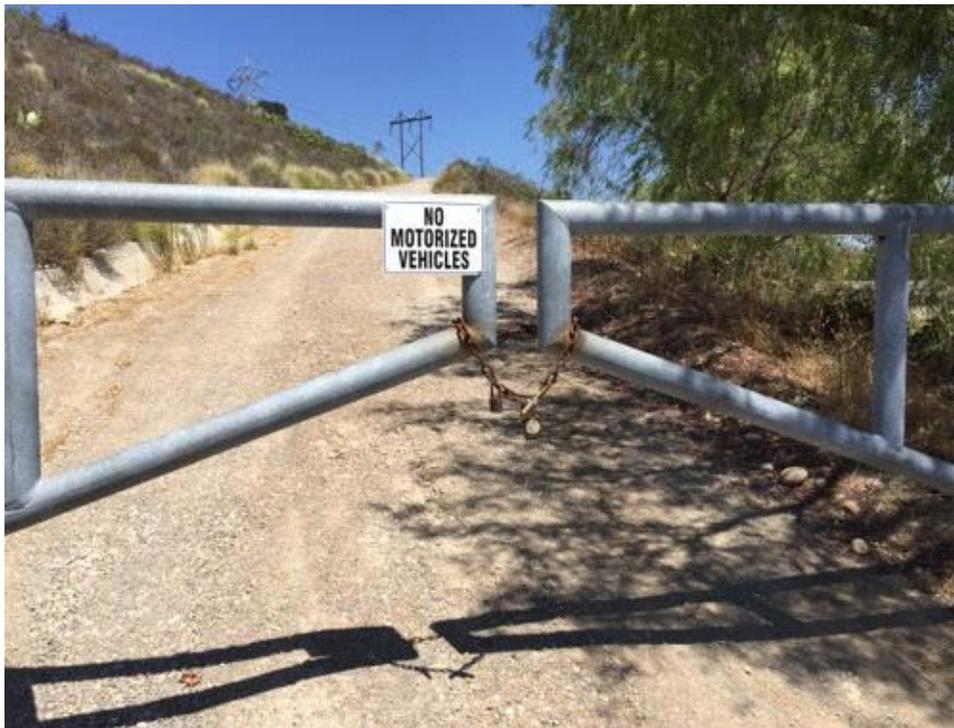
Caption Entrance locked at access to Pole 05 & P06.

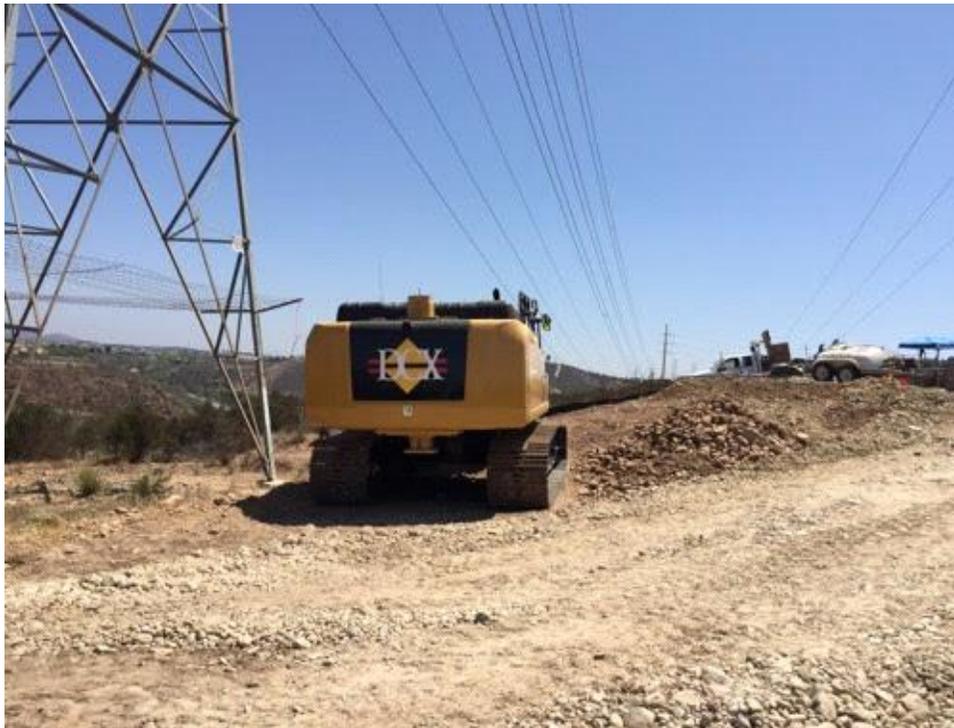
Caption Equipment staged with absorbent pad beneath at Pole 04.

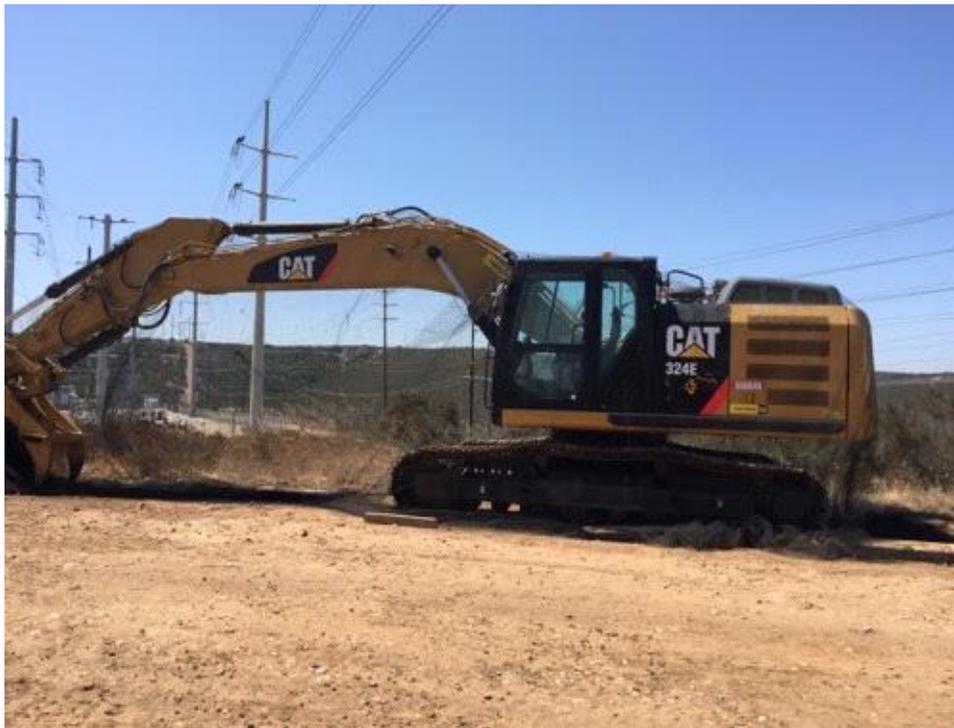
Caption Equipment covered with bird netting and absorbent pad beneath at Pole 03.

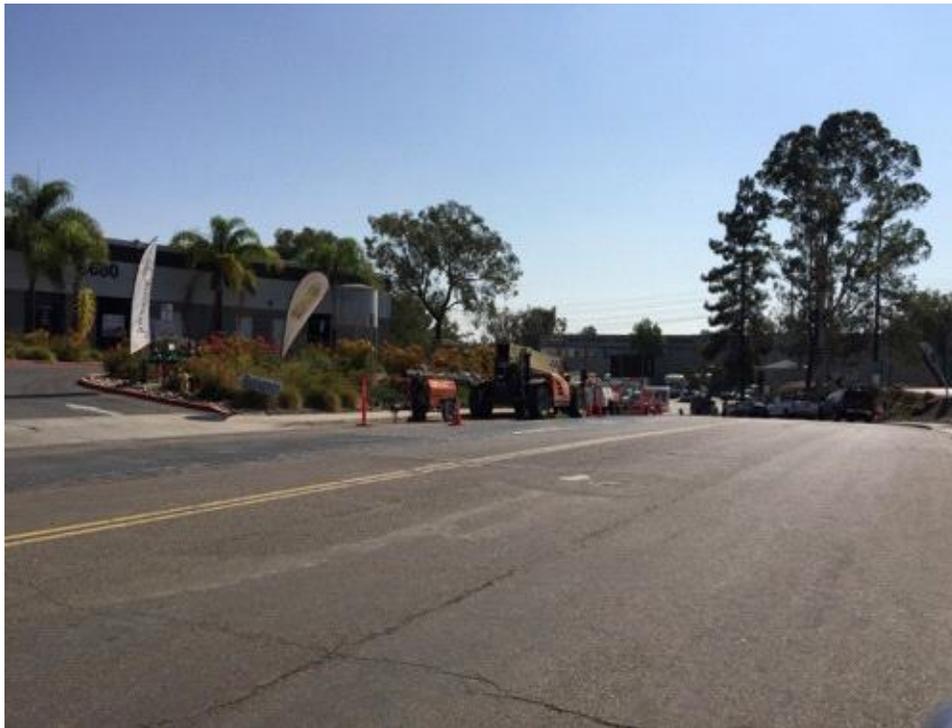
Caption Drip pans in place on Miralani Drive.

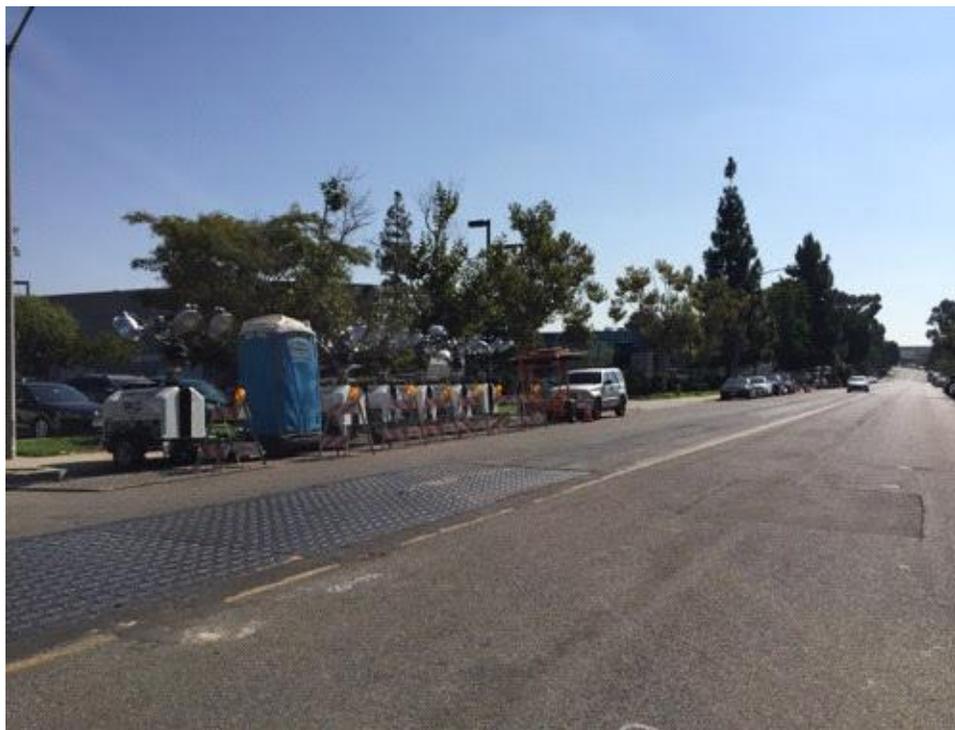
Caption Equipment properly staged on Trade Street.

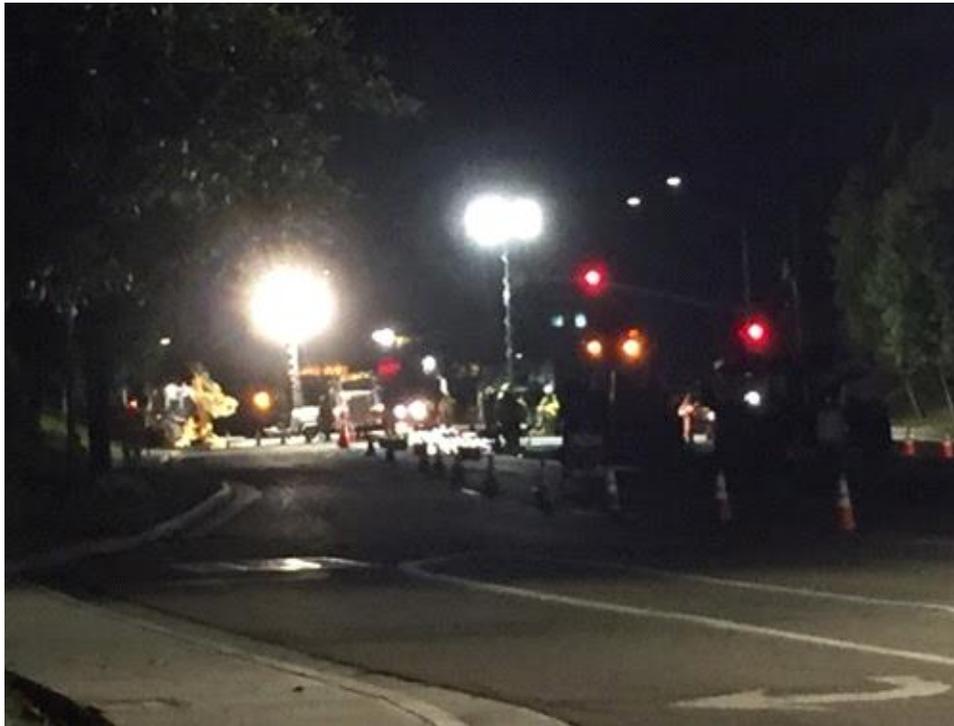
Caption Crews installing conduit on Camino Ruiz.

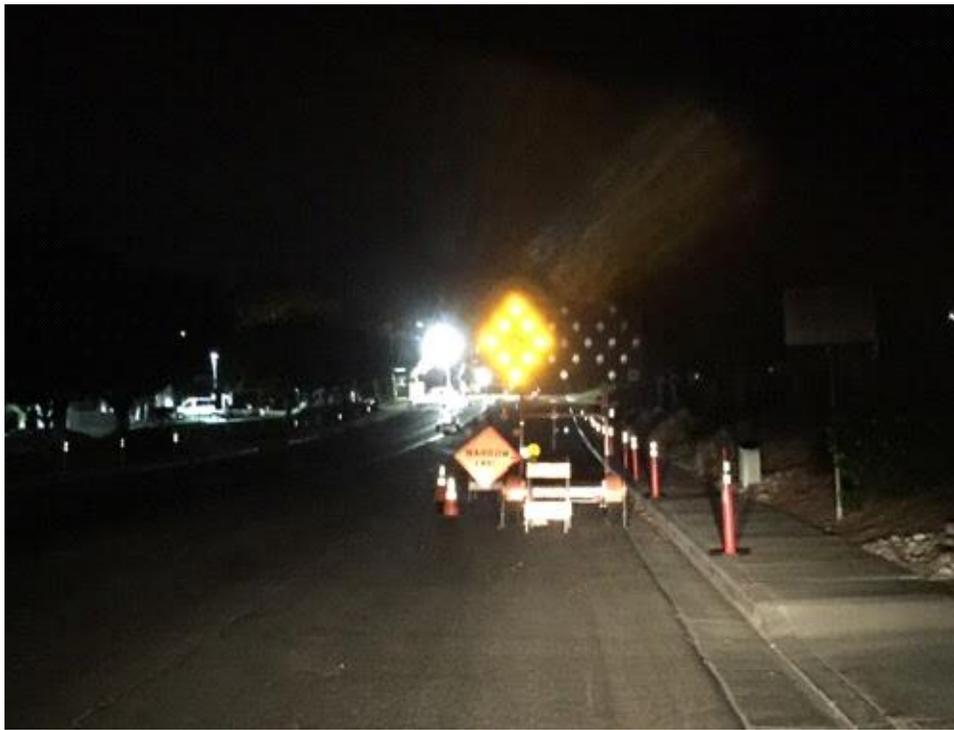
Caption Construction signage on Trade Place.

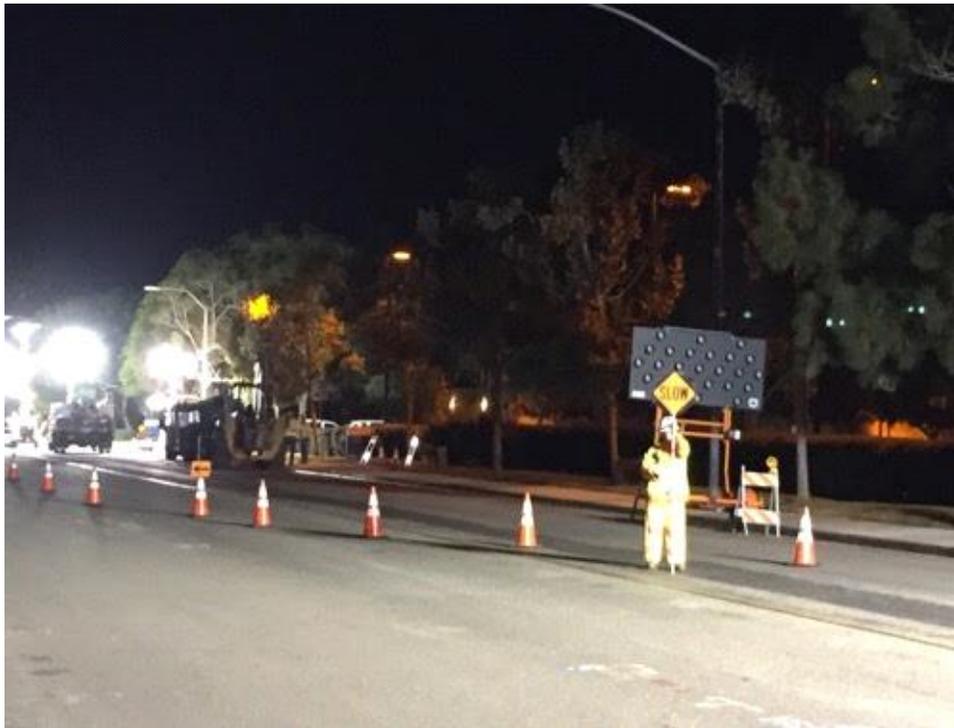
Caption Traffic flaggers in place on Trade Street.

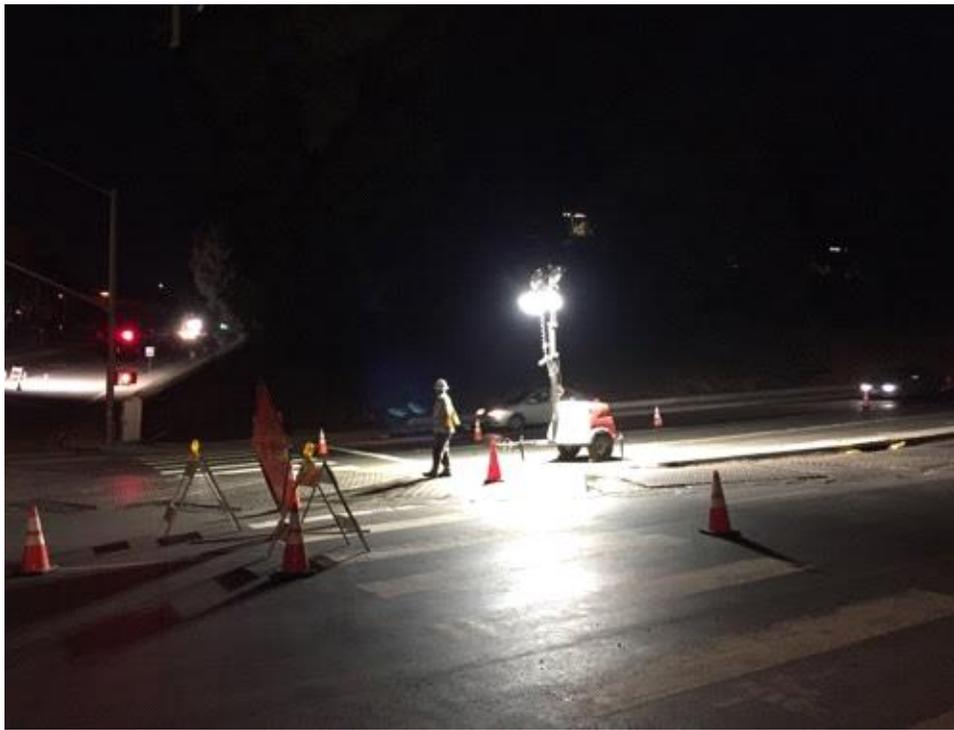
Caption Lighting being erected at Camino Santa Fe and Trade Street.

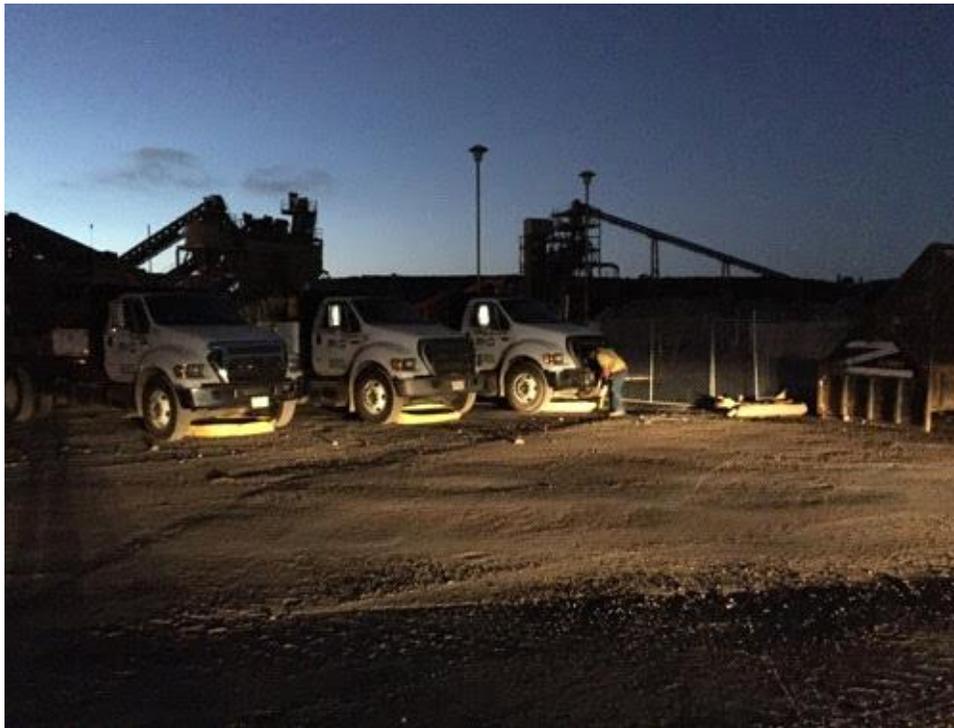
Caption Drip pans in place at Hanson Yard (Vulcan).

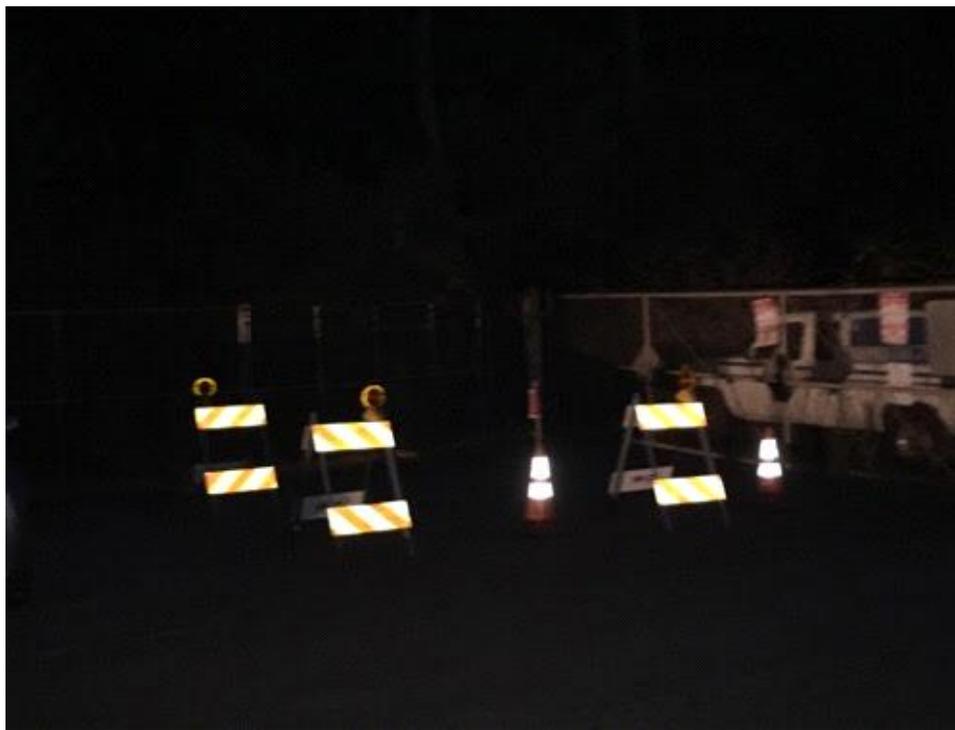
Caption Bird nesting buffer in place at Hanson Yard.

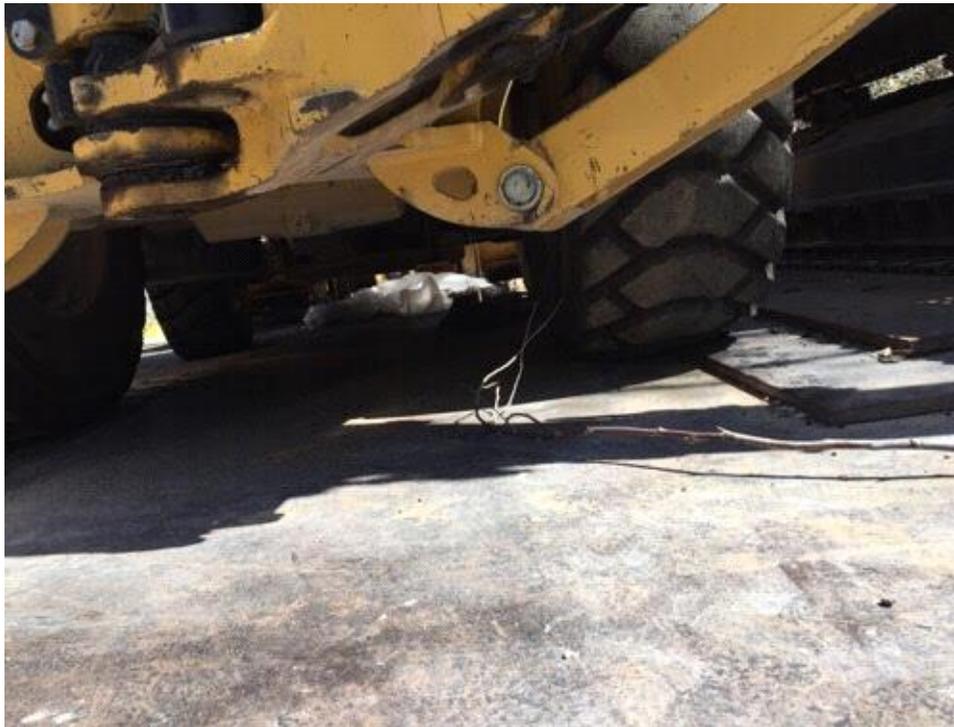
Caption No secondary containment under staged equipment on Pomerado Road.

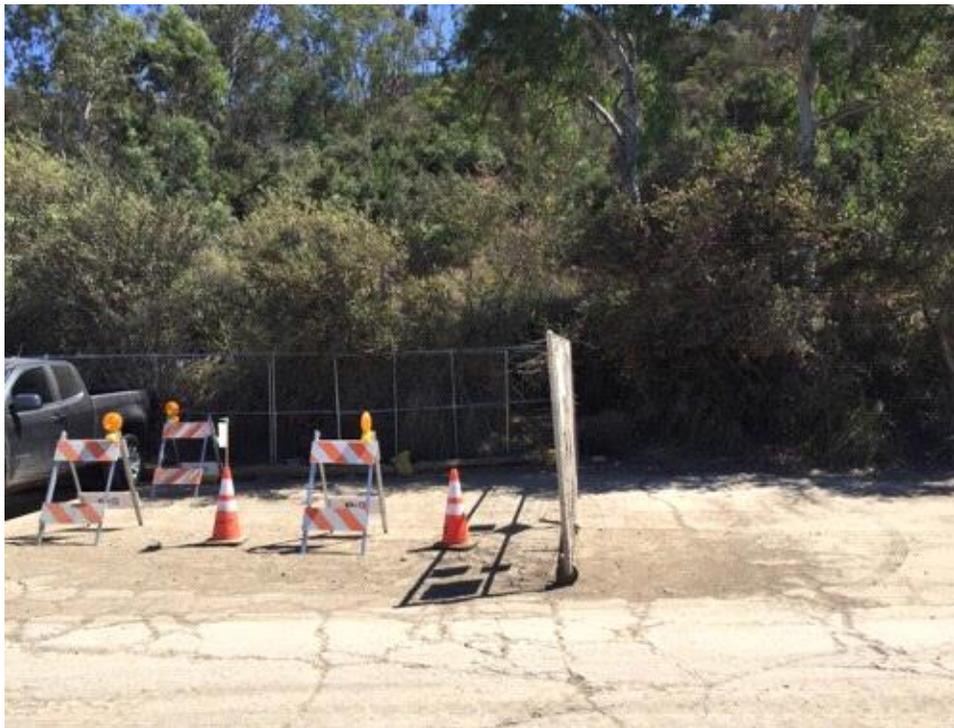
Caption Buffer in place for Gold Finch nest at Hanson Yard (Vulcan).

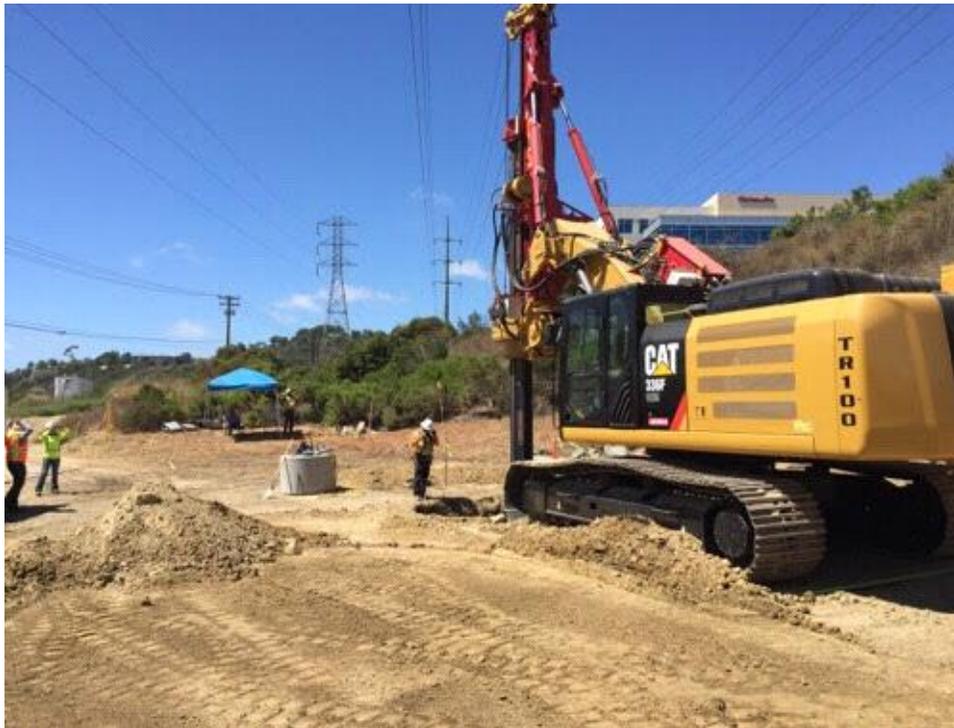
Caption Auger in use at the CC MM CP site.

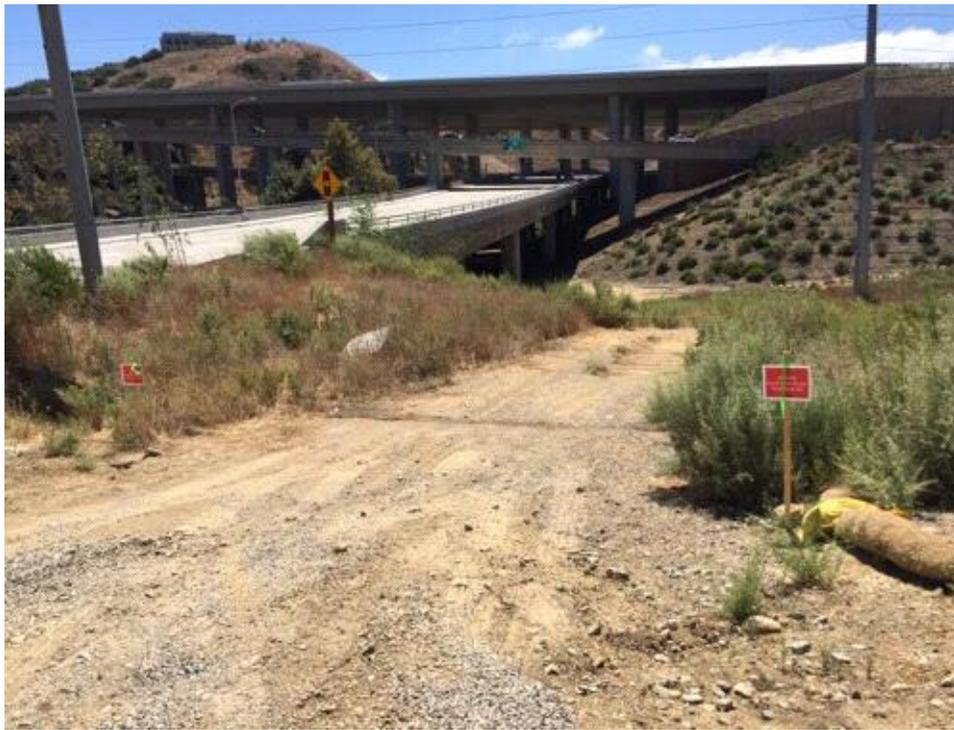
Caption Construction areas marked at CC MM CP site.

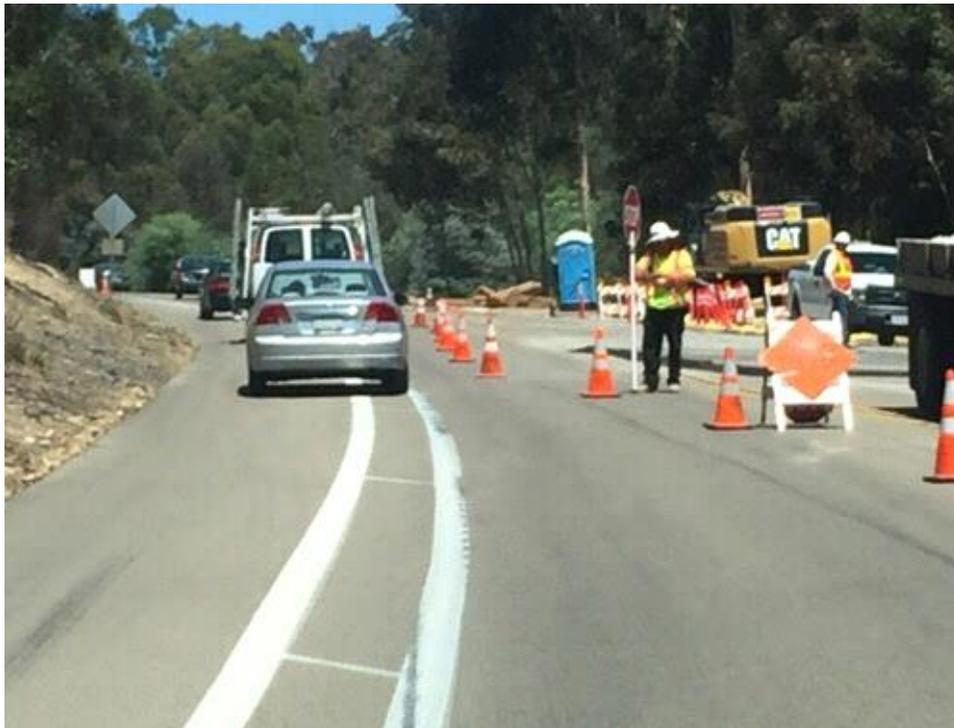
Caption Traffic flaggers in place on Pomerado Road.

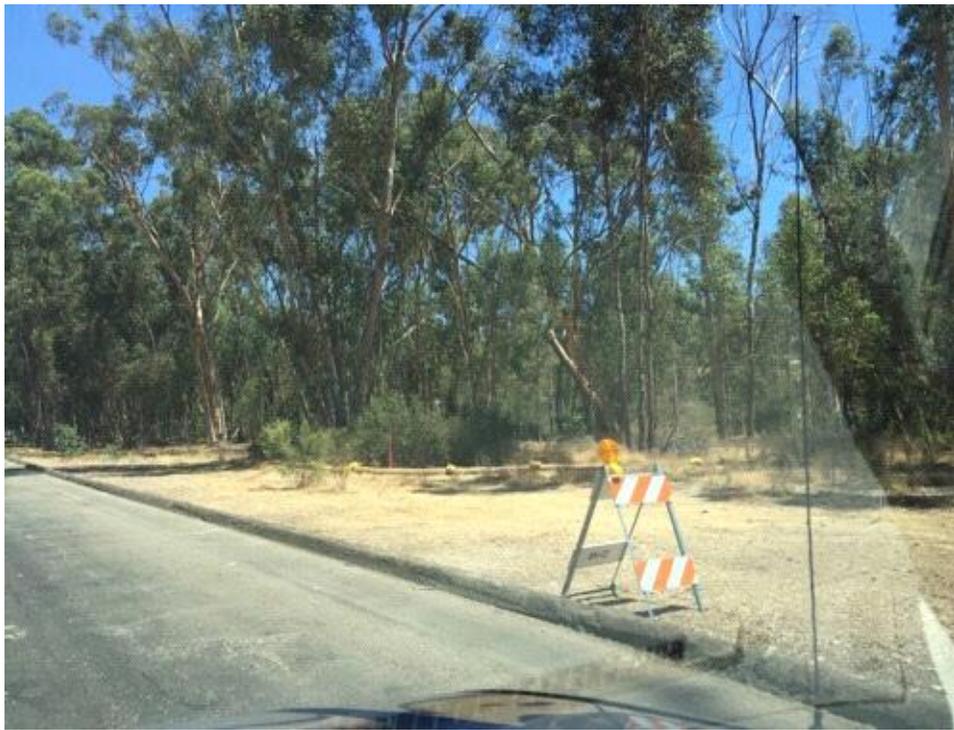
Caption Wattles in place on Pomerado Road.

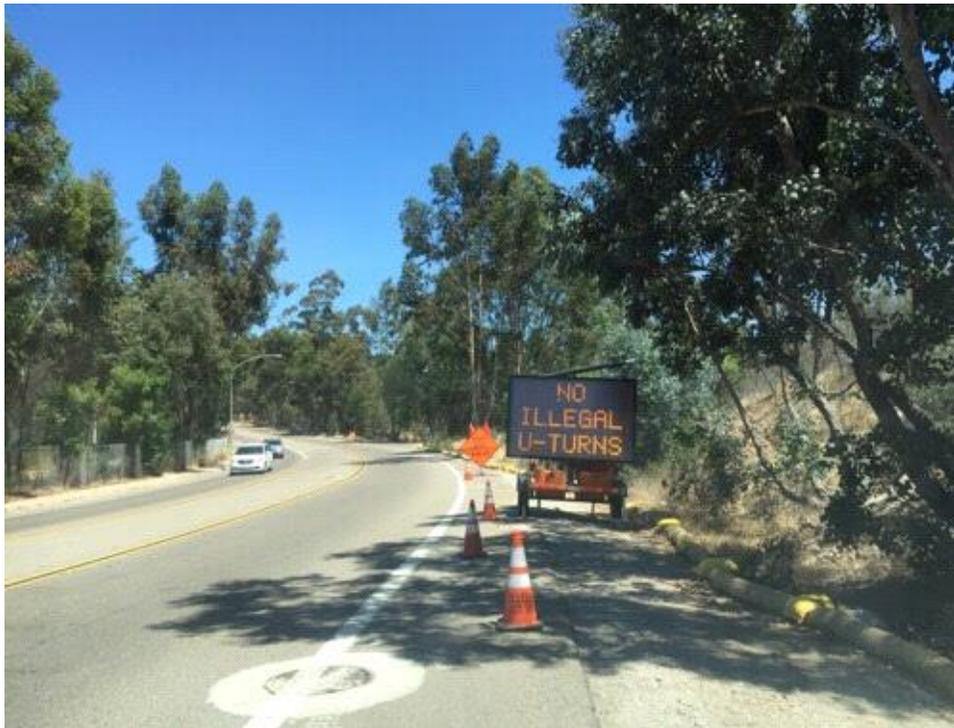
Caption Construction signage in place on Pomerado Road.

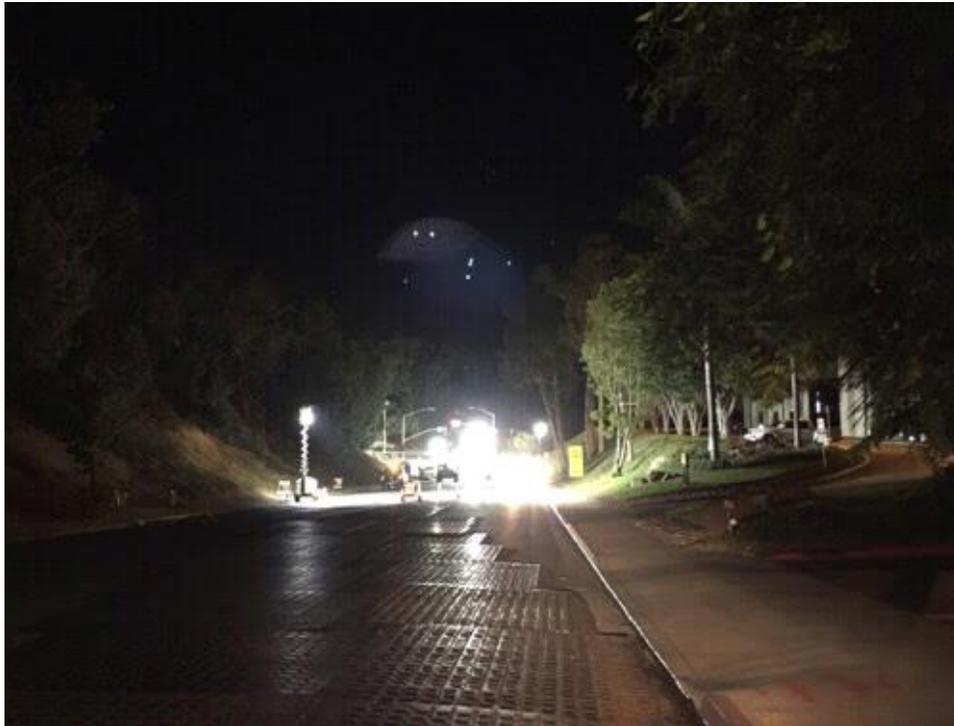
Caption Abundant downward-facing lighting in place for night work on Camino Santa Fe.

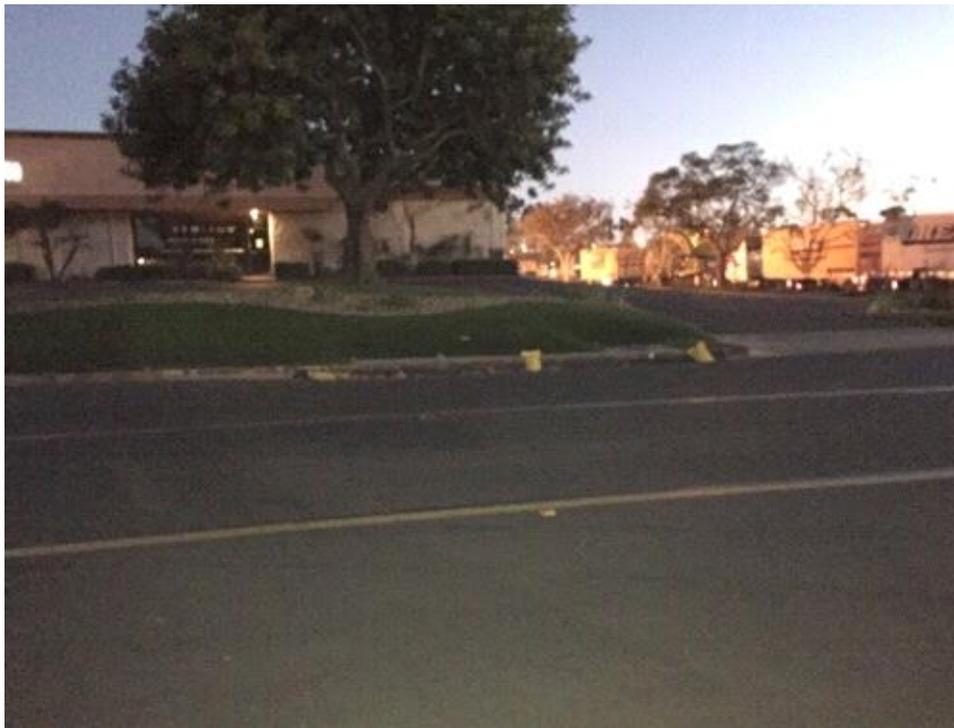
Caption BMPs in place on Activity Road.

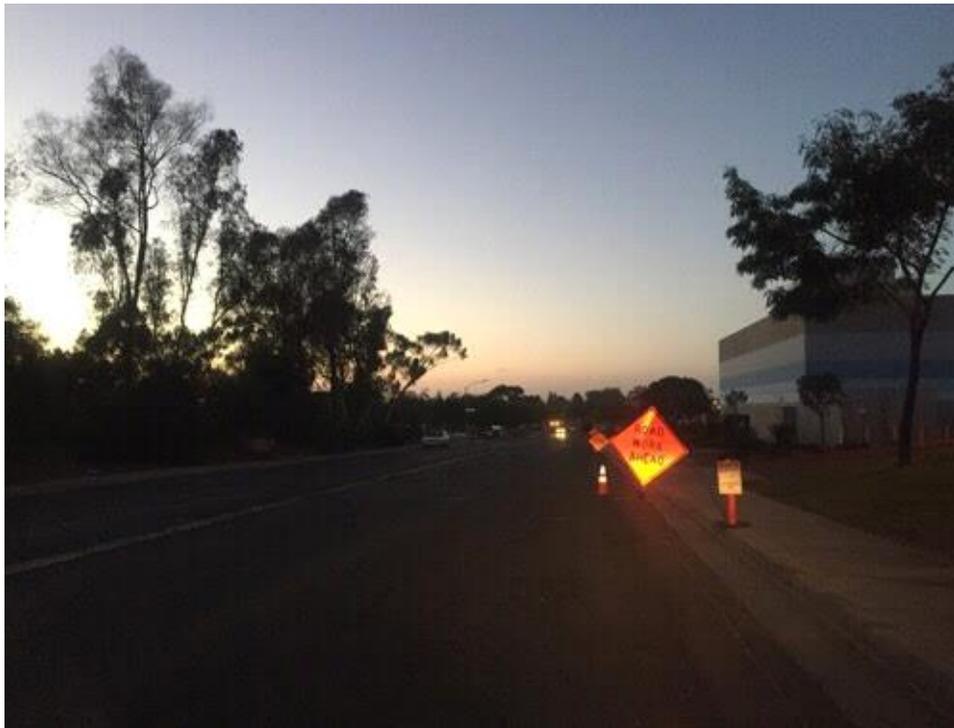
Caption Construction signage in place on Trade Place.

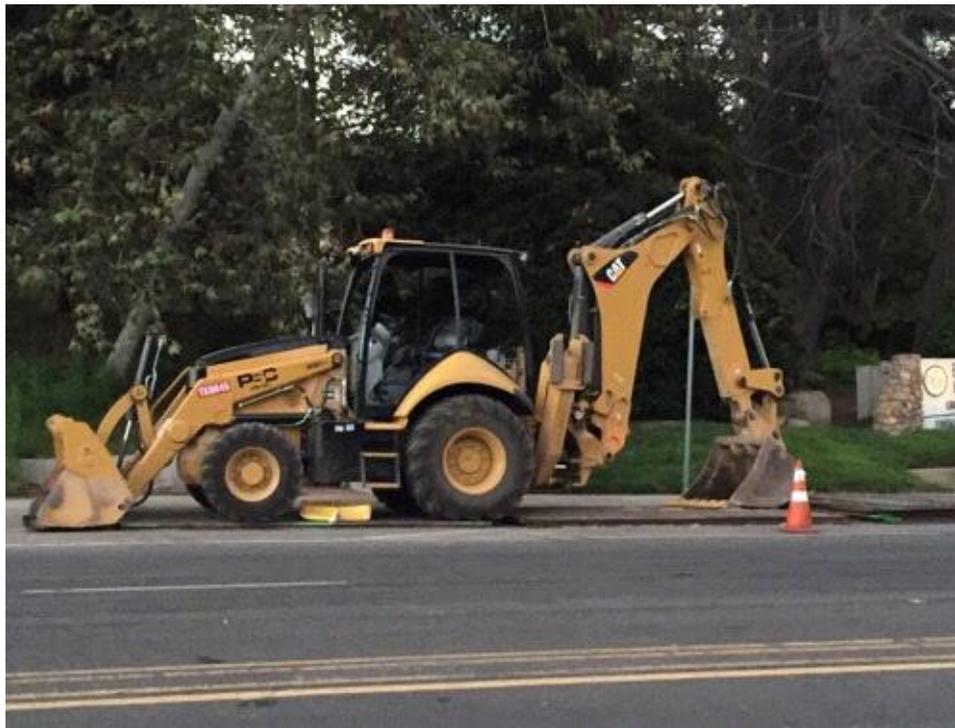
Caption Drip pans in place under staged equipment on Carroll Canyon Road.

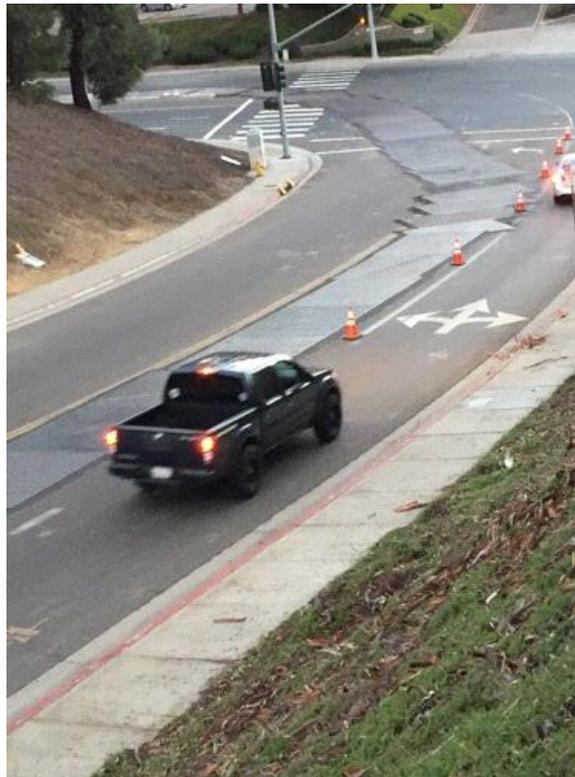
Caption Steel plates covering trenches in place on Trade Street and Camino Santa Fe.

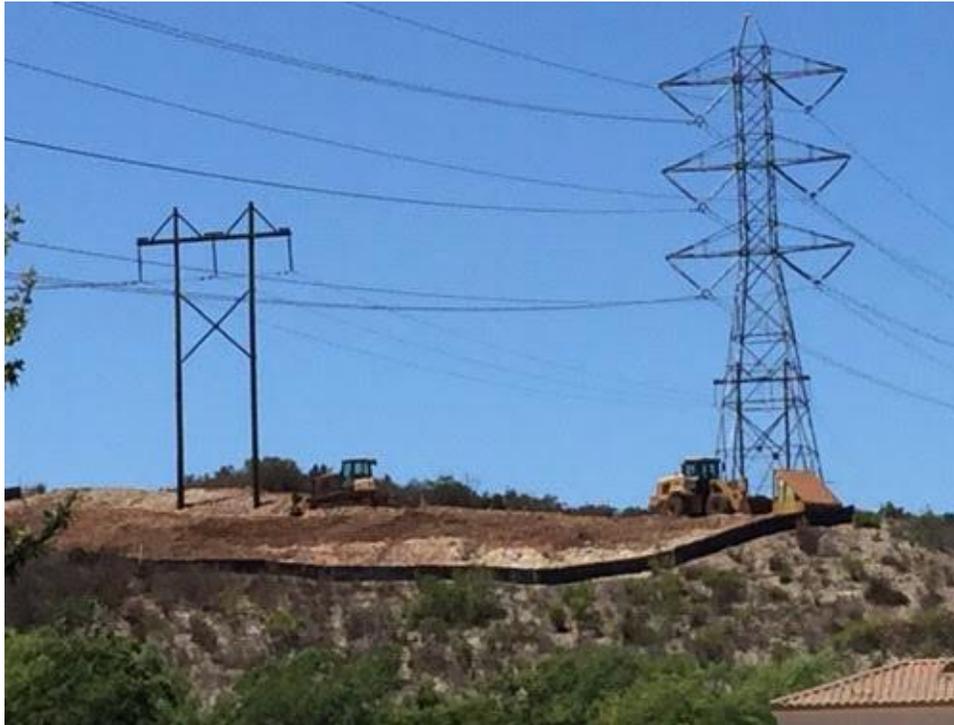
Caption No work observed on Pole 05 & P06.

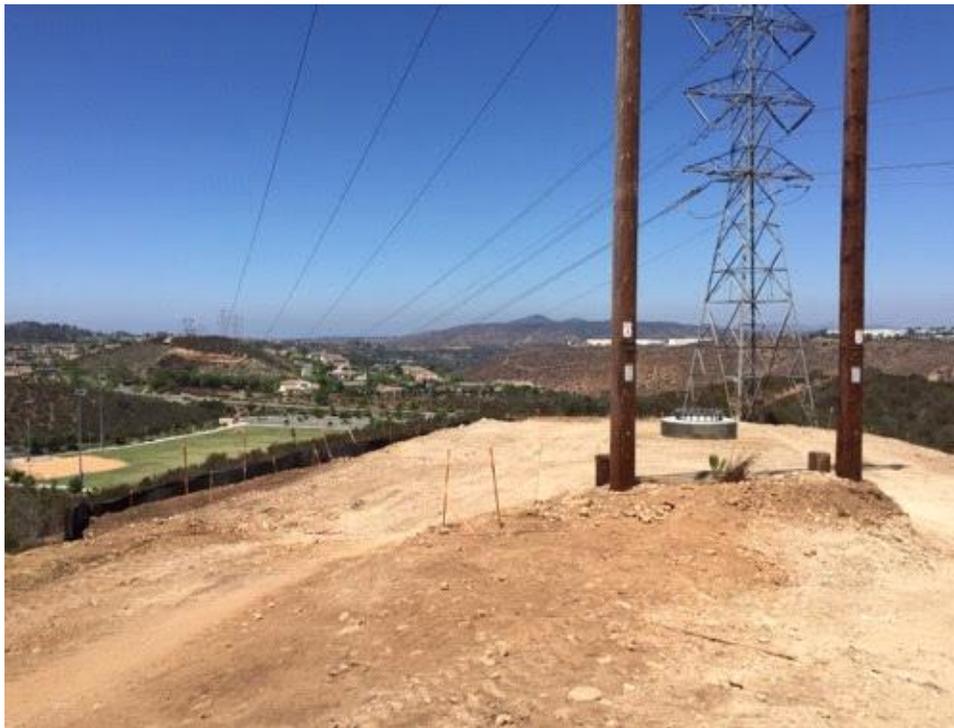
Caption No work observed at Pole 04.

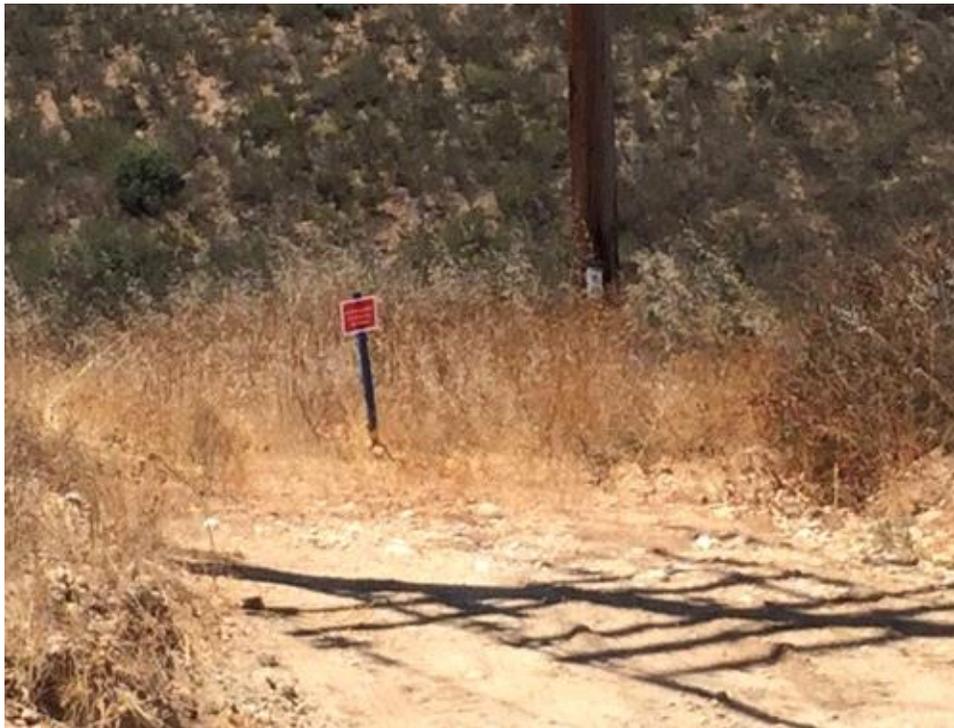
Caption Sensitive area signage at Pole 03.

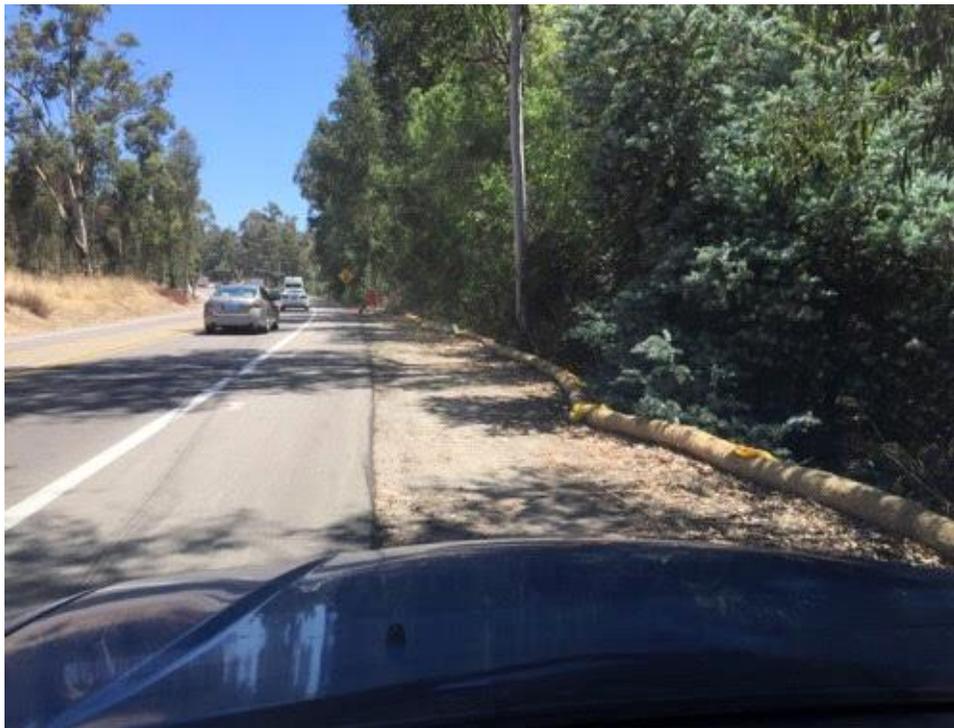
Caption Wattles in place on Pomerado Road.

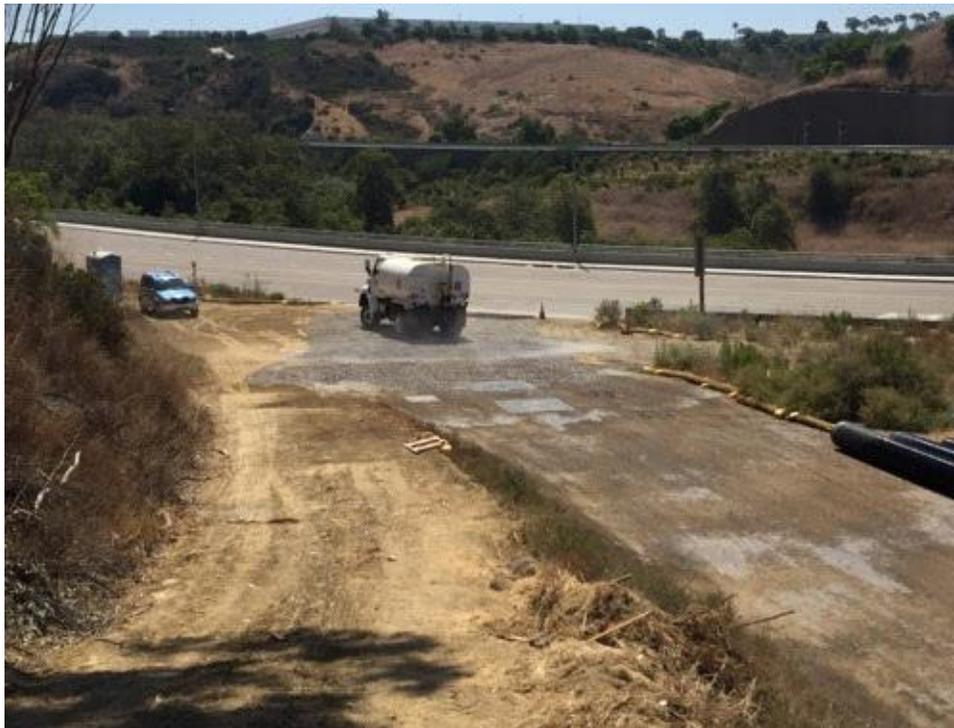
Caption Fugitive dust control at CC MM CP.

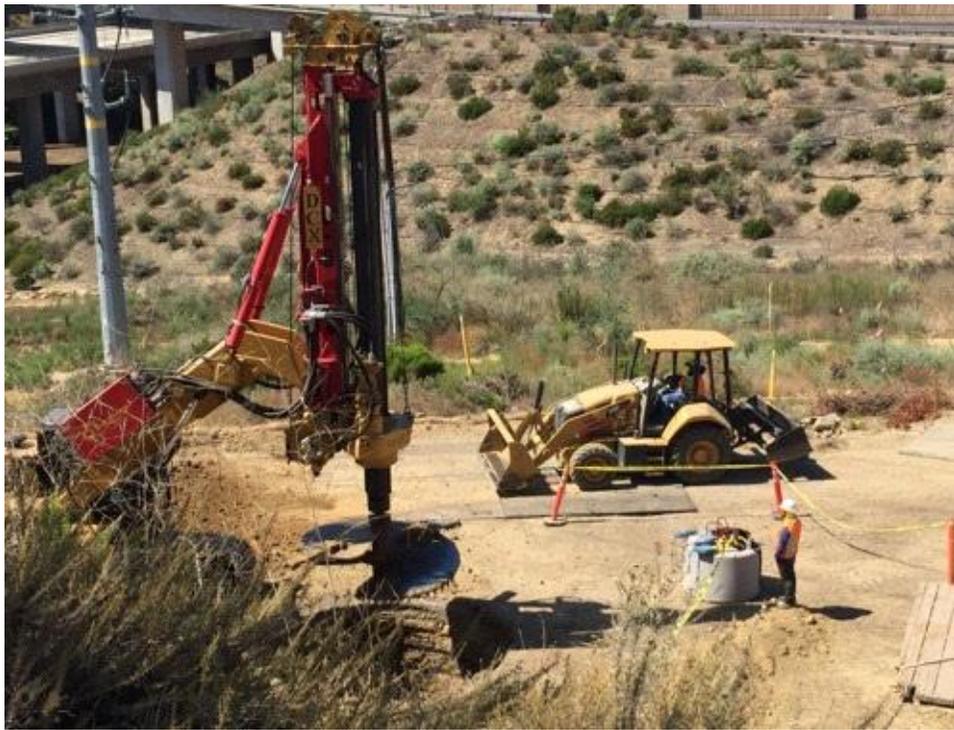
Caption Drilling at CC MM CP.

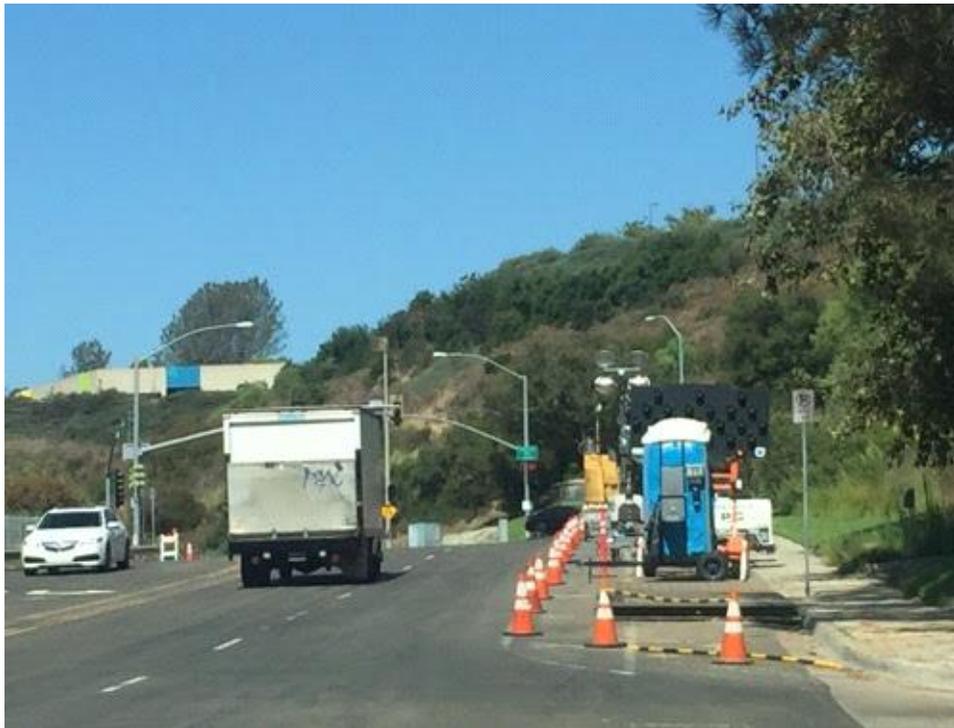
Caption Staged equipment on Carroll Canyon Road.
