## PROJECT MEMORANDUM SYCAMORE-PEÑASQUITOS 230-KV TRANSMISSION LINE PROJECT

Date: August 25, 2017  
To: Billie Blanchard, CPUC Project Manager  
From: Sheila Hoyer, CPUC Monitoring Supervisor  
Subject: Weekly Report #33 – August 13 to August 19, 2017

# 2017-08-14 AM Inspection Report

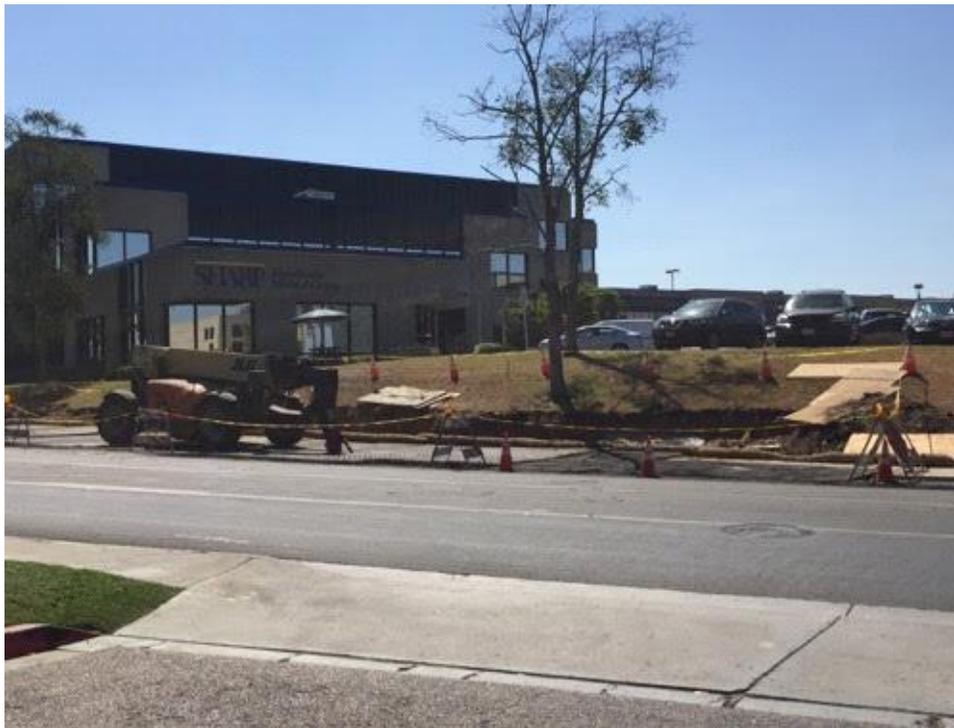
Caption Staged work area on Activity Road.
