PROJECT MEMORANDUM SYCAMORE-PEÑASQUITOS 230-KV TRANSMISSION LINE PROJECT

Date: September 8, 2017
To: Billie Blanchard, CPUC Project Manager
From: Sheila Hoyer, CPUC Monitoring Supervisor
Subject: Weekly Report #35 – August 27 to September 2, 2017

SDG&E Sycamore-Peñasquitos 230-kV Transmission Line Project: Daily Inspection Report

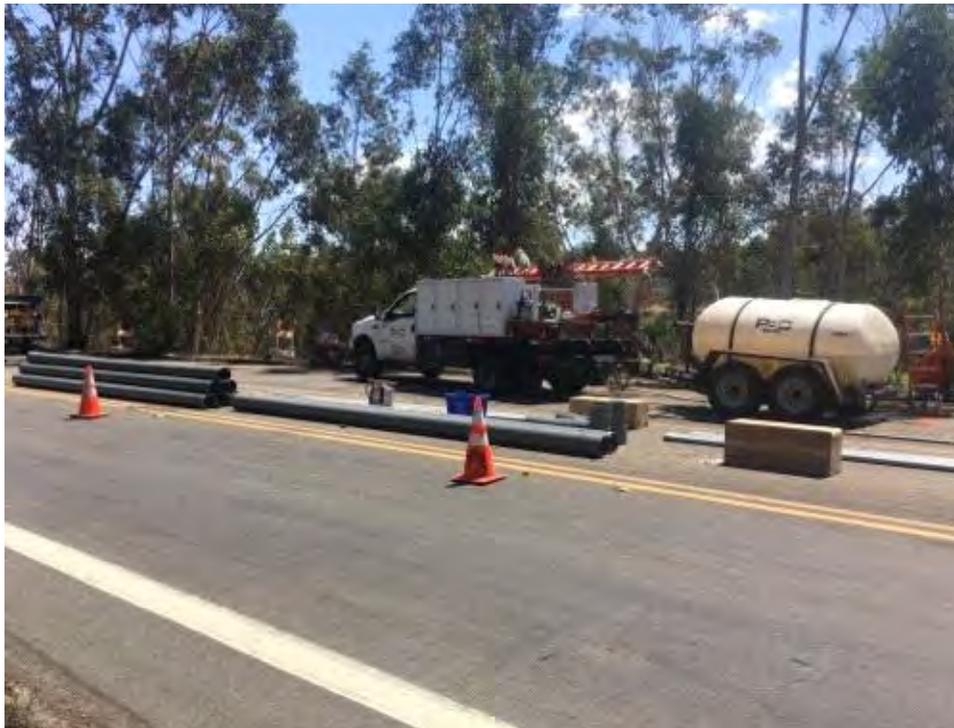
Caption Fire equipment on site on Pomerado Road.

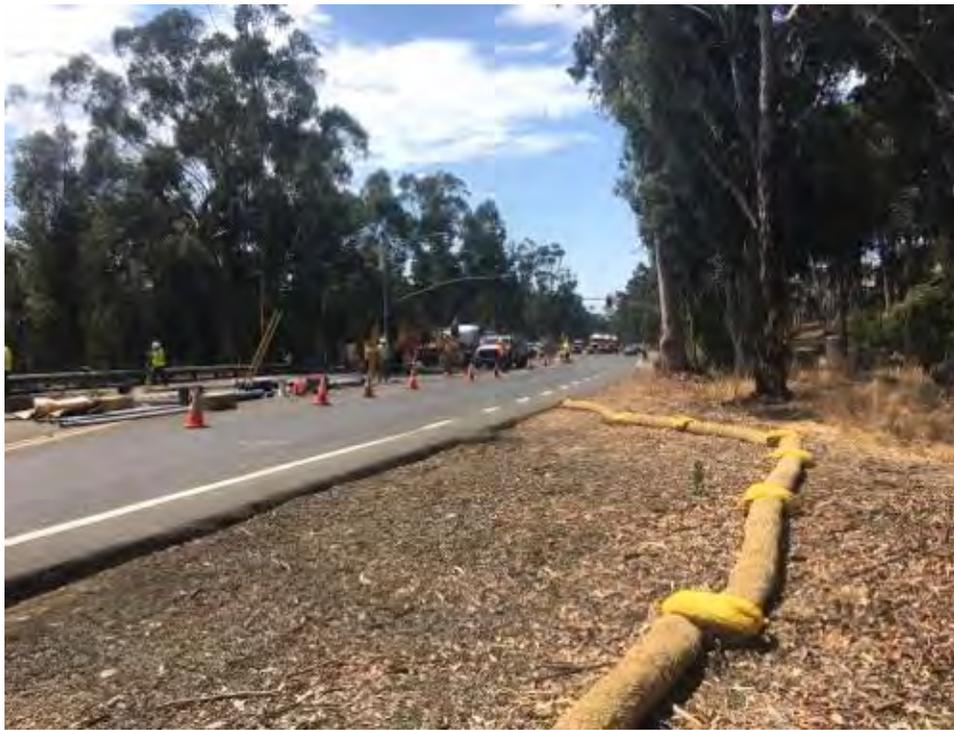
Caption Pomerado Road just east of Scripps Ranch Blvd., notice BMPs.

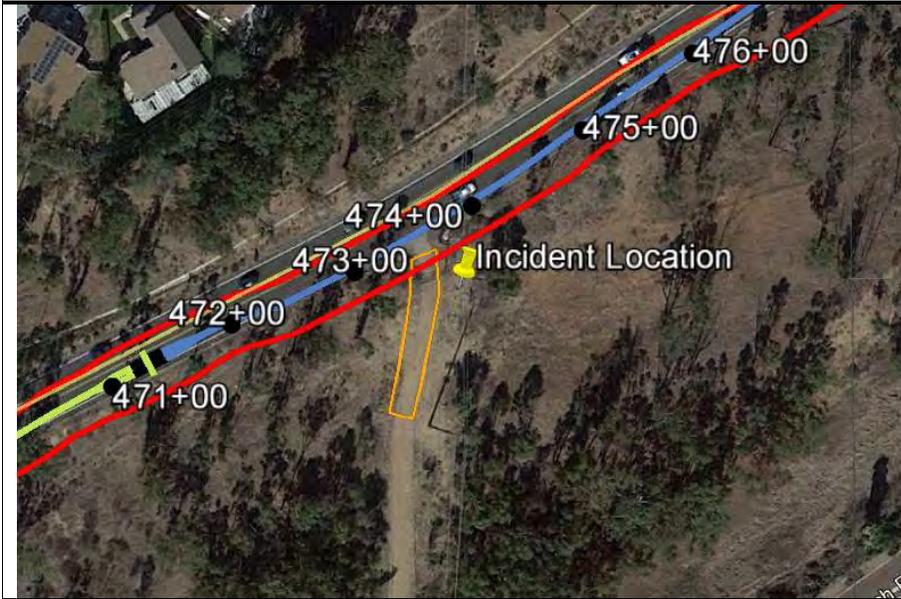
Photograph 1:

During daytime work on August 28, 2017, SDG&E's Field Construction Advisor (FCA) observed a crew repairing a backhoe outside of the approved work area off of Pomerado Road near station 474 + 00. The FCA immediately stopped the work and notified the Lead Environmental Inspector and SDG&E's Construction Manager.

Location of Incident Observation Near Station 474+00

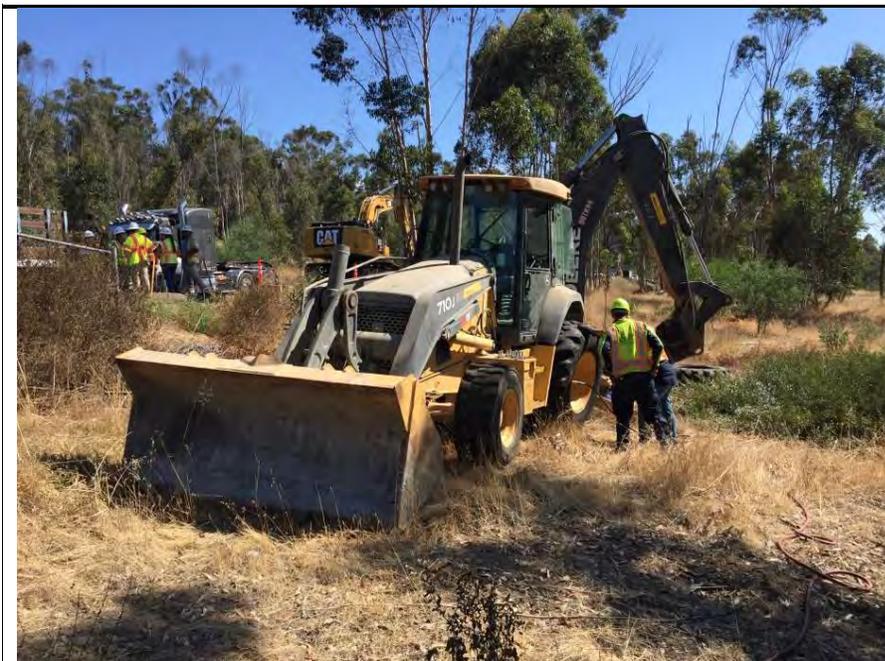
Photograph 2:

Upon investigation, it was determined that the crew observed by the FCA was a specialty equipment repair crew called onsite to repair a backhoe. The equipment repair crew was a subcontractor to SDG&E's construction contractor. The backhoe requiring repair was initially parked within a Project staging area that was approved by the California Public Utilities Commission under Minor Project Refinement request #6 on August 4, 2017. The entrance to the staging area had a locked gate—blocking the equipment repair crew's access to the backhoe. The equipment repair crew proceeded to park on the road shoulder near station 474 + 00, walked around the locked gate, and drove the backhoe outside of the approved work limits onto non-native grassland in order to stage the backhoe closer to their work vehicles and conduct the necessary repairs (See Photographs 1-3).

Backhoe parked outside of approved work area. This photo was taken from within the approved Project staging area looking east.

Corrective Actions: Construction activities along Pomerado Road, east of Scripps Ranch Road, were shutdown for the duration of the day on August 28, 2017. Repair crews that had not been properly trained were sent home. Equipment was placed within approved Project limits, and the Qualified Biologist inspected the area to ensure no biological resources were impacted.

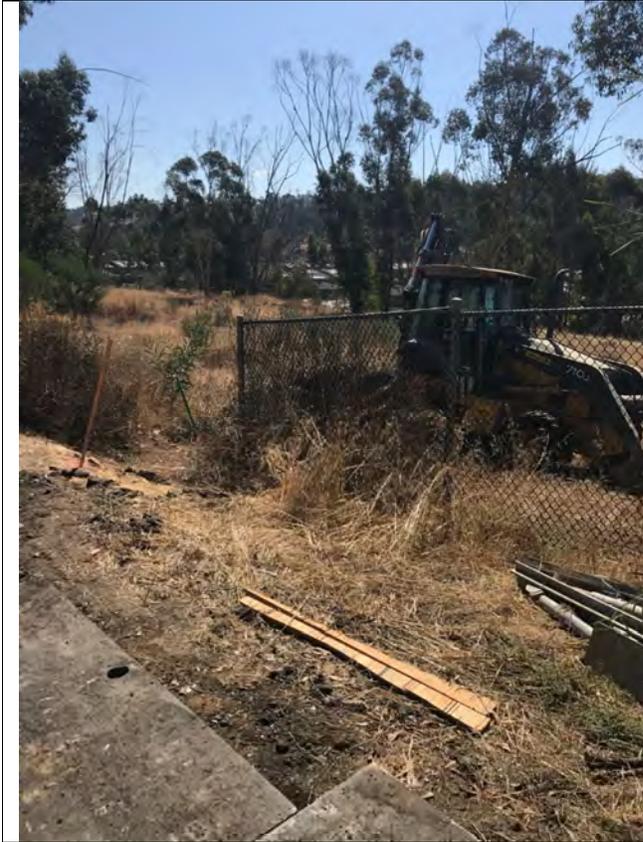
Photograph 3:

This photo was taken from Pomerado Rd. near station 474 + 00 looking south east.

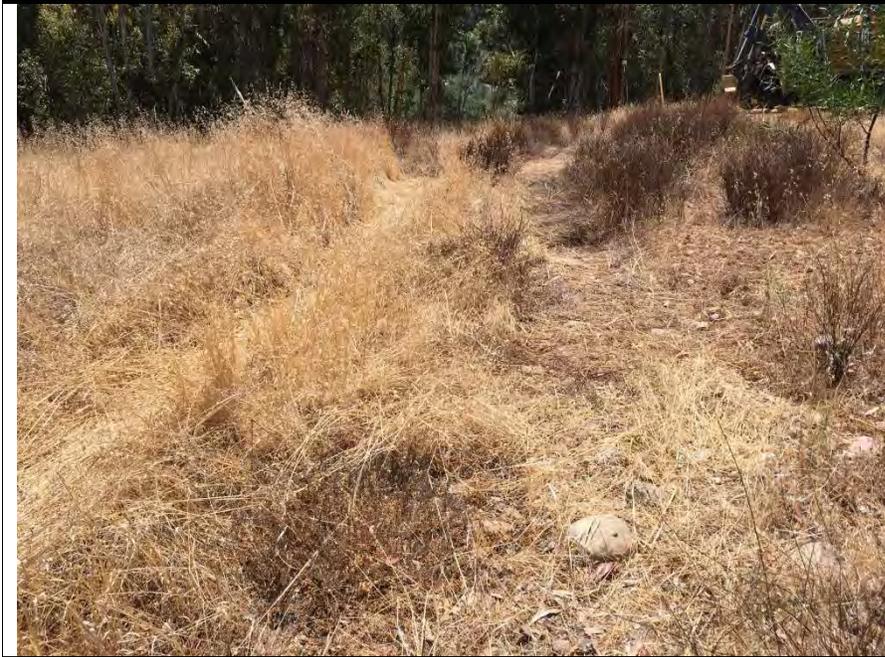
Photograph 4:

Post-Incident, site was cleaned up. Vegetation was crushed but expected to recover.

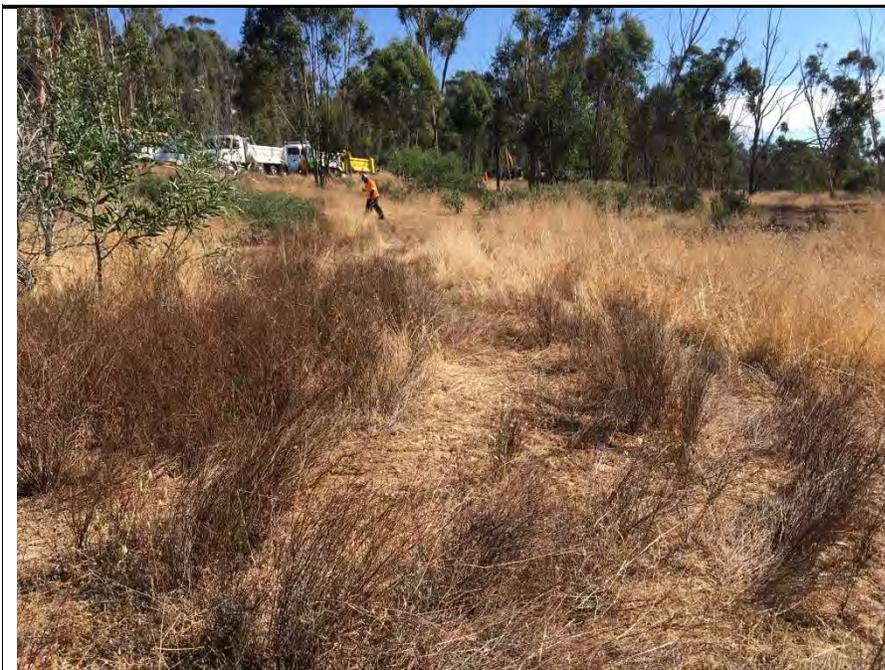
Photograph 5:

Post-Incident, site was cleaned up. Vegetation was crushed but expected to recover.
