PROJECT MEMORANDUM  
SYCAMORE-PEÑASQUITOS 230-KV TRANSMISSION LINE PROJECT

Date: September 22, 2017  
To: Billie Blanchard, CPUC Project Manager  
From: Sheila Hoyer, CPUC Monitoring Supervisor  
Subject: Weekly Report #37 – September 10 to September 16, 2017

## SDG&E Sycamore-Peñasquitos 230-kV Transmission Line Project: Daily Inspection Report

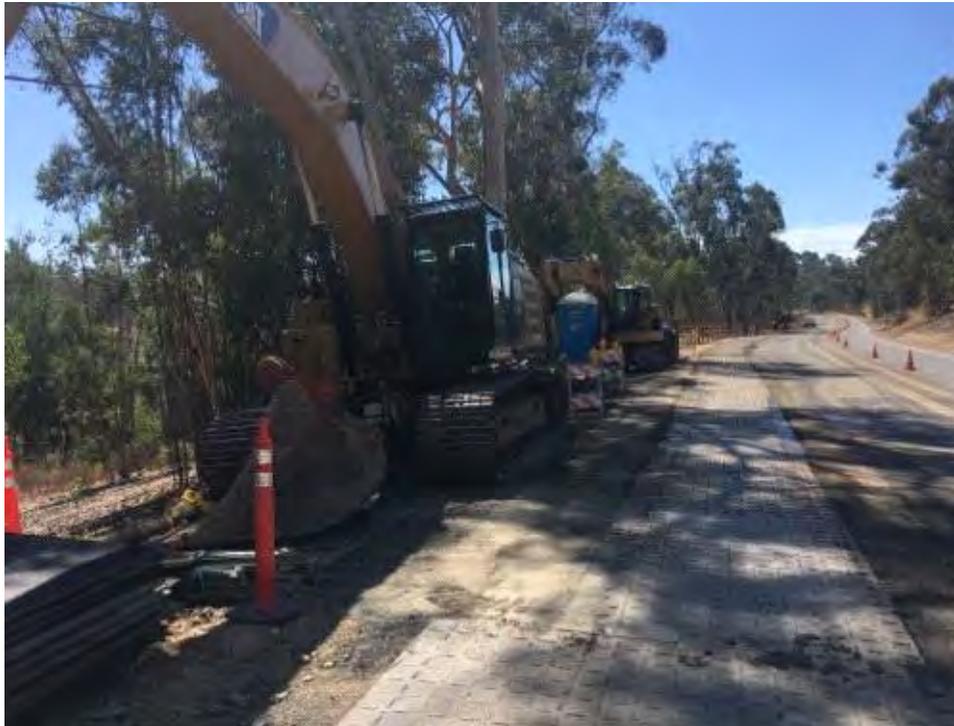
Caption Equipment properly stored on Pomerado Road.

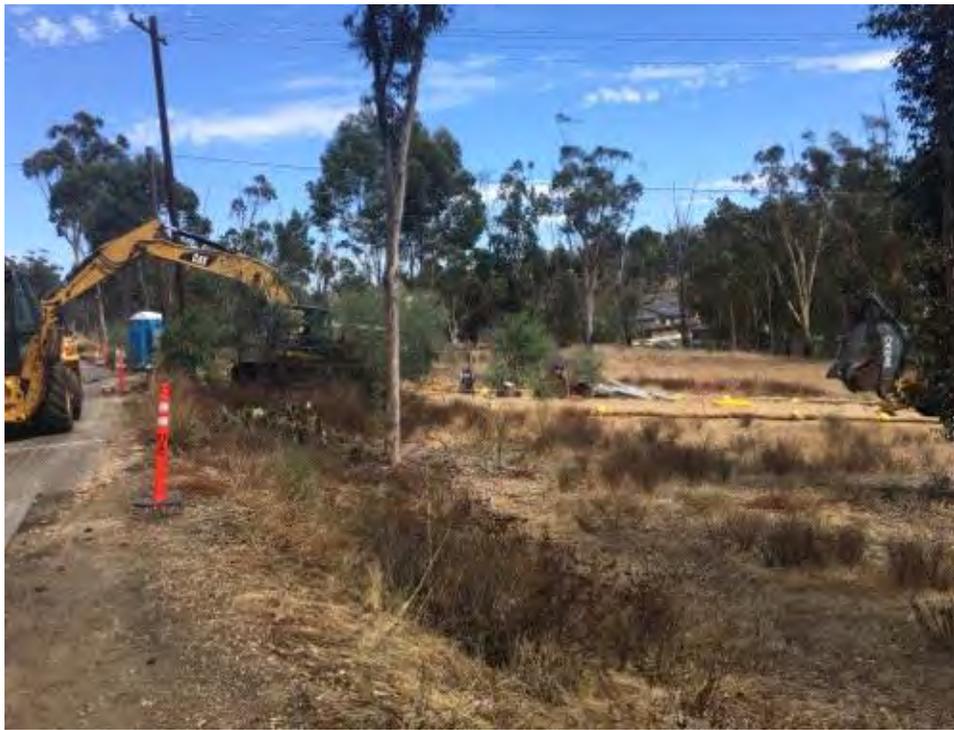
Caption Equipment storage location south of Pomerado Road.

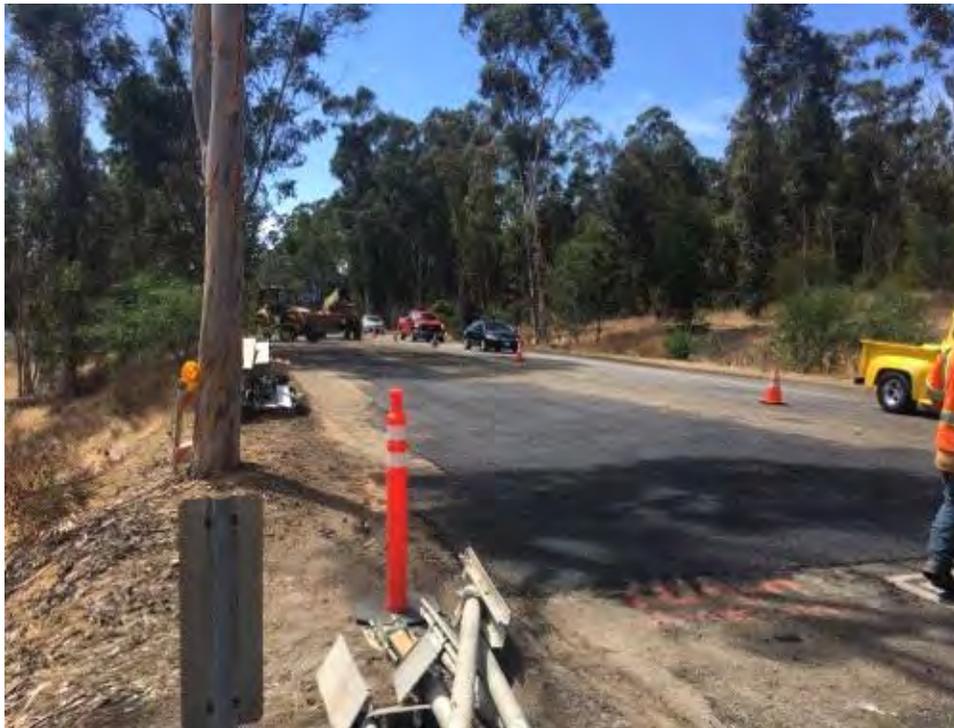
Caption Fresh pavement just west of vault and east of Scripps Ranch Blvd.

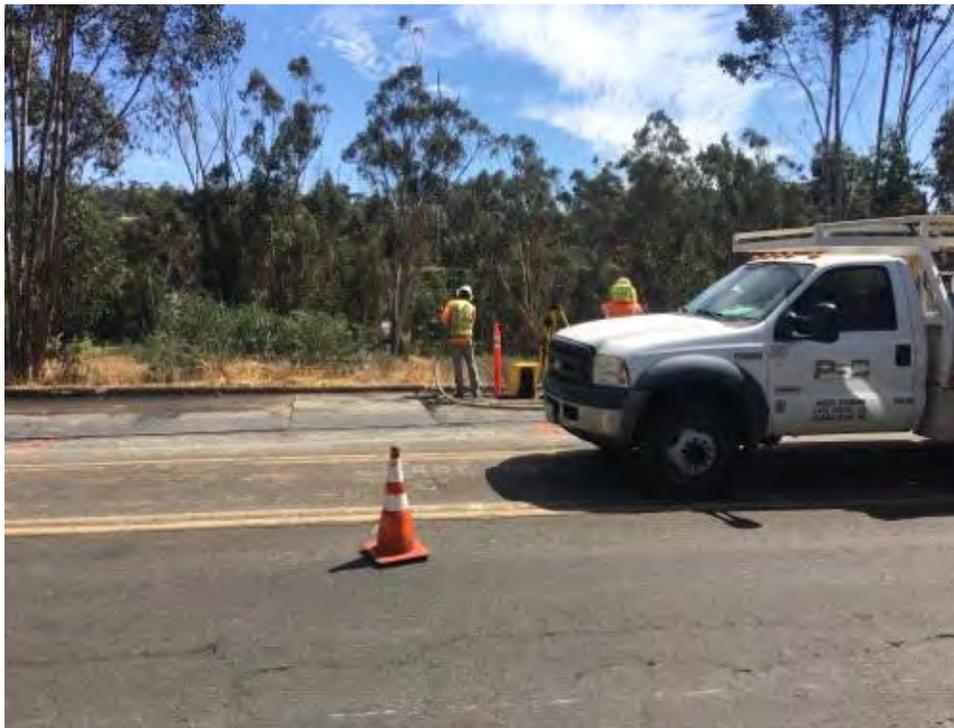
Caption Fire hose in use to wet vegetation along Pomerado Road work site.

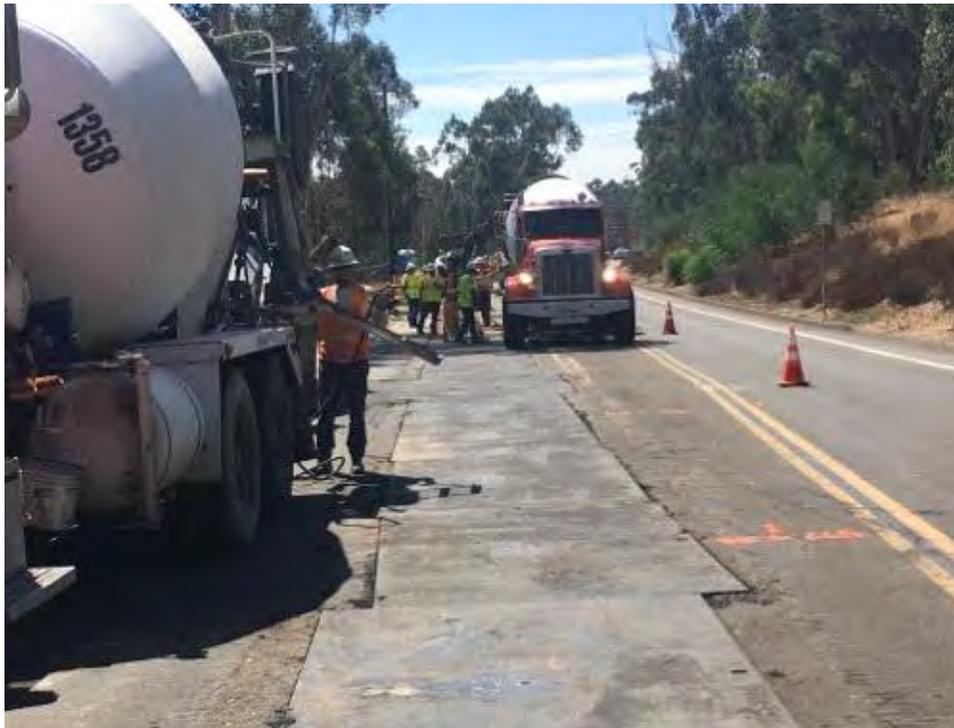
Caption Trench just east of Scripps Ranch Blvd.

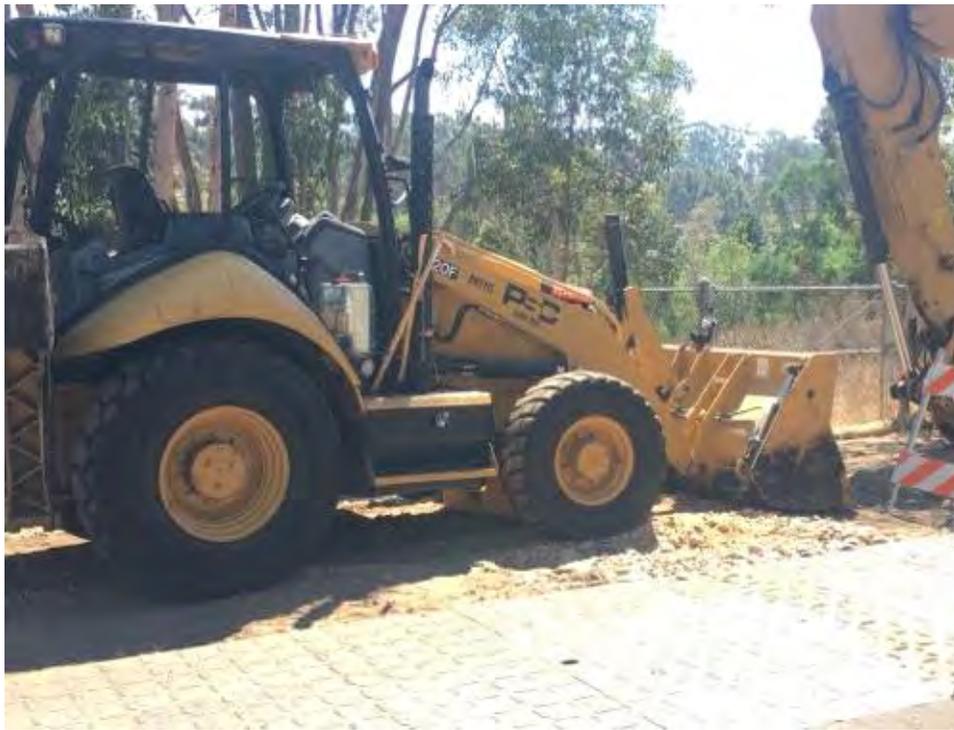
Caption Fire tools and drip pan present on equipment stored along Pomerado Road.

Q9 Notes	Drip pans were observed beneath stored equipment.
Q10 – Fire Management: (a) Were fire prevention procedures in place? (b) Was firefighting equipment available on site?	Met Requirements

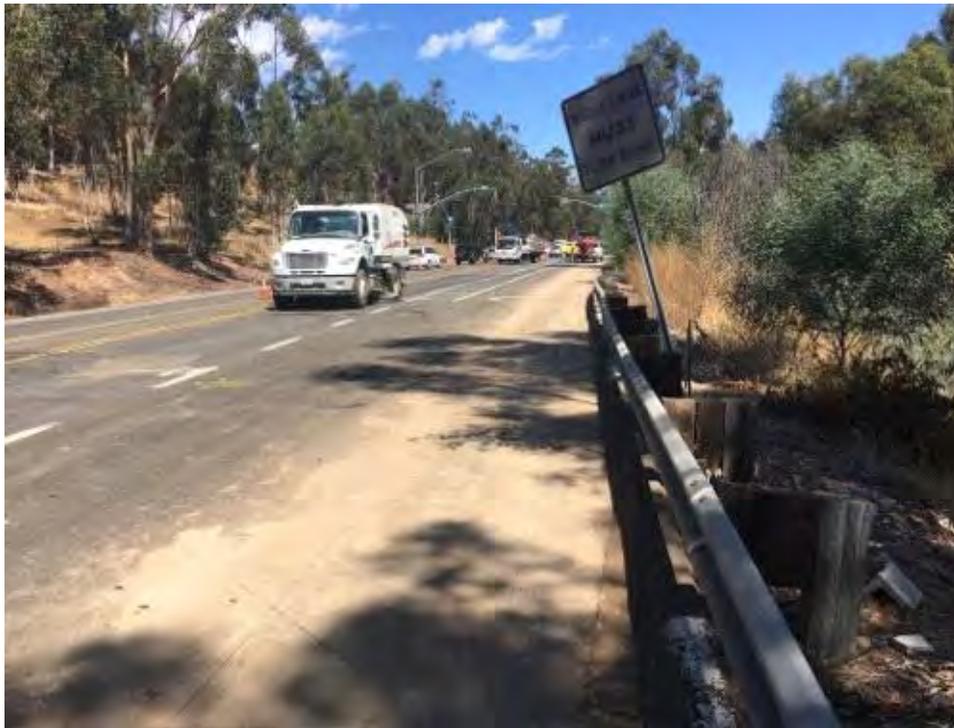
Caption Street sweeper cleaning road following work.

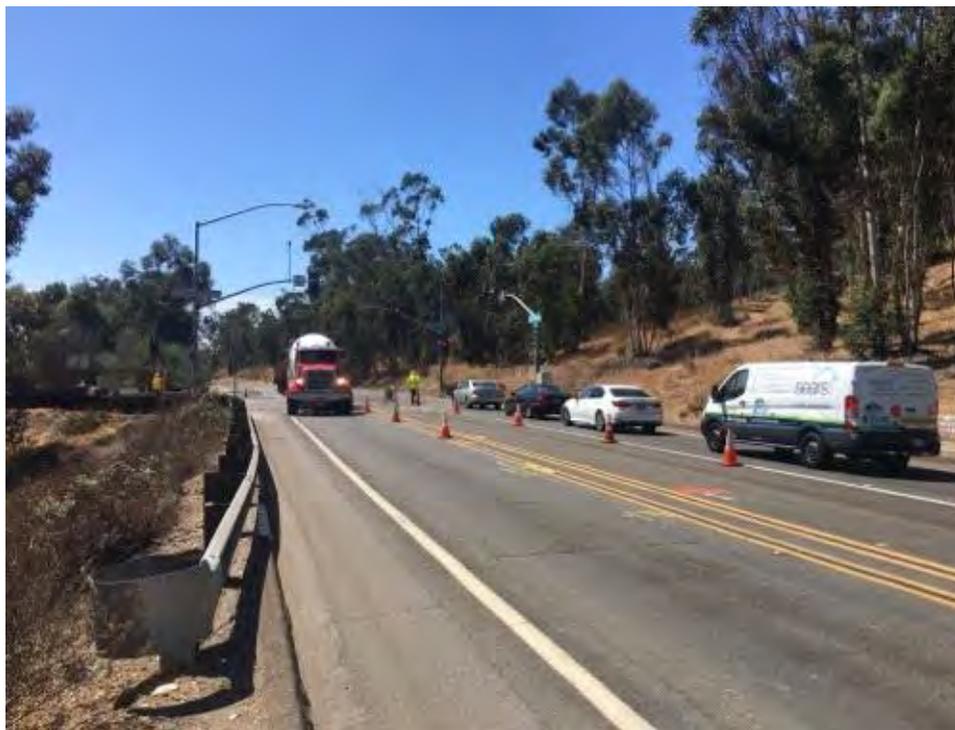
Caption Traffic control on Pomerado Road at Chabad Center.

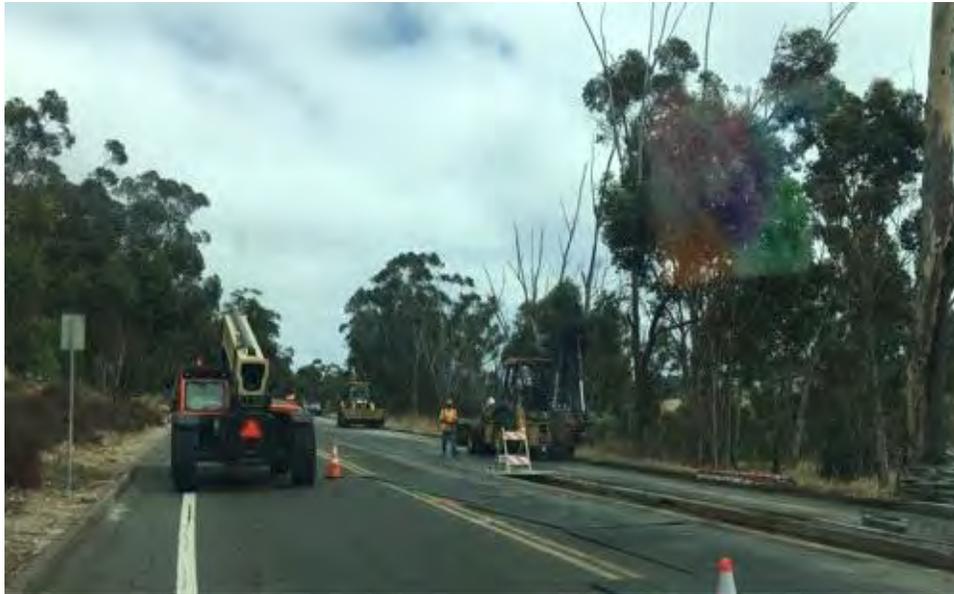
Caption Pomerado Road work area east of Scripps Ranch Blvd.

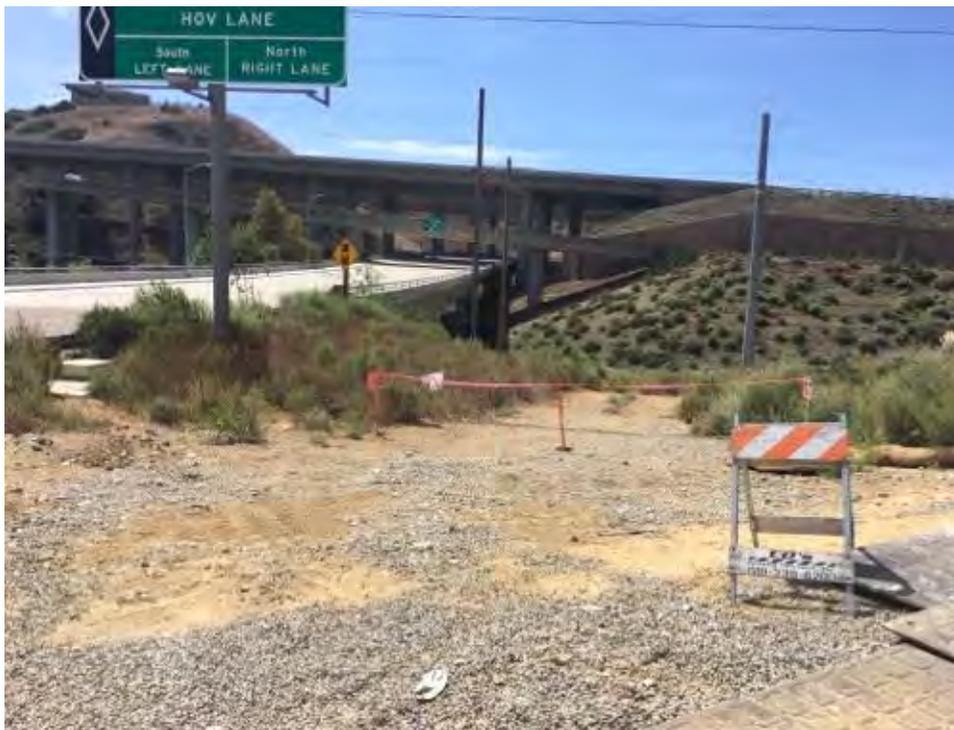
Caption Work site boundary at Carroll Canyon Road and CC MM CP pole site access road.

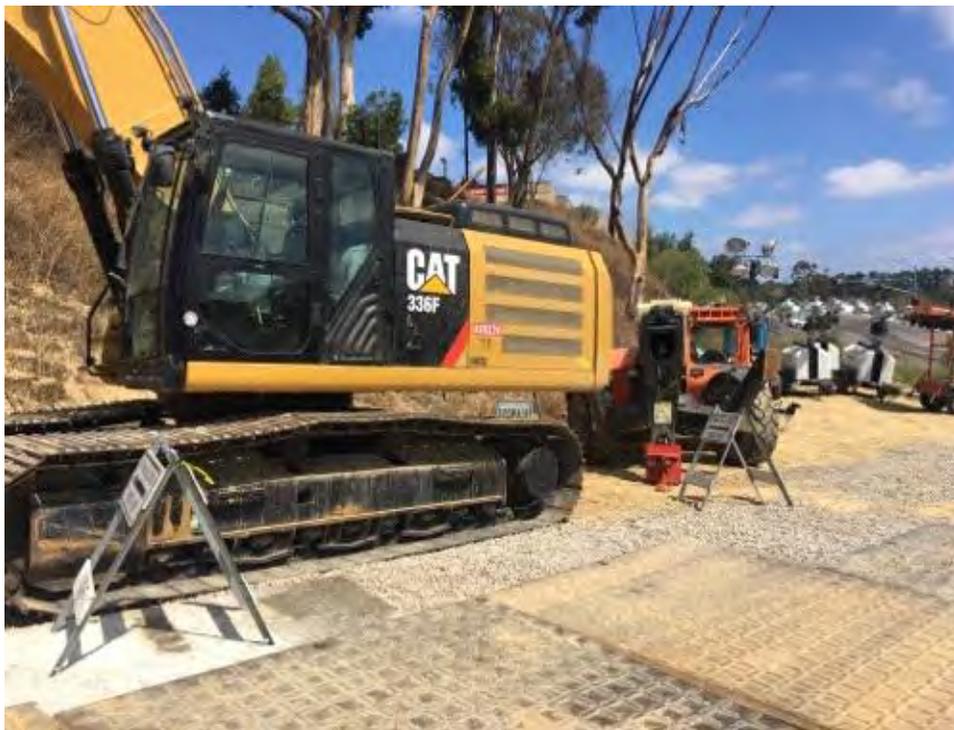
Caption Equipment stored along Carrol Canyon road. Note fire tools and drip pans present.

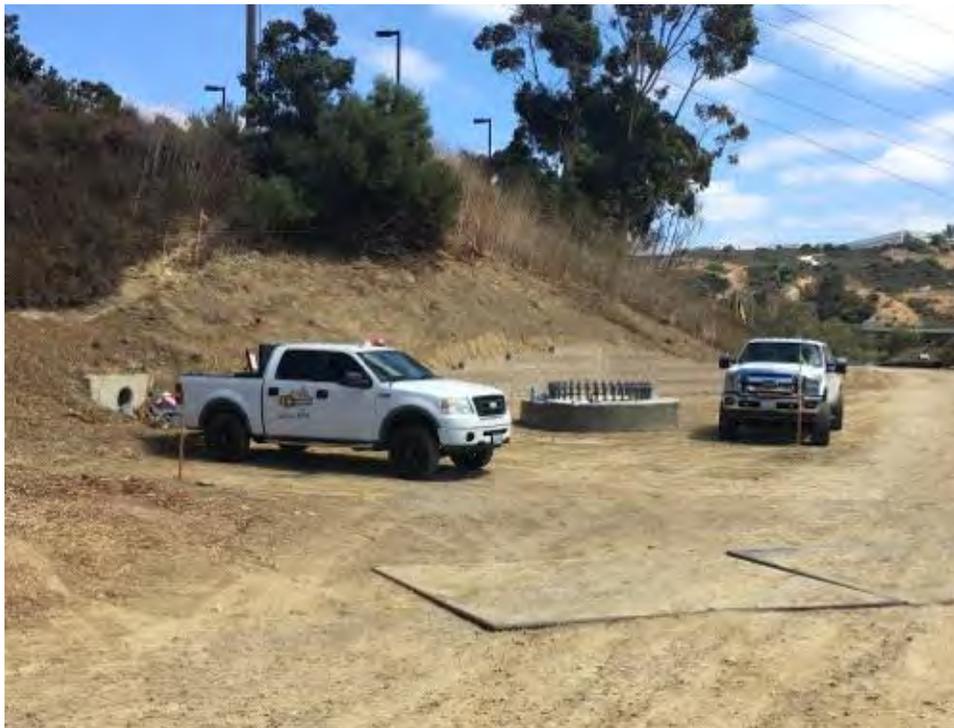
Caption CC MM CP pole site. DCX crew doing final work on retaining wall.

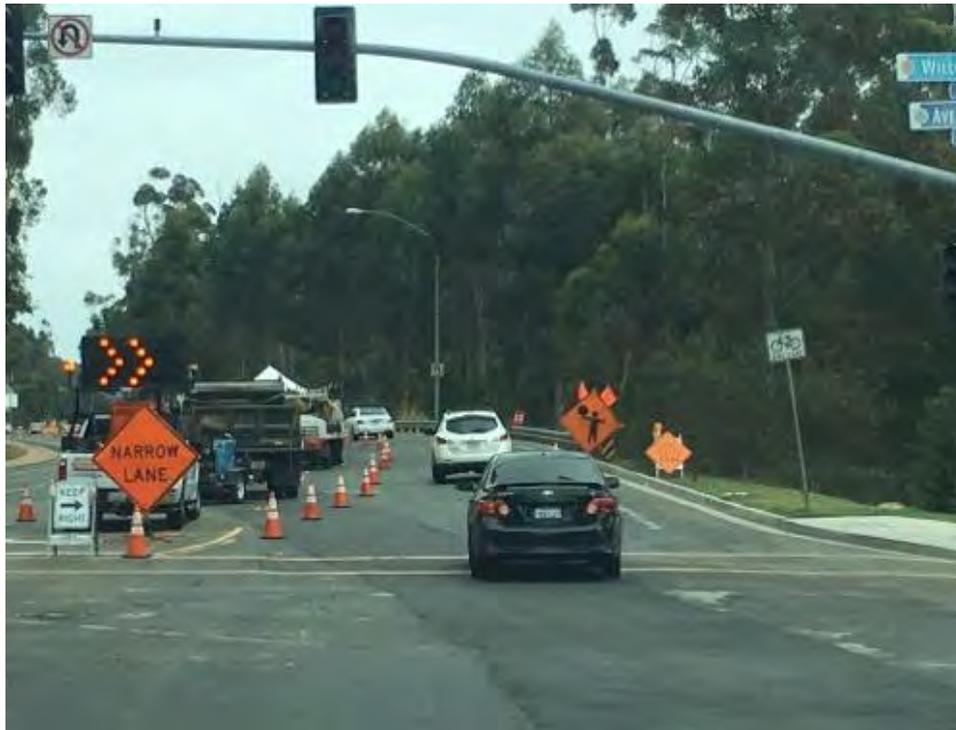
Caption Traffic control on Pomerado Road at Avenue of Nations.

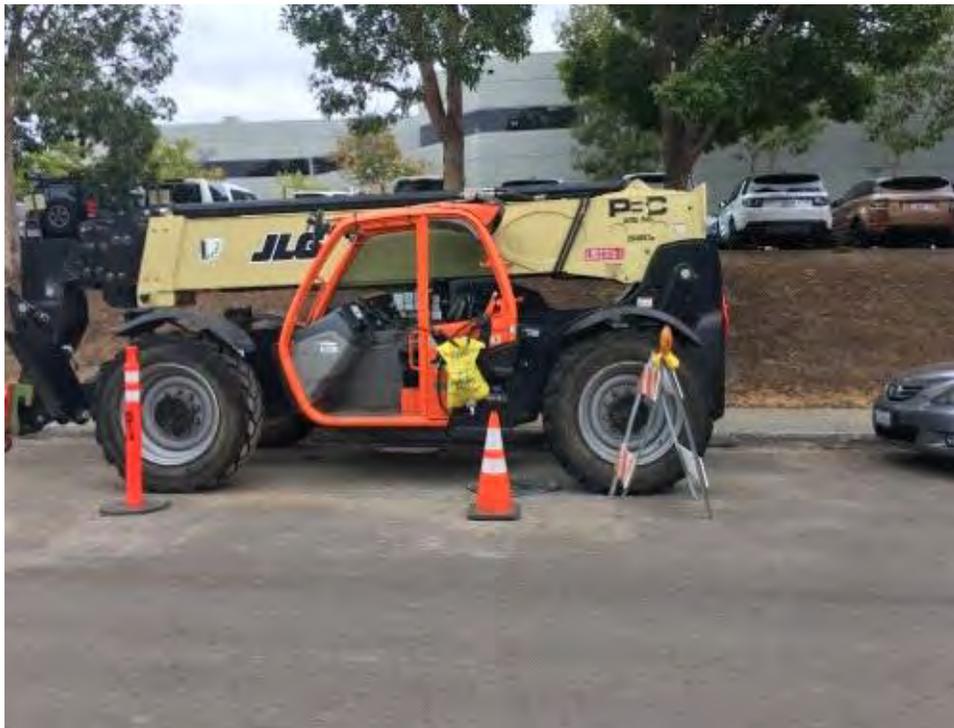
Caption Fire tools and equipment stored on Clayton Drive.

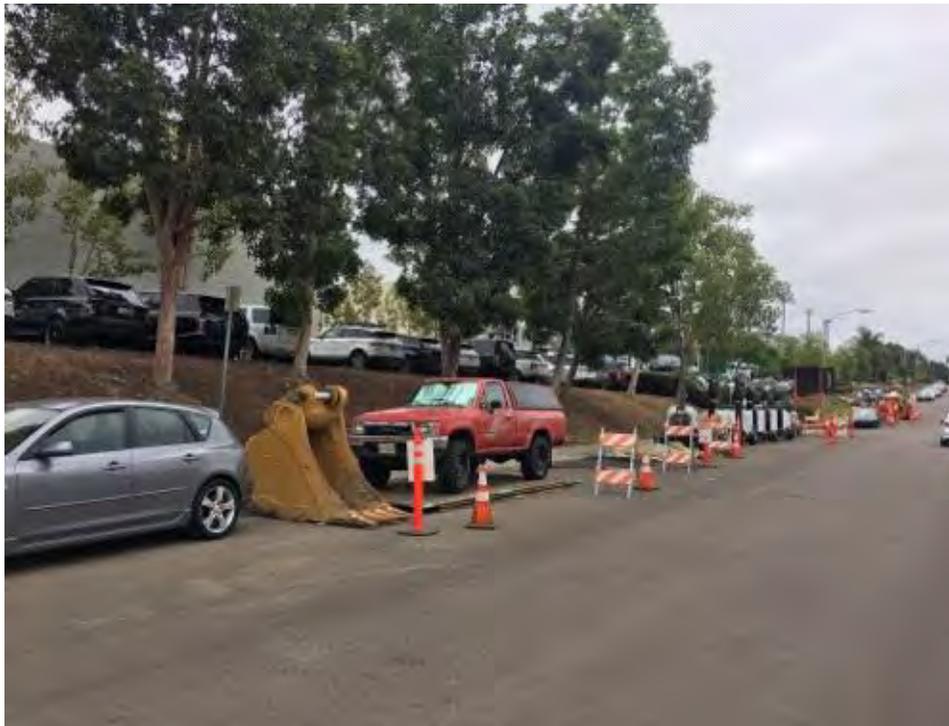
Caption Equipment and BMP storage on Clayton Drive. Not sure if the red truck is project related or someone illegally parking?

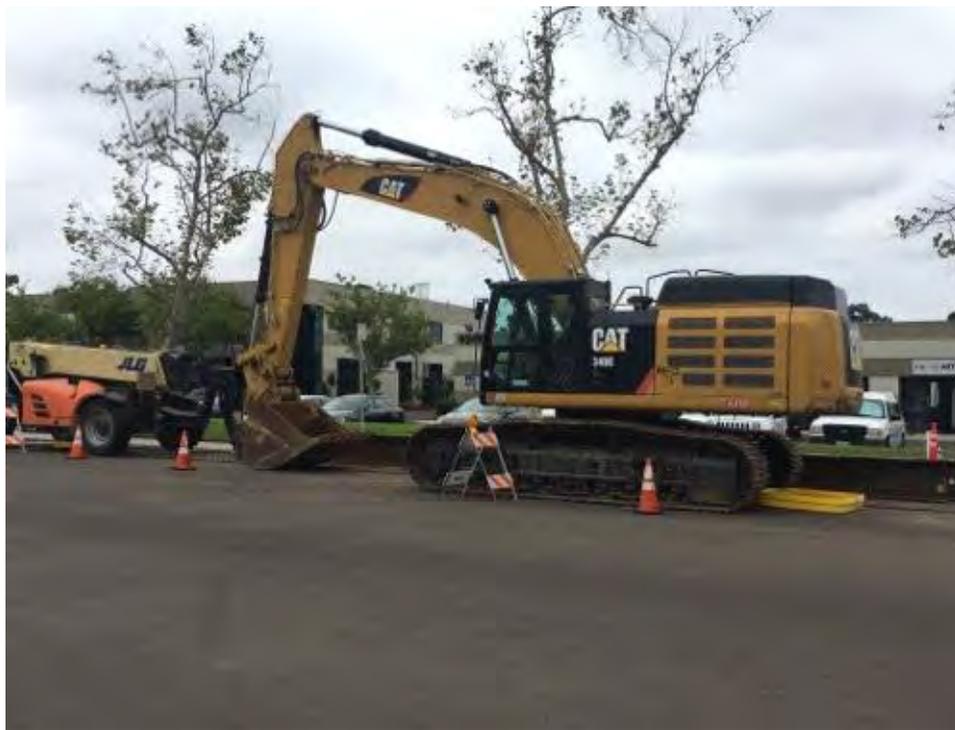
Caption Equipment stored properly on Padget Street.

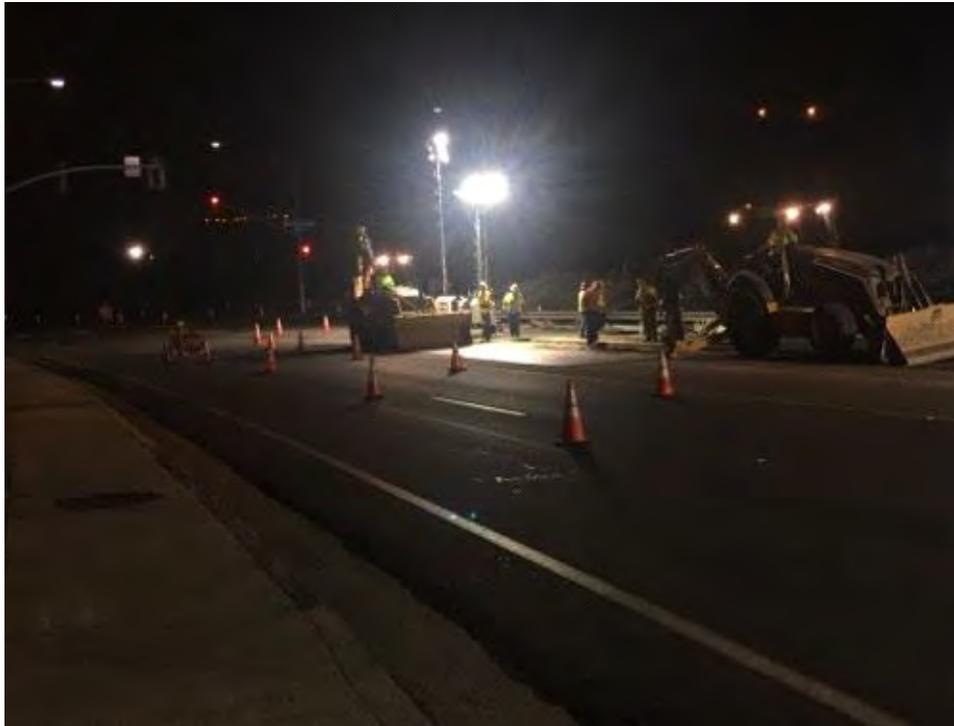
Caption Excavation on Carroll Canyon Road near Nancy Ridge Drive.

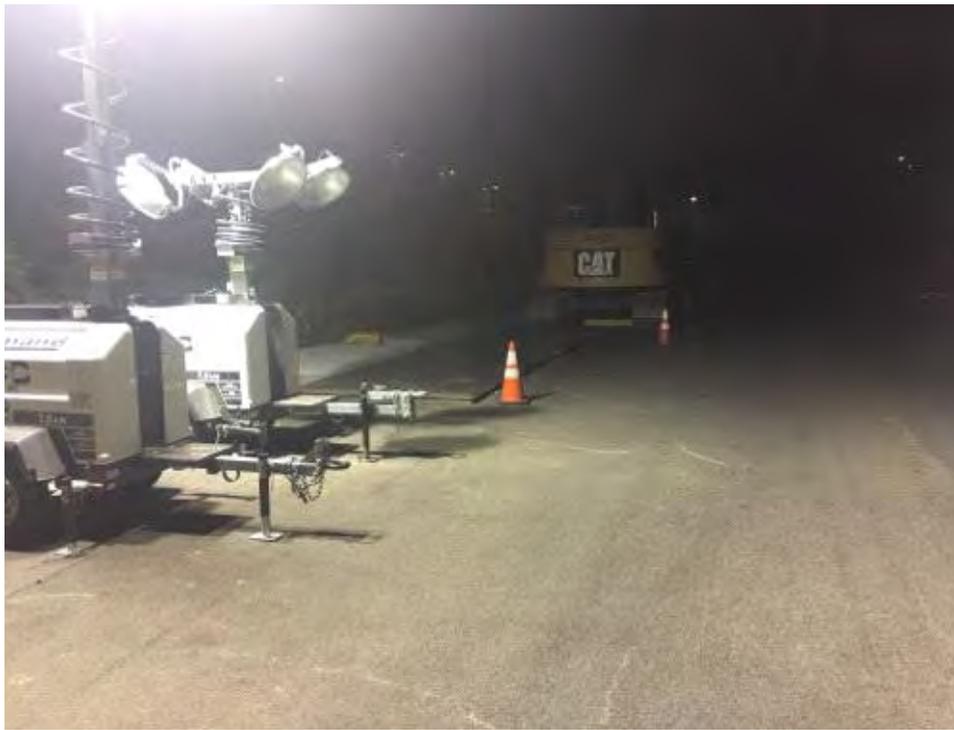
Caption Excavator not being used and stored on Yougstown Way.

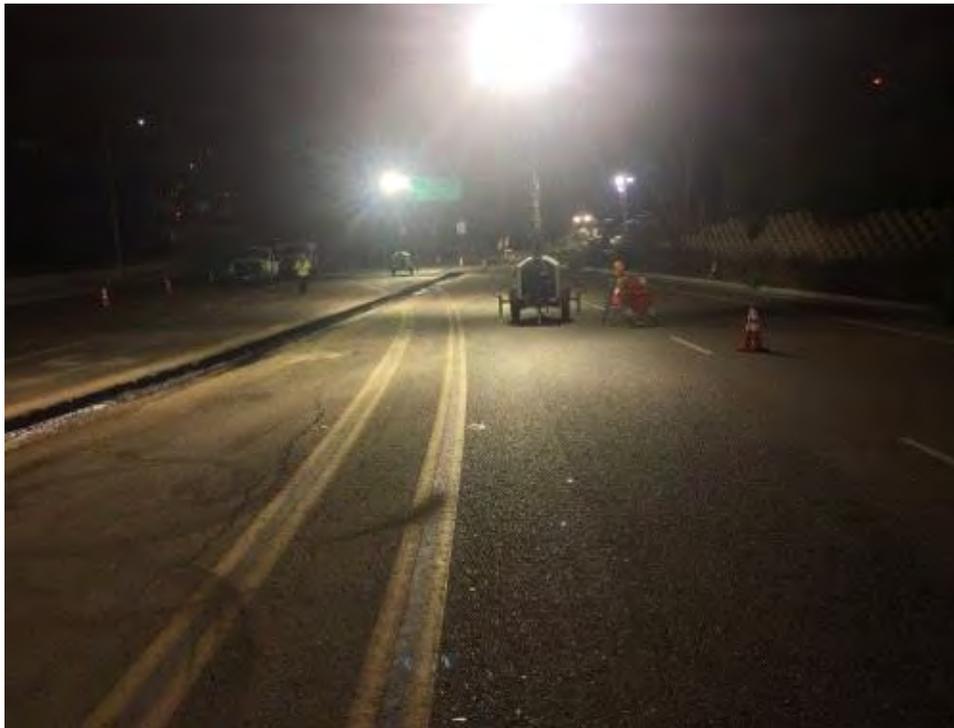
Caption Trench ready for paving on Carrol Canyon Road near I-805.

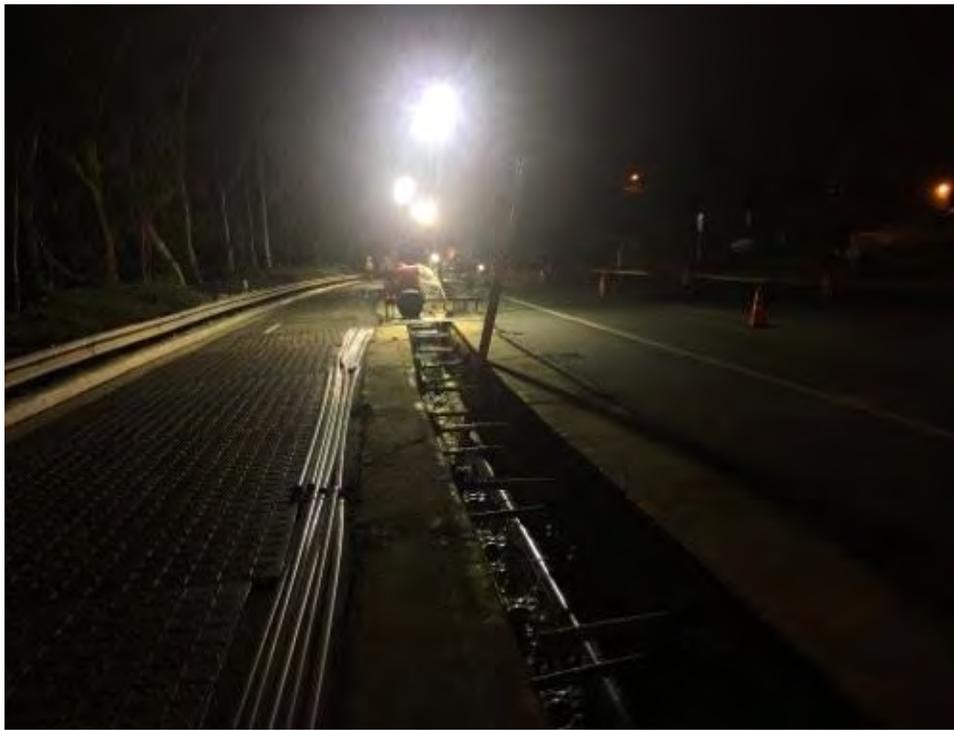
Caption Trench and conduit install on Carroll Canyon Road.

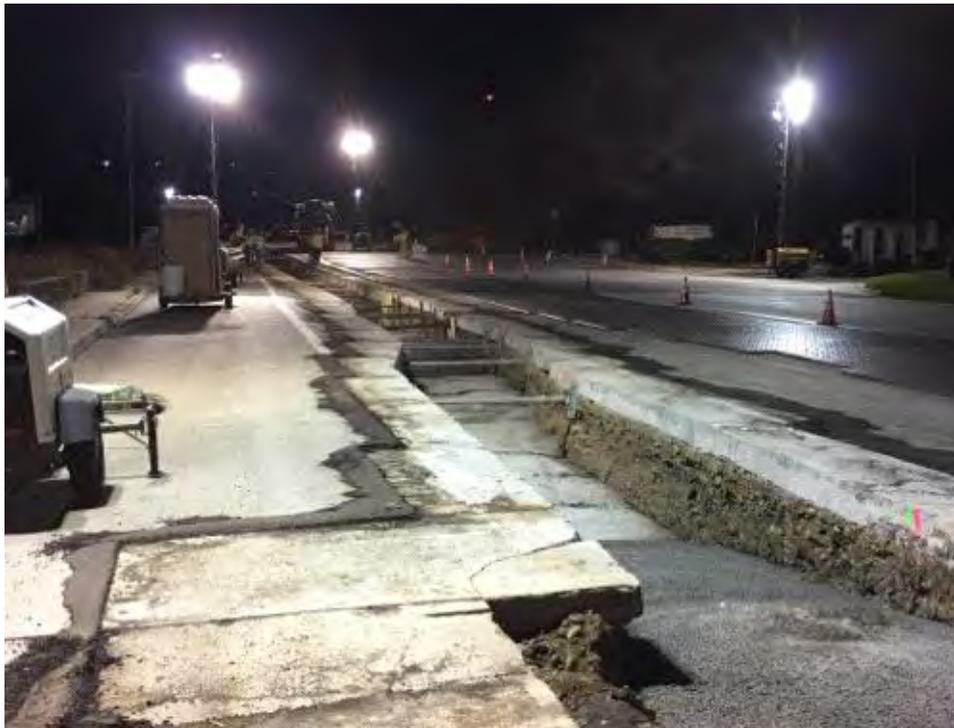
Caption Carroll Road trench. Note fresh concrete work.

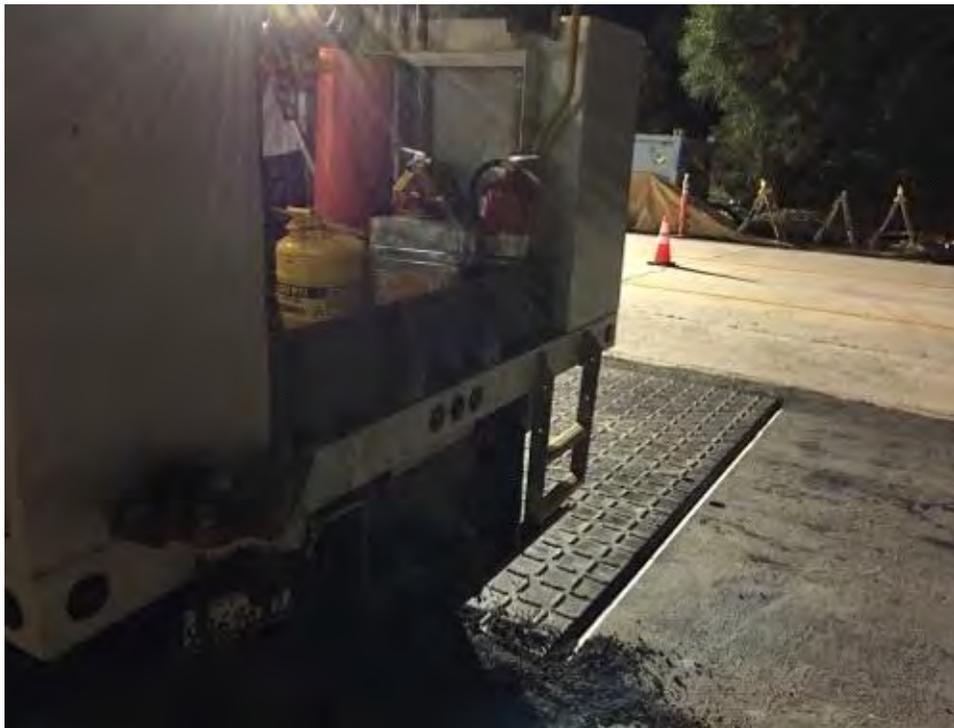
Caption Fire tools on work truck within active work area on Carroll Road.

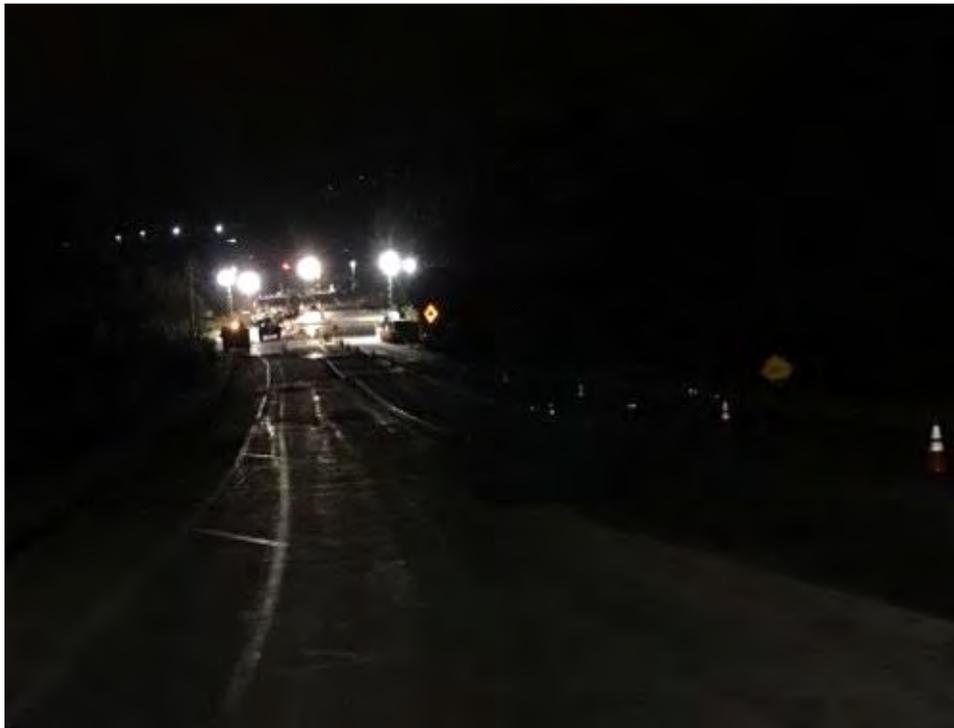
Caption Work site on Carroll Road at eastern end.

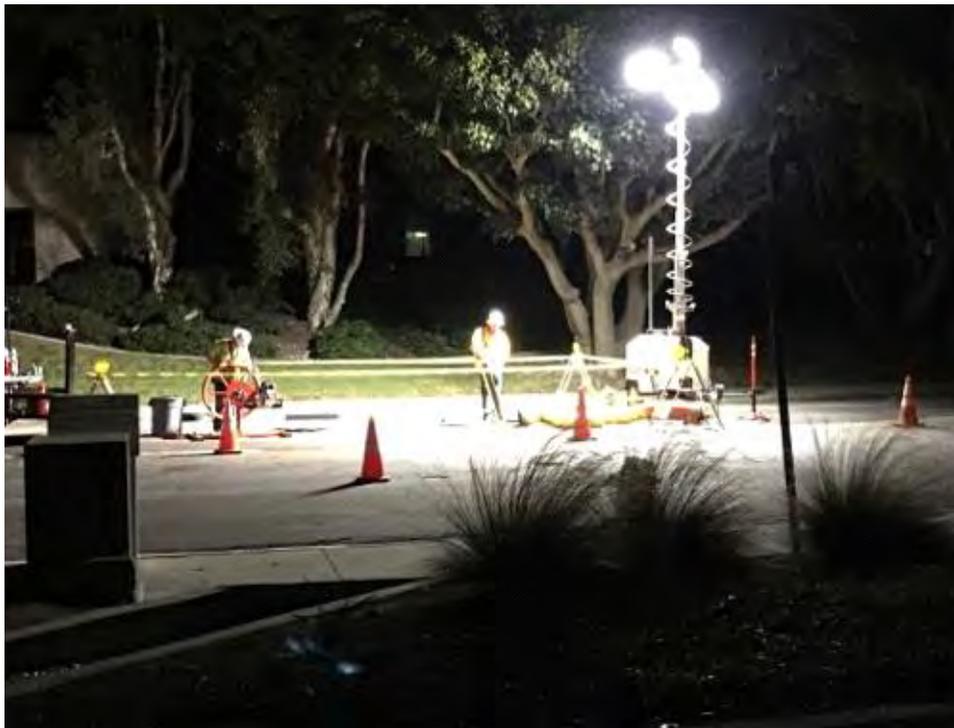
Caption Vault work on Miralani Drive.

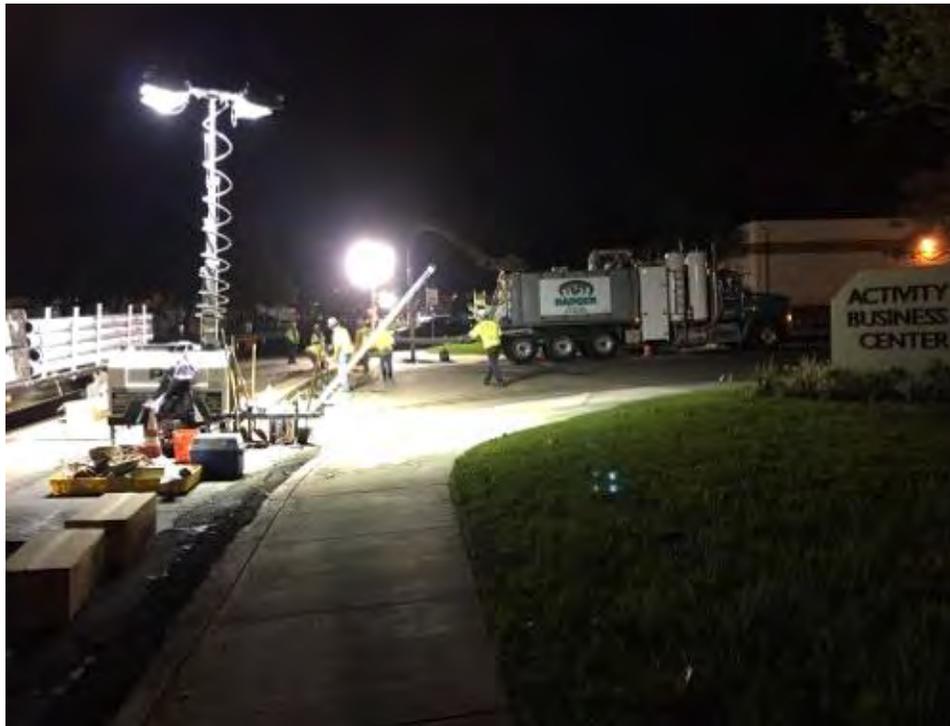
Caption Conduit install on Activity Road at Padgett Street.

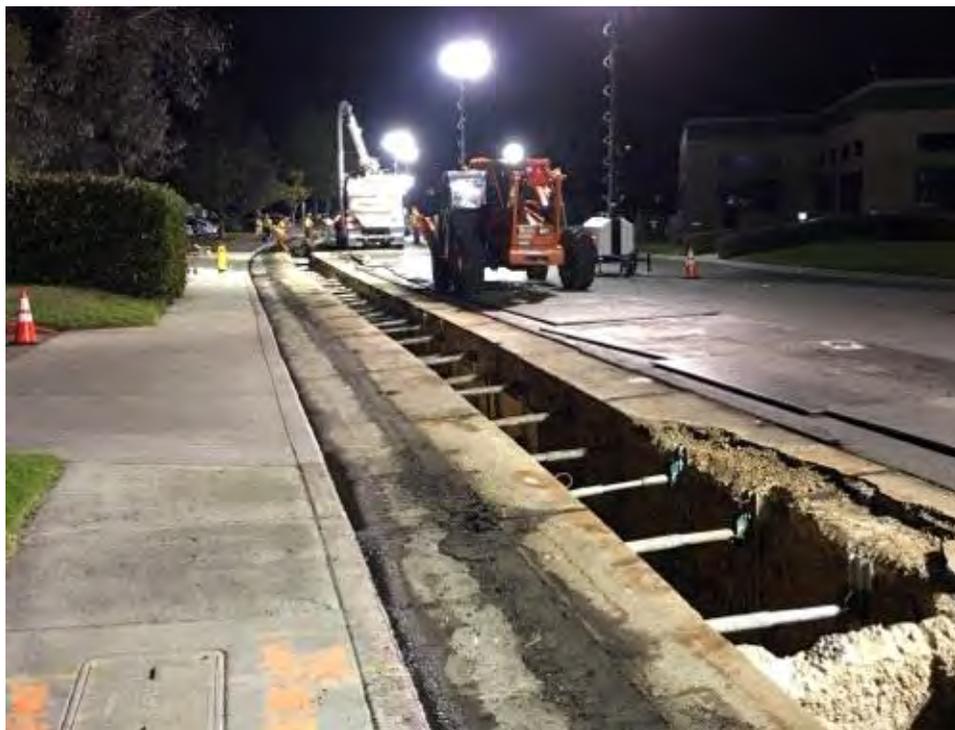
Caption Work site on Activity Road.

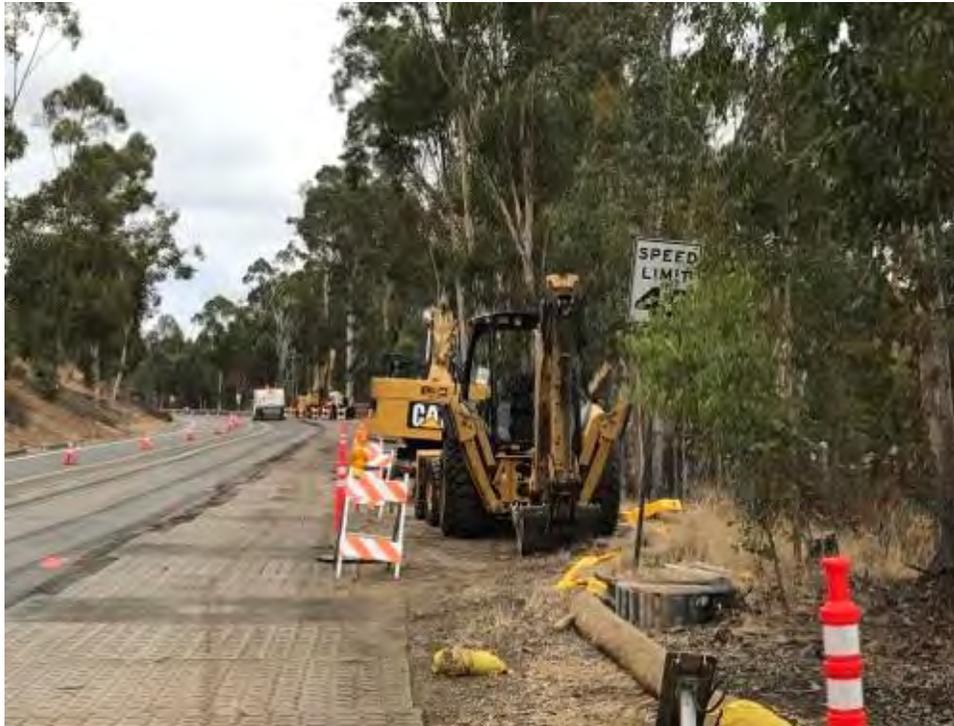
Caption Equipment stored along Pomerado Road by 2:15 pm.

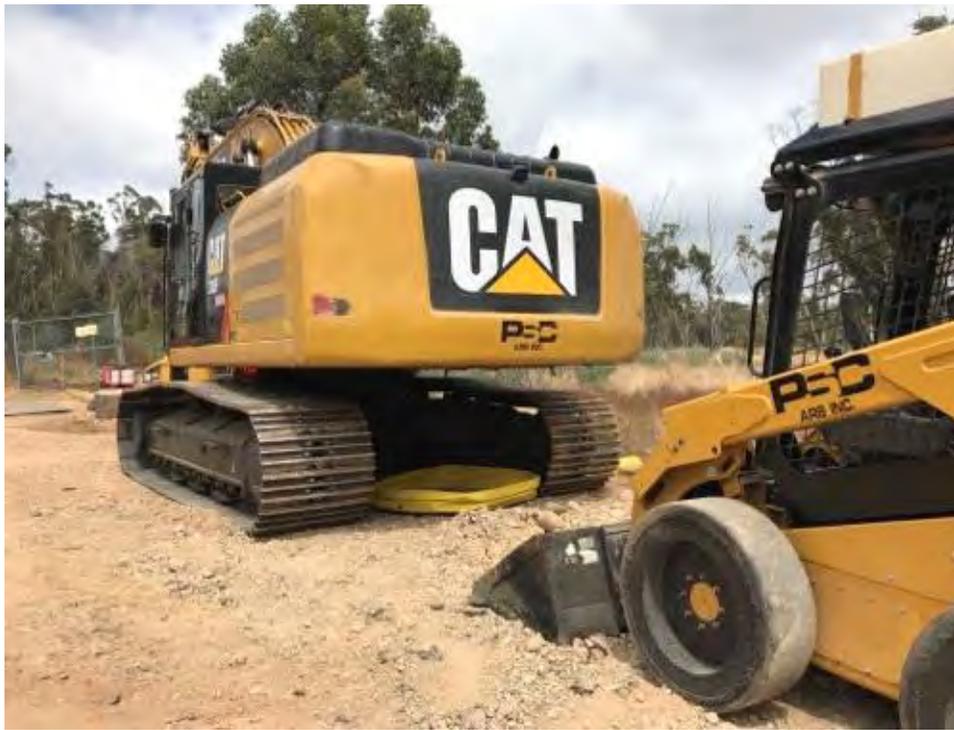
Caption Drip pans in place in temporary staging yard on Pomerado Road.

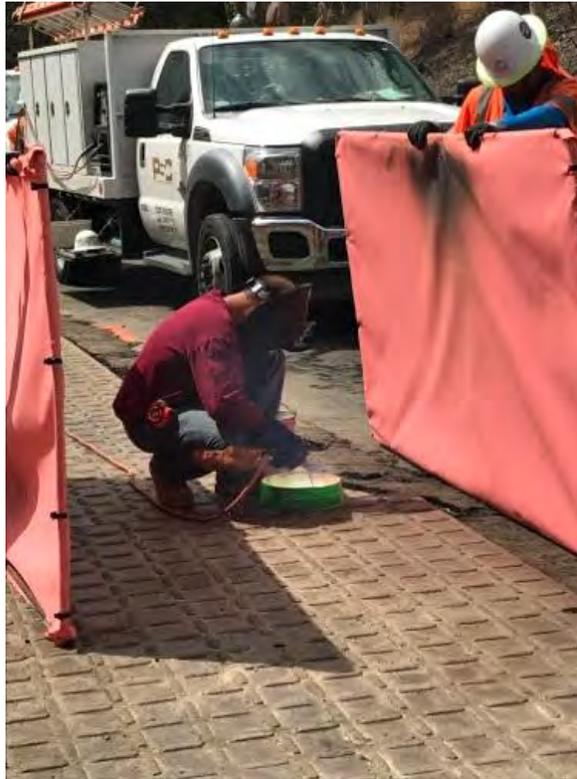
15. On September 14, 2017, at approximately 10:00 a.m., a small grassy area off of Pomerado Road near Station 490+00 (east of Scripps Ranch Boulevard) caught on fire from a spark

from grinding activities on trench plates. The area was extinguished immediately, and all protocols in accordance with the Project's Construction Fire Prevention Plan were implemented. The Miramar Fire Department was notified and was dispatched to inspect the area.

Caption Trench plate welding with fire blankets mounted on metal frames as a response to yesterday's fire.

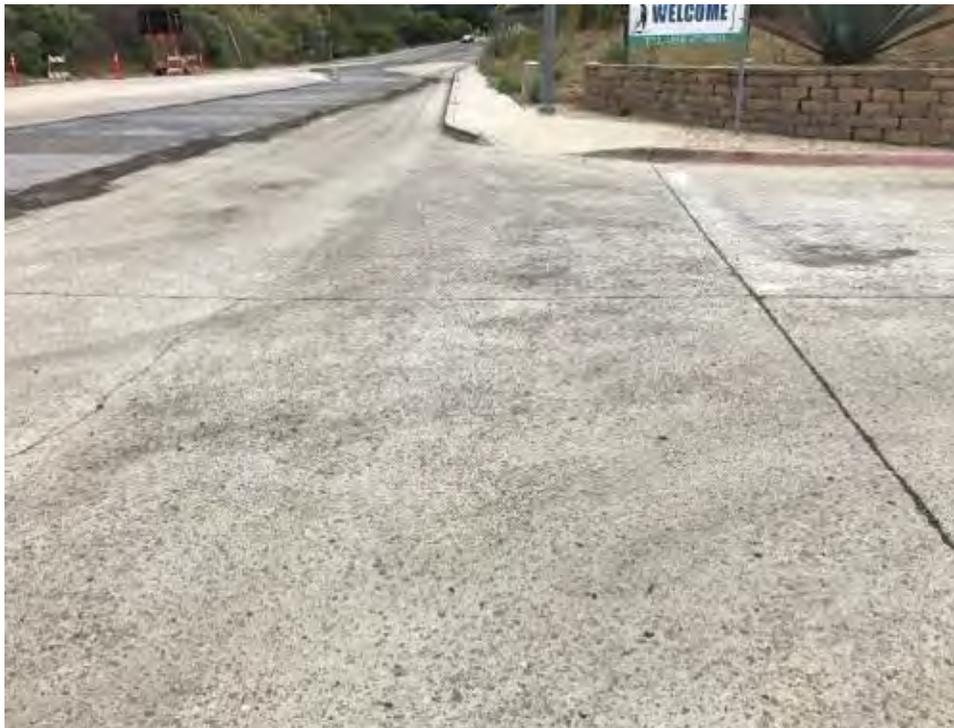
Caption Debris on Carroll Canyon Road from cold patch at entrance to Sorrento Canyon Golf Center.

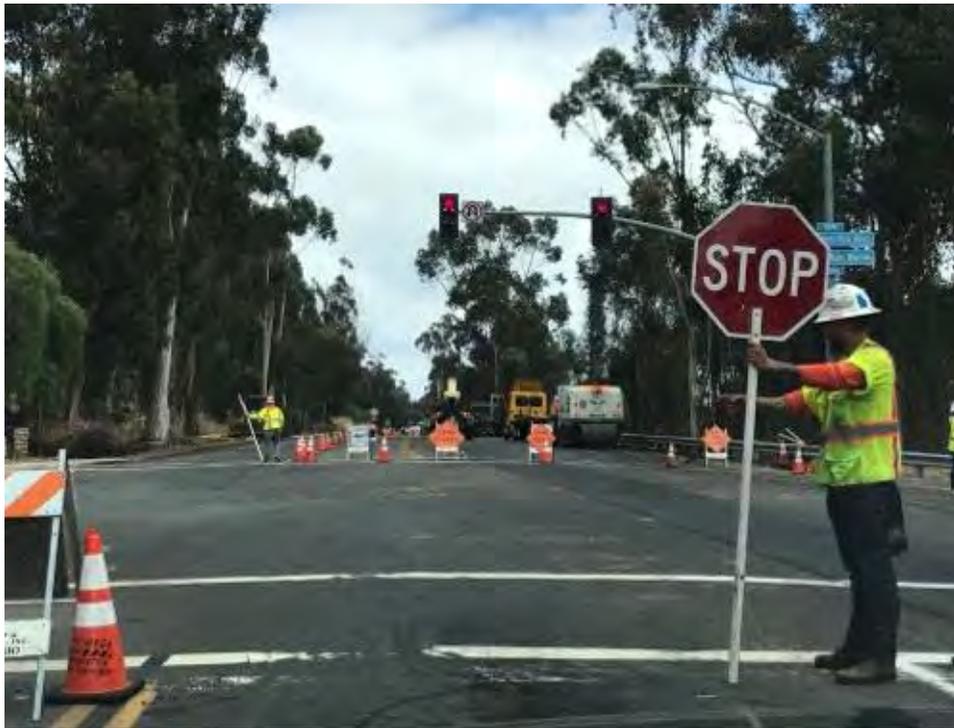
Caption Traffic control and street sweeper at corner of Pomerado Road and Scripps Ranch Blvd.

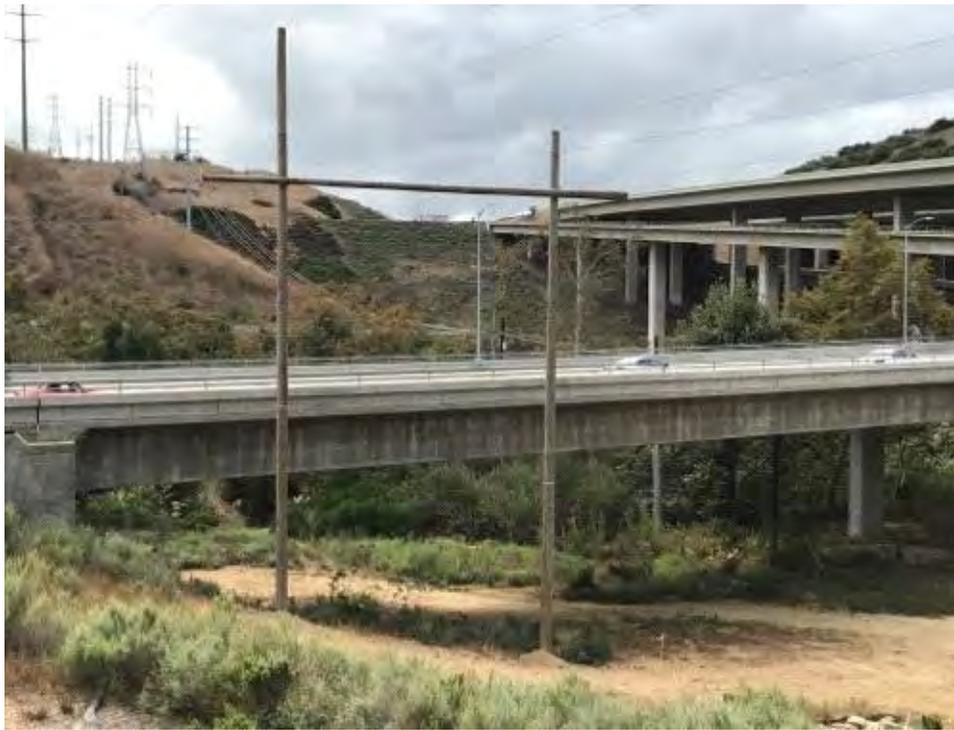
Carroll Canyon Road direct-bury guard structure.
