PROJECT MEMORANDUM  
SYCAMORE-PEÑASQUITOS 230-KV TRANSMISSION LINE PROJECT

Date: September 22, 2017  
To: Billie Blanchard, CPUC Project Manager  
From: Sheila Hoyer, CPUC Monitoring Supervisor  
Subject: Weekly Report #37 – September 10 to September 16, 2017

## SDG&E Sycamore-Peñasquitos 230-kV Transmission Line Project: Daily Inspection Report

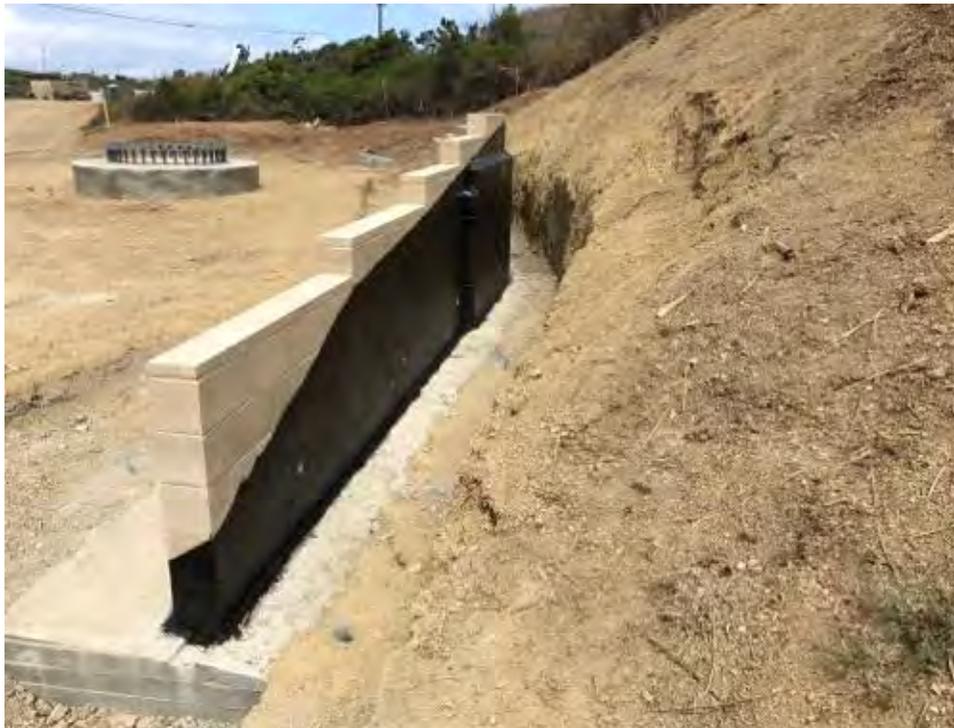
Waterproofing on retaining wall at CC MM CP.

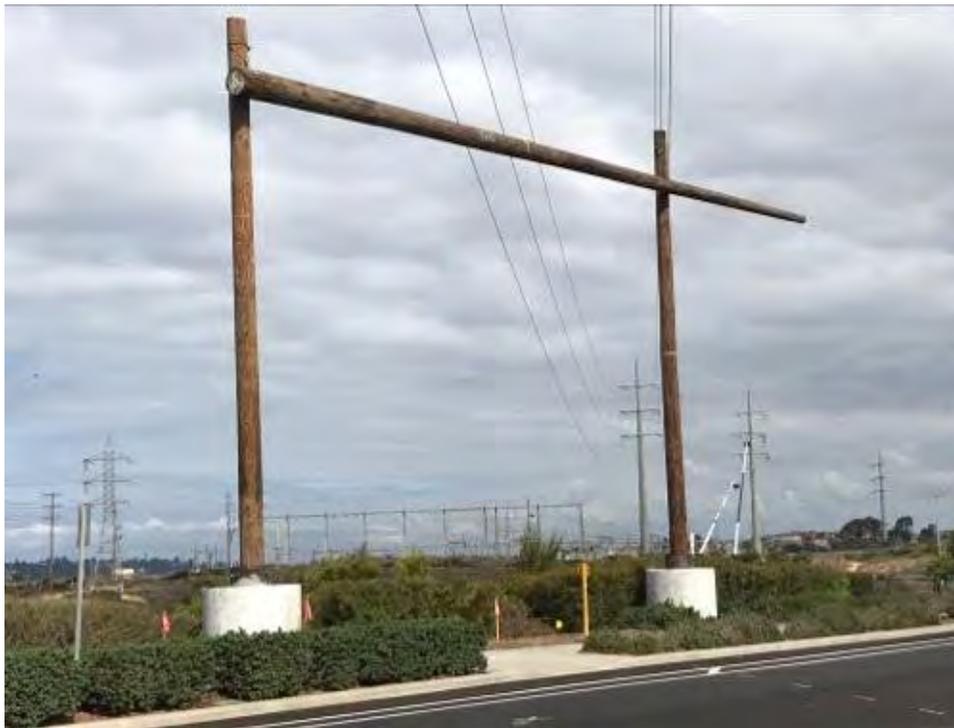
Caption Flower pot guard structure on Ocean Air Drive. Penasquitos substation in background.

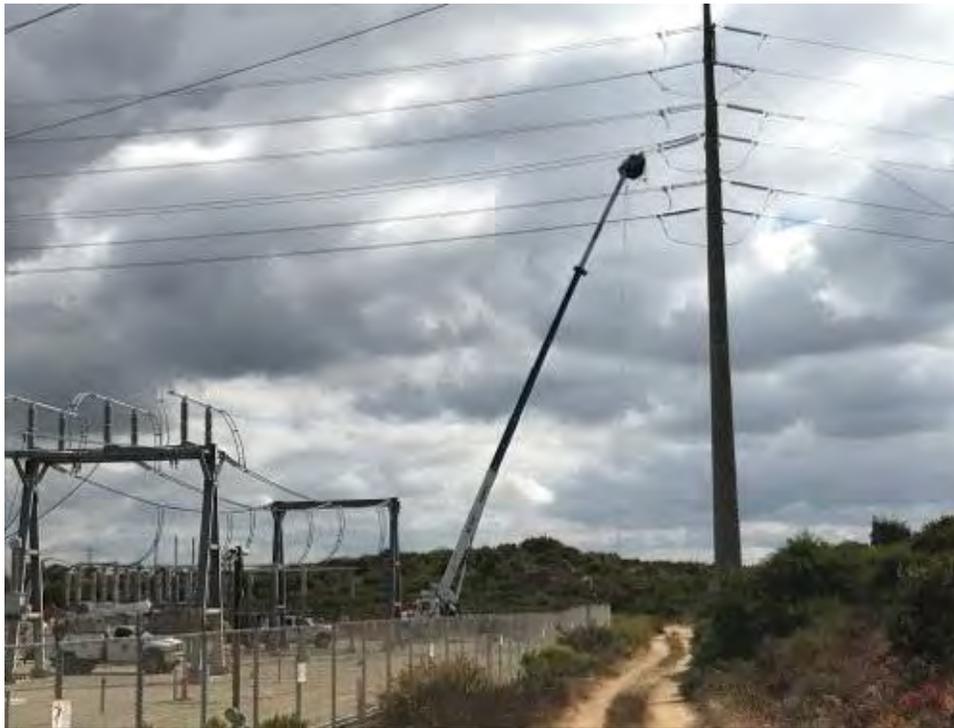
Caption Pulling wire to connect to Penasquitos substation.
