PROJECT MEMORANDUM SYCAMORE-PEÑASQUITOS 230-KV TRANSMISSION LINE PROJECT

Date: October 2, 2017
To: Billie Blanchard, CPUC Project Manager
From: Sheila Hoyer, CPUC Monitoring Supervisor
Subject: Weekly Report #38 – September 18 to September 23, 2017

SDG&E Sycamore-Peñasquitos 230-kV Transmission Line Project: Daily Inspection Report

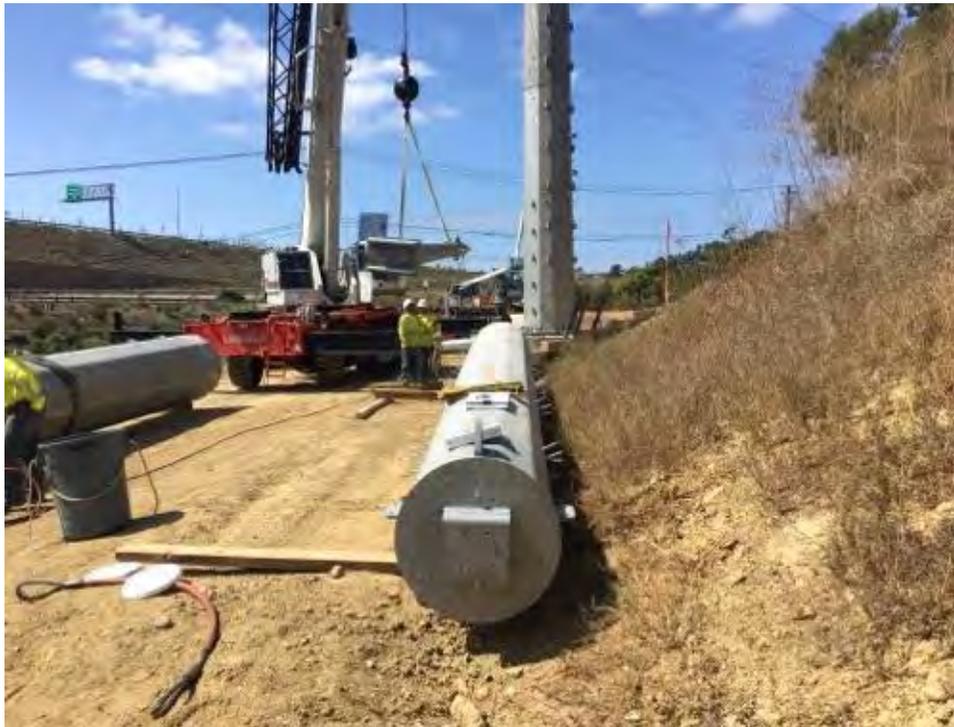
Caption CC MM CP pole installation.

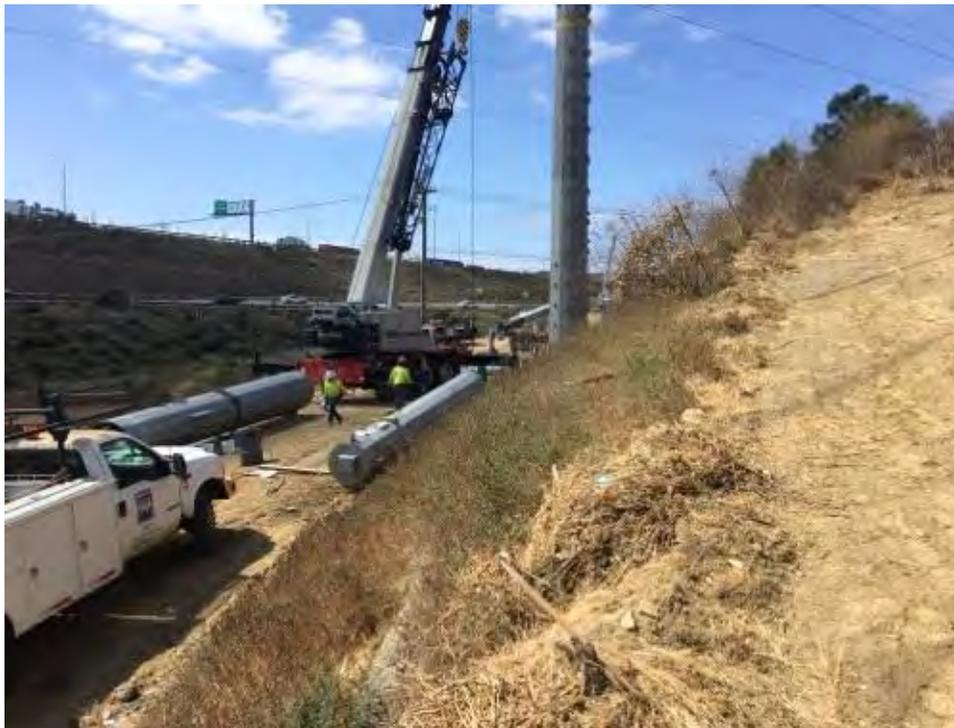
Caption Pole installation at CC MM CP.

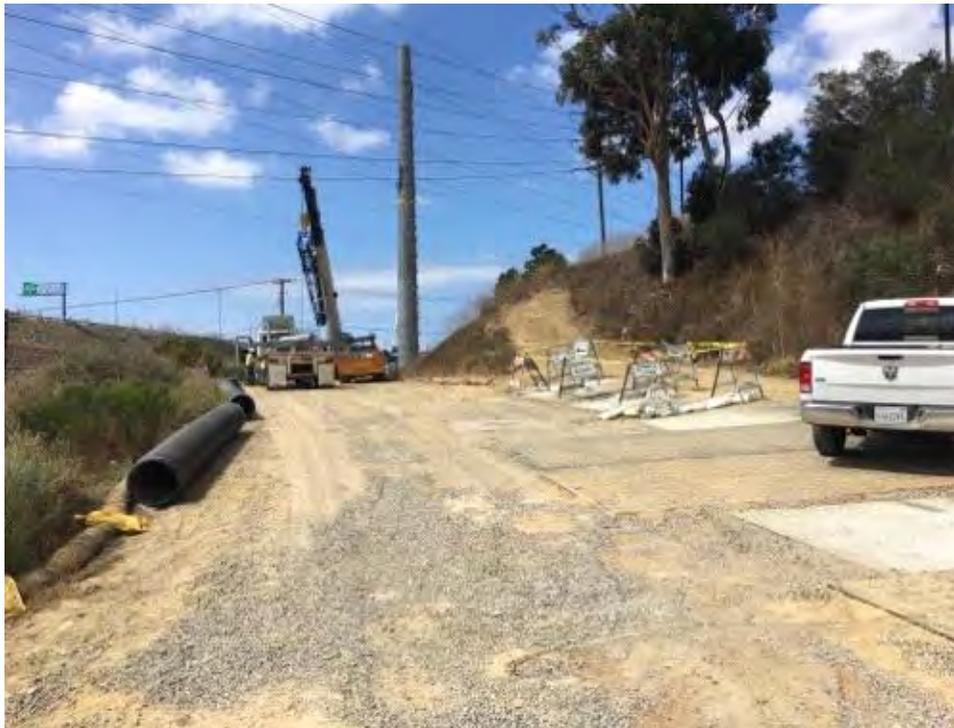
Caption CC MM CP overhead work.

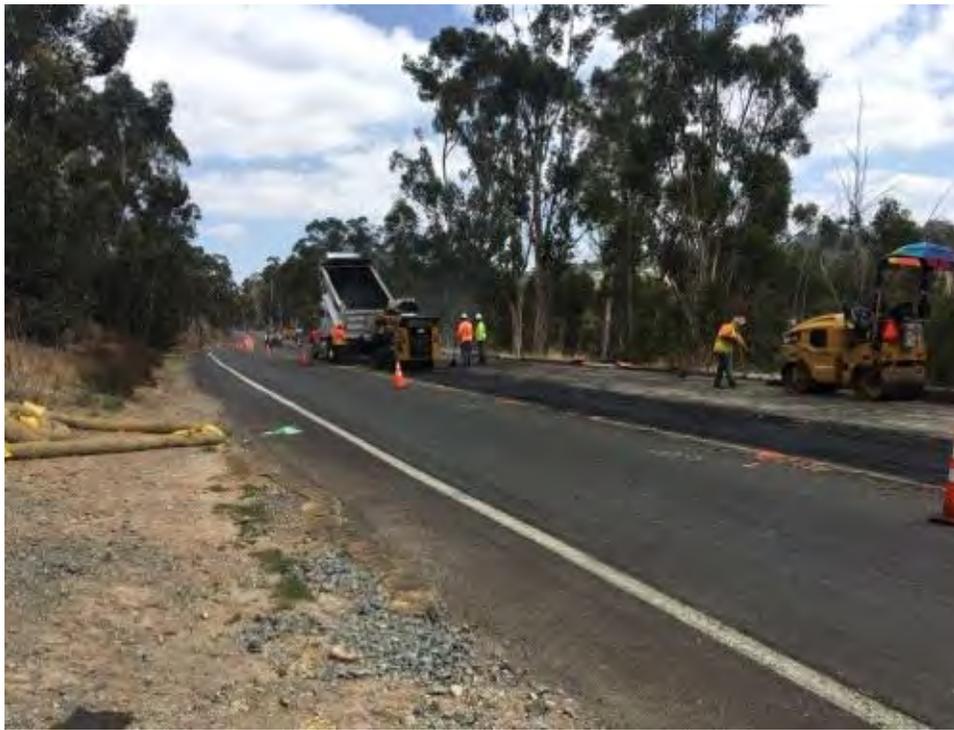
Caption Paving on Pomerado Road between Chabad Center and Scripps Ranch Blvd.

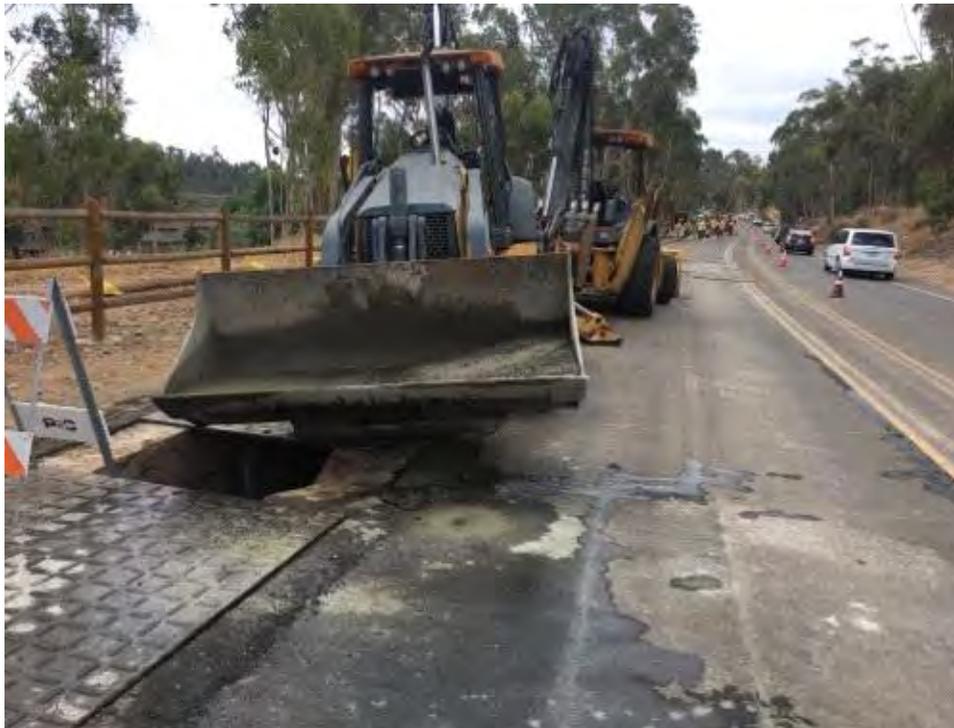
Caption Cement washout on Pomerado Road.

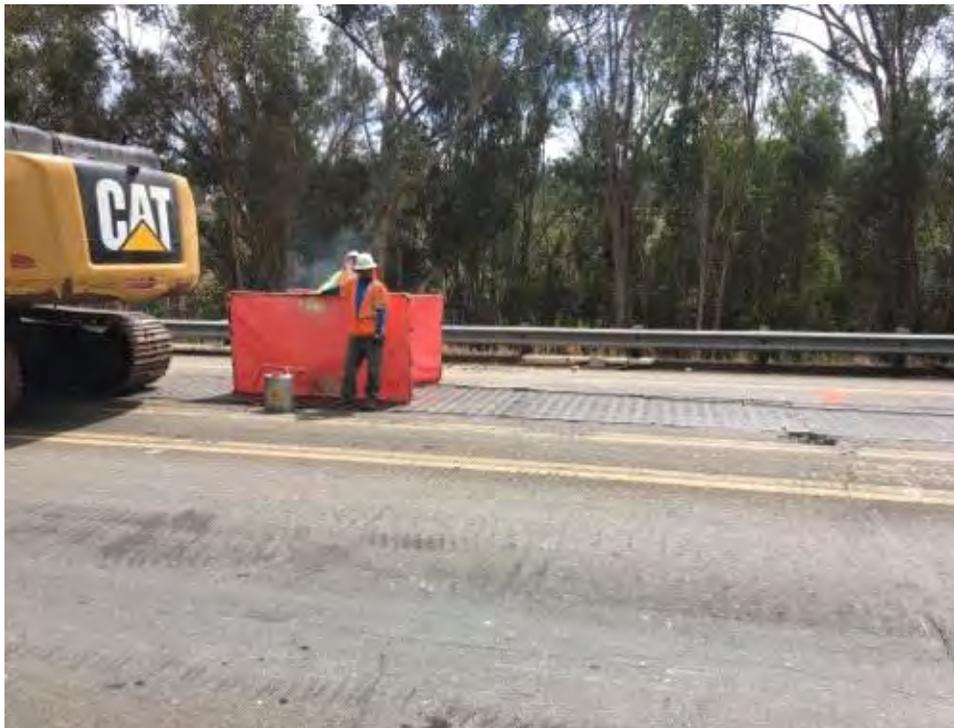
Caption Fire safety measures implemented during plate welding on Pomerado Road.

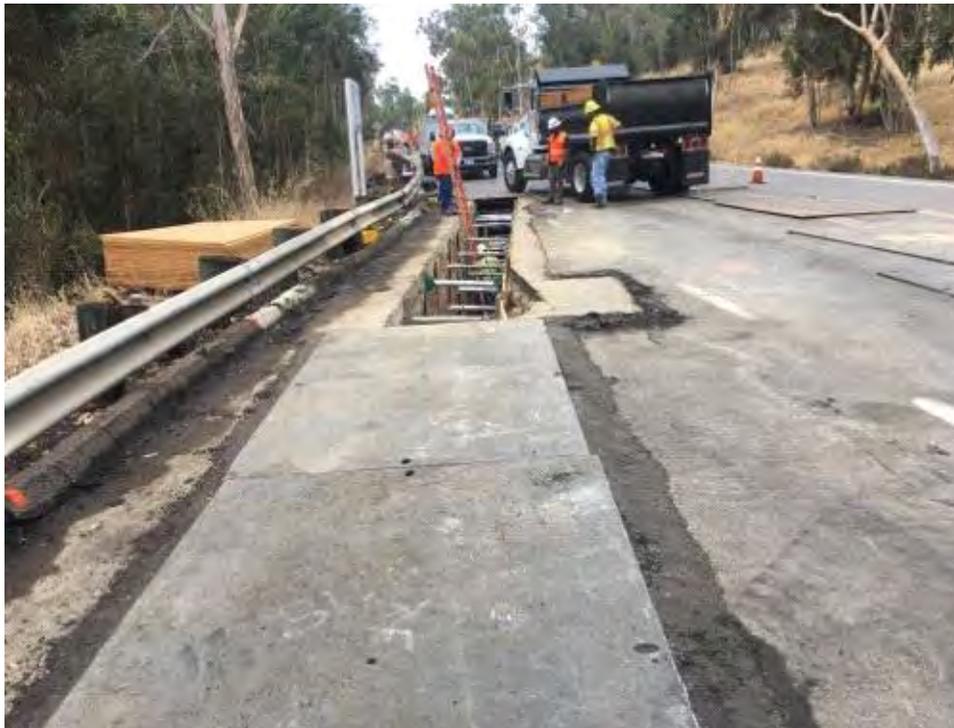
Caption Trench work east of Chabad Center on Pomerado Road.

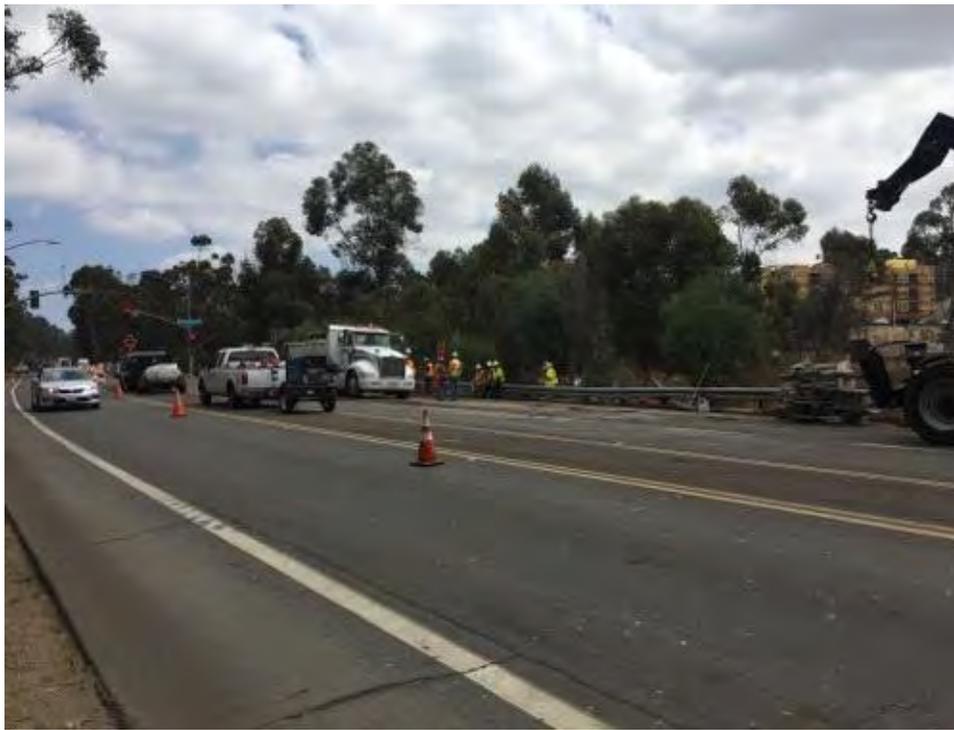
Caption Excavation/trench work with monitors present on Pomerado Road.

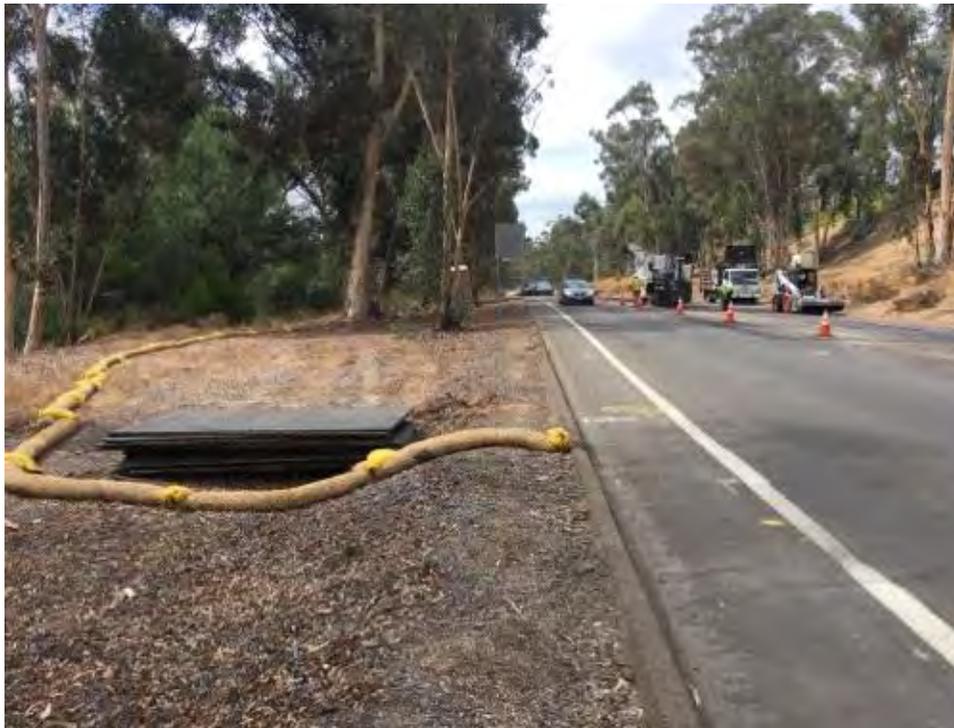
Caption MPR #6 work limits and pavement removal on Pomerado Road.

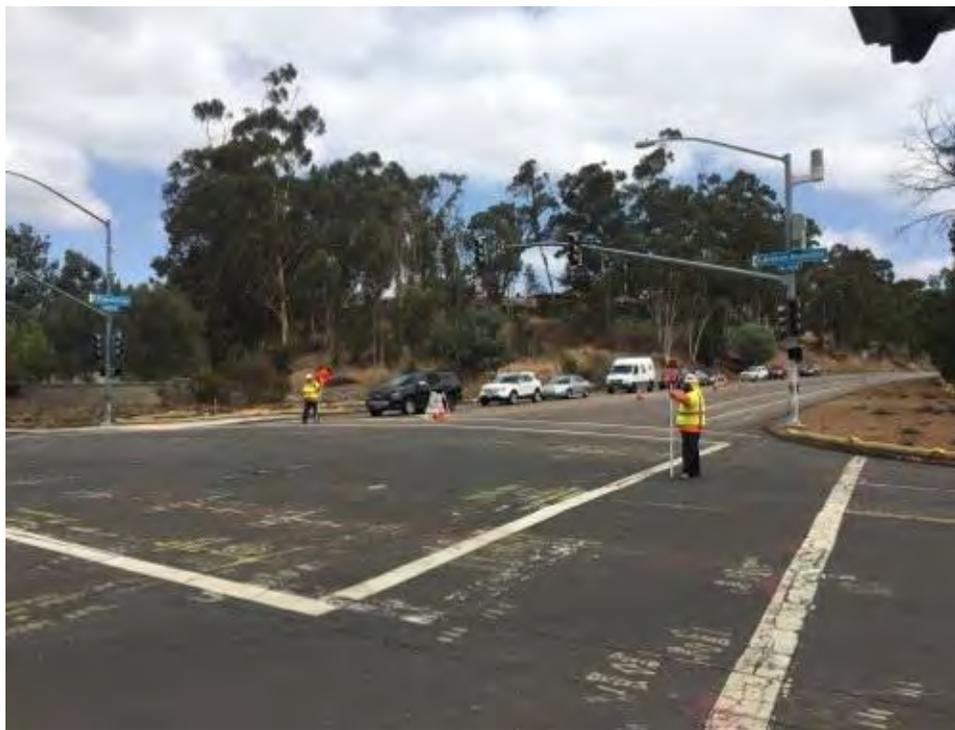
Caption Traffic control on Pomerado Road at Avenida Magnifica.

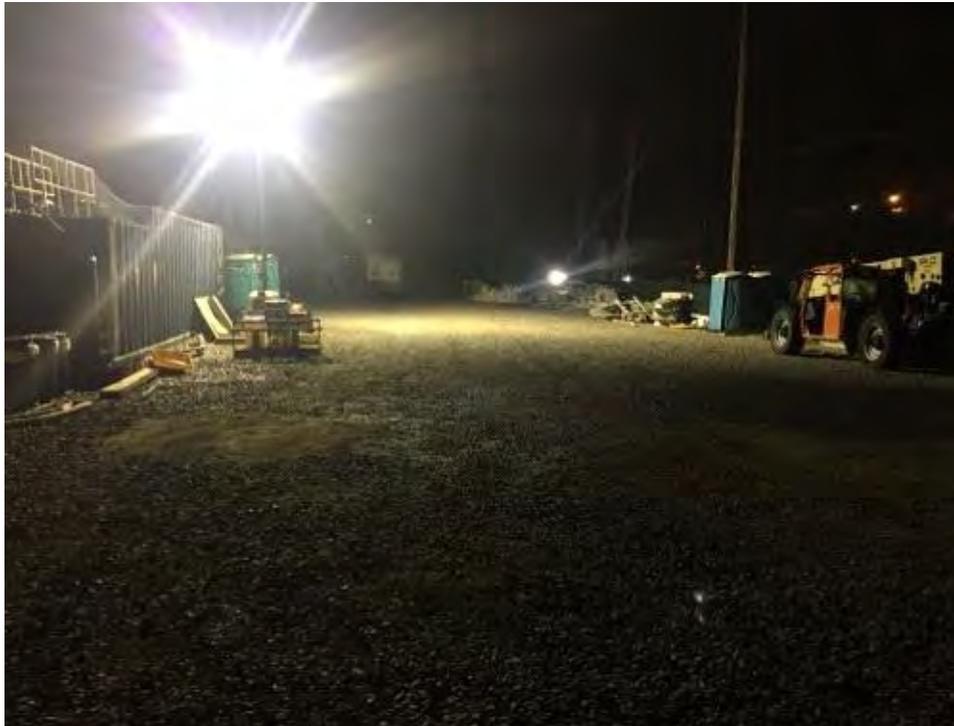
Caption Driving Range Yard. Inspection of yard was clean.

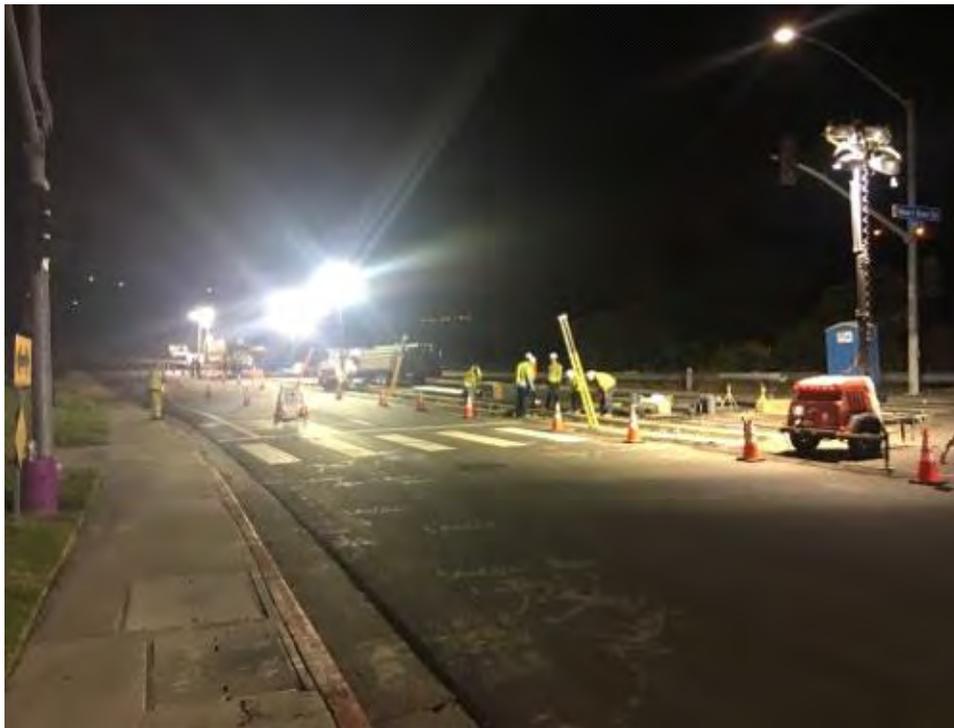
Caption Trench work on Carroll Canyon Road/Nancy Ridge Drive intersection.

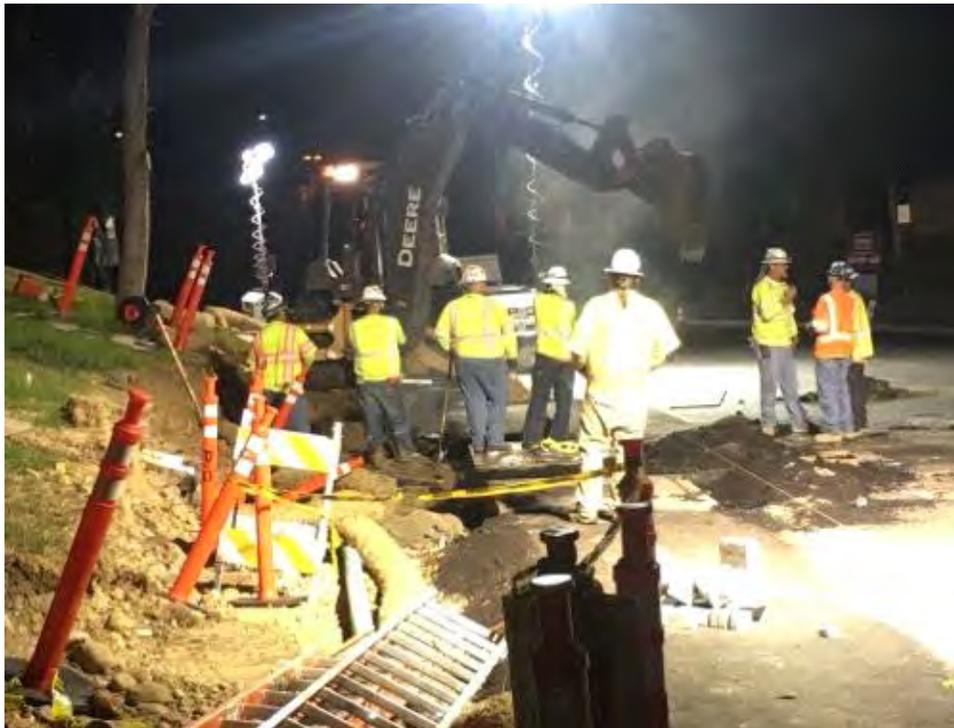
Caption Excavation on Activity Road near Camino Ruiz. Note LEI in foreground.

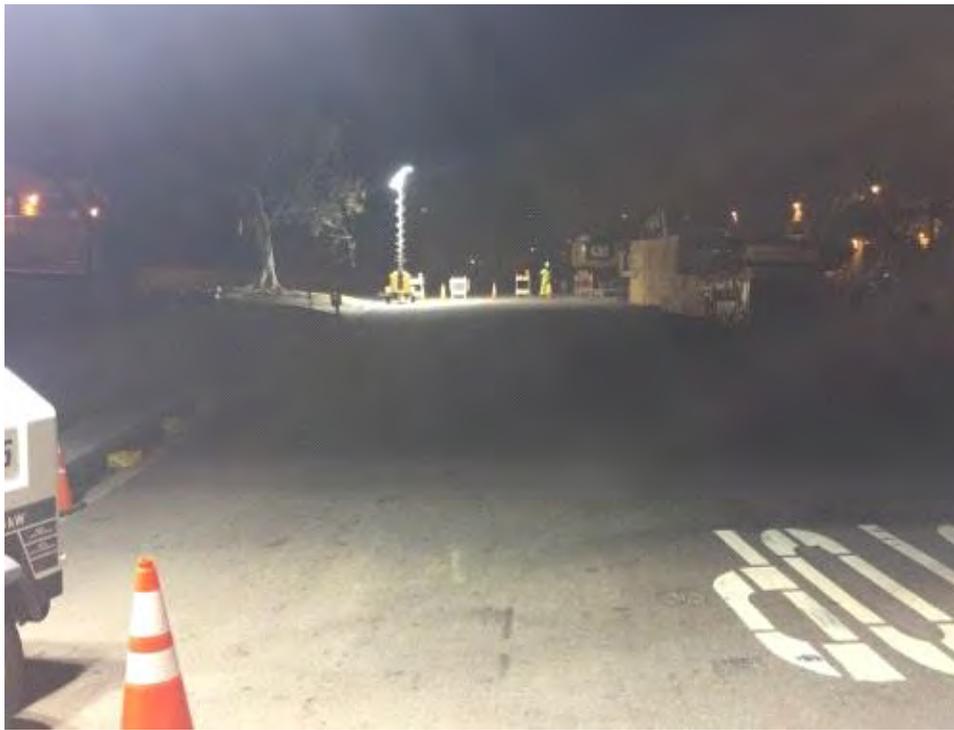
Caption Traffic road block on Padget Street near work activity.

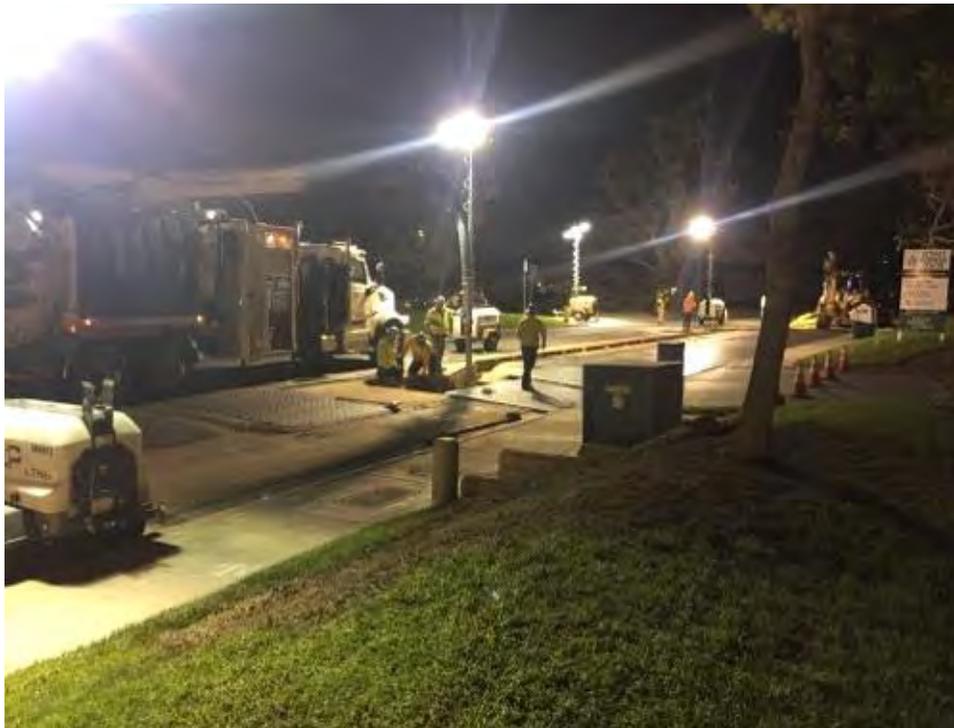
Caption Potholing on Activity Road.

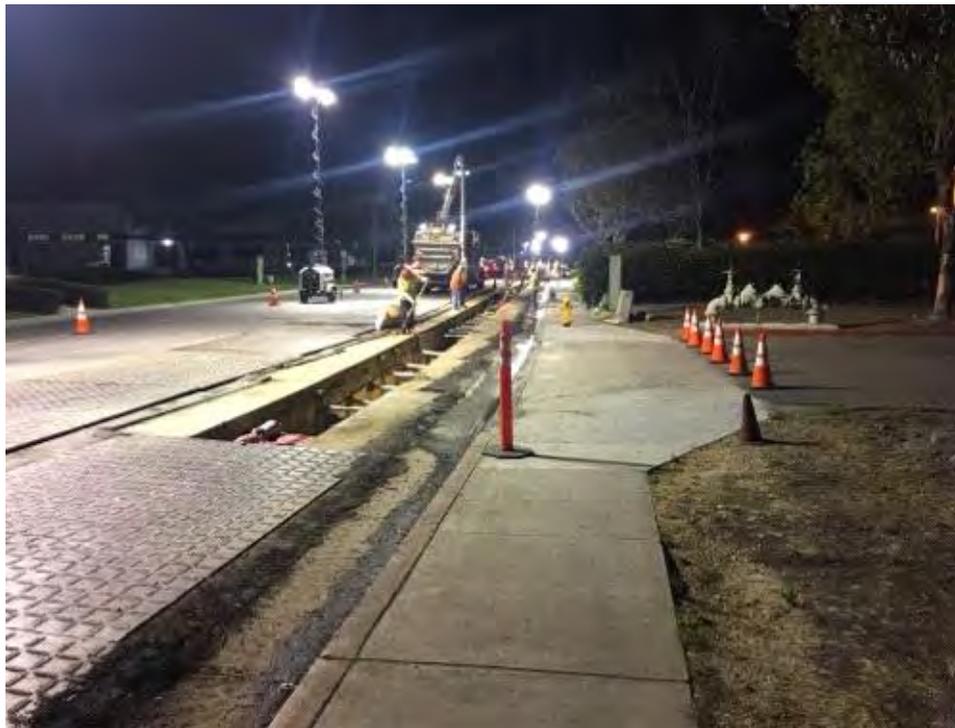
Caption Trench work on Activity Road.

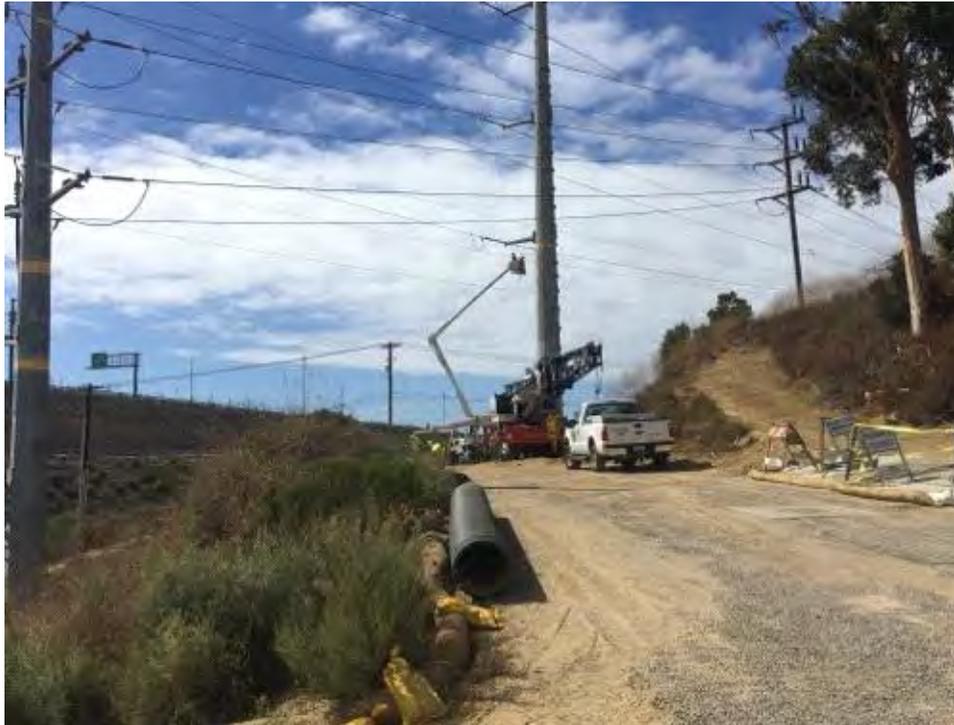
Caption CC MM CP work site. Note arms are now installed and wire is in place.

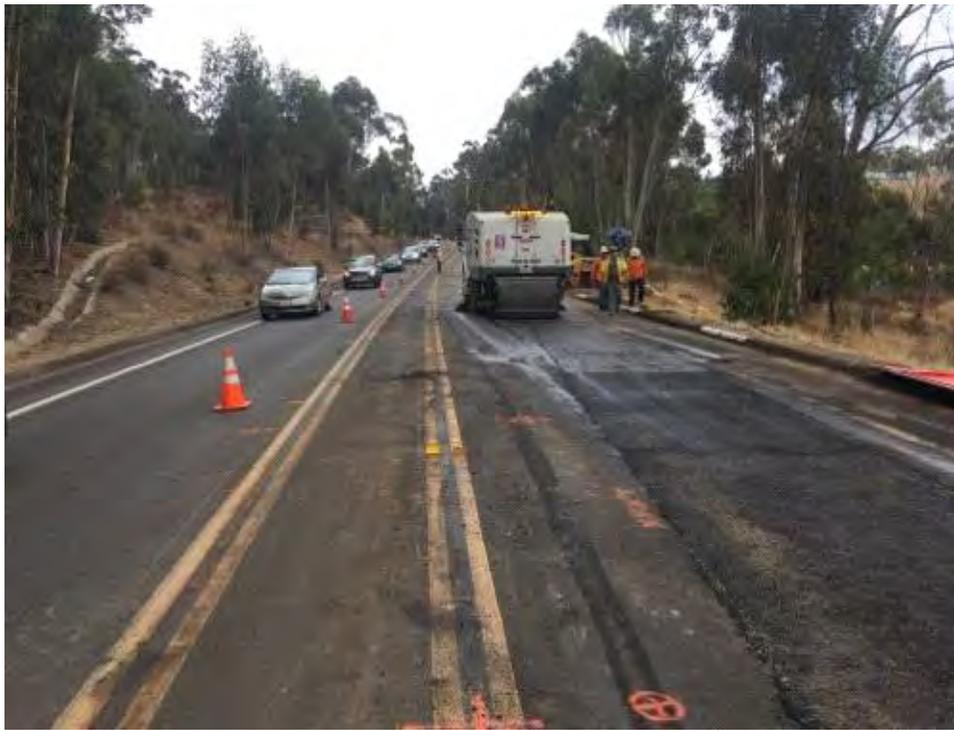
Caption Post work cleanup on Pomerado Road.

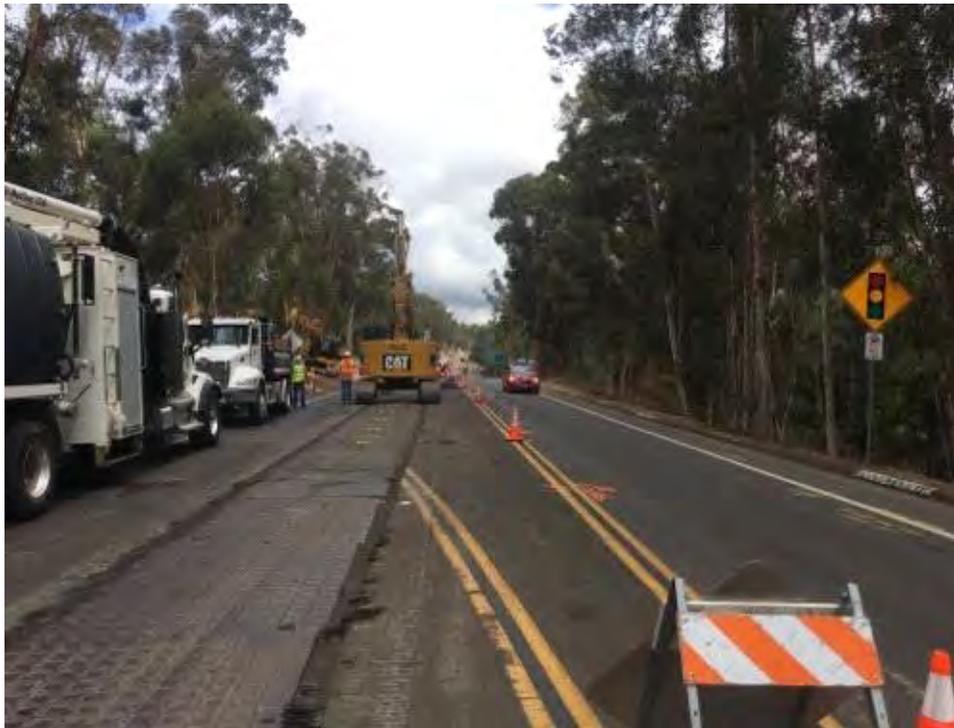
Caption Work site east of Chabad Center and west of Avenida Magnifica.

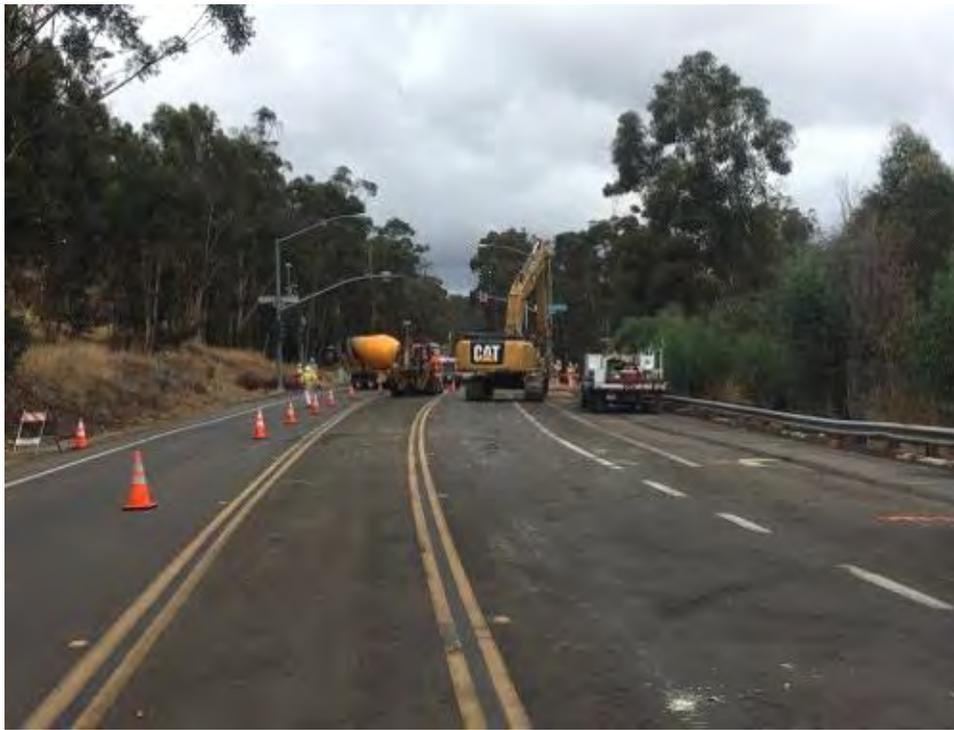
Caption Chabad Center and Pomerado Road.

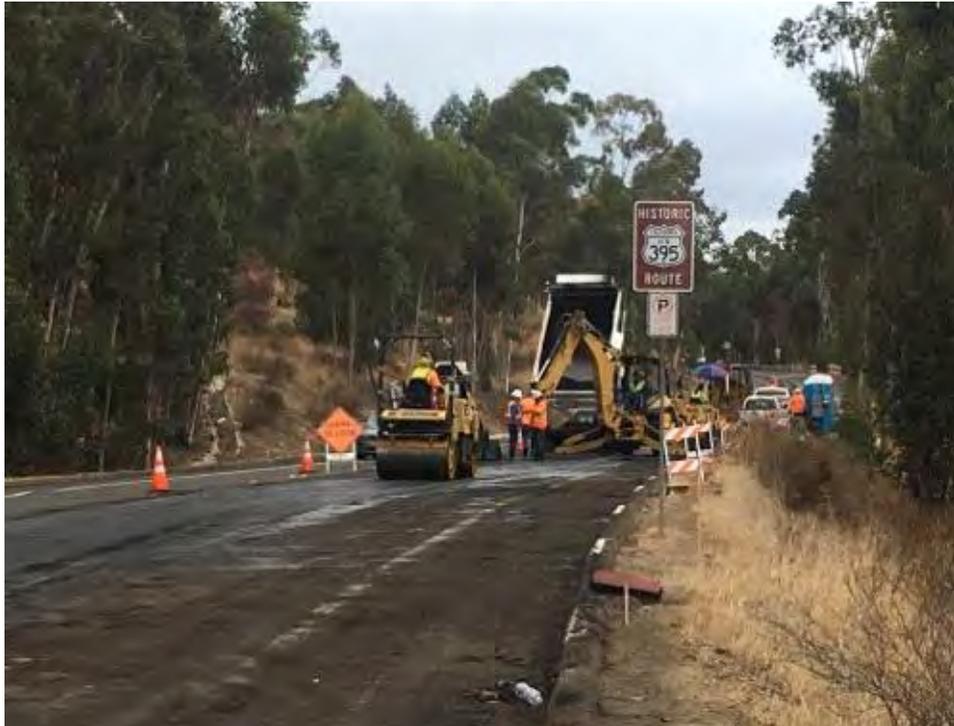
Caption Pomerado Road - western edge of active construction.

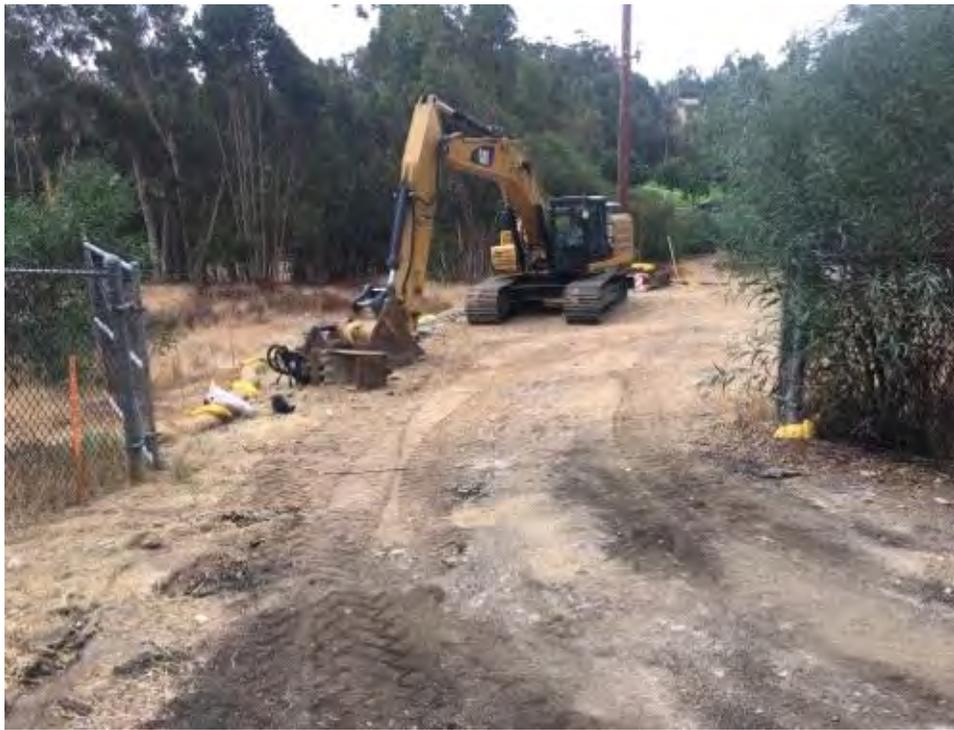
Caption Equipment storage area south of Pomerado Road.

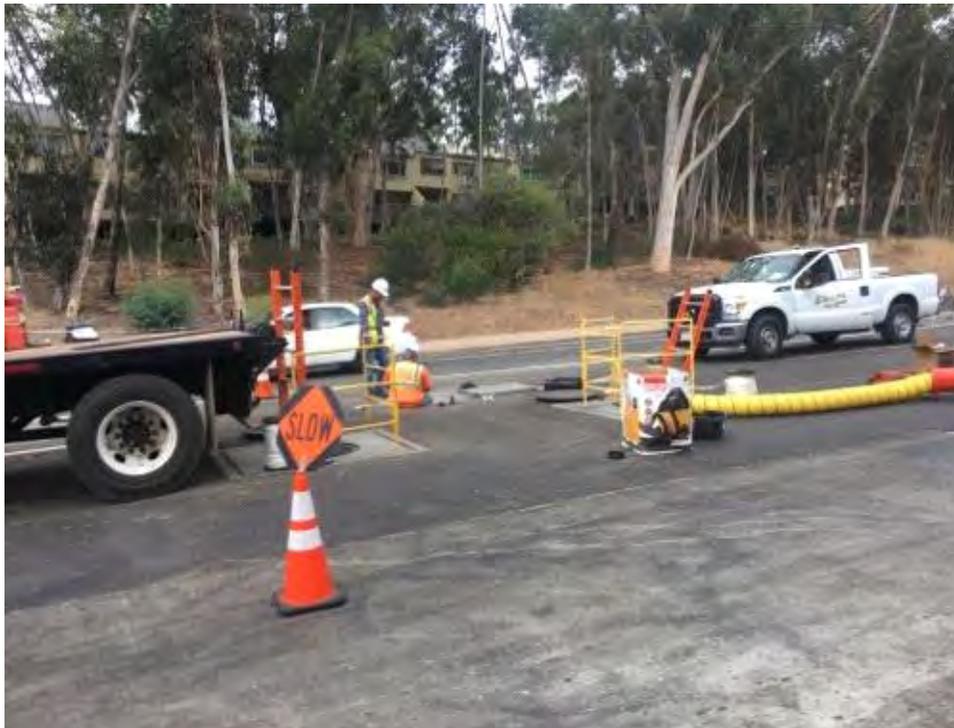
Caption Vault between Avenue of Nations and Scripps Ranch Blvd.

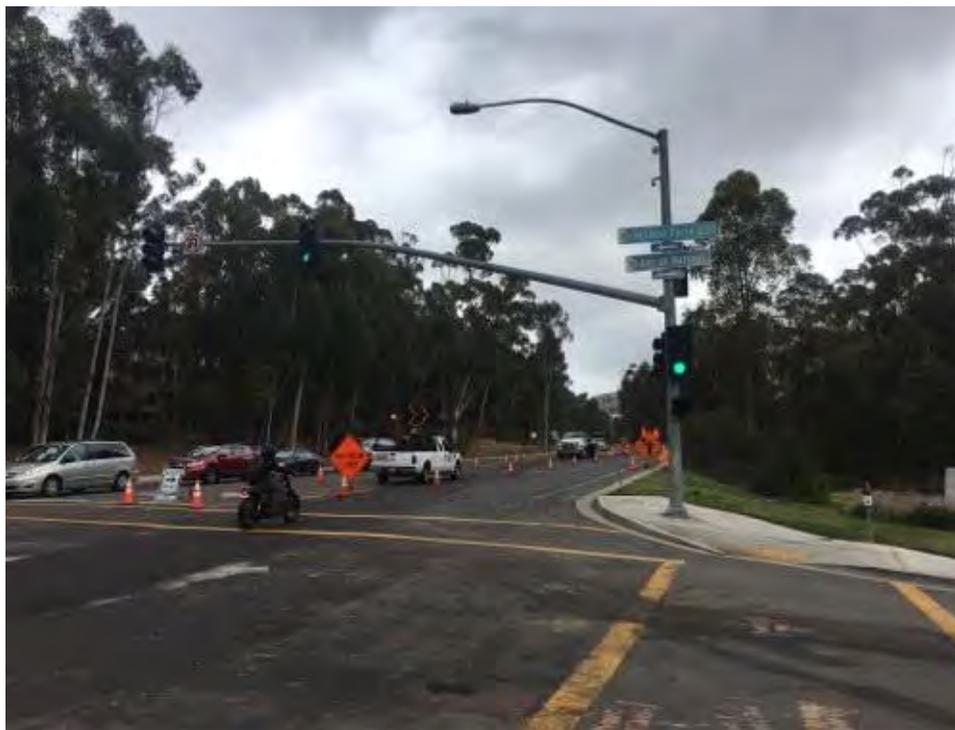
Caption Start of traffic control on Pomerado Road.

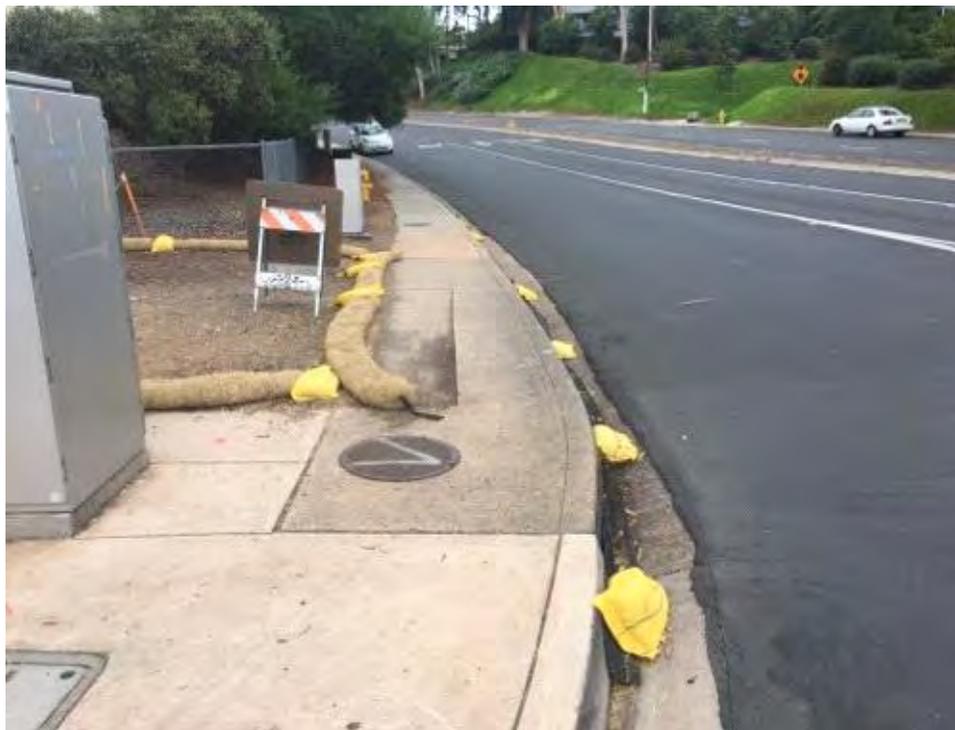
Caption BMPs on Pomerado Road at Willow Creek Road.

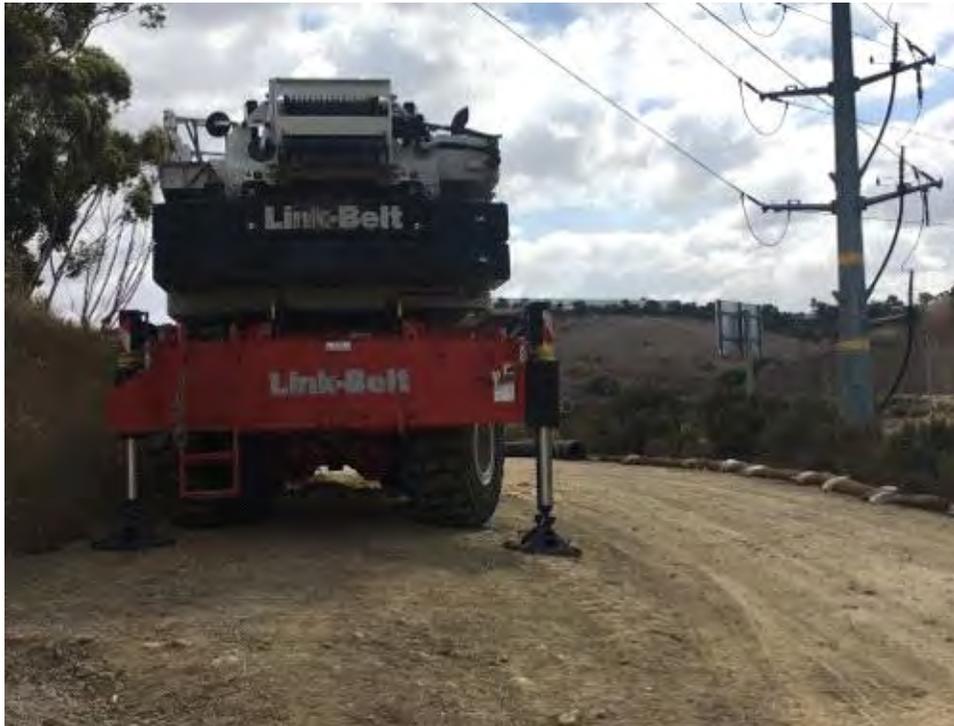
Caption Crane parked without drip pan.

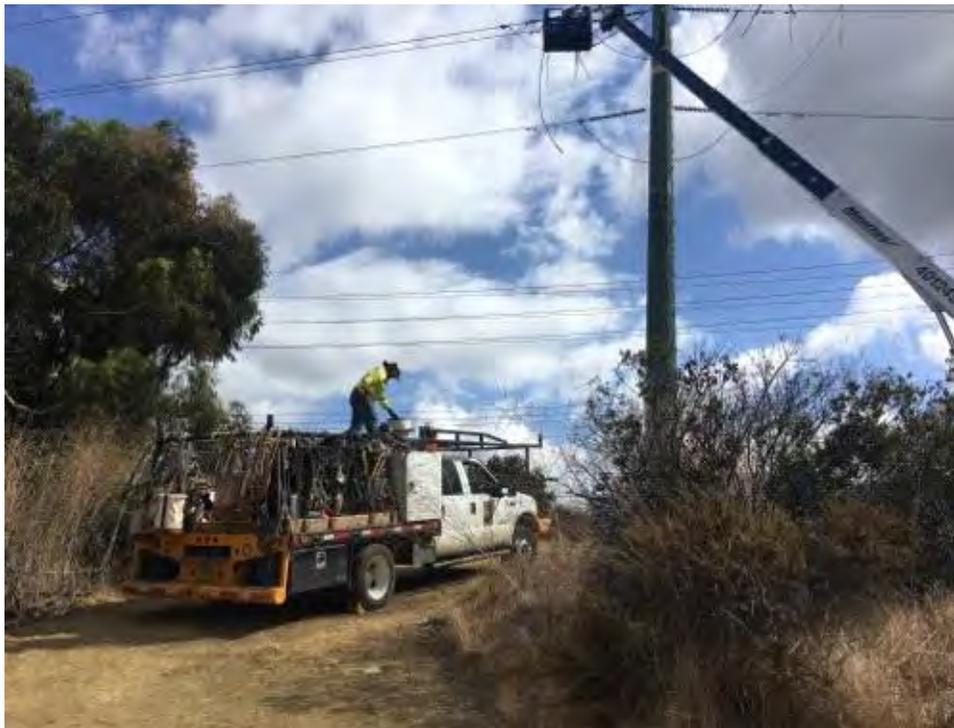
Caption CC MM CP wire site.

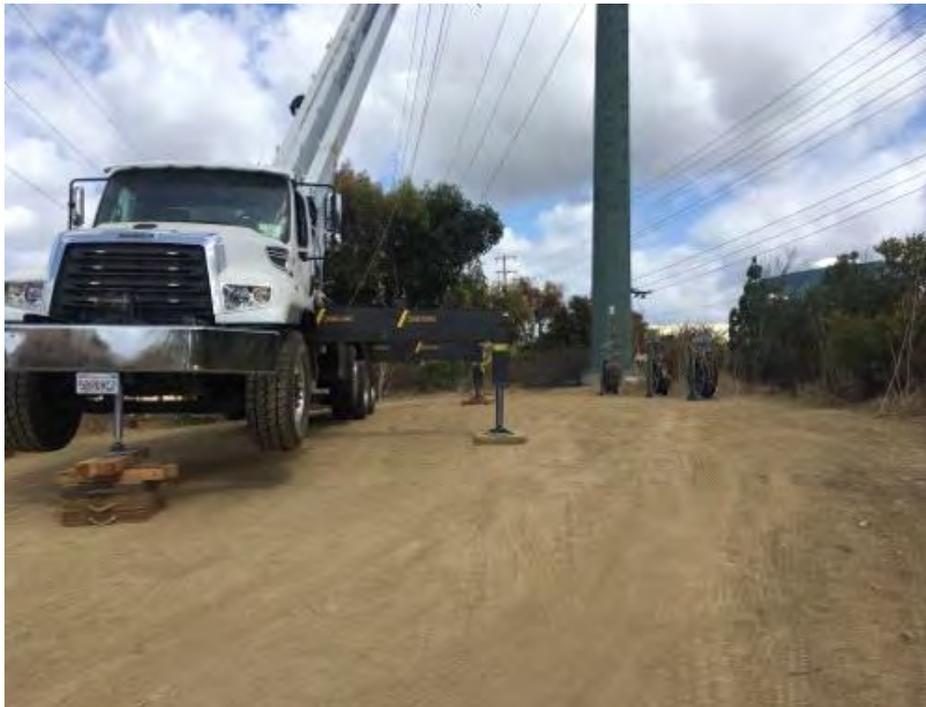
Caption CC MM CP wire site,

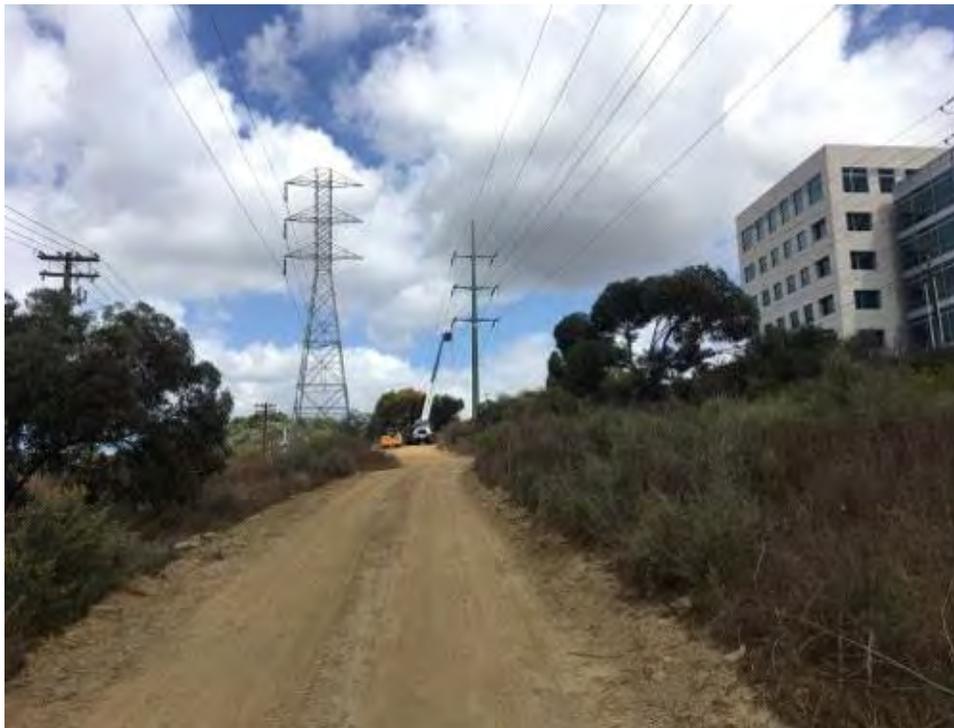
Caption Wire work north of CC MM CP pole site.

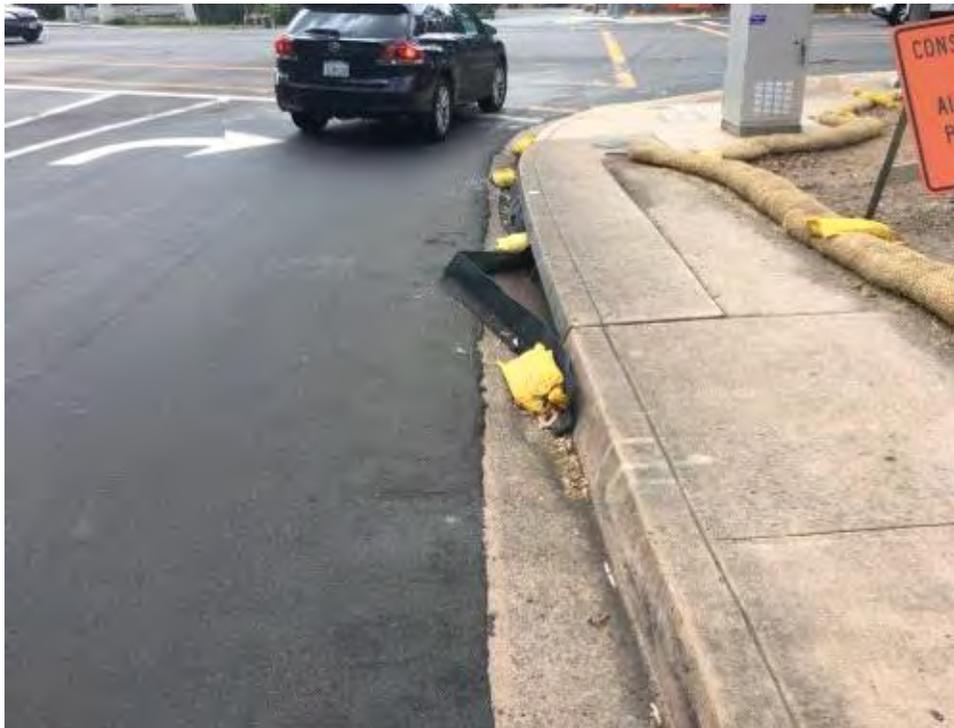
Caption BMP maintenance needed near intersection of Pomerado Road and Willow Creek Road.

Q7 – Stormwater, Erosion, and Sediment Control: (a) Were erosion and sediment control BMPs in place and functioning properly? (b) Were inactive or completed work areas stabilized and/or restored adequately?	Corrections Required.
Q8 – Invasive Weed Control: Were procedures to prevent the spread of invasive weeds implemented adequately?	Met Requirements
Q9 – Hazardous Materials and Waste Management: (a) Were hazardous materials stored and labeled properly? (b) Was hazardous material waste disposed of appropriately? (c) Were any spills or leaks addressed adequately? (d) Was solid waste collected and disposed of adequately?	Corrections Required
Q9 Notes	Crane at CC MM CP was staged without drip pan. Asked LEI to resolve issue.
Q10 – Fire Management: (a) Were fire prevention procedures in place? (b) Was firefighting equipment available on site?	Met Requirements
Q10 Notes	Fire tools observed throughout active work locations and on vehicles within ROW.

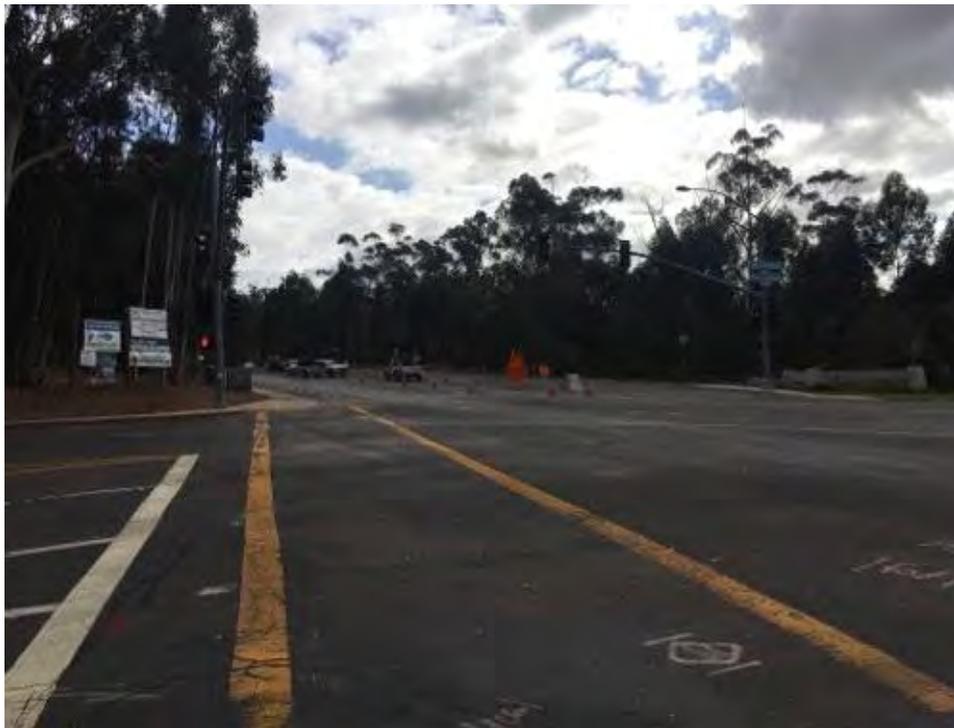
Caption Vault site on Pomerado Road.

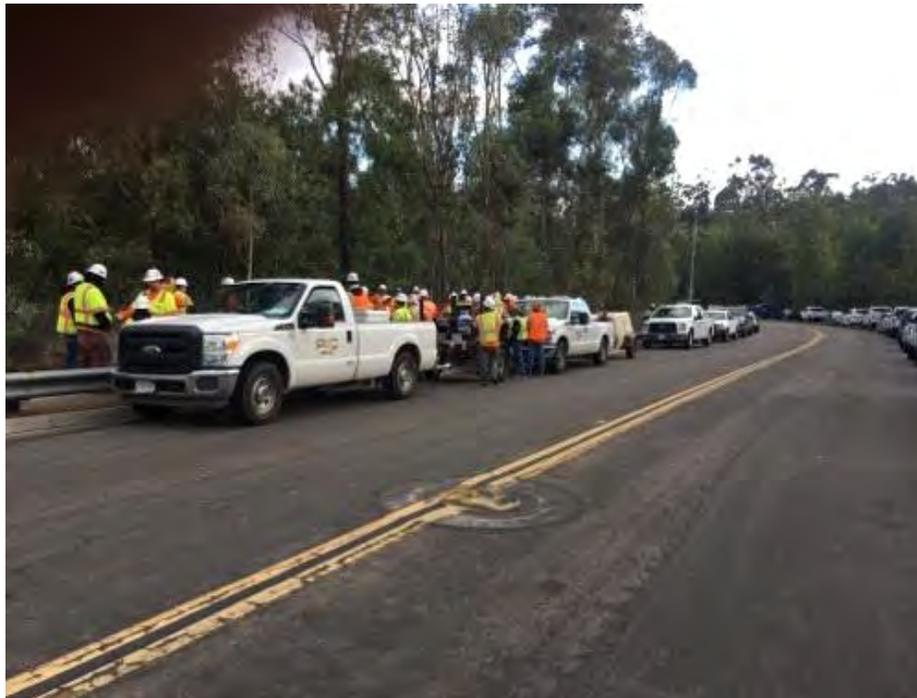
Caption Tailboard on Avenida Magnifica.
