PROJECT MEMORANDUM SYCAMORE-PEÑASQUITOS 230-KV TRANSMISSION LINE PROJECT

Date: October 6, 2017
To: Billie Blanchard, CPUC Project Manager
From: Sheila Hoyer, CPUC Monitoring Supervisor
Subject: Weekly Report #39 – September 25 to September 30, 2017

SDG&E Sycamore-Peñasquitos 230-kV Transmission Line Project: Daily Inspection Report

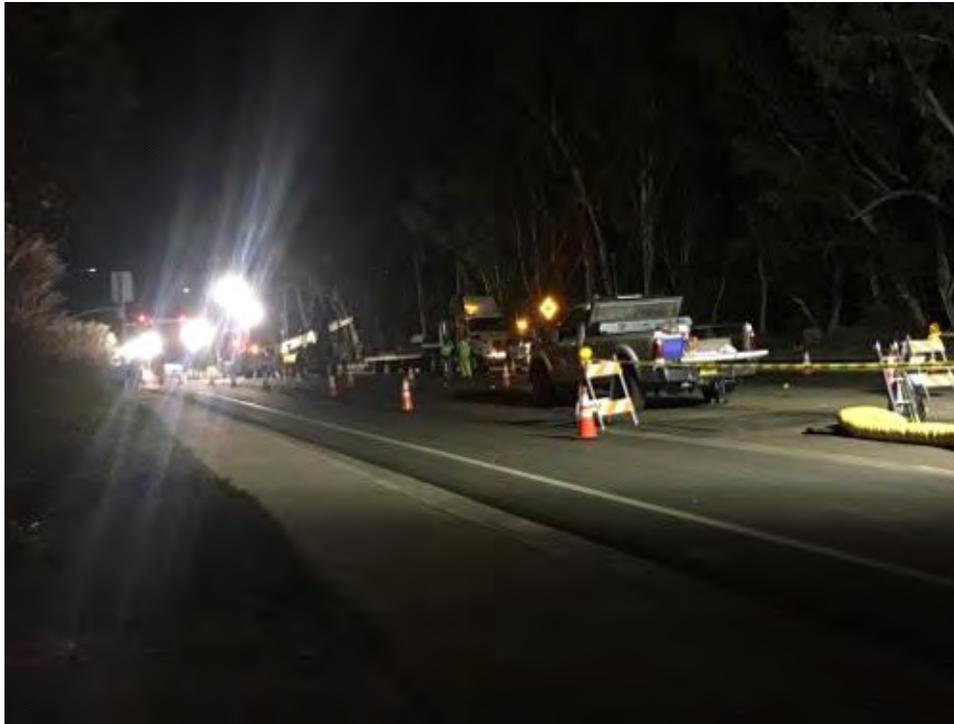
Caption Western edge of work on Carroll Canyon Road.

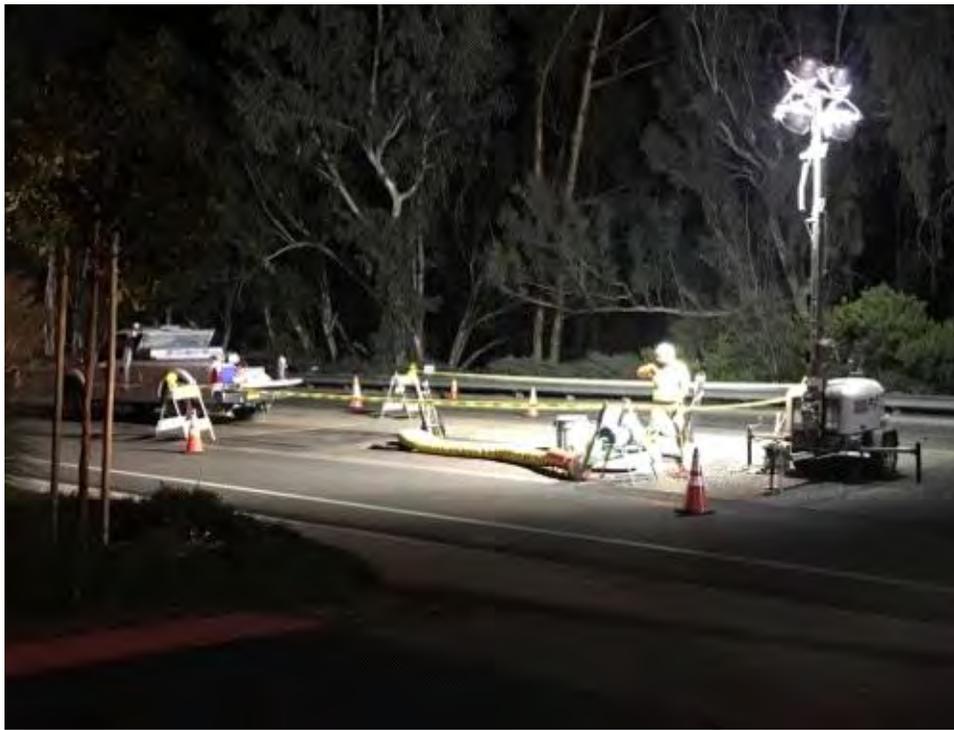
Caption Vault on Carroll Canyon Road.

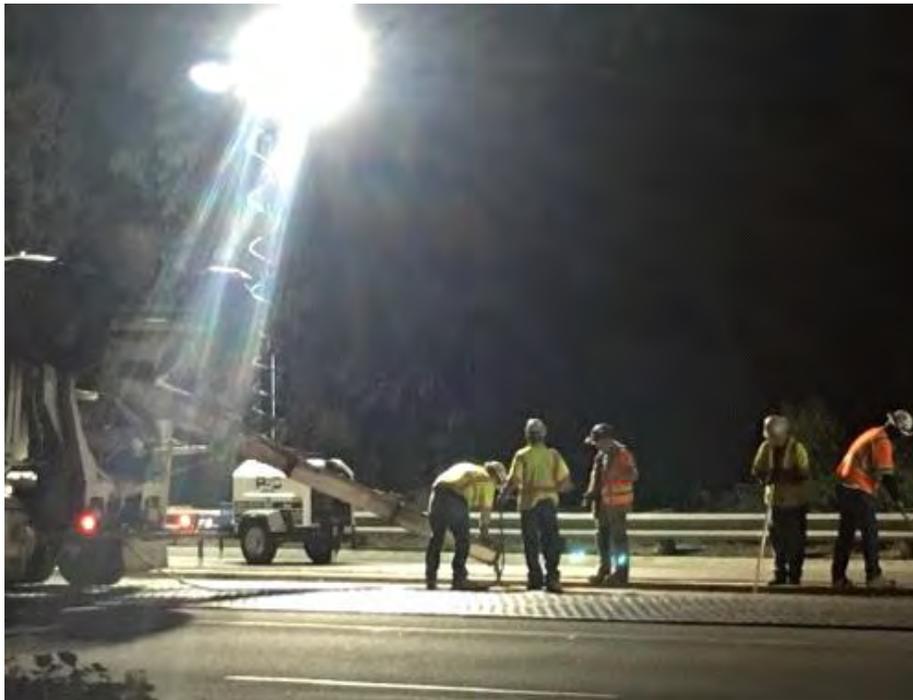
Caption Cement work on Carroll Canyon Road.

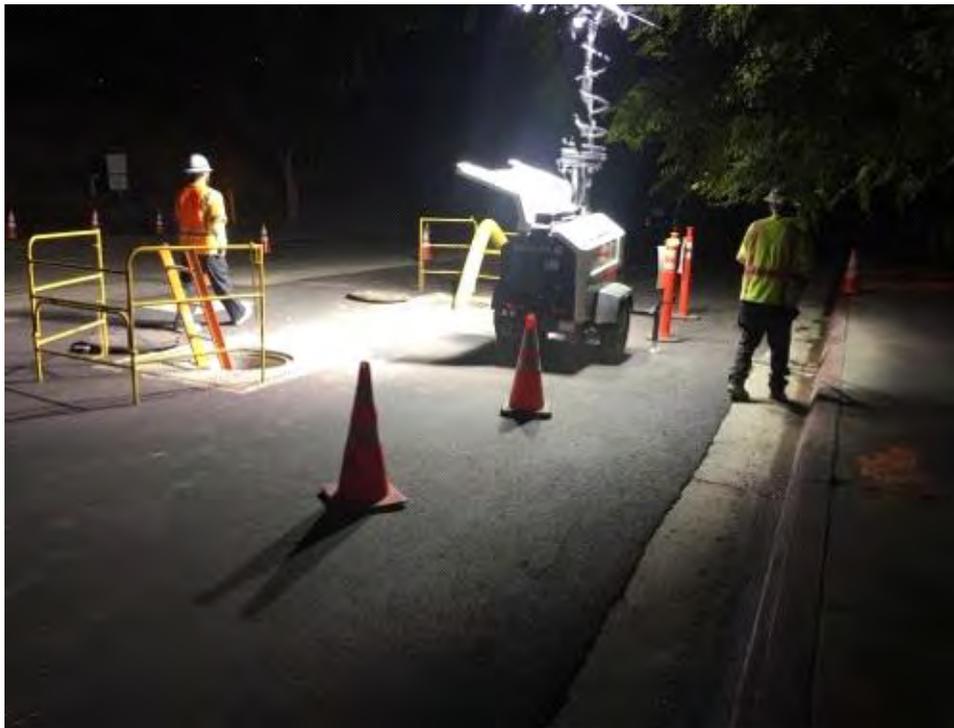
Caption Vault site on Trade Street.

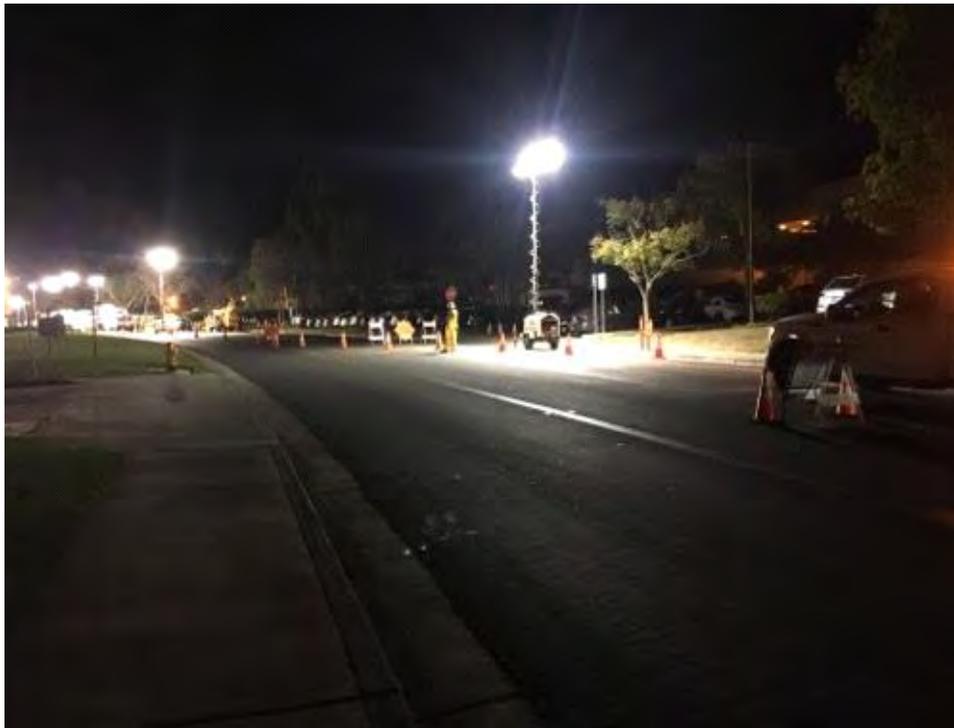
Caption Traffic control on Activity Road.

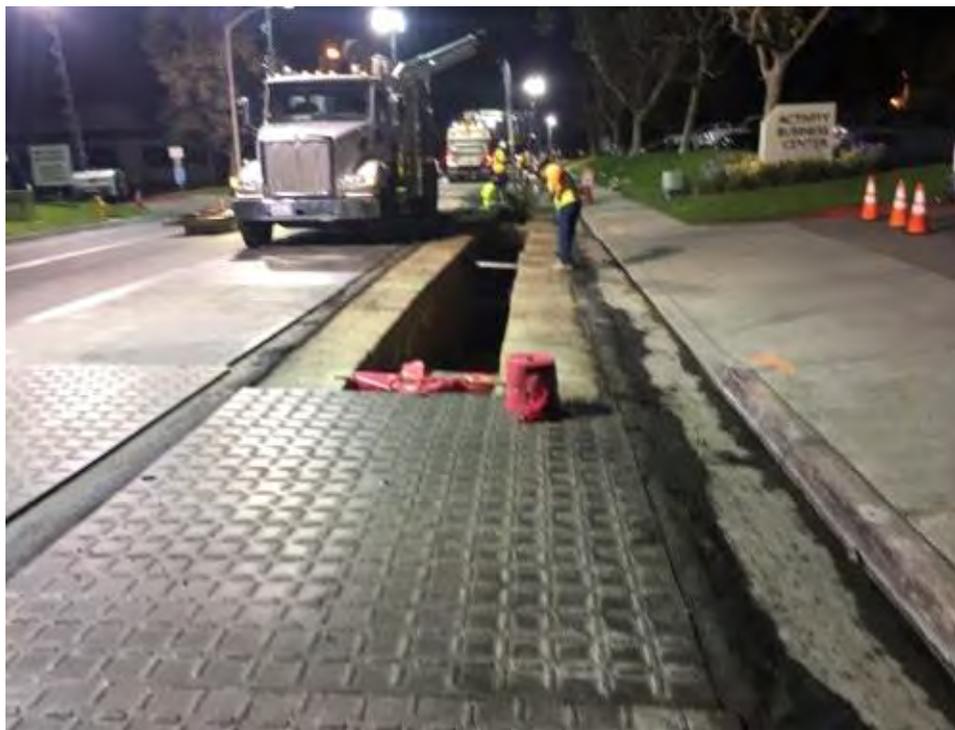
Caption Potholing on Activity Road.

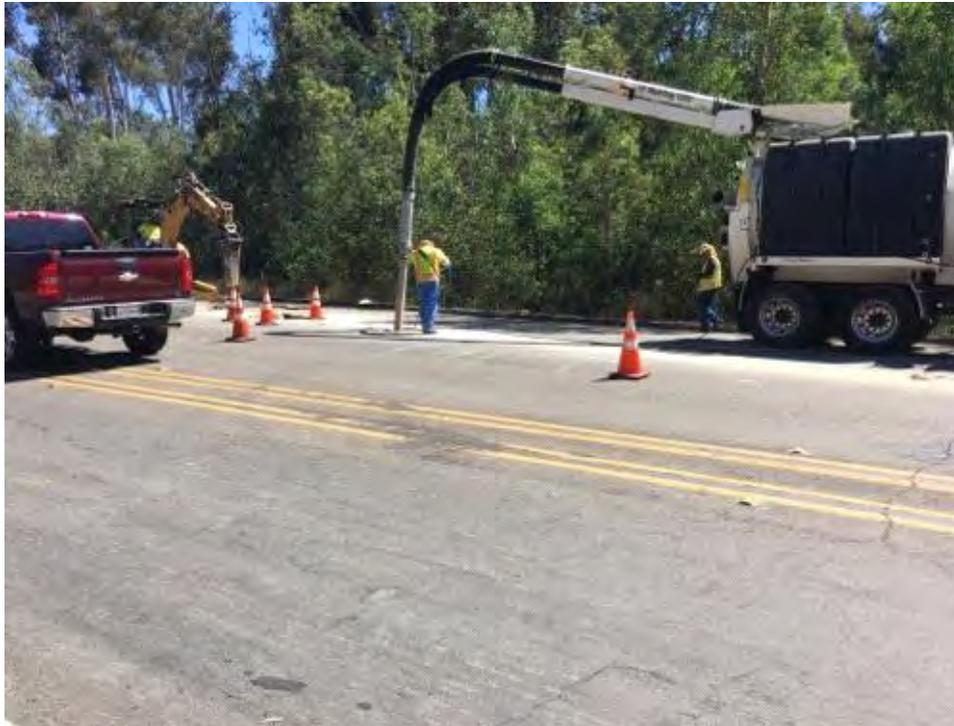
Caption Potholing on Pomerado Road.

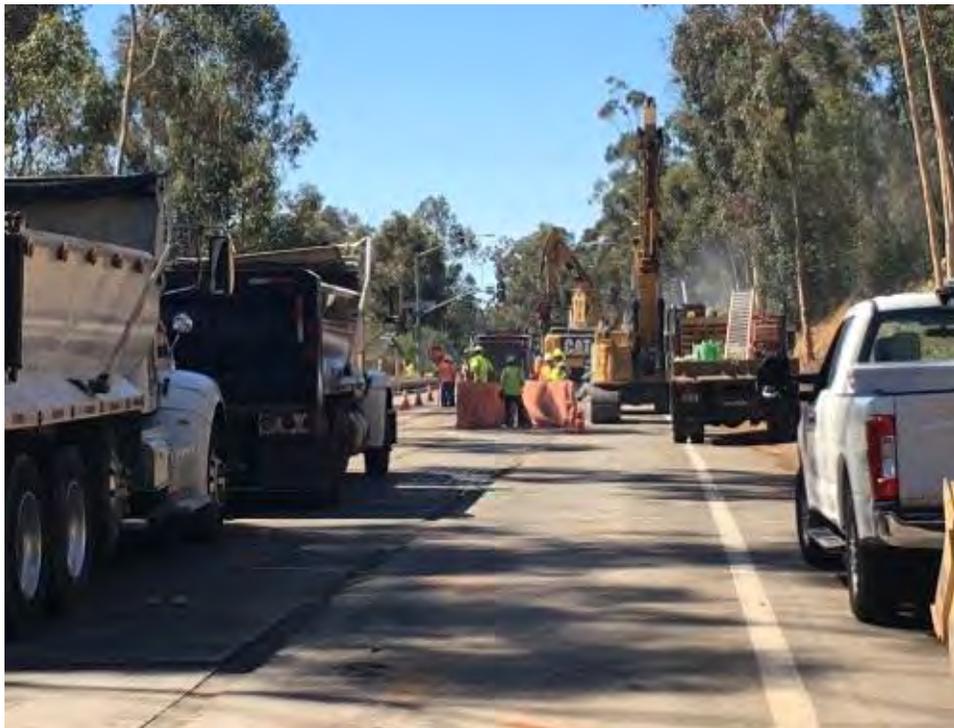
Caption Pomerado Road work site.

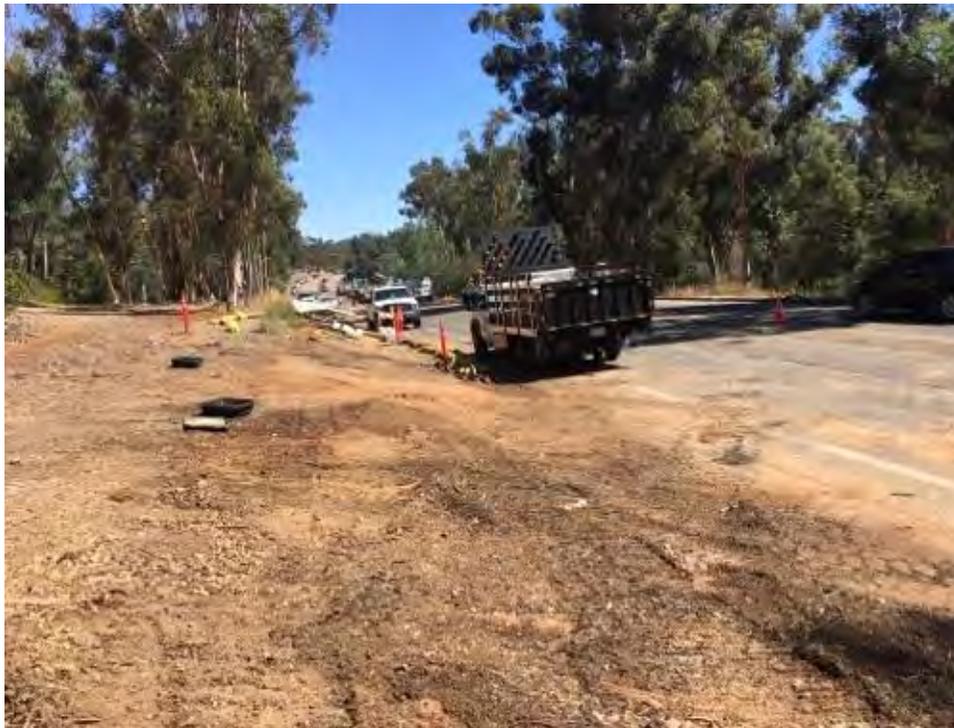
Caption South side of Pomerado Road. Limits of disturbance right along approved work area.

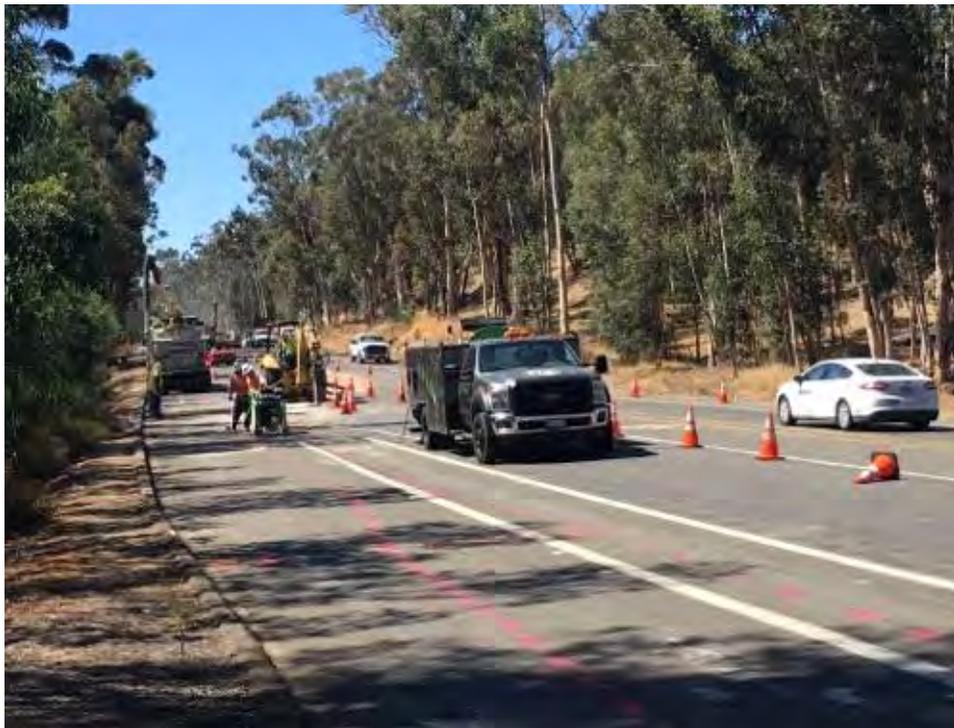
Caption Eastern edge of trench on Pomerado Road. Just before Avenida Magnifica.

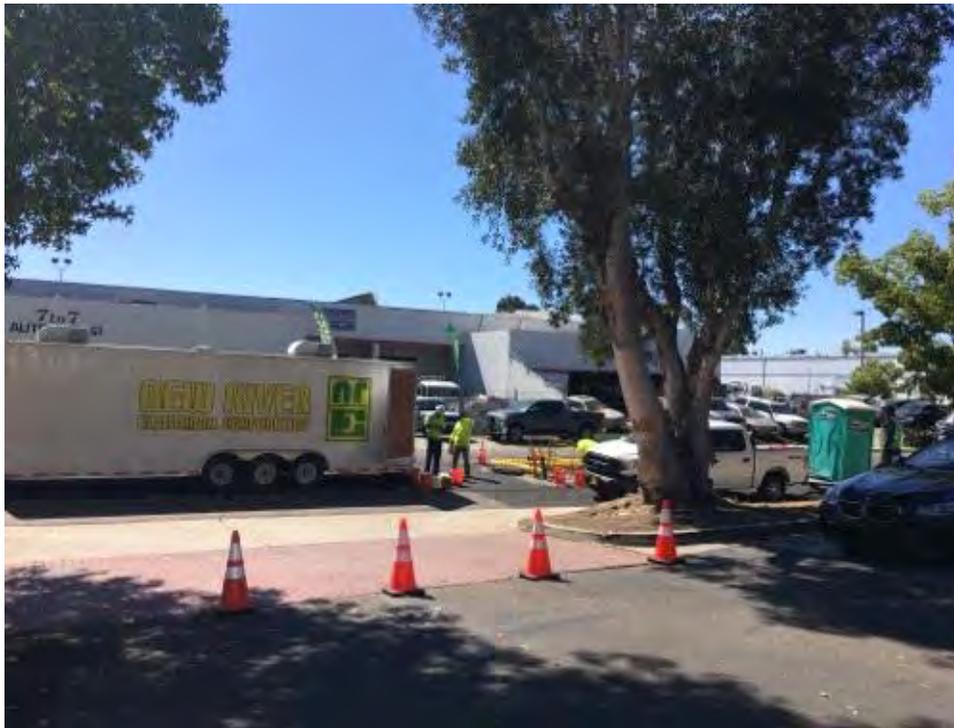
Caption Vault site with cable crew on Arjons Drive.

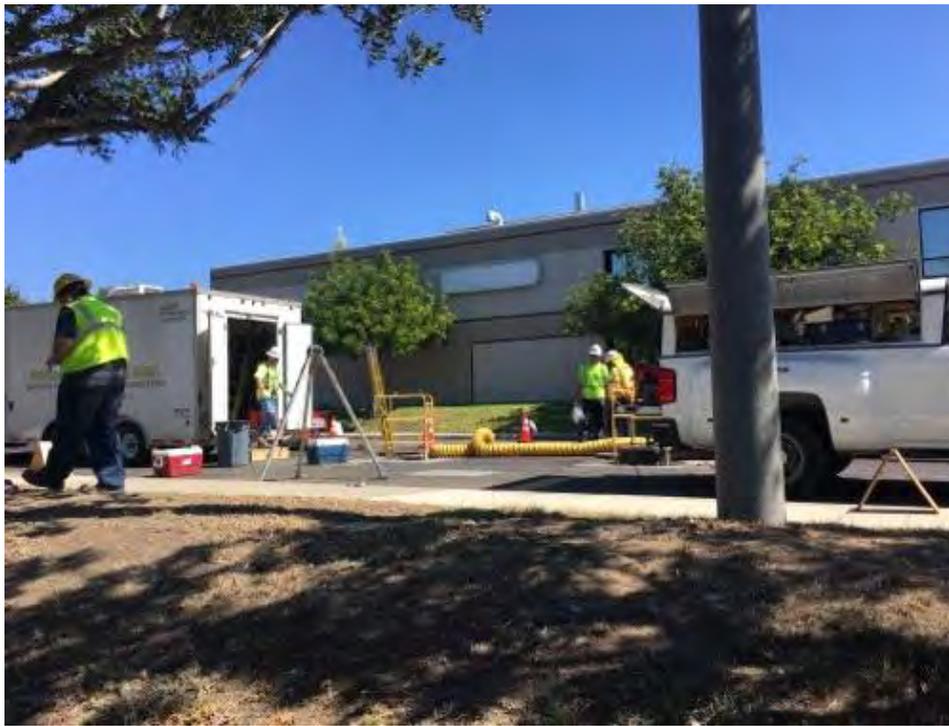
Caption Trade Place vault.

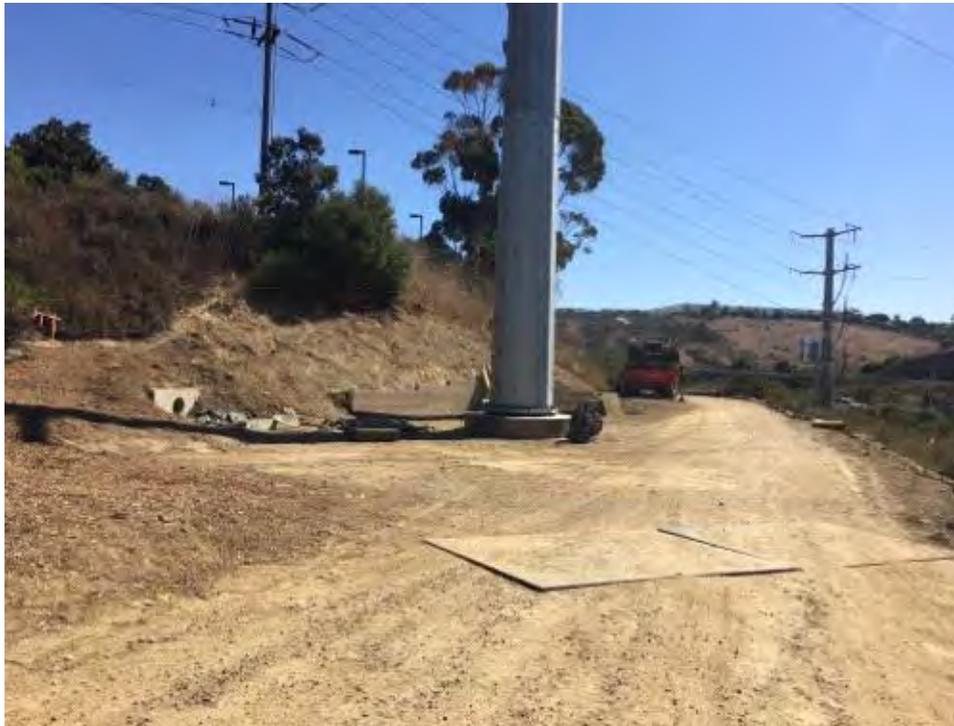
Caption CC MM CP work site. No active work in this area.

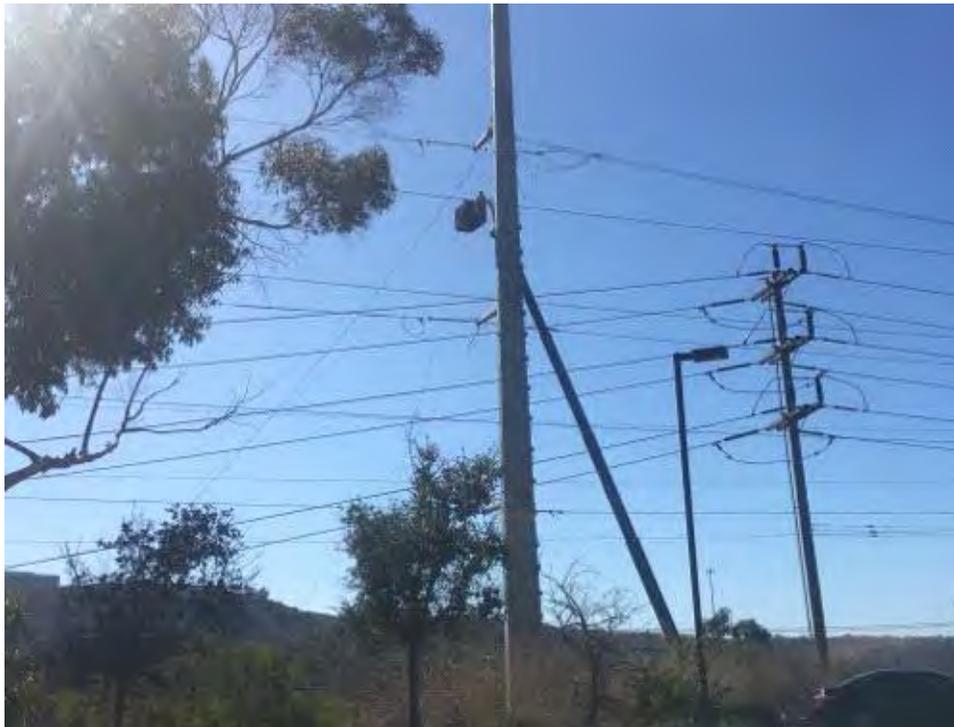
Caption CC MM CP wire crew.

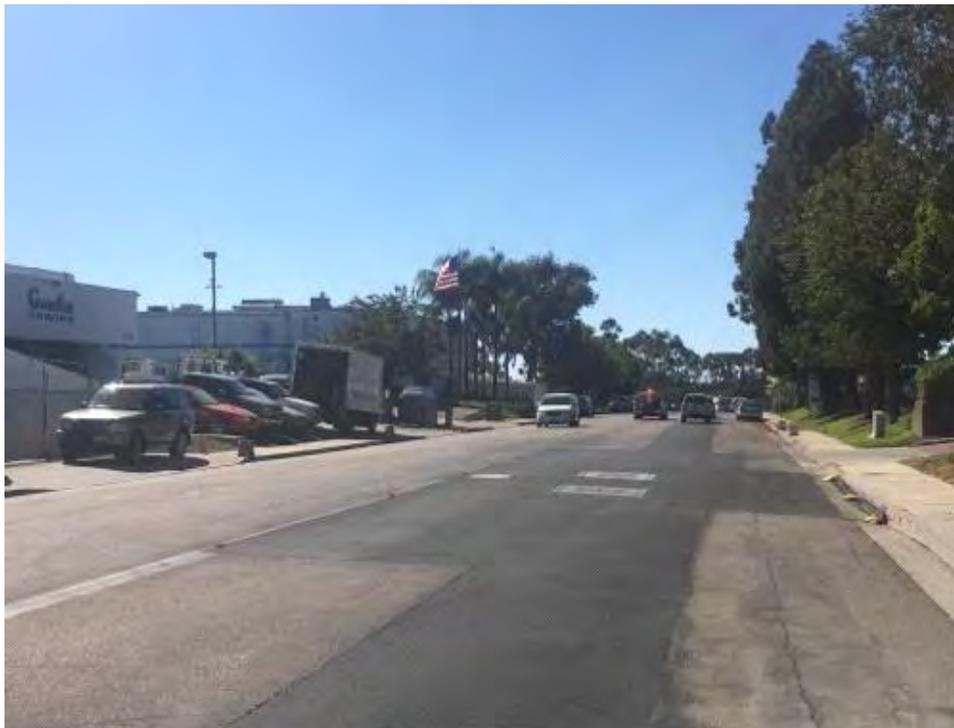
Caption Arjons Drive vault site work completed prior to 3 pm.

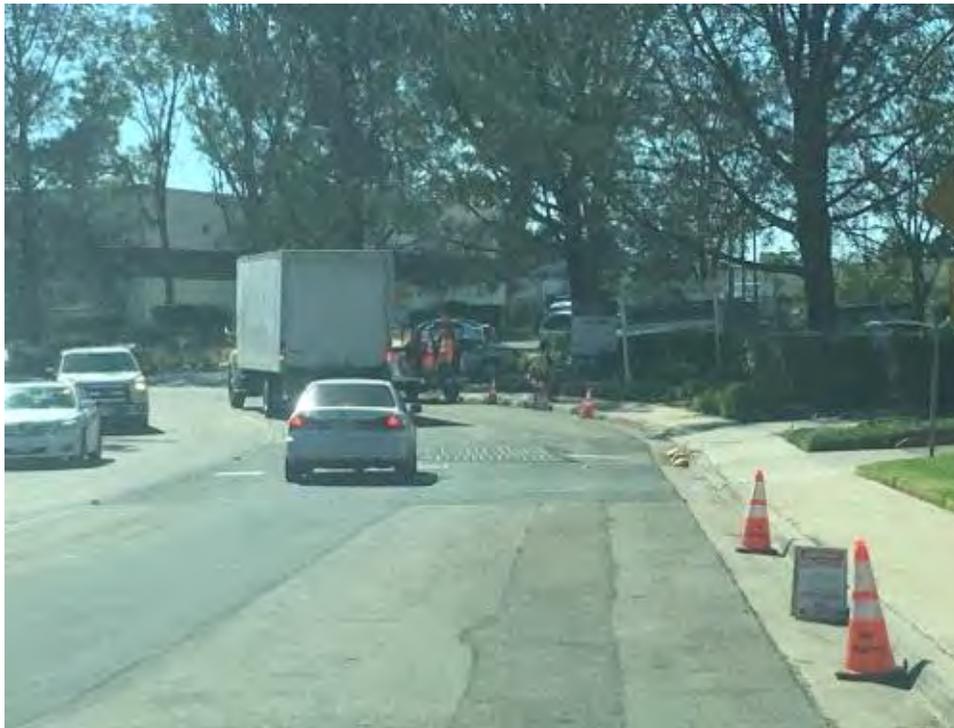
Caption Miralani Drive vault site, work completed by 3 pm.

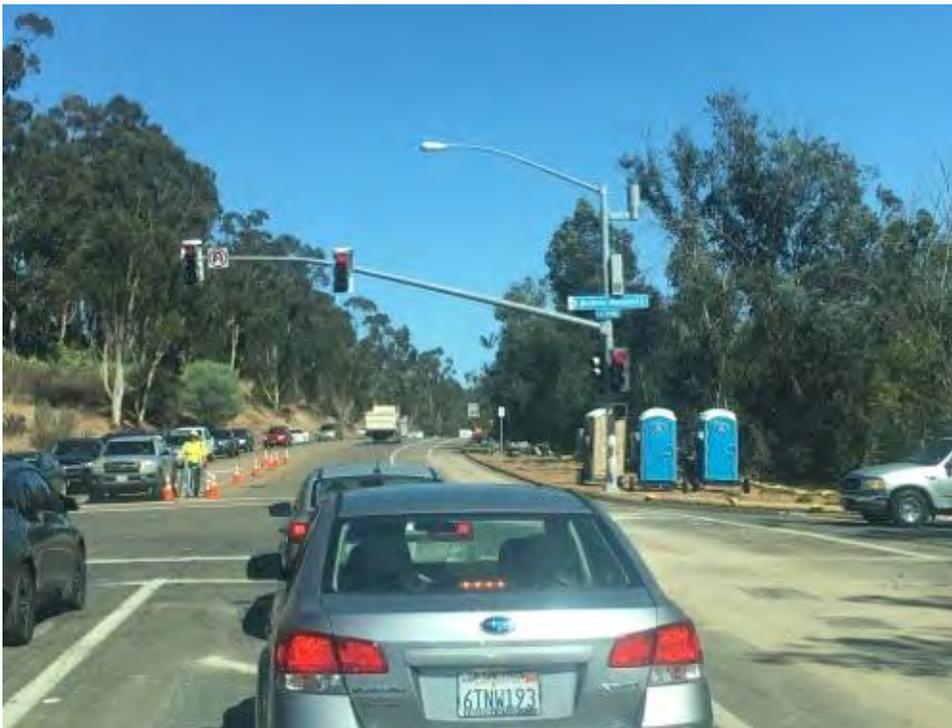
Caption Avenida Magnifica work completed for day - site cleanup in process.

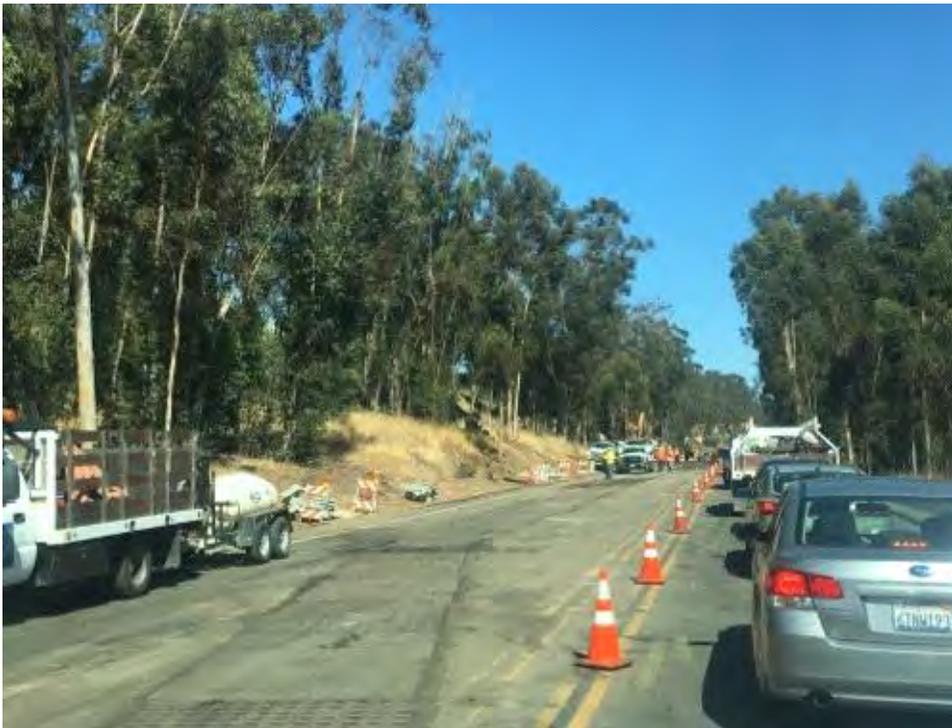
Caption Traffic control east of Chabad Center.

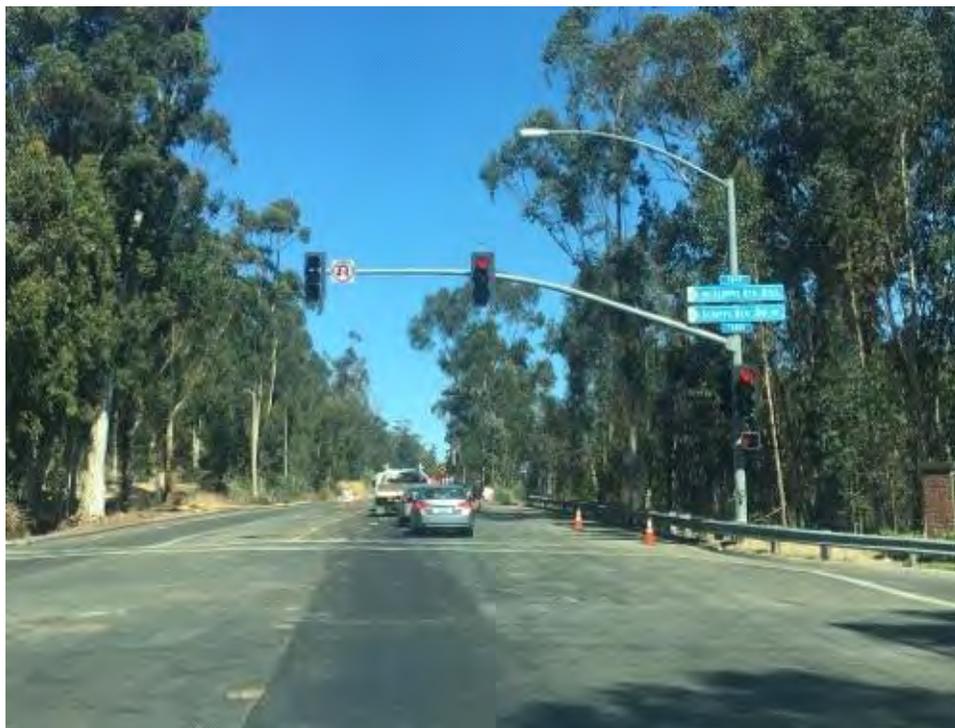
Caption Traffic control at Scripps Ranch Blvd. and Pomerado Road.

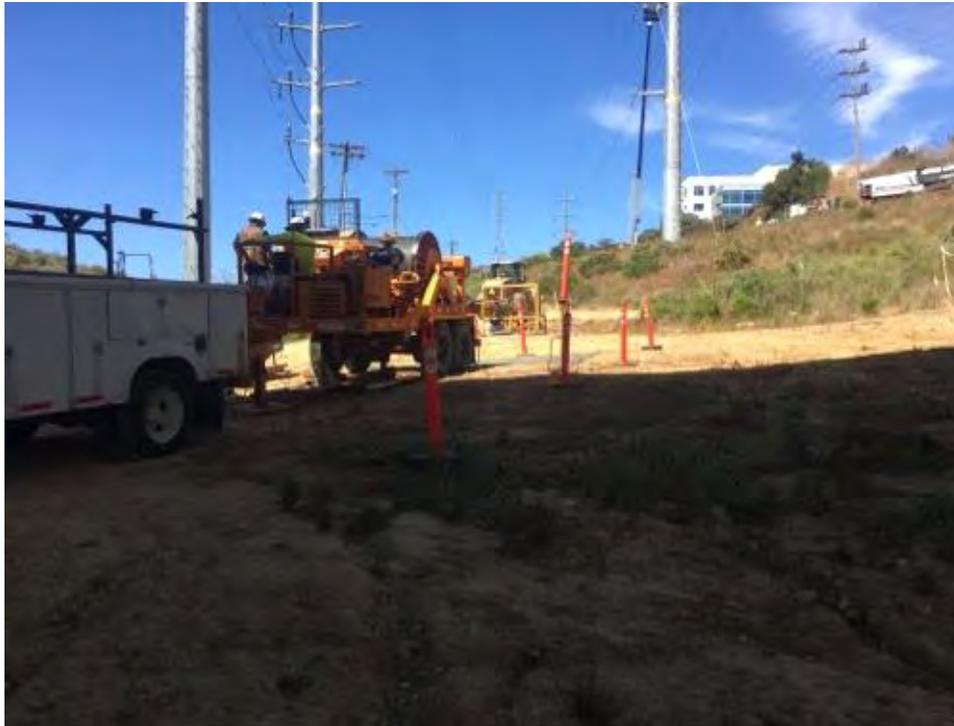
Caption Wire crew beneath Carroll Canyon Road bridge.

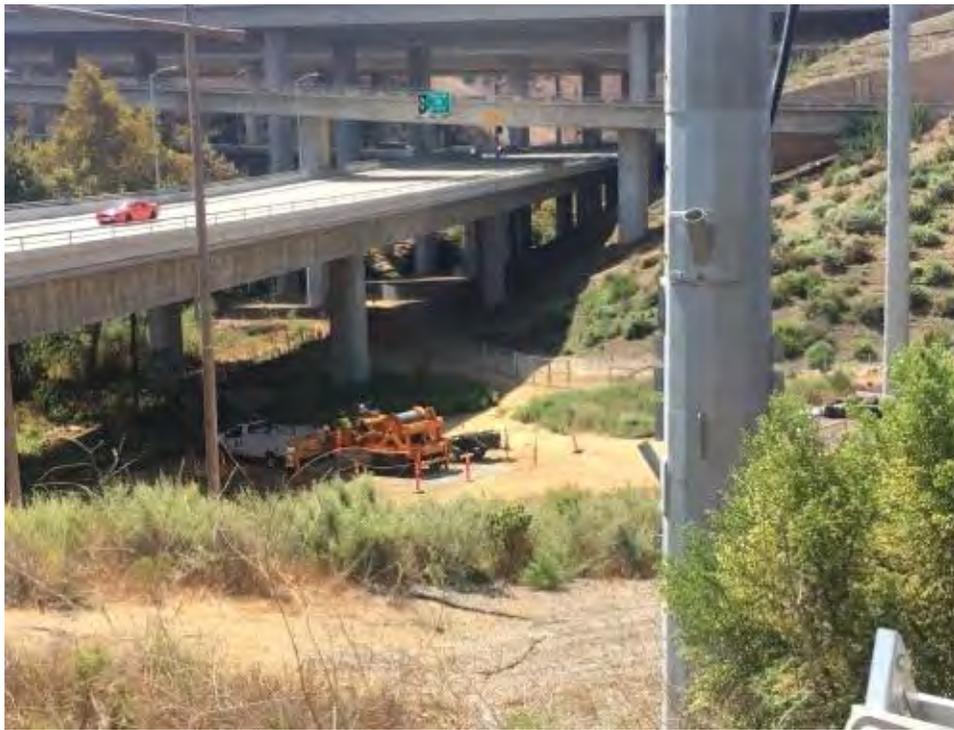
Caption Wire crew beneath Carroll Canyon Road bridge. AECOM monitor was with crew.

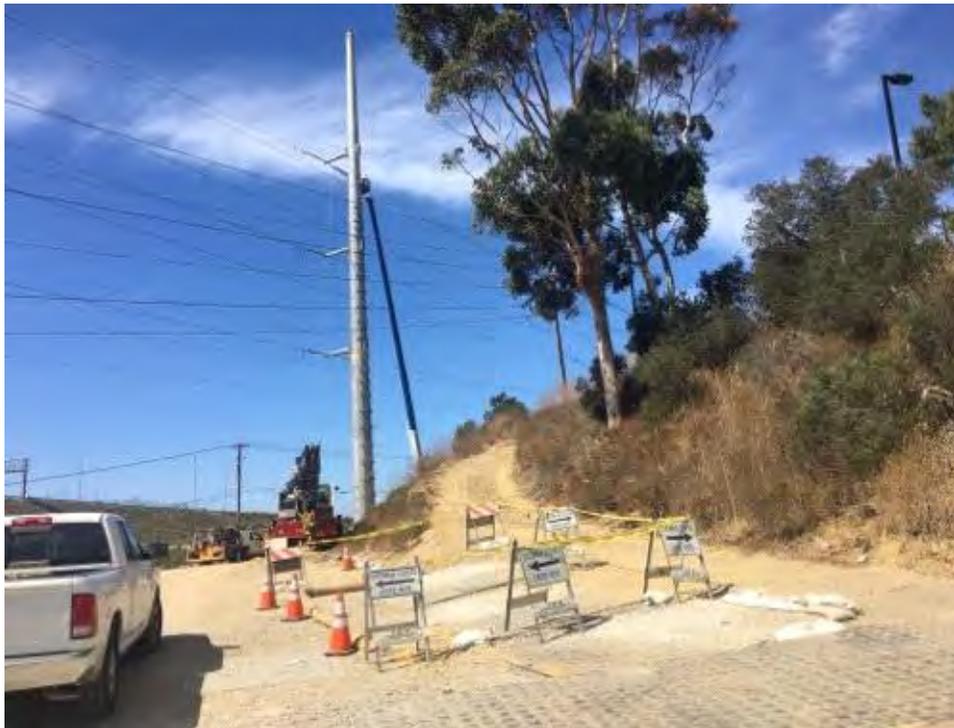
Caption Wire work continues at CC MM CP. Top wire almost complete. Will move to lower wires next week.

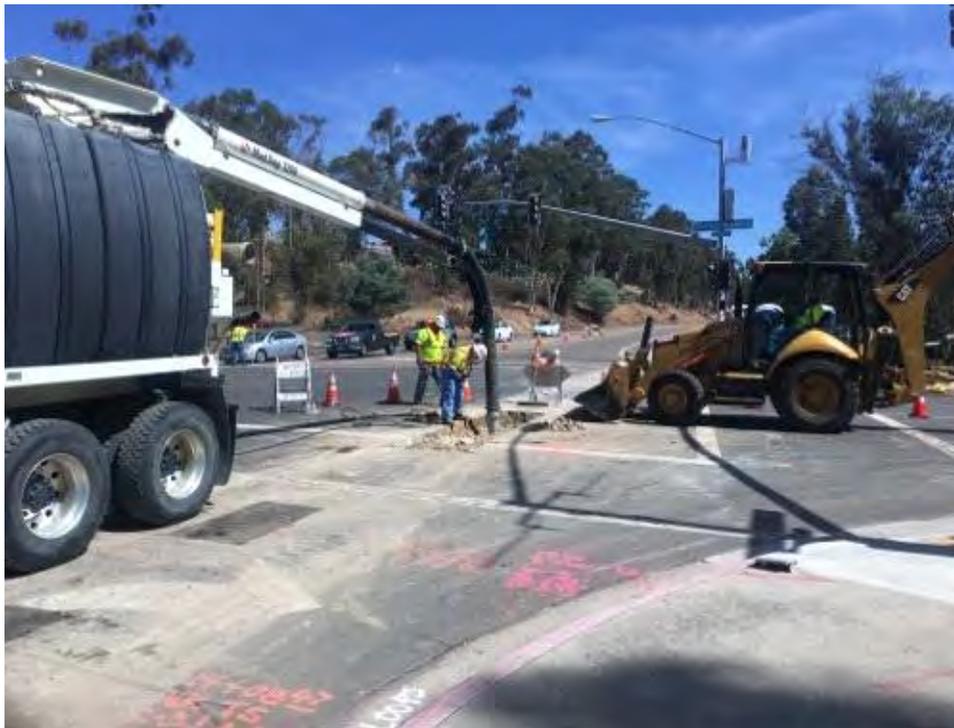
Caption Potholing at Avenida Magnifica.

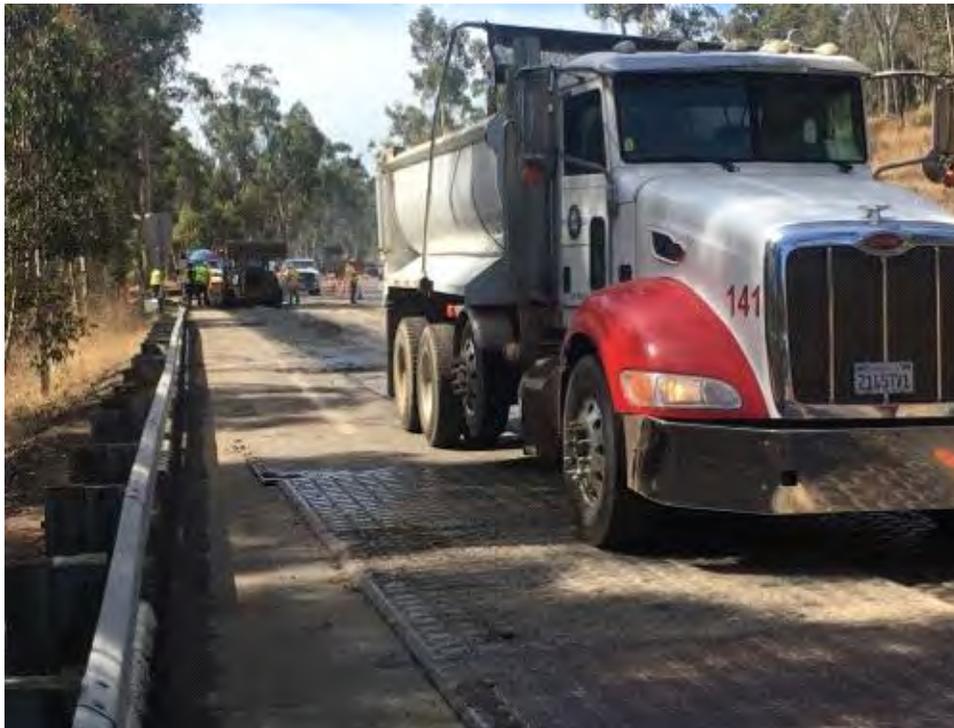
Caption Asphalt repaving on Pomerado Road on western portion of work site.

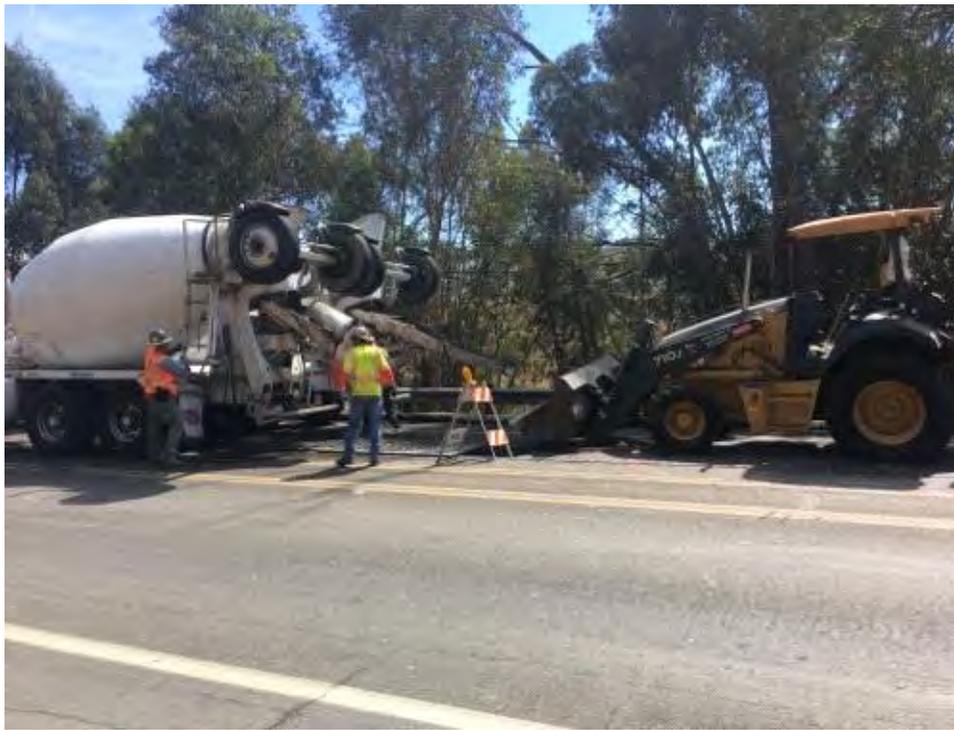
Caption Cement clean-out area.

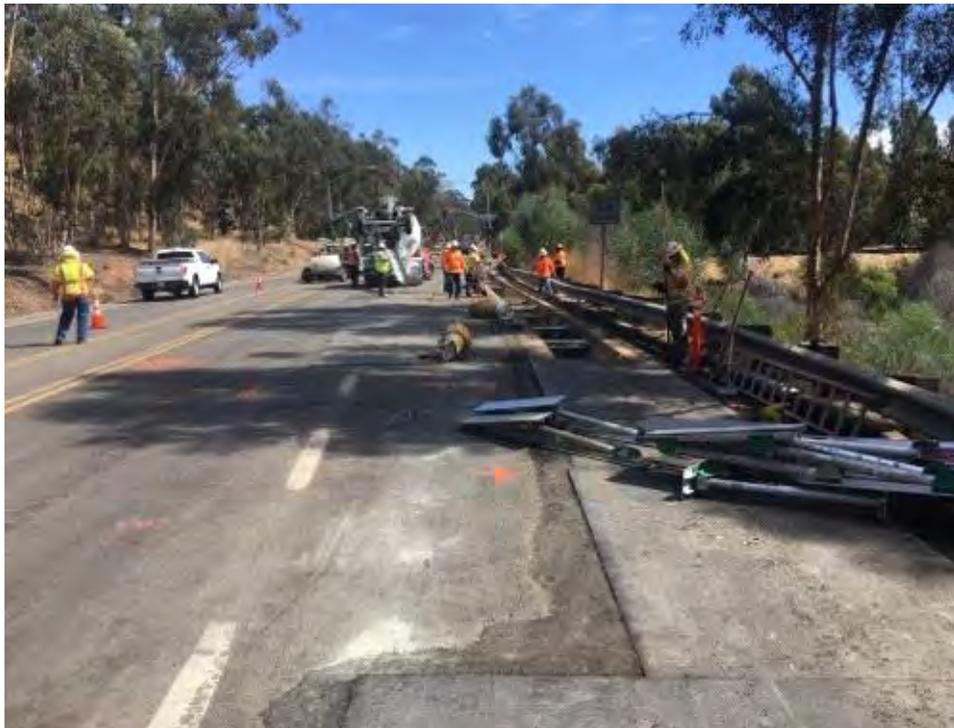
Caption Cement work/backfill on Pomerado Road.

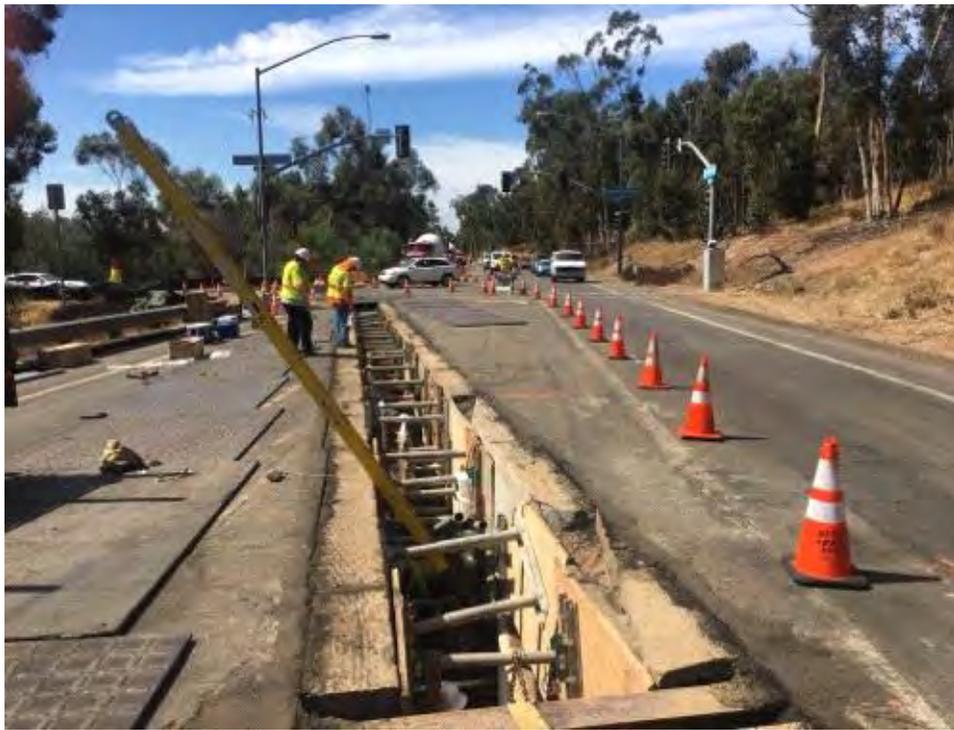
Caption Conduit install at Chabad Center and Pomerado Road.

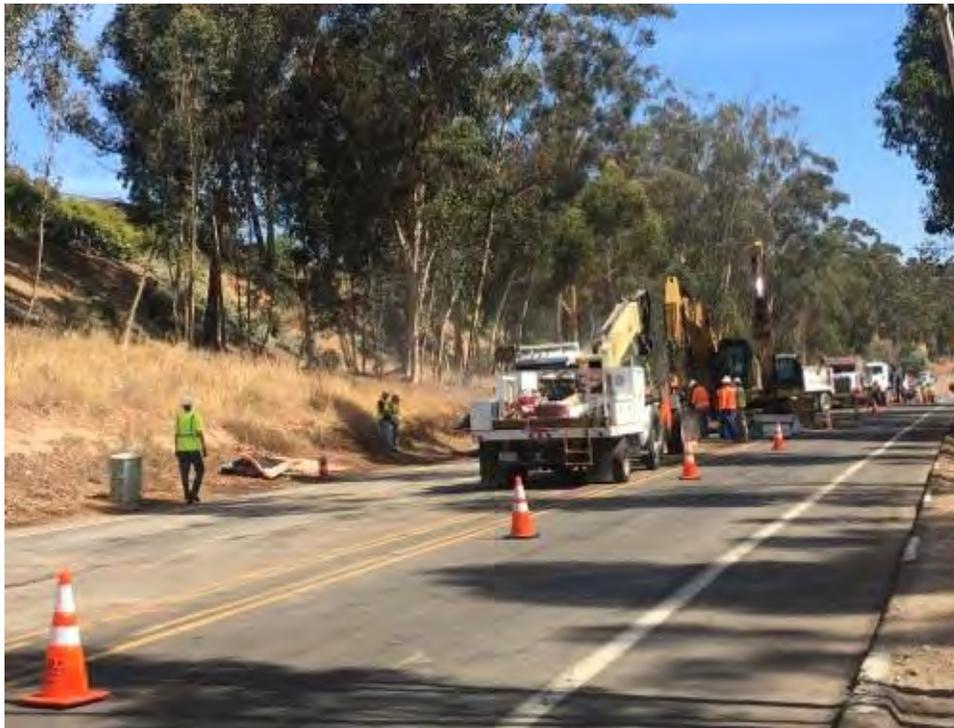
Caption Trenching/excavation on Pomerado Road. Note monitors present north and south of digging area.

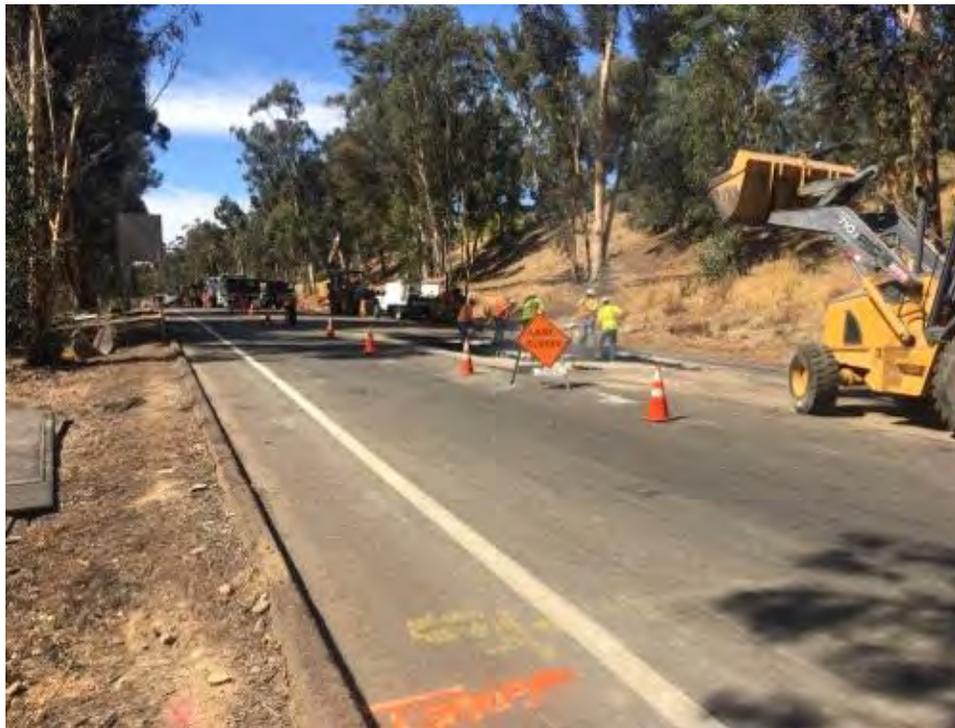
Caption Vault site on Pomerado Road just west of Avenida Magnifica.
