PROJECT MEMORANDUM SYCAMORE-PEÑASQUITOS 230-KV TRANSMISSION LINE PROJECT

Date: October 20, 2017
To: Billie Blanchard, CPUC Project Manager
From: Sheila Hoyer, CPUC Monitoring Supervisor
Subject: Weekly Report #41 – October 8 to October 14, 2017

SDG&E Sycamore-Peñasquitos 230-kV Transmission Line Project: Daily Inspection Report

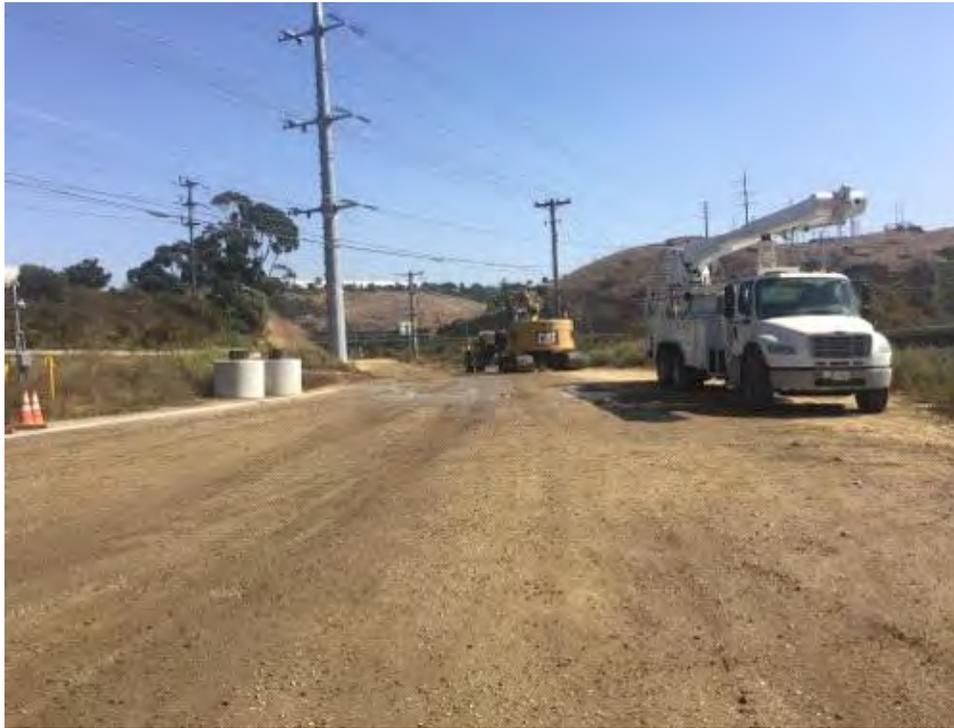
Caption CC MM CP work site, no active work. Water truck just put down water on roads.

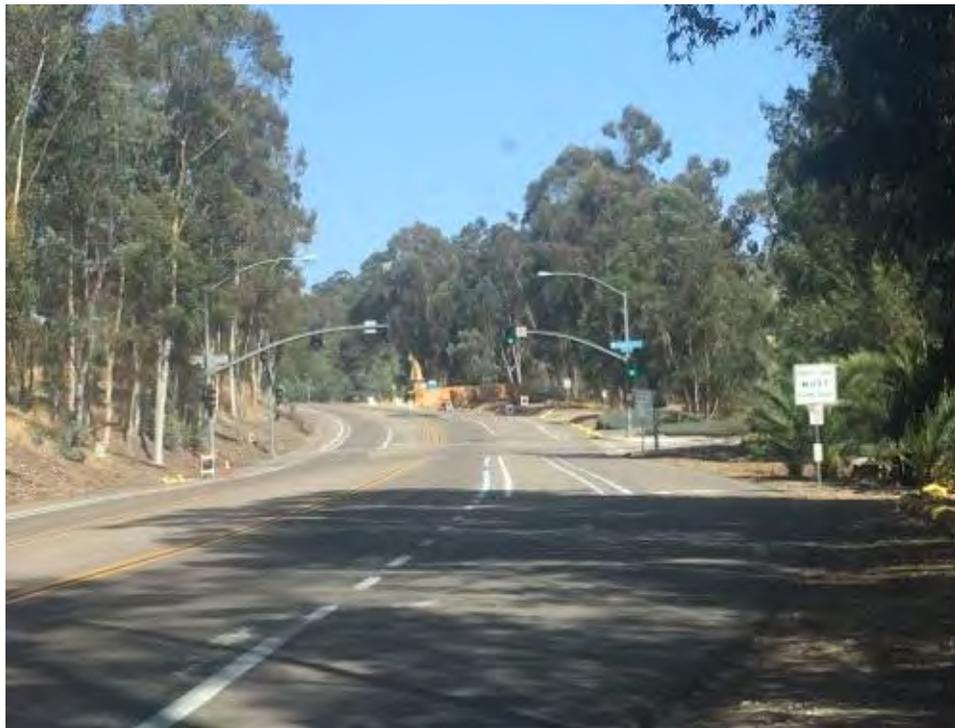
Caption Fairbrook Road and Pomerado Road intersection, no active work on Pomerado Road.

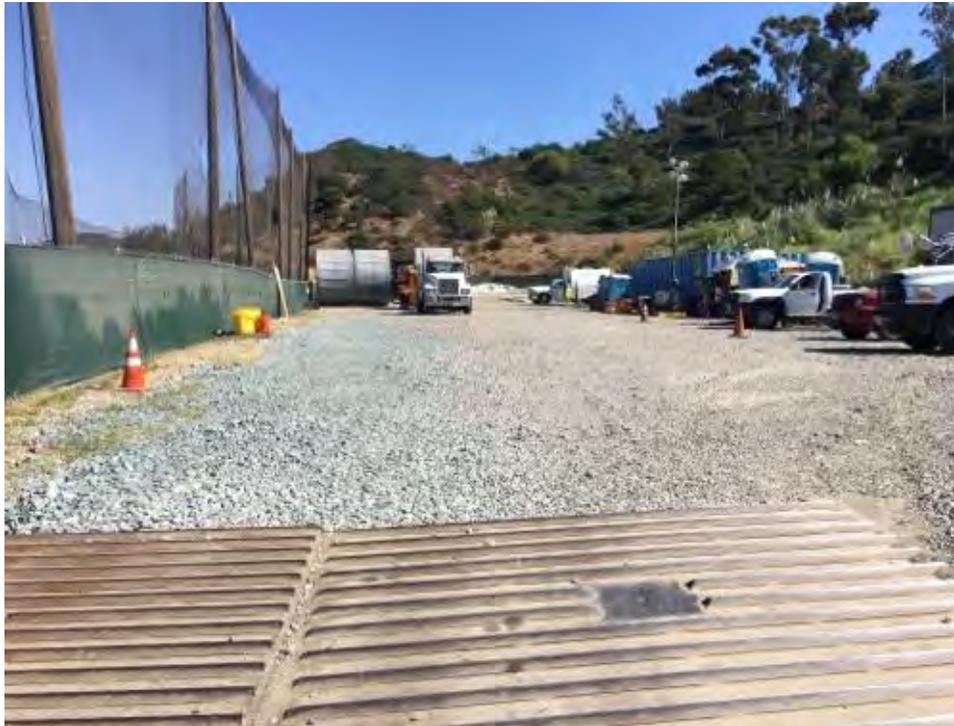
Caption Driving Range Yard.

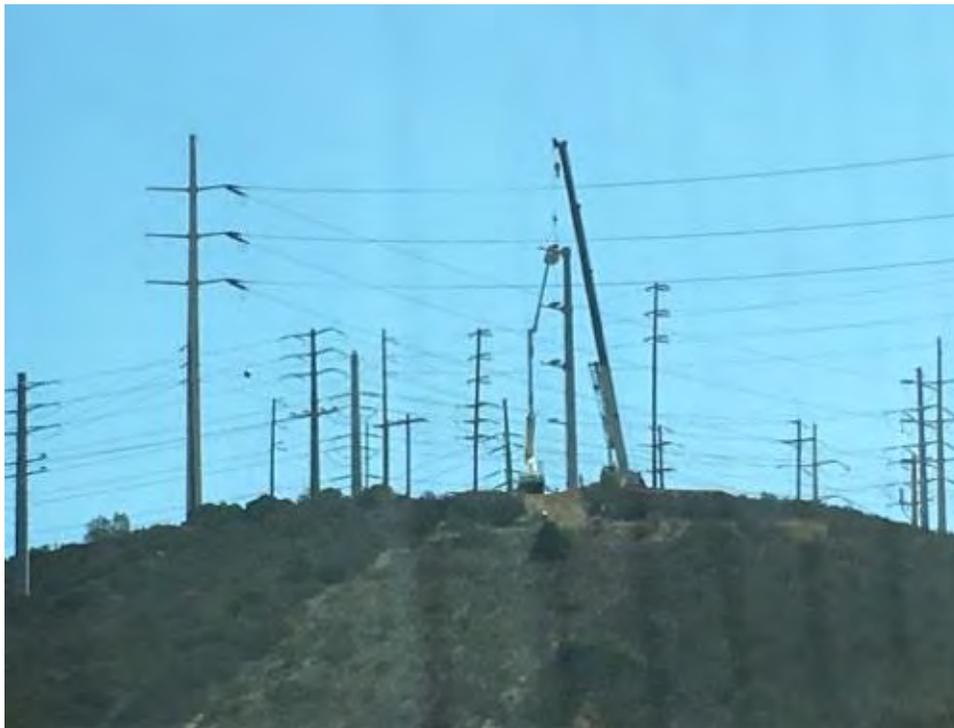
Caption Hanging wire arms on P03.

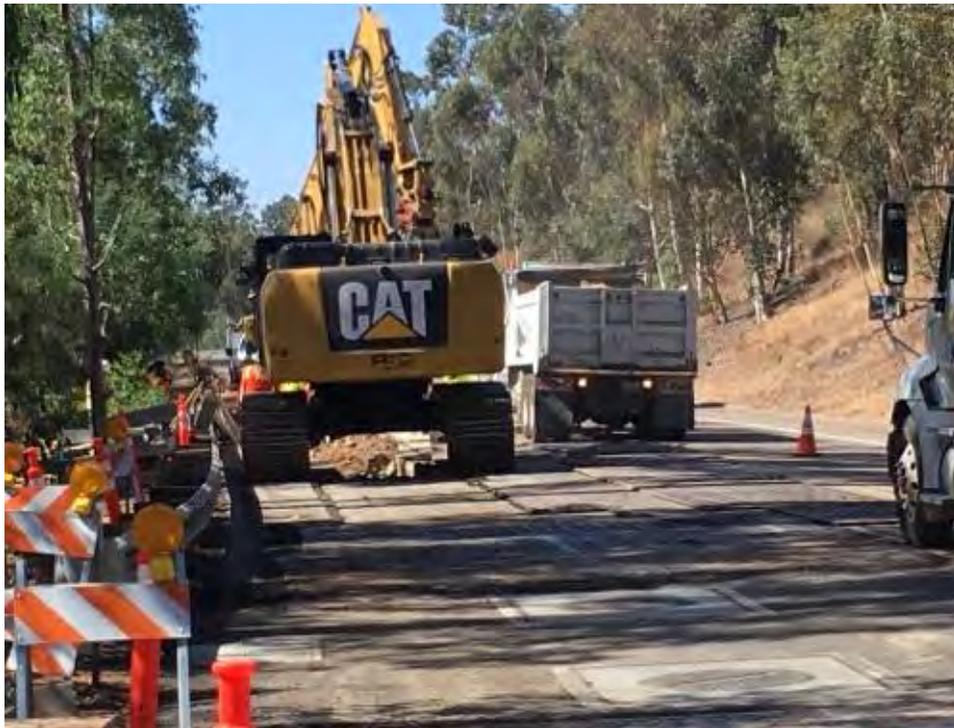
Caption Excavation on Pomerado Road, monitors present.

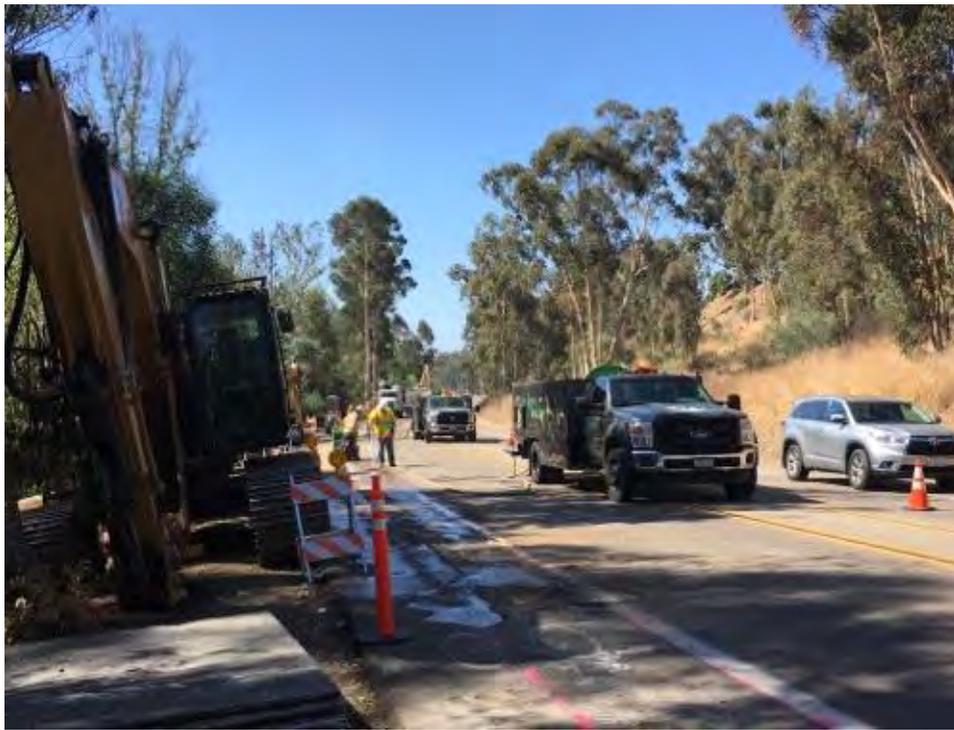
Caption Excavation on Pomerado Road, and pavement cutting.

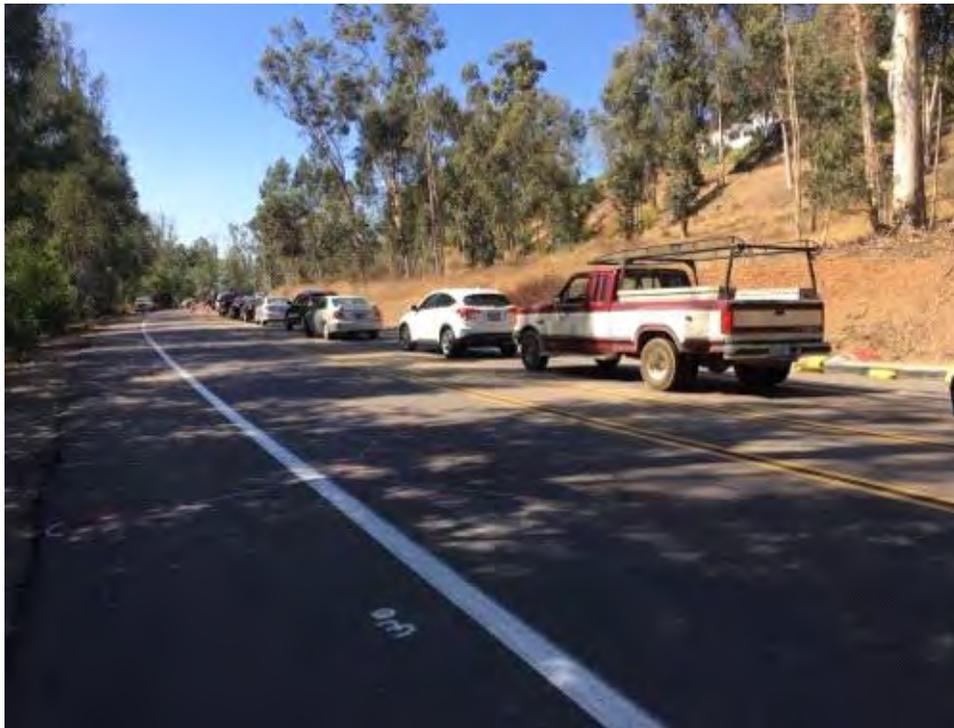
Caption Traffic west of Fairbrook Road. BMPs installed and eastern edge of work on Pomerado Road.

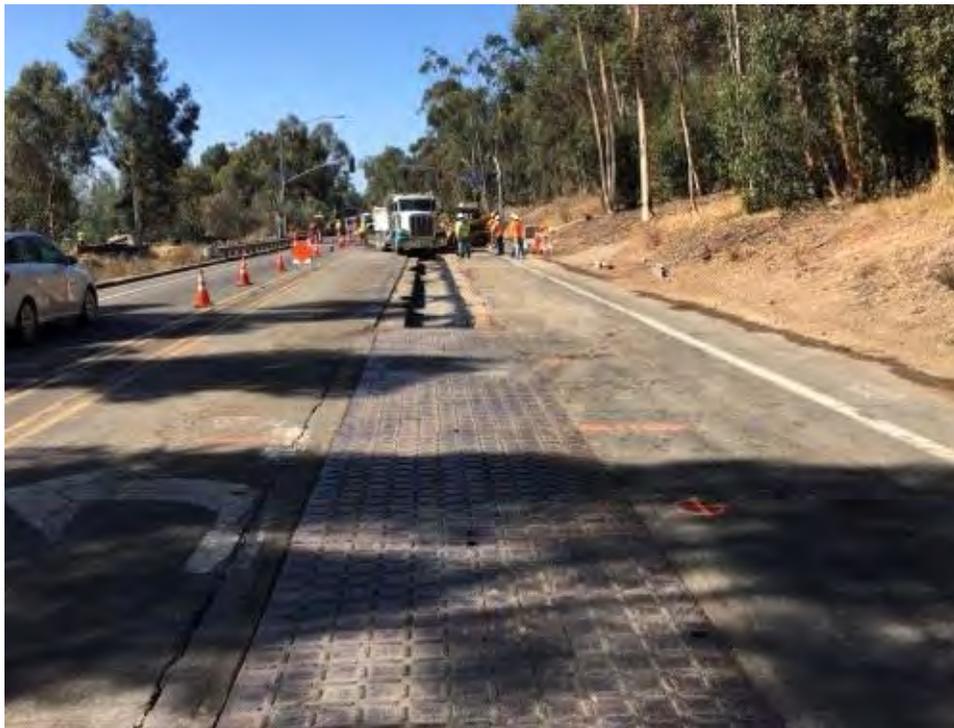
Caption Paving of Pomerado Road east of Chabad Center.

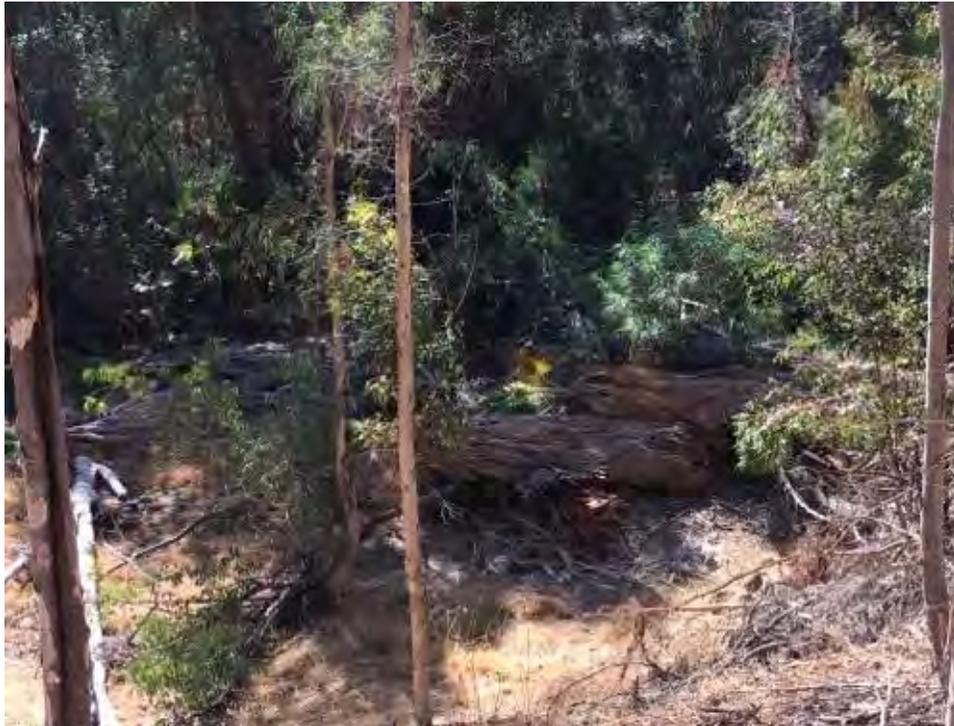
Caption Down palm trees south of Pomerado Road. City of San Diego project.

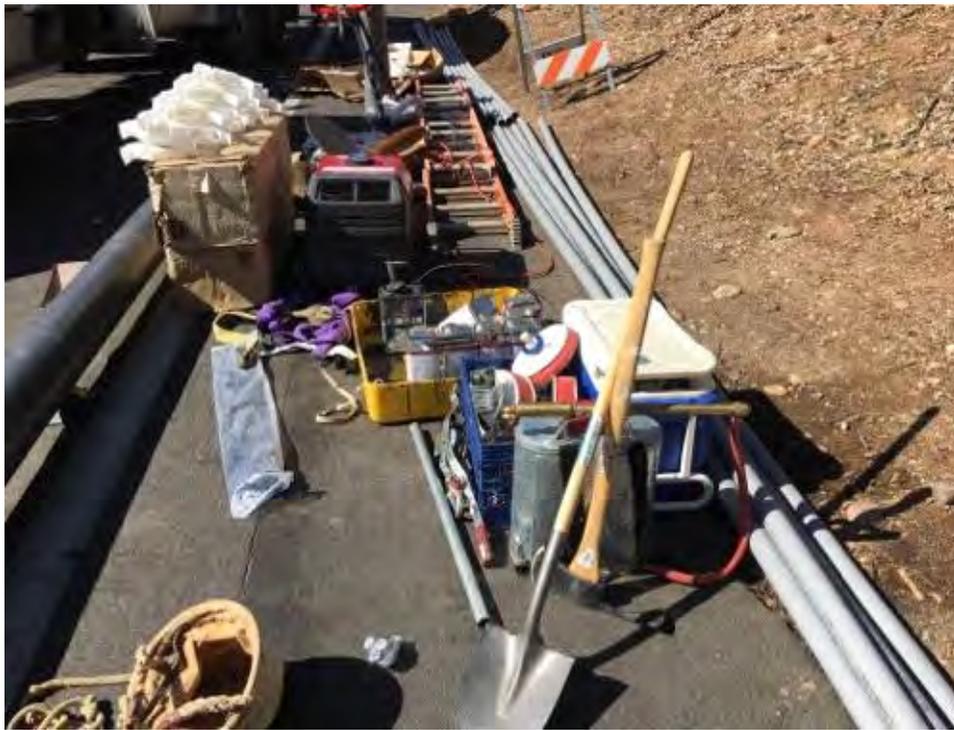
Caption Fire tools.

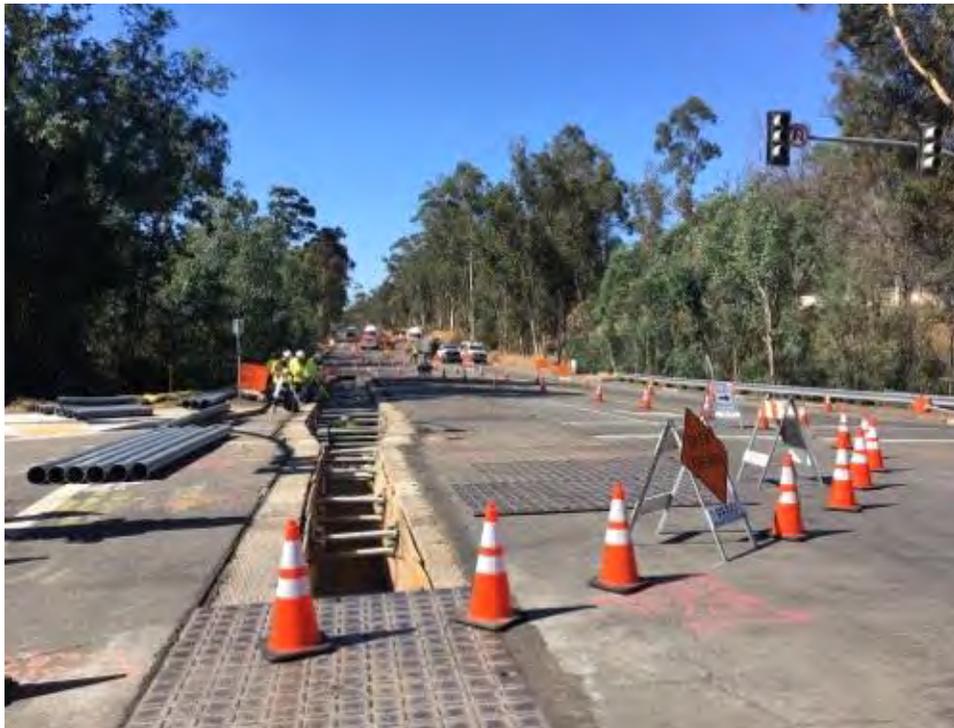
Caption Work site west of Avenida Magnifica.

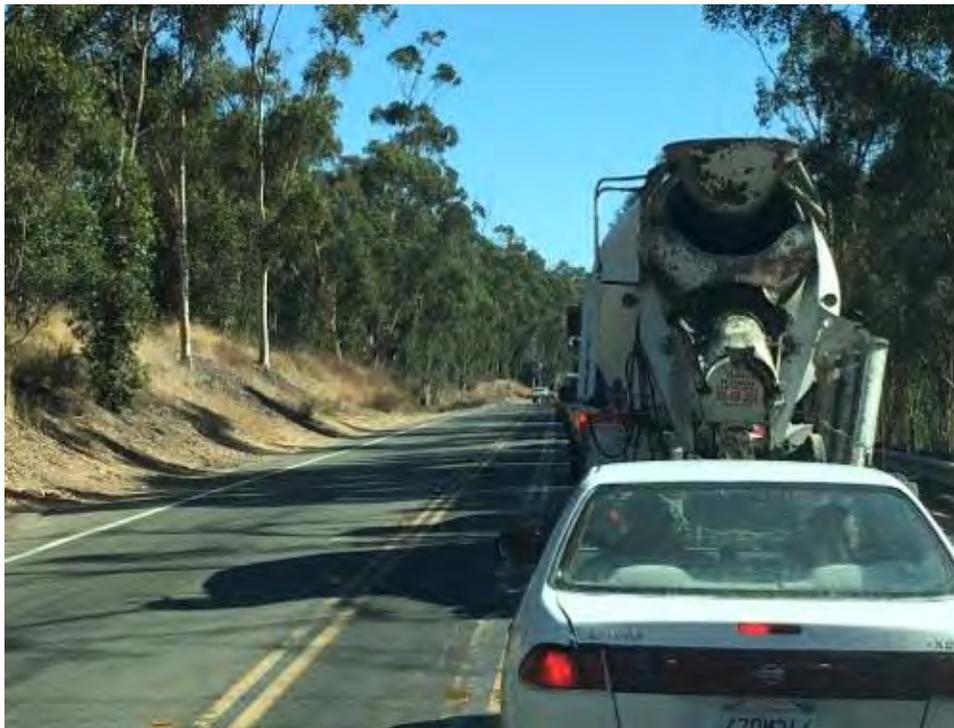
Caption Traffic on Pomerado Road west of Chabad Center.

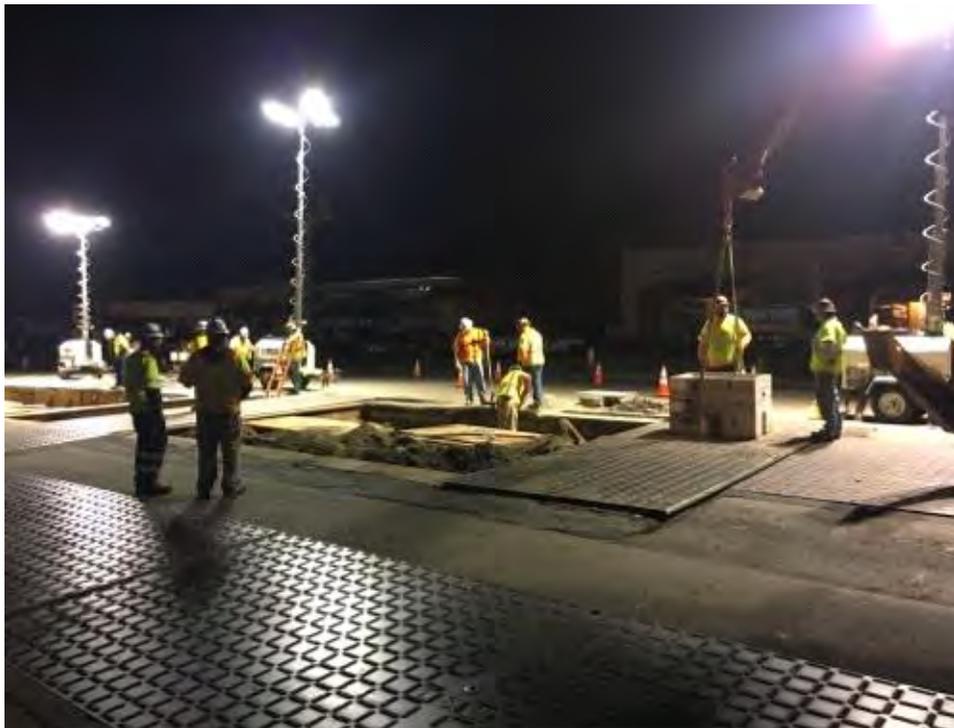
Caption Vault on Black Mt. Road, note monitors and LEI onsite.

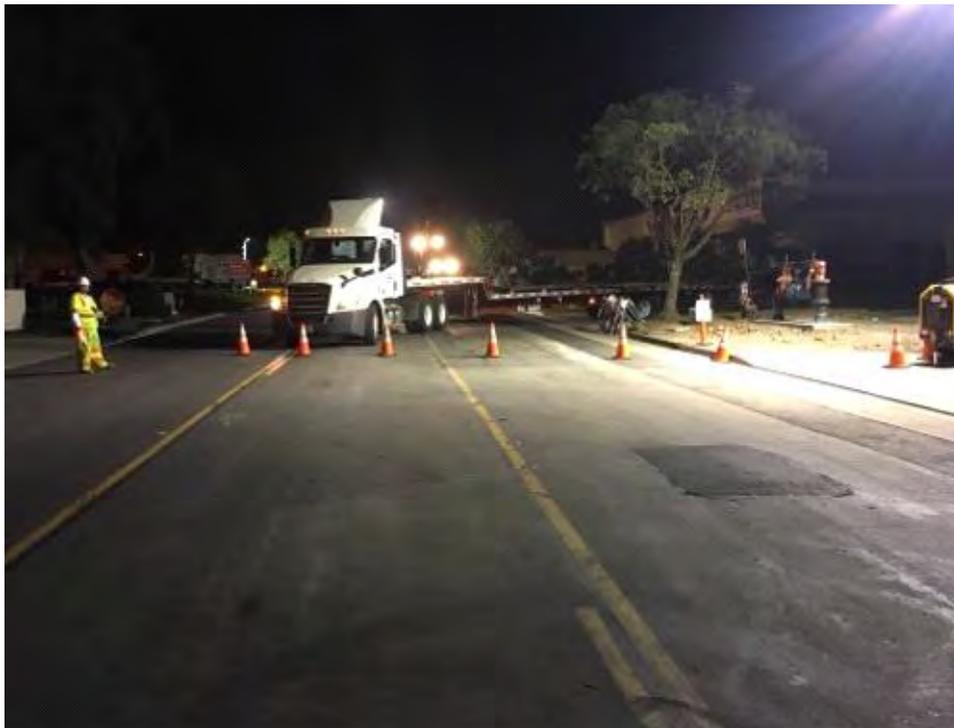
Caption Western edge of work of work on Activity Road.

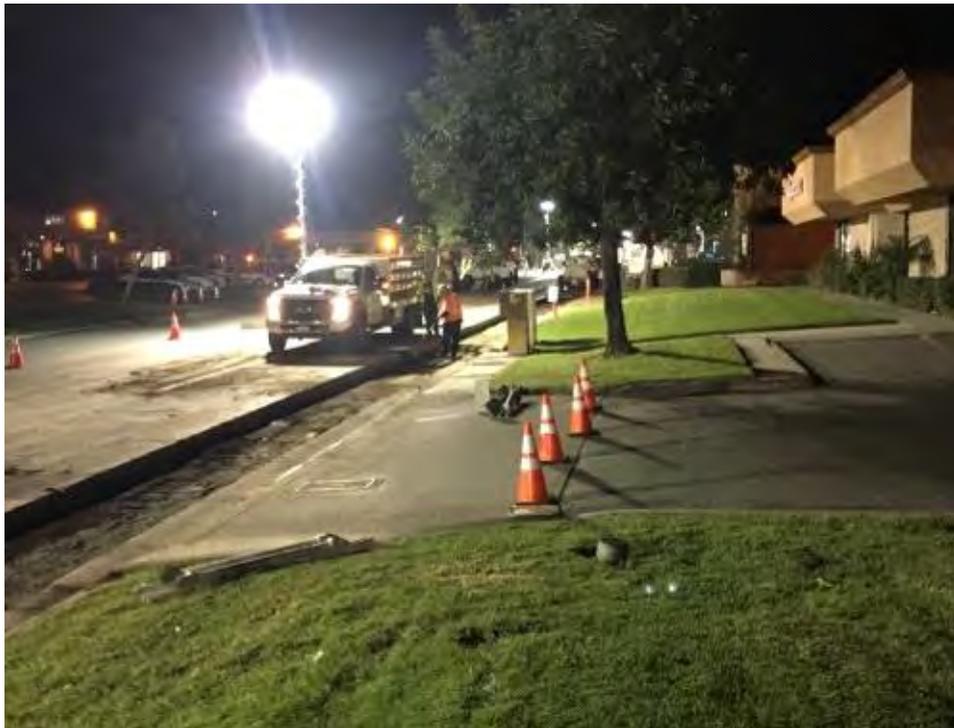
Caption Prep for paving.

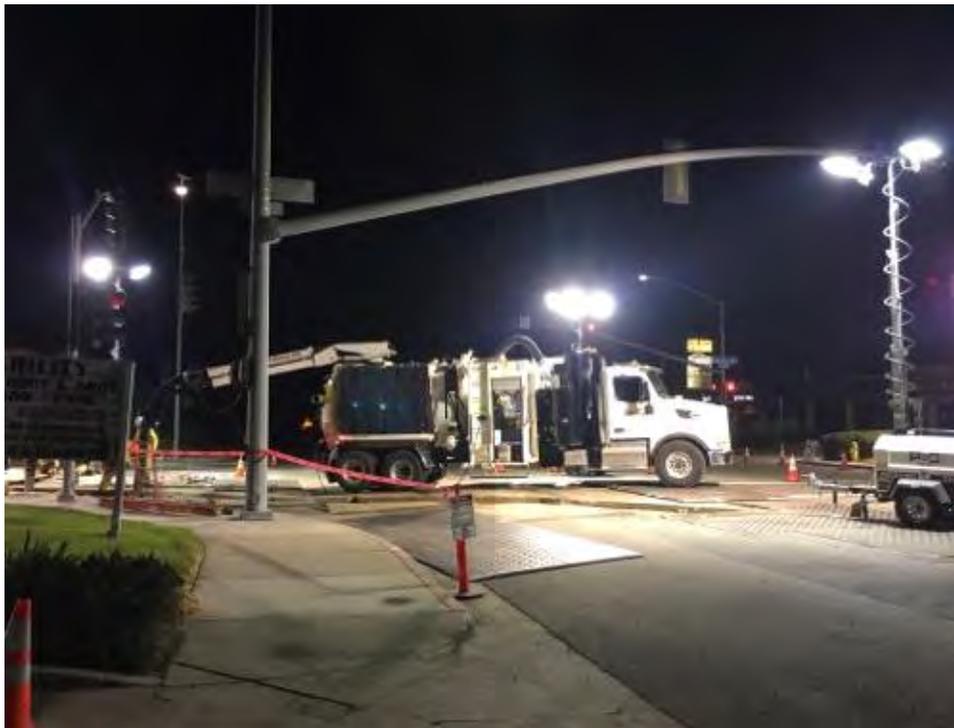
Caption Potholing at Black Mt. Road and Activity Road.

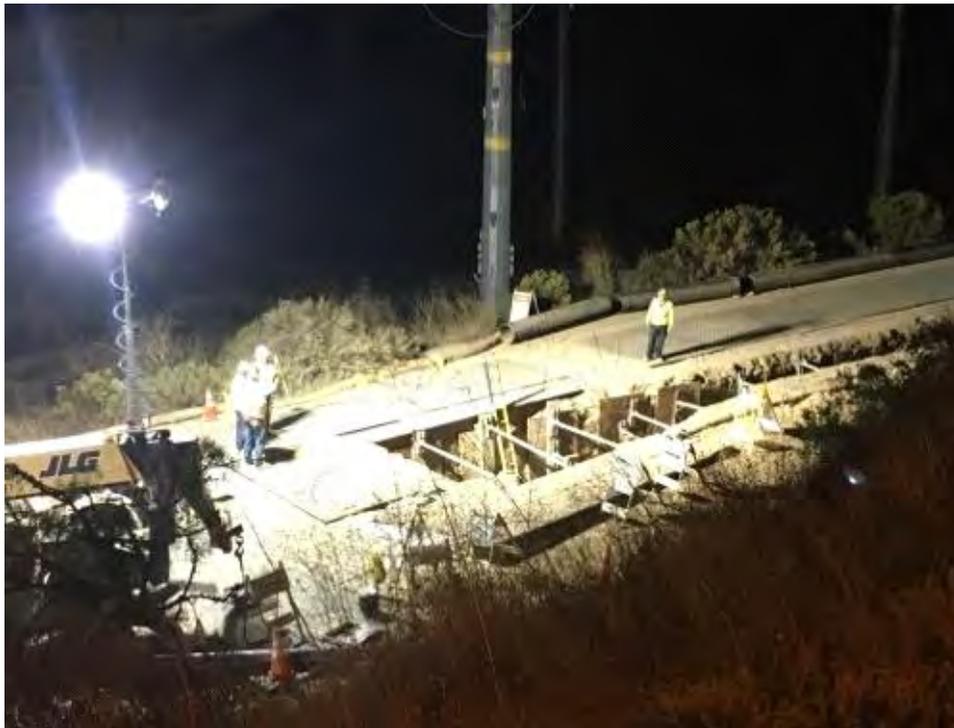
Caption Trench along access road to CC MM CP.

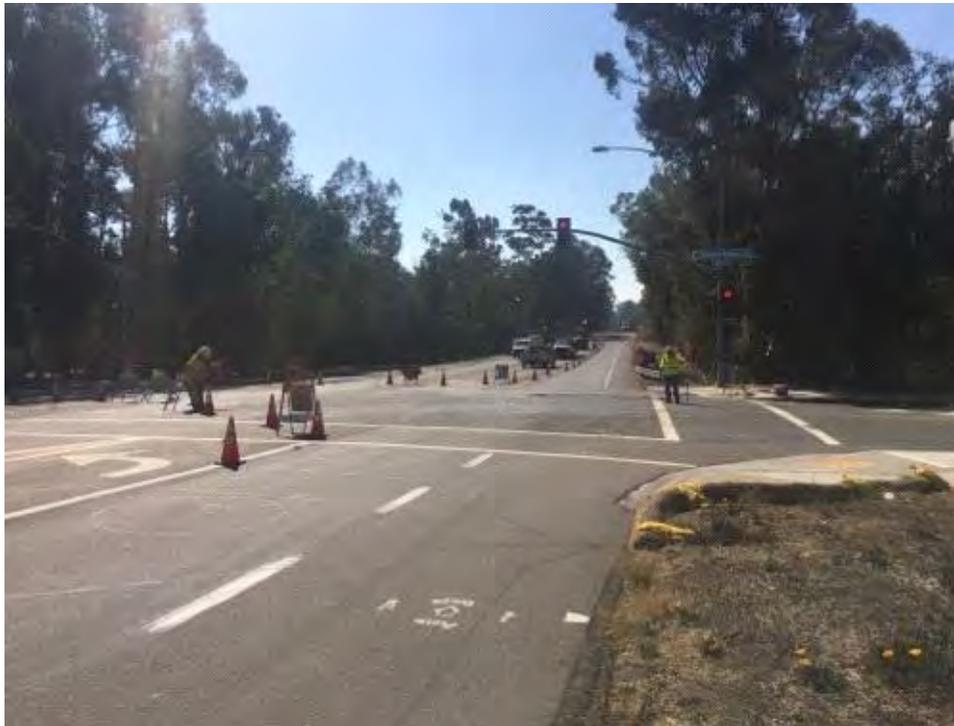
Caption Wrapping up work for the day at Avenida Magnifica and Pomerado Road. 8:30-4:30 work day planned for Pomerado Road tomorrow (Saturday).

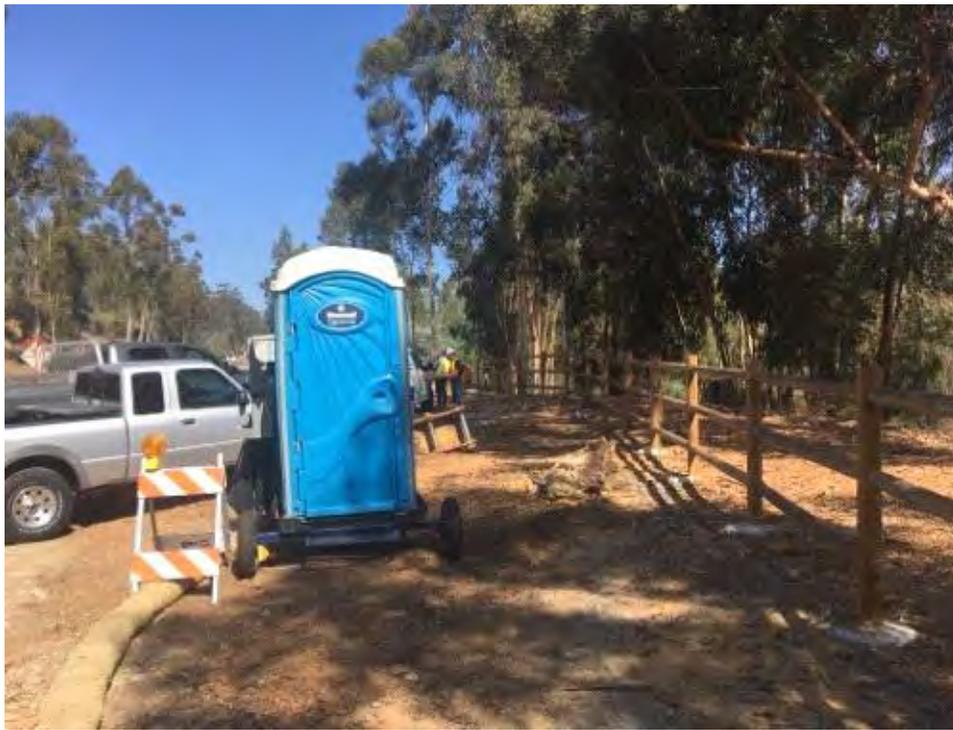
Caption Site where City tree removal operations planned for Saturday will be centered. Includes use of Helicopter and additional traffic control. Approved by City and unrelated to Sycamore project.

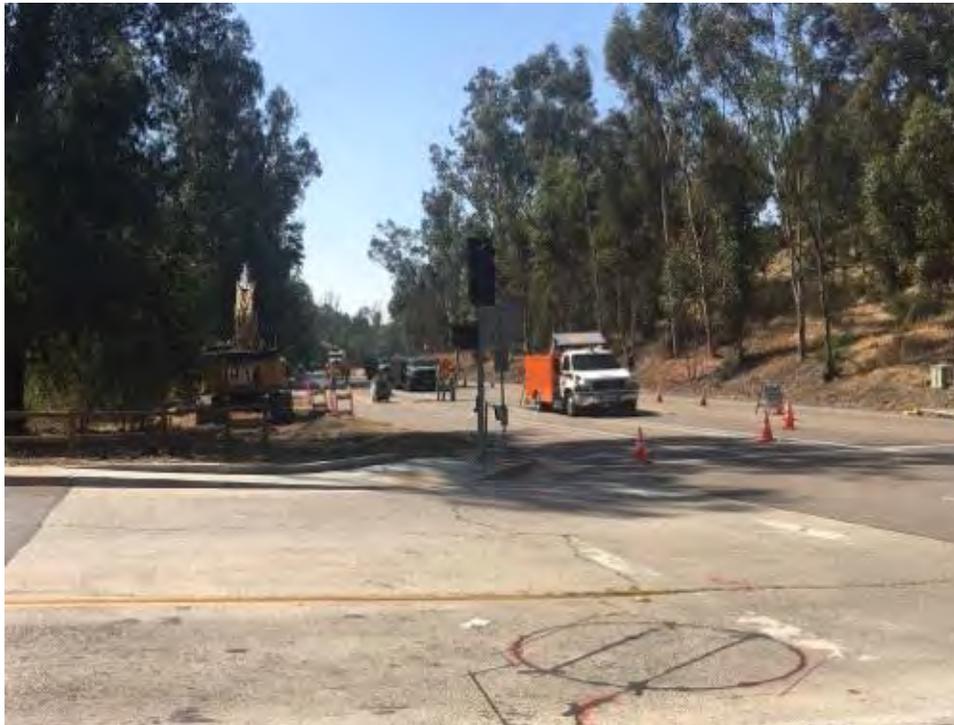
Caption Work site on Pomerado Road at Fairbrook Road.

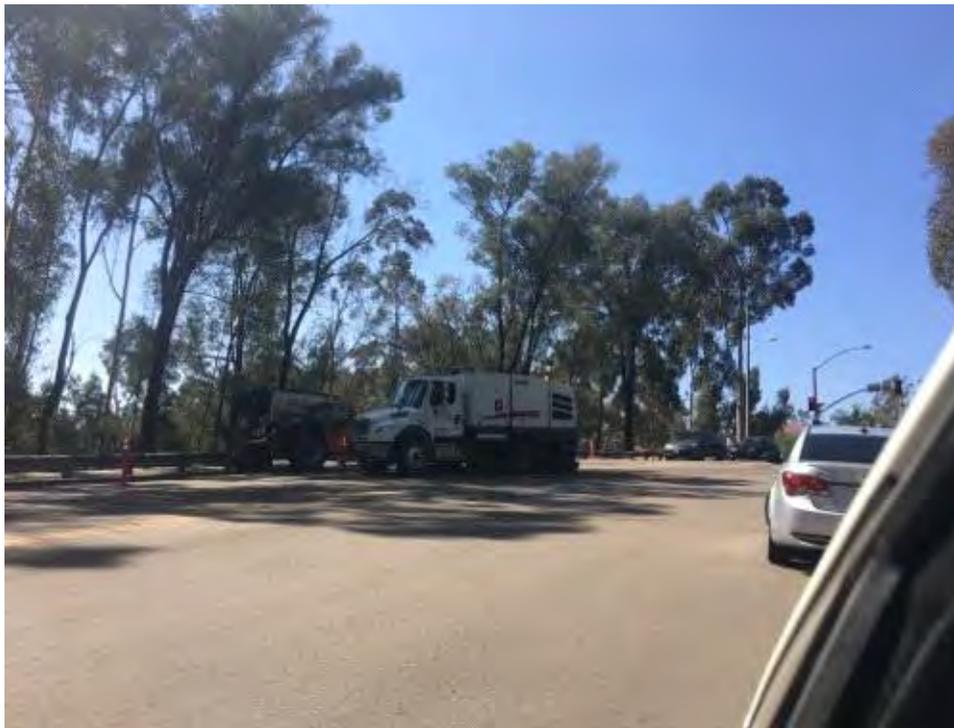
Caption Street sweeper on Pomerado Road.

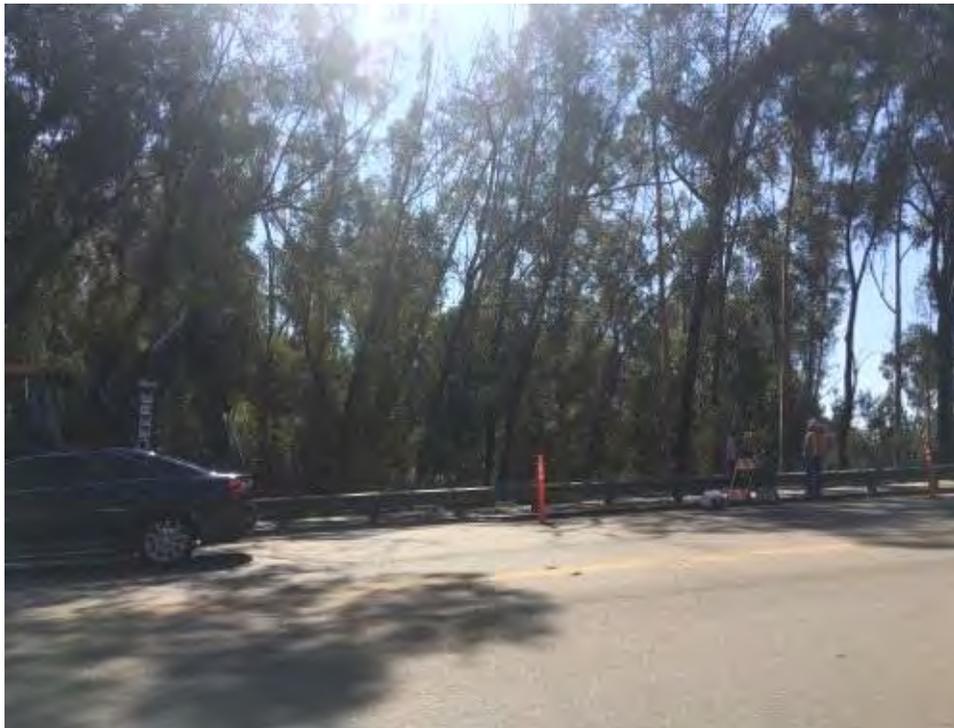
Caption Public interacting with construction personnel. Vehicle parked in active traffic lane.

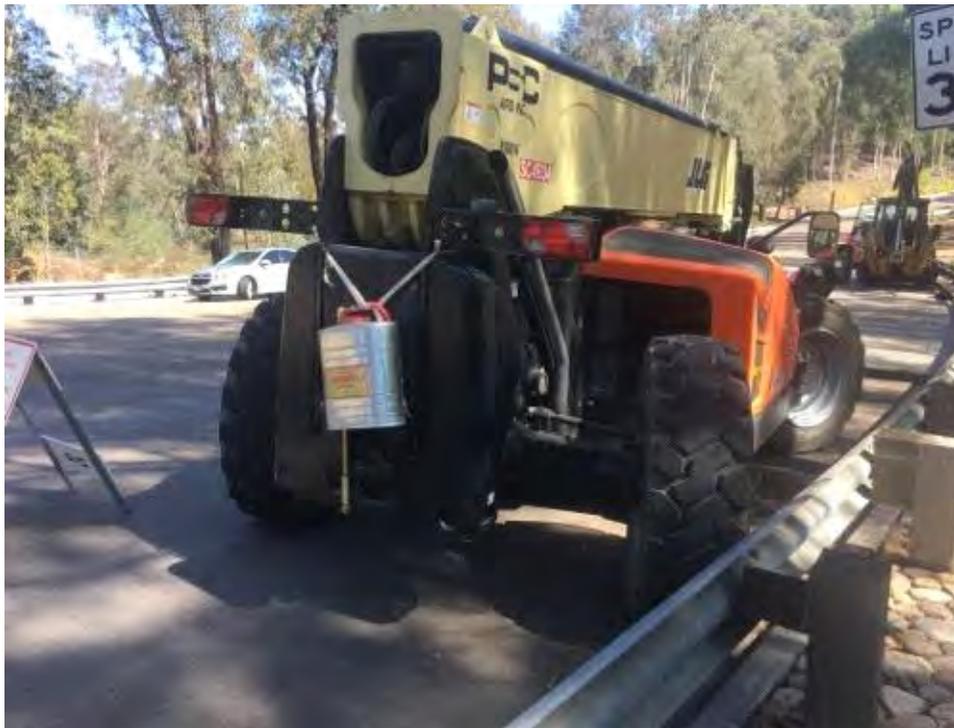
Caption Fire tools on parked lift.

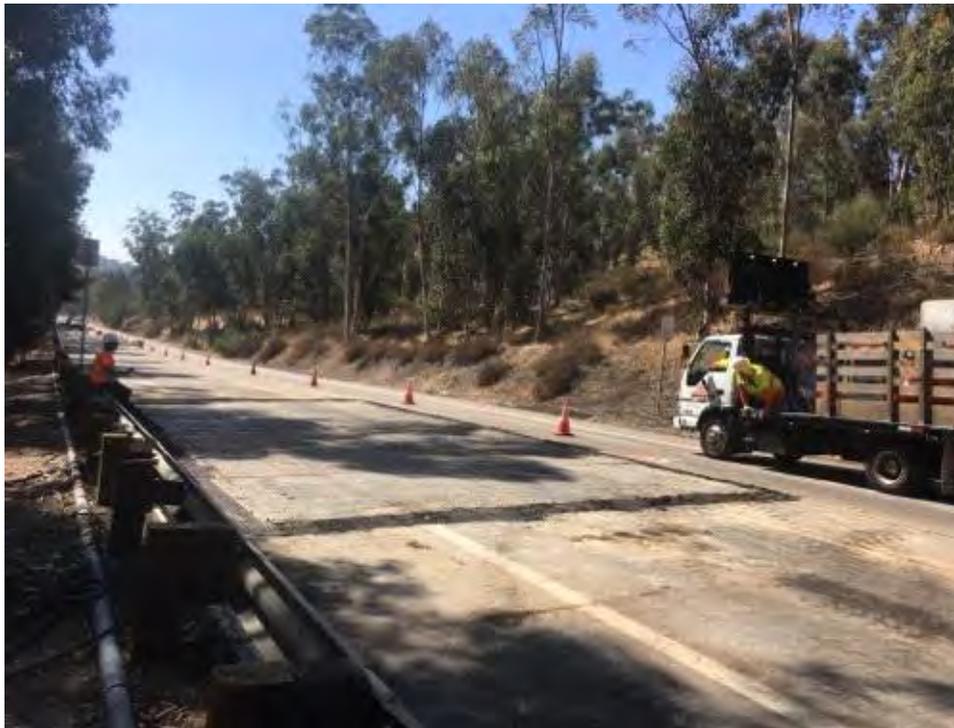
Caption Demobilizing at vault and prepping to move to next vault east on Pomerado Road.

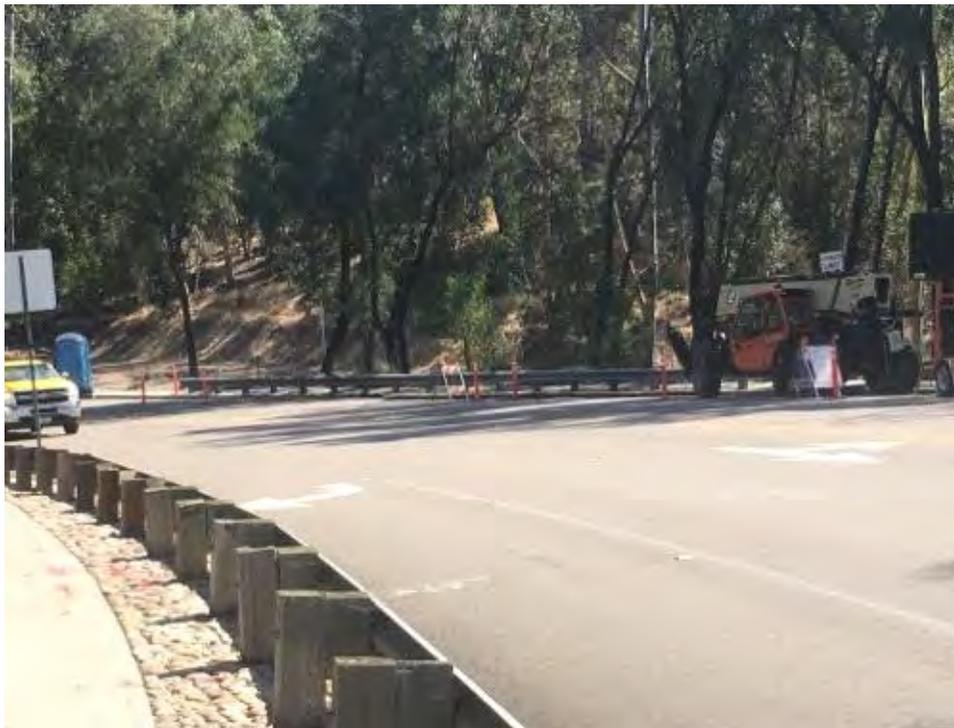
Caption Equipment staging on Semillon Blvd.

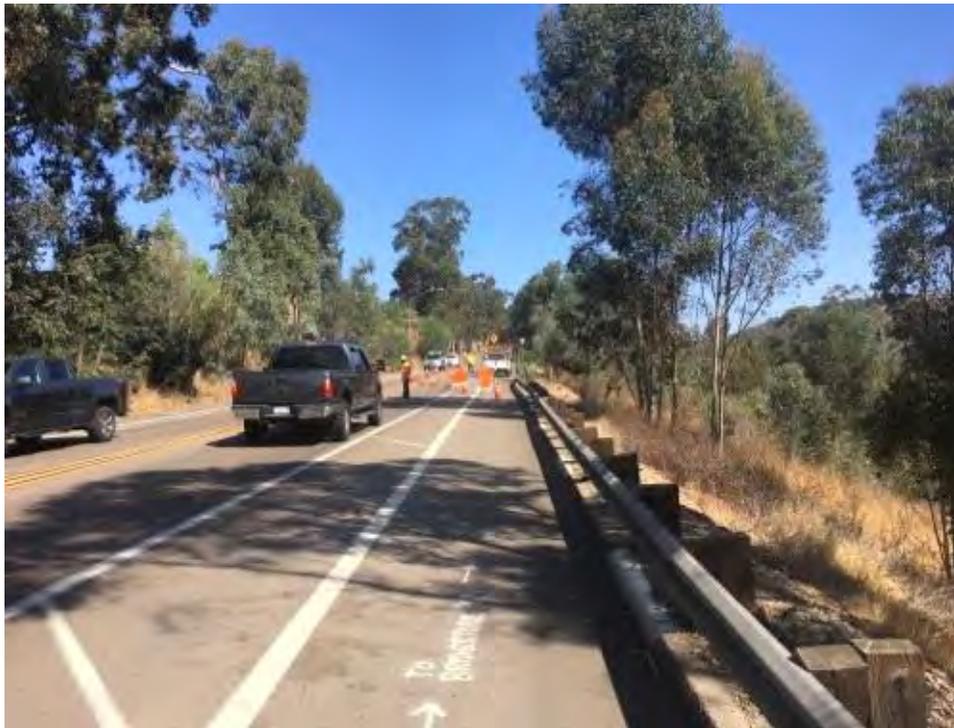
Caption Traffic control east of Semillon Blvd., preparing for saw cutting that will move later in the day.
