PROJECT MEMORANDUM SYCAMORE-PEÑASQUITOS 230-KV TRANSMISSION LINE PROJECT

Date: November 6, 2017
To: Billie Blanchard, CPUC Project Manager
From: Sheila Hoyer, CPUC Monitoring Supervisor
Subject: Weekly Report #43– October 22 to October 28, 2017

SDG&E Sycamore- Peñasquitos 230-kV Transmission Line Project: Daily Inspection Report

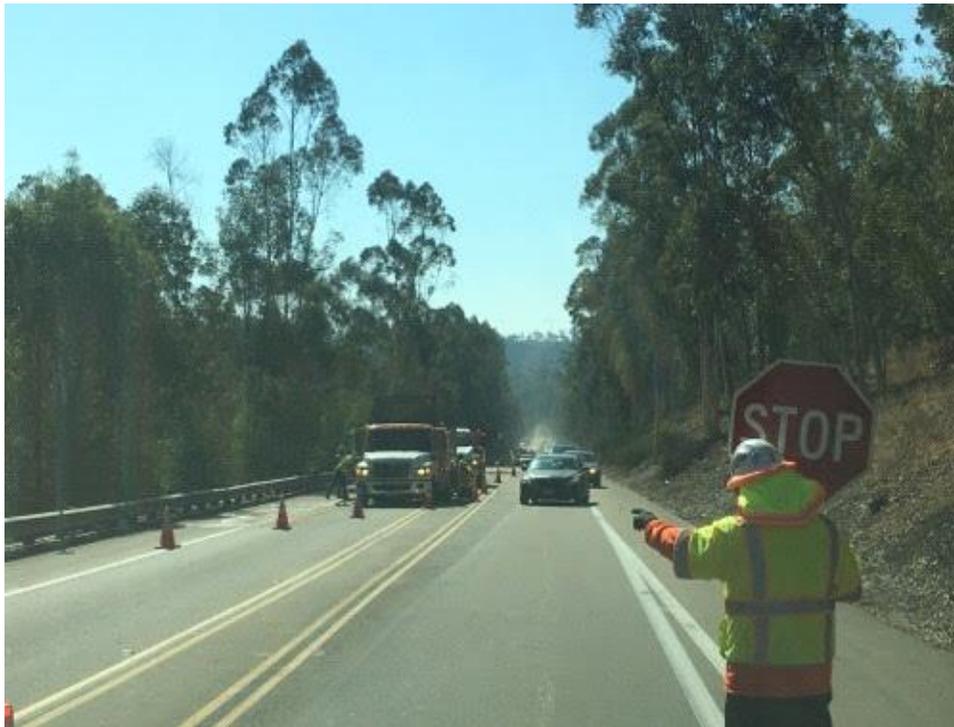
Caption Eastern edge of work on Pomerado Road.

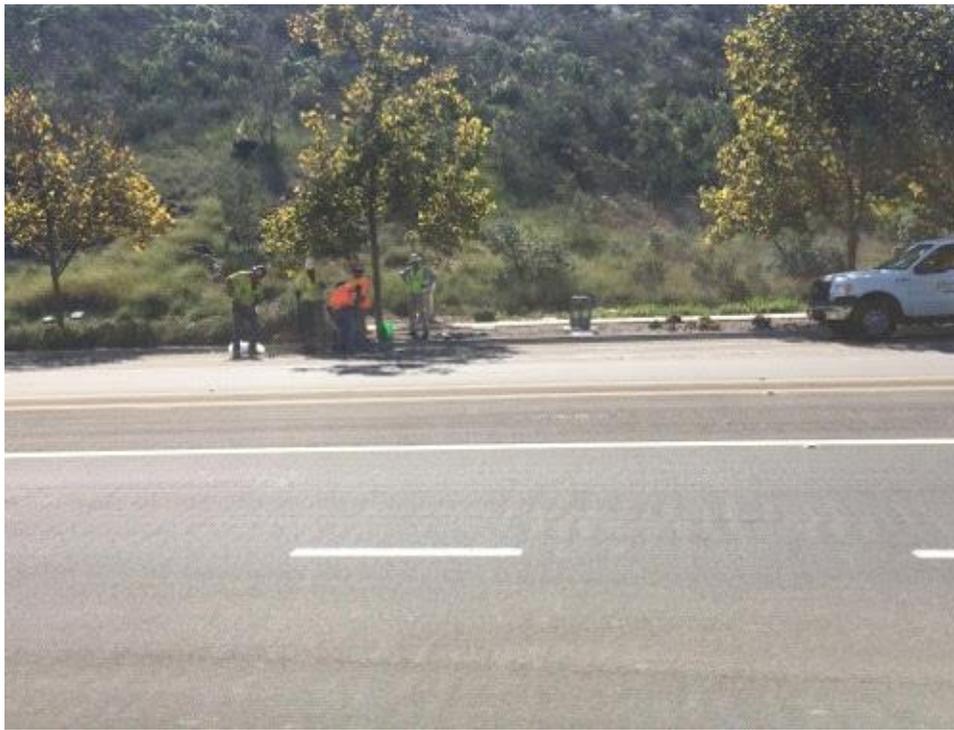
4. On October 26, 2017, approximately 4 ounces of hydraulic fluid were released onto the street surface at Segment 3, Section 14, near station 631+00. The release occurred when an excavator was being loaded onto a lowboy trailer for demobilization. The release was cleaned up on the same day with absorbent material and pads, which were stored in the hazardous waste storage bins located in the Stonebridge Staging Yard. No other hazardous material spills occurred during this reporting period.

Caption Clean up of hydraulic spill on Stonebridge Pkwy.

Small 4oz hydraulic spill from an excavator on Stonebridge Pkwy. Spill was properly dealt with and materials were removed from ROW.

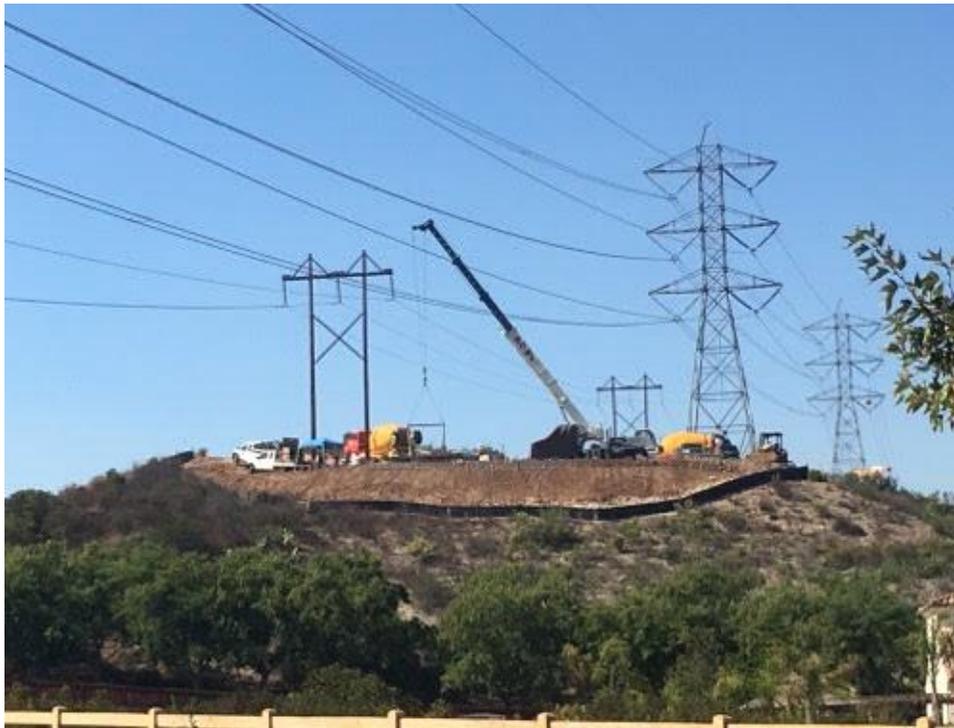
Caption P05 concrete work for tower.

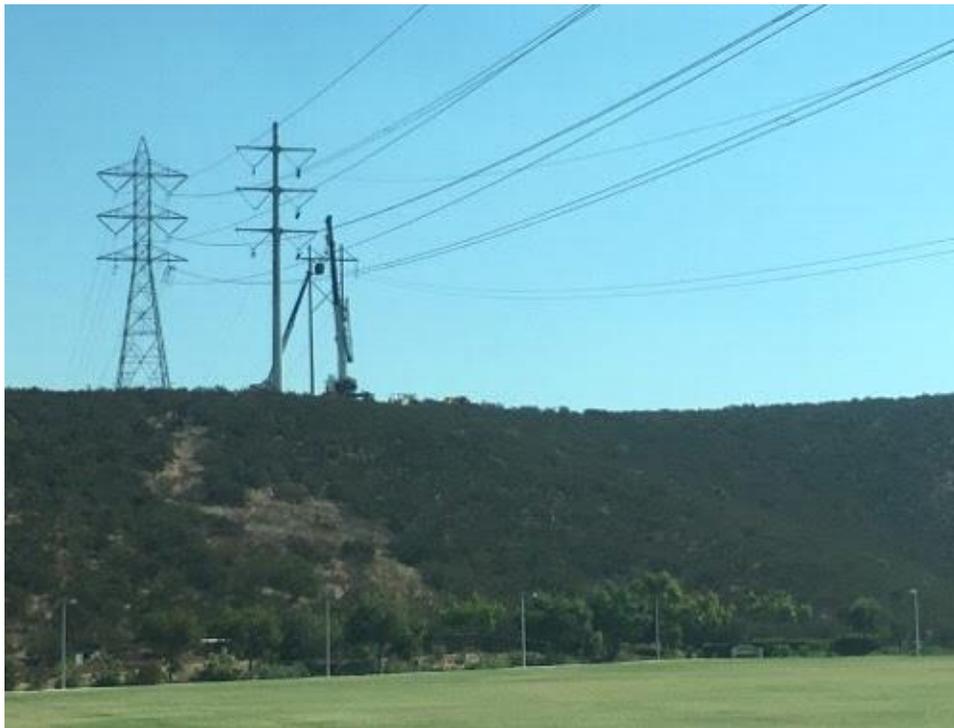
Caption Overhead line sag work at P04.

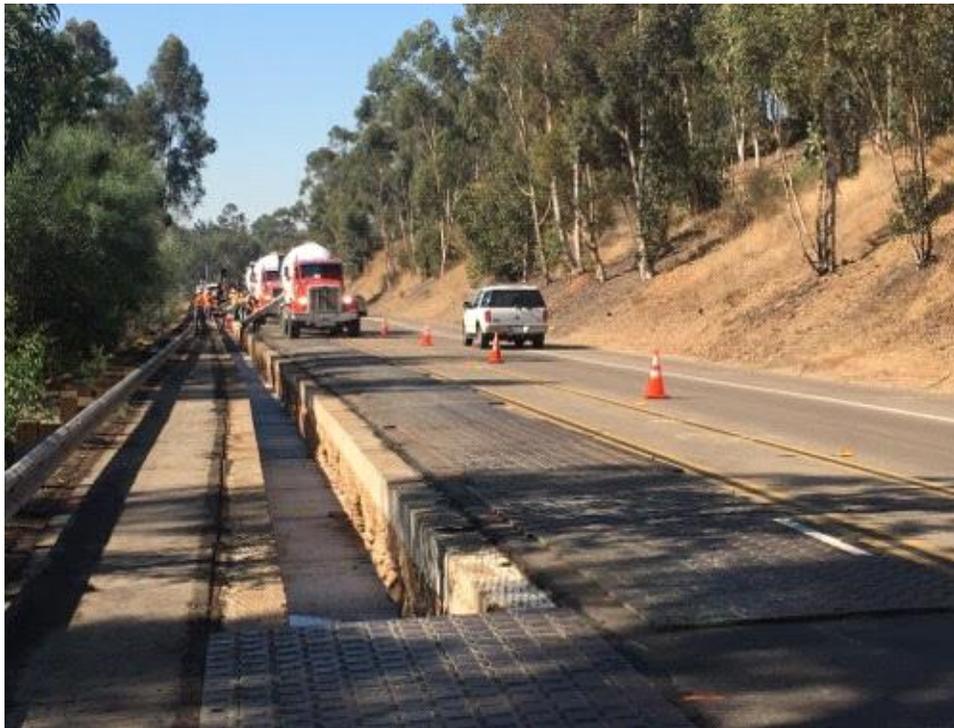
Caption Concrete backfill on Pomerado Road.

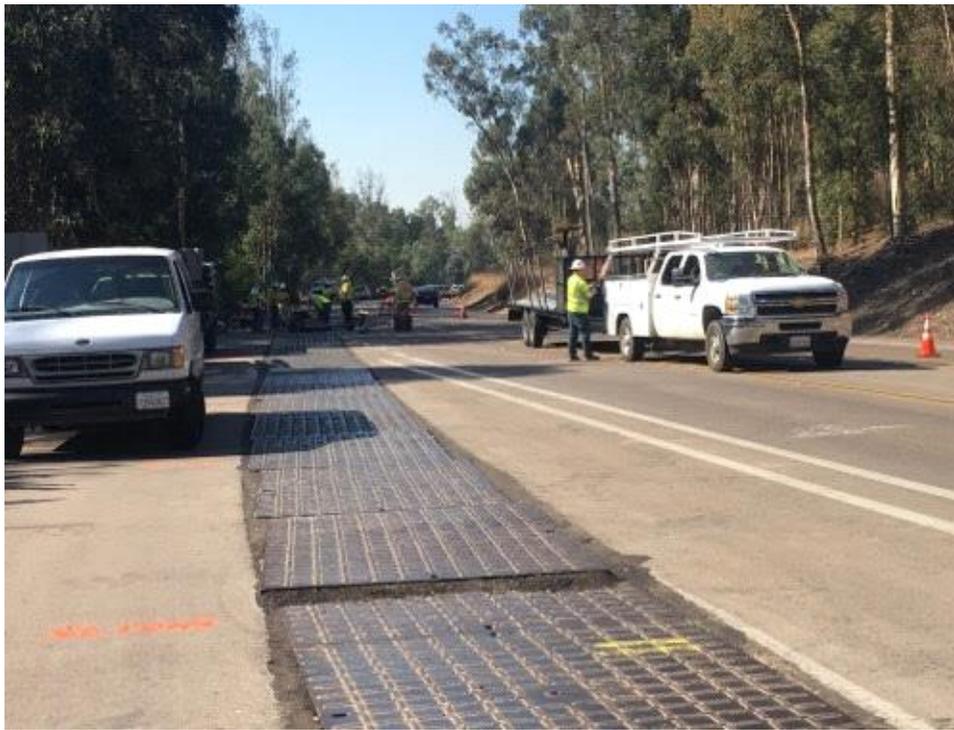
Caption Trench work on Pomerado Road west of Fairbrook Road.

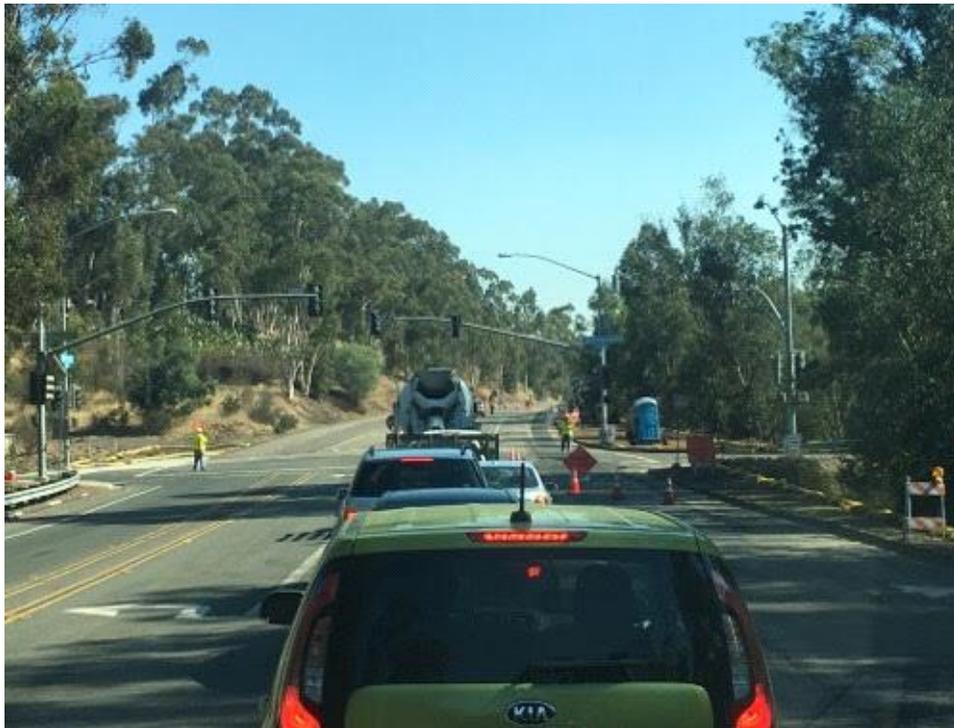
Caption Western edge of work on Pomerado Road.

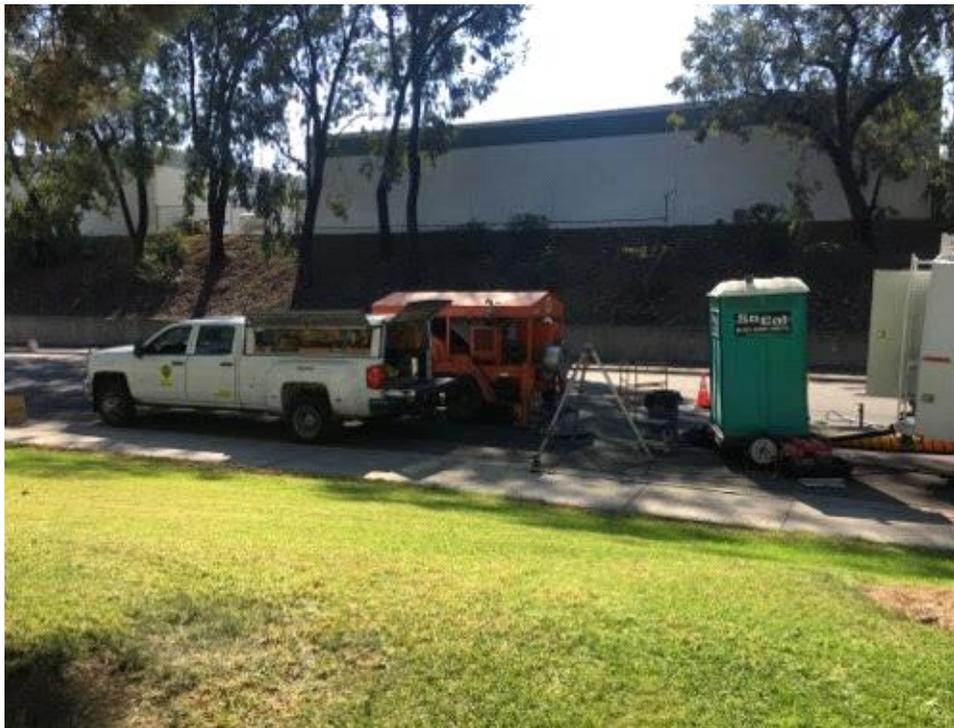
Caption Vault mandrelling.

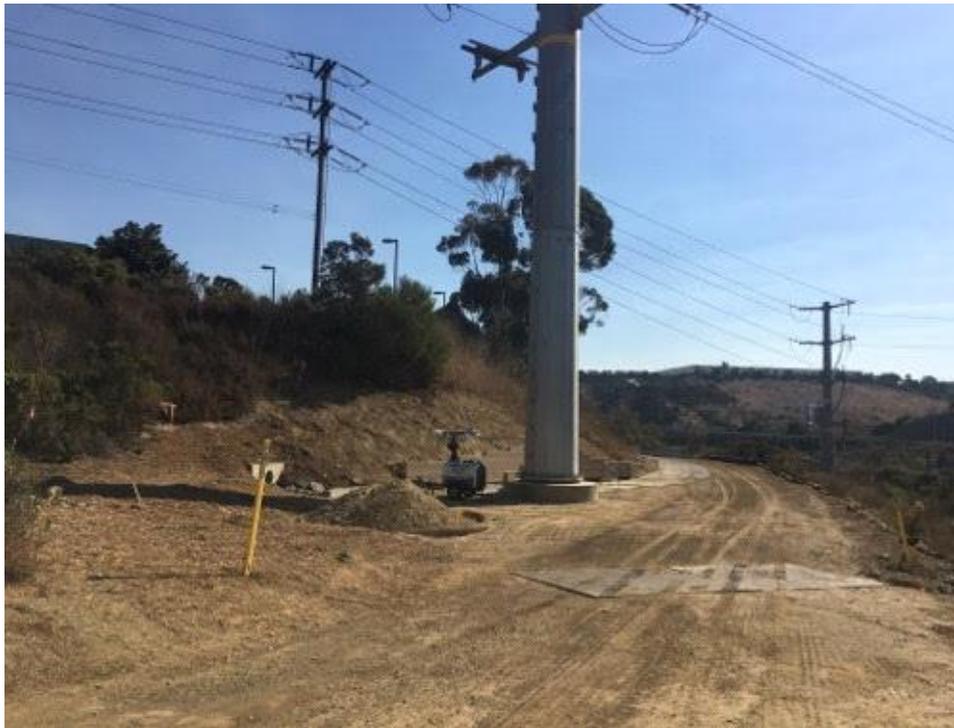
Caption CC MM CP pole site, no active work.

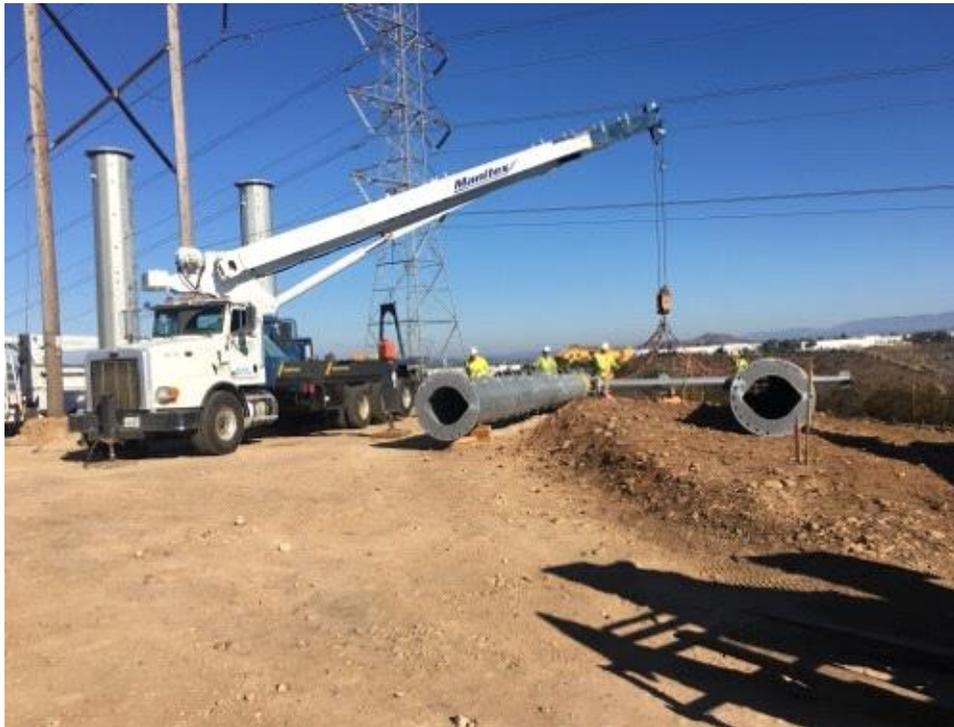
Caption Pole installation at P06.

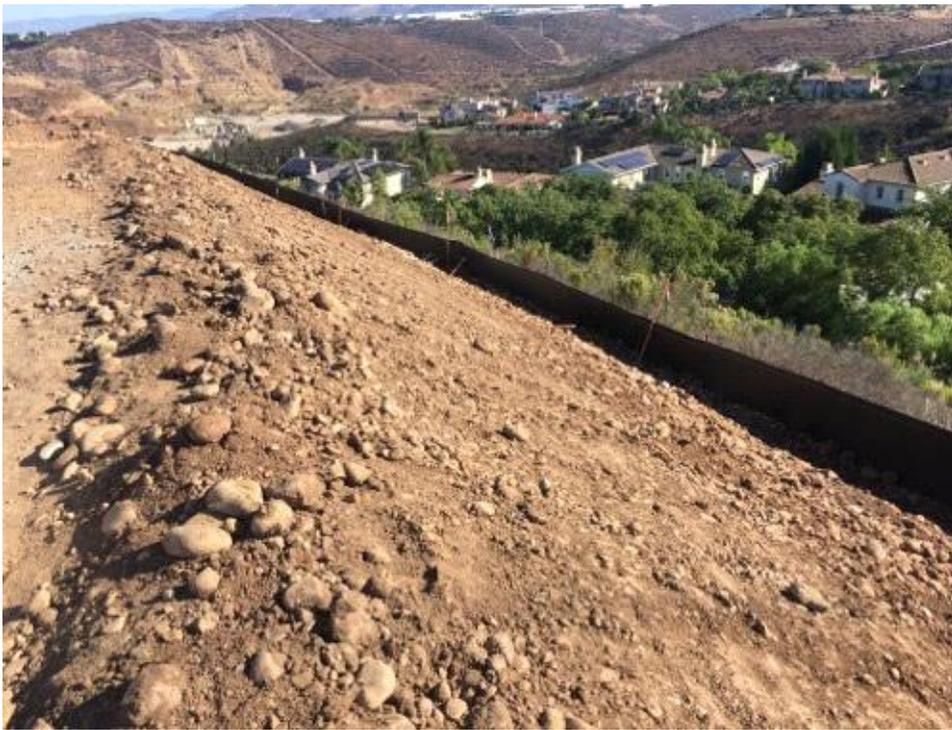
Caption P05 cut slope and BMPs.

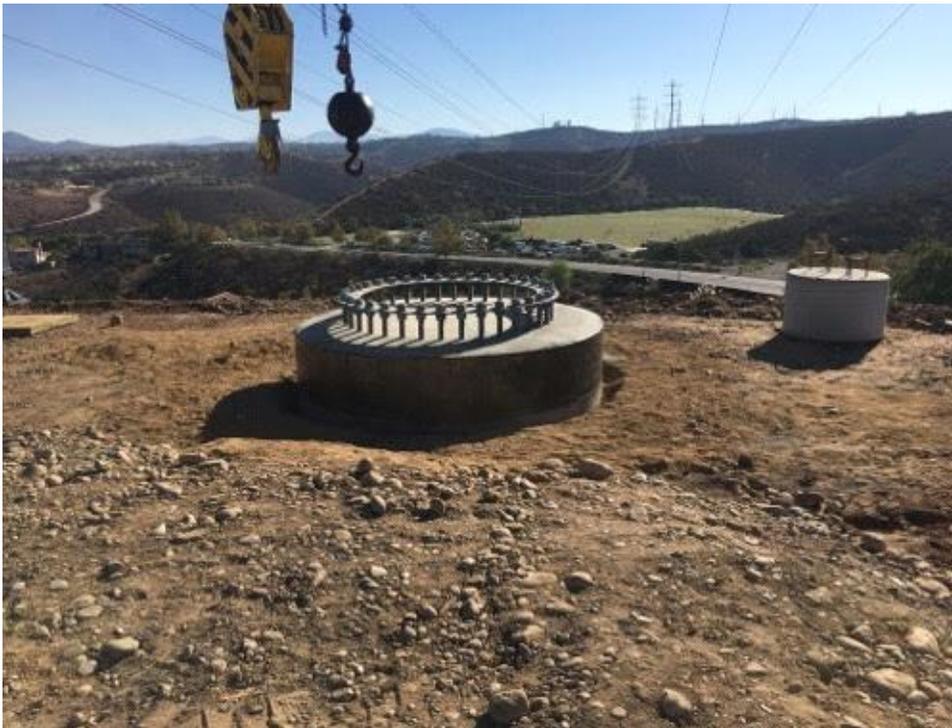
Caption P05 concrete foundations.

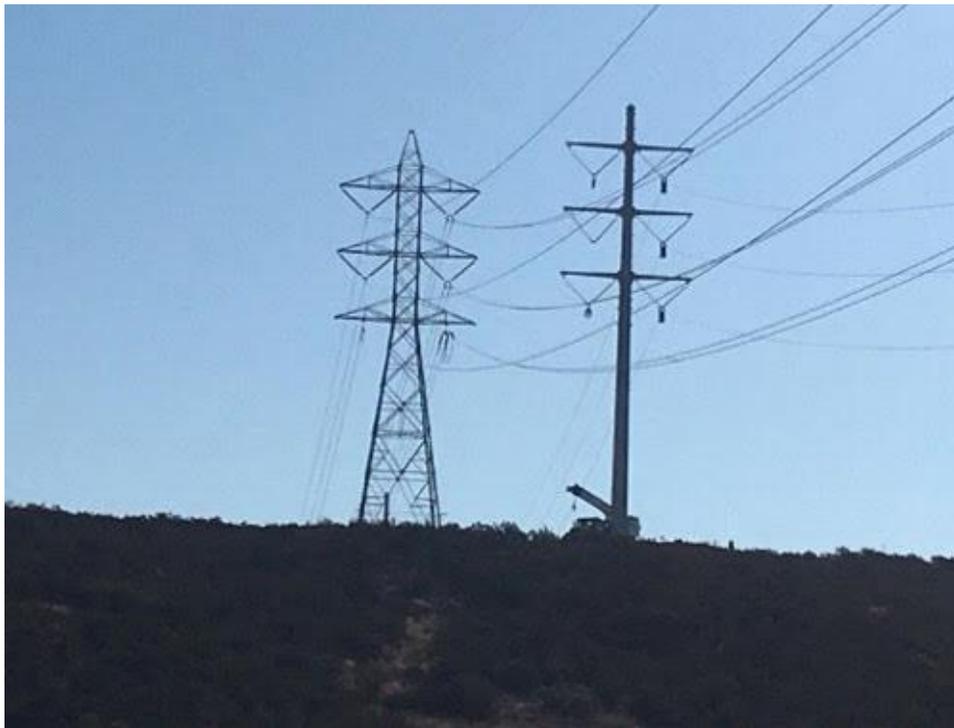
Caption Wire pullies installed at P04. Crew is actively working at P05.

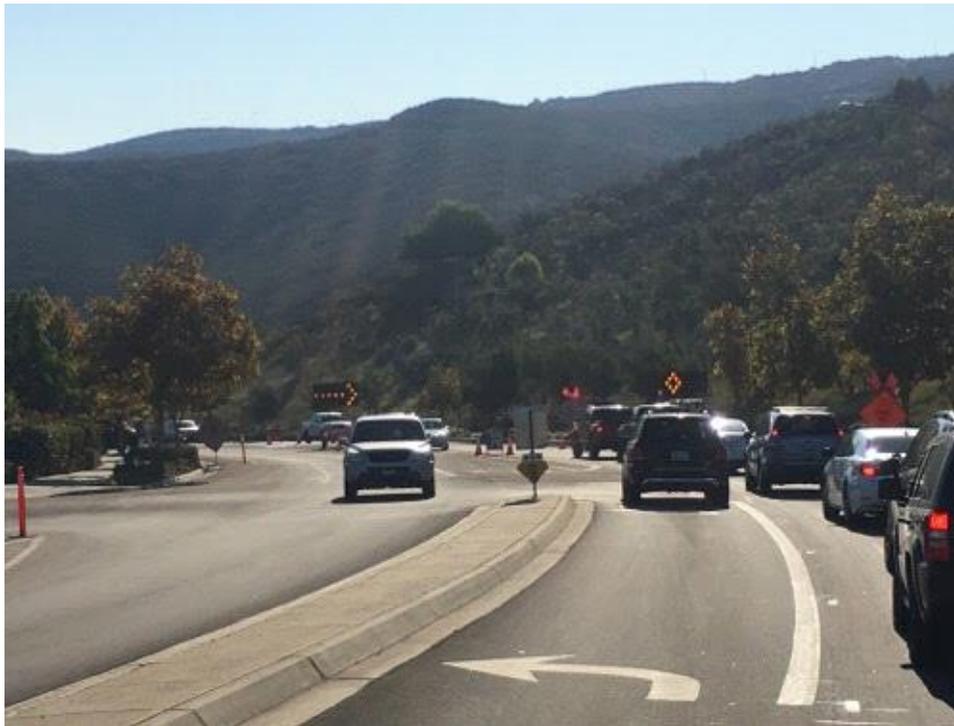
Caption Traffic control on Stonebridge Pkwy.

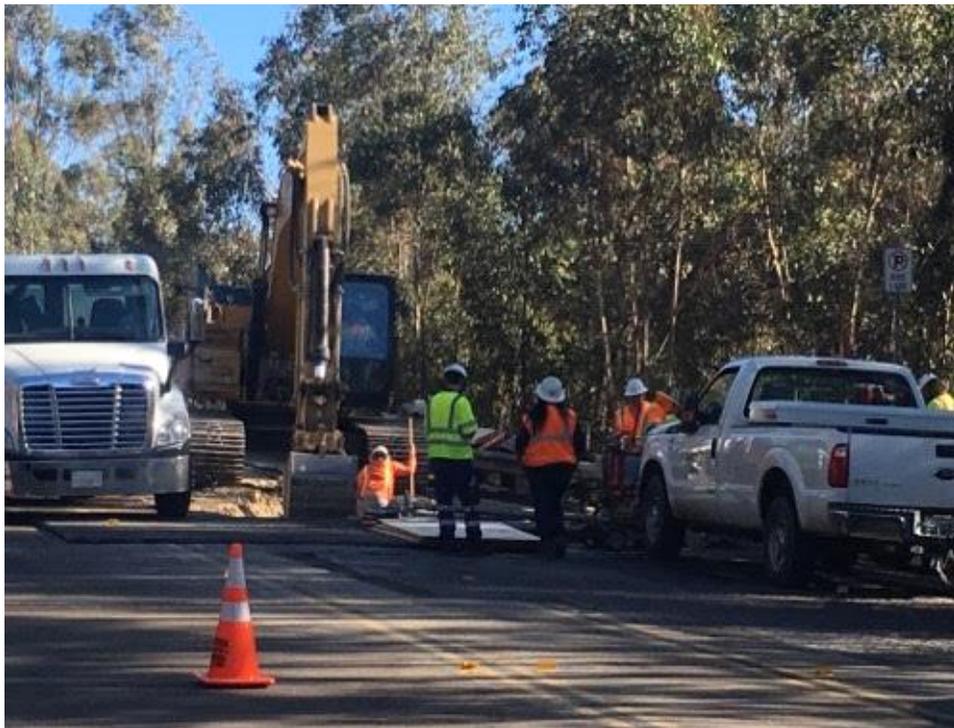
Caption Excavation on Pomerado Road.

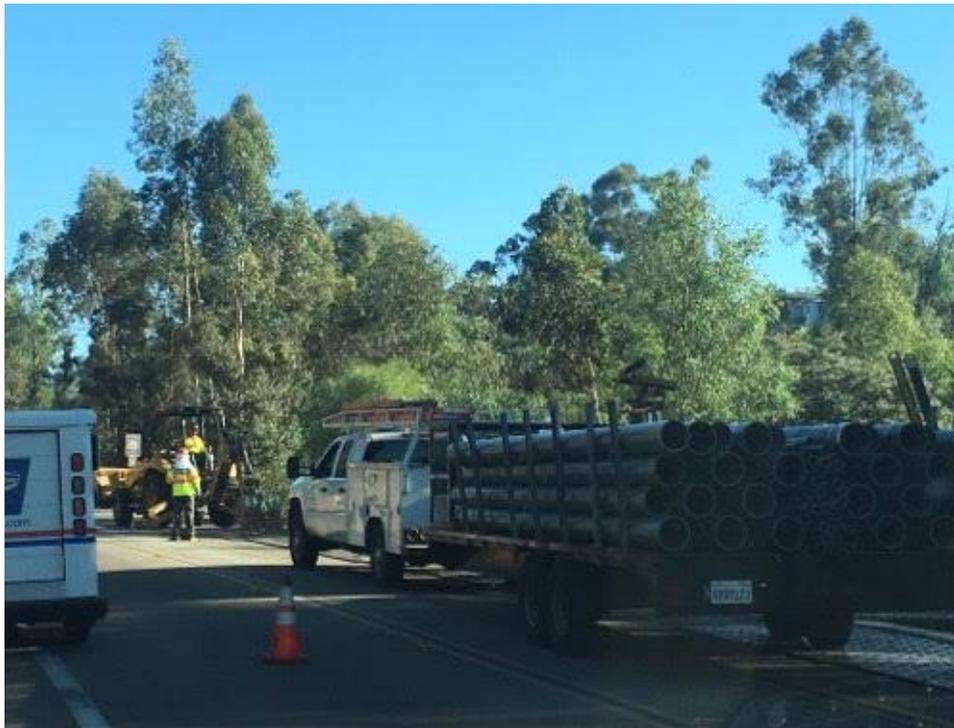
Caption Conduit installation on Pomerado Road.

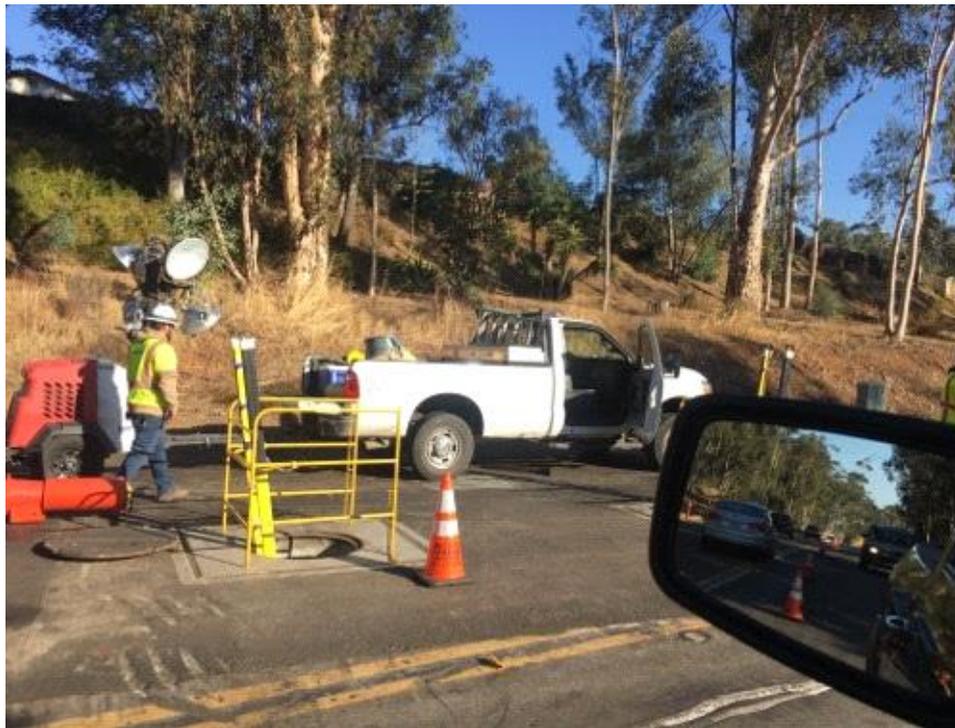
Caption Vault work west of Avenida Magnifica.
