PROJECT MEMORANDUM SYCAMORE-PEÑASQUITOS 230-KV TRANSMISSION LINE PROJECT

Date: January 12, 2018
To: Billie Blanchard, CPUC Project Manager
From: Sheila Hoyer, CPUC Monitoring Supervisor
Subject: Weekly Report #53 – January 2 to January 6, 2018

SDG&E Sycamore-Peñasquitos 230-kV Transmission Line Project: Daily Inspection Report

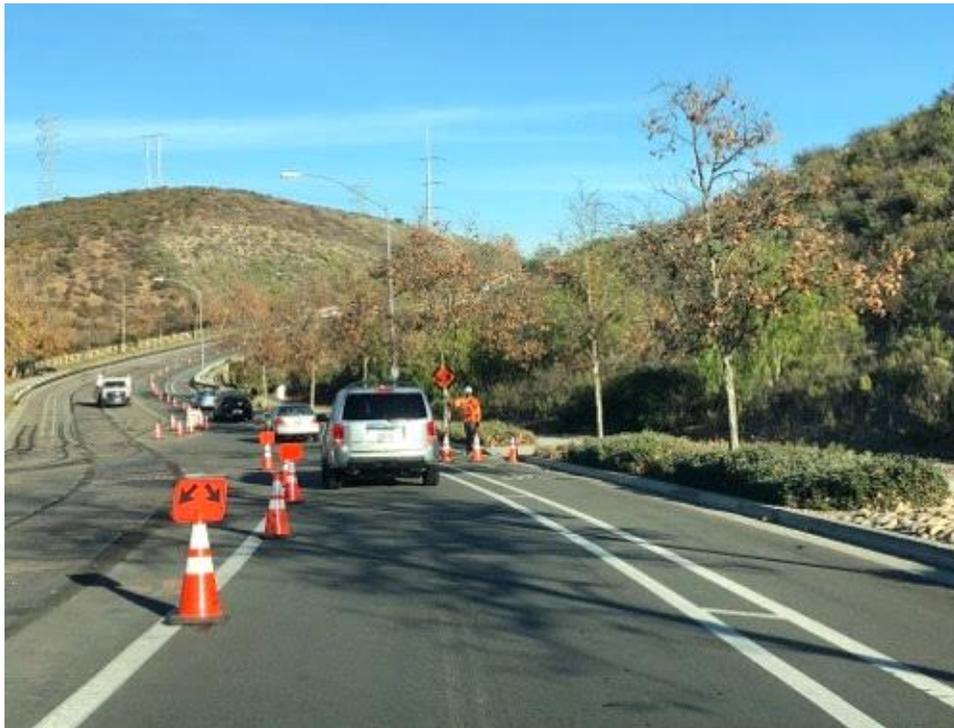
Caption Traffic control and clean-up work on Stonebridge Parkway.

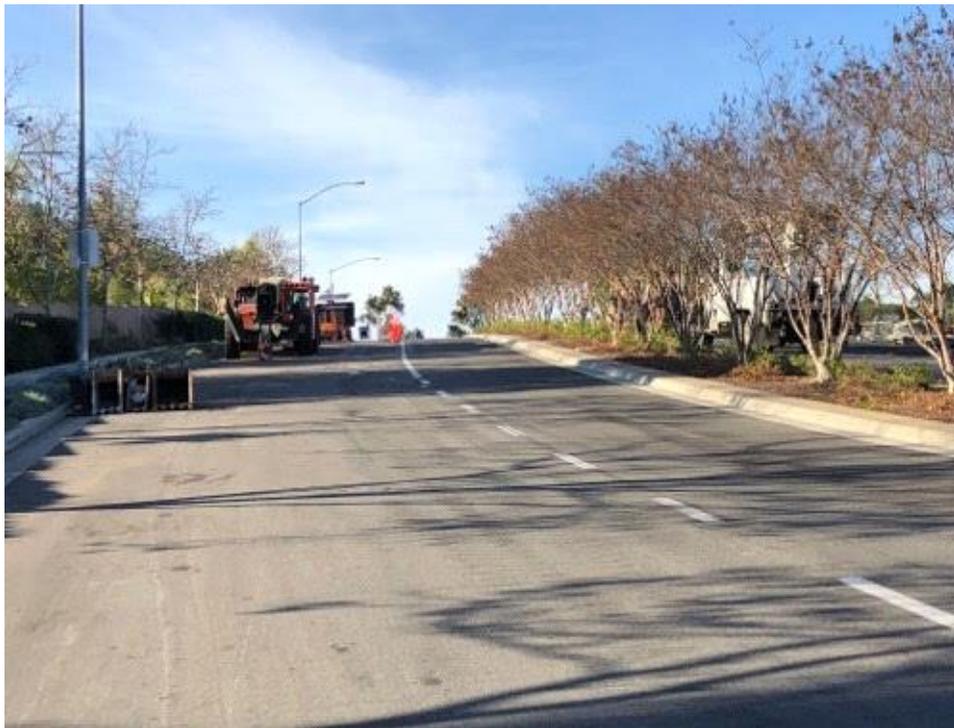
Caption Stonebridge Parkway work complete and all equipment staged properly.

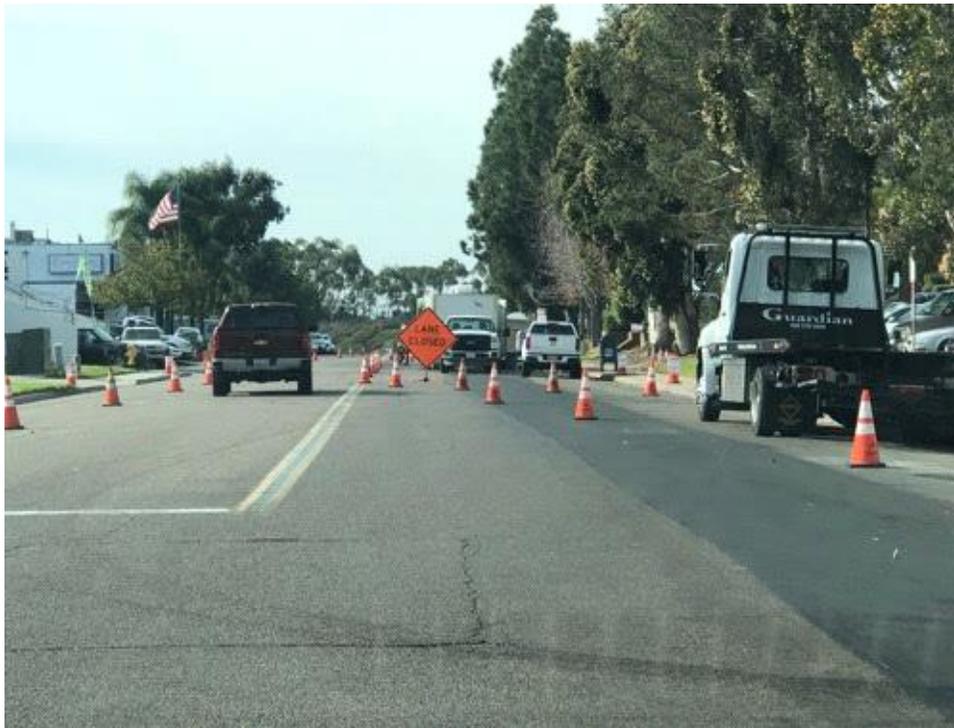
Caption Vault work and traffic control on Arjons Drive.

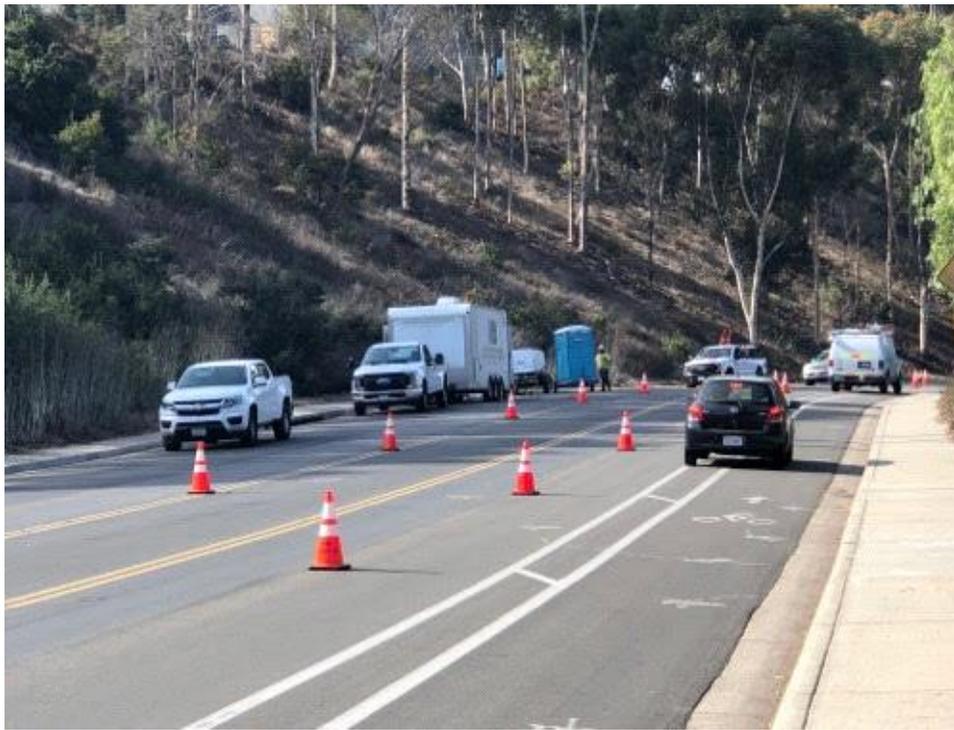
Caption Vault and traffic control on Carroll Road.

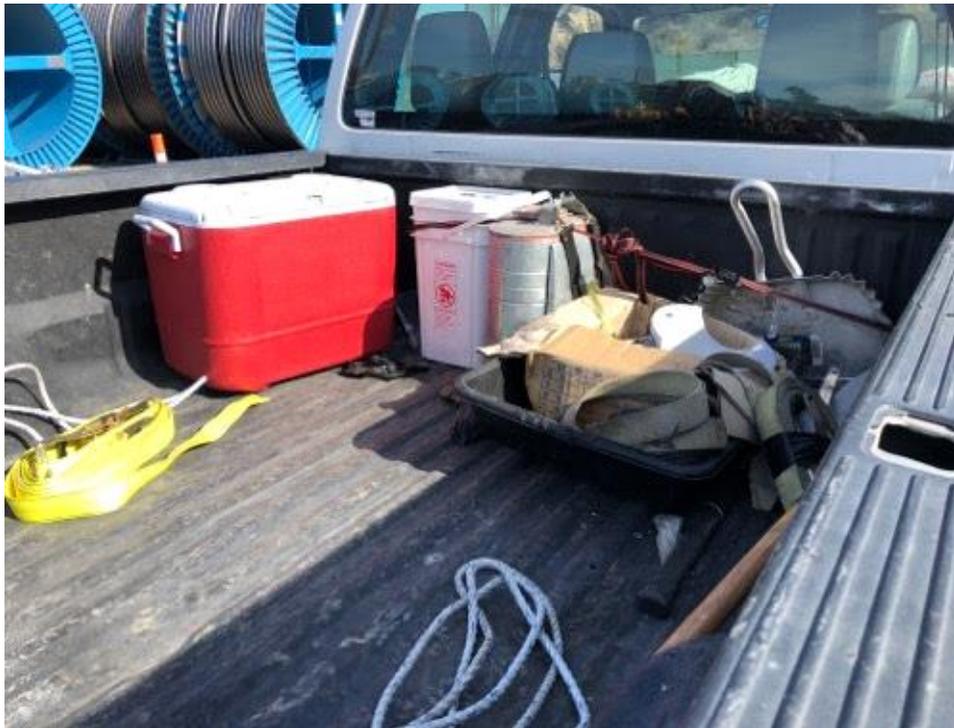
Caption Vehicle at Driving Range Staging Yard with fire tools.

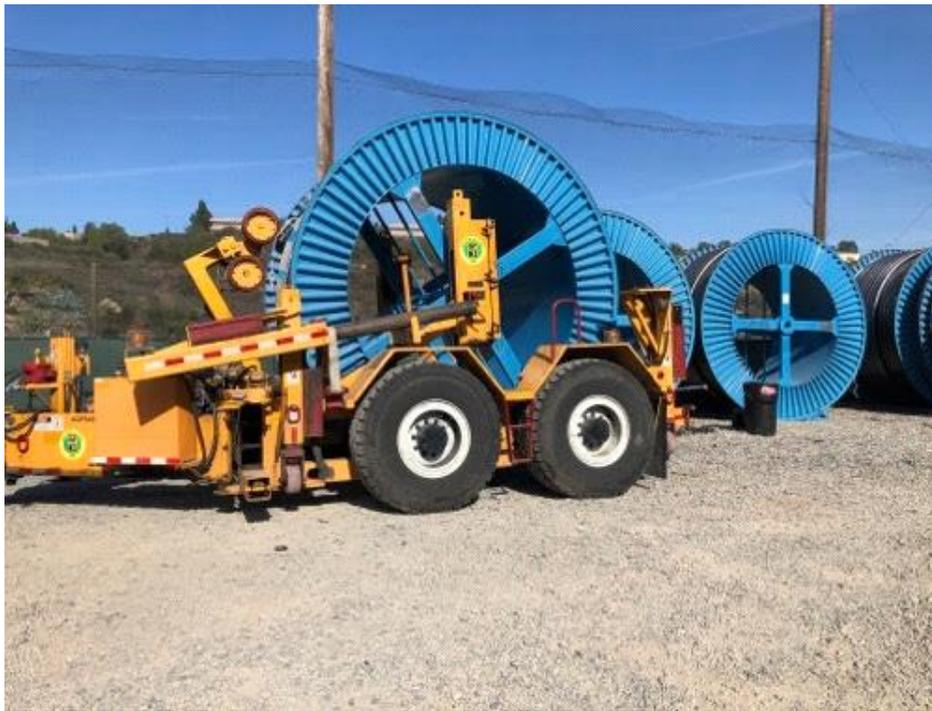
Caption Yard work at Driving Range staging Yard.

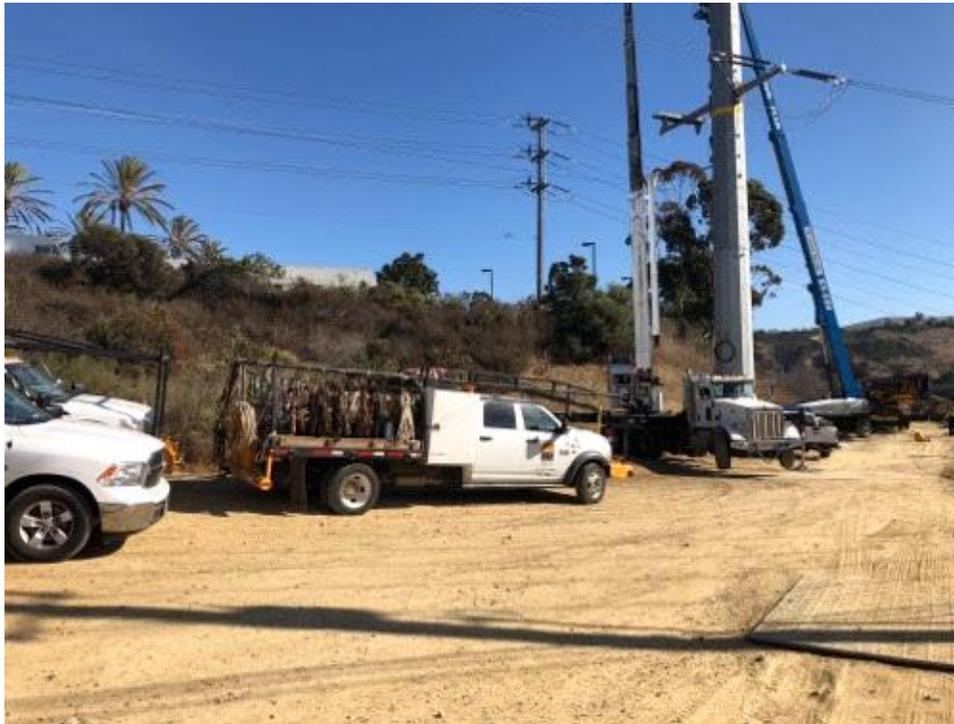
Caption CC MM CP work site fire tools present at each vehicle.

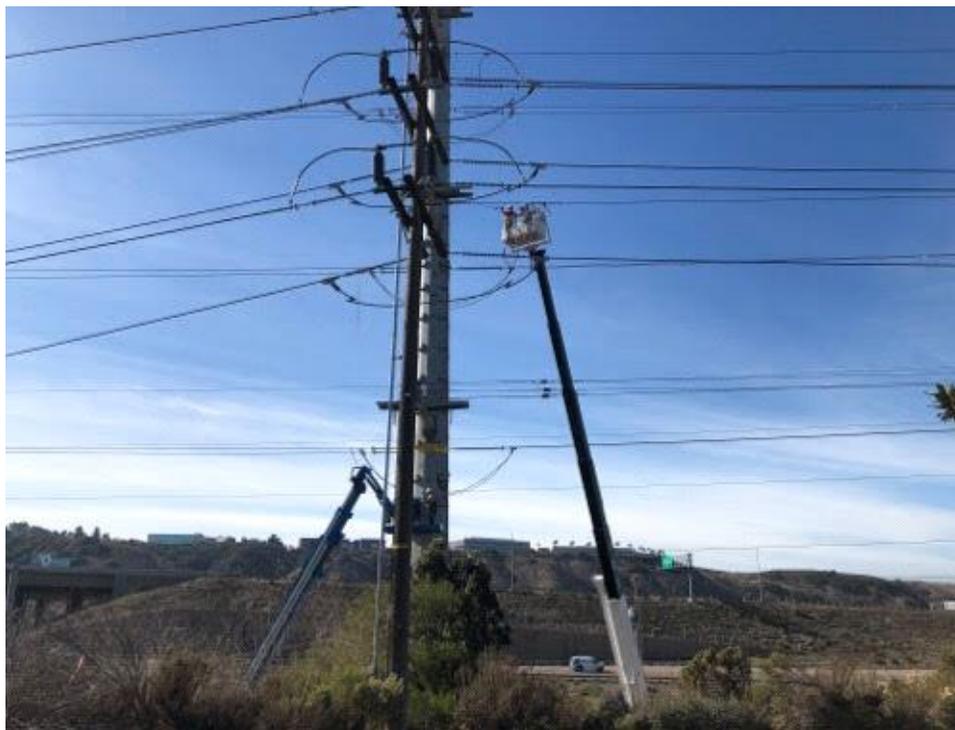
Caption Wire work at CC MM C.P

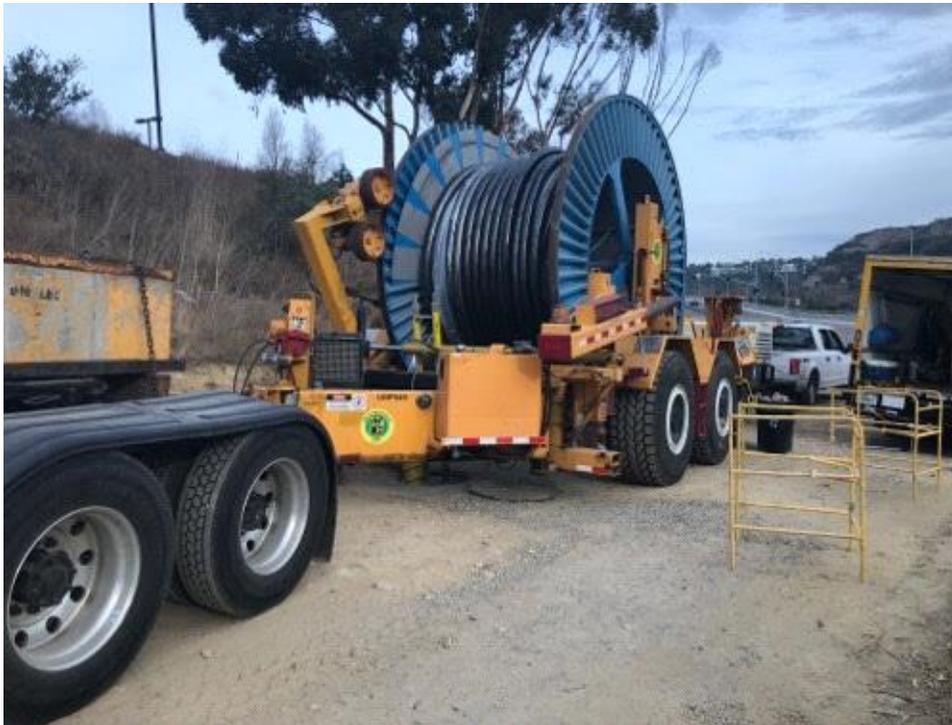
Caption Cable at vault CC MM CP.

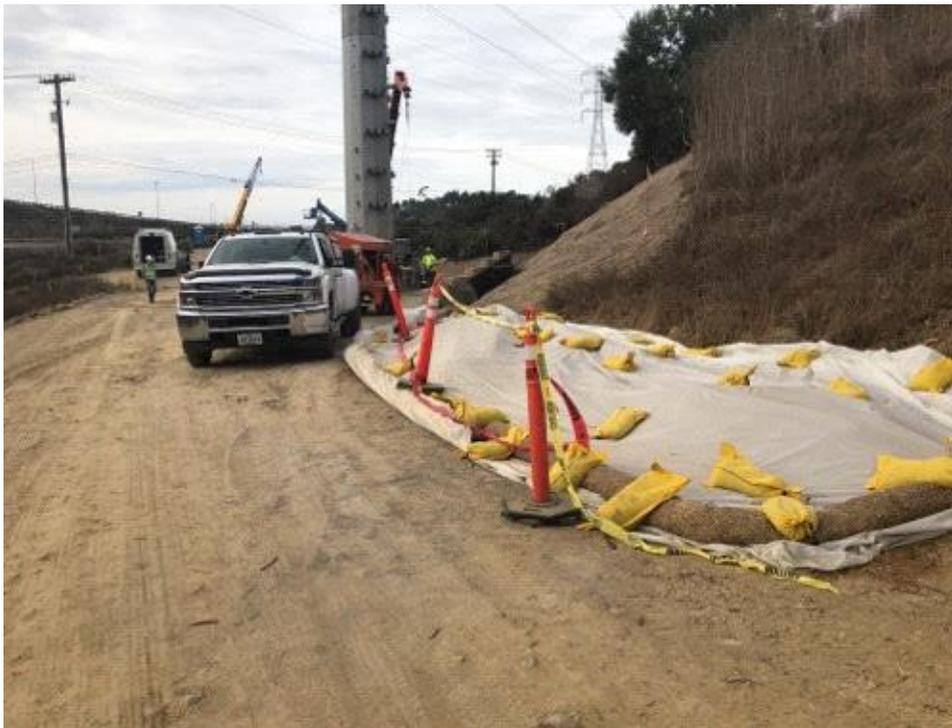
Caption CC MM CP BMPs in place covering stock pile.

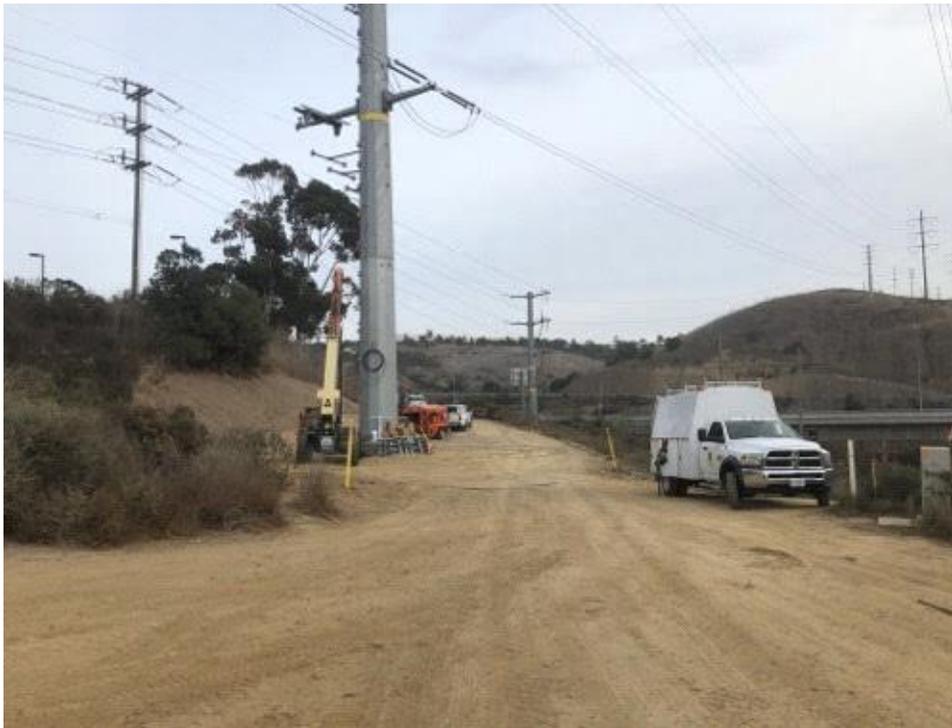
Caption CC MM CP cable install at base of pole.

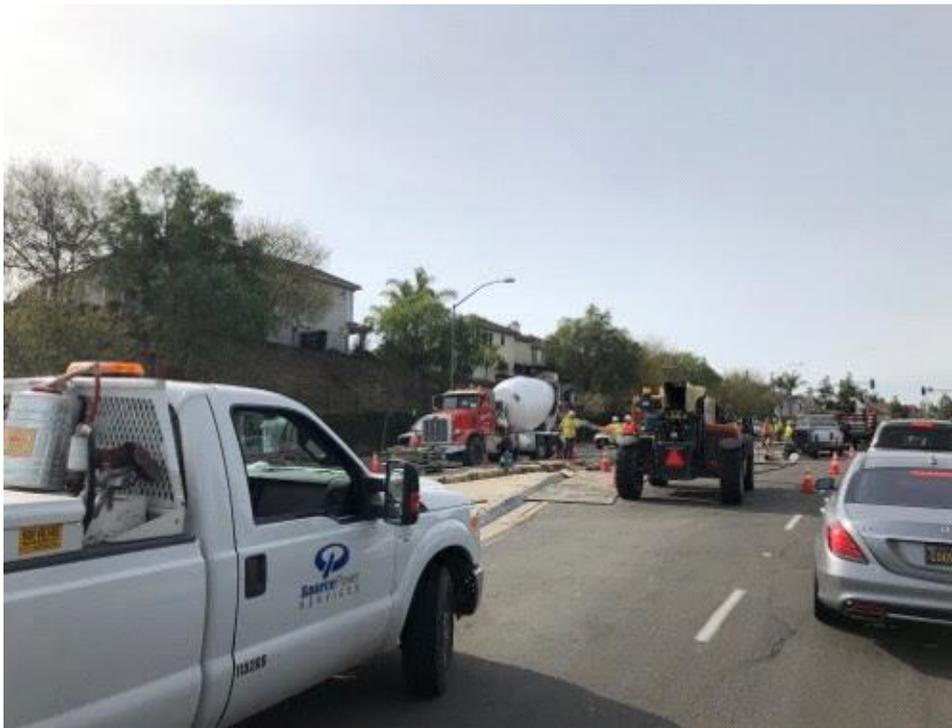
Caption Trench work on Pomerado Road.

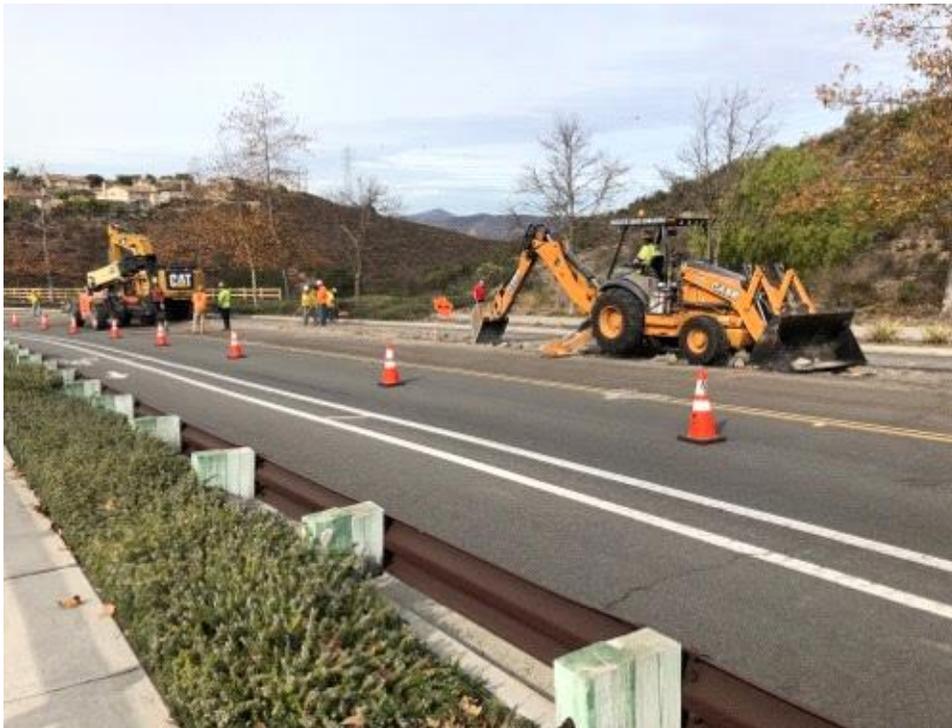
Caption Excavation on Stonebridge Parkway.

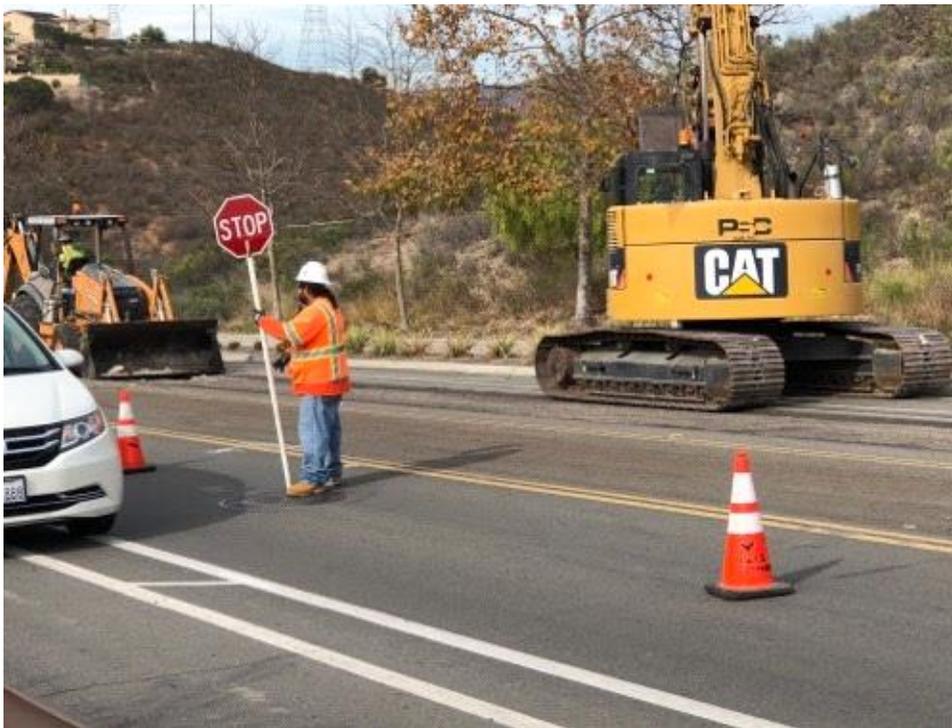
Caption Traffic control and note fire tools on excavator.

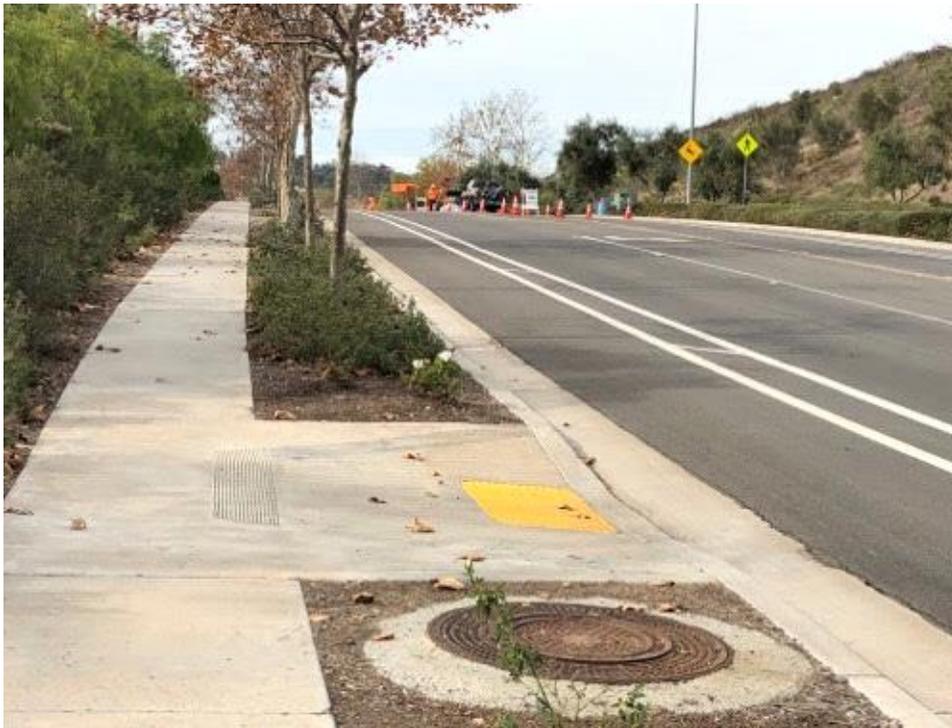
Caption Traffic control on Stonebridge Parkway.

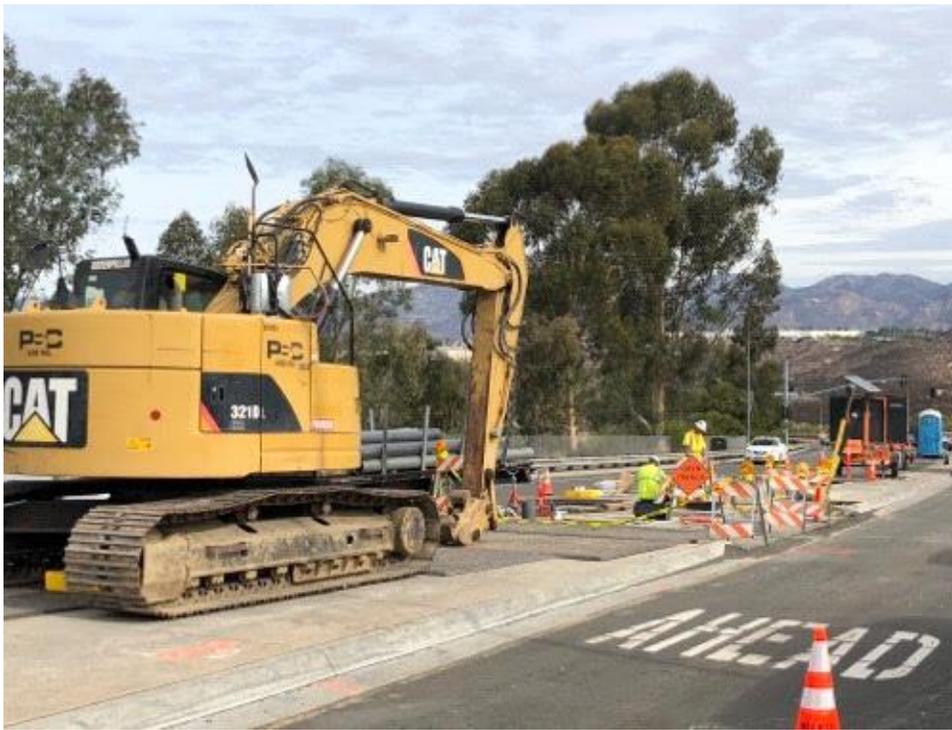
Caption Vault construction in median on Pomerado Road.

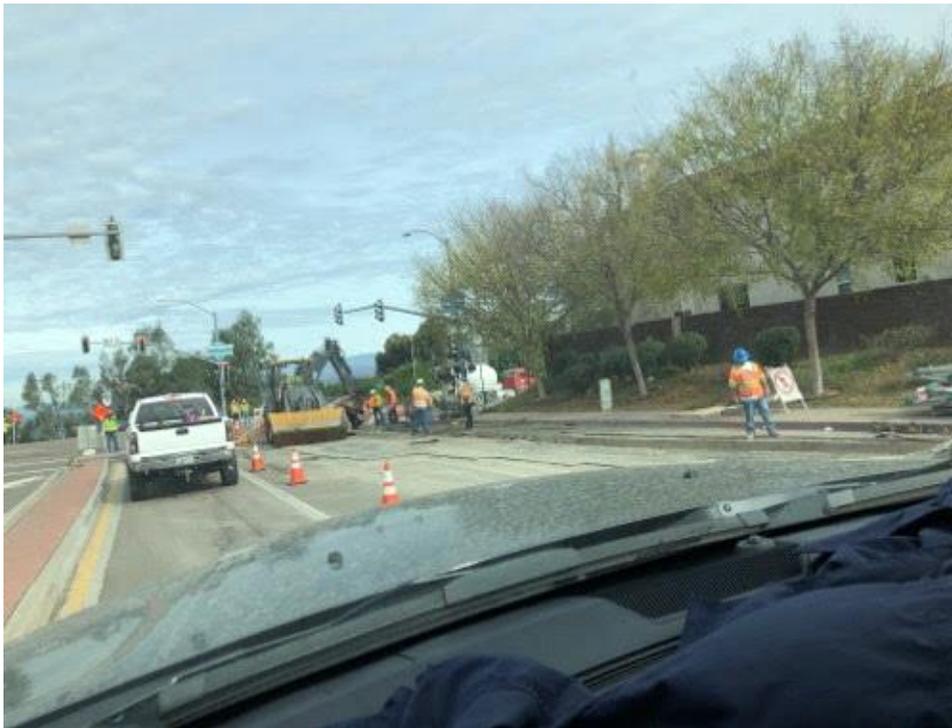
Caption Trench work at Pomerado Road.

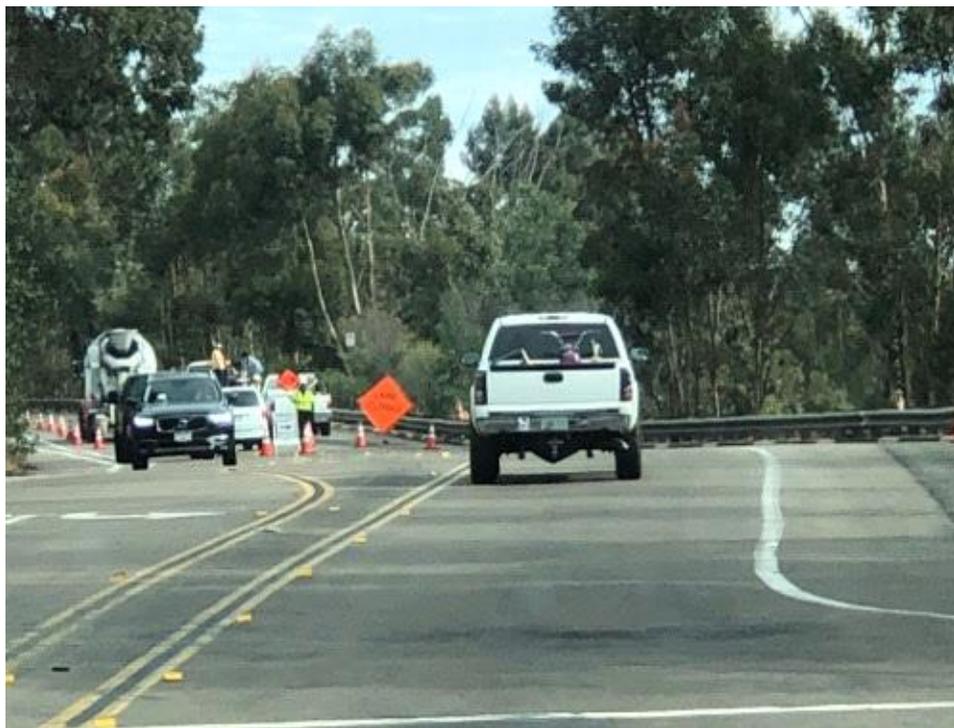
Caption Vault mandreling on Pomerado Road.
