PROJECT MEMORANDUM SYCAMORE-PEÑASQUITOS 230-KV TRANSMISSION LINE PROJECT

Date: January 22, 2018
To: Billie Blanchard, CPUC Project Manager
From: Sheila Hoyer, CPUC Monitoring Supervisor
Subject: Weekly Report #54 – January 8 to January 13, 2018

2018-01-10 AM Inspection Report

SDG&E Sycamore-Peñasquitos 230-kV Transmission Line Project: Daily Inspection Report

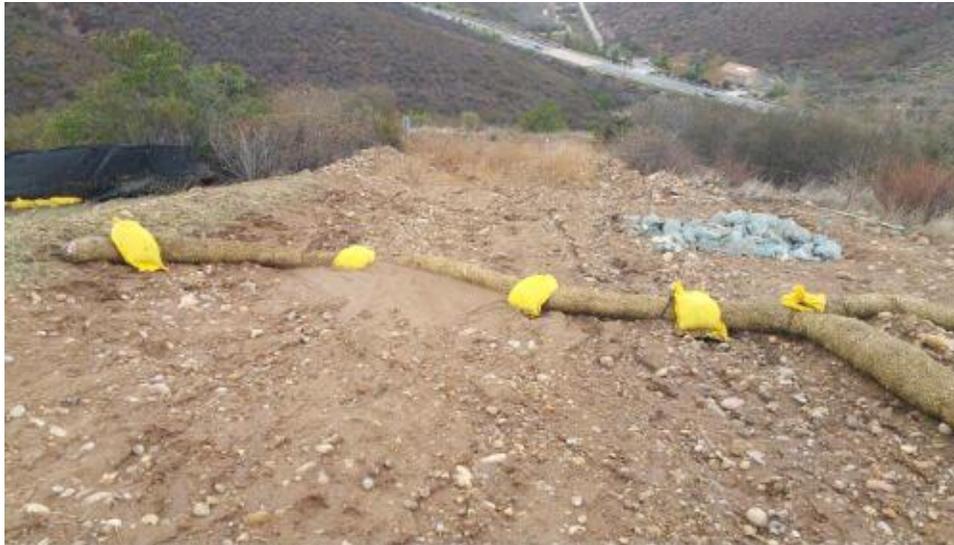
Caption Straw wattles overtopped by sediment, rills in disturbed area below BMPs at PO4.

| Q7 Notes | In general, erosion control BMPs held up well after major rain (1.7 inches at Airport) event. BMPs were braced at PO4, and sediments apparently ran into native vegetation off site, but not onto jurisdictional waters. |

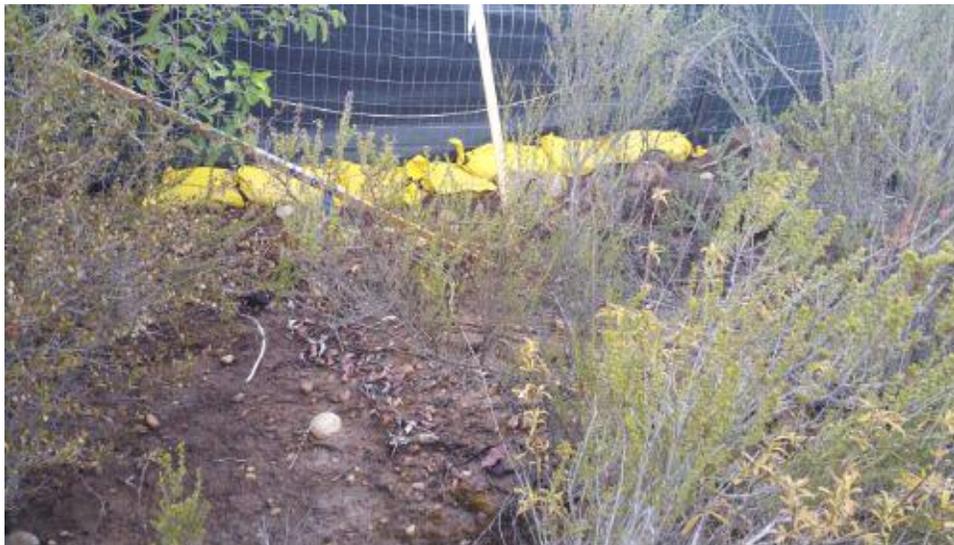
Caption Erosion control BMPs below main work area of PO4 intact, with minimal or no sedimentation below them.

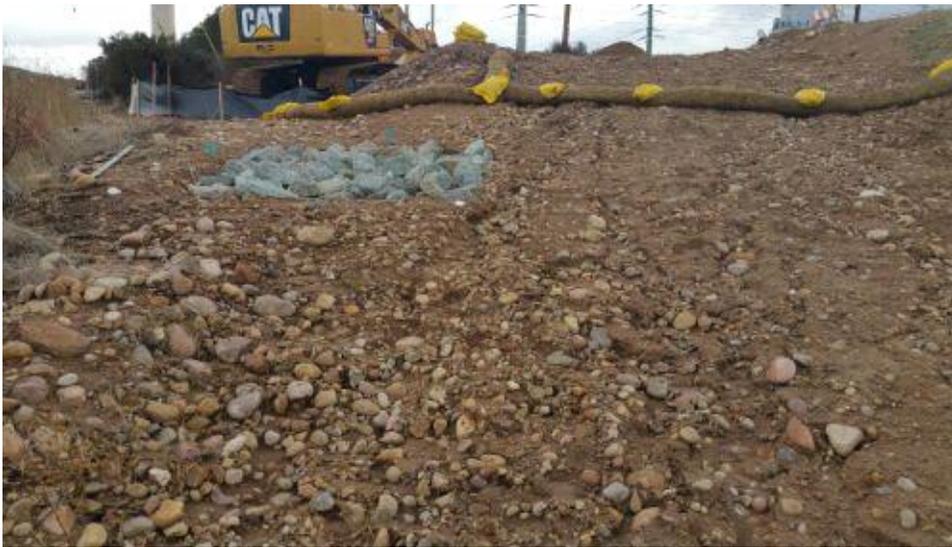
Caption Sedimentation and rills below BMPs at PO4.

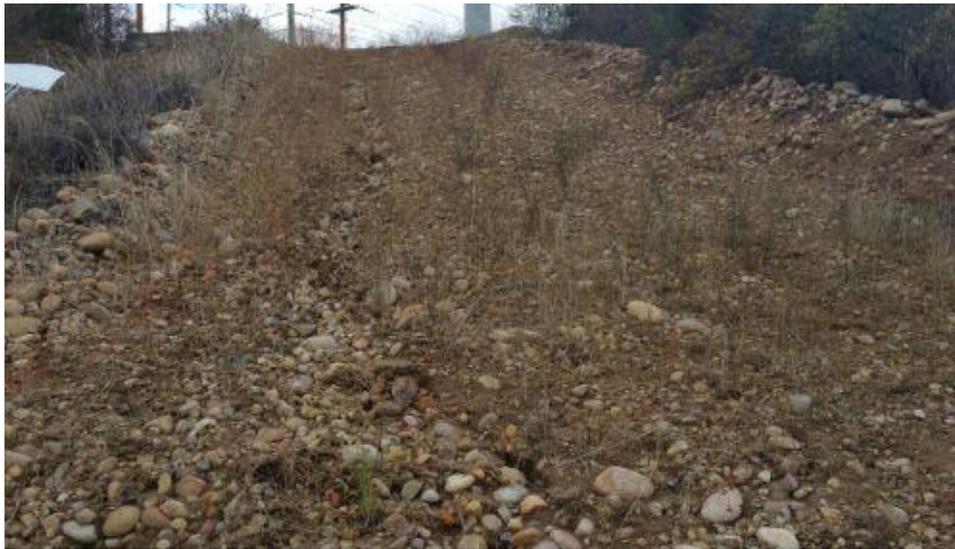
Caption Erosional rills through disturbed area off PO4 site.

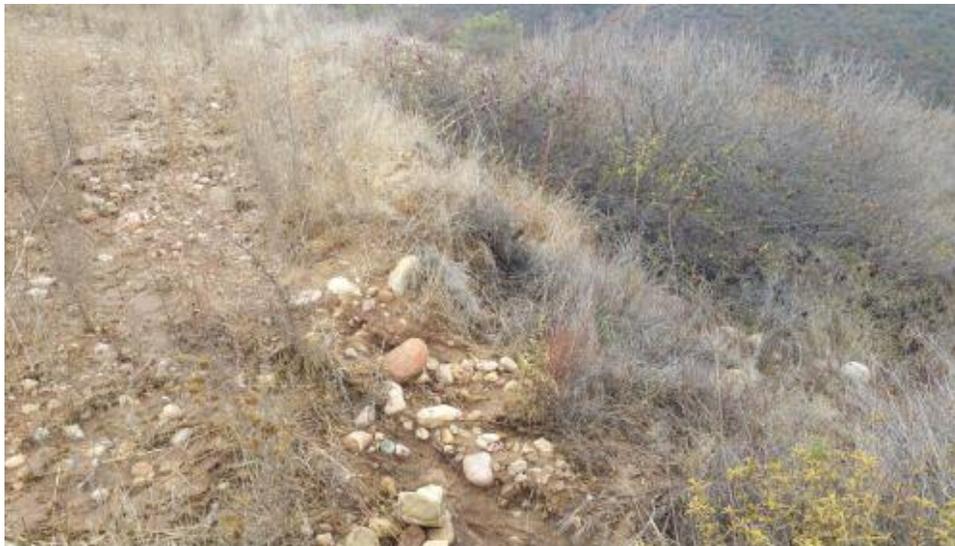
Caption Point where sediments from PO4 went from disturbed area into native vegetation.

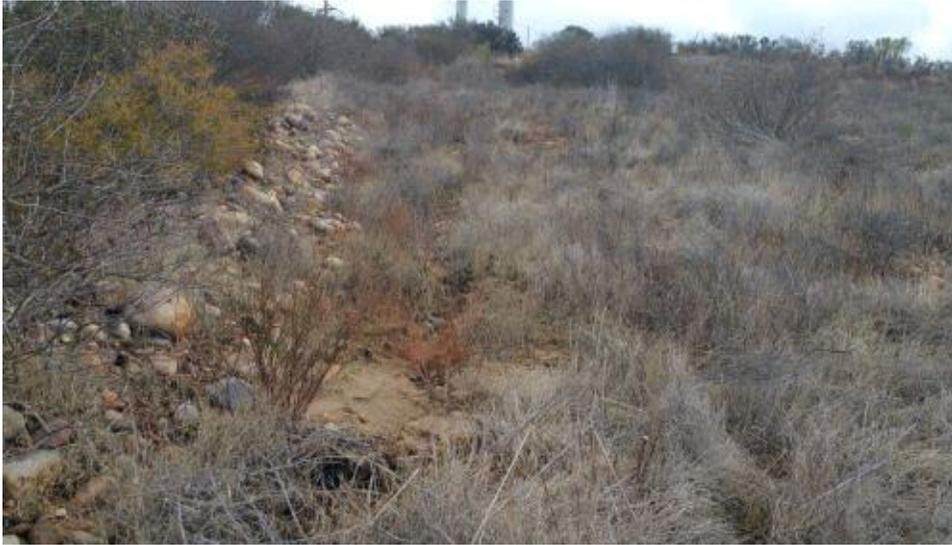
Caption Offsite. sedimentation extends approx. 150 ft beyond disturbed area at PO4.

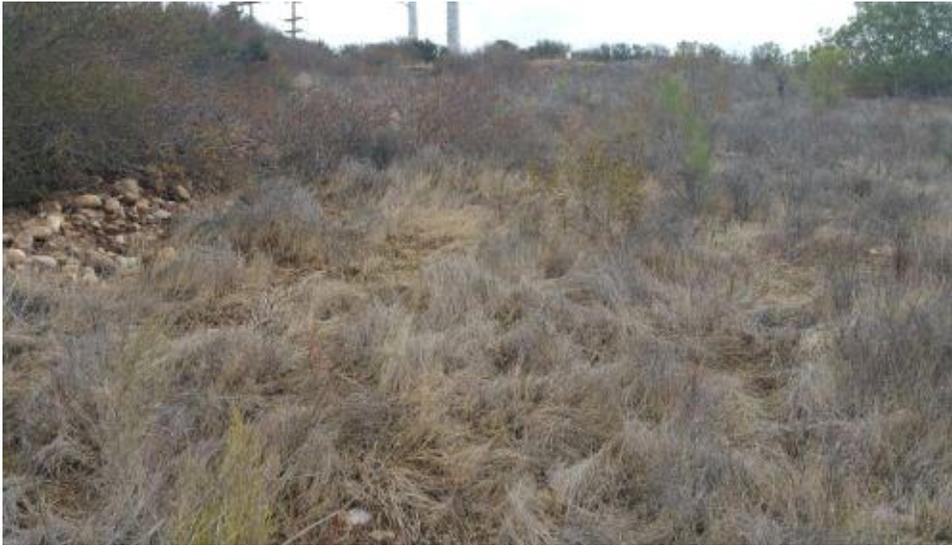
Caption Apparent limit of offsite sediment deposition from PO4 (no impact to waters).

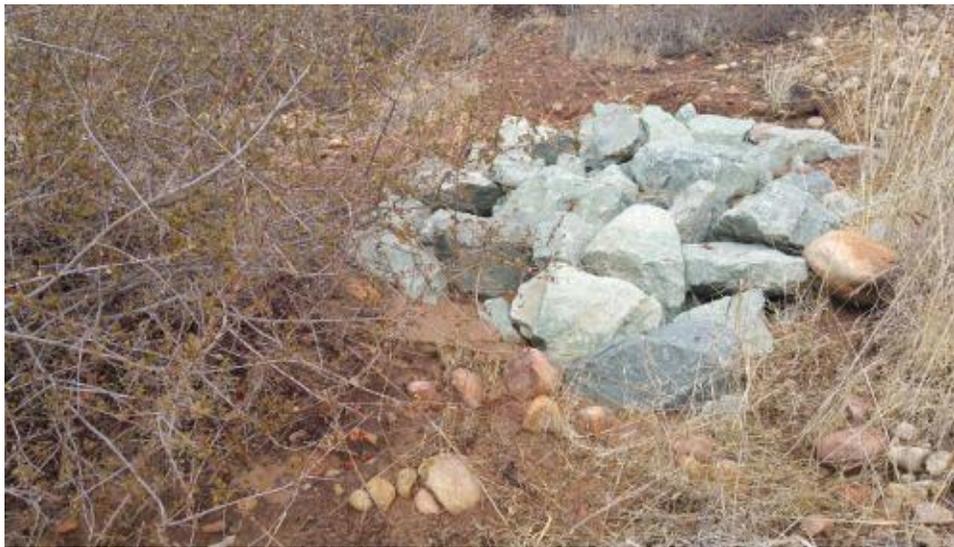
Caption Very minor sediment deposition beyond erosion control BMPs off south side of PO4.

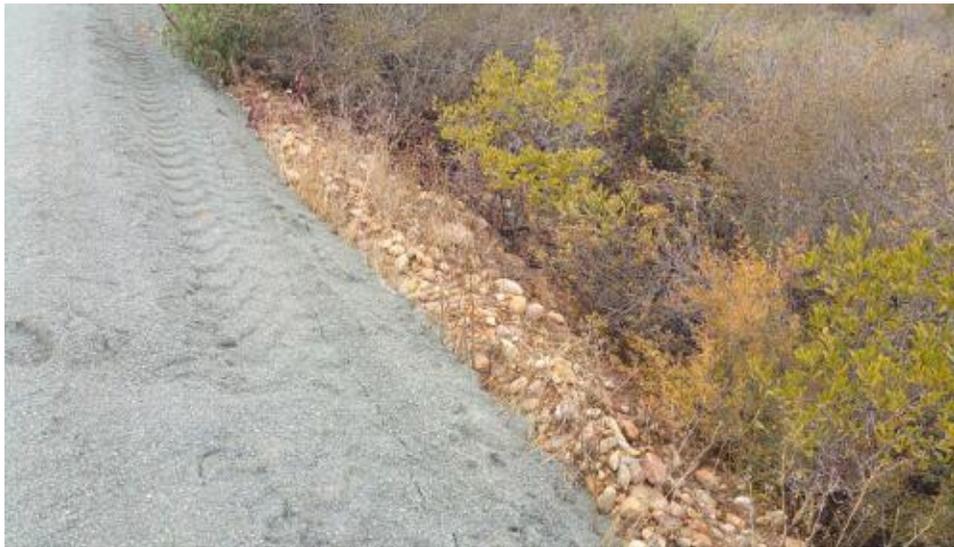
Caption No detectable sedimentation at low point in access road to PO6.

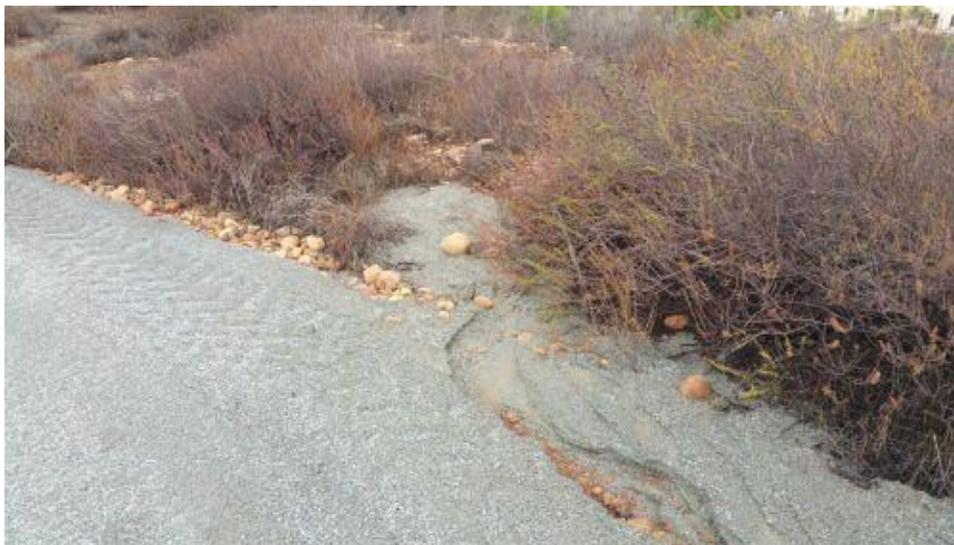
Caption Minor sediment deposition (20 sq ft) off PO6 access road.

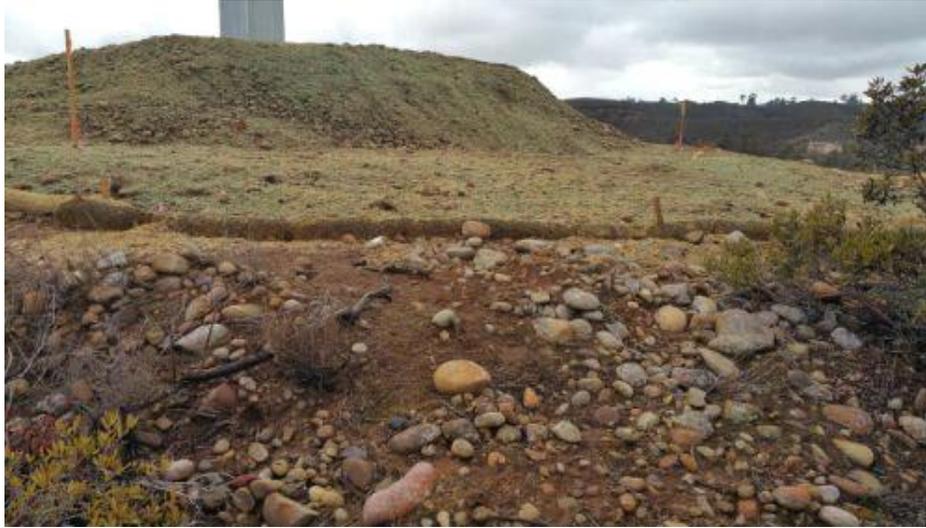
Caption Erosion control BMPs effective at PO6.

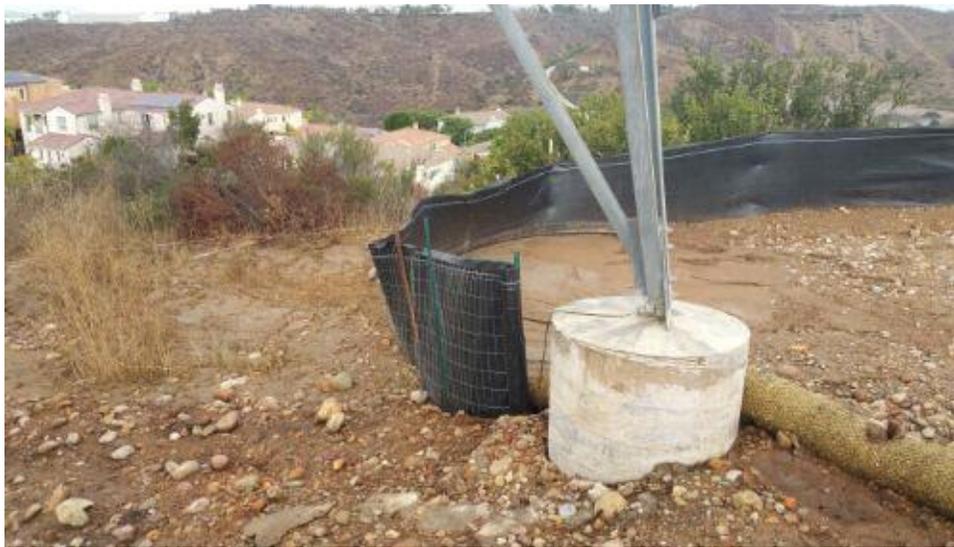
Caption Erosion control BMPs effective at PO5 (no sediment ran off site).

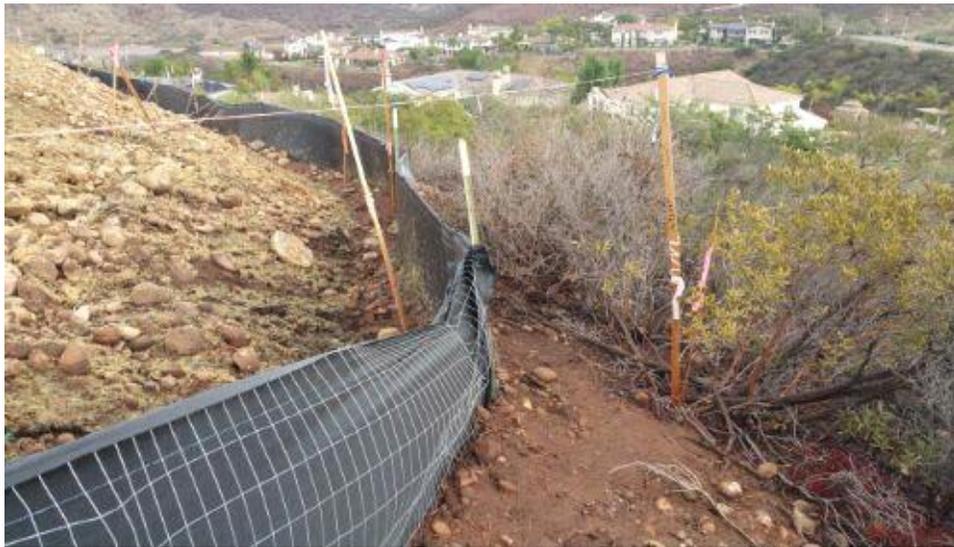
Caption Erosion control BMPs effective at PO4.

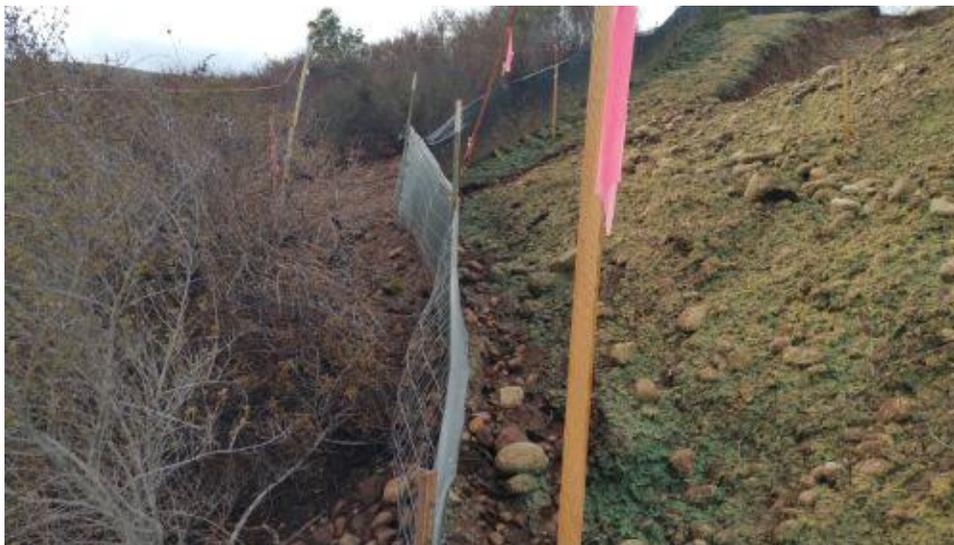
Caption Erosion control BMPs at bottom of PO5 site were effective.

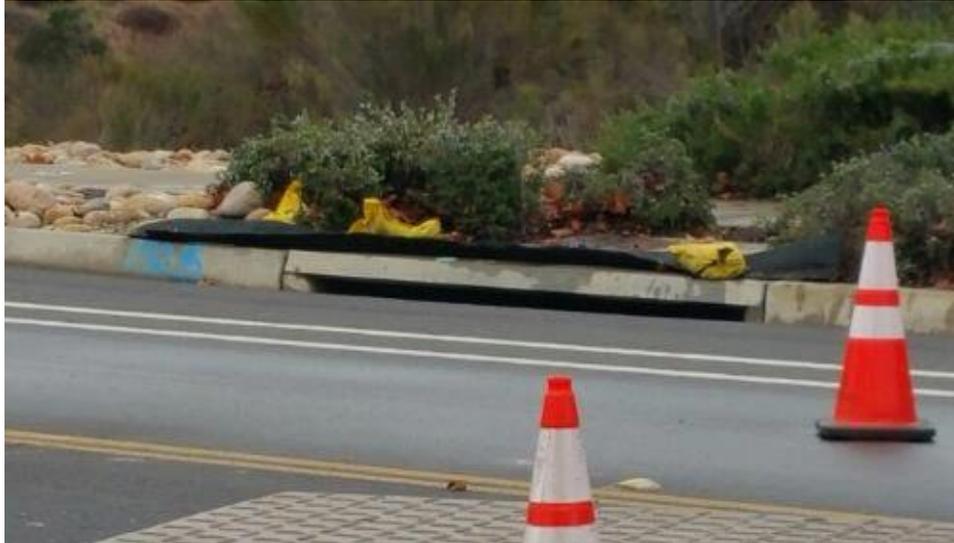
Caption Storm drain at bottom of hill on Stonebridge uncovered during rain event to prevent water back-ups.

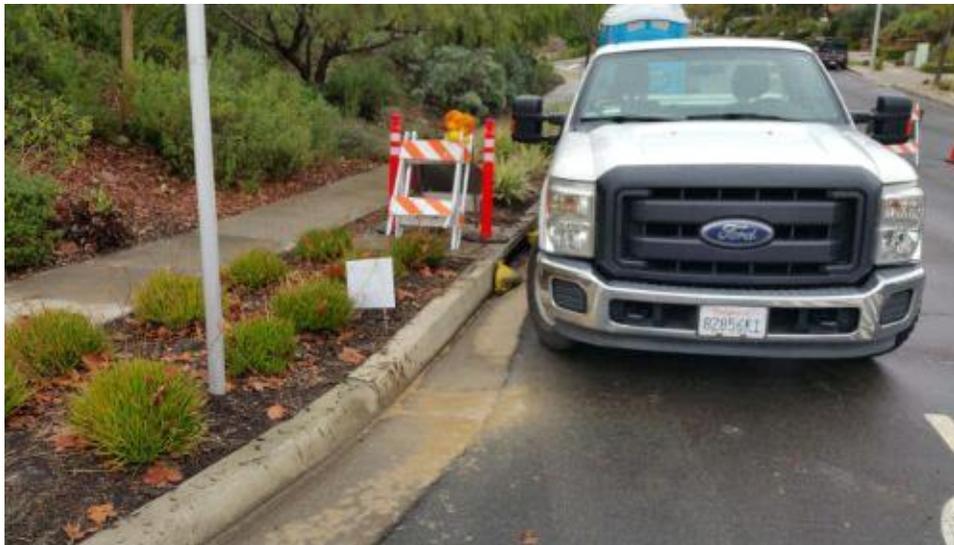
Caption Storm drain cover in place and intercepting sediments on Downing Lane at Stonebridge Parkway.

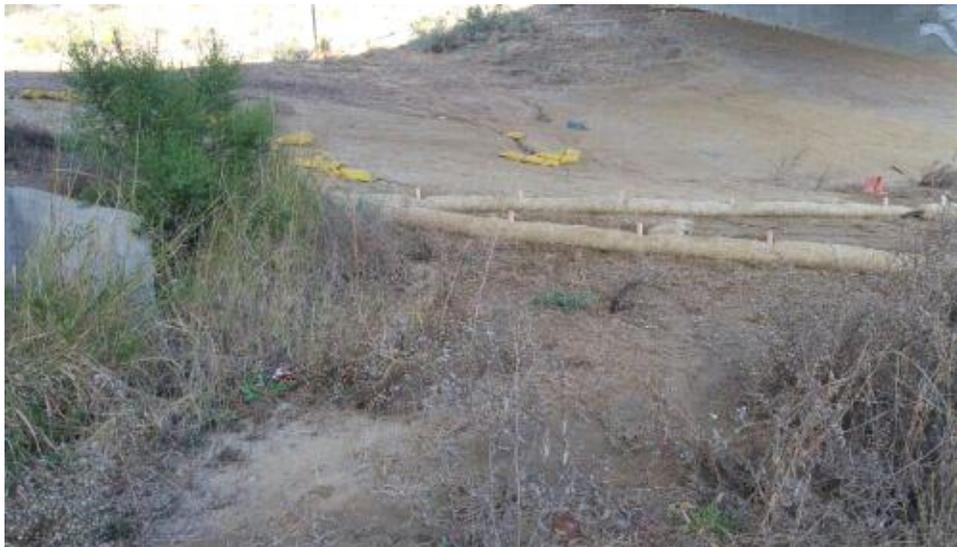
Caption Sediment flow past last project BMPS at bottom of roadway below CC MM CP site. Appears to be minor portion of total sediment deposition.

| Q6 Notes | I observed sediment deposition from the CC MM CP site to the edge of a riparian area (poison oak precluded further investigation). It appears that massive inflows from a culvert overran the riprap, straw wattles, and plastic lining that were in place. |

| Q7 Notes | Damaged/ destroyed erosion control BMPs at CC MM CP need replacement (I understand this will happen next week; no rain is imminent). |

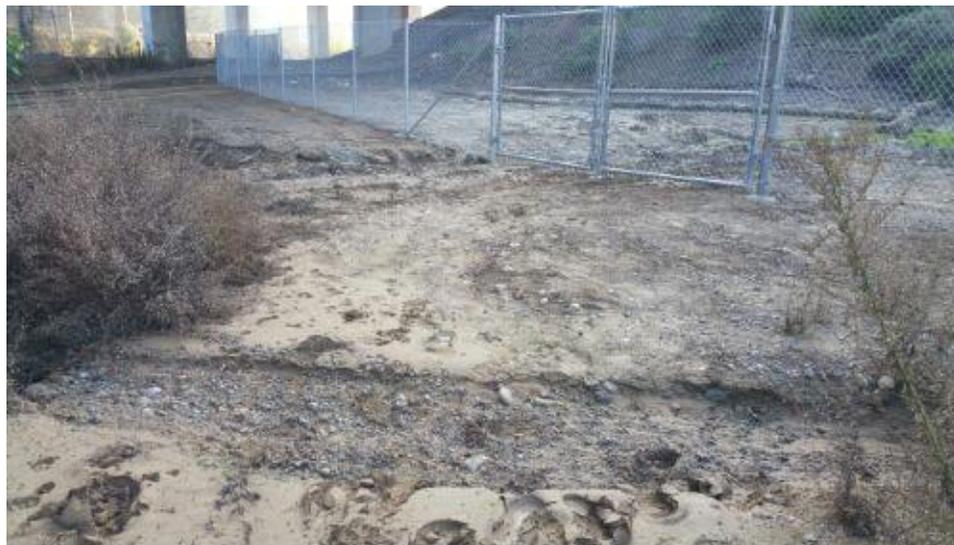
Caption Two sediment sources above jw: from project (foreground, 2 ft x 3 in.) and (fenced) I-805 off-ramp ROW (background, 2 ft x 6 in).

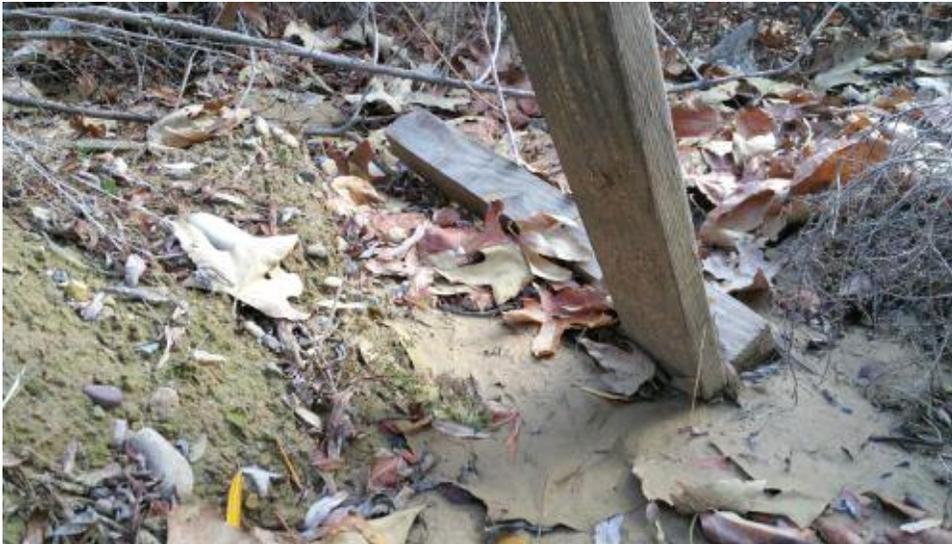
Caption Sediment flow into riparian area adjacent to jurisdictional water.

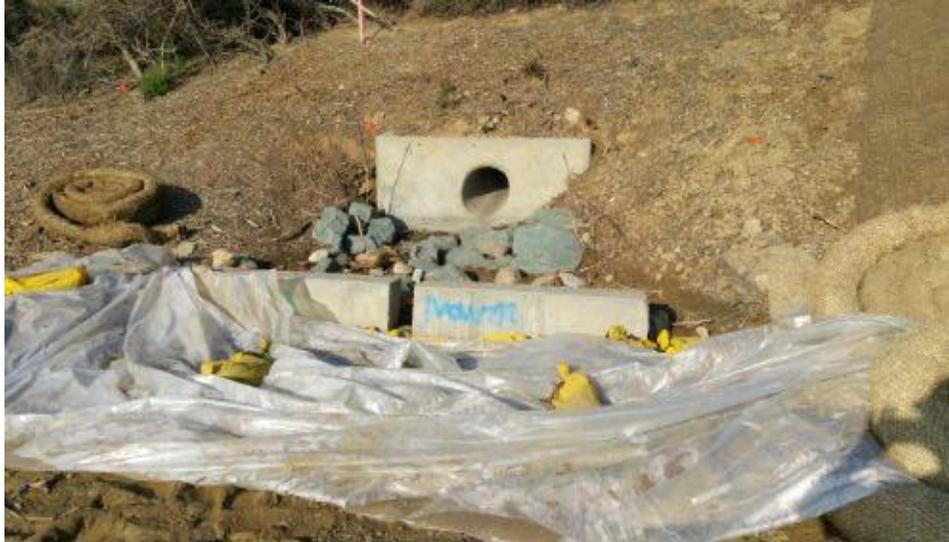
Caption Point of discharge into CC MM CP site. Wattles that had been in place were removed after being overran, per foreman.

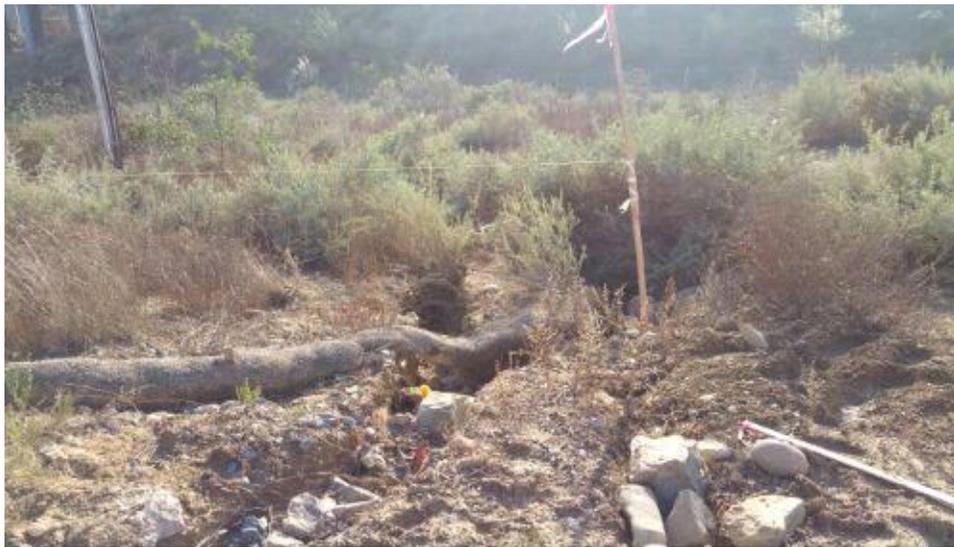
Caption Erosion gully breached BMPs at CC MM CP. Series of wattles and plastic had been in place per foreman,

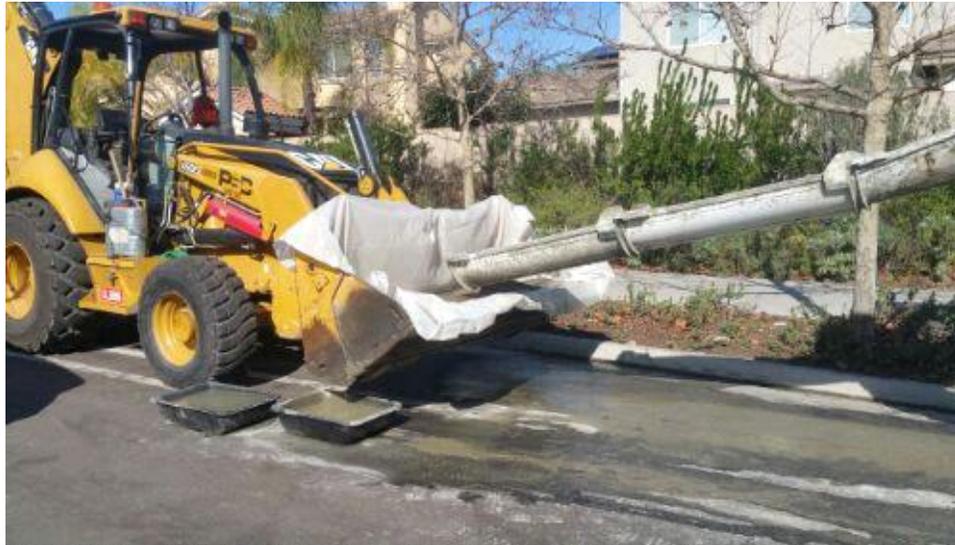
Caption Rinse water from concrete mixer captured on site.
