PROJECT MEMORANDUM SYCAMORE-PEÑASQUITOS 230-KV TRANSMISSION LINE PROJECT

Date: February 15, 2018
To: Billie Blanchard, CPUC Project Manager
From: Sheila Hoyer, CPUC Monitoring Supervisor
Subject: Weekly Report #58 – February 5 to February 10, 2018

SDG&E Sycamore-Peñasquitos 230-kV Transmission Line Project: Daily Inspection Report

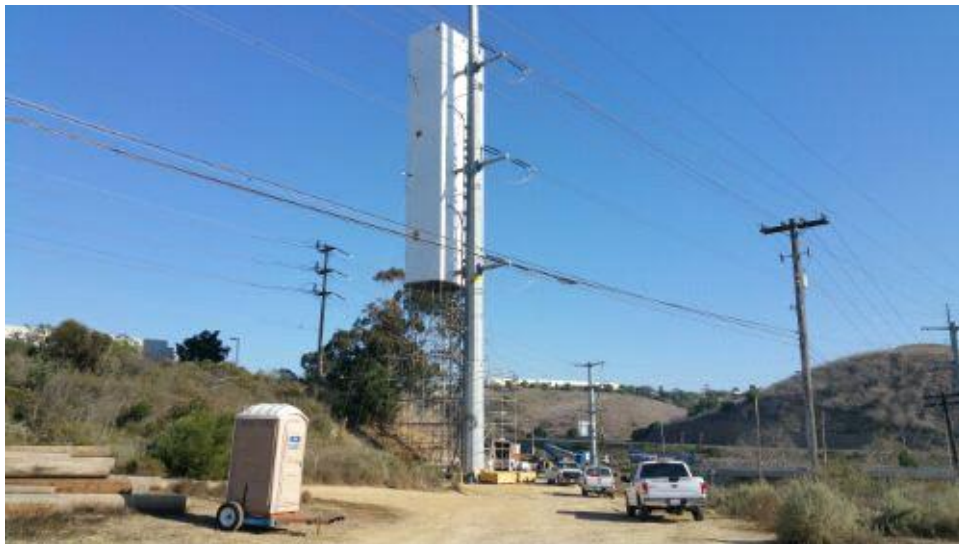
Caption Scaffolding around tower at CC MM CP site.

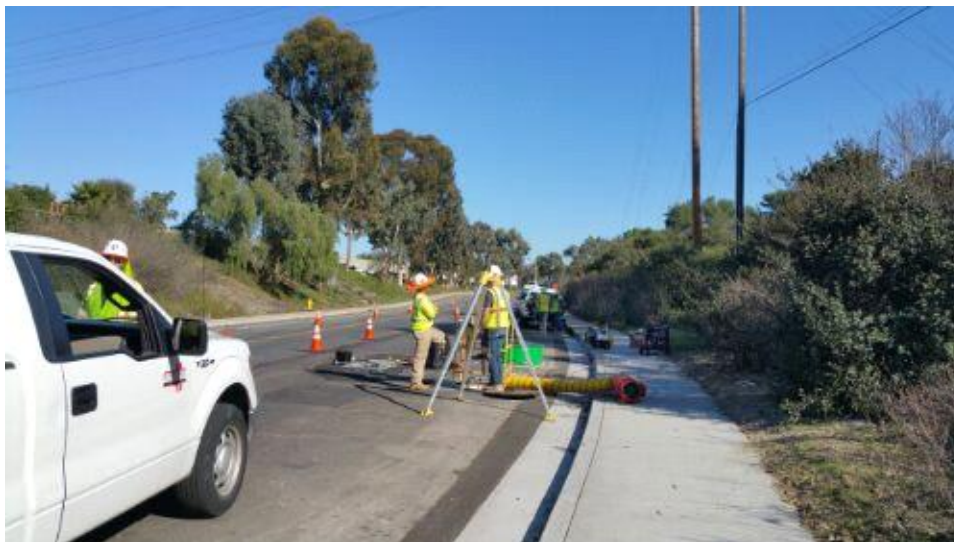
Caption Vault work, Carroll Canyon Road.

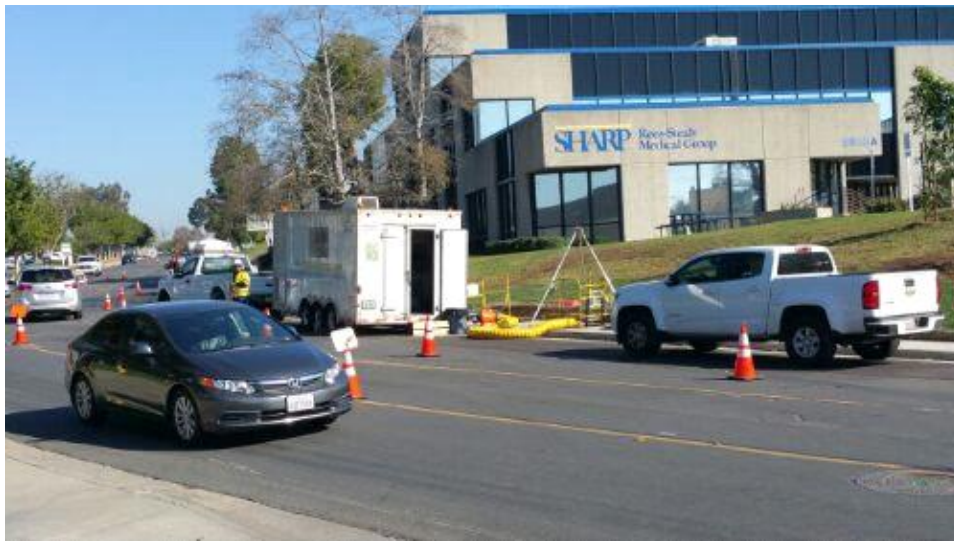
Caption Vault work, Activity Road.

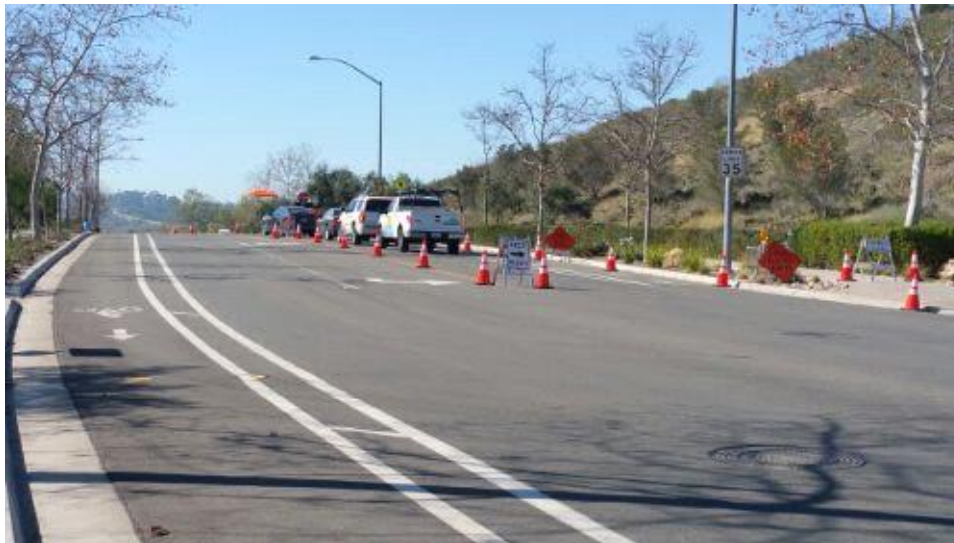
Caption Approach to Stonebridge Parkway work area from east.

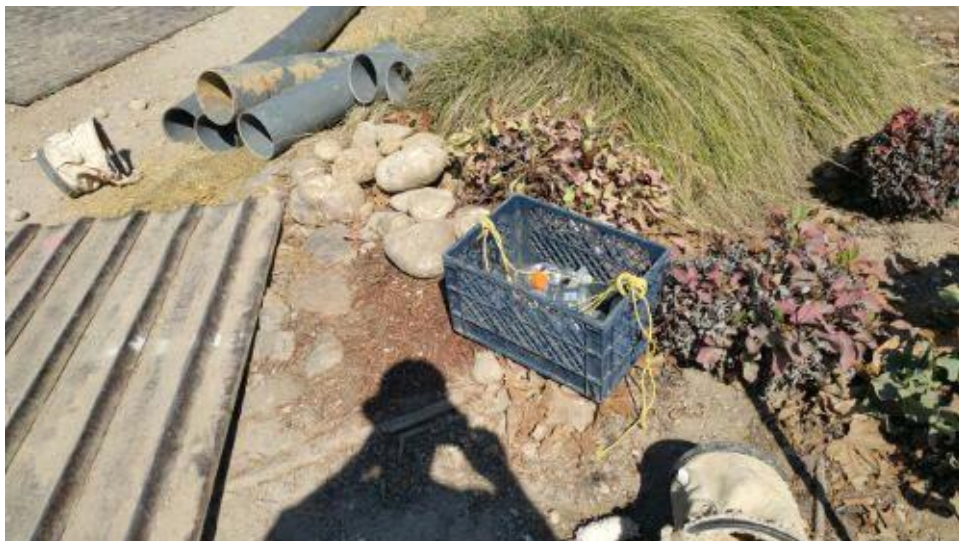
Caption Temporary waste receptacle.

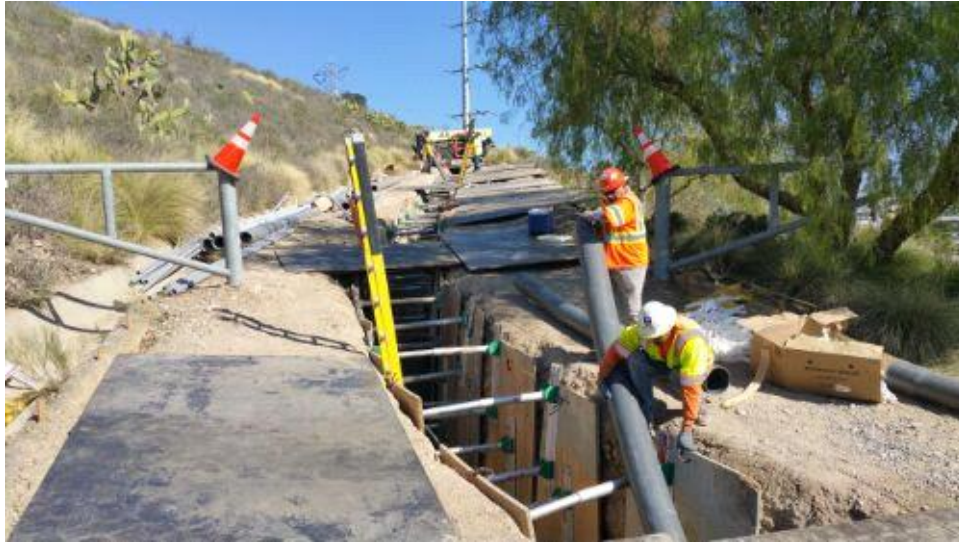
Caption Placing conduit in trench, P05 access road.

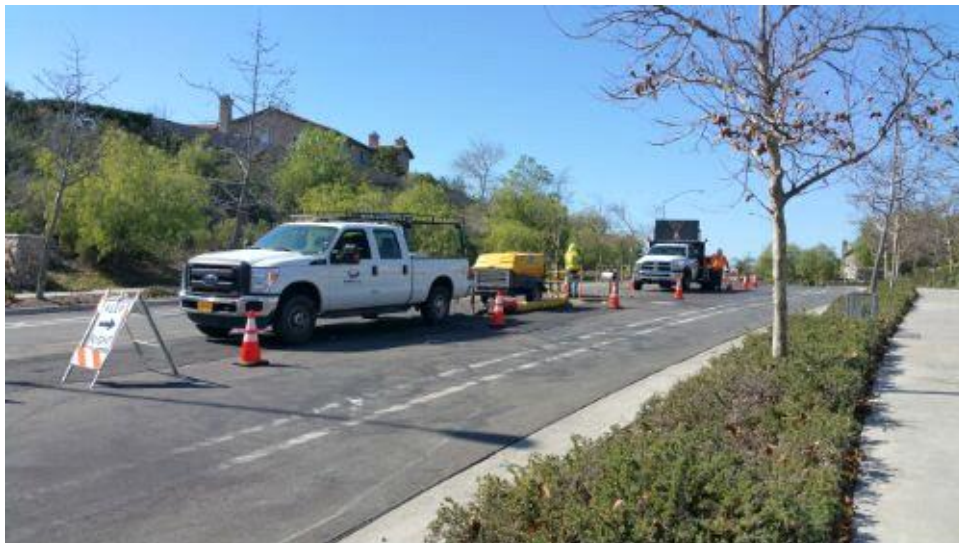
Caption Mandreling site, Stonebridge Parkway.

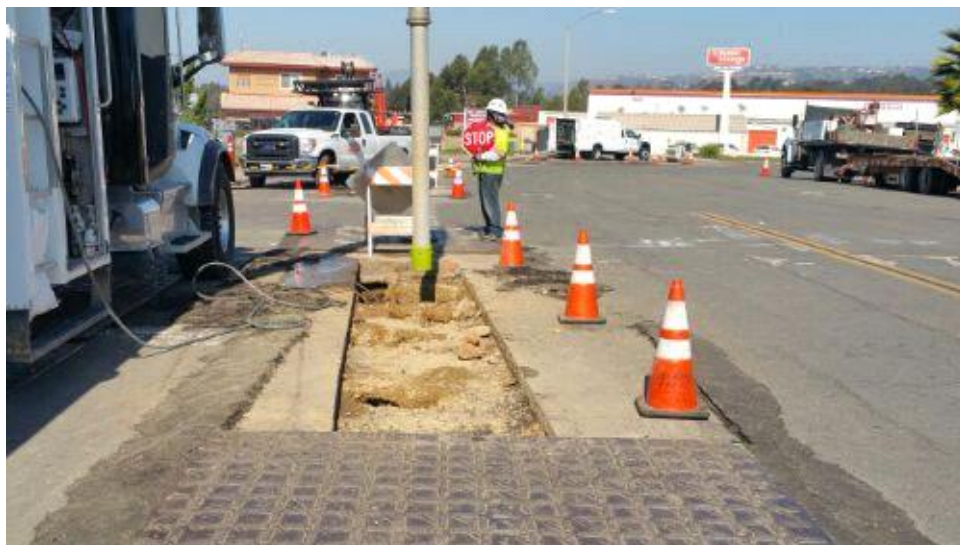
Caption Potholing site, Kearney Mesa Road.

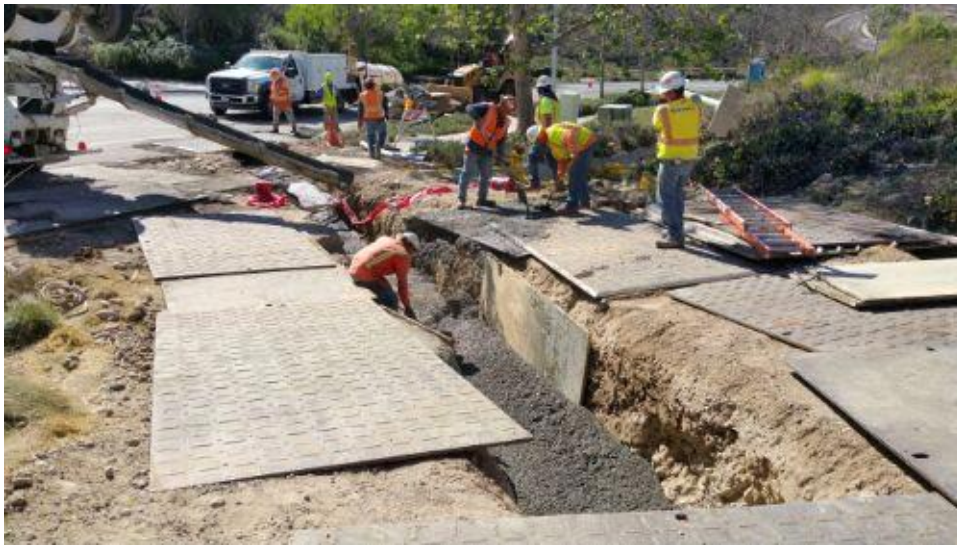
Caption Filling trench at base of P05 access road.

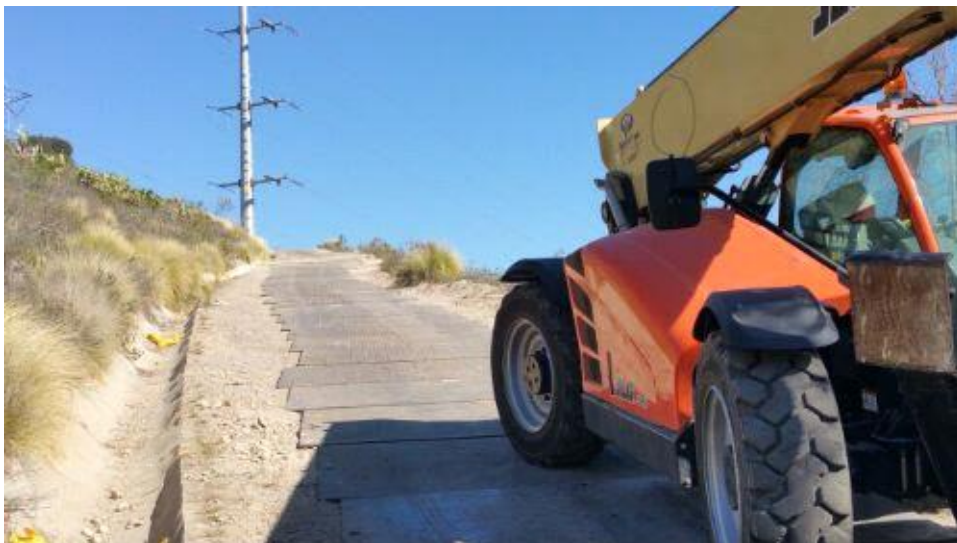
Caption Trench plates on P05 access road.

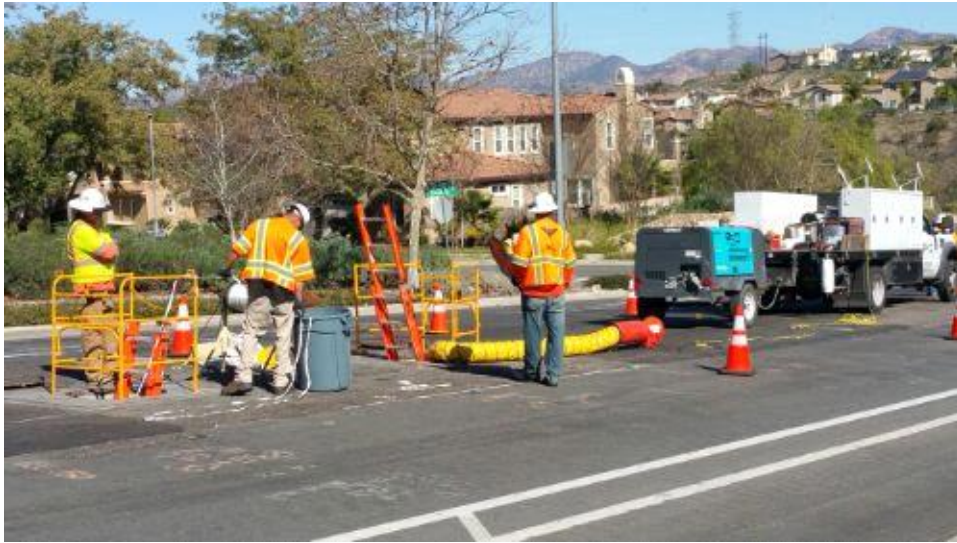
Caption Mandreling work area, Stonebridge Parkway.

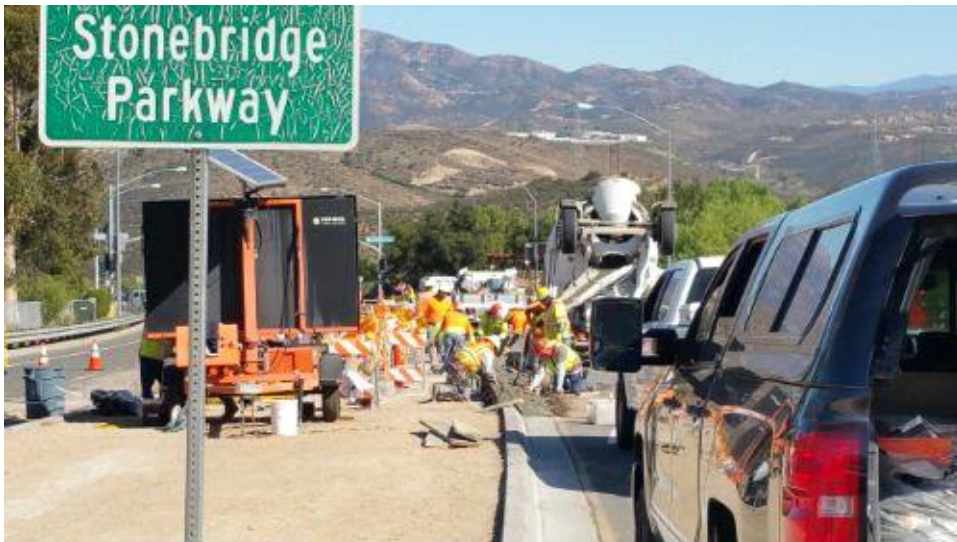
Caption Curb replacement, upper Pomerado Road.

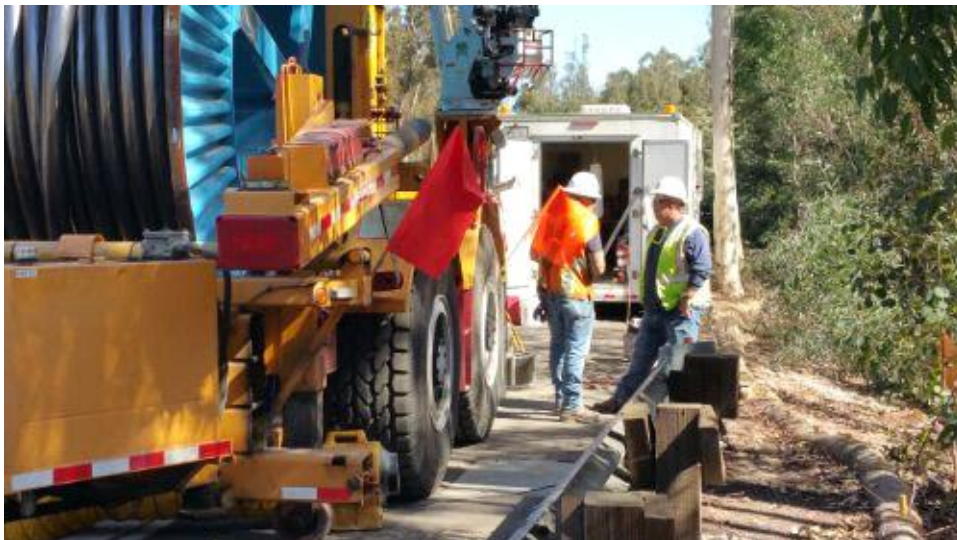
Caption Cable stringing work area, Pomerado Road.
Photo Attributes Capture Date/Time: Thu Feb 08 2018 12:16:38 GMT-0800 (PST)
Coordinates: 32.90597, -117.080612
View Direction: East

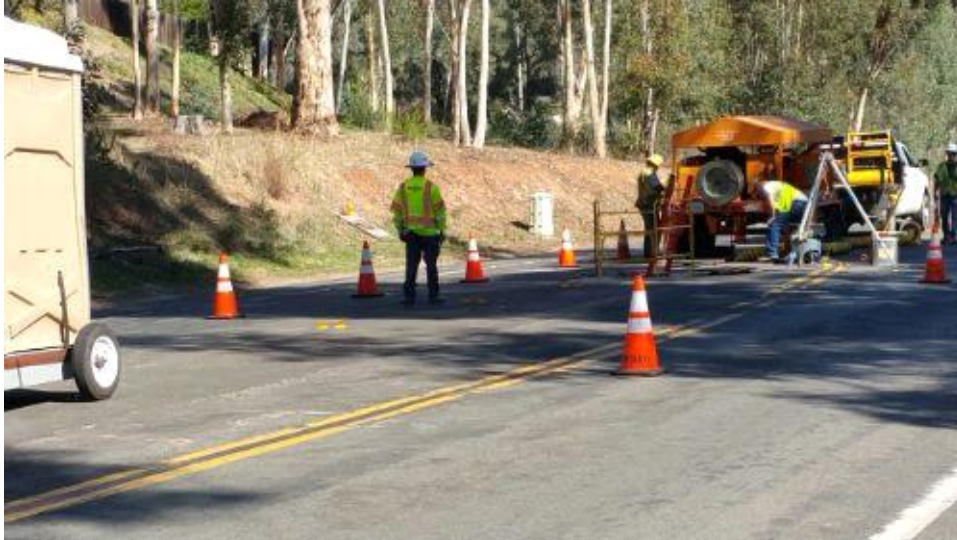
Caption Vault work area, Pomerado Road.
Photo Attributes Capture Date/Time: Thu Feb 08 2018 12:03:18 GMT-0800 (PST)
Coordinates: 32.904425, -117.0865
View Direction: Northeast

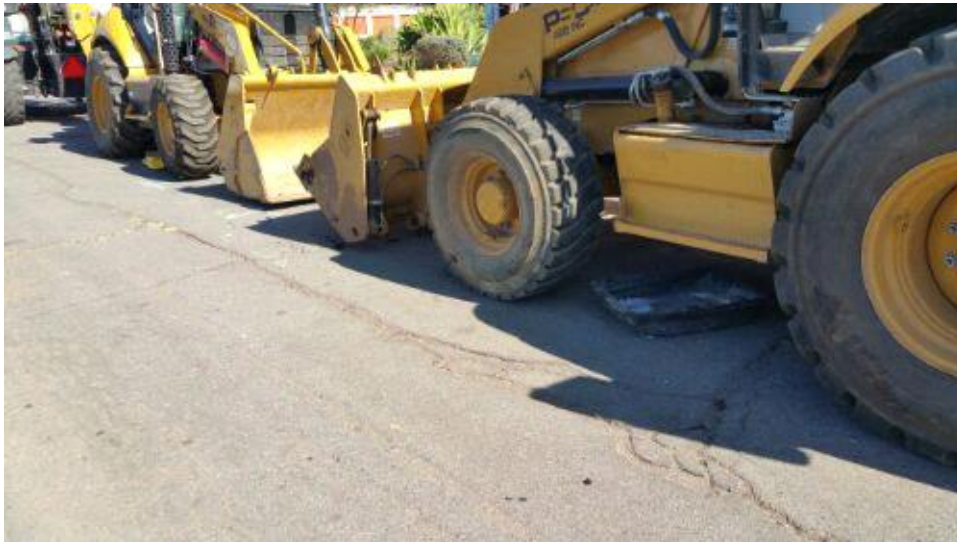
Caption Drip pans in place, Kearney Mesa Road staging area.
Photo Attributes Capture Date/Time: Thu Feb 08 2018 11:41:27 GMT-0800 (PST)
Coordinates: 32.894275, -117.118273
View Direction: Northeast

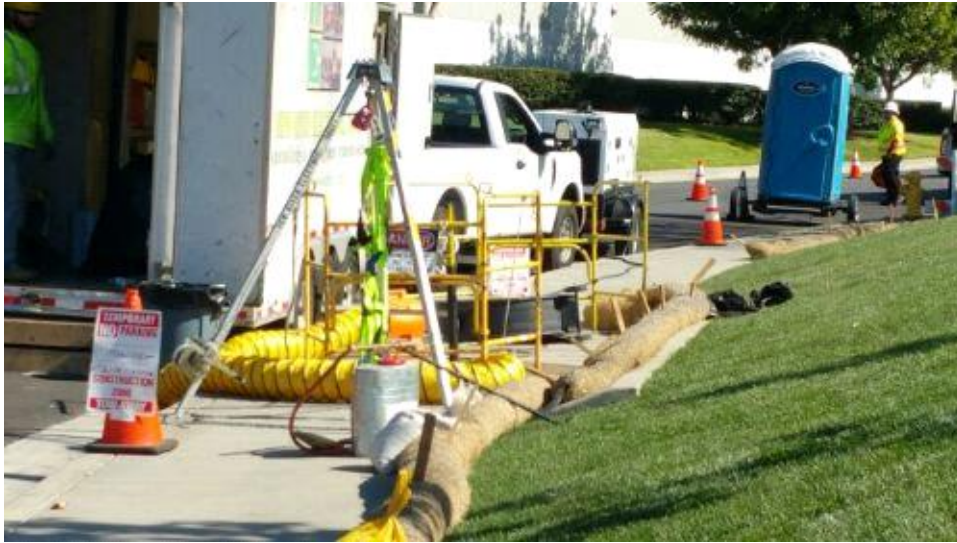
Caption Vault work area, Activity Road.

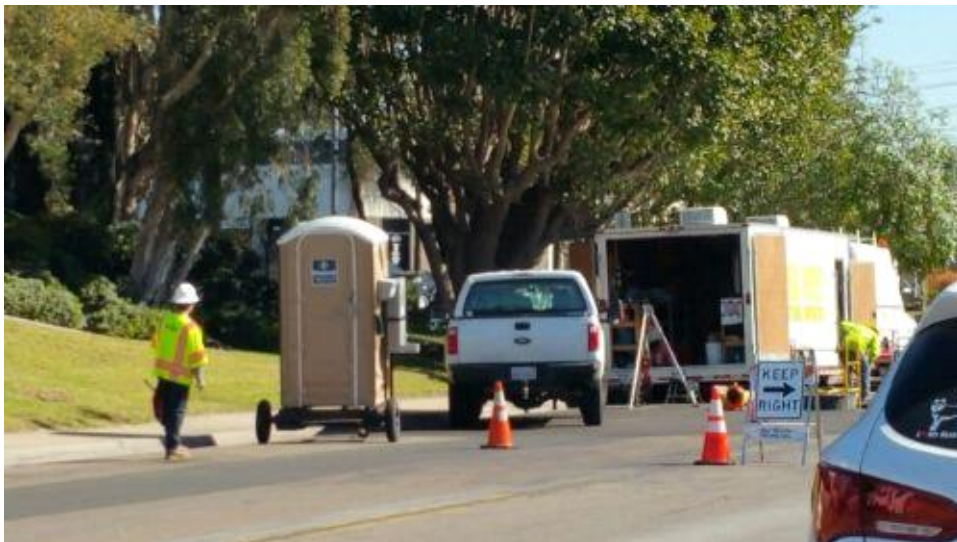
Caption Vault work area, Marilani Road.

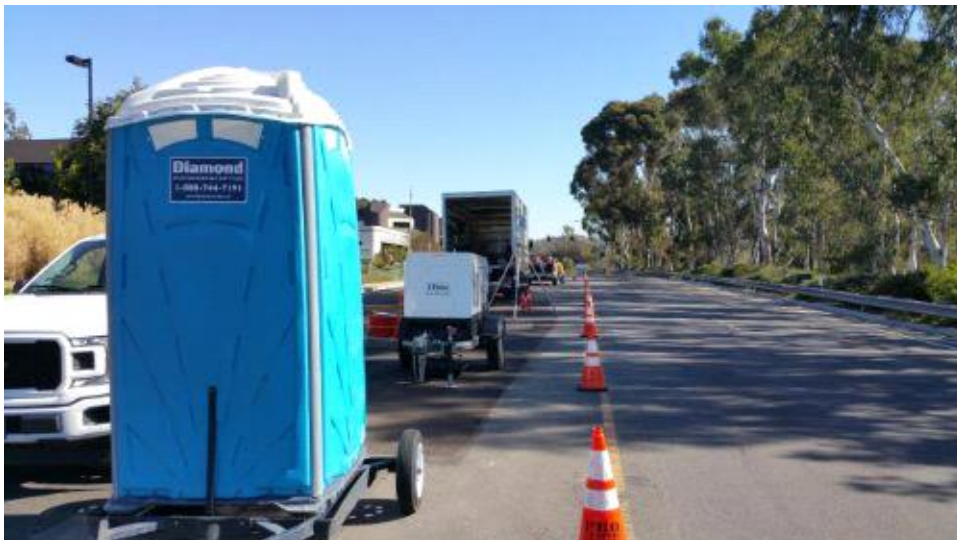
Caption Vault work area, Carroll Canyon Road.
 Photo Attributes Capture Date/Time: Thu Feb 08 2018 10:37:57 GMT-0800 (PST)
 Coordinates: 32.890639, -117.196351
 View Direction: East

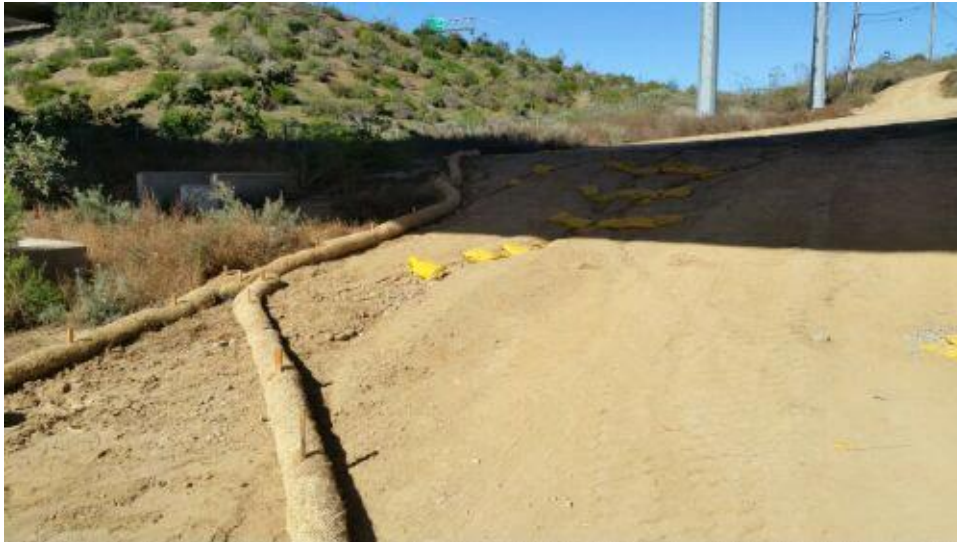
Caption Erosion control BMPs below CC MM CP site.

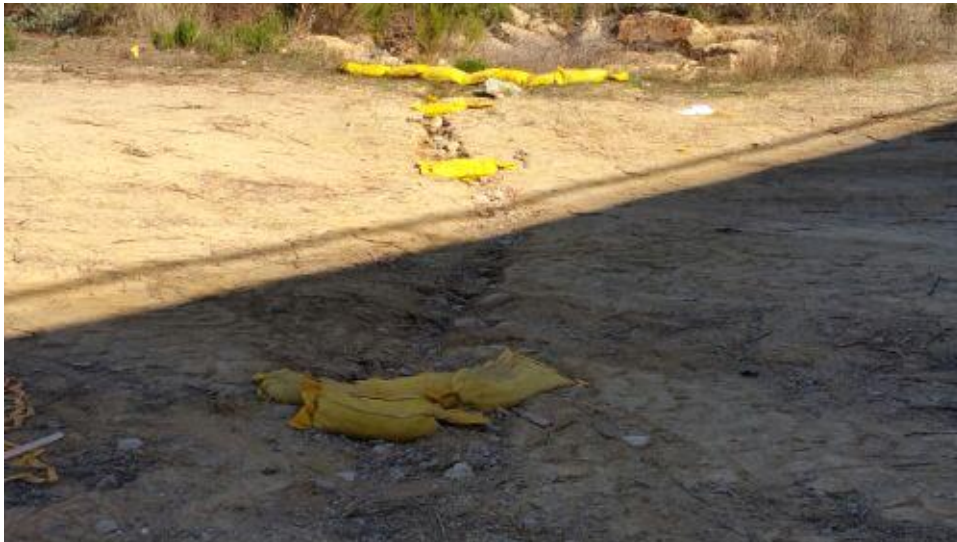
Caption Erosion control BMPs below CC MM CP site.
